Inspection Photos

API: 055-06316

Operator: OXY USA INC

Inspection Date: 10/6/2022

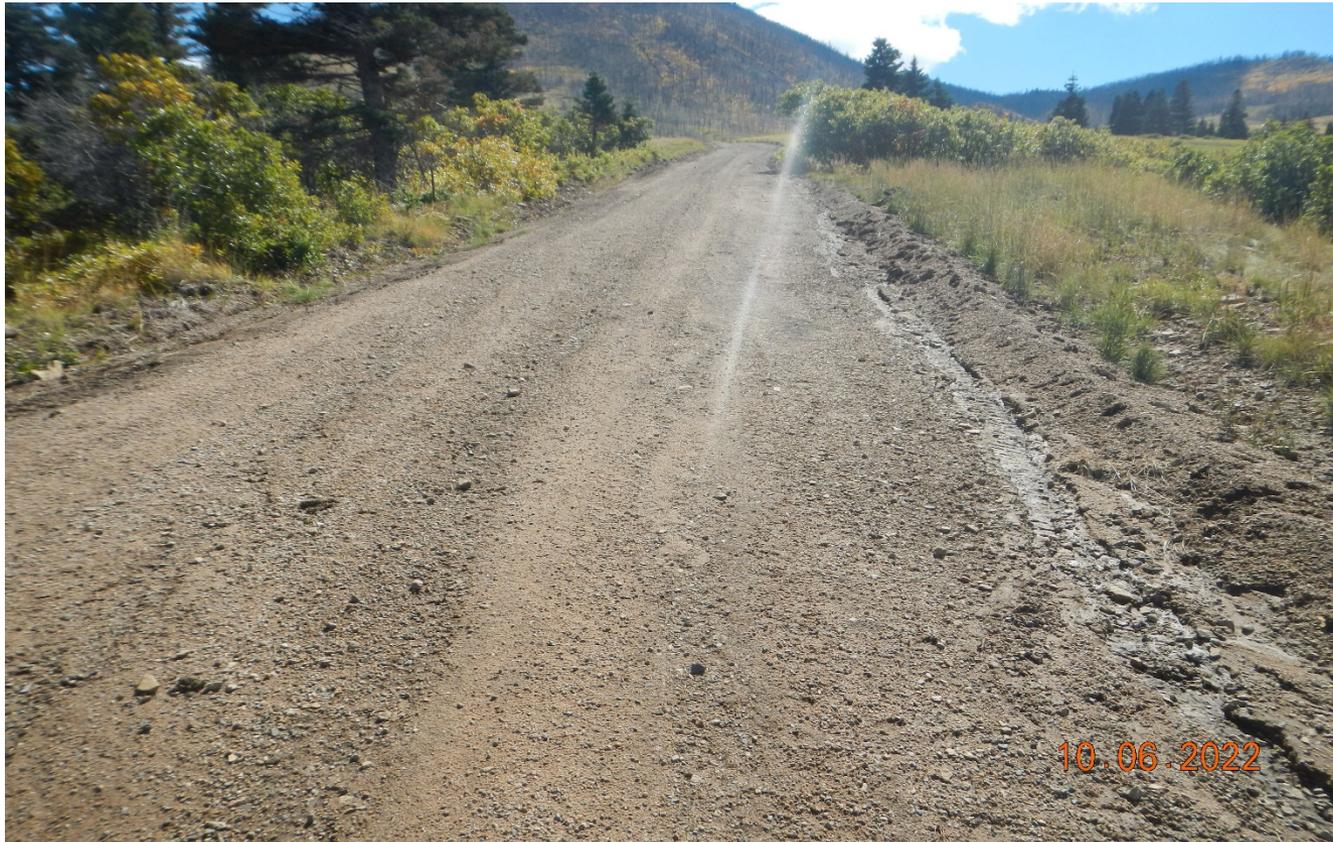
Photo 1. Facing south along the access road. There are signs of erosion along the steep grade of the road. Stormwater should be diverted off the road to reduce erosion.

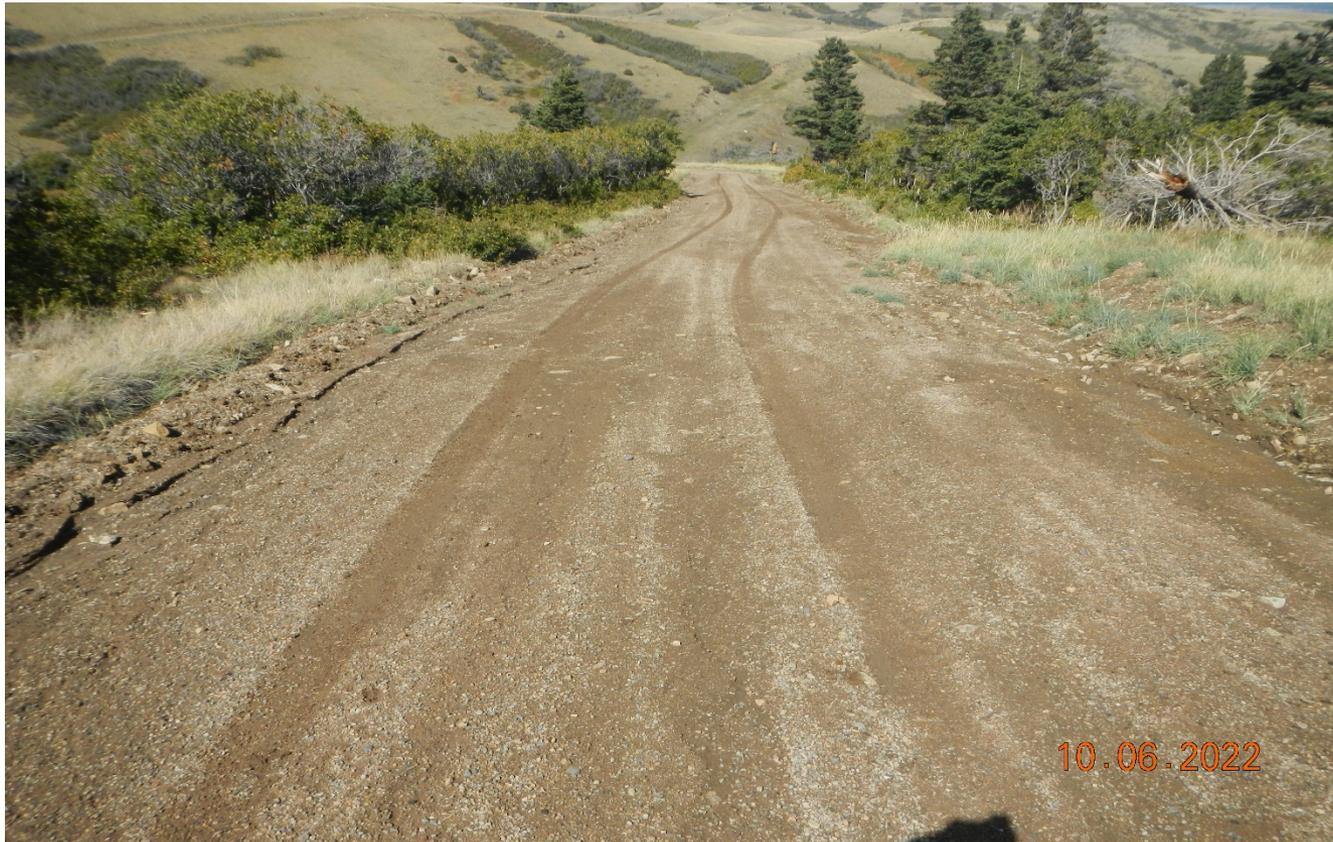
Photo 1. Facing back north the steep grade of access road. This road has eroded in the past and is susceptible to erosion. BMP's need to be installed along the road to prevent erosion e.g. water bars, diversion ditch, checkdams.

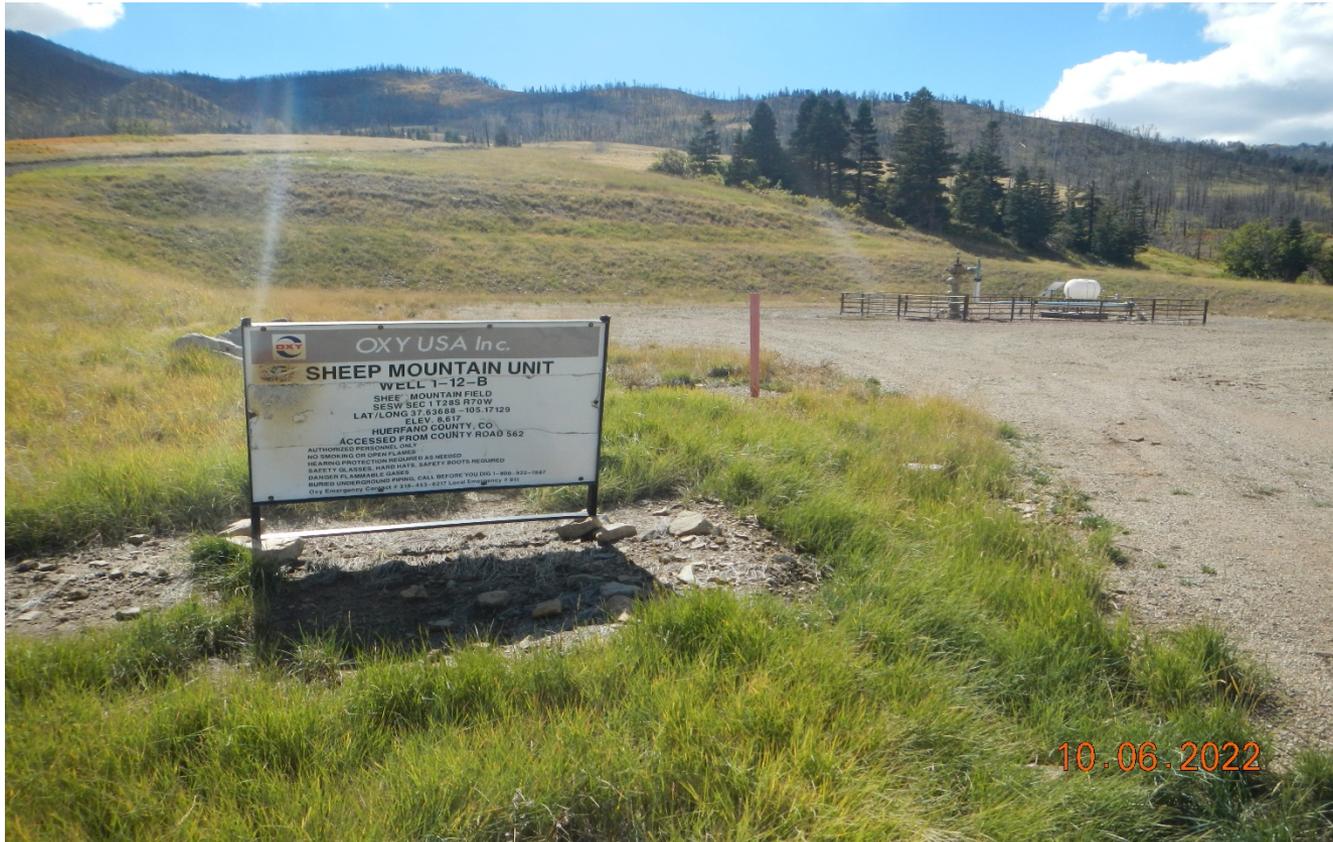
Photo 2. Sign is posted at the location.

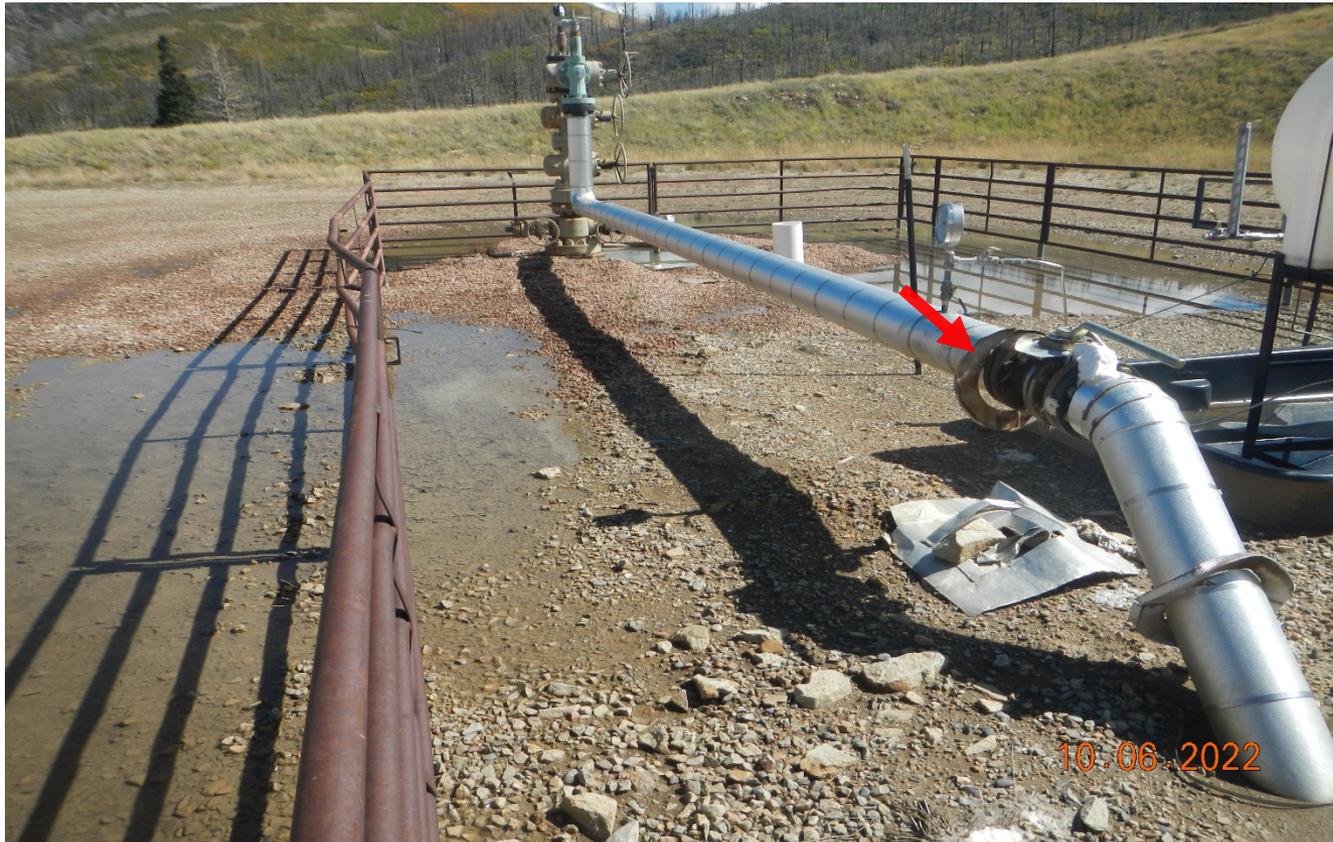
Photo 4. There was an audible noise coming from this area. Does not appear to have been fixed.

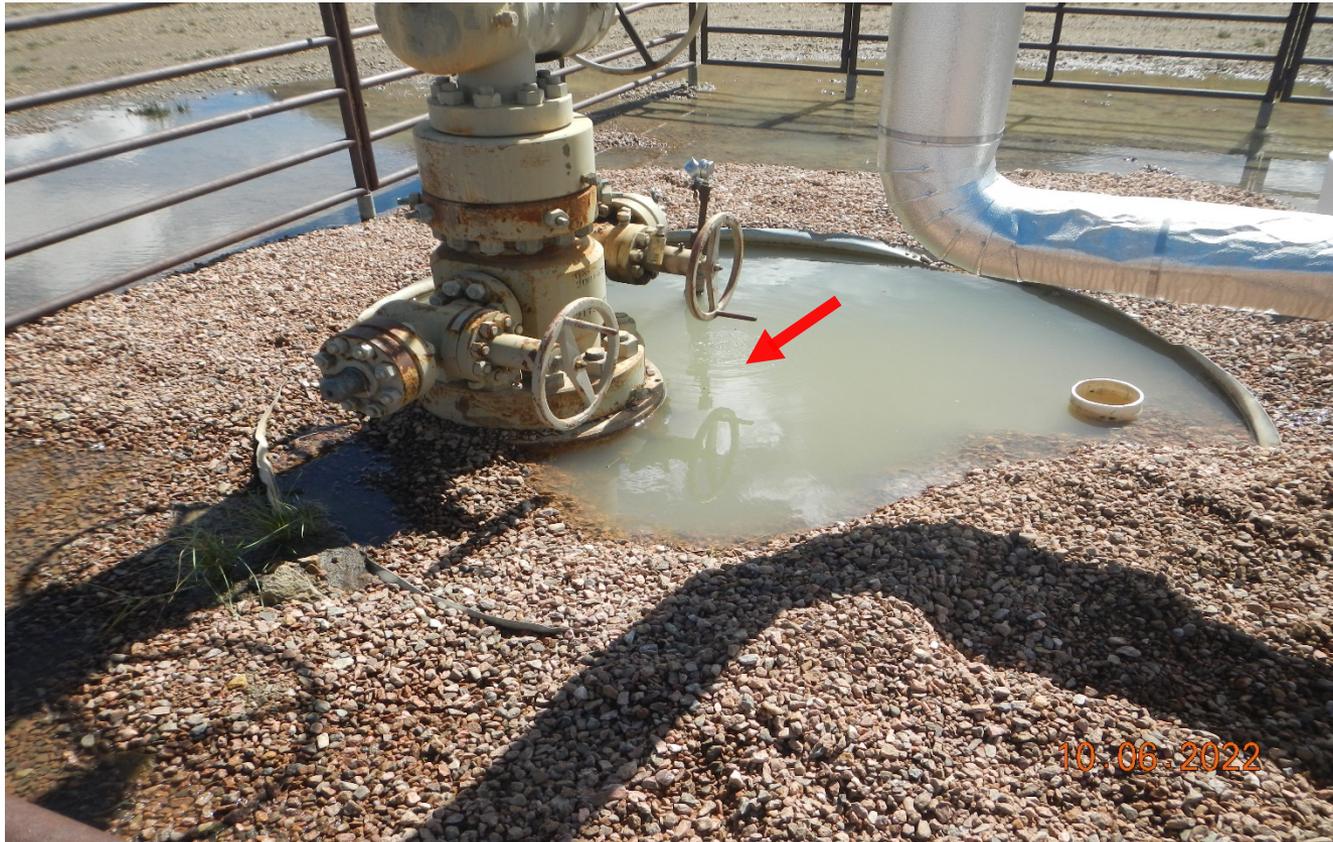
Photo 5. There were bubbles coming out of the water which indicates a leak at the wellhead.

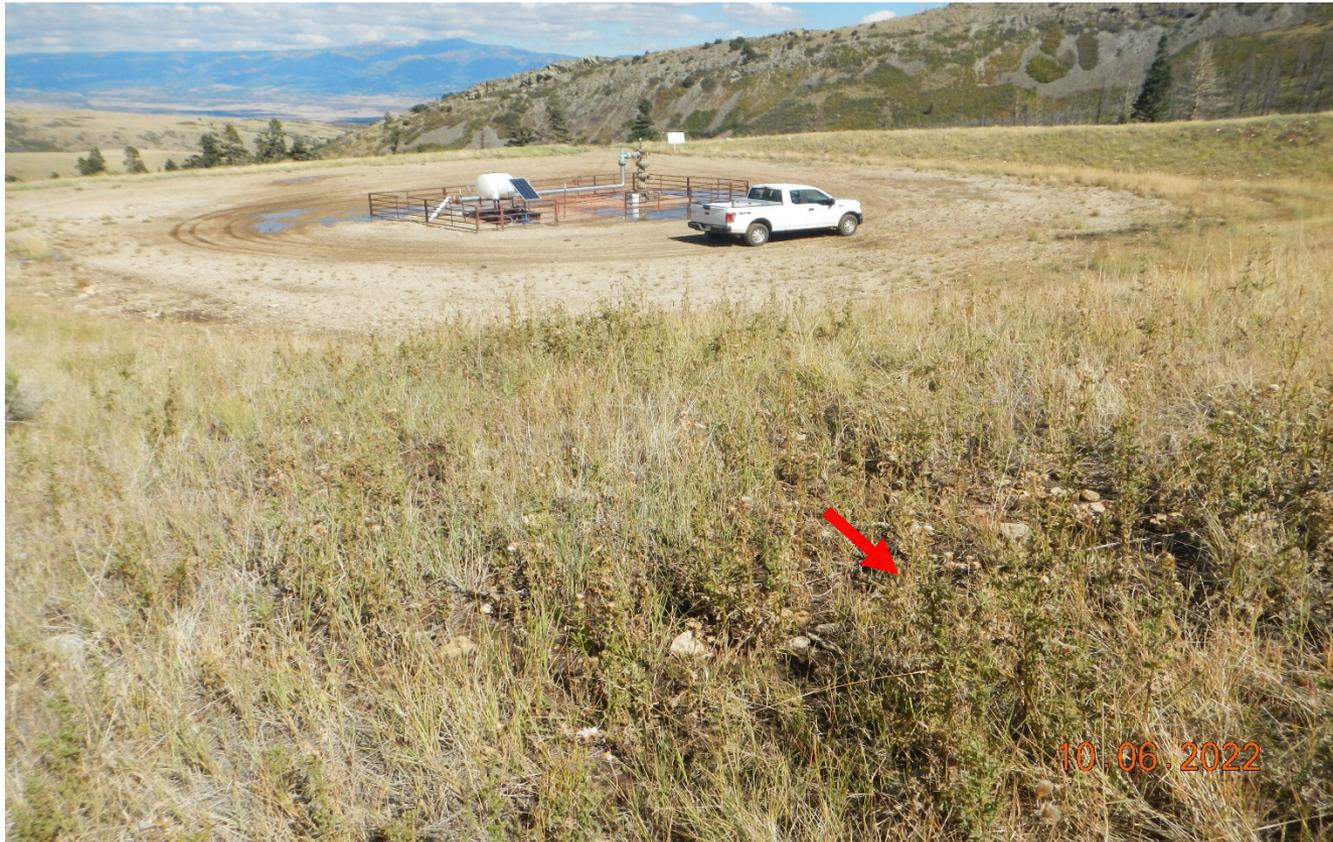
Photo 6. There are noxious weeds at the southwest corner of the location.
Red arrow → Canada thistle
