## Inspection Photos

Location Name: CAERUS PICEANCE LLC LAST DANCE-66S92W /34SESE

Location ID: 334620

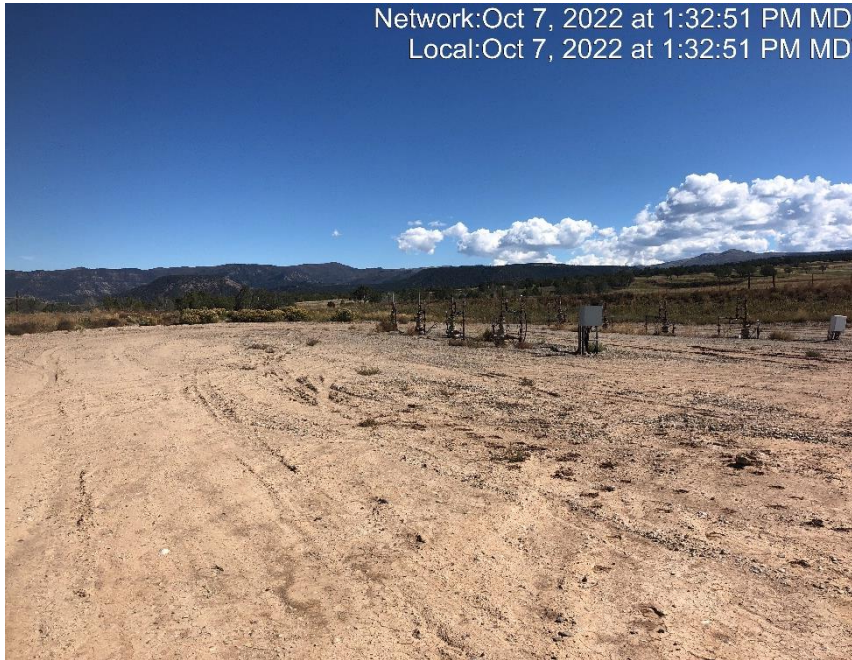
**Photo #7964 From entrance to location.**

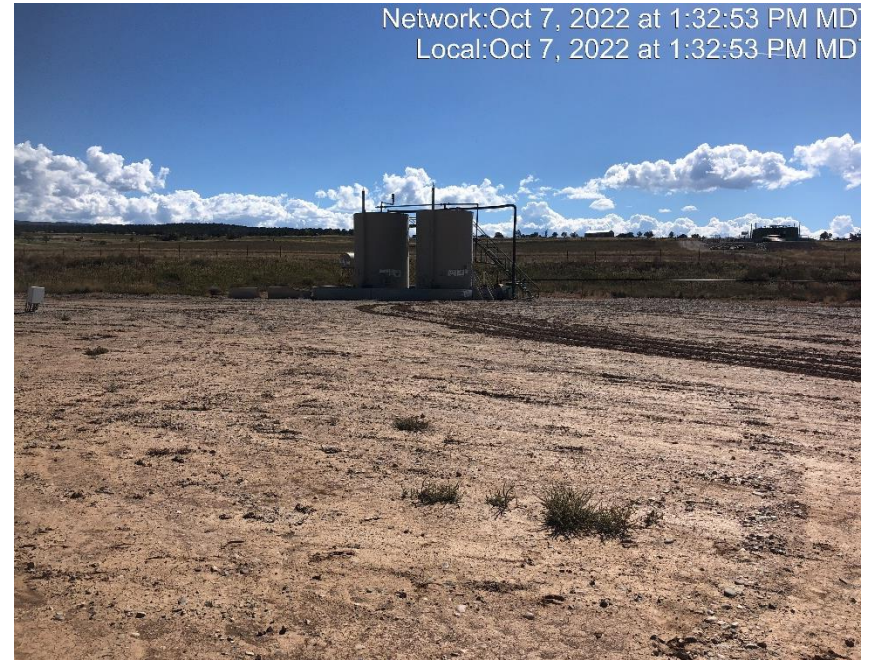
**Photo #7965 From entrance to location.**

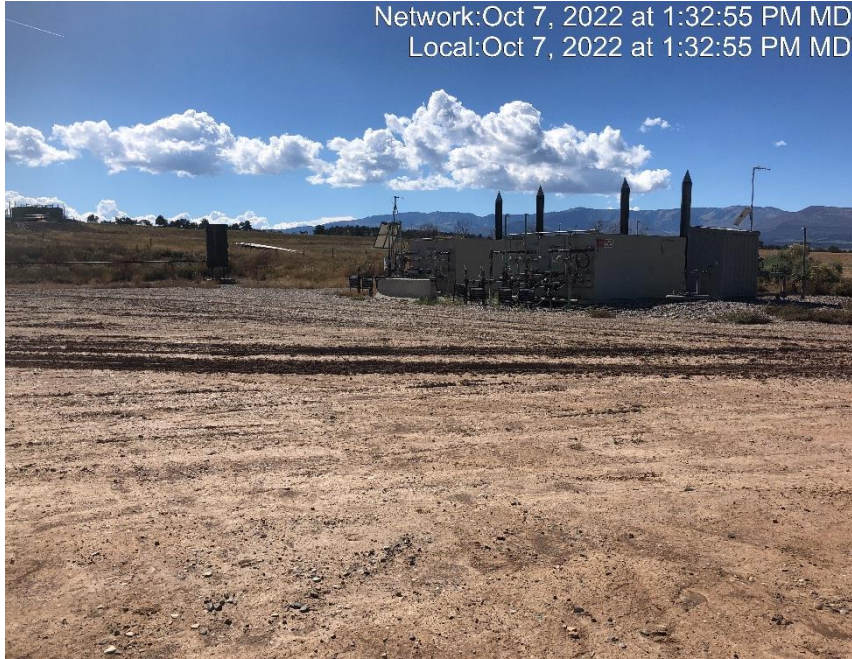
Photo #7966 From entrance to location.

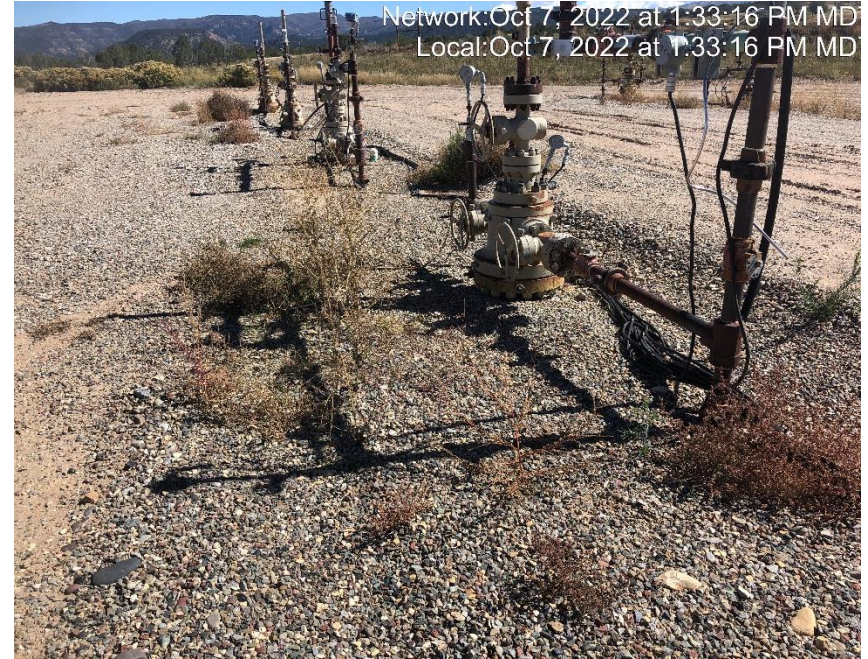
Photo #7967 Multiple places with undesirable plant species.

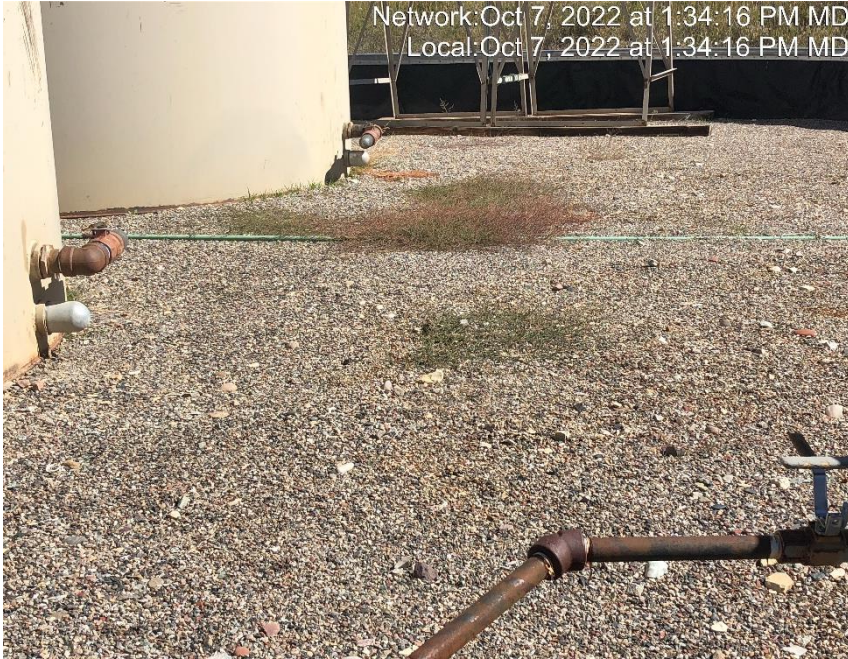
Photo #7972 Multiple places with undesirable plant species.

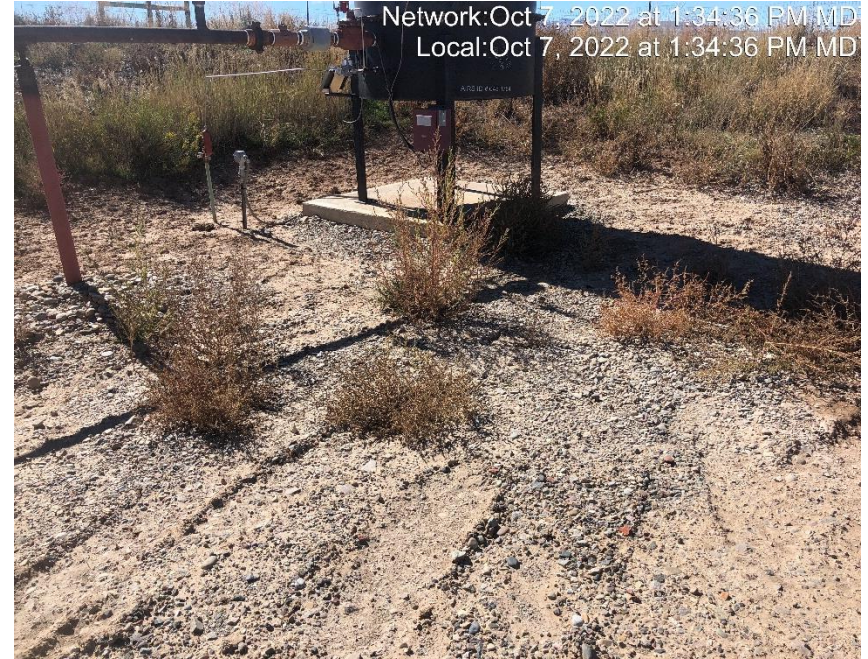
Photo #7973 Multiple places with undesirable plant species.

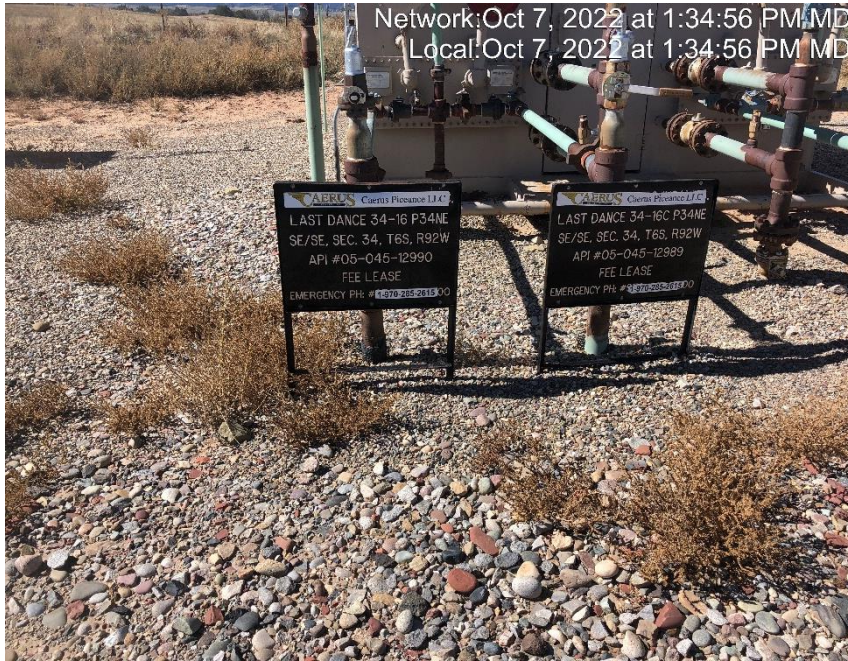
**Photo #7974** Multiple places with undesirable plant species.

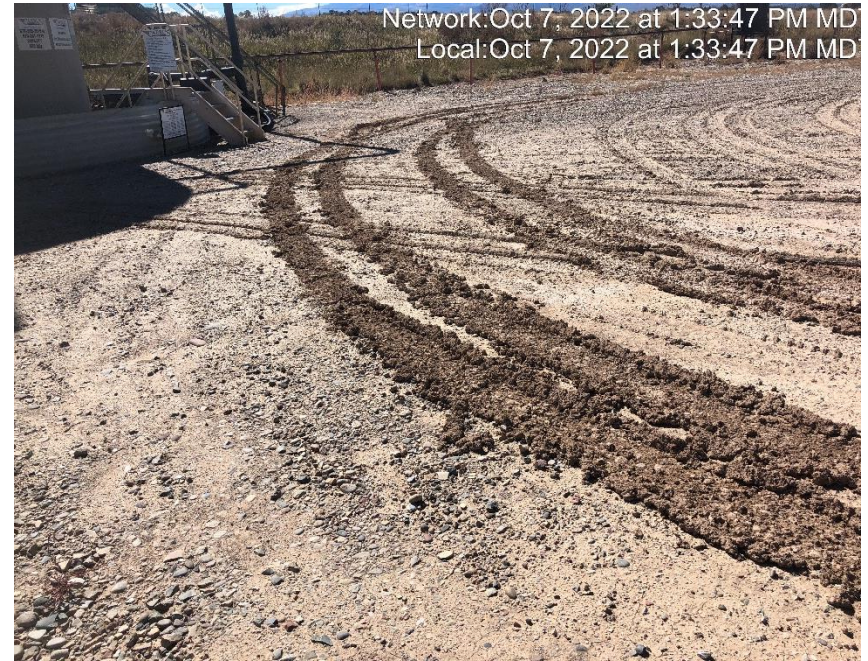
**Photo #7970** Location lacks stabilization.

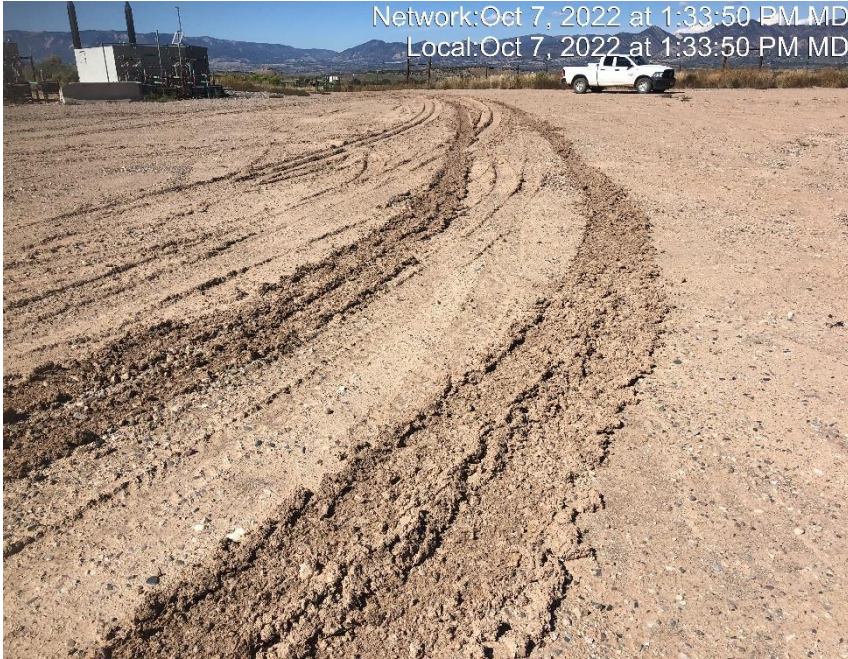
**Photo #7971** Location lacks stabilization.

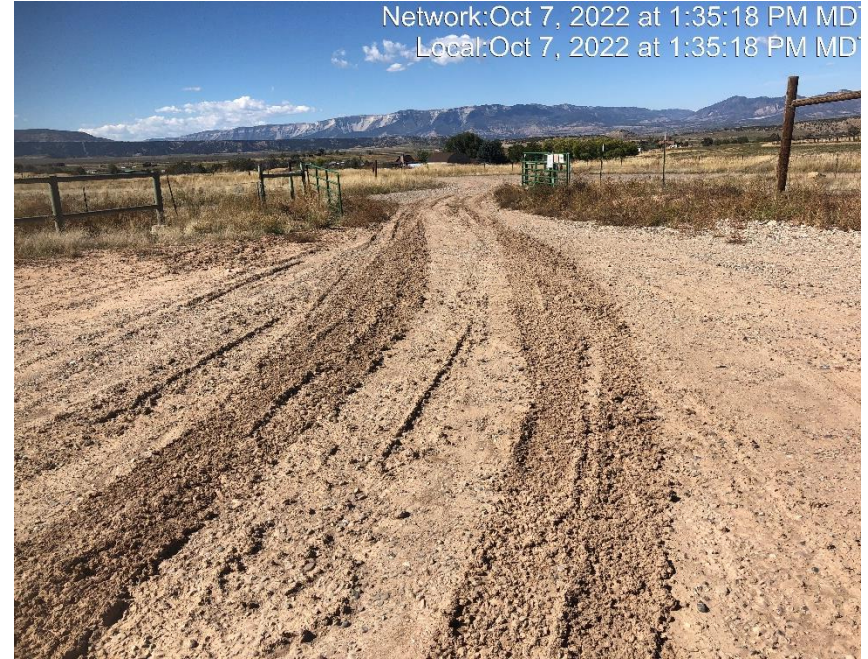
**Photo #7976** Insufficient tracking BMP located at entrance to location.
