Inspection Photos

API: 055-06301

Operator: CAPTUREPOINT LLC

Inspection Date: 10/6/2022

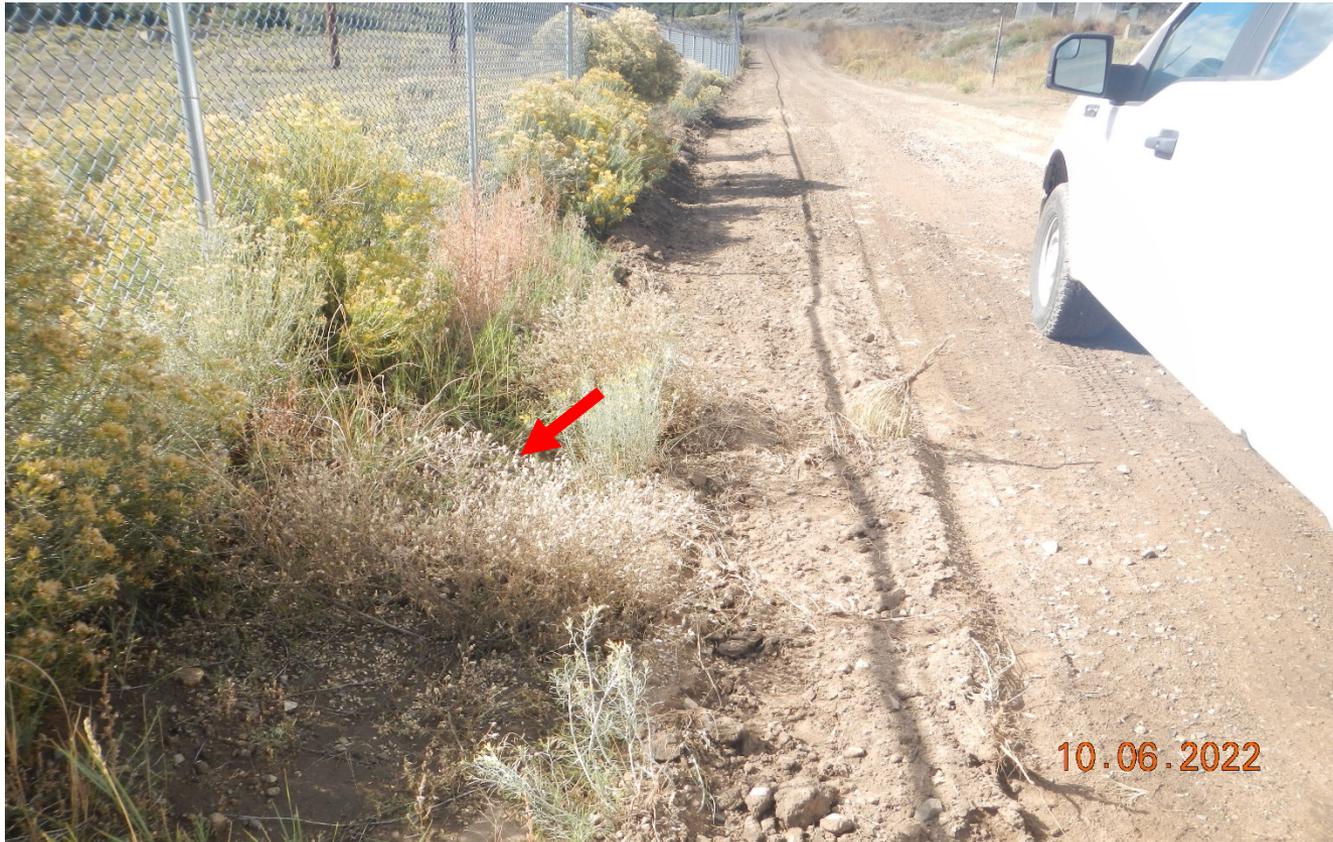
Photo 1. Facing west at the entrance of the Gas Plant. There are noxious weeds along the road that need to be controlled. Red arrow → Diffuse knapweed.

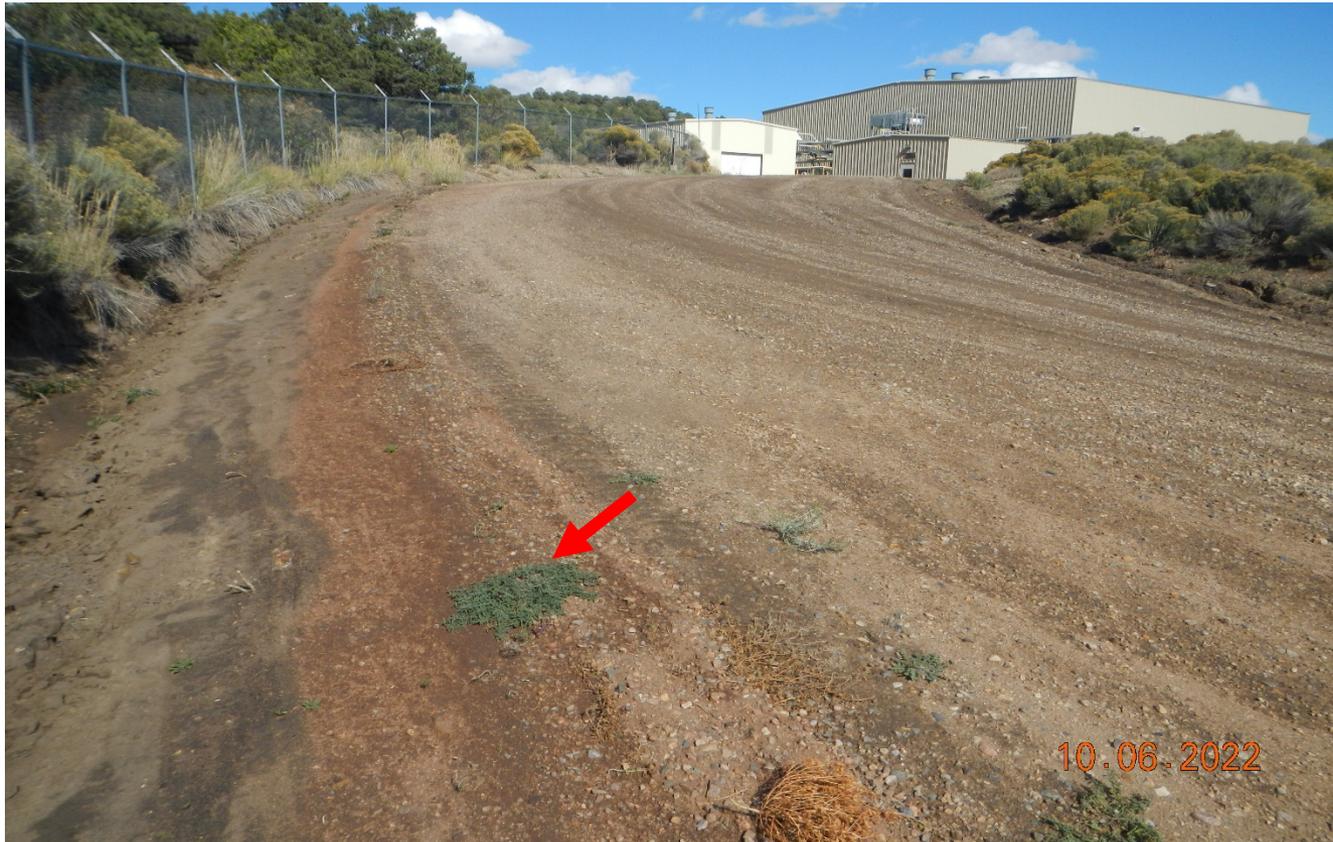
Photo 2. Facing northeast at the Gas Plant. There are noxious weeds along the road that needs to be controlled. Red arrow → Diffuse knapweed.

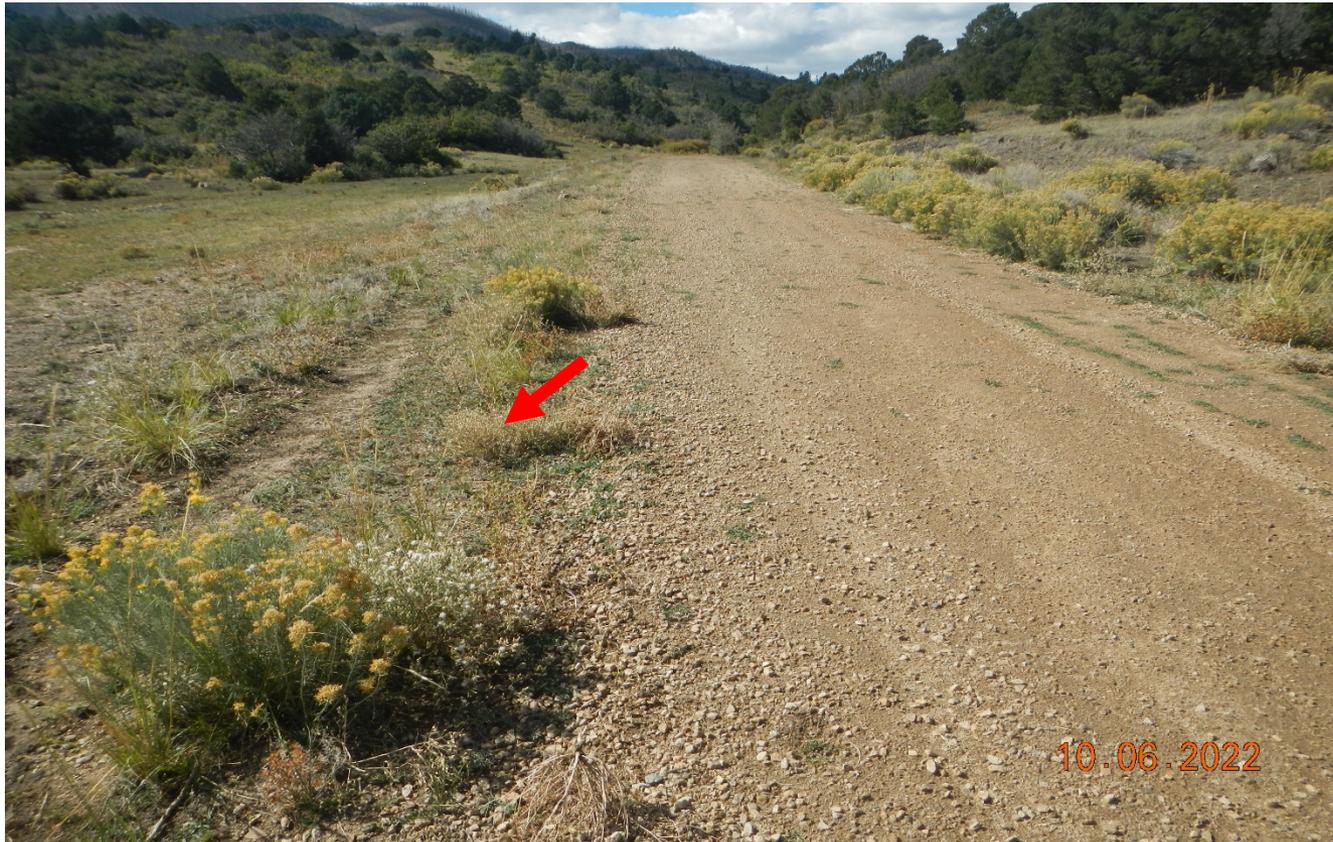
Photo 3. Facing southwest along the access road. There are noxious weeds that need to be controlled. Red arrow → Diffuse knapweed.

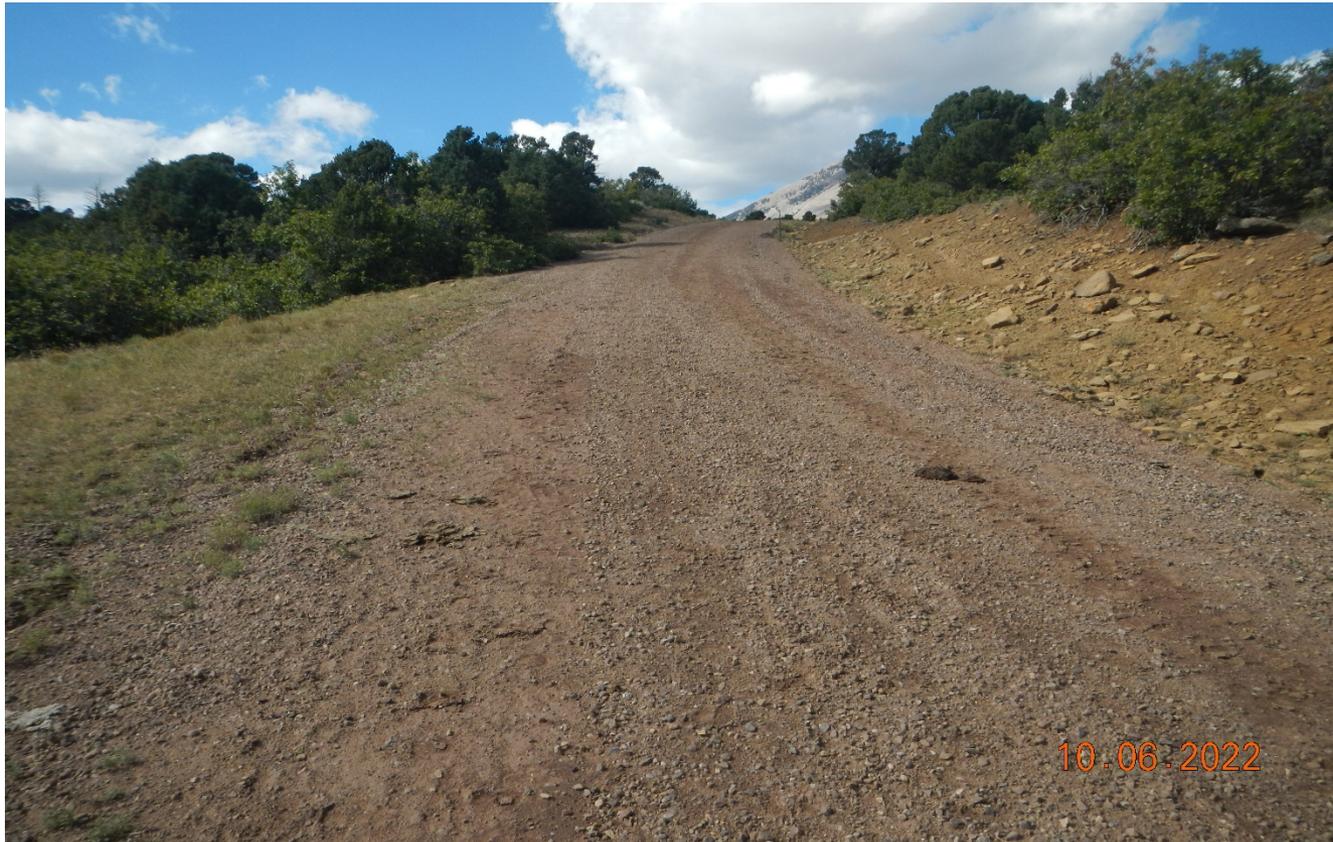
Photo 4. Facing northwest along the road. The road has been regraded.

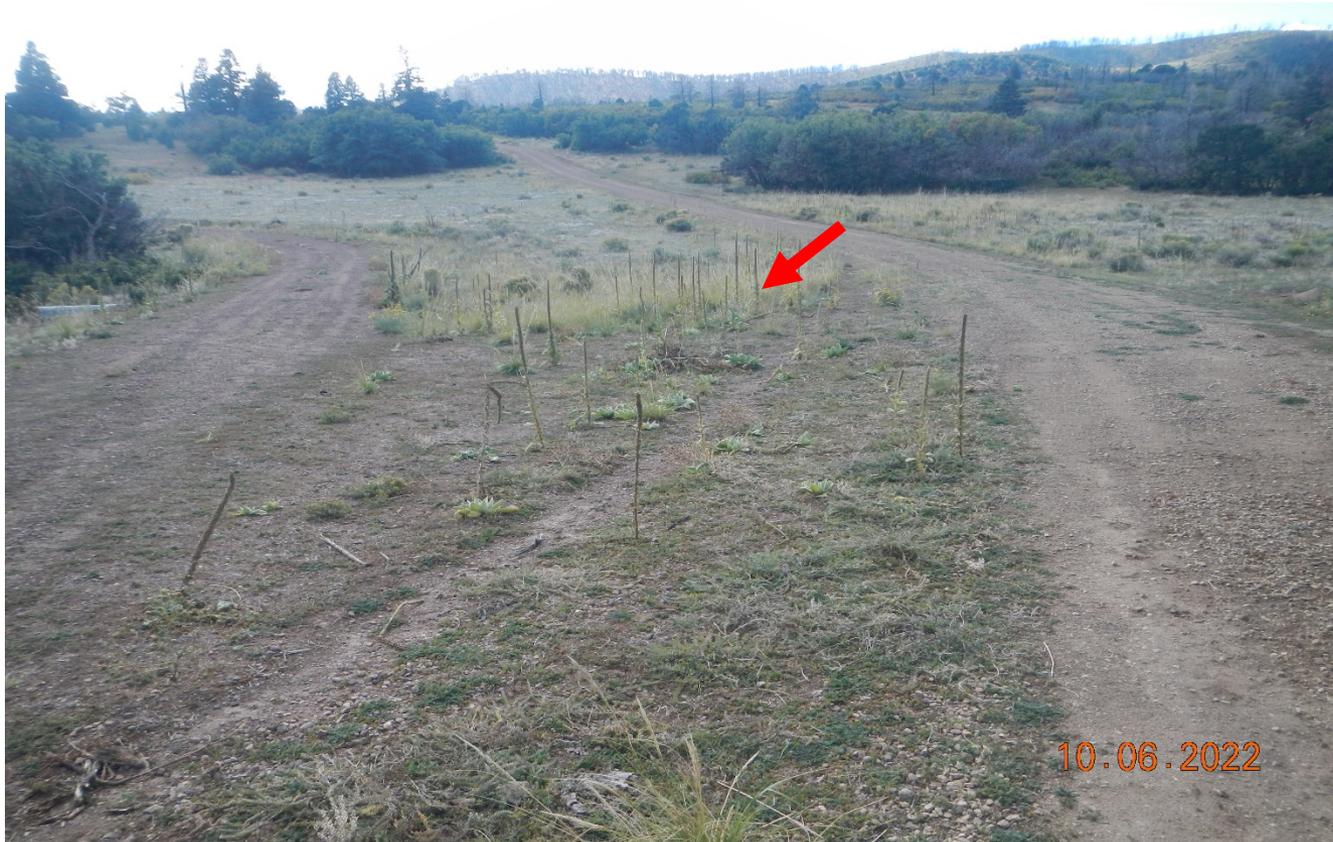
Photo 5. Facing southwest along the access road. There are noxious weeds that need to be controlled. Red arrow → Mullein.

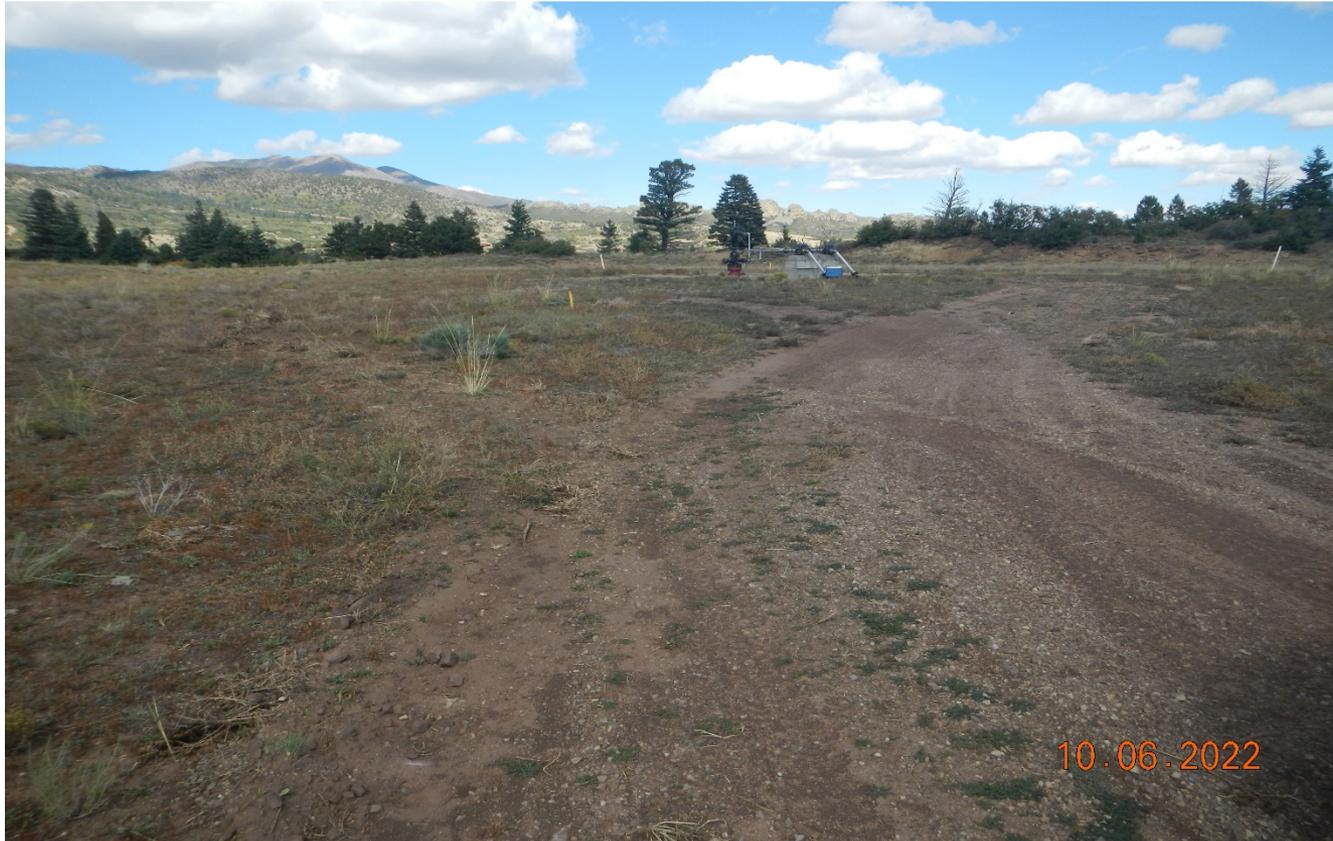
Photo 6. Facing north toward the location.

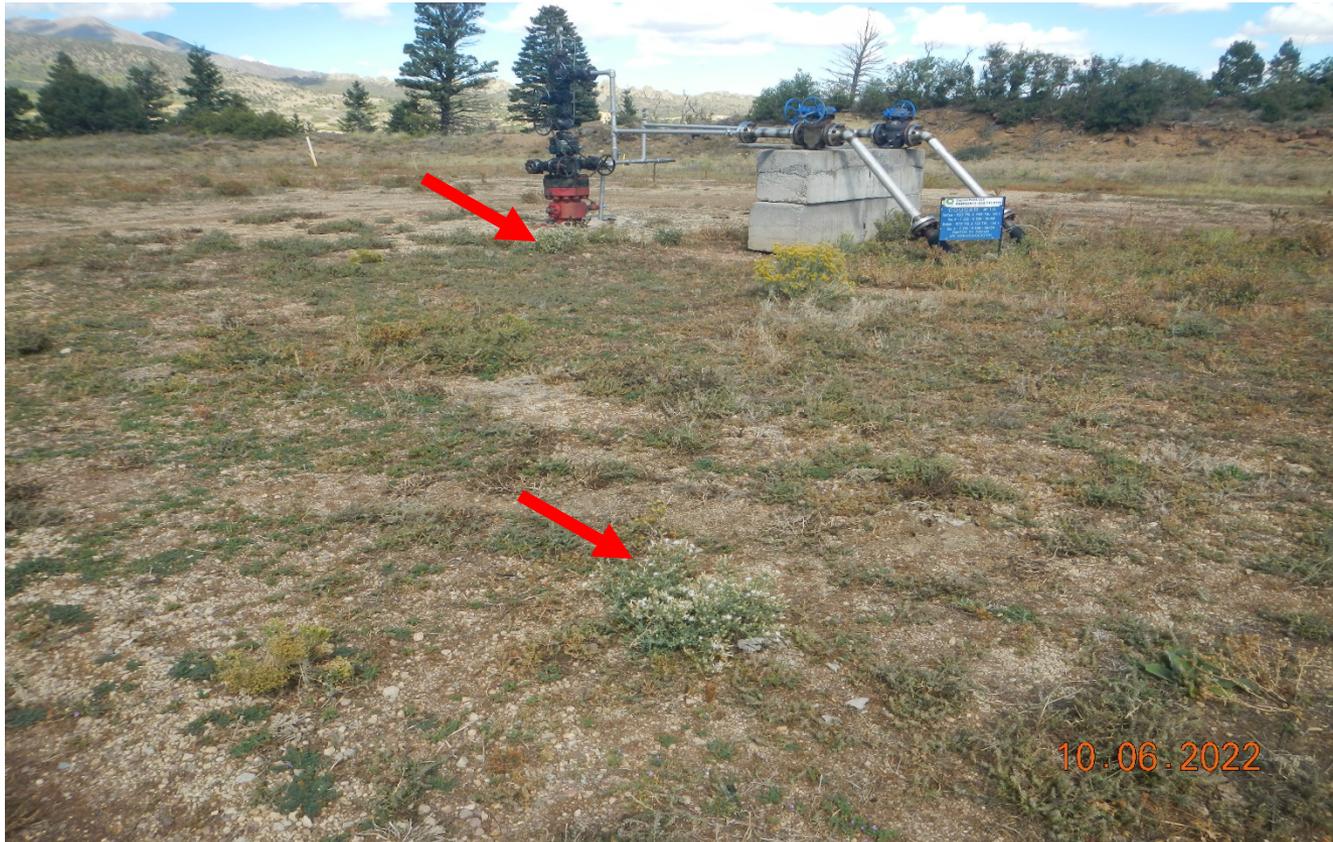
Photo 7. Facing toward the wellhead. There are noxious weeds at the location that need to be controlled. Red arrow → Diffuse knapweed
