# Final Reclamation Inspection

Operator: PDC ENERGY INC - 69175

Location ID: 330601

Inspection Photos  
Location Name: Andy 29-2  
Location ID: 330601

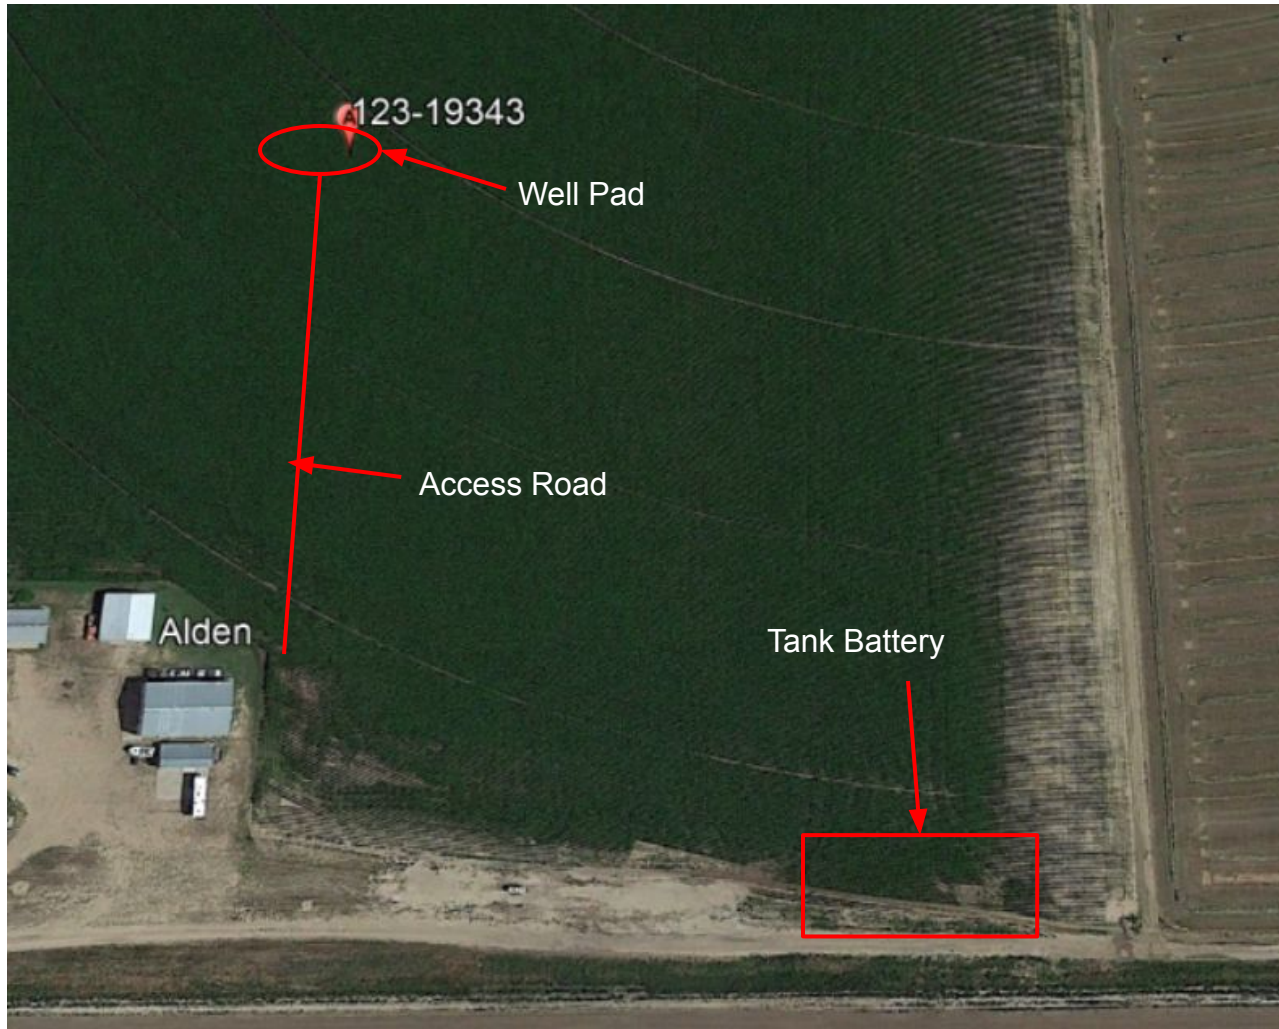
**Photo 1.** 2021 aerial imagery of the well pad, access road and tank battery.

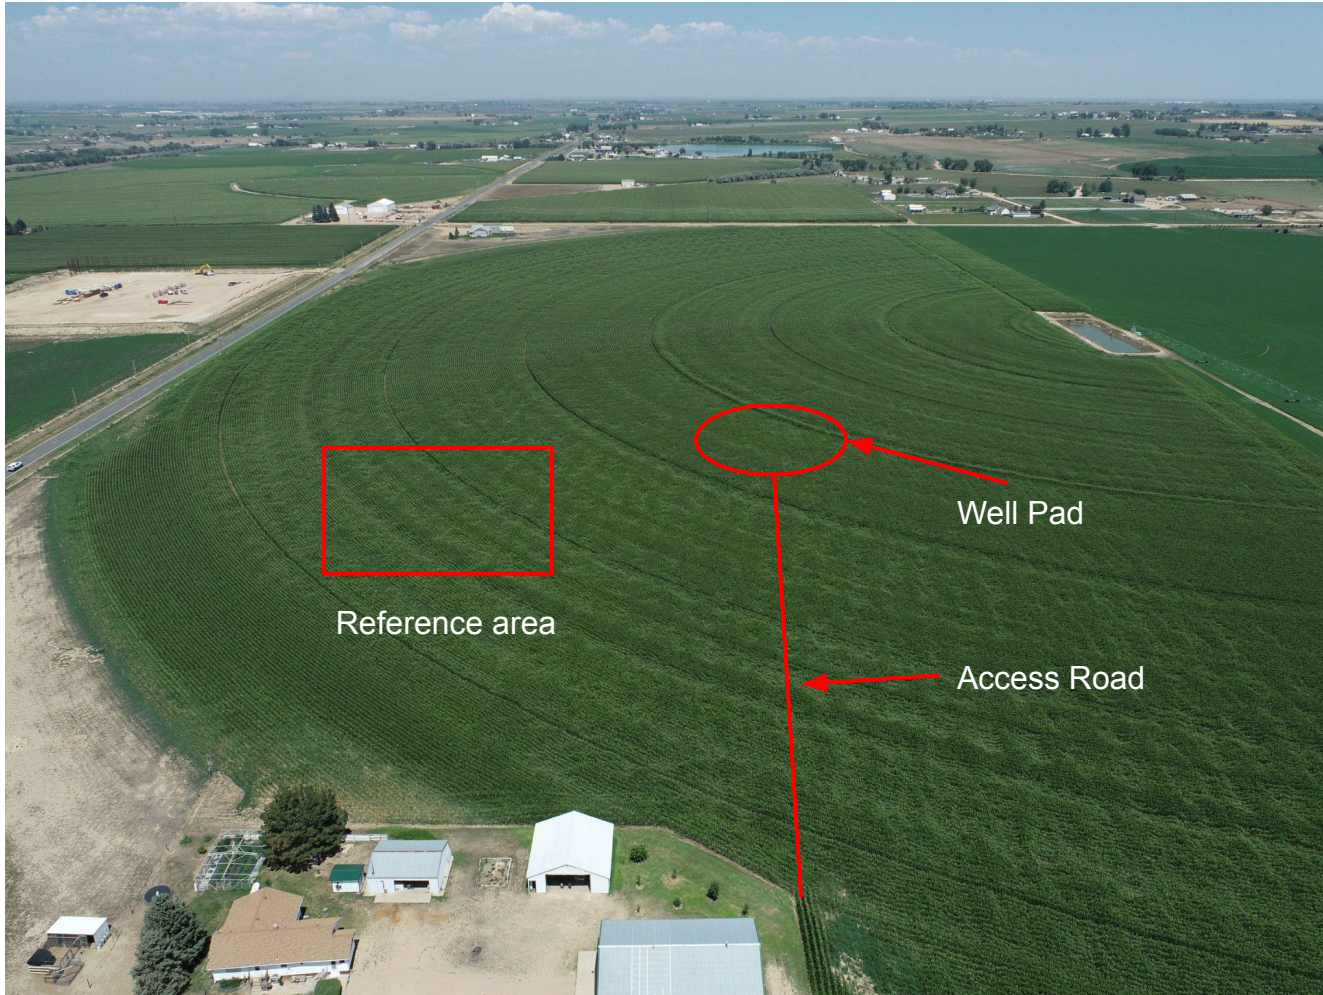
**Photo 2.** Overview photo of the well pad, access road and reference area taken from the southern edge facing north using a drone. Note: well pad and access road appears consistent with adjacent reference area.

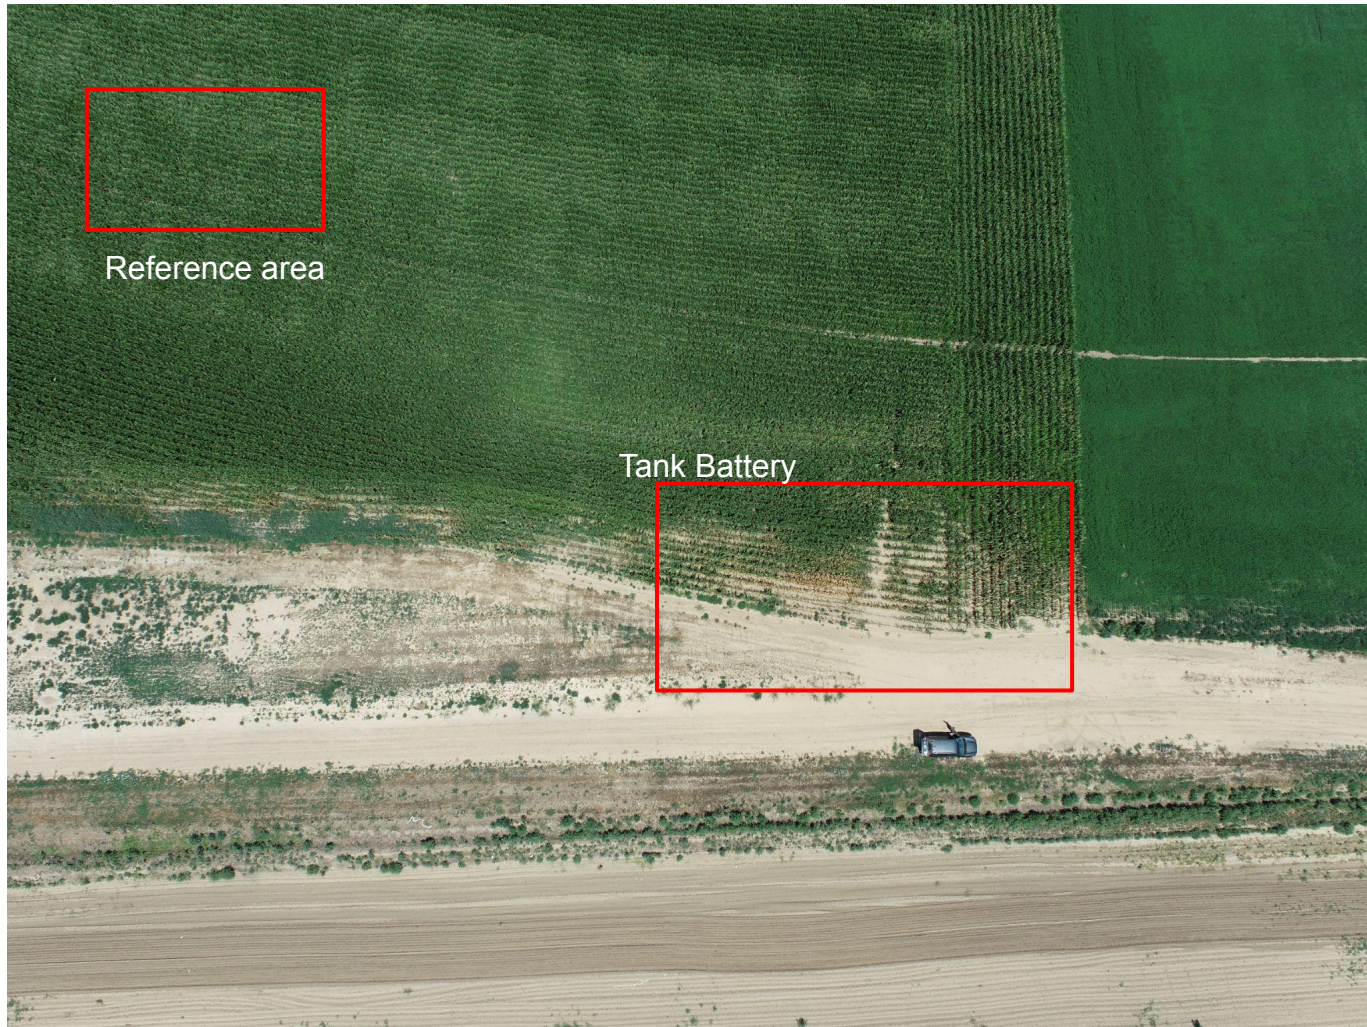
**Photo 3.** Overview photo of the tank battery and reference area taken from directly above the tank battery using a drone. Note: tank battery shows stunted crop growth and is not consistent with the adjacent crop reference area.

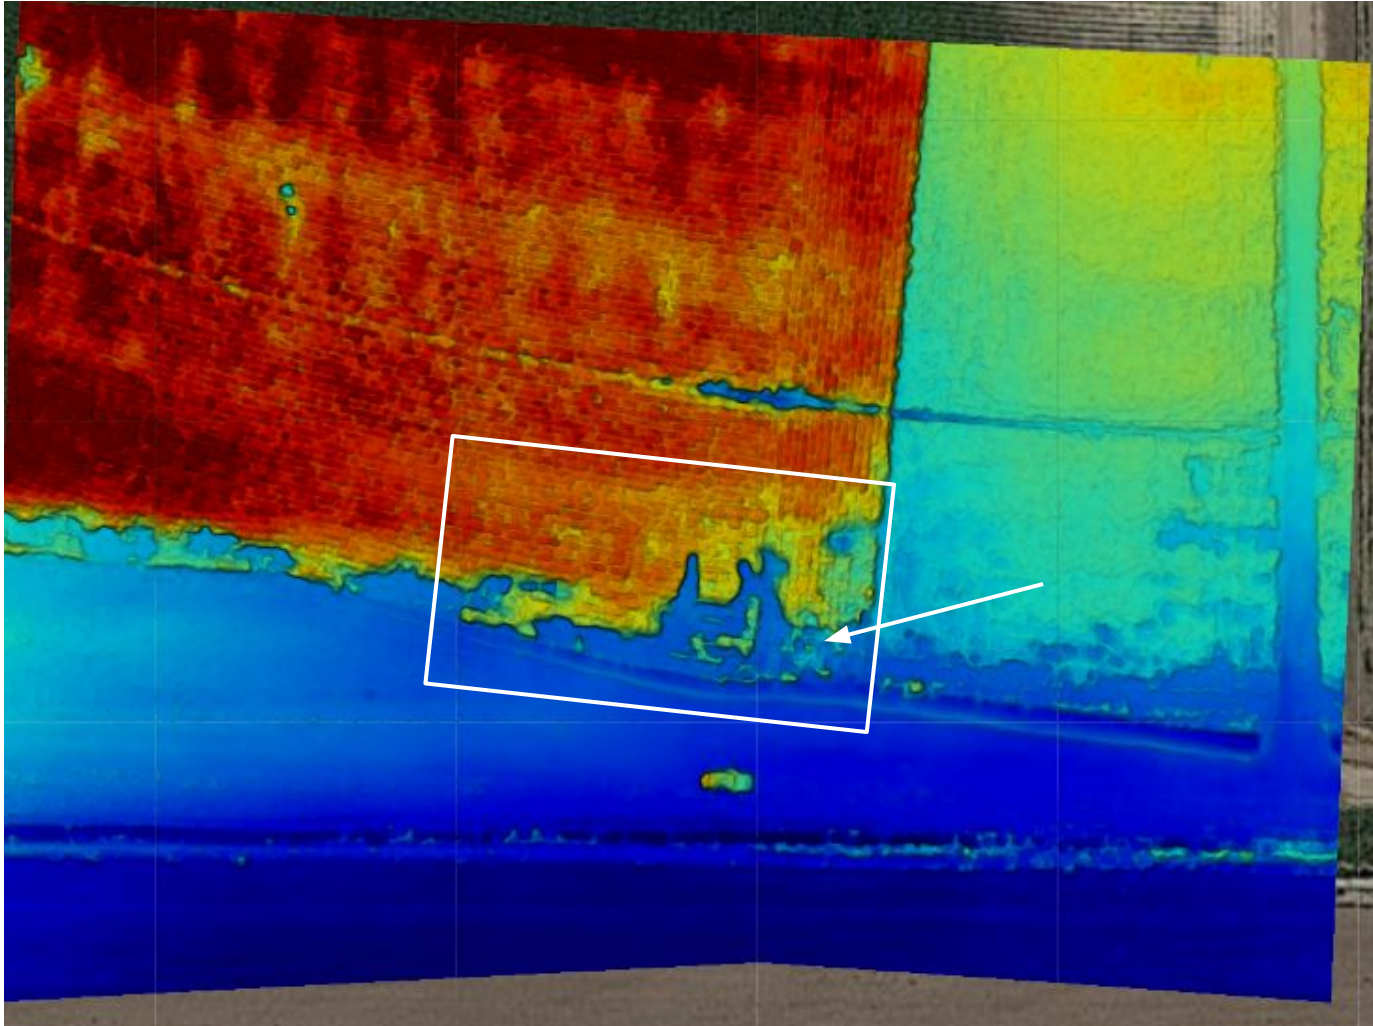
**Photo 4.** Plant elevation model overview photo of the tank battery taken using a drone during the inspection. Note: stunted crop growth in eastern portion of the tank battery indicated by white arrow.

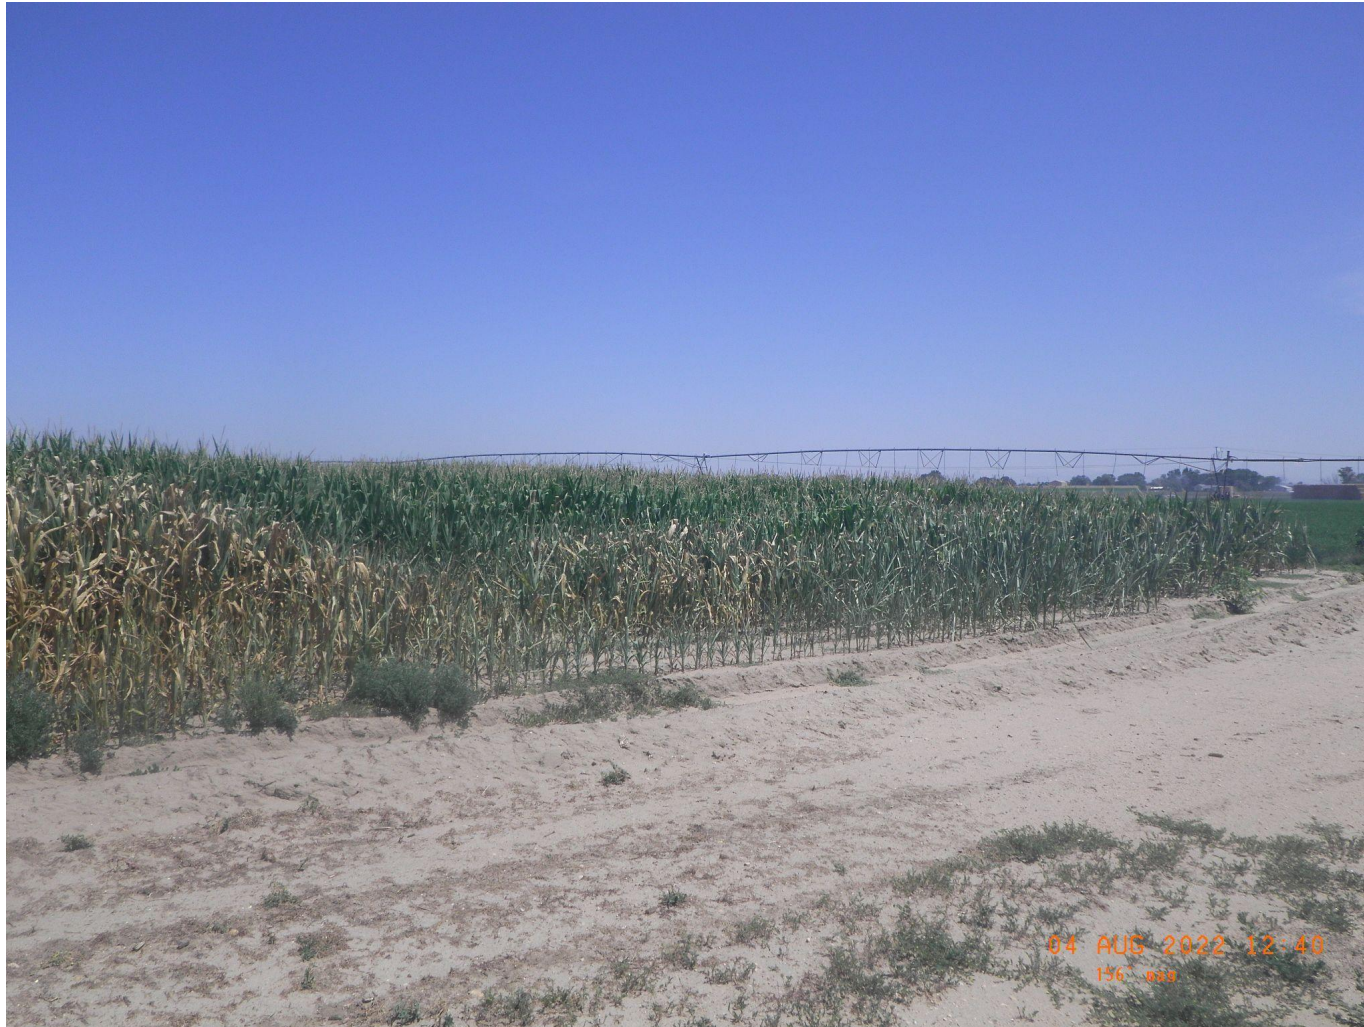
**Photo 5.** Overview photo of the tank battery taken at ground level from the southern edge facing north. Photo shows stunted crop growth at the tank battery location.
