Final Reclamation Inspection

Operator: PDC ENERGY INC - 69175

Location ID: 330540

Inspection Photos
Location Name: Wacker 31-10
Location ID: 330540

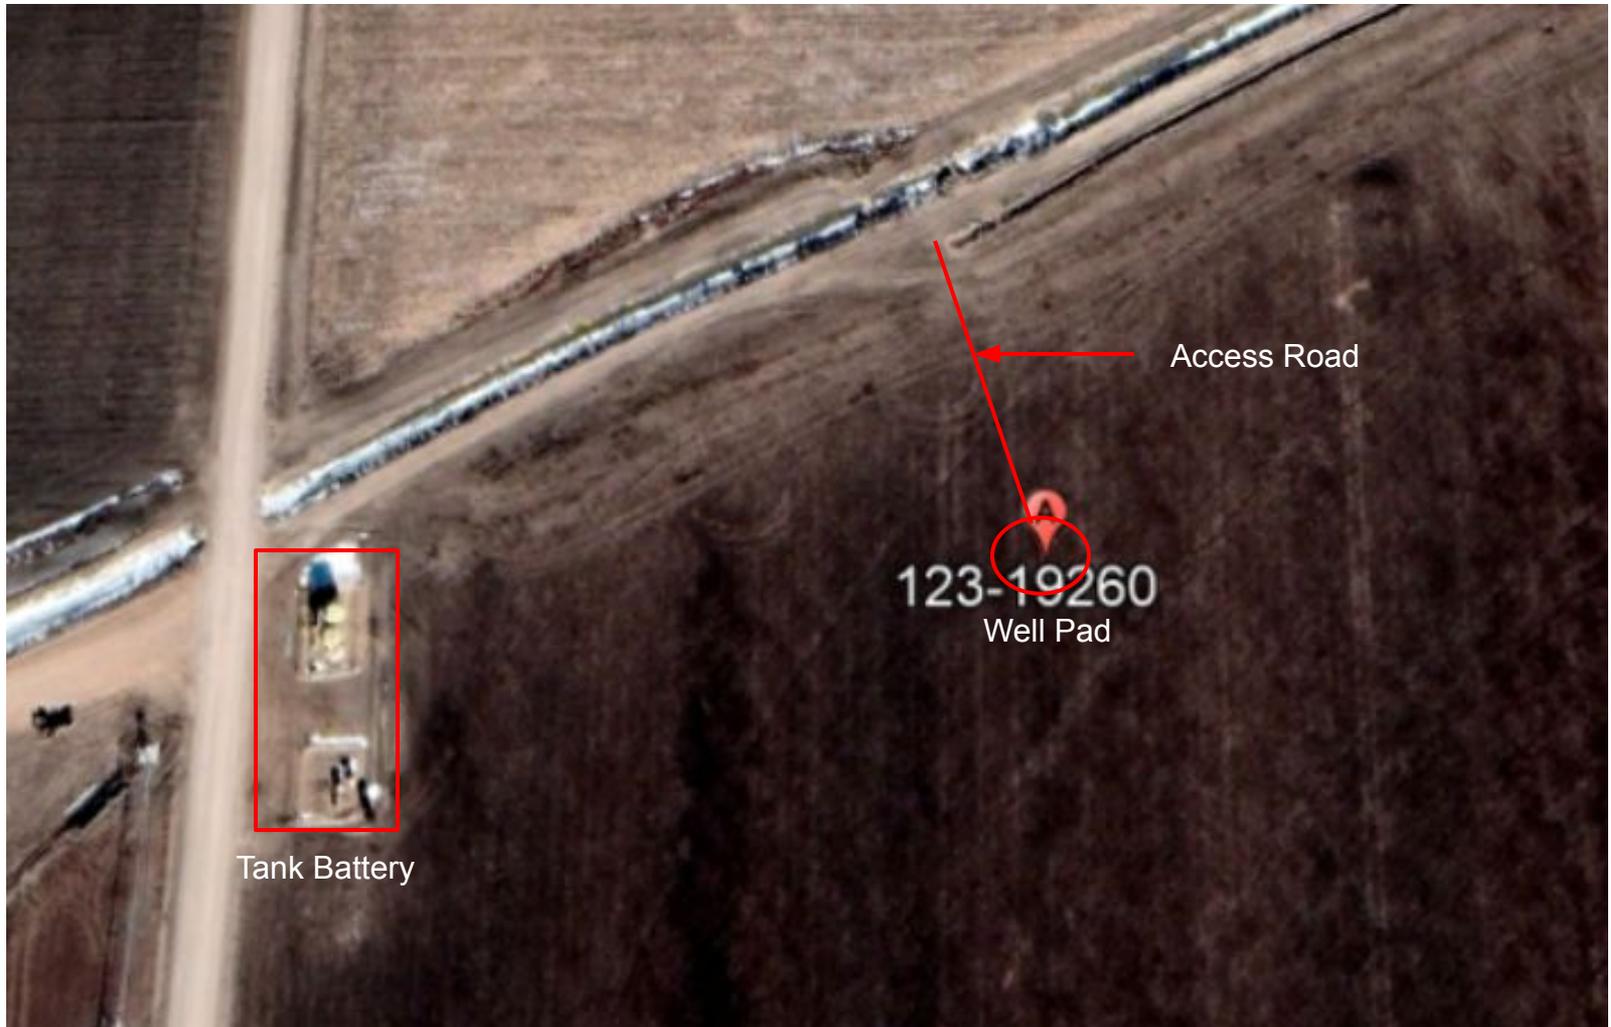
Photo 1. 2020 aerial imagery of the well pad, access road and tank battery.

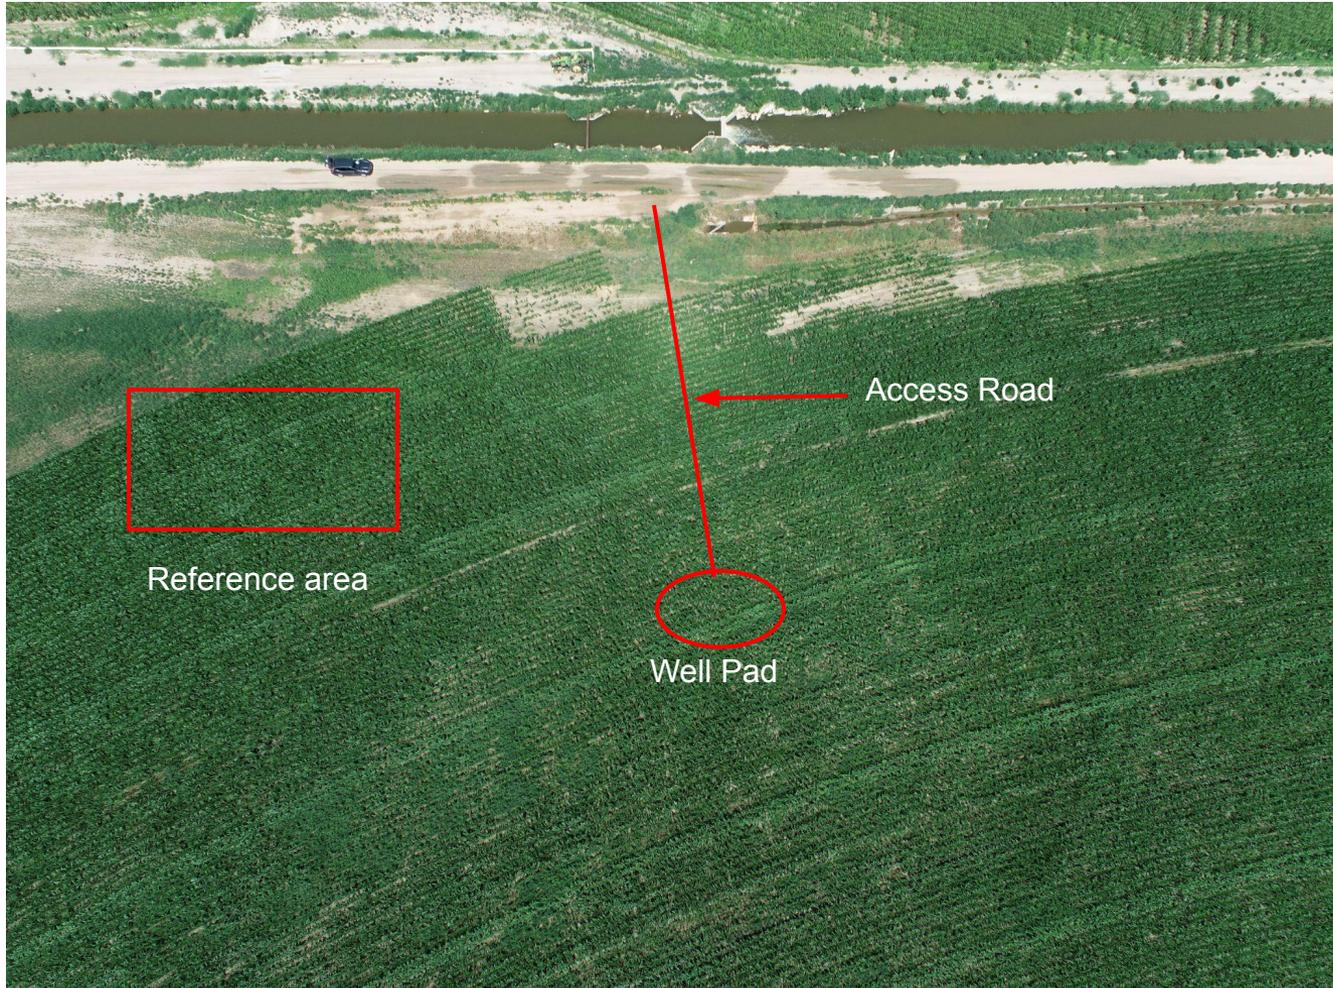
Photo 2. Overview photo of the well pad, access road and reference area taken from the southern edge facing north using a drone. Note: well pad and access road appear consistent with adjacent crop reference area.

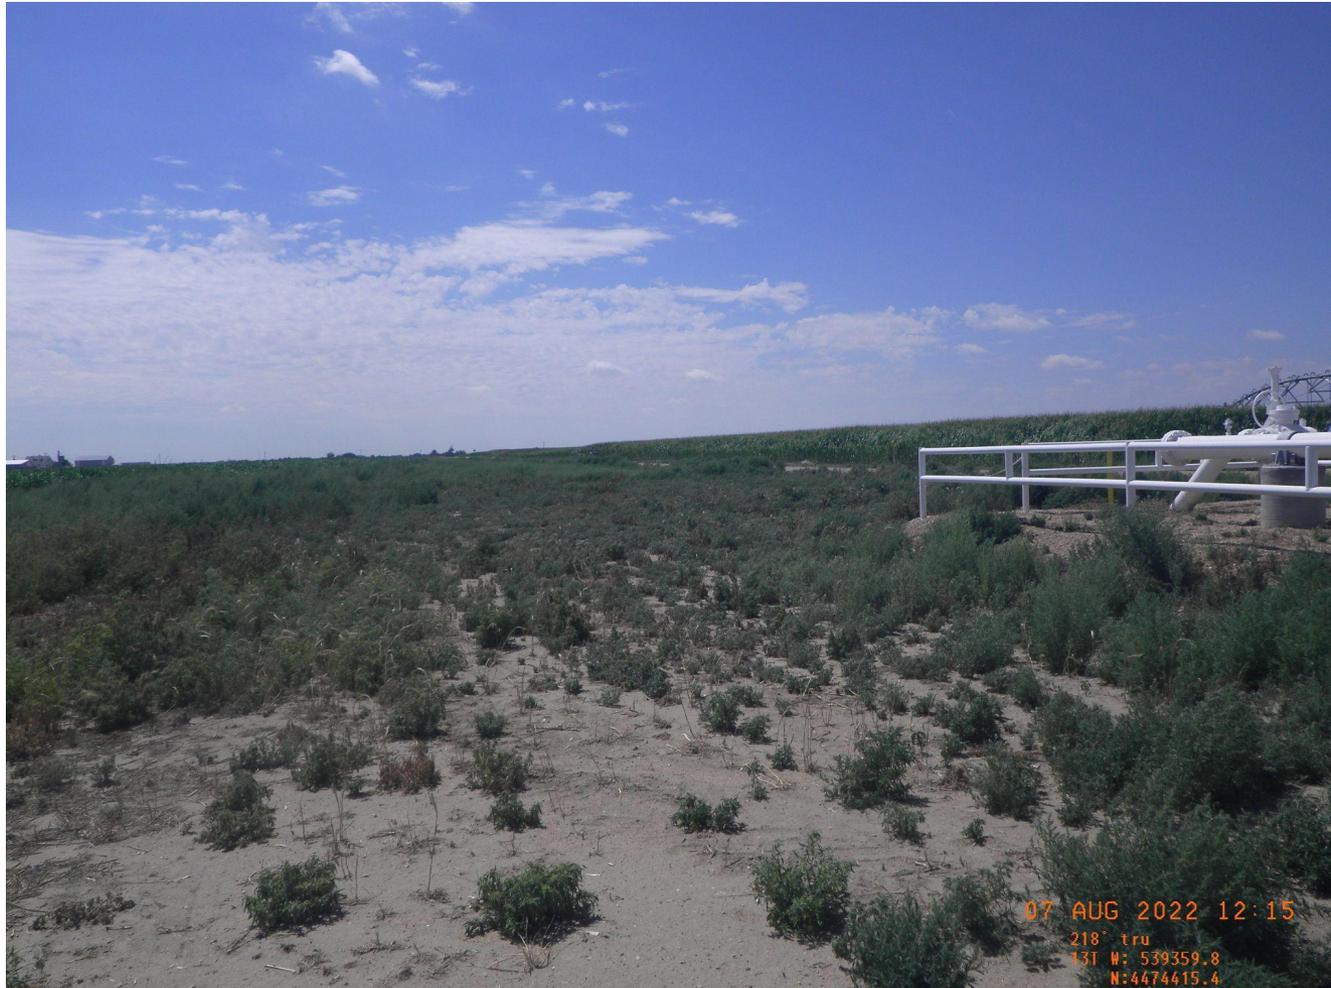
Photo 3. Overview photo of the tank battery taken at ground level from the northern edge facing south. Note: new DCP Midstream riser exists at the disturbance.

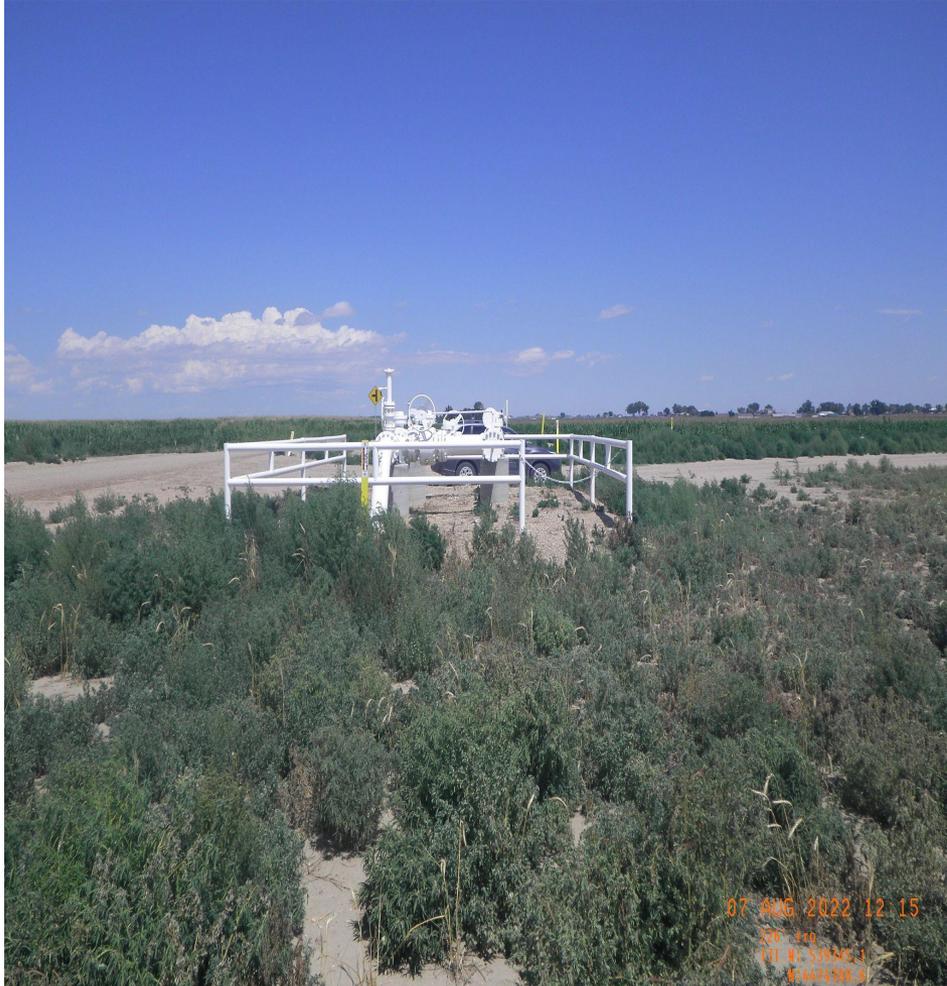
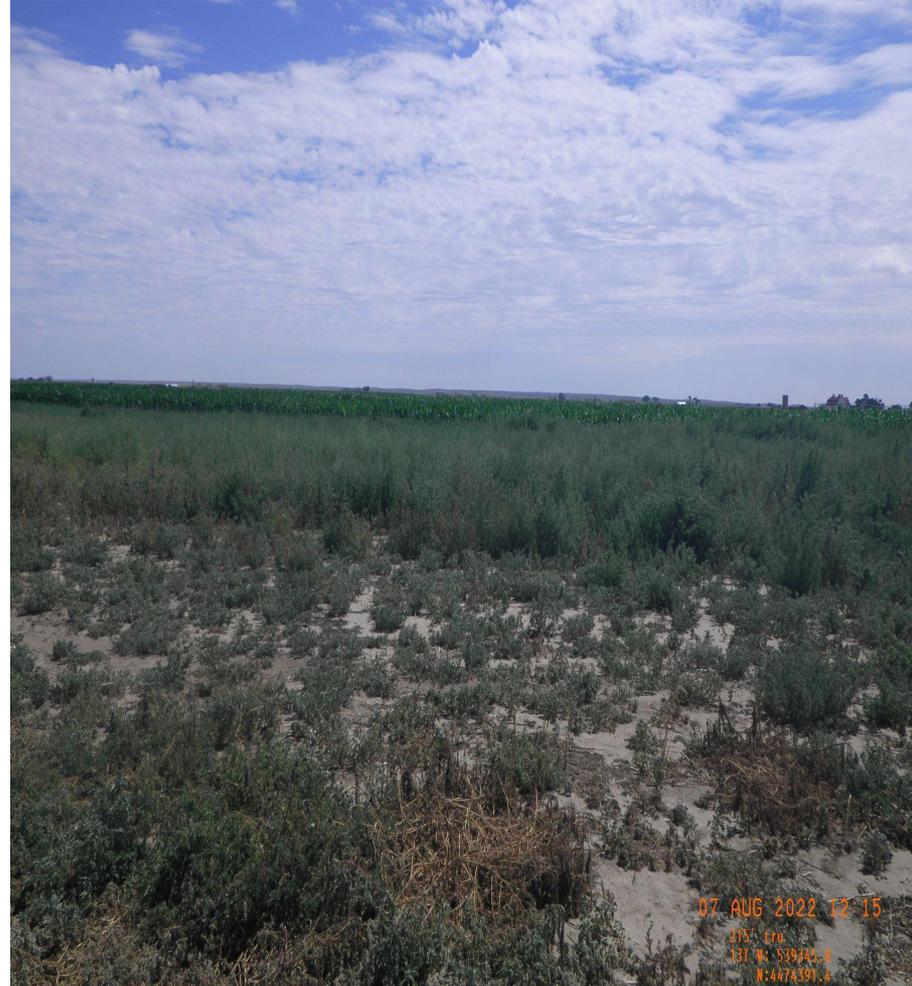
Photo 4. Cardinal photos taken from the middle of the tank battery. Left photo facing north, right photo facing east.

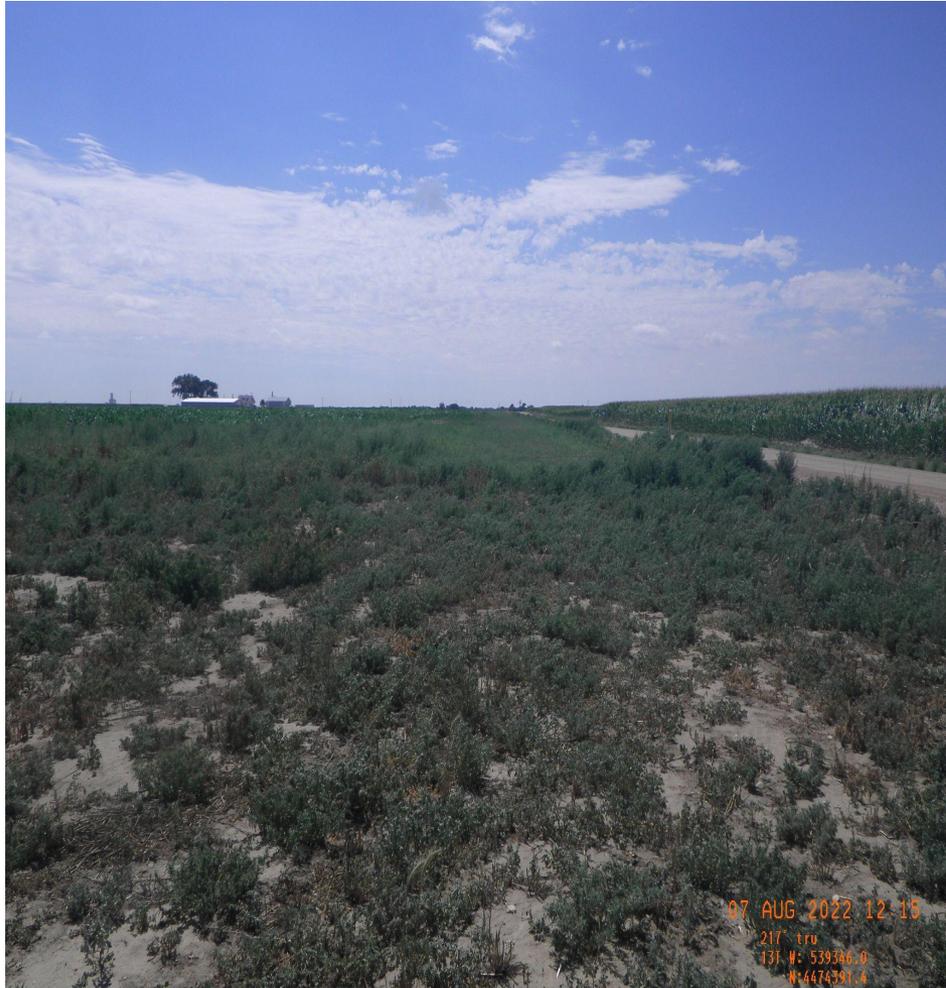
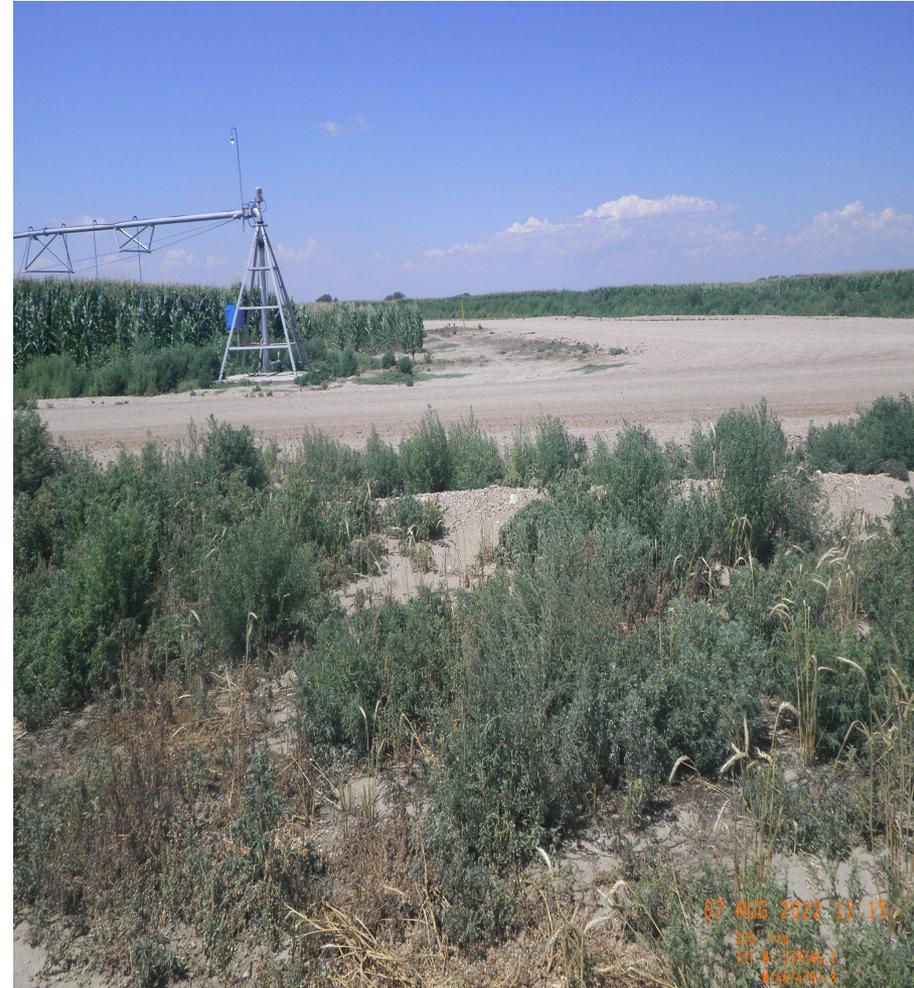
Photo 5. Cardinal photos taken from the middle of the tank battery. Left photo facing south, right photo facing west. Note: tank battery falls within a corner crop area but has higher density of kochia and does not appear consistent with the other corner crop areas (see photo 6).

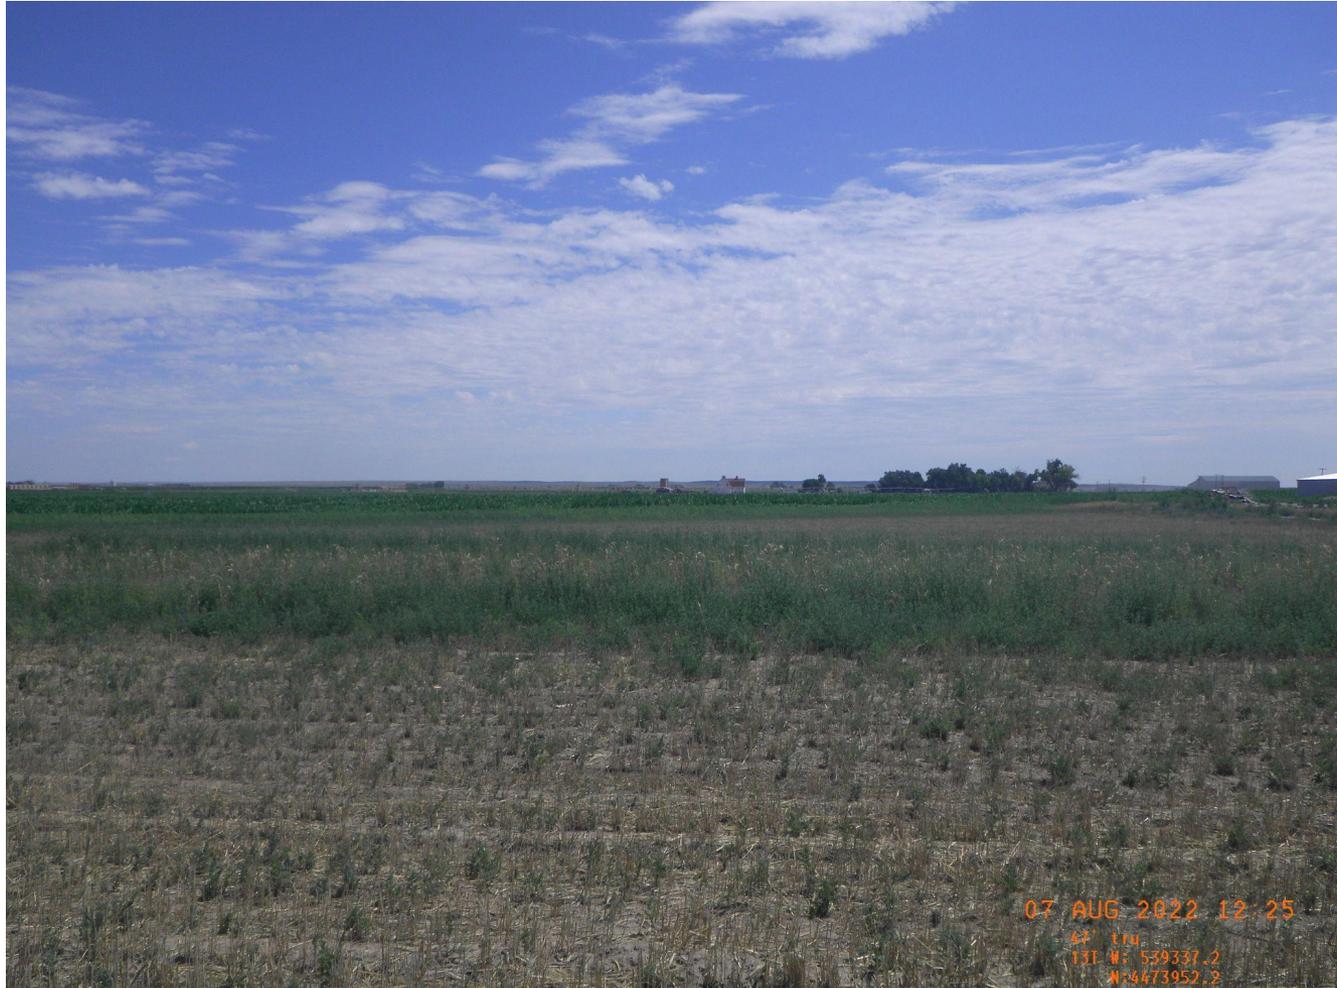
Photo 6. Tank battery reference are.
