Inspection Photos and Issue Report

Operator: LARAMIE ENERGY LLC - 10433 /
BLACK HILLS PLATEAU PRODUCTION LLC

Location #312420

Mesa County, CO

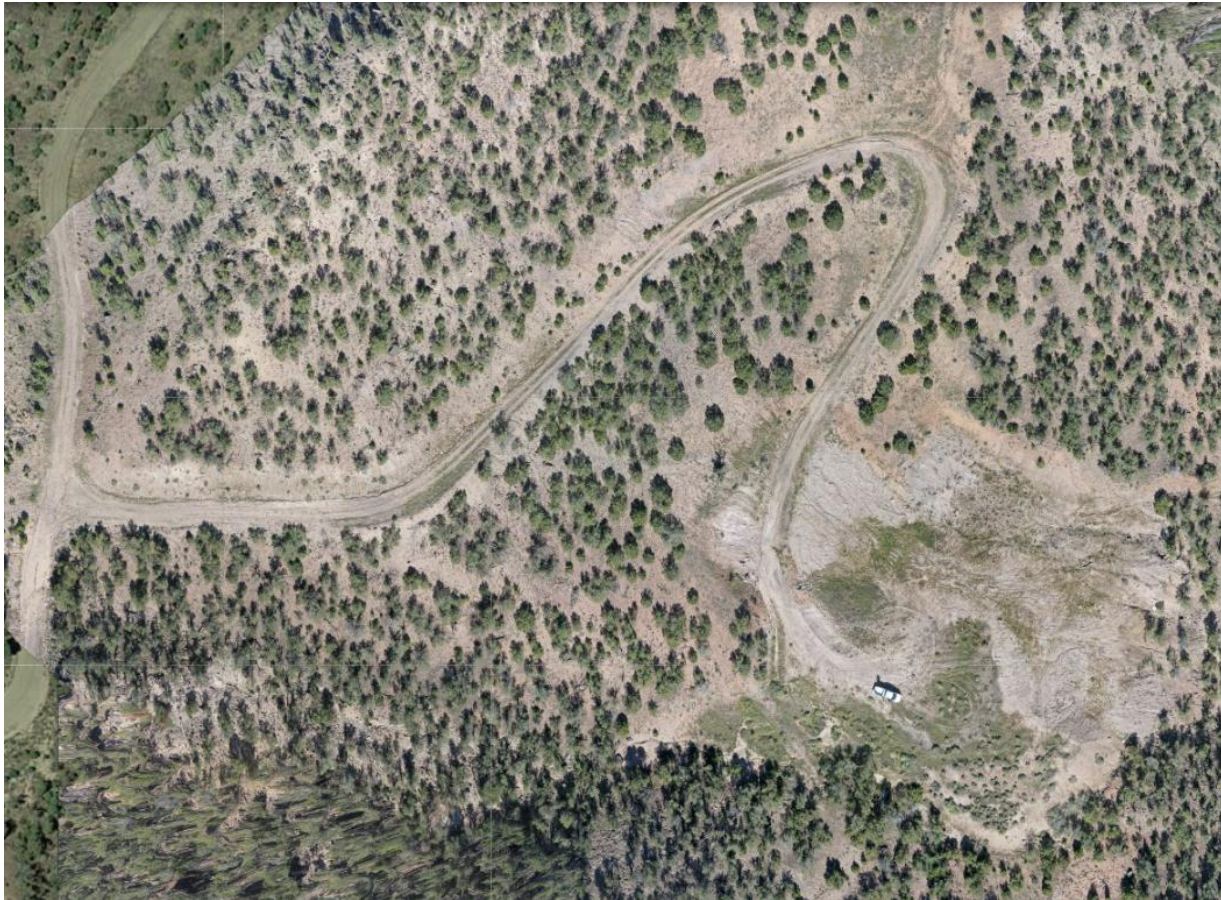
Photo 1: Aerial imagery of Location dated 10/11/2022 taken with use of a sUAS. Image shows overview of the Location and access road; final reclamation has not been conducted in accordance with 1004 requirements.

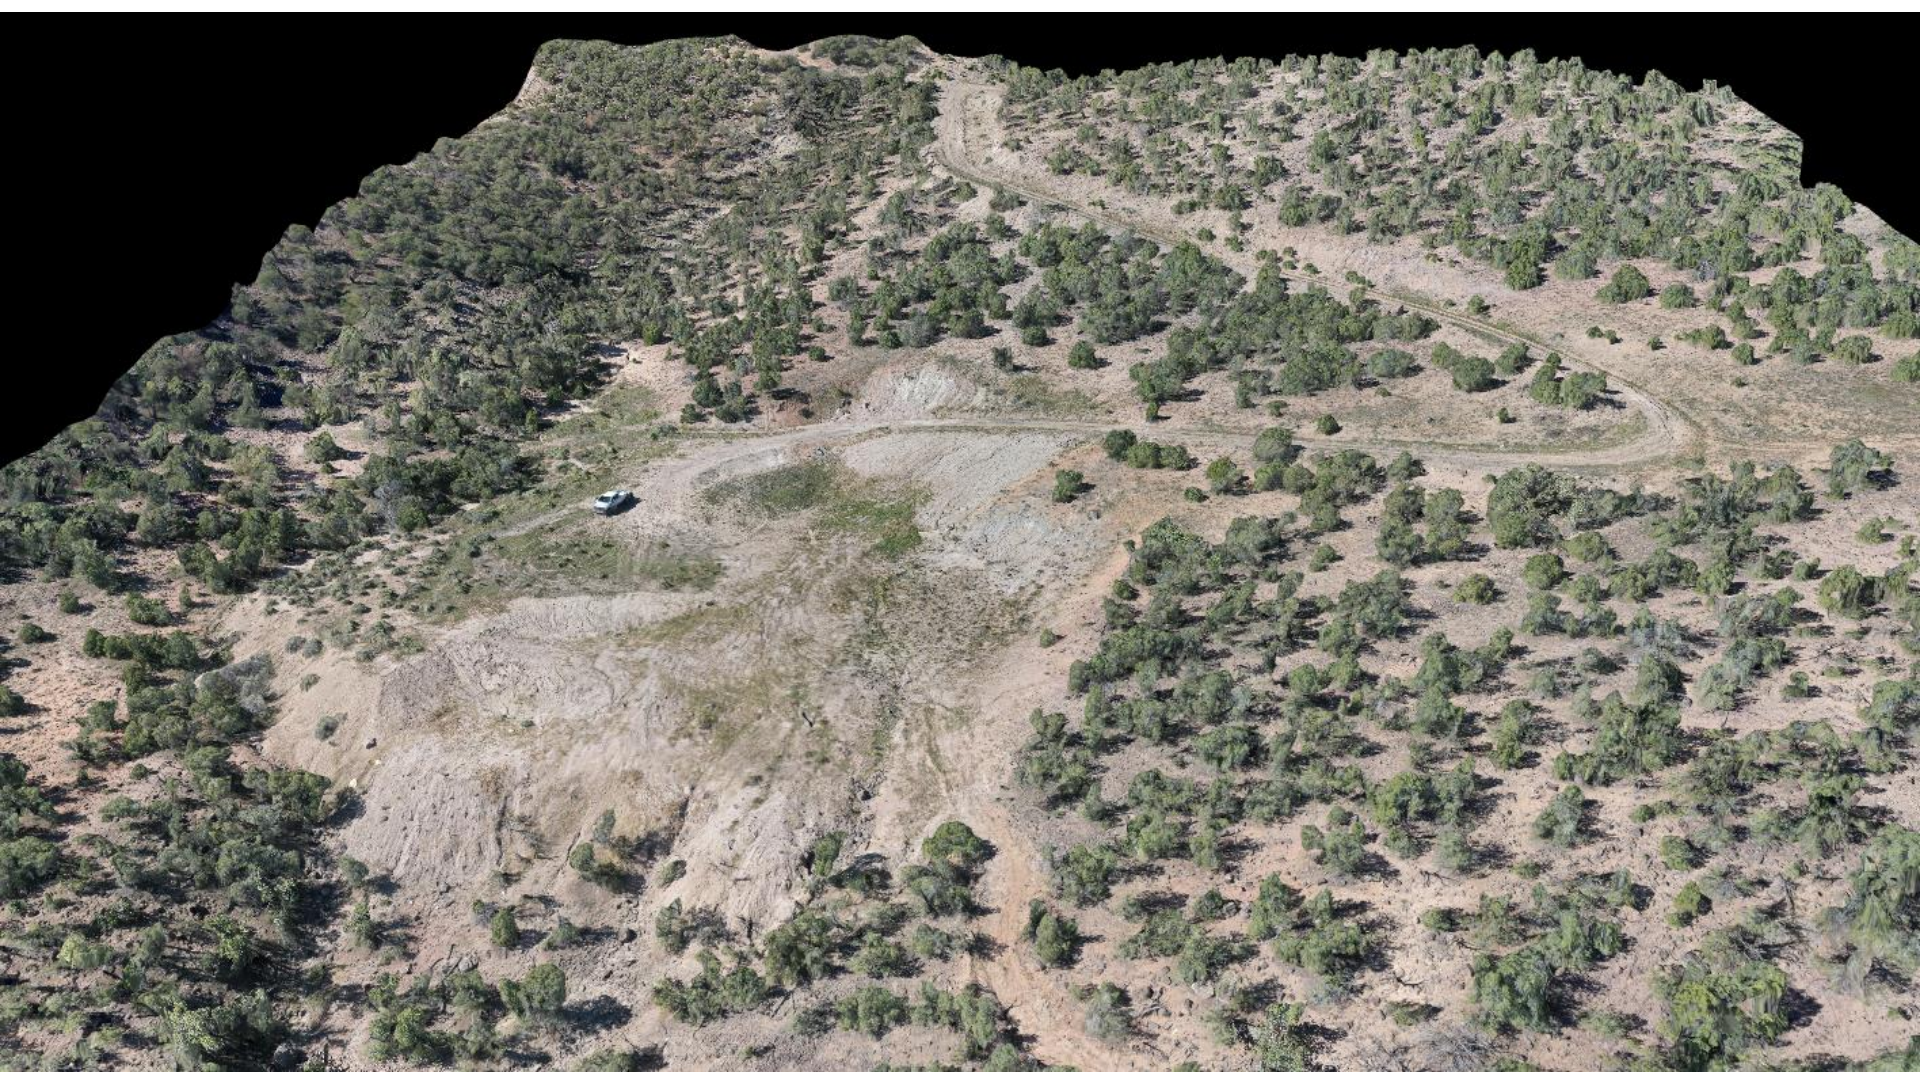
Photo 2: Image a 3-D model of the Location and access road. Model shows final reclamation including, but not limited to, recontouring/regrading of the Location and access road has not been conducted in accordance with 1004 requirements .

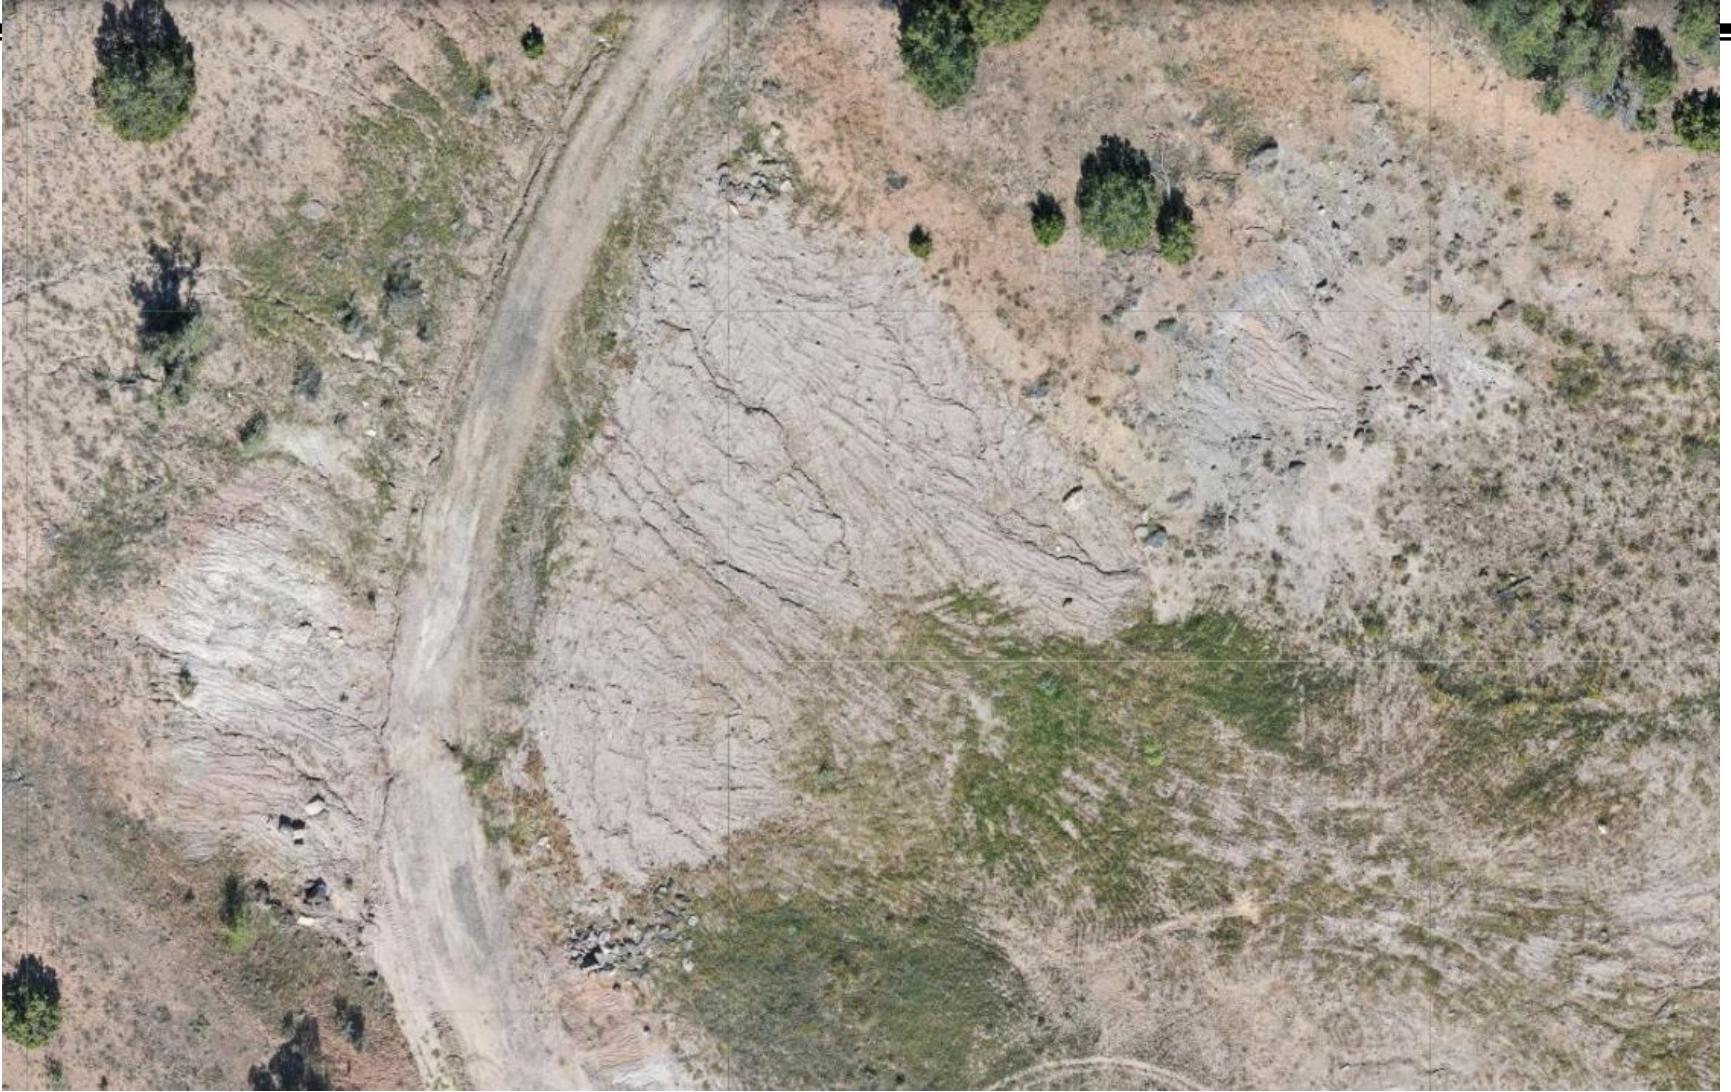
Photo 3: 10/11/2022 aerial imagery showing cut slopes- erosion degradation evident through cut and fill slopes of the Location.

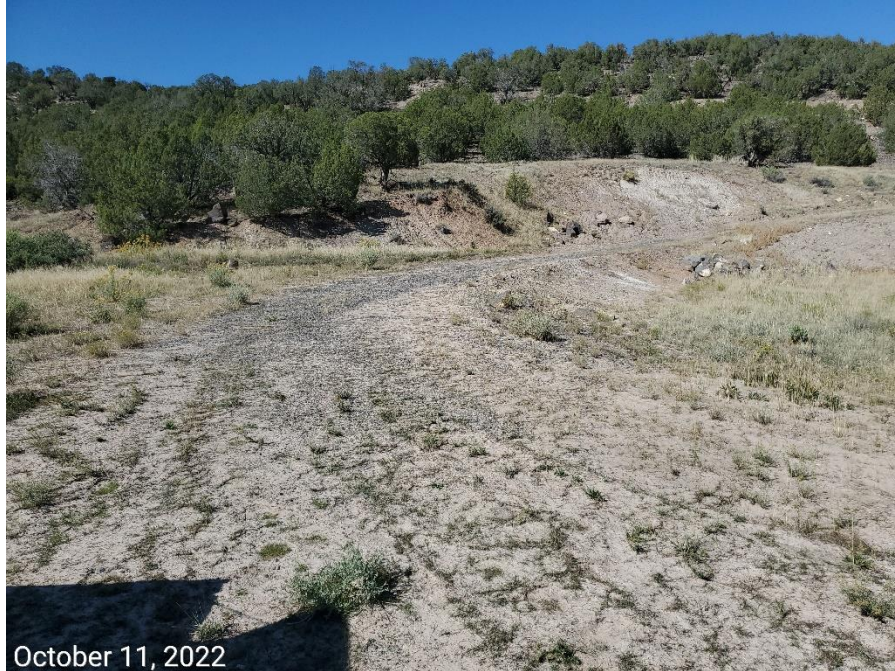
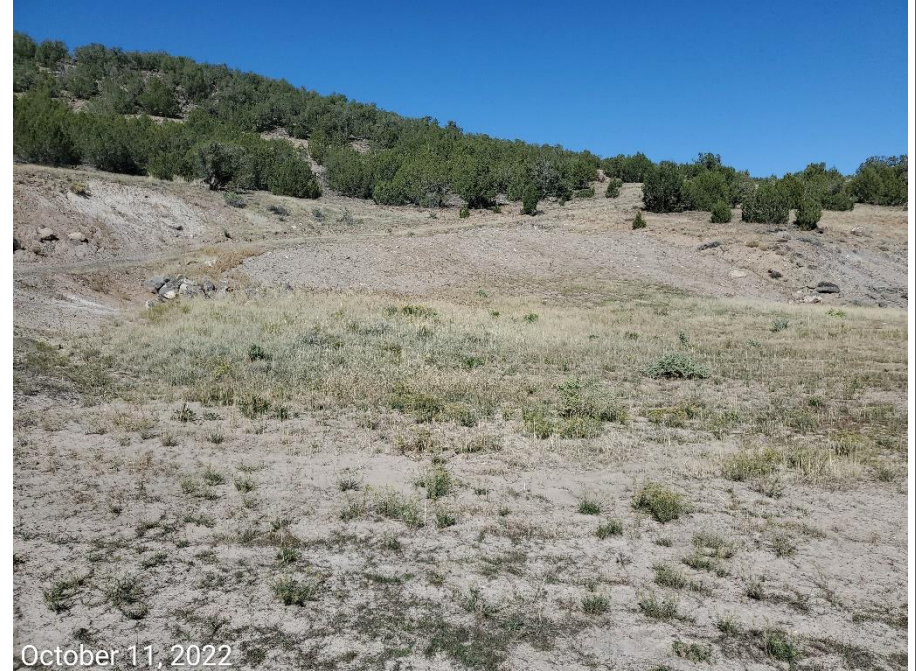
Photo 4: Photos 4-5 taken from the southwest end of the Location. Photos provide an overview of the Location from northwest, north, northeast to southeast. Photos show Location has not been recontoured, regraded and reclaimed in accordance with COGCC 1004 requirements.

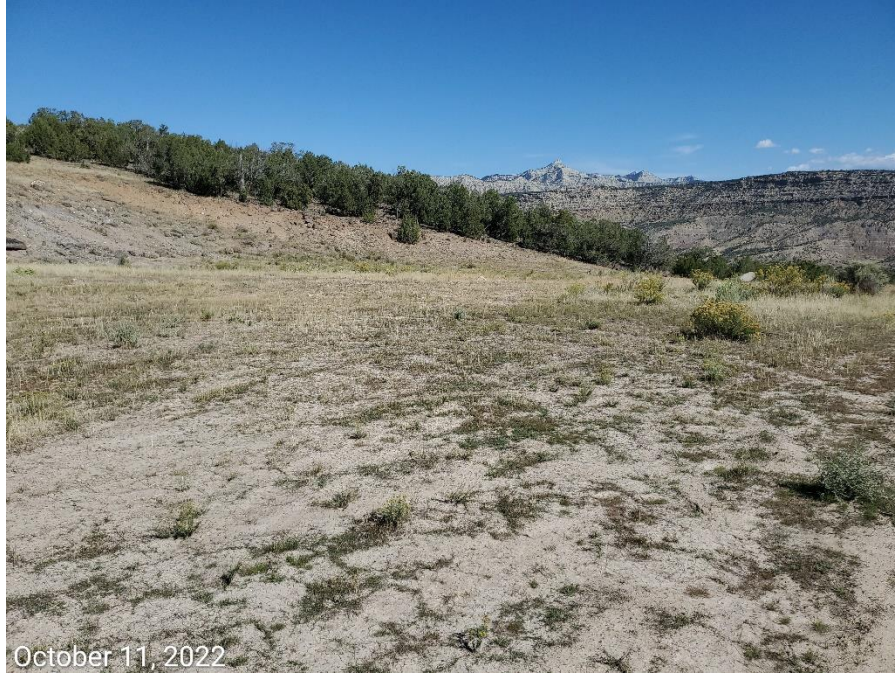
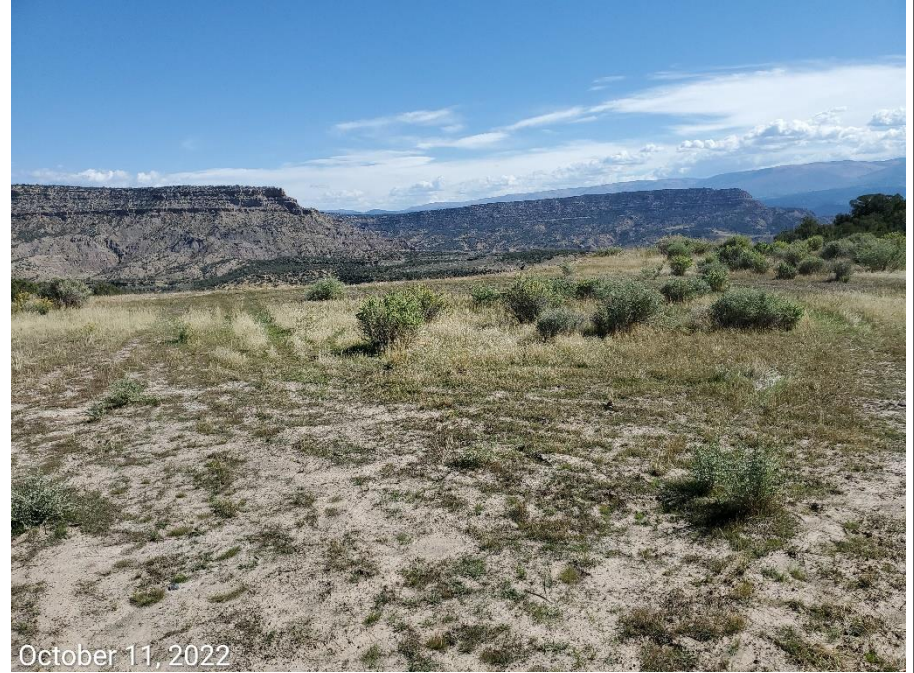
Photo 5: See comments under photo 4.

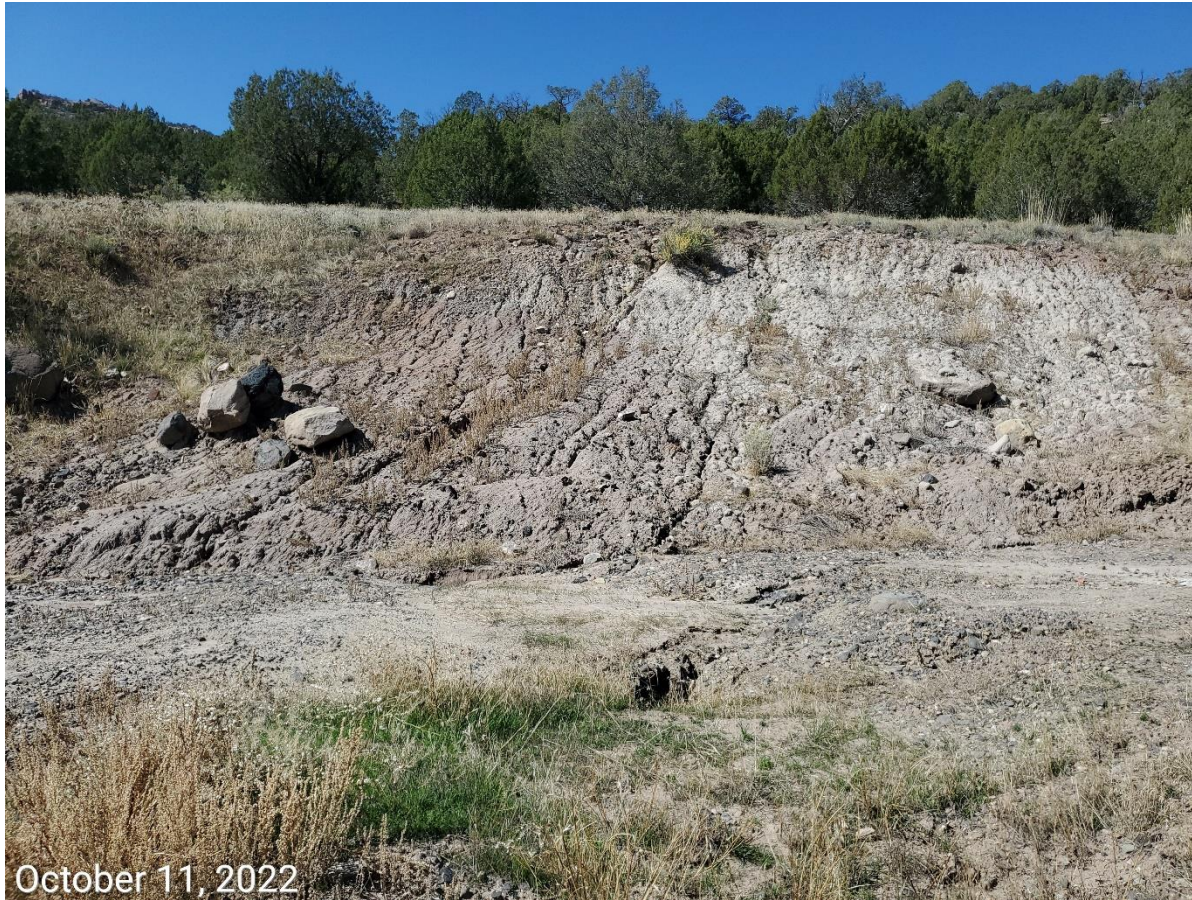
Photo 6: Photo shows erosion degradation at the cut slopes of the Location. BMPs to manage stormwater runoff missing or insufficient on the Location

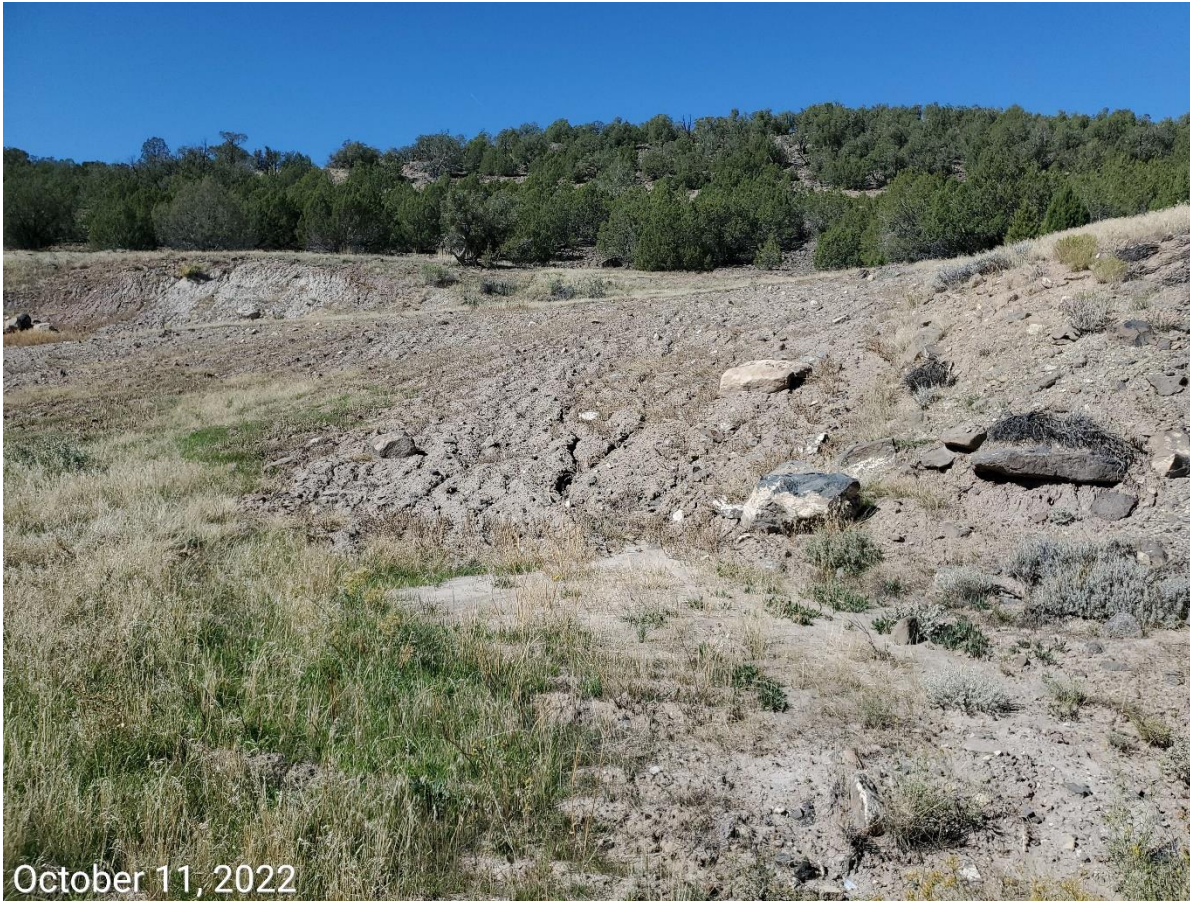
Photo 7: See comments under photo 6.

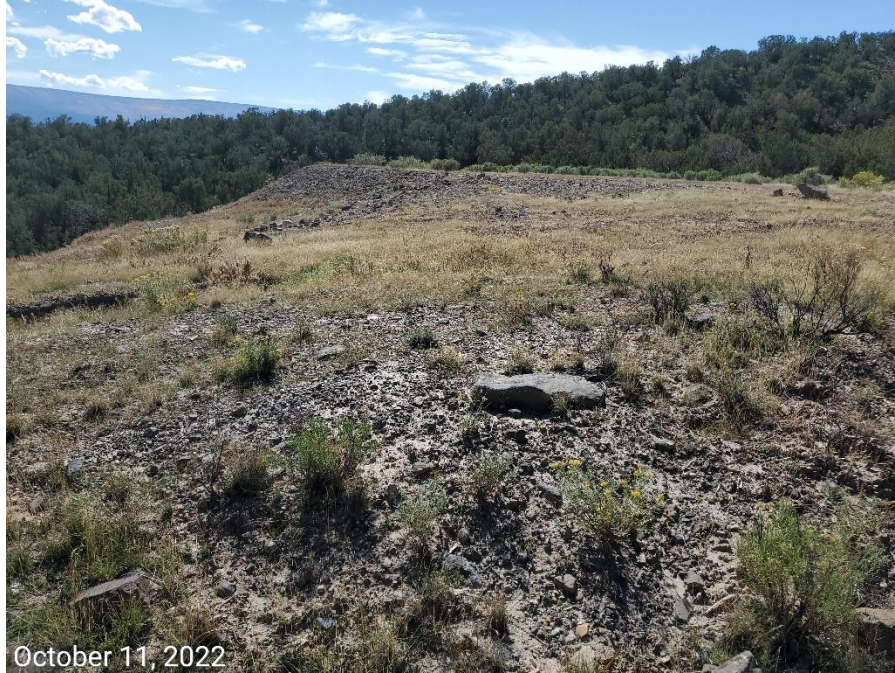
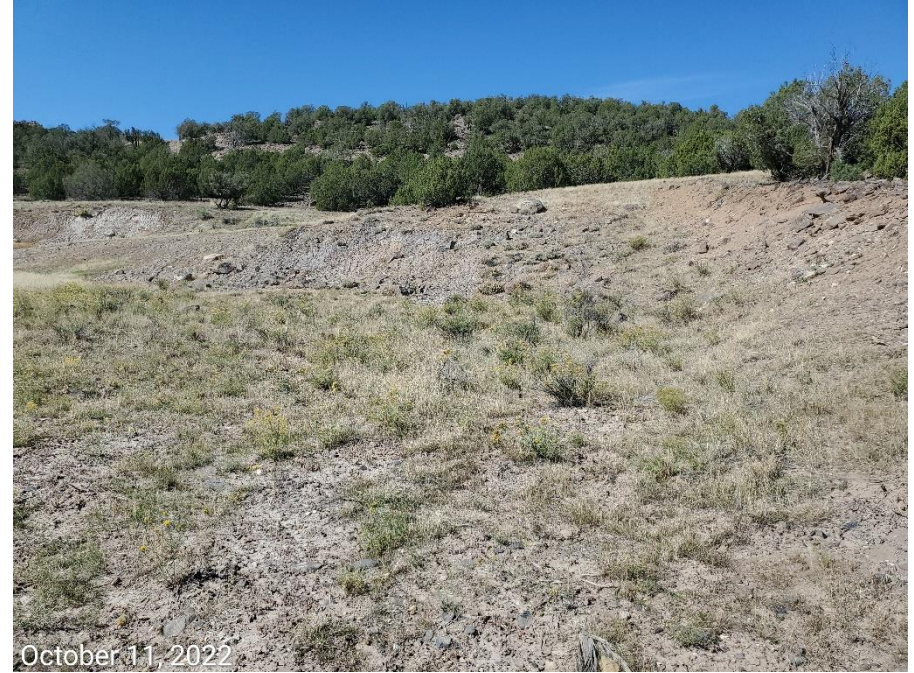
Photo 8: Photos taken from the east end of the Location, facing southwest and northwest. Photos show cut (photo right) and fill (photo left) slope remaining- Location has not been reclaimed.

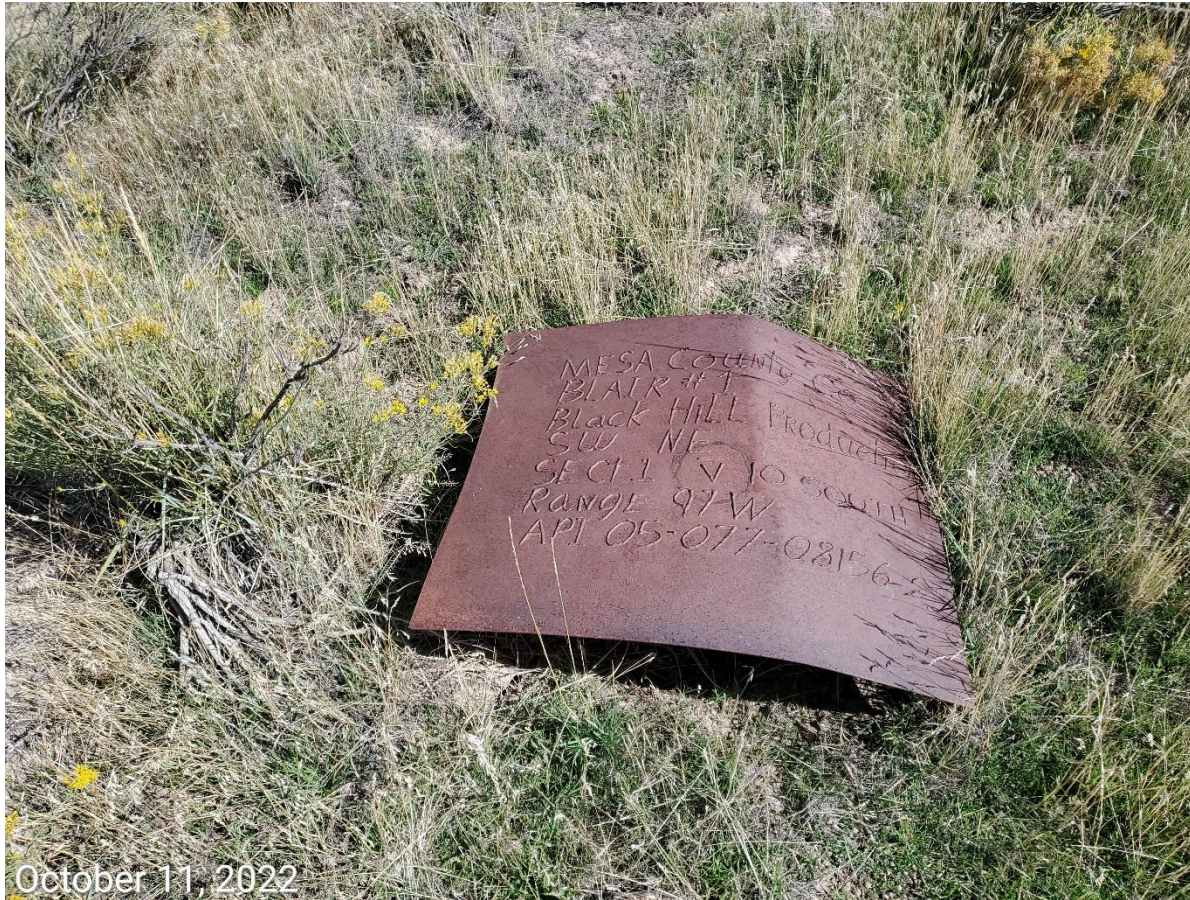
Photo 9: Photo shows welded plate representing the well marker left at the surface. Rules at time of plugging required permanent monuments marking well at surface was required to be a piece of pipe not less than 4 inches in diameter and not less than 10 feet in length, of which 4 feet shall be above the general ground level; monument left at surface does not comport with abandoned well marker requirements.

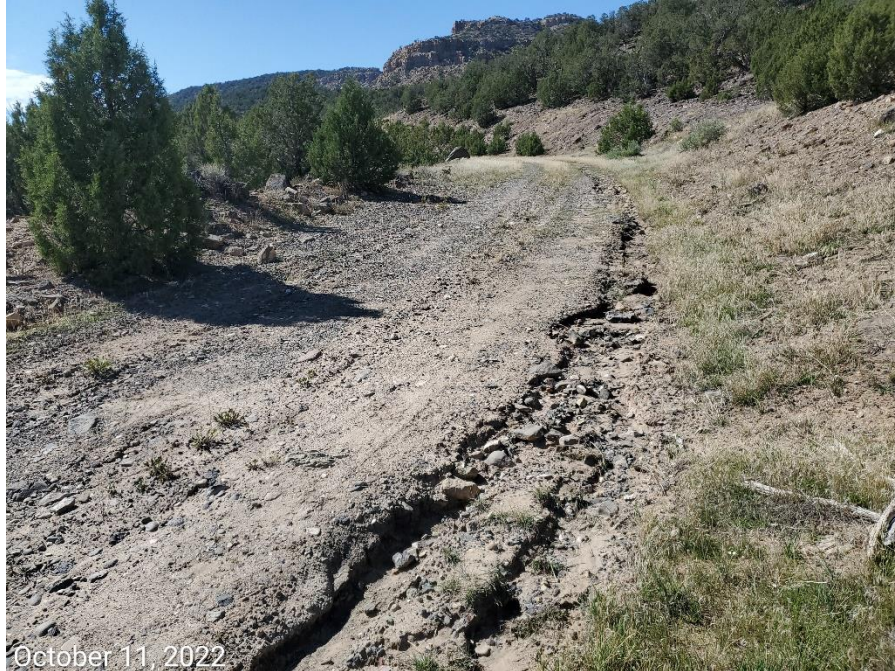
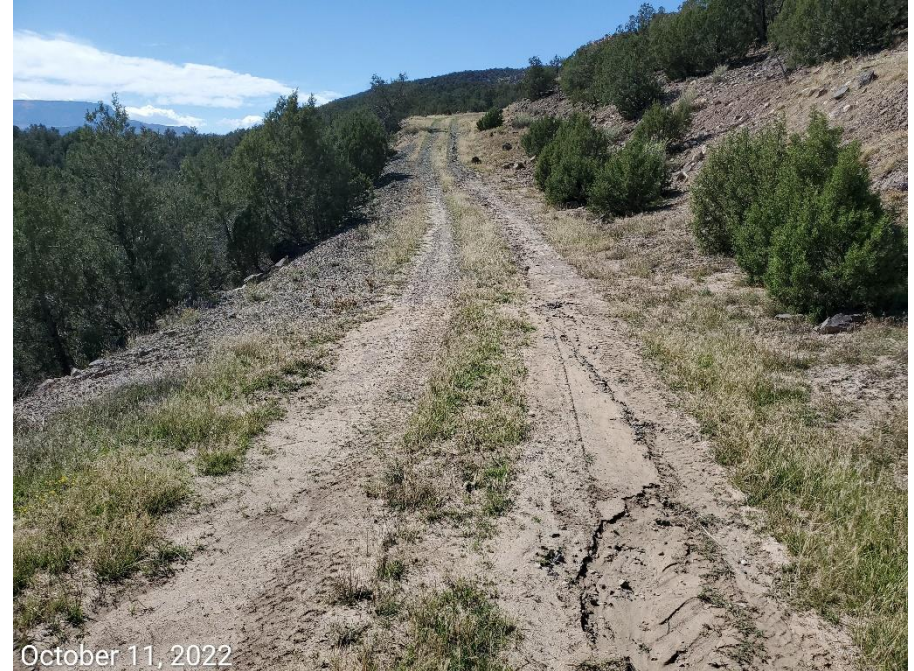
Photo 10: Photos examples showing access road has not been recontoured, regraded and reclaimed; gravel/road base remains evident. Photo shows stormwater erosion degradation issues also apparent.
