Inspection Photos

October 10, 2022

Location Name: MDP #21 Pad /13A-19-691

Inspection Document #: 702800790

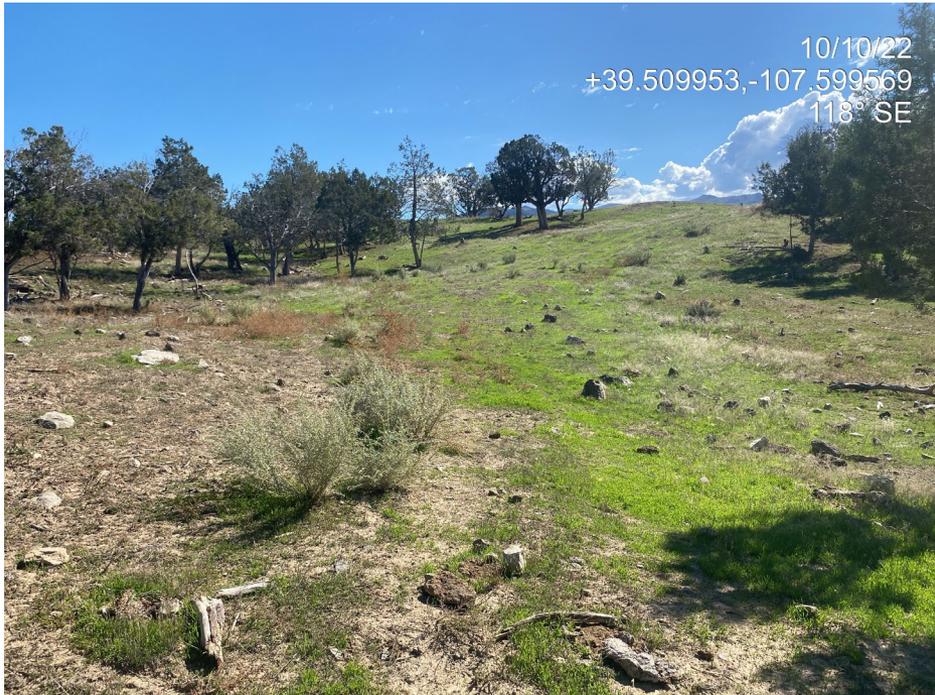
Photo 1. Photo shows the reclaimed access road to the southeast of the Location. Vegetation is dominated by annual weeds. Fourwing saltbush (native shrub) is also present.

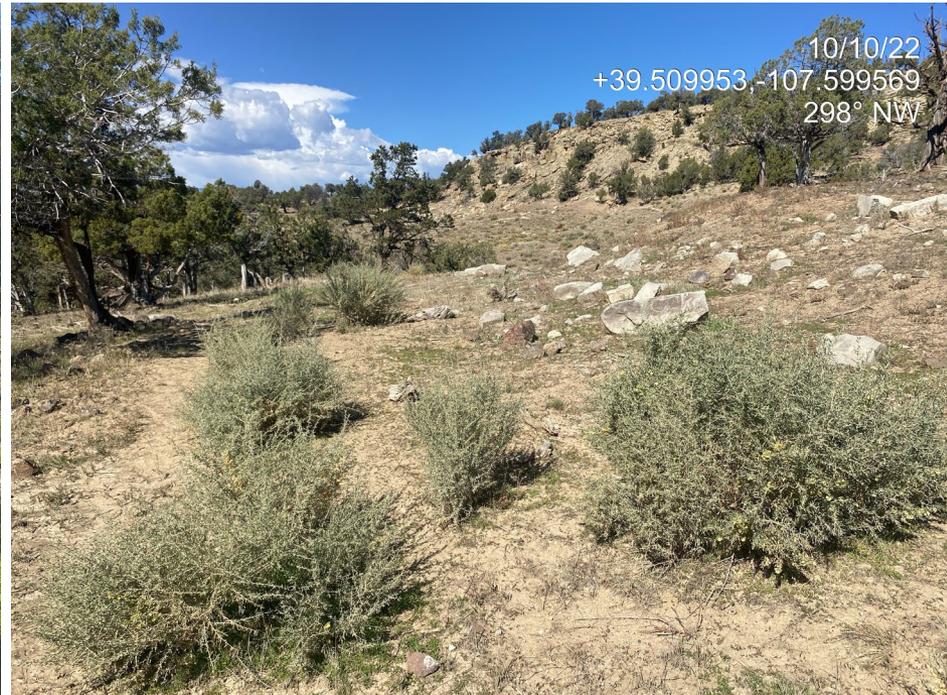
Photo 2. Refer to Photo 1 comment.

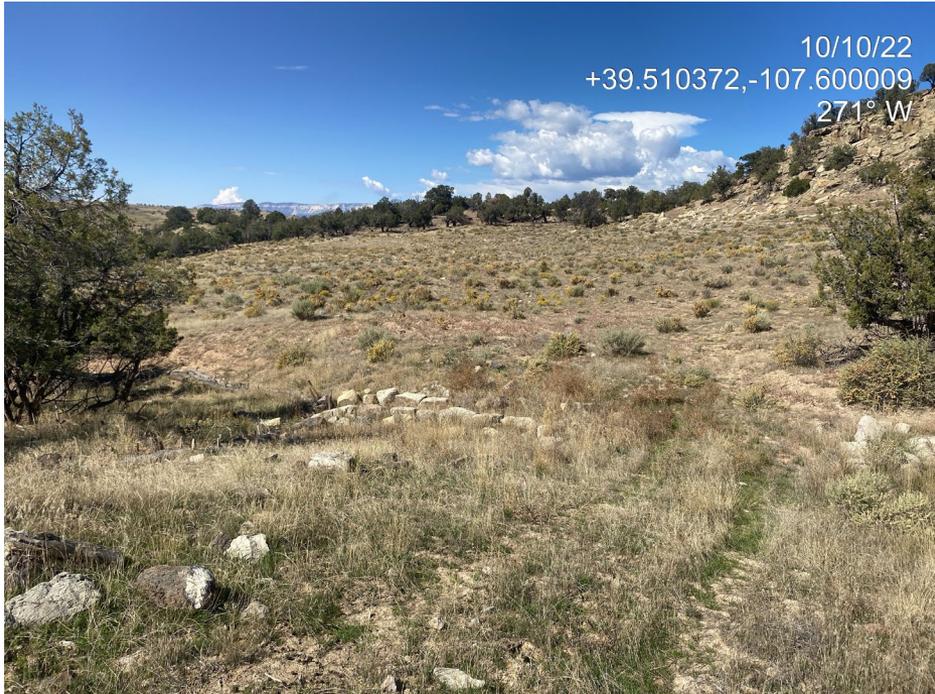
Photo 3. Photo taken from the Location entrance to the east shows an overview of the reclaimed Location.

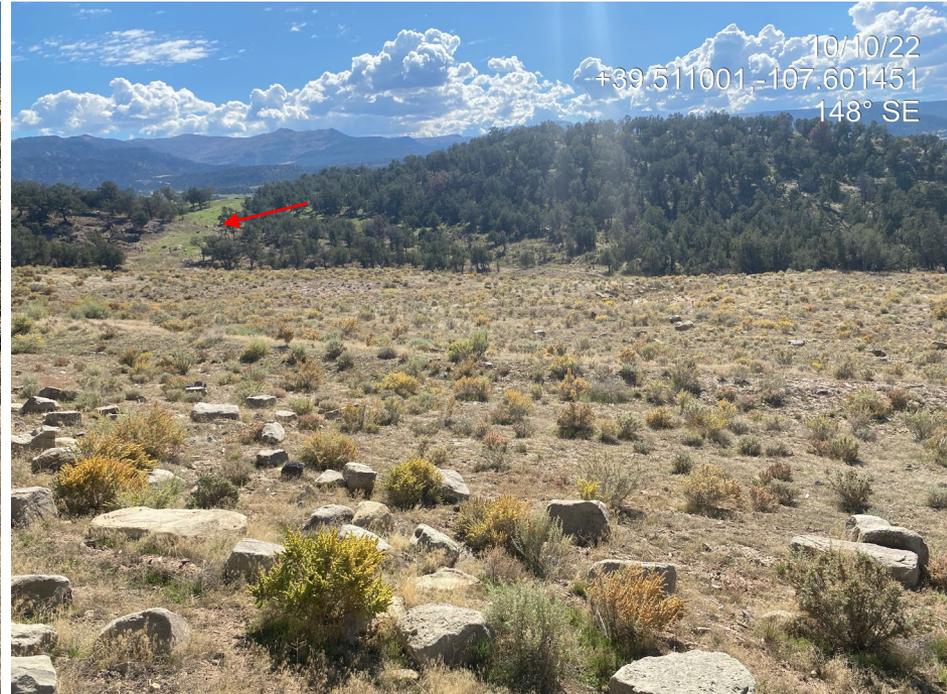
Photo 4. Photo taken from the north shows an overview of the reclaimed Location and access road (red arrow).

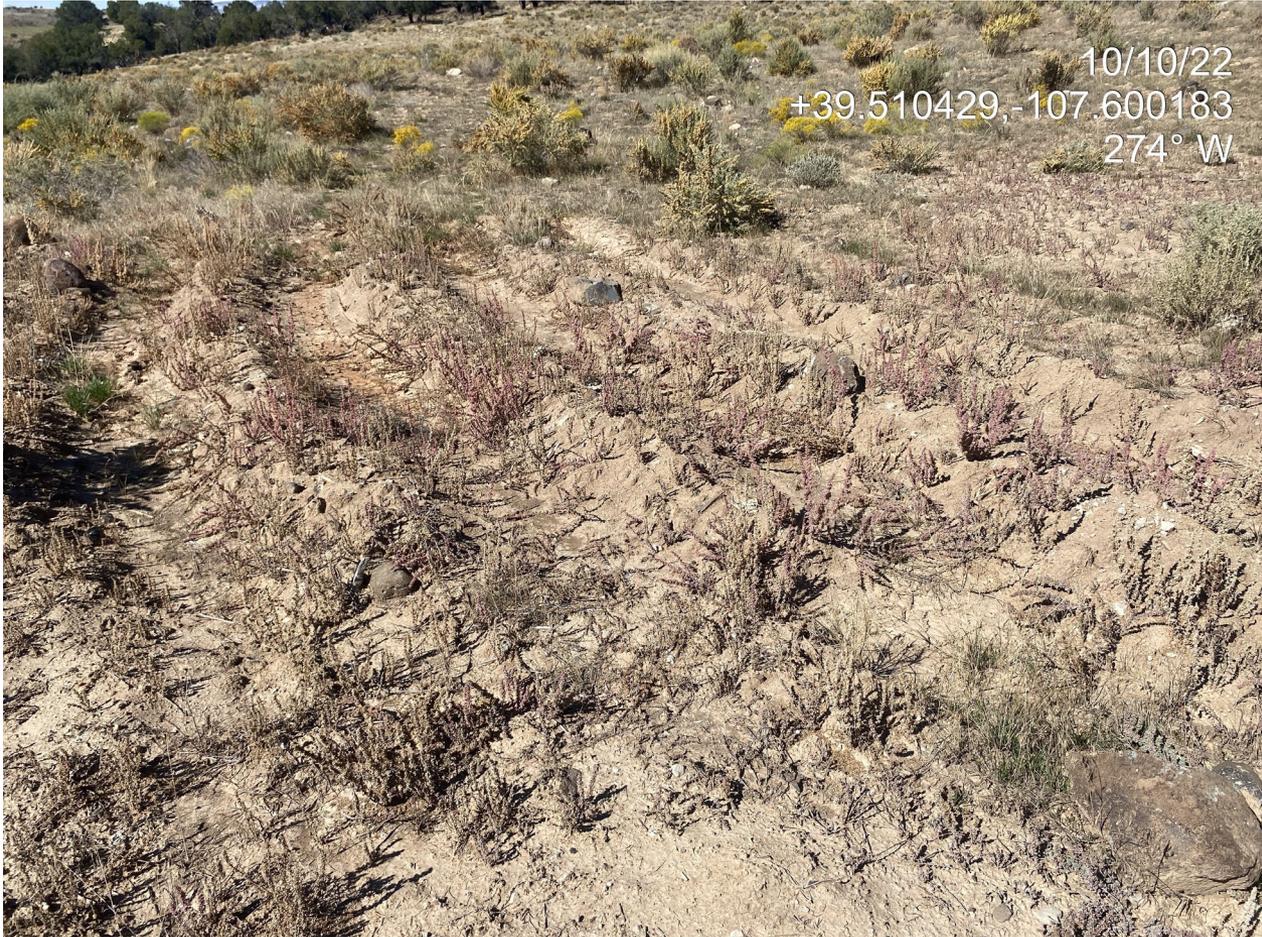
Photo 5. Photo shows an example of an area with poor perennial establishment and dominance of annual undesirable plant species and noxious weeds.

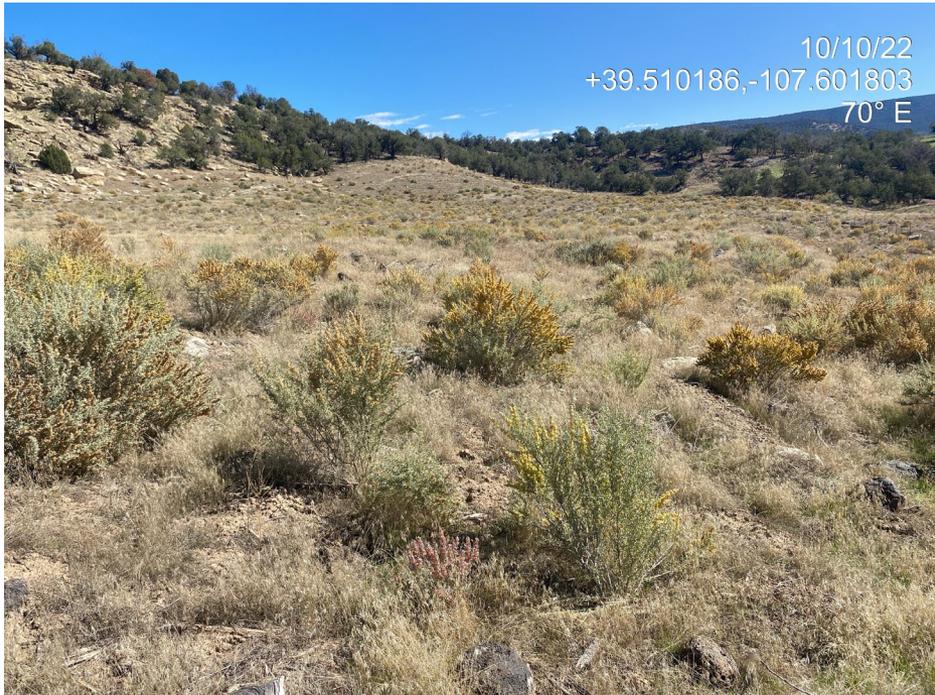
Photo 6. Photo shows an example of an area where shrubs are well established but the herbaceous understory is dominated by the annual noxious weed, cheatgrass. Perennial herbaceous plants are absent.

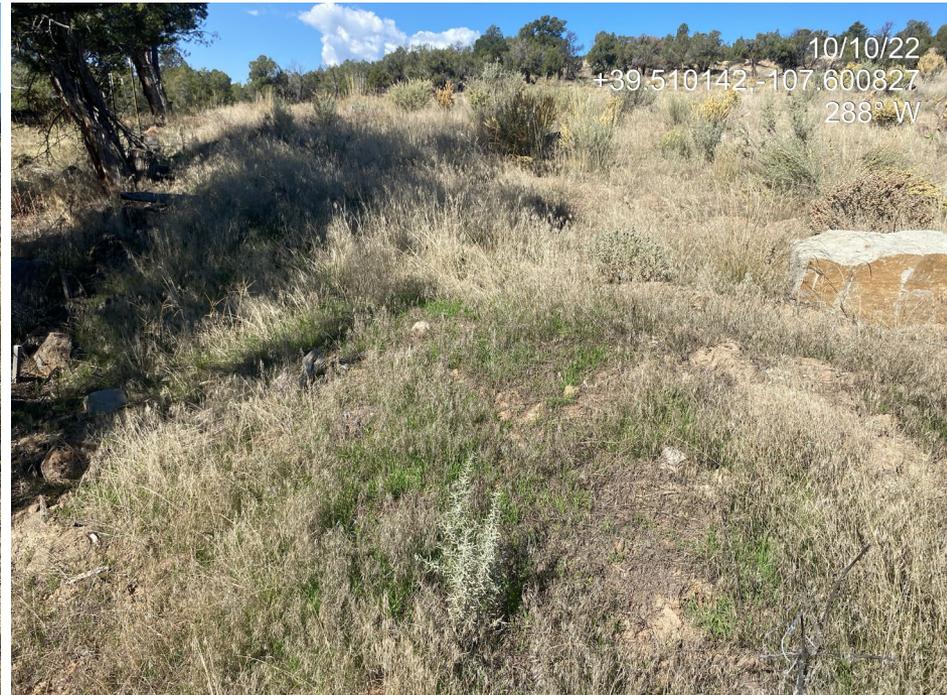
Photo 7. Photo shows dense establishment of cheatgrass and absence of desirable perennials.

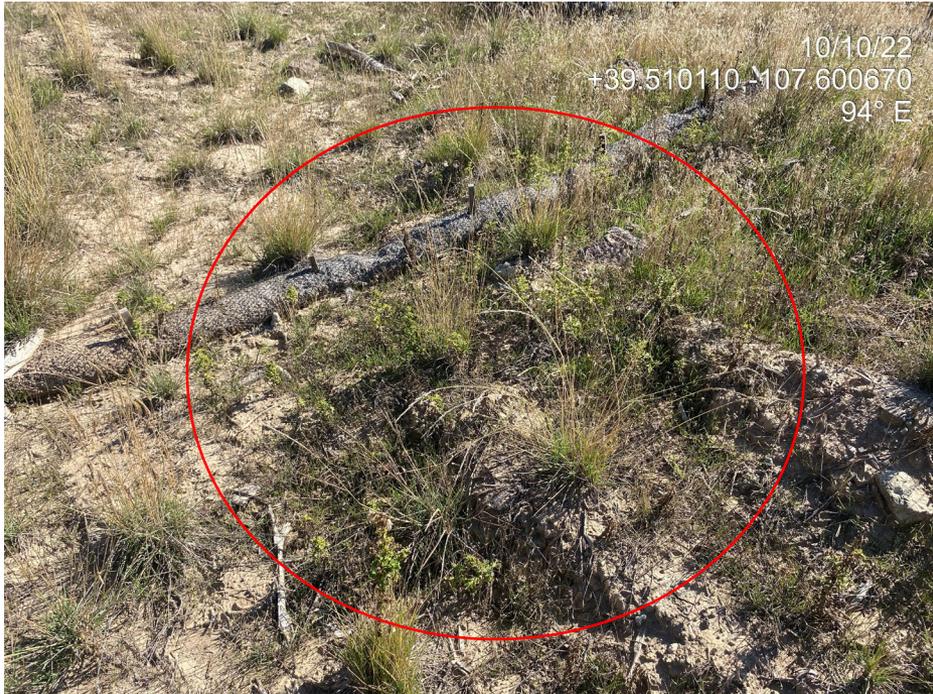
Photo 8. Photo shows a patch of Canada thistle, a CO List B Noxious Weed.

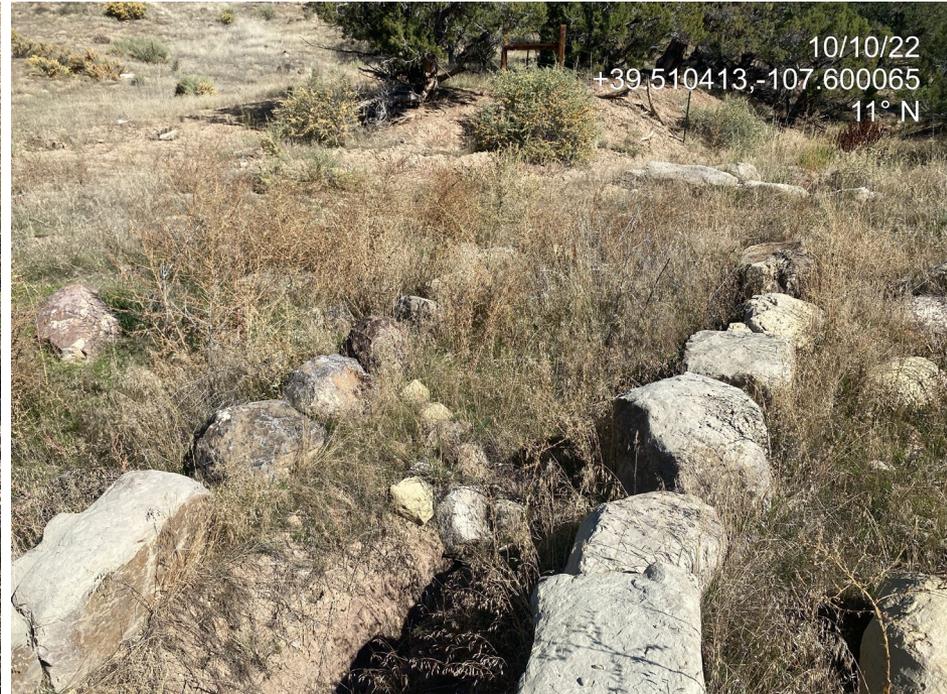
Photo 9. Photo shows stormwater control measures and dense establishment of cheatgrass and kochia and absence of desirable perennial species.

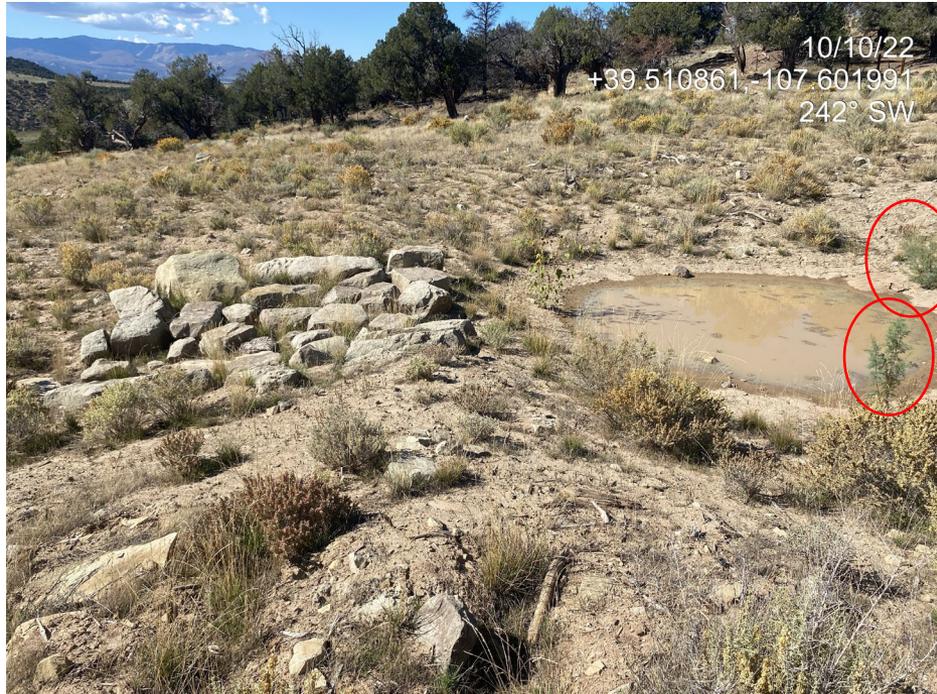
Photo 10. Photo shows stormwater control measures and vegetation establishment. Red circles indicate tamarisk, a CO List B Noxious Weed.

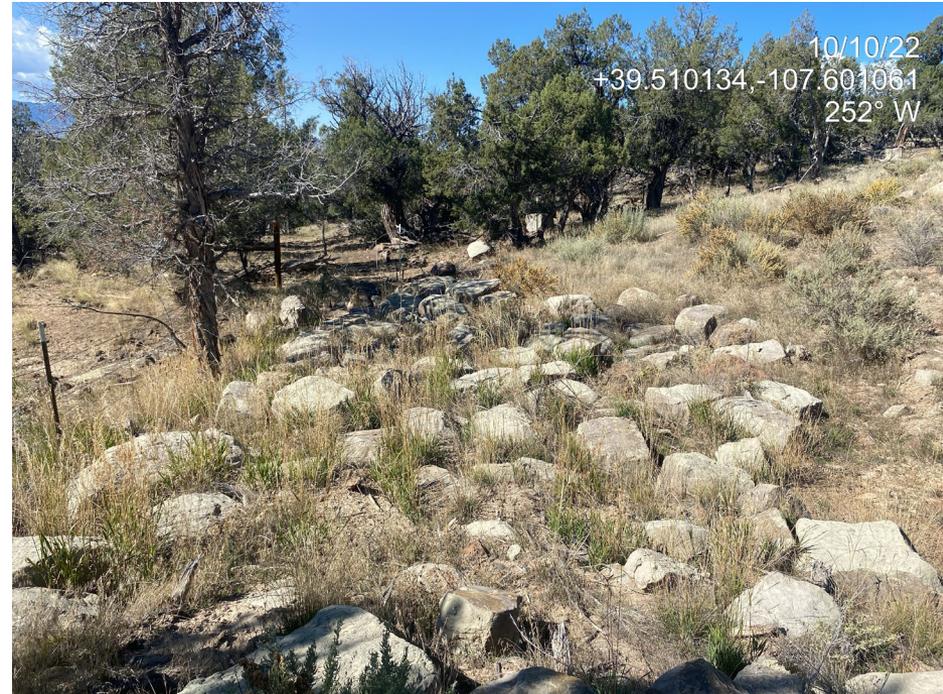
Photo 11. Photo shows stormwater control measures and vegetation establishment.

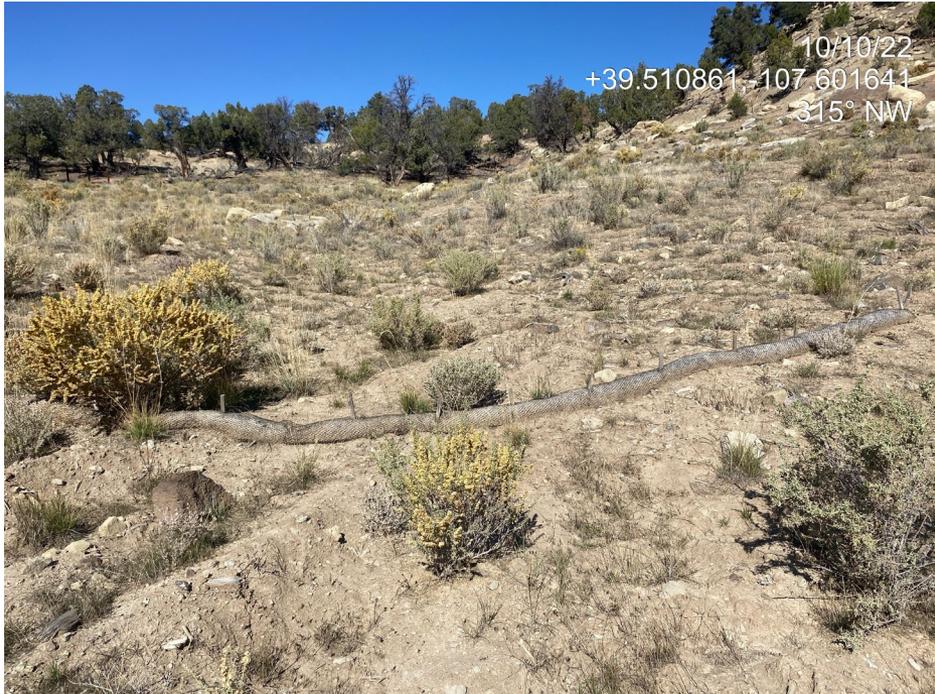
Photo 12. Photo shows stormwater control measures and vegetation establishment.

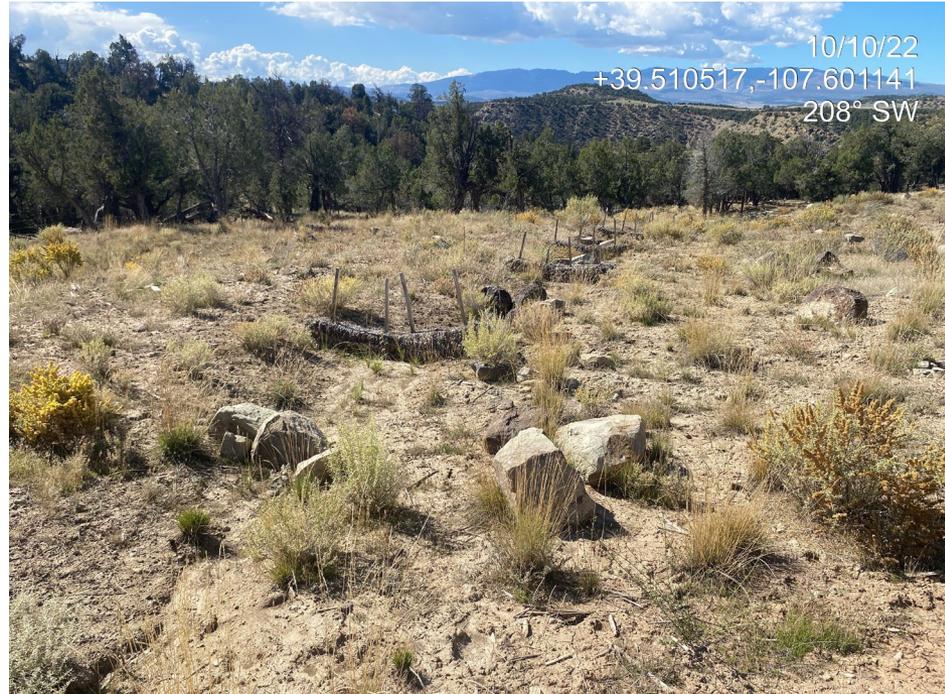
Photo 13. Photo shows stormwater control measures and vegetation establishment.

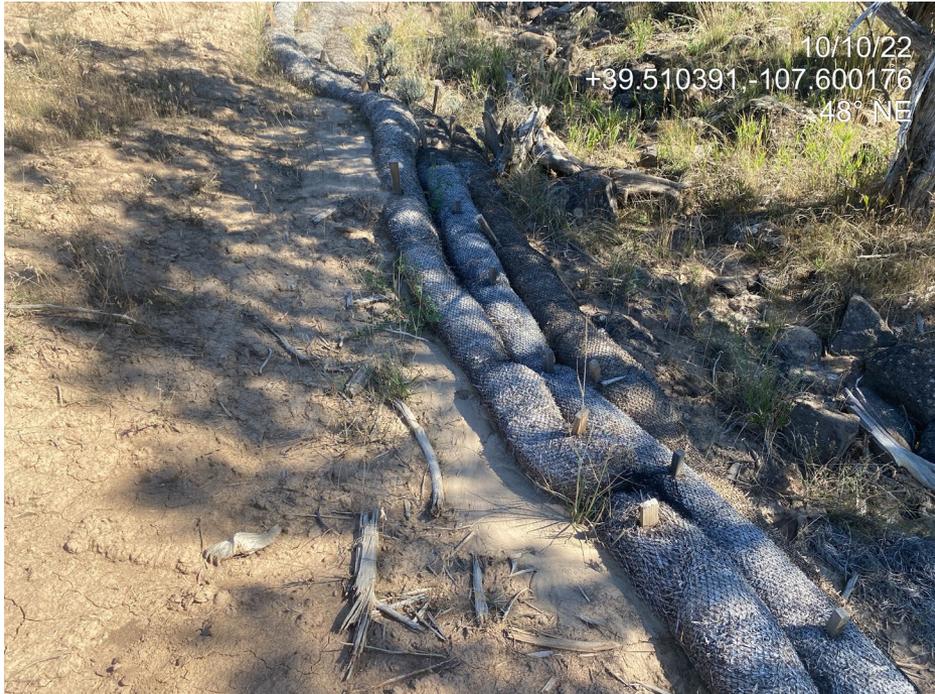
Photo 14. Photo shows stormwater control measures and vegetation establishment.

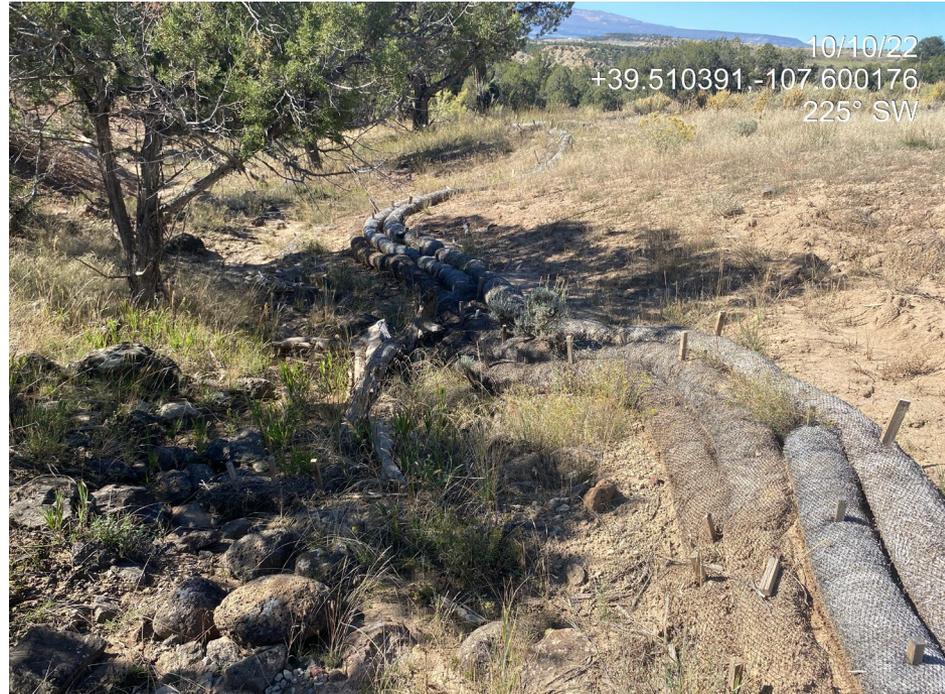
Photo 15. Photo shows stormwater control measures and vegetation establishment.

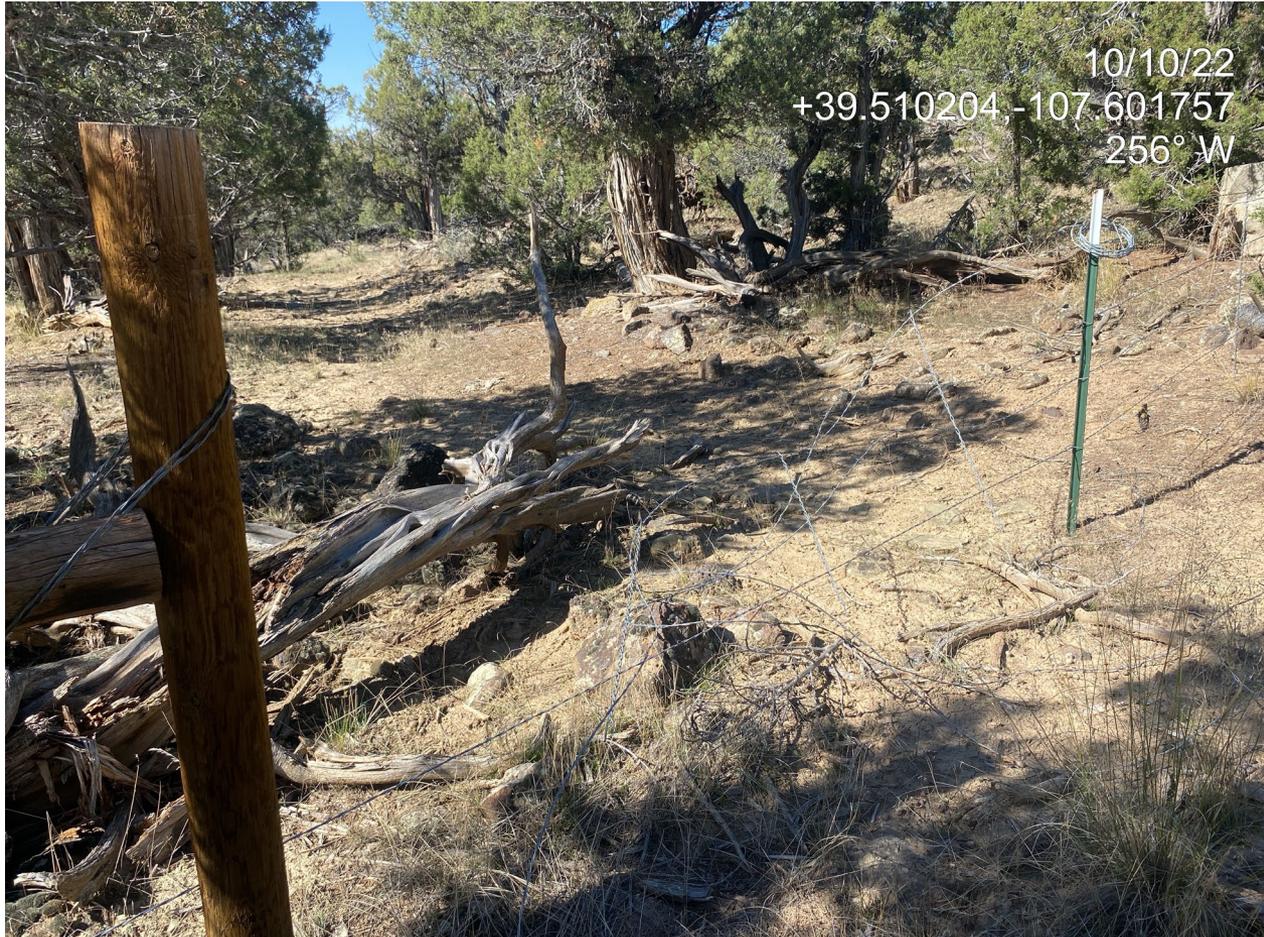
Photo 16. Photo taken to the west of the Location shows the perimeter fence is non-functioning. It appears to have been cut.

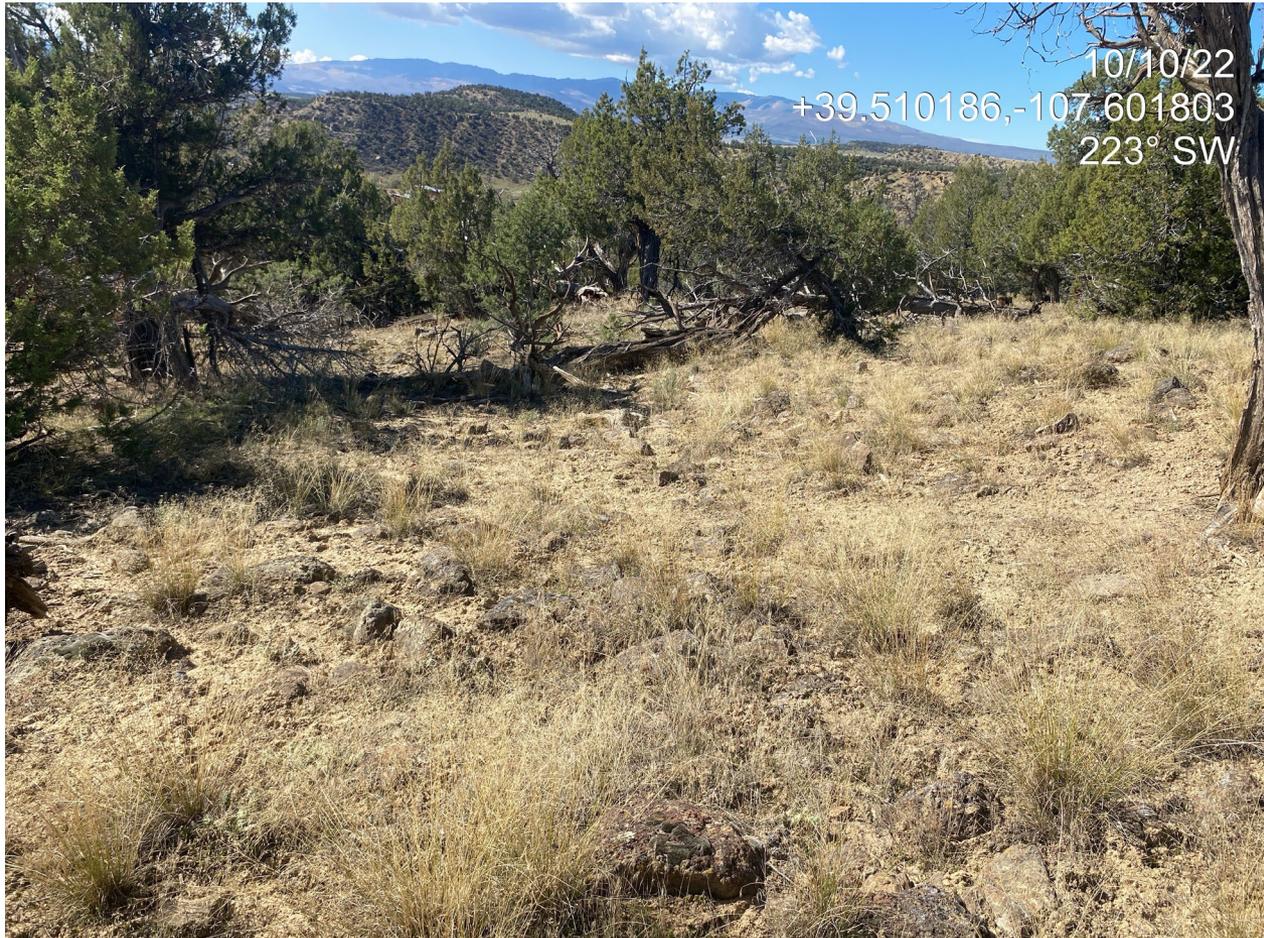
Photo 17. Photo taken to the west of the Location shows the reference area vegetation community is dominated by pinyon and juniper with an Indian ricegrass understory.
