# Inspection Photos

API: 055-06012

Operator: OXY USA INC

Inspection Date: 10/6/2022

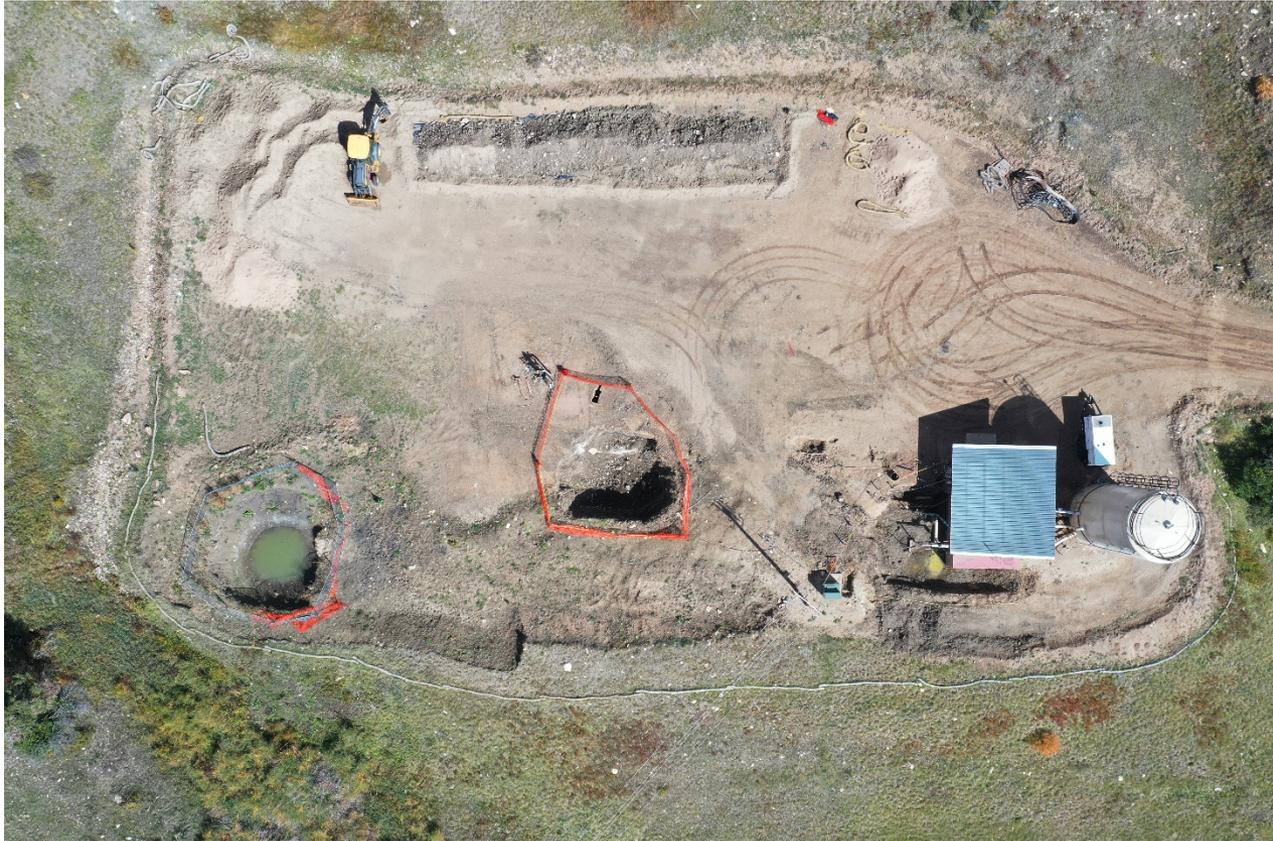
**Photo 1.** Drone aerial photo of the location showing the excavated areas of the remediation project.

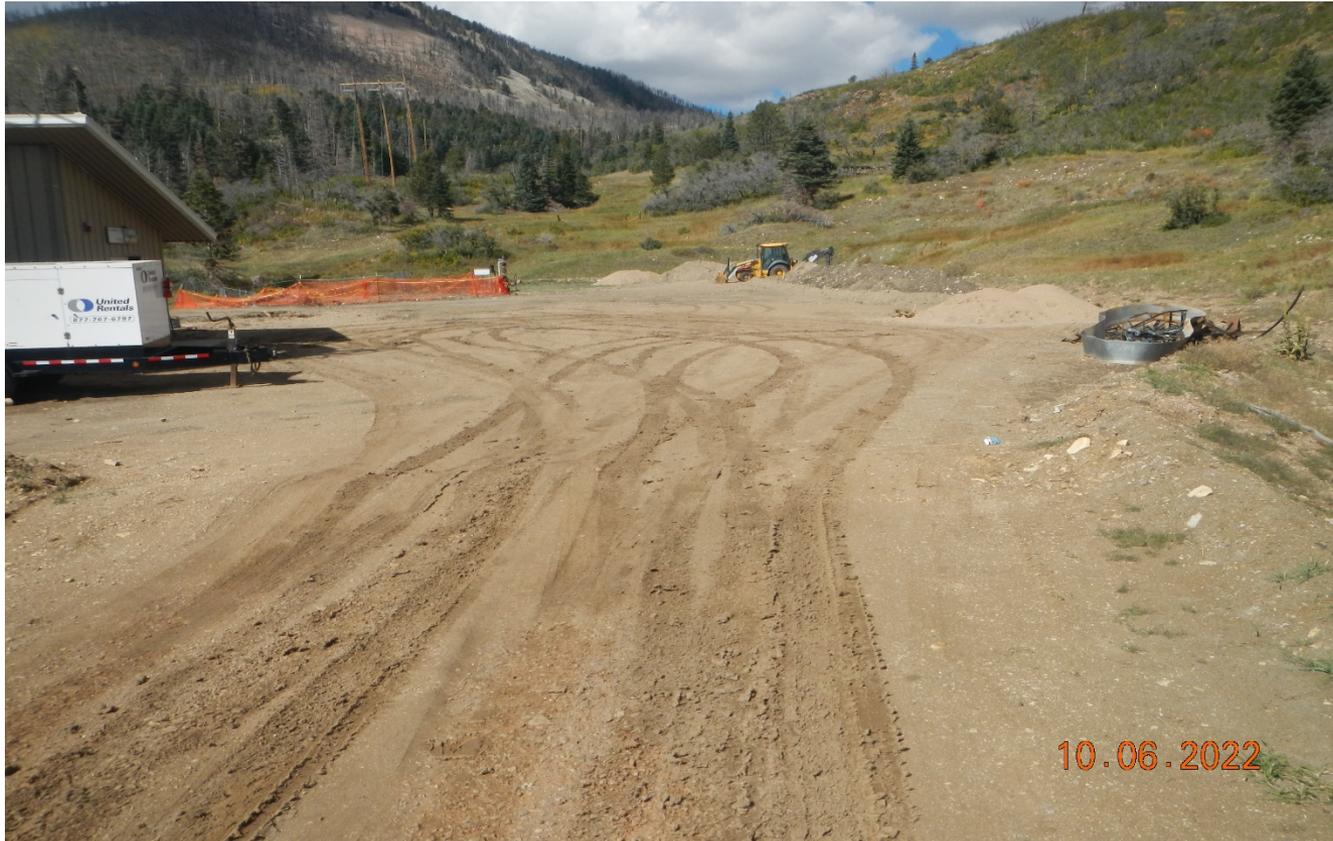
**Photo 2.** Facing northwest toward the location.

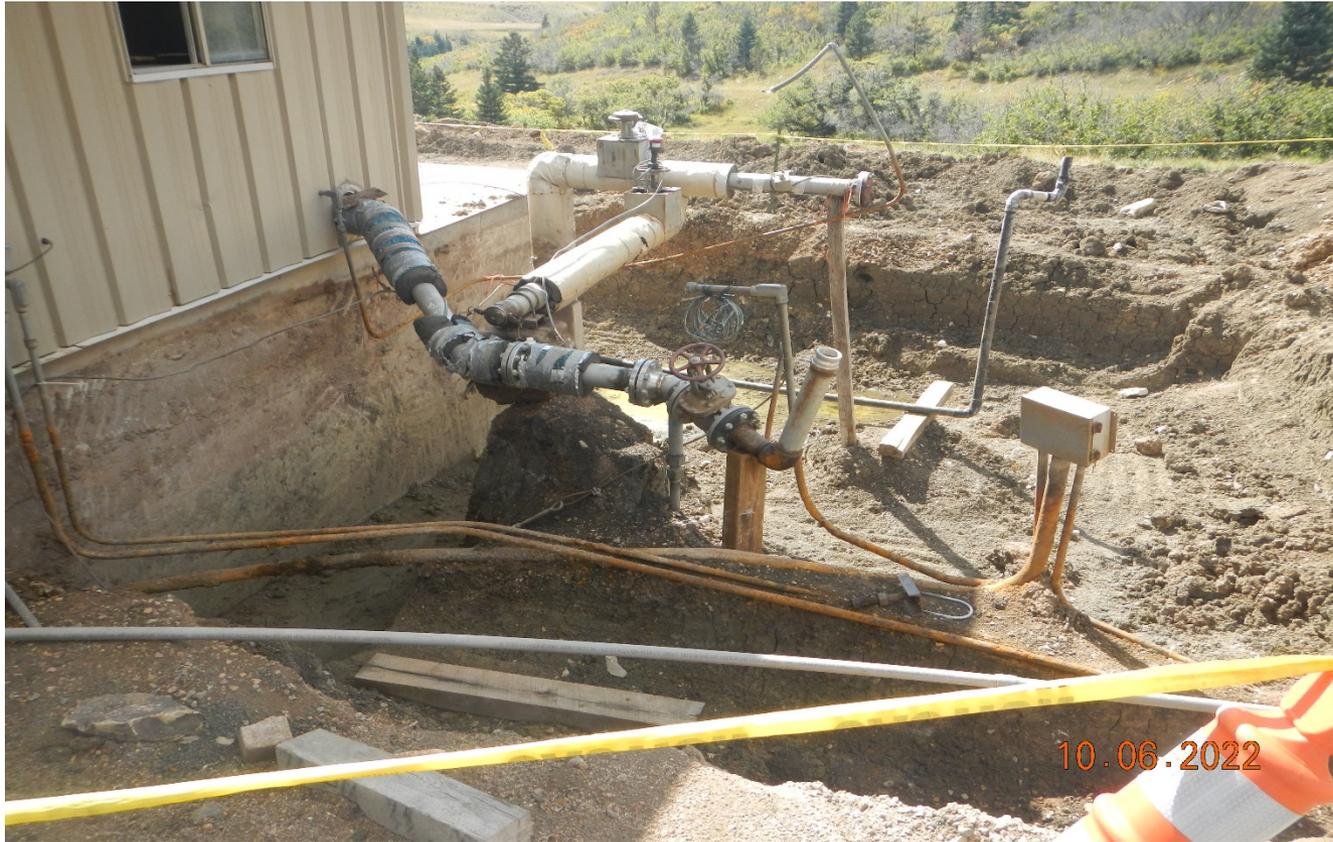
**Photo 3.** Facing where tank was located. Impacted soil were excavated from this area.

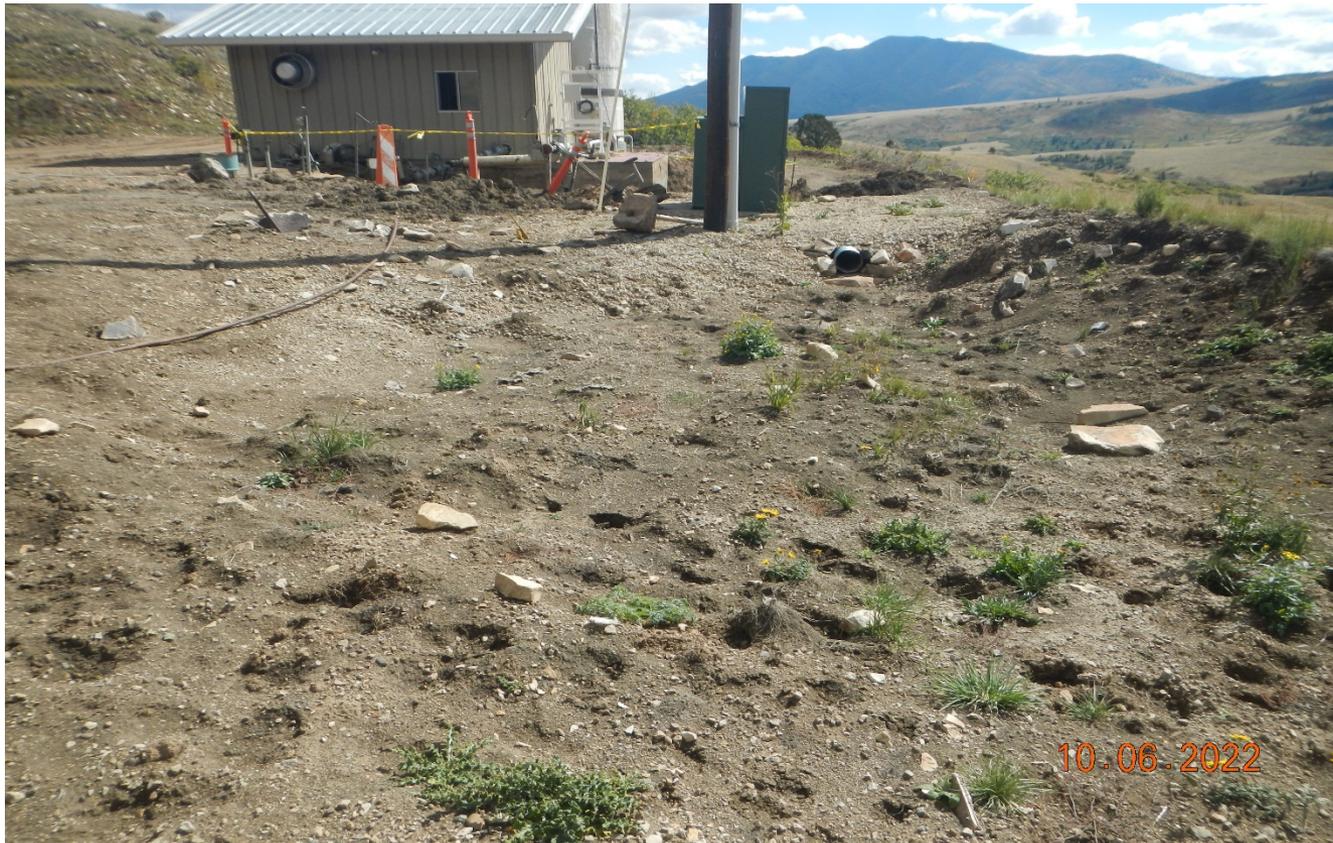
**Photo 4.** Standing at the shallow pit facing southeast.

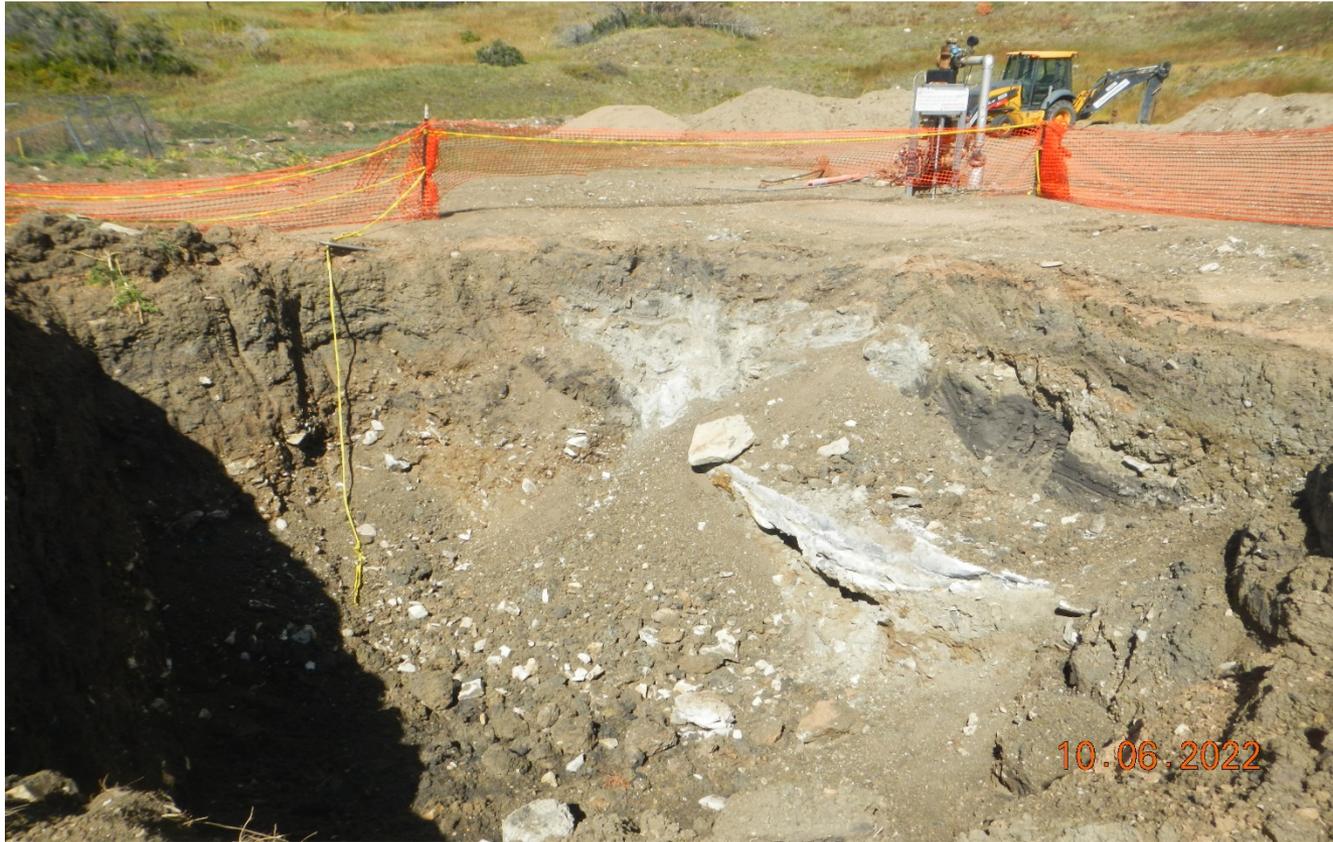
**Photo 5.** There is an excavation area at the center of the location.

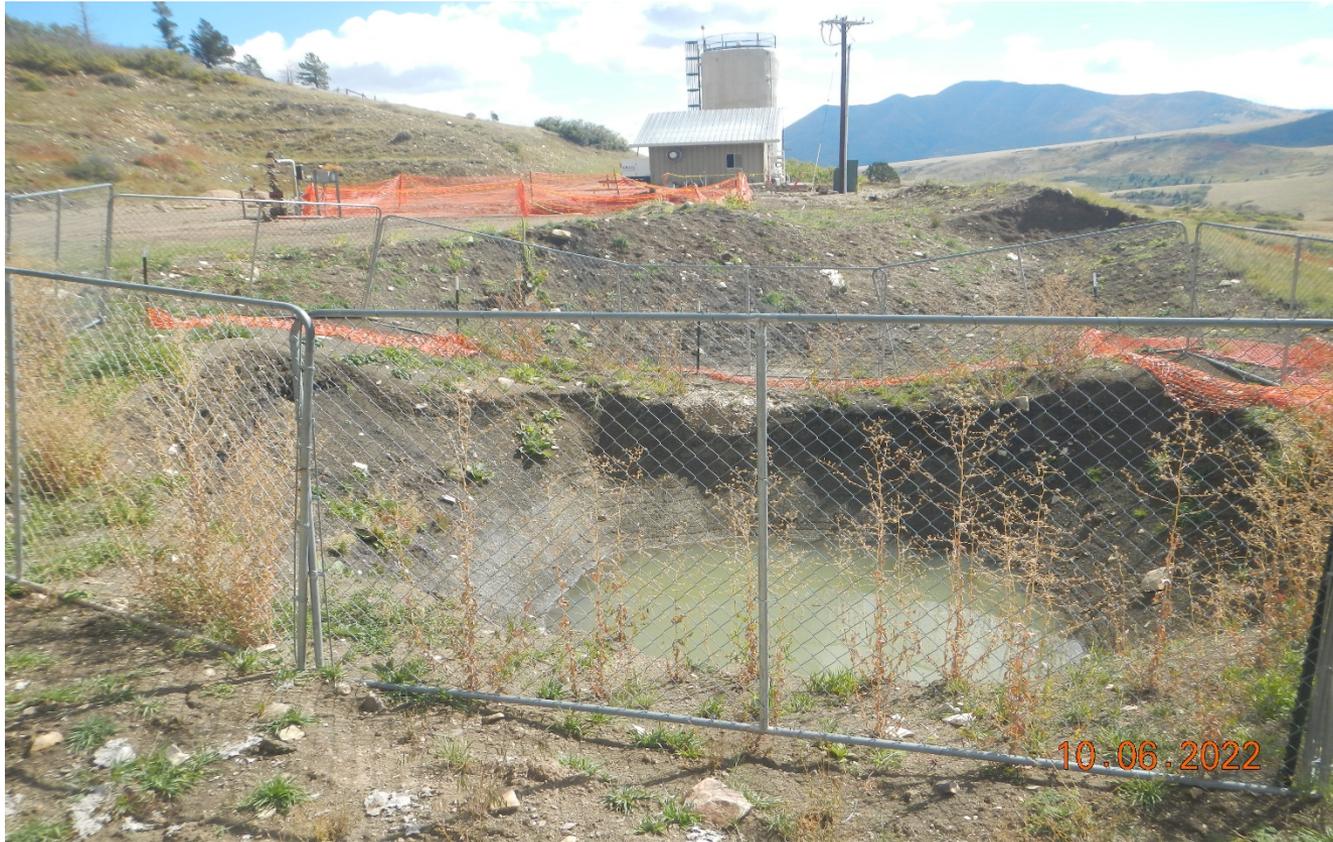
**Photo 6.** Southwest side of the location facing east.

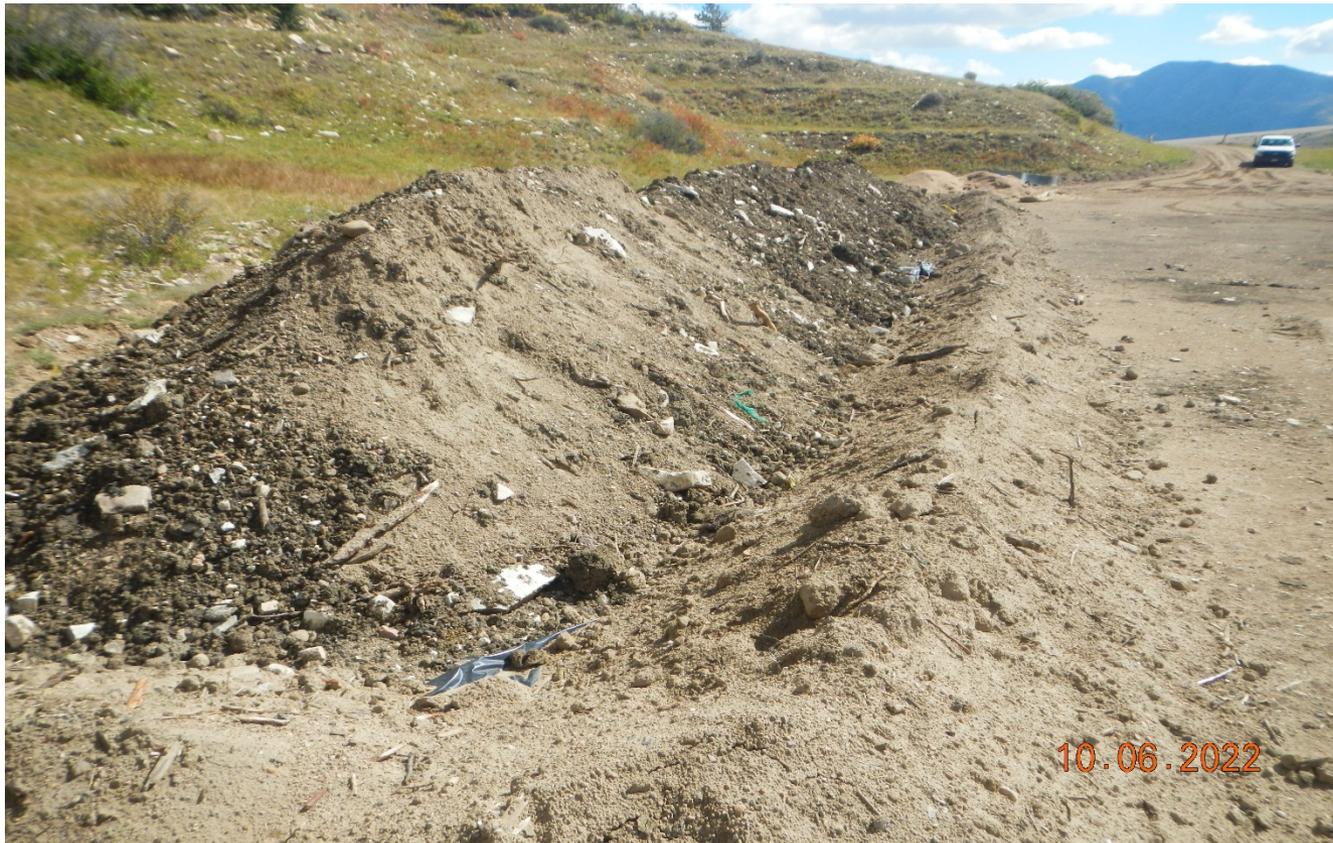
**Photo 7.** There is impacted soils being stored at the north side of the location.
