# Inspection Photos

API: 061-06023

Operator: WESTERN OPERATING COMPANY

Inspection Date: 10/12/2022

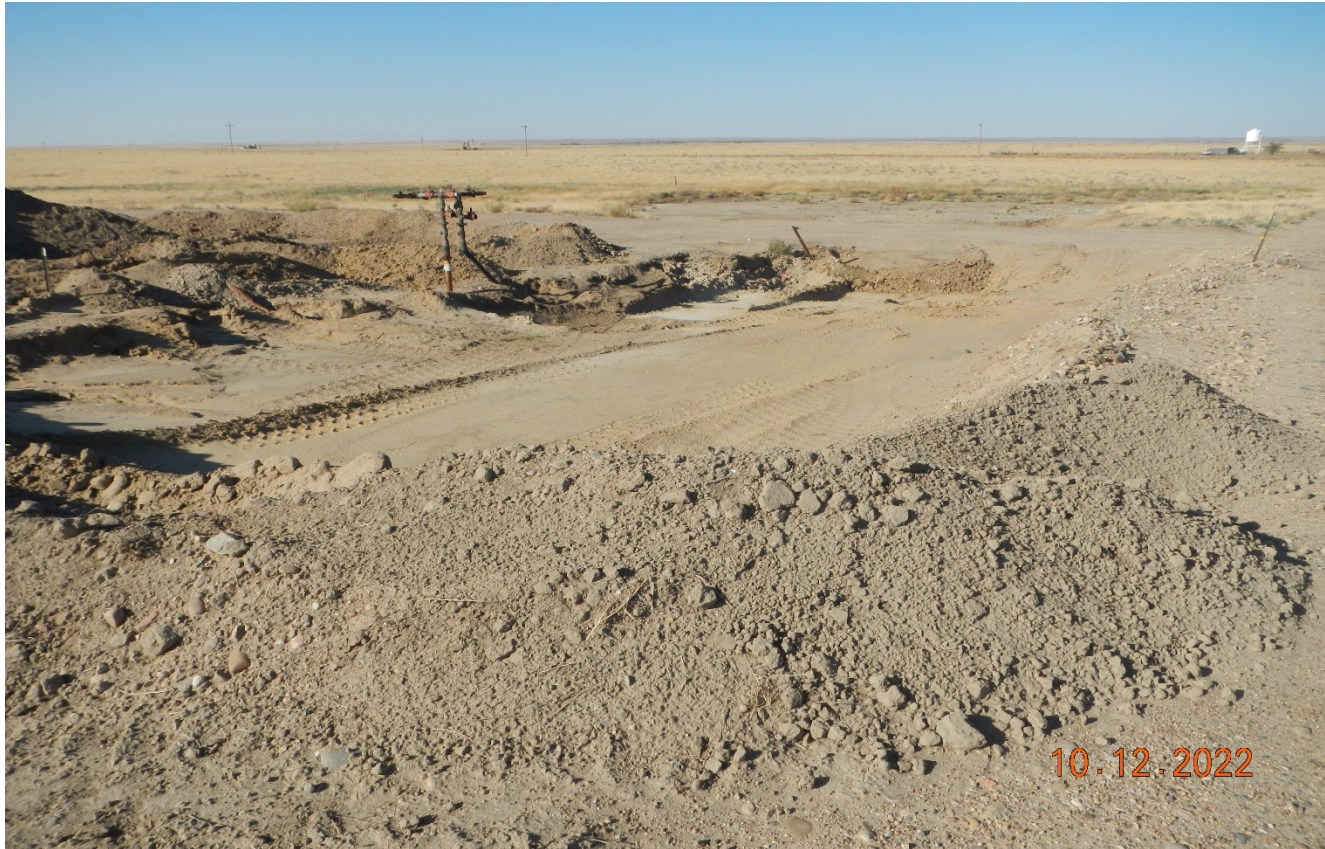
**Photo 2.** Facing southwest toward the tank battery facility. The tank was removed and soils have been excavated in this area. Remediation project: 20712

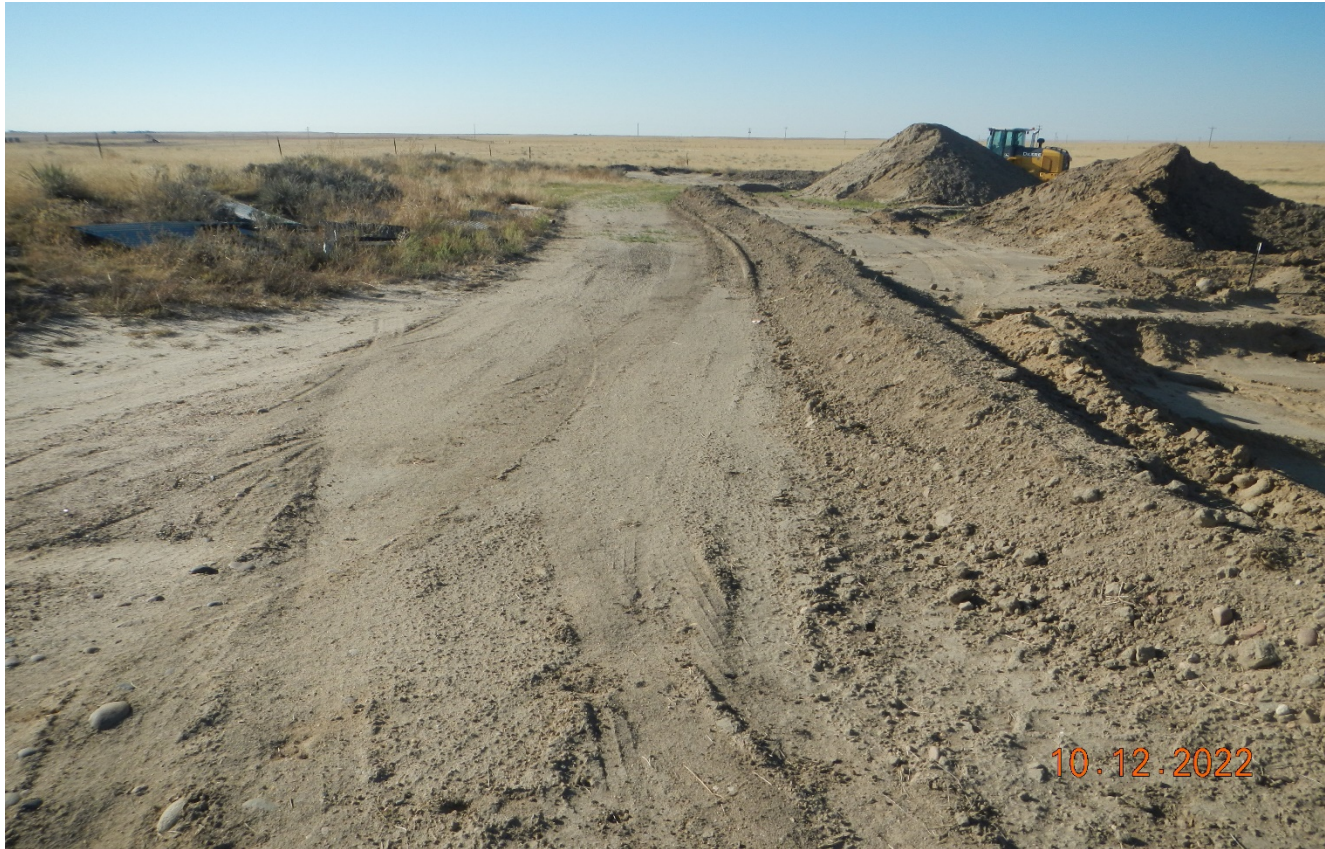
**Photo 3.** Facing south toward the east side of the tank battery location. A berm was installed around the perimeter of the soil piles. Berms are not compacted and may not withstand heavy precipitation.

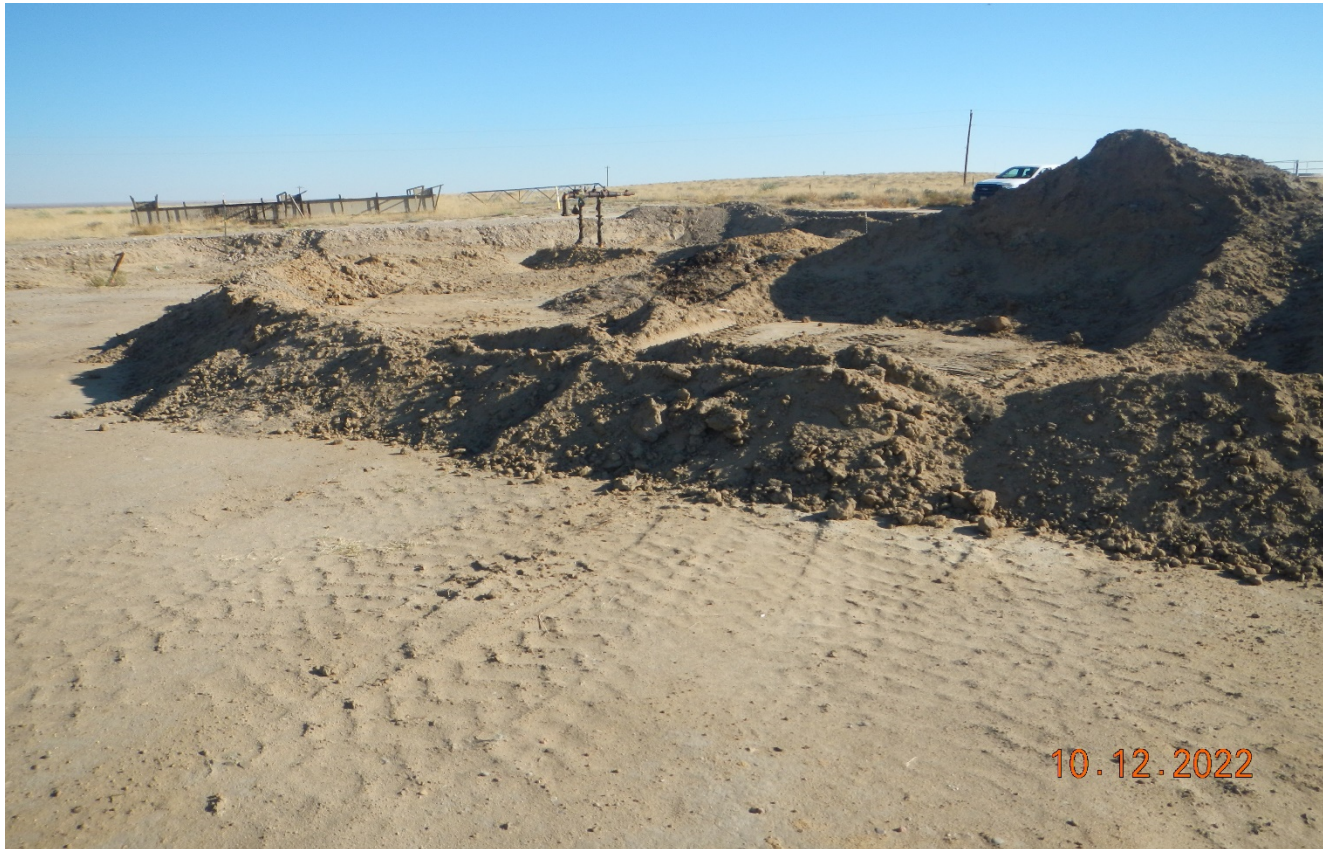
**Photo 4.** The berms around the soil piles have been constructed larger but were not compacted. Also, no liner was observed under the contaminated soils. Contaminated soils should be removed and properly disposed.

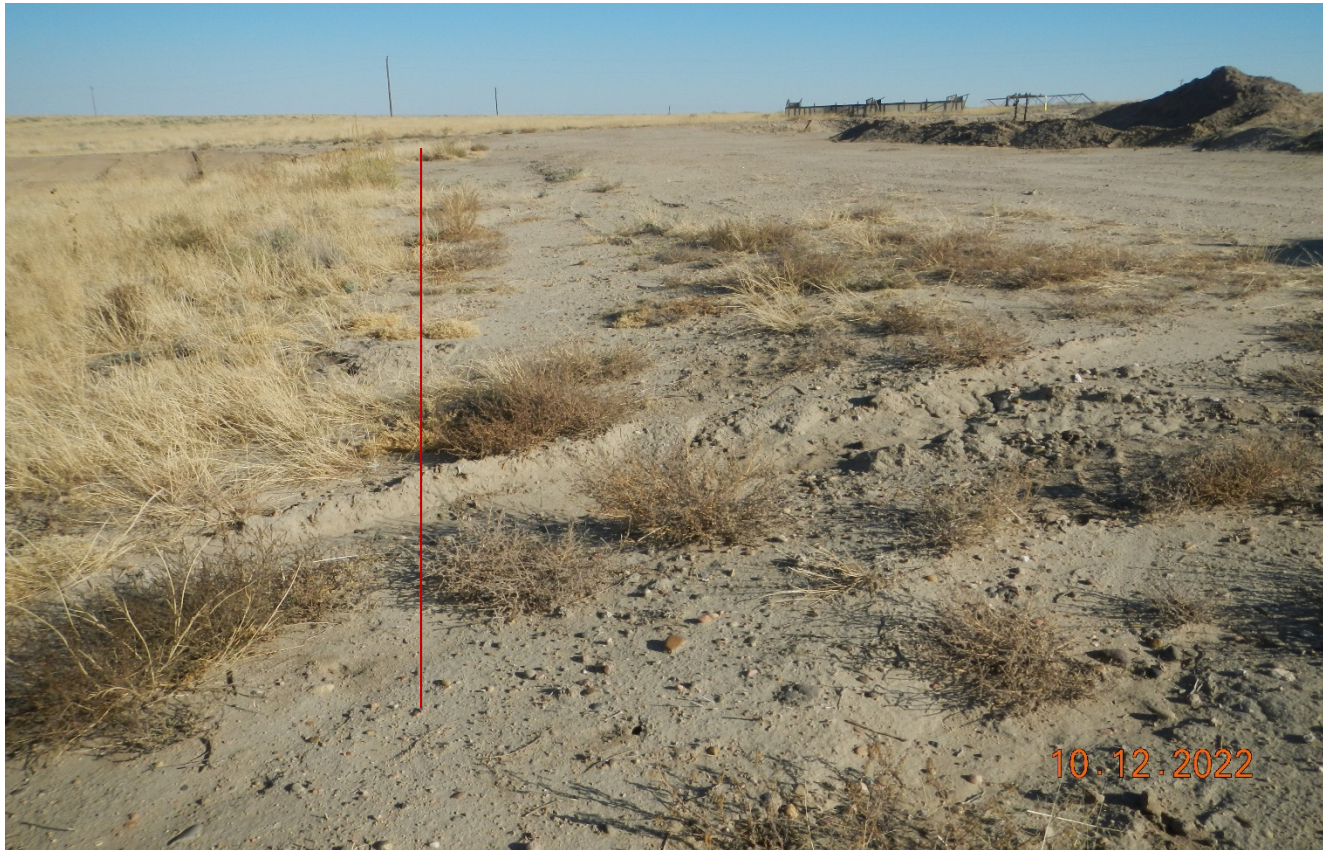
**Photo 5.** Facing north at the southwest side of the tank battery location. Additional BMP's should be installed on the down gradient side shown at red arrow.

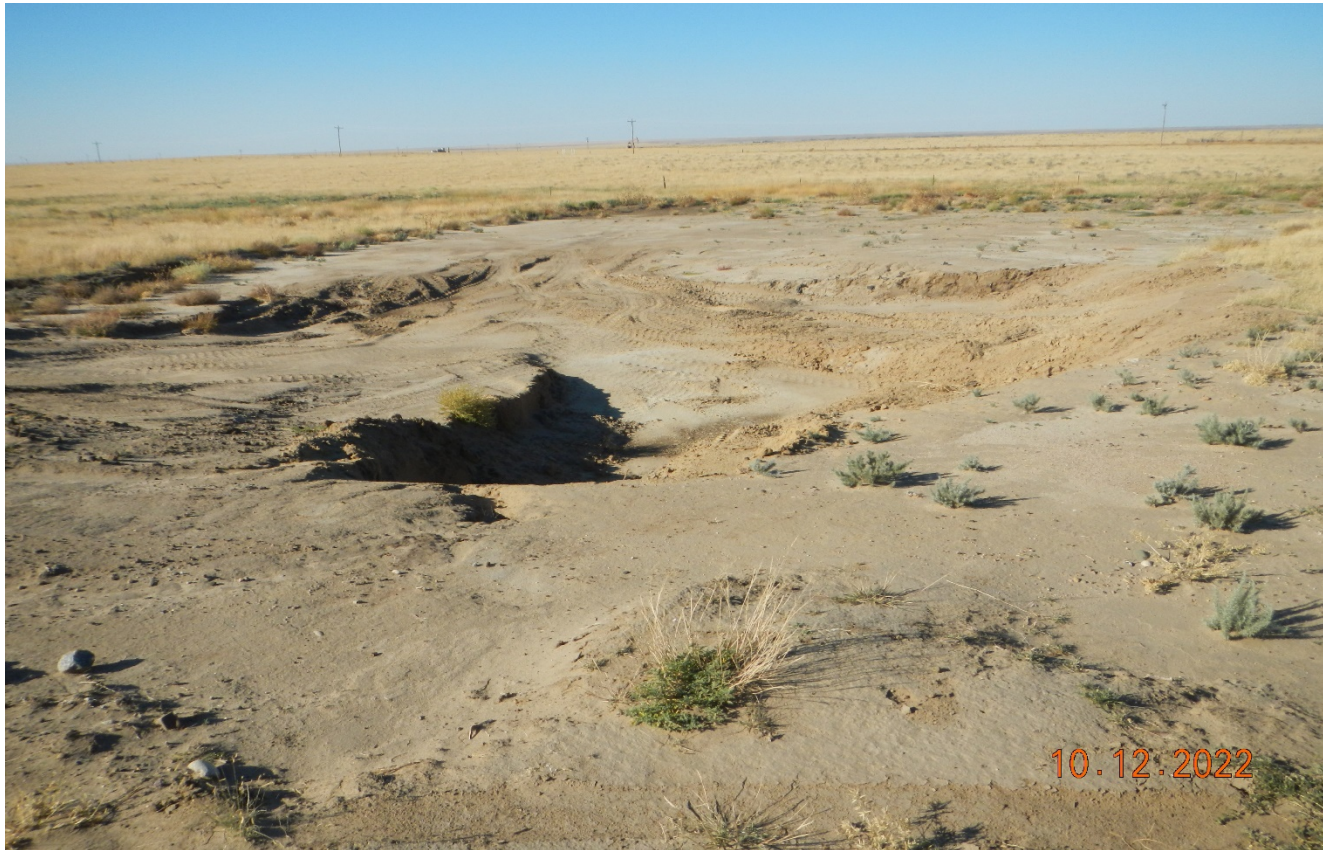
**Photo 6.** Facing southwest toward the area where the spill occurred. Remediation project: 20712. Some areas have been excavated more than other areas.

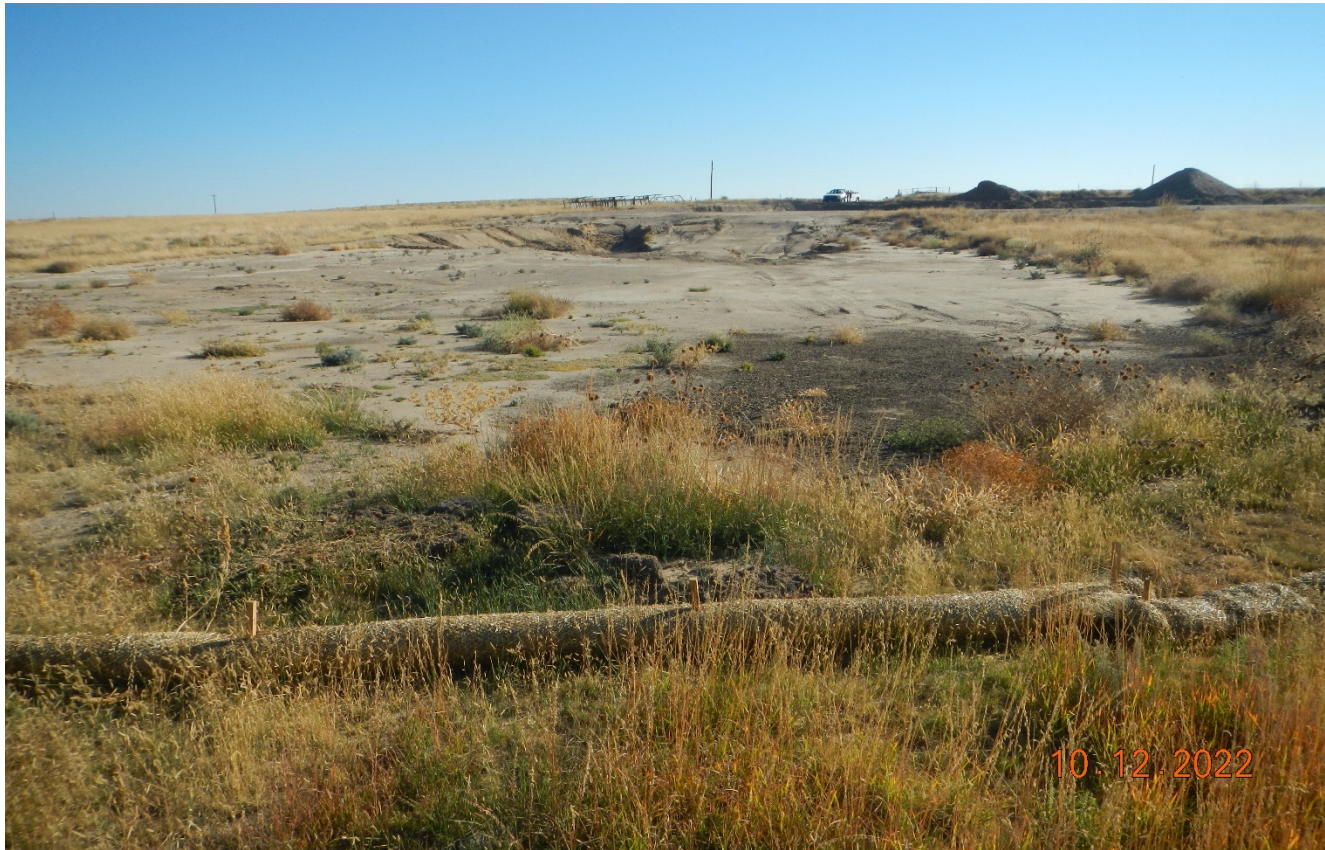
**Photo 7.** Facing northeast at the down gradient side of the spill area. Straw wattles have been installed along the edge of the disturbance.

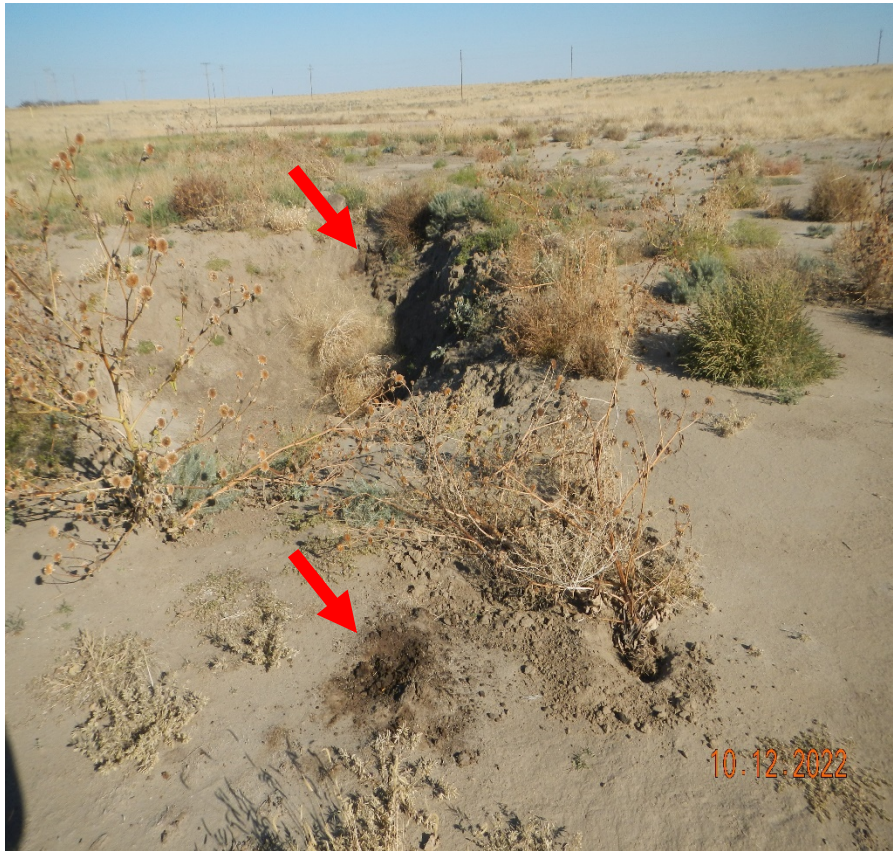
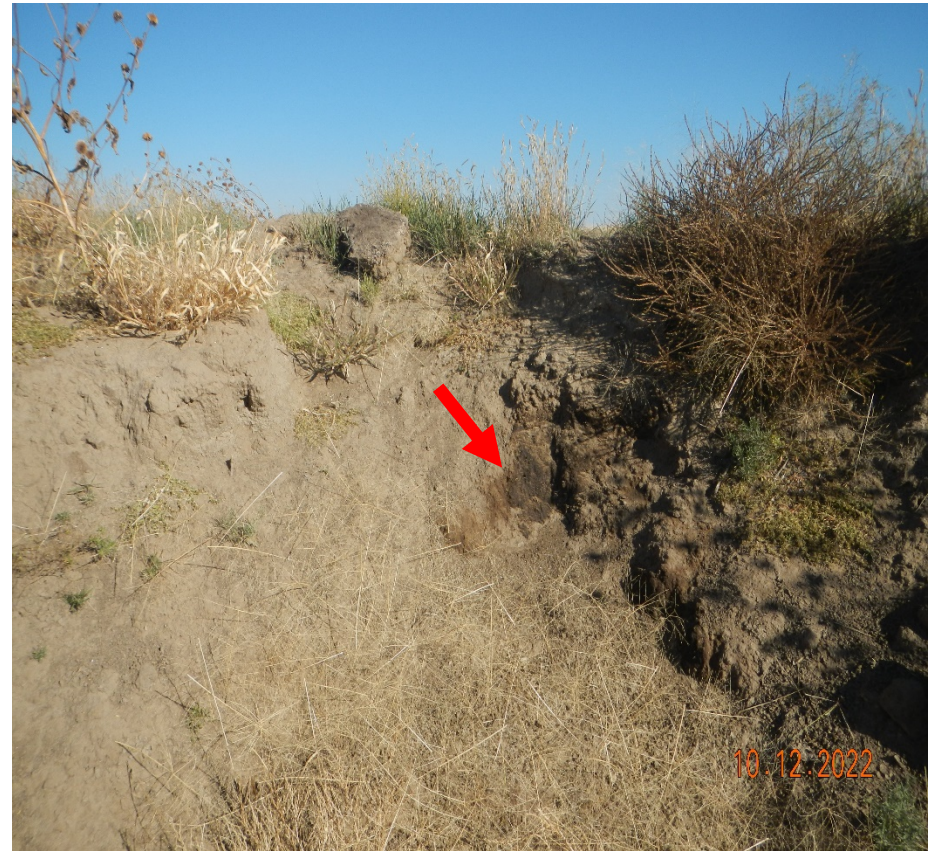
**Photo 8.** Located at the western side of the spill area. There is an excavated hole at this area approximately 12'x12'6'. There are still areas of oil stained soils at the surface (Bottom left) and 2ft. Down into the excavation area (right photo). Further excavation is needed.

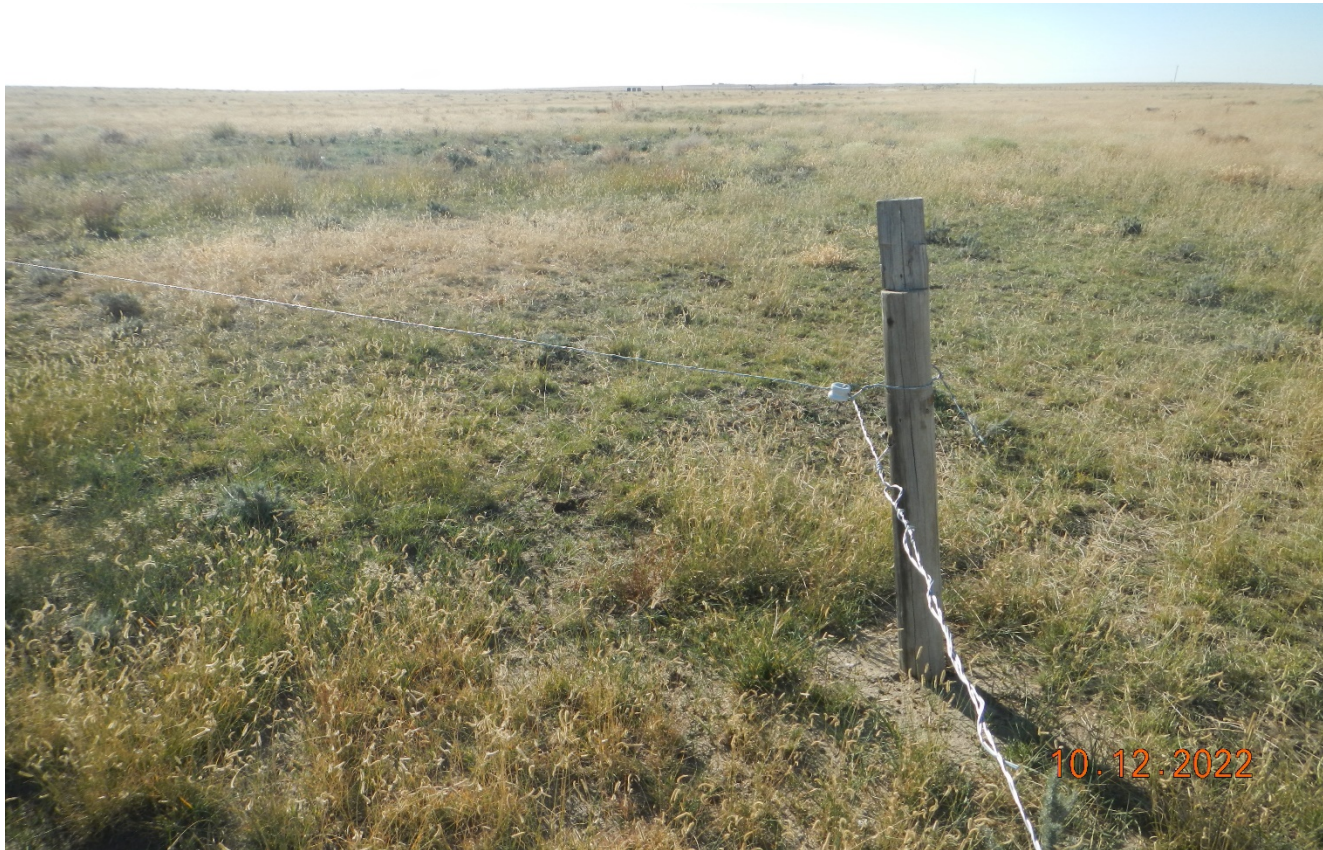
**Photo 9.** Insulators have been put on the posts for the electric perimeter fence.

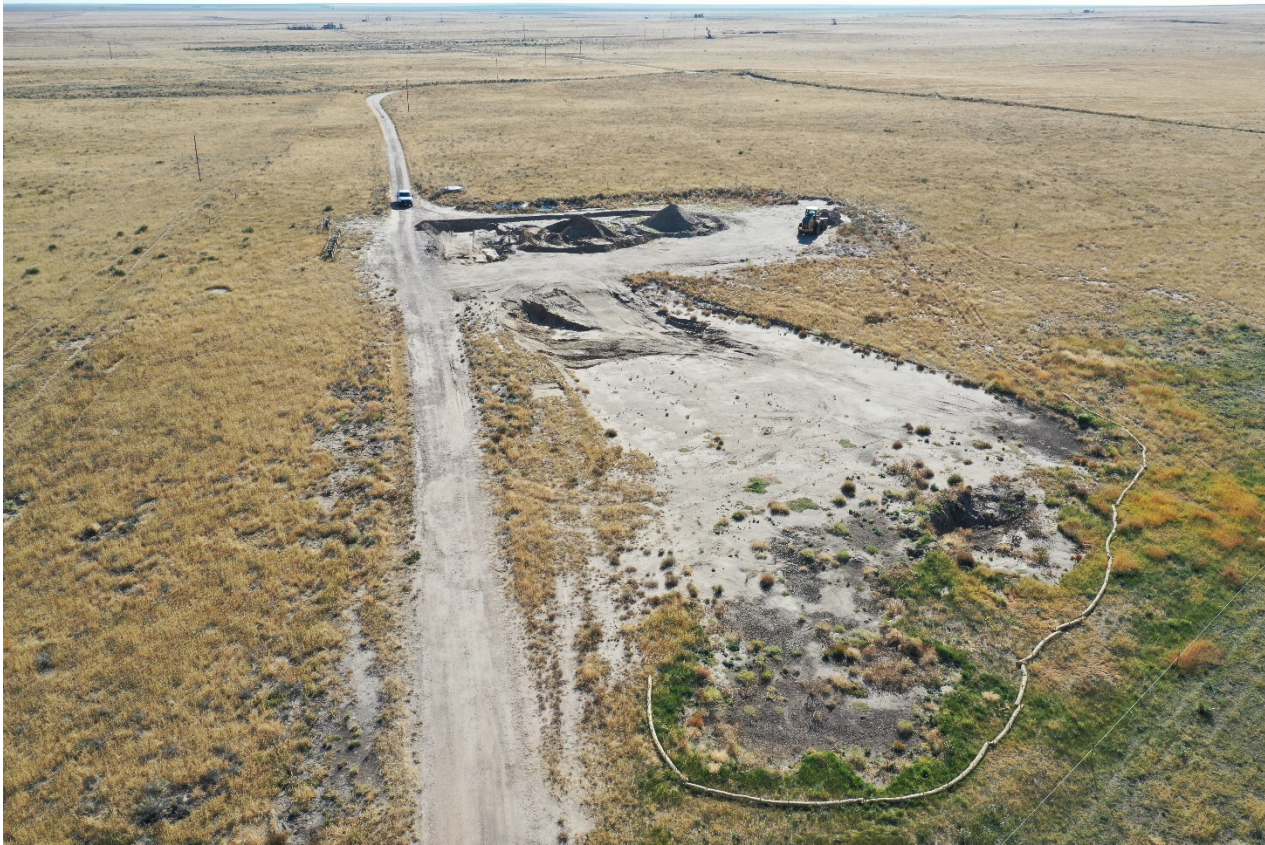
**Photo 10.** Drone aerial photo facing east toward the battery and remediation project.
