Inspection Photos

API: 061-06020

Operator: WESTERN OPERATING COMPANY

Inspection Date: 10/12/2022

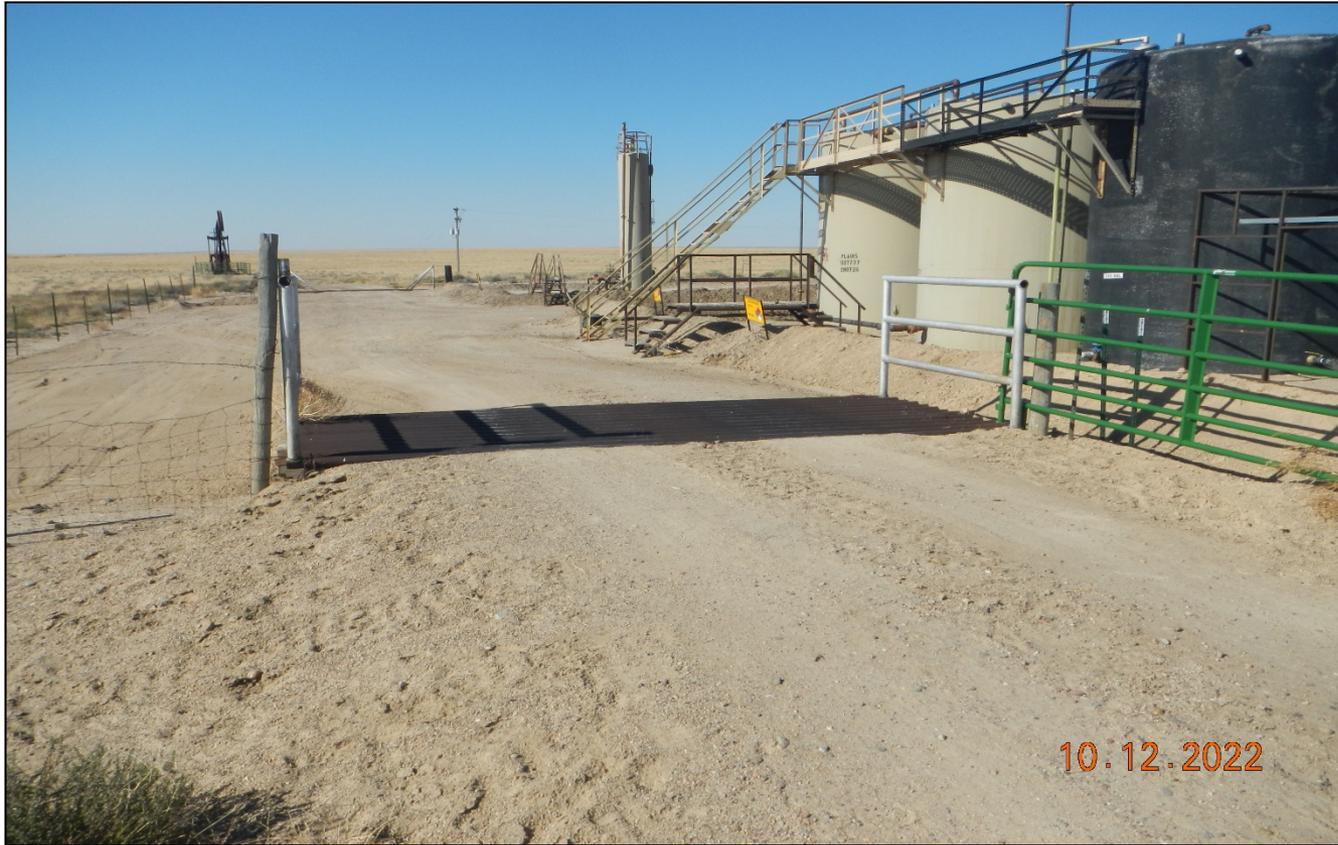
Photo 2. Facing west toward the tank battery.

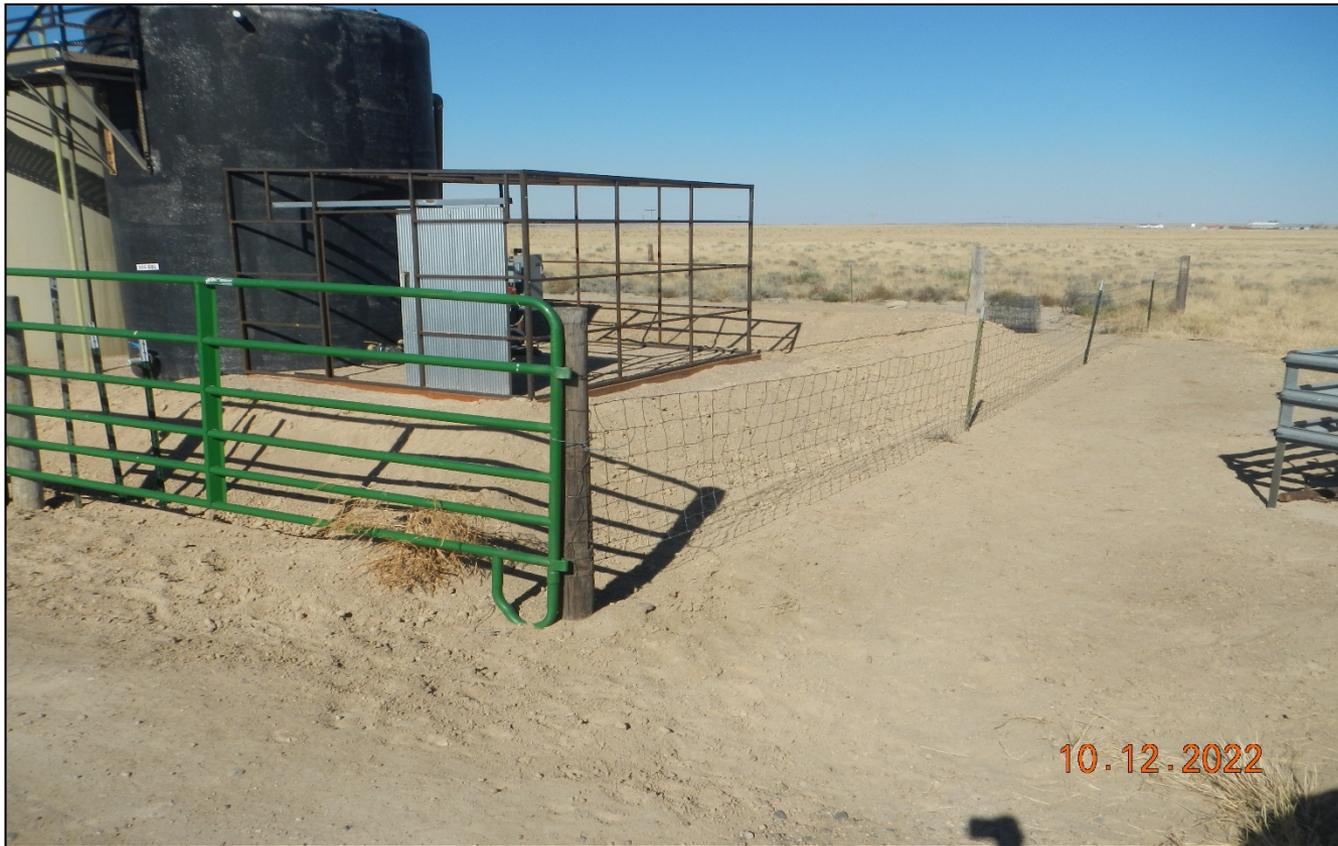
Photo 2. The fence at the tank battery has been repaired.

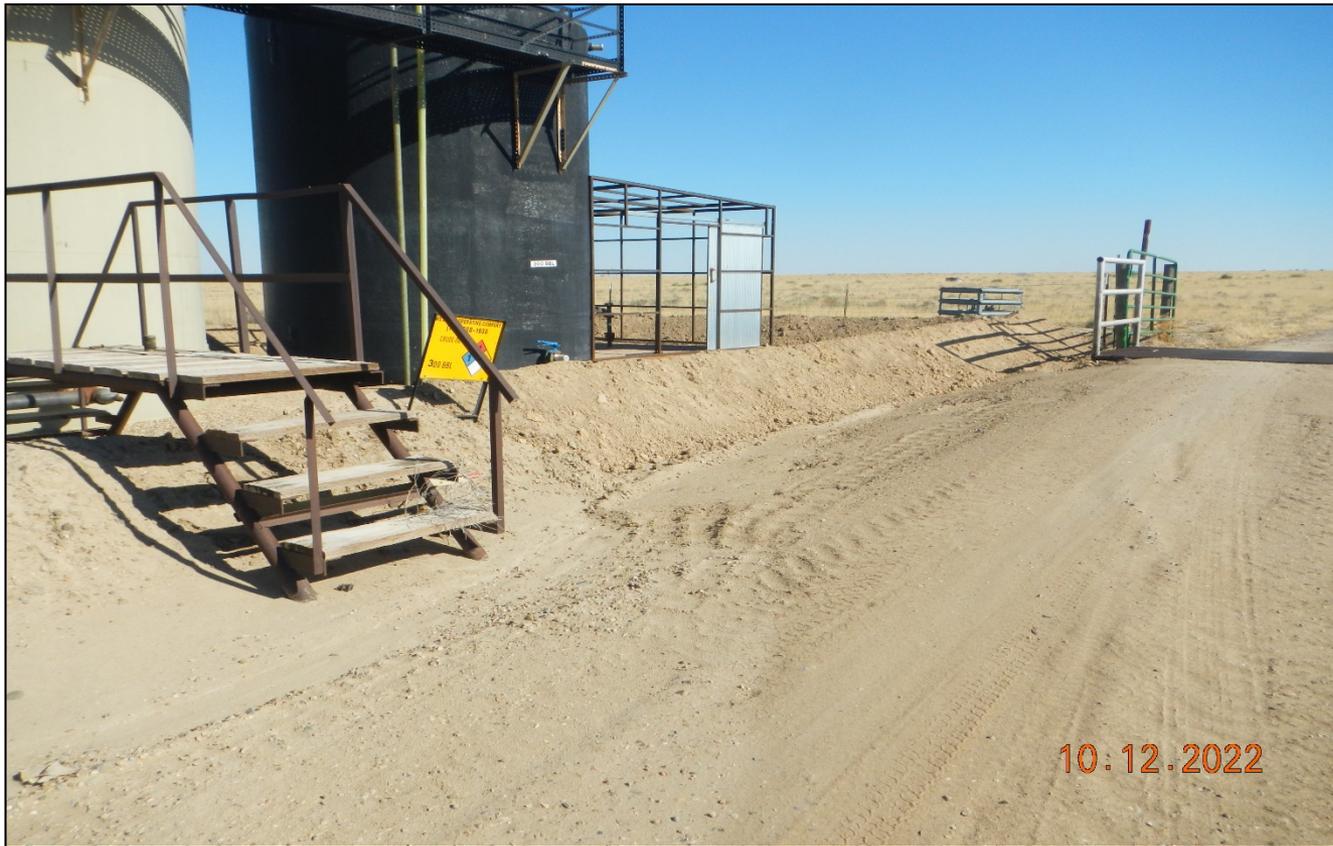
Photo 3. A secondary containment berm has been installed around the tank battery. The berm still needs to be compacted.

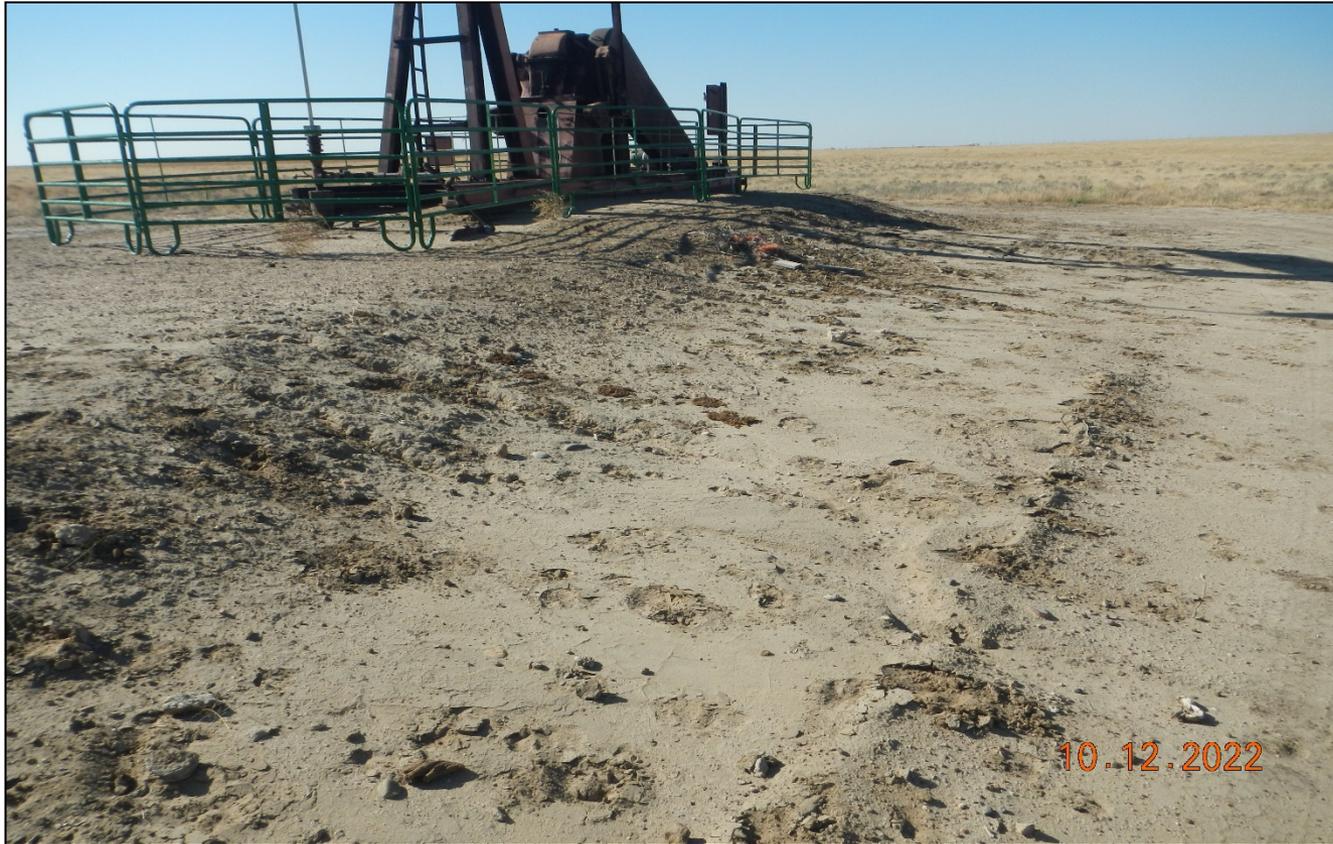
Photo 4. Facing toward the pumpjack. There is stormwater runoff transporting sediment offsite. Previous corrective action not completed to install BMP's.

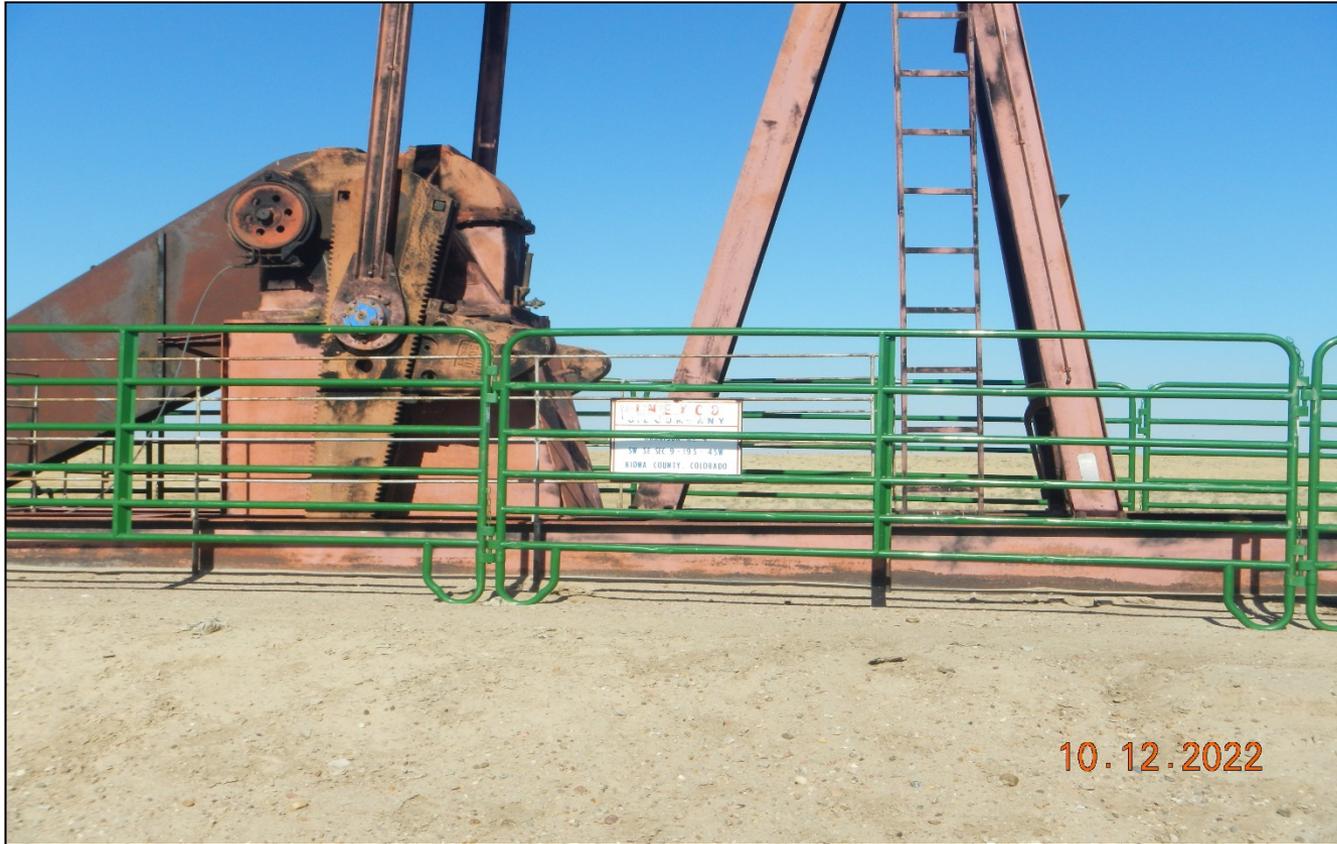
Photo 5. The sign at the wellhead does not reflect current Operator.
