# Inspection Photos

API: 061-06891

Operator: KUENZLER & FLORA RESERVE COMPANY

Inspection Date: 10/12/2022

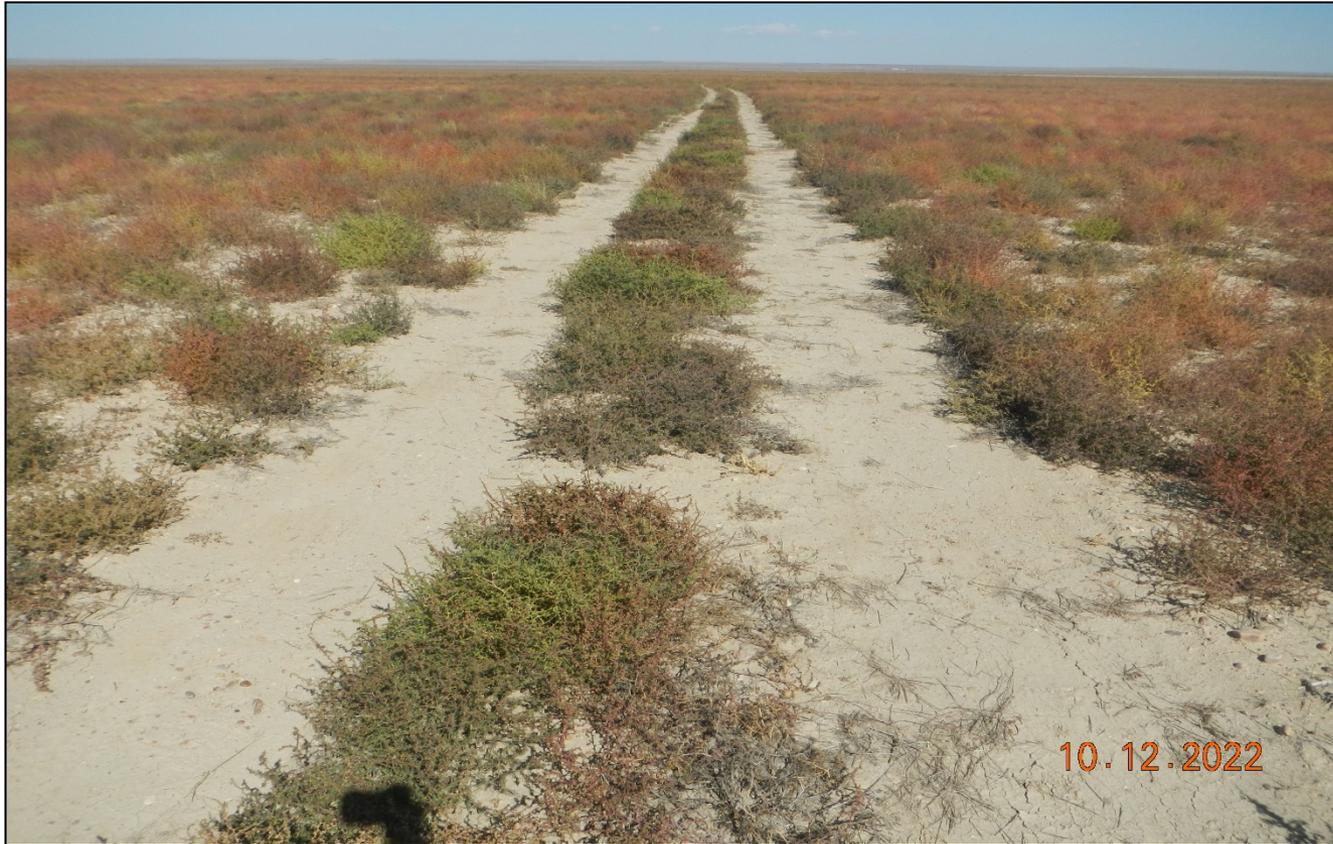
**Photo 1.** Facing north along the access road. There is no vegetation growth along the two track road which indicates possible soil compaction. Soils must be decompacted by cross-ripping to at least 18 inches.

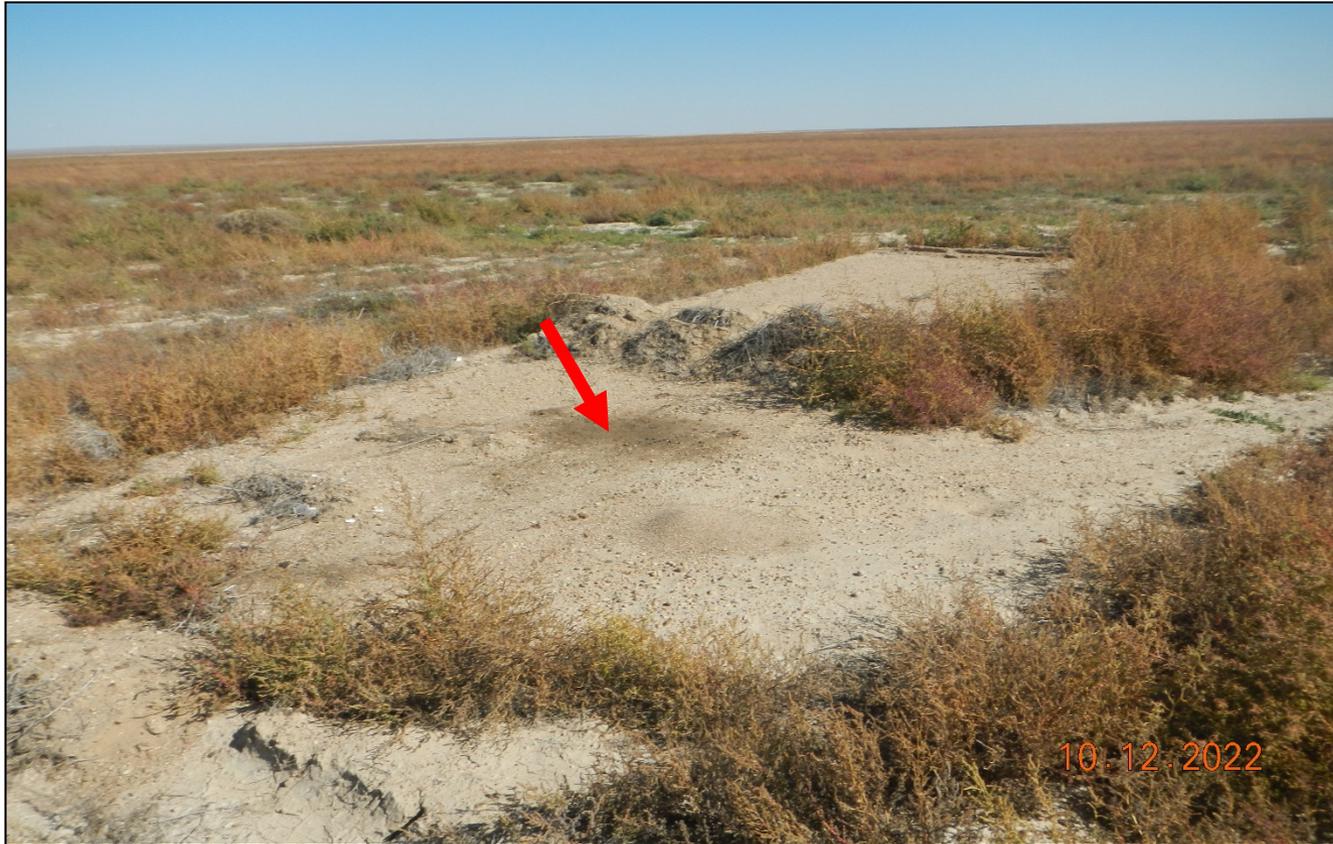
**Photo 2.** Facing northeast at the location. This where the pumpjack was removed was not leveled out. There are oil stained soils shown at red arrow and gravel remains.

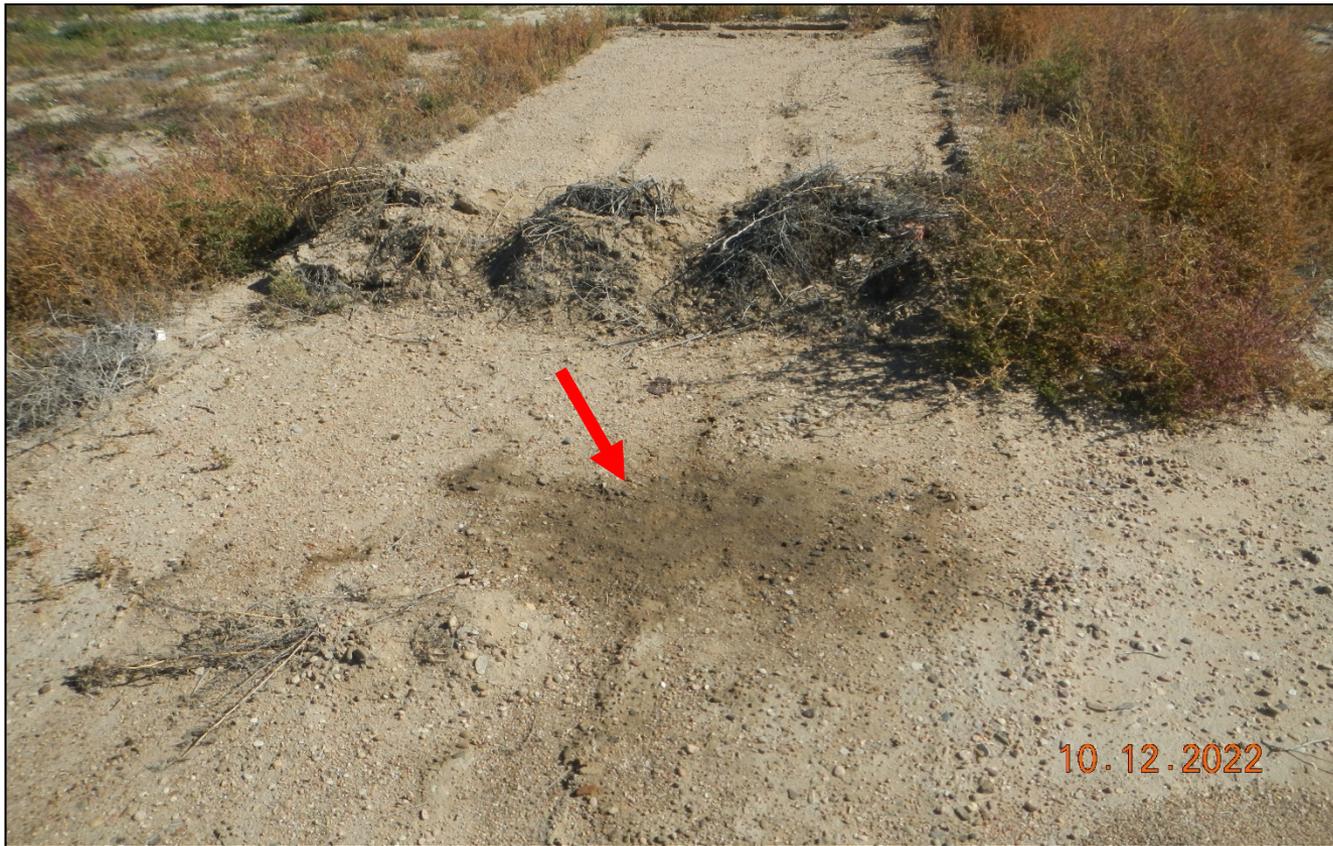
**Photo 3.** Facing toward the area where the pumpjack was located. Soils were not leveled out and decompacted. There is oil stained soil at red arrow.

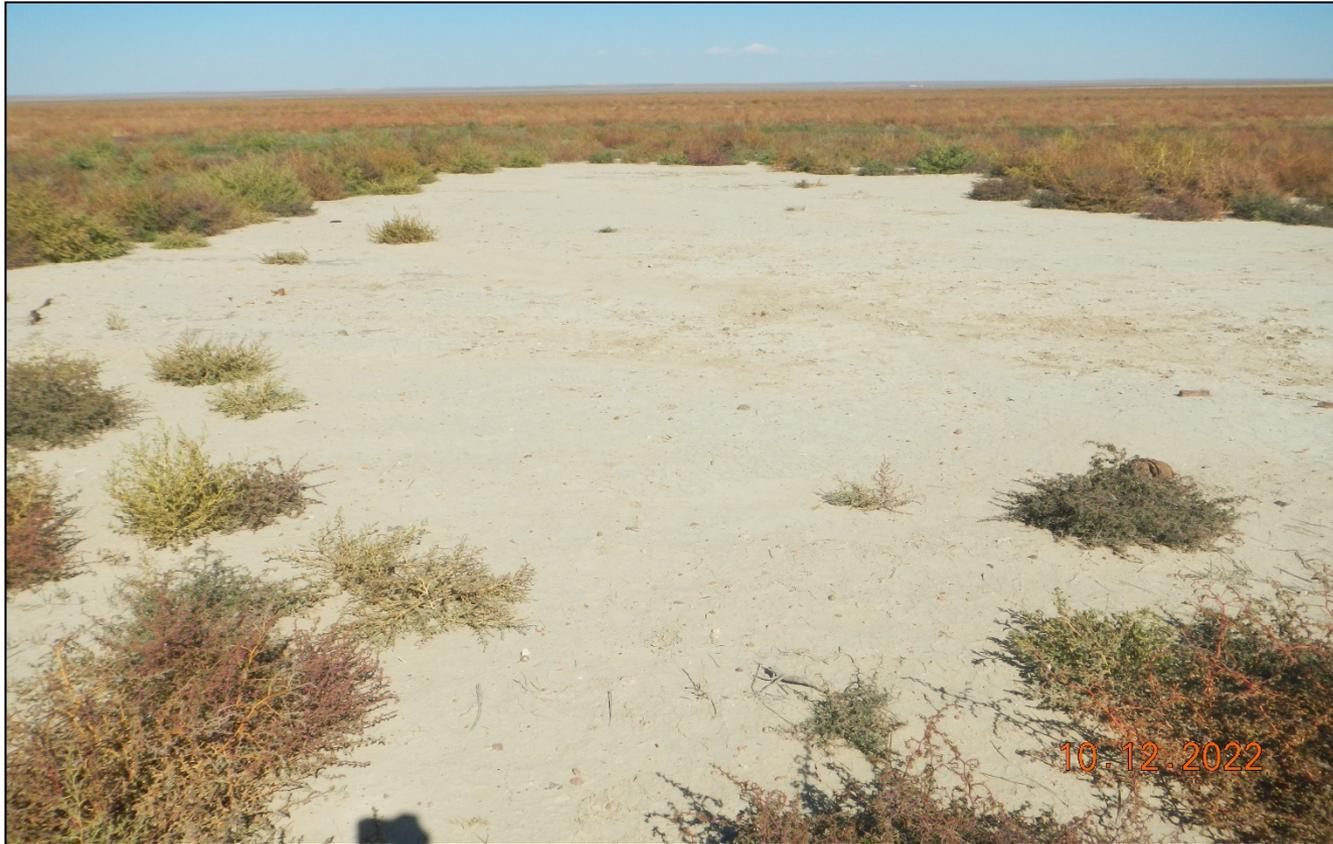
**Photo 4.** Facing north at the location. This is the area of the former pit which has no vegetation or weeds which is a concern of possible impacted soils.

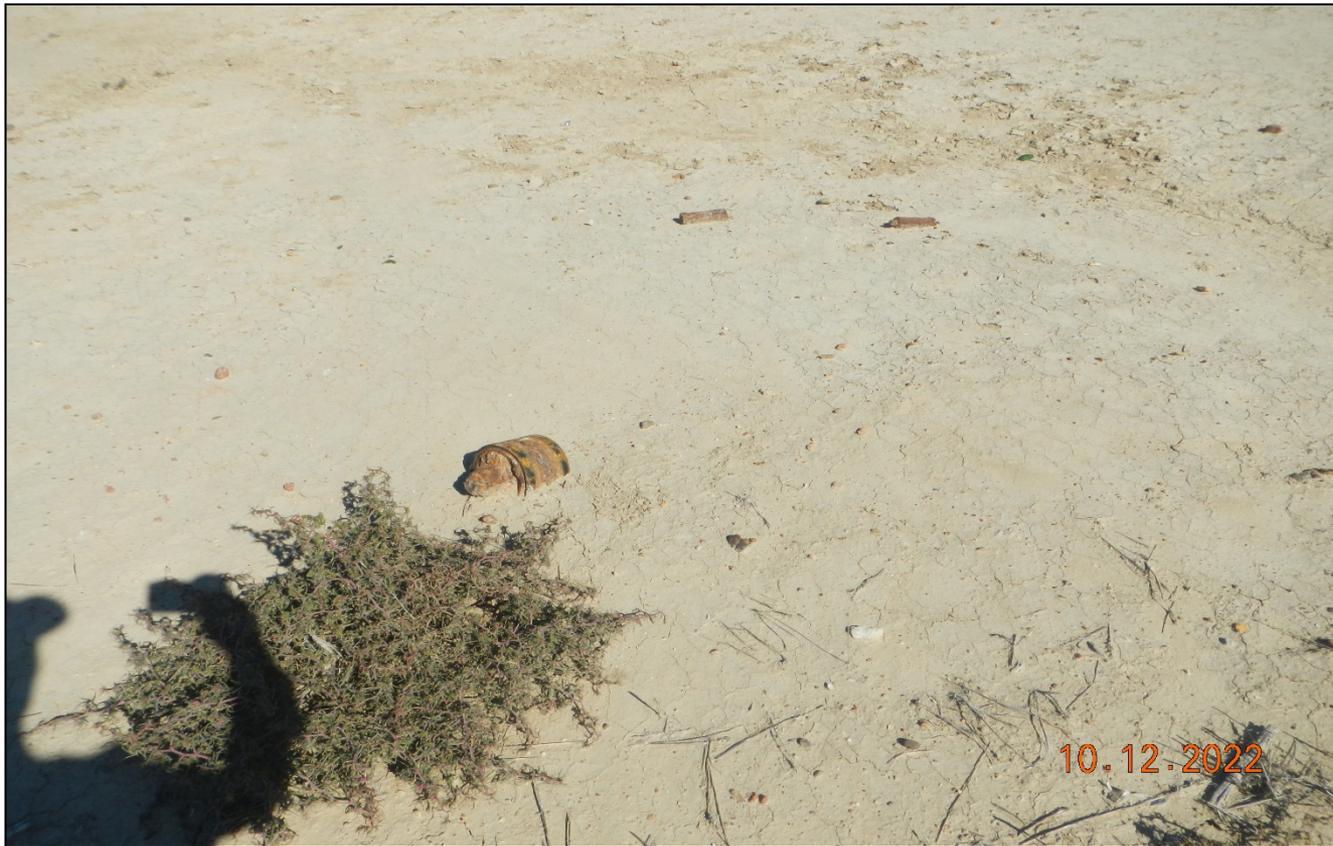
**Photo 5.** There is some remnant scrap metal pieces that remain and need to be removed.

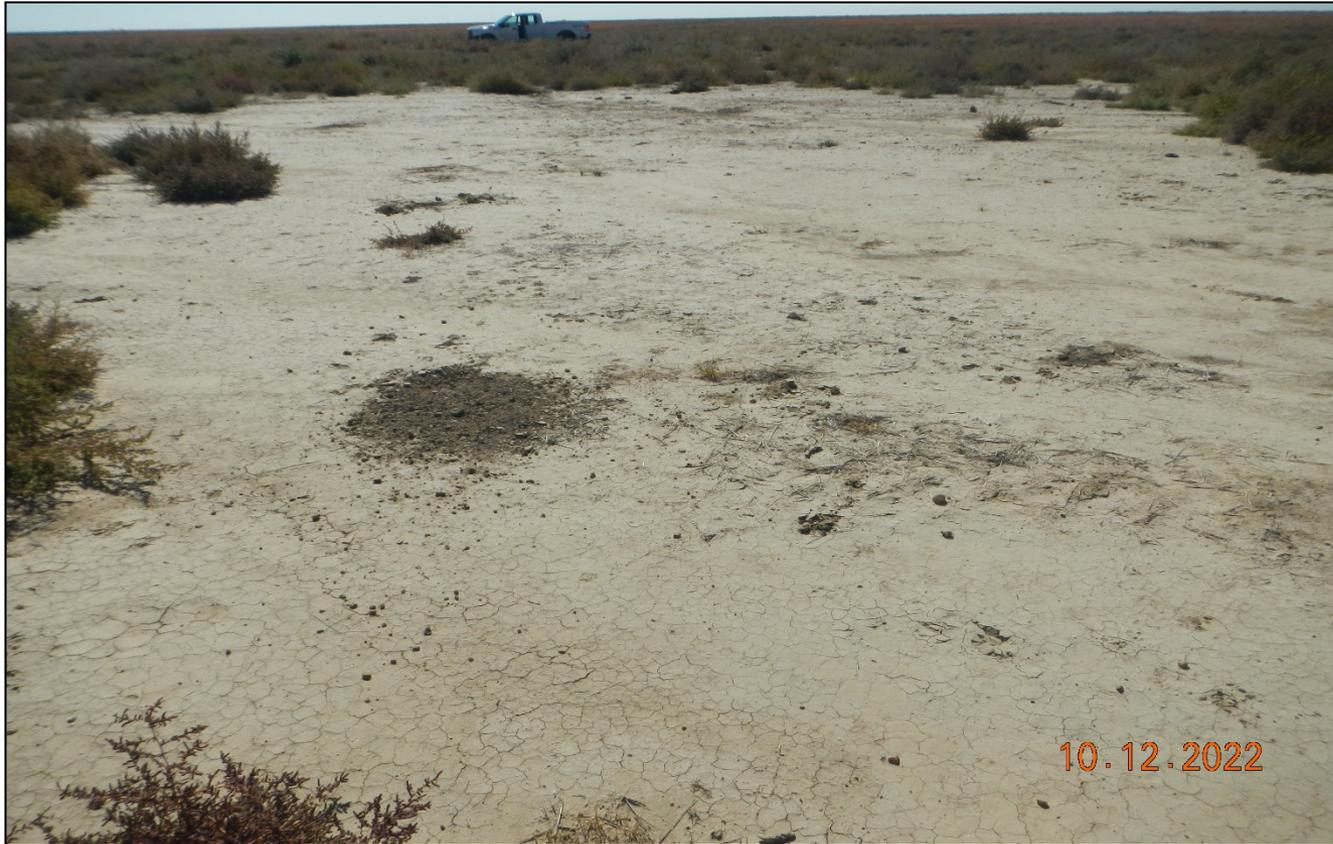
**Photo 6.** Facing south toward the area of no vegetation which is approx. 100'x75'.
