Inspection Photos

Location Name: CAERUS PICEANCE LLC KRK-67S92W /7SWSE

Location ID: 334883

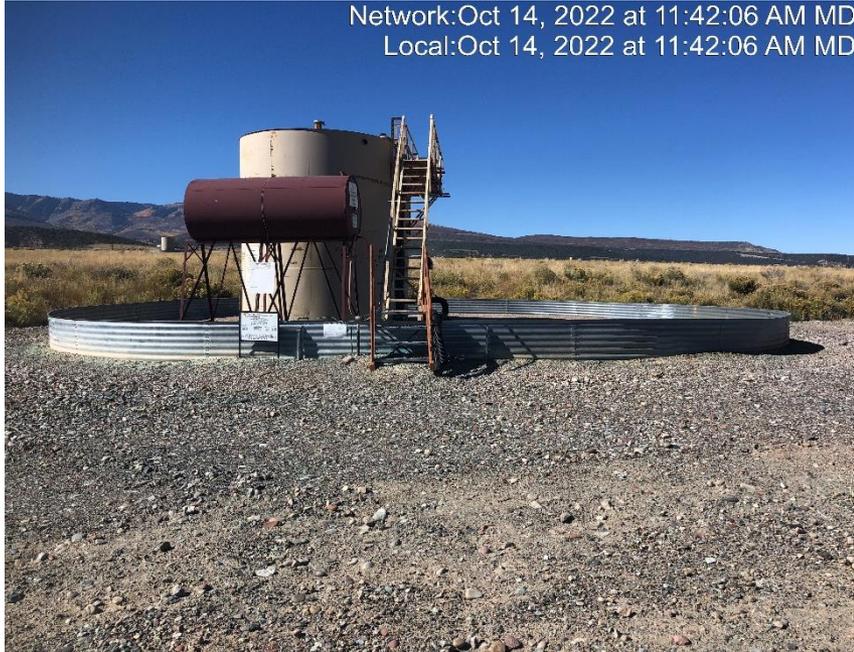
Photo #8080 From entrance to location.

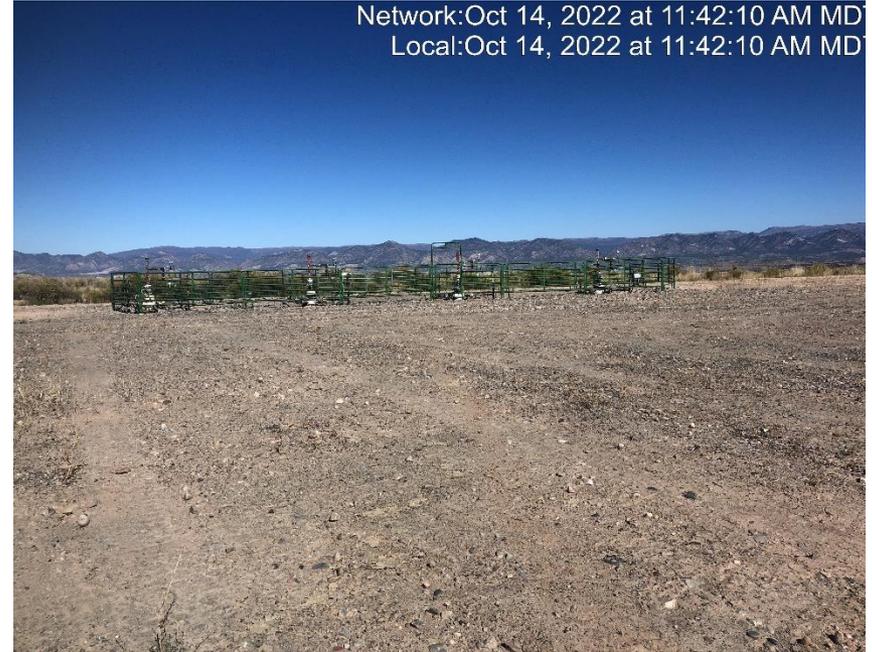
Photo #8081 From entrance to location.

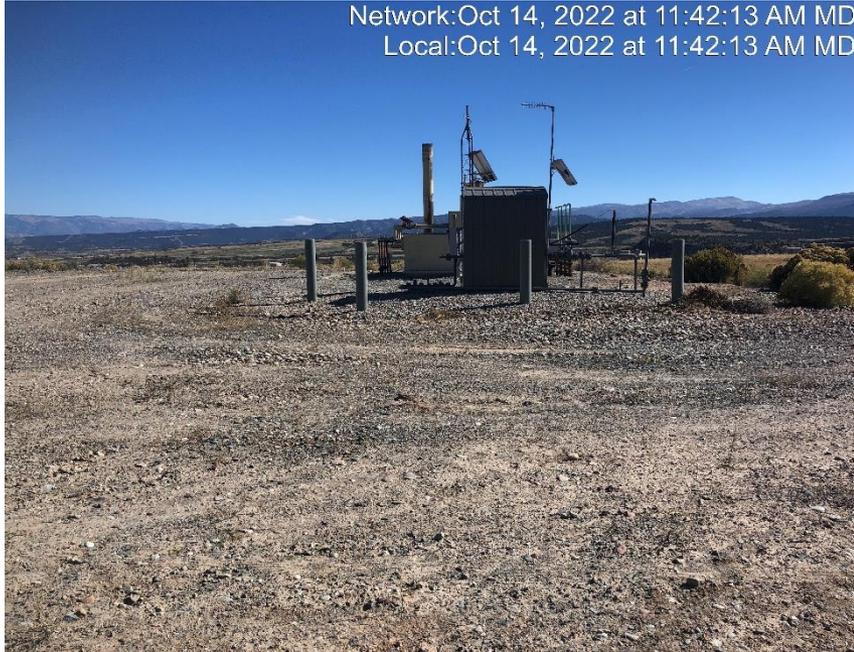
Photo #8082 From entrance to location.

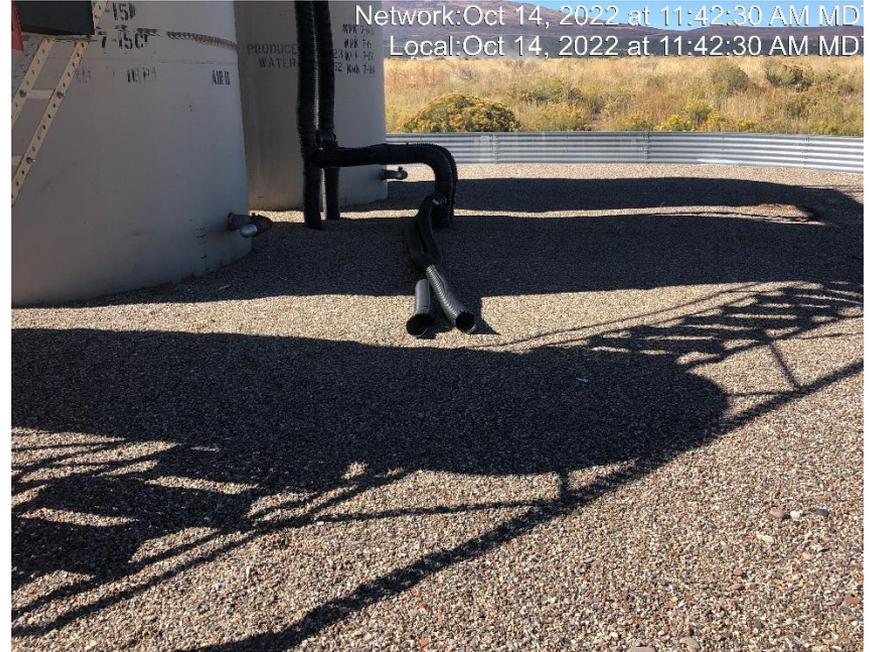
Photo #8083 Flow line heating insulation open ended.
