Inspection Photos and Issue Report

10/17/2022

Operator: LARAMIE ENERGY LLC - 10433

Location #335482

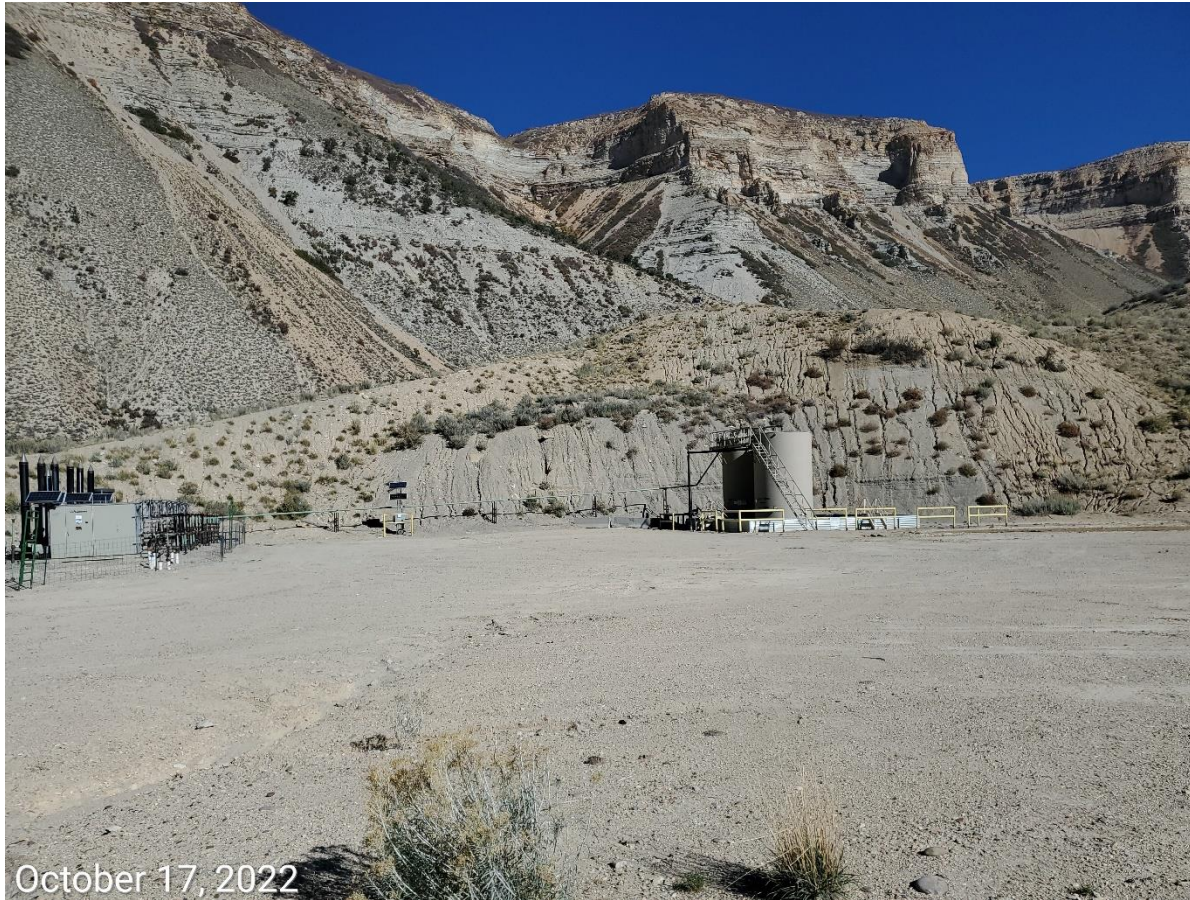
Photo 1: Photo taken from the south end of the Location, facing north. Photo provides overview of the cut slopes on the Location, and the erosion degradation issues observed; BMPs to minimize erosion, degradation, and to protect/stabilize the cut slopes are missing or insufficient per good engineering requirements.

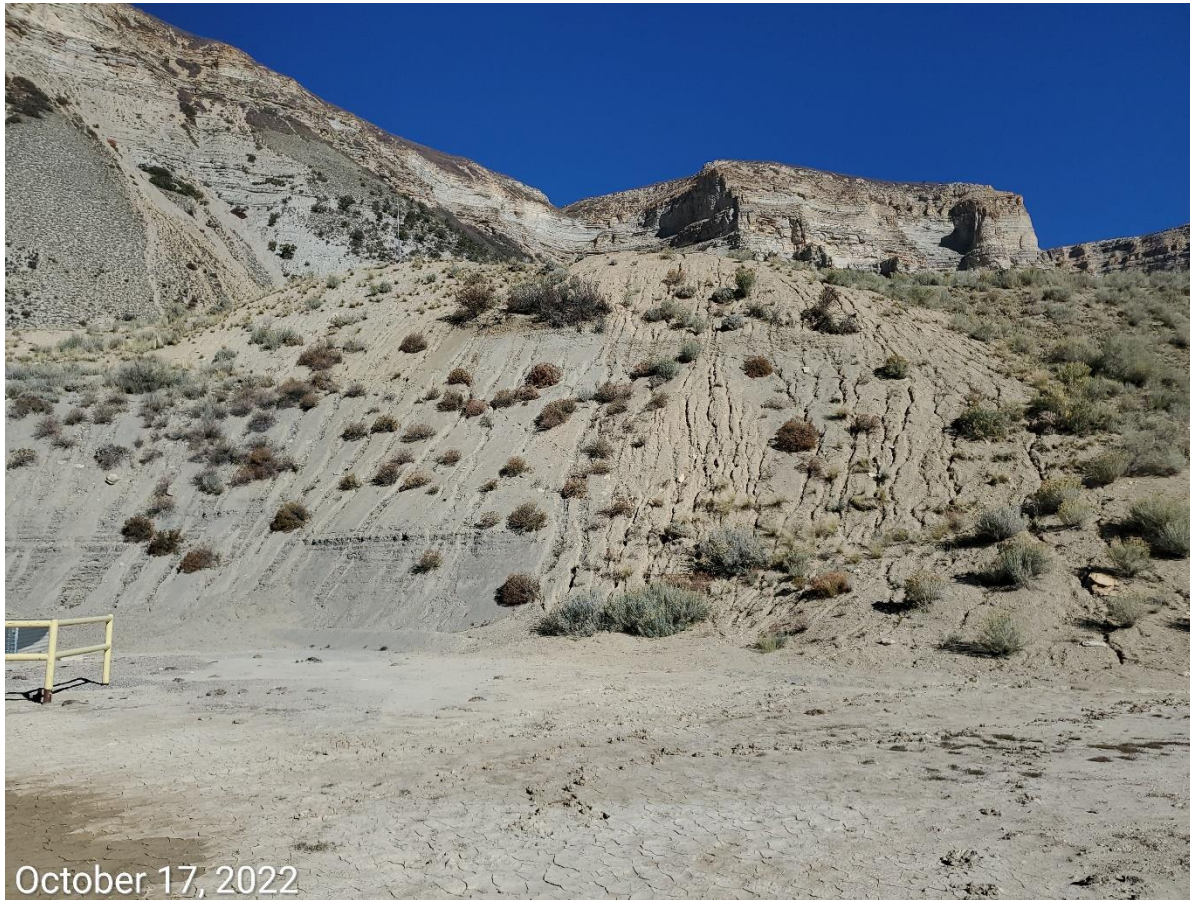
Photo 2: Photos 2-7 show erosion degradation and sediment deposition (yellow arrow) due to missing or insufficient stormwater and erosion control BMPs at the cut slopes of the Location

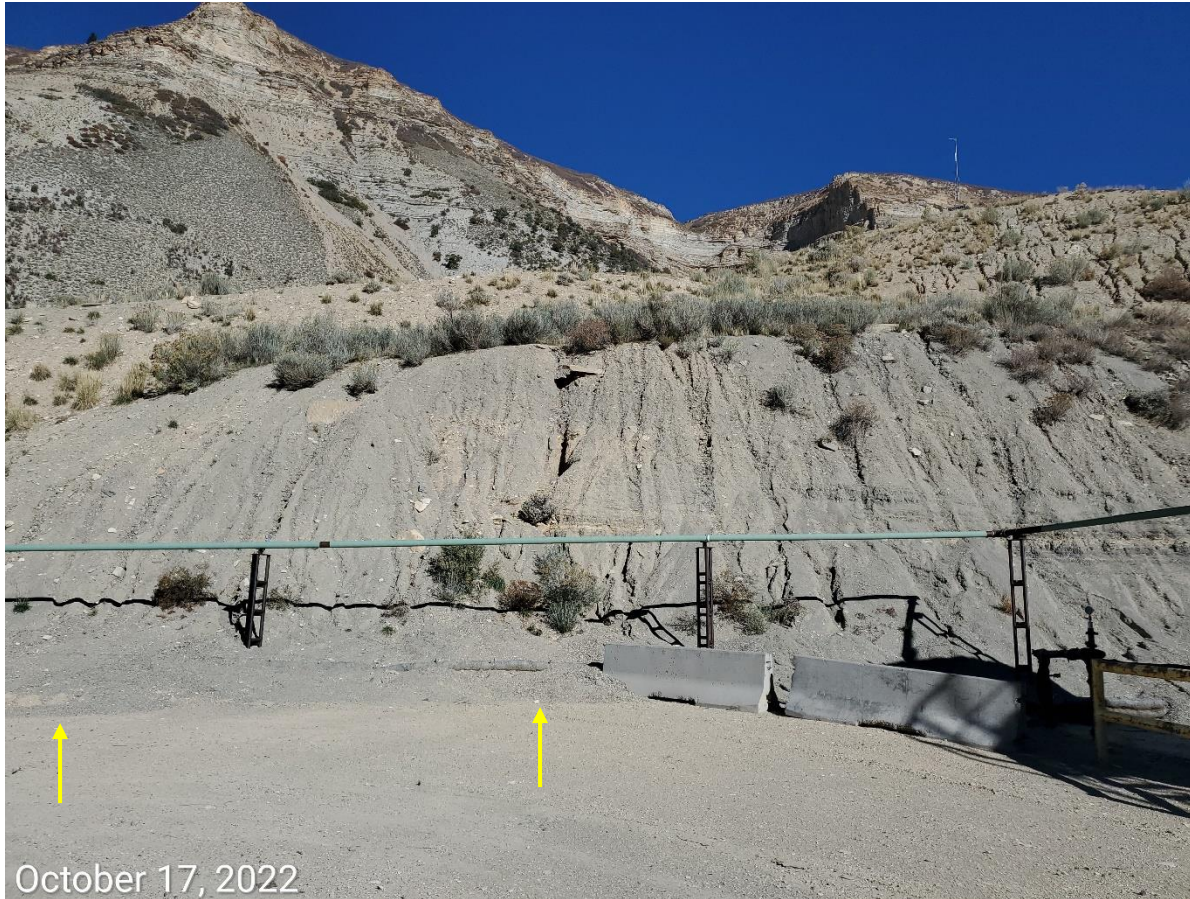
Photo 3: See comments under photo 2.

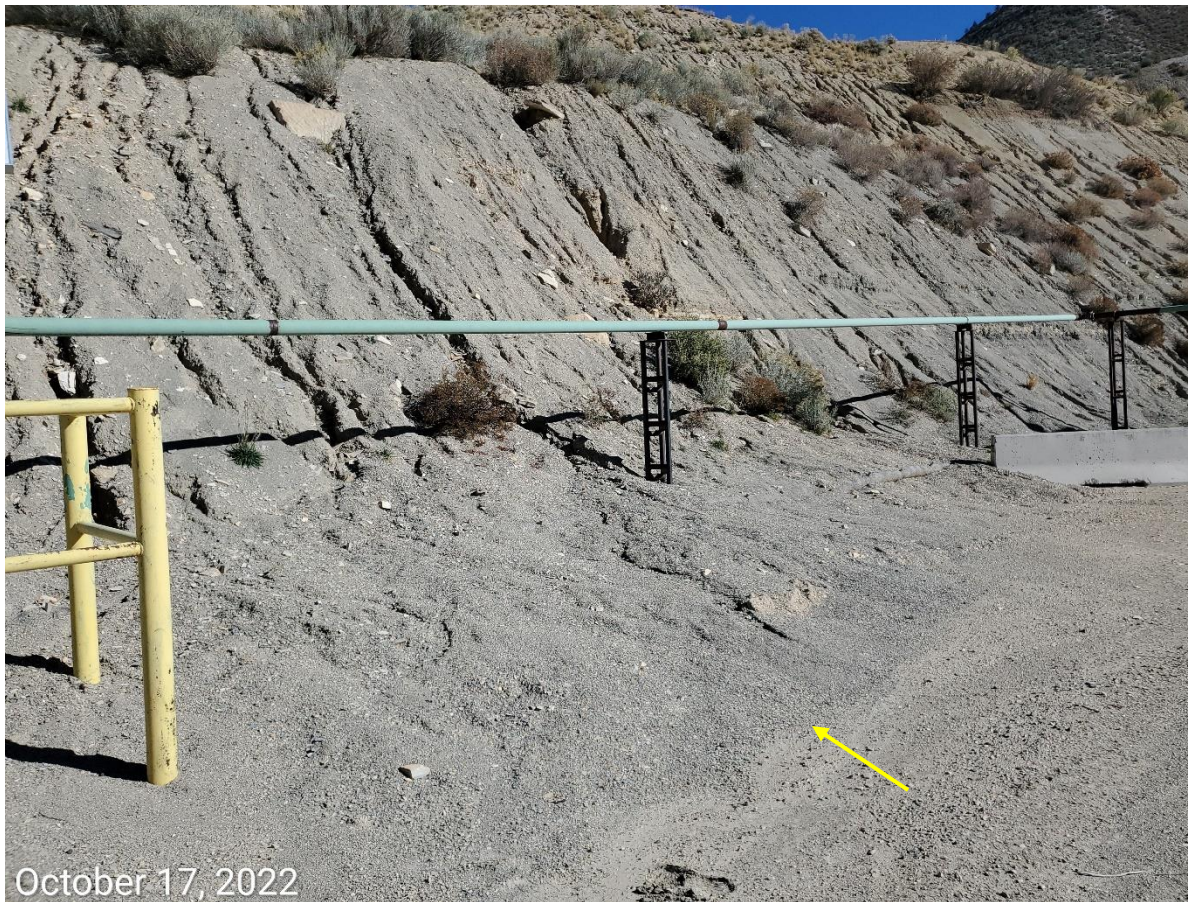
Photo 4: See comments under photo 3.

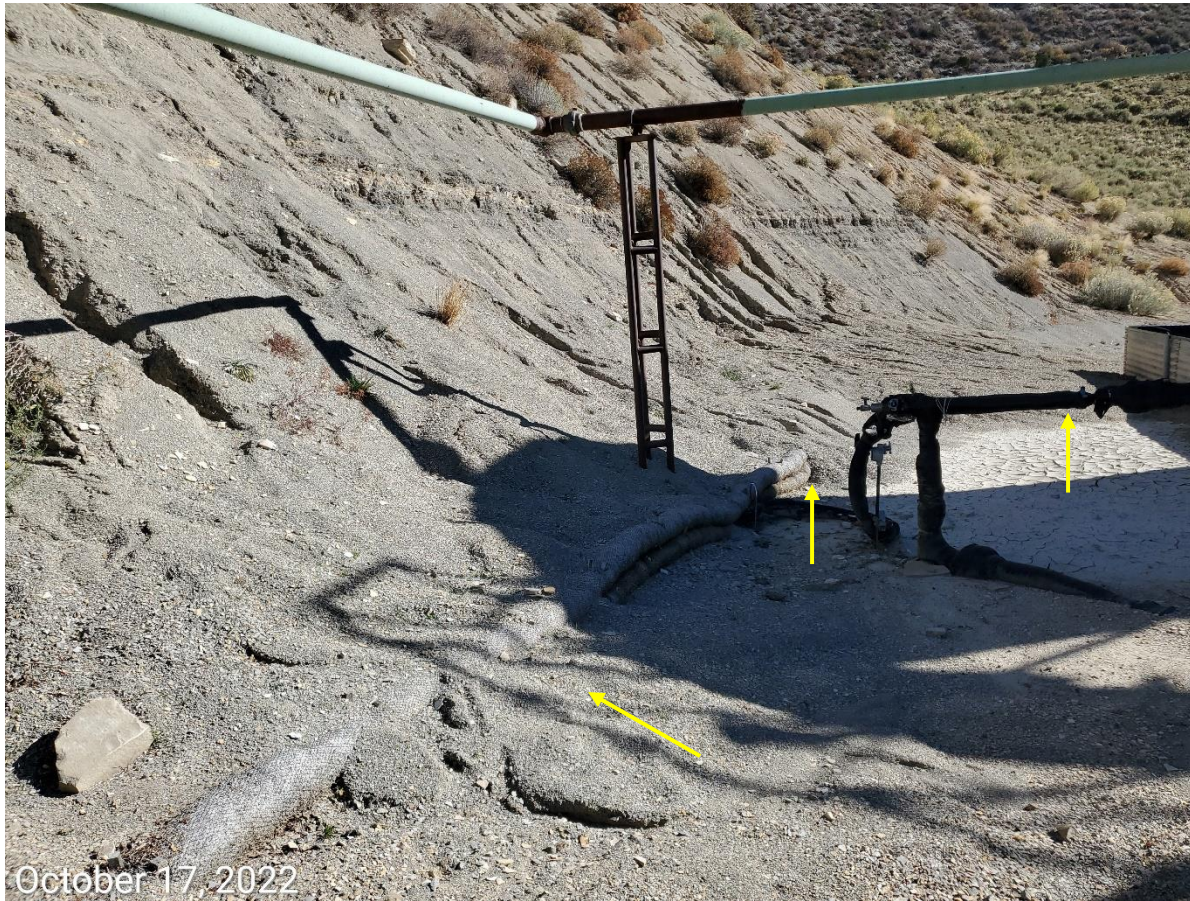
Photo 5: See comments under photo 8.

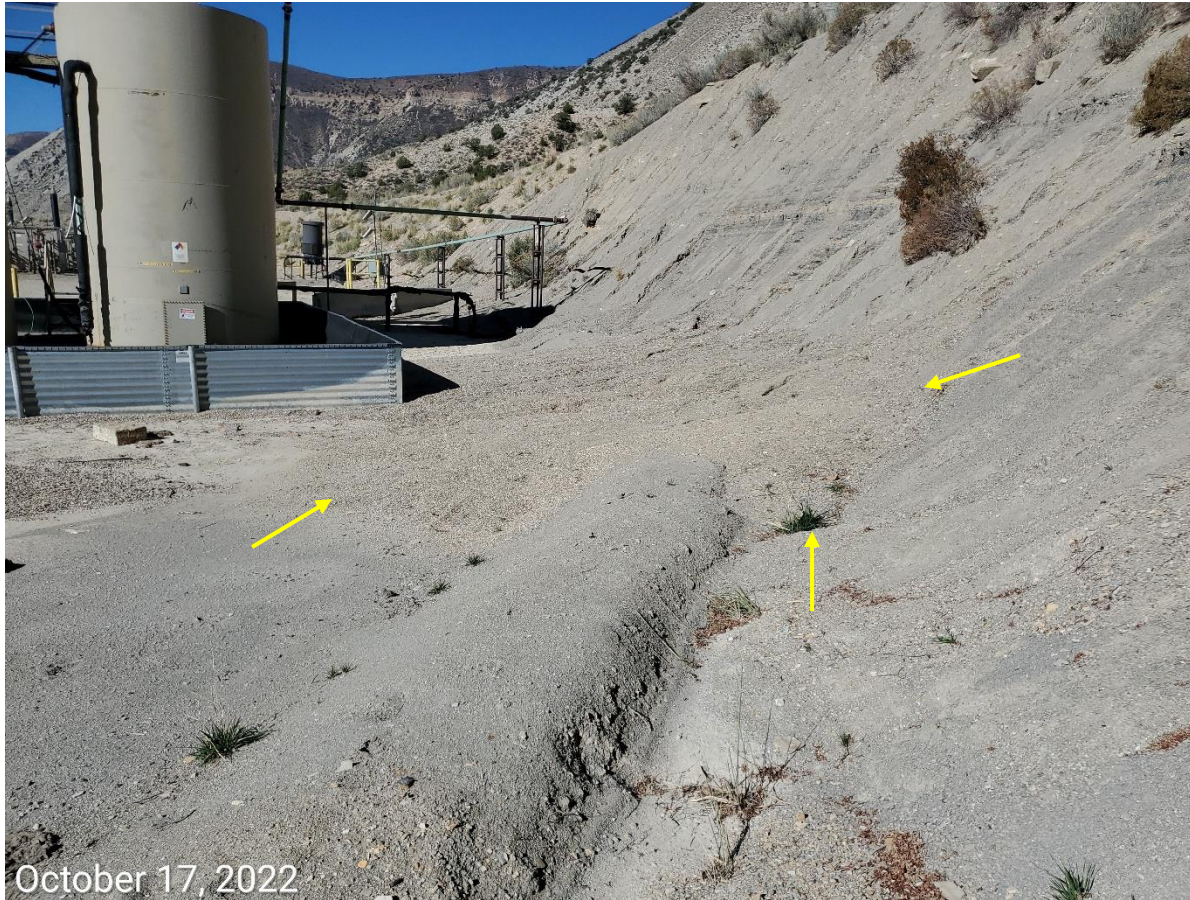
Photo 6: See comments under photo 3.

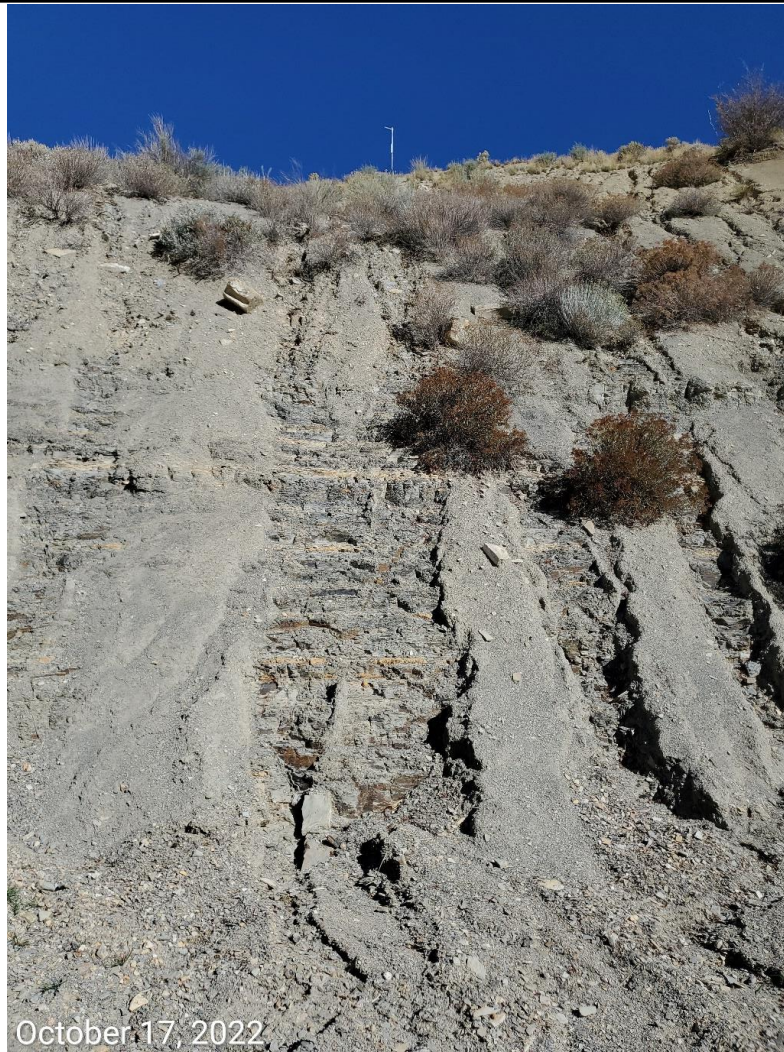
Photo 7: See comments under photo 3. Photo also shows areas where all fine soil material on the slopes have been lost due to erosion.

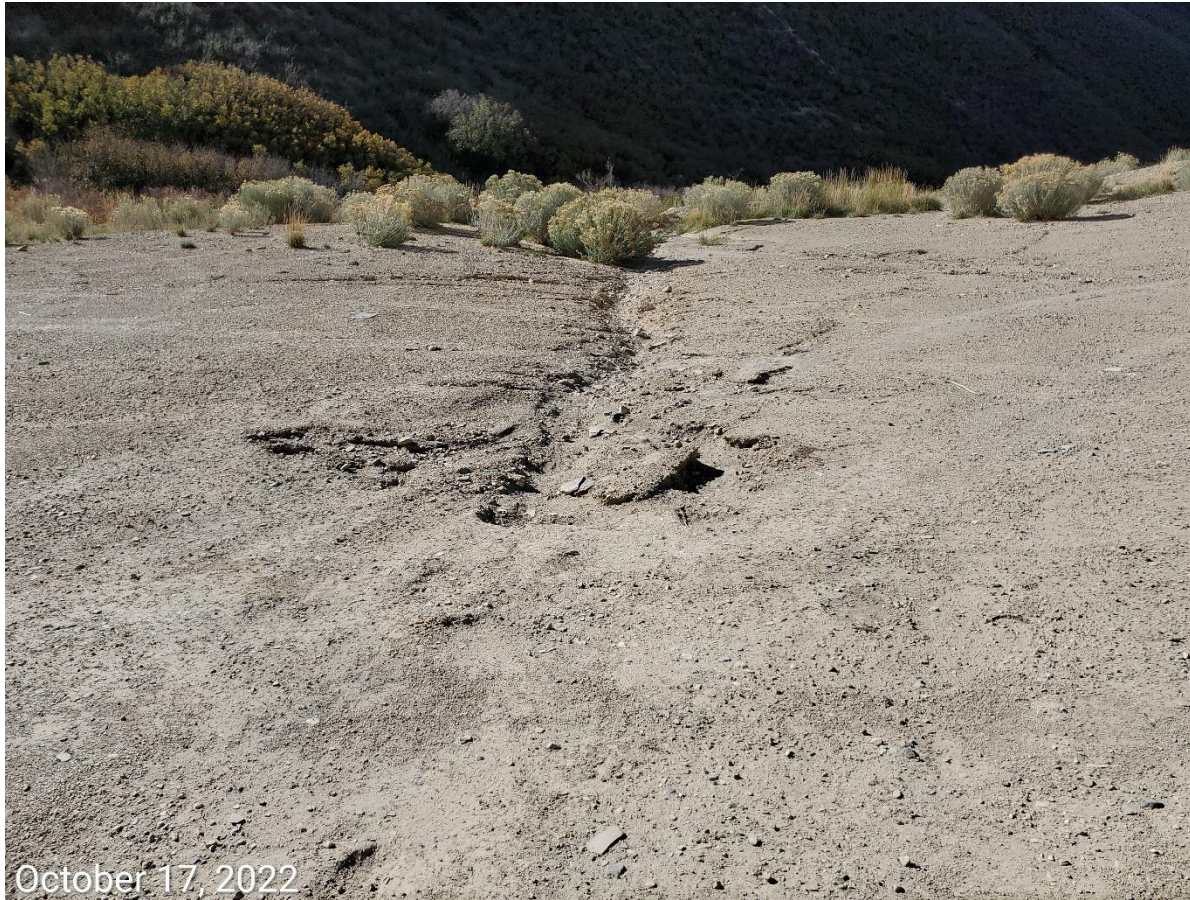
Photo 8: Photos 8-11 taken from the southwestern production areas of the Location. Photos show stormwater discharge point from the pad has not been constructed with a properly engineered outlet; stormwater runoff has resulted in degradation at the outlet, with erosion progressing into the working pad area.

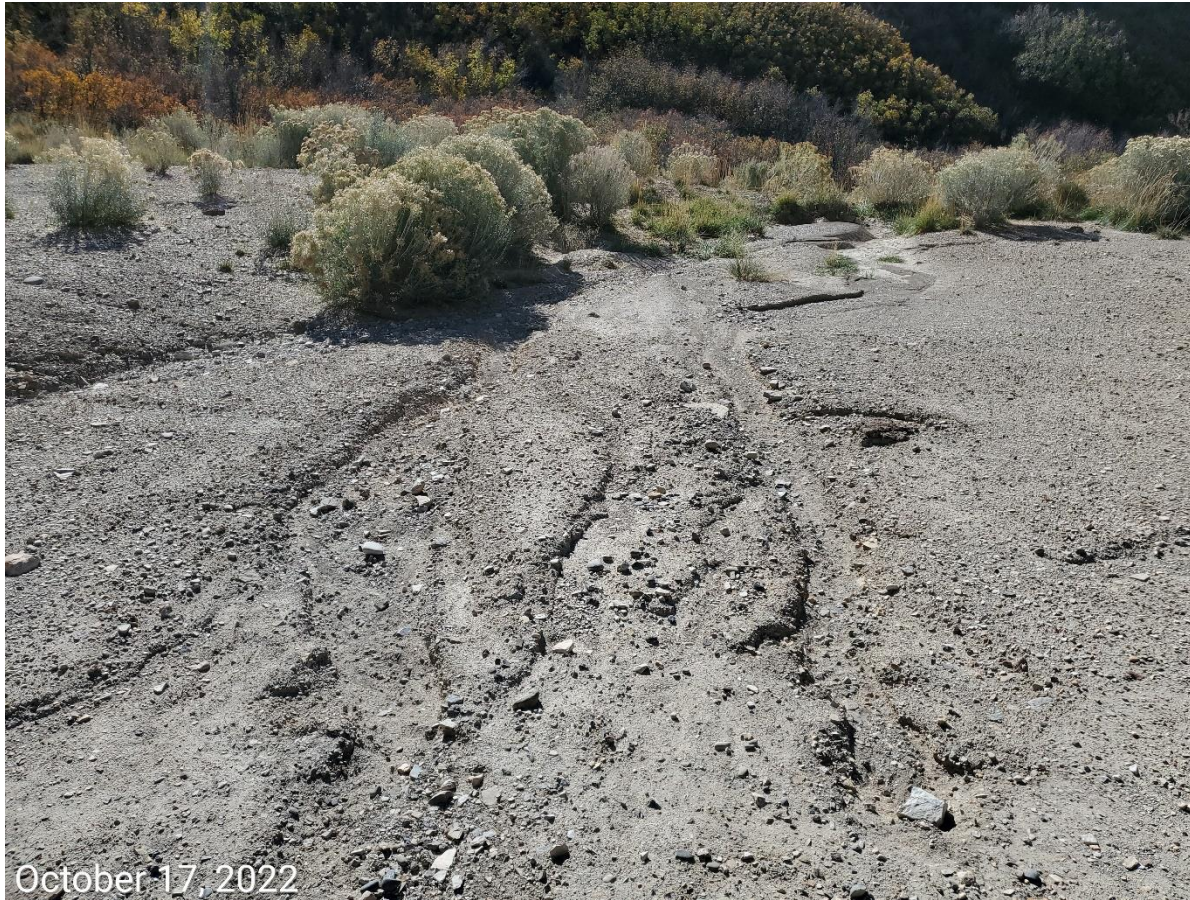
Photo 9: See comments under photo 8.

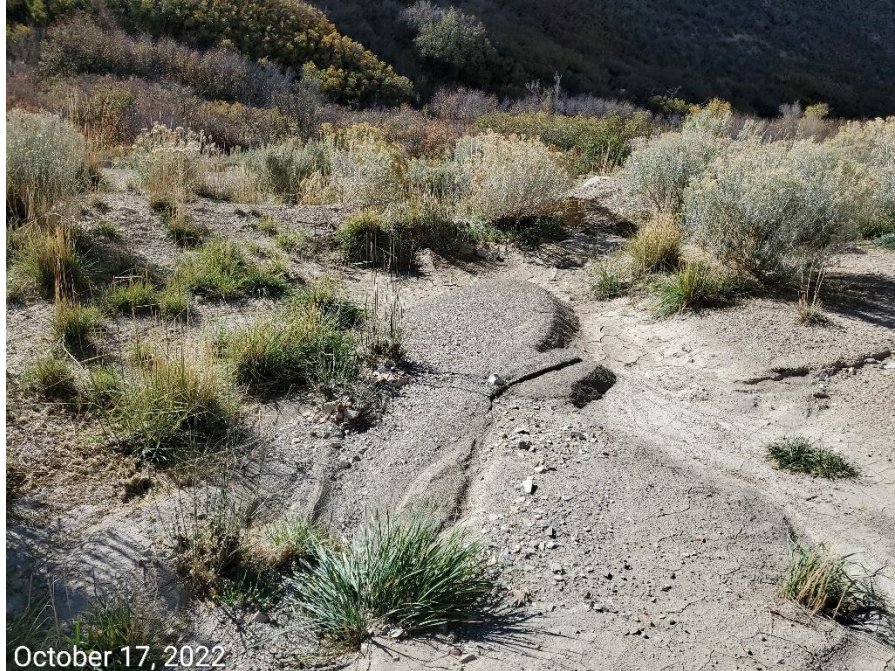
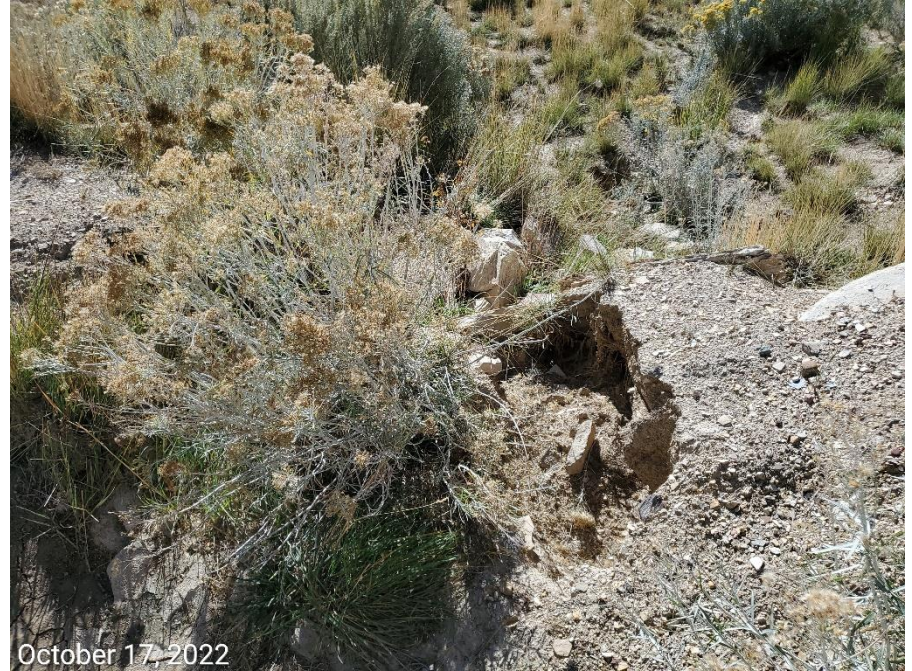
Photo 10: See comments under photo 8. rip-rap armoring at outlet has been “blown out”- gully erosion evident; outlet does not appear to have been constructed with a geotextile lining in conjunction with rip-rap material, per good engineering requirements.

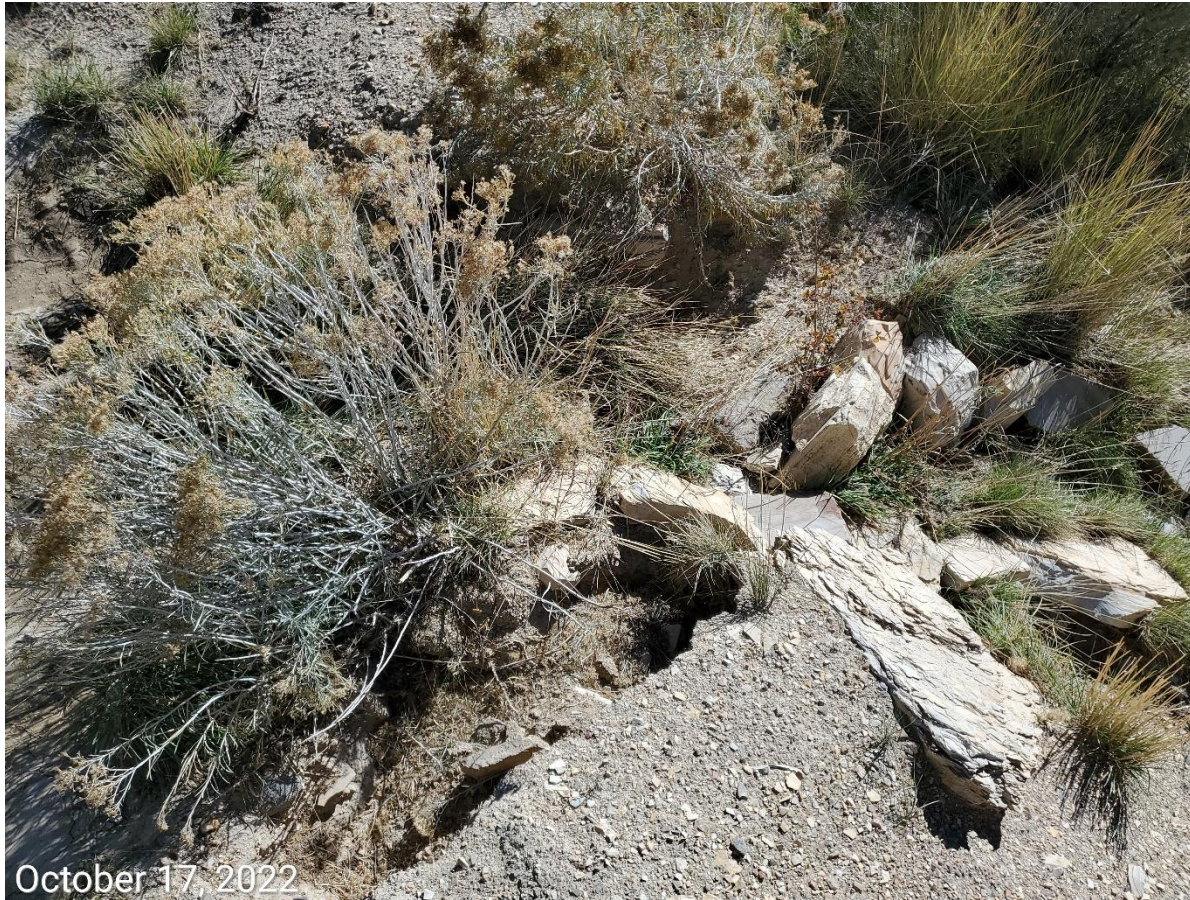
Photo 11: See comments under photo 8. rip-rap armoring at outlet has been “blown out” - gully erosion evident; outlet does not appear to have been constructed with a geotextile lining in conjunction with rip-rap material, per good engineering requirements.

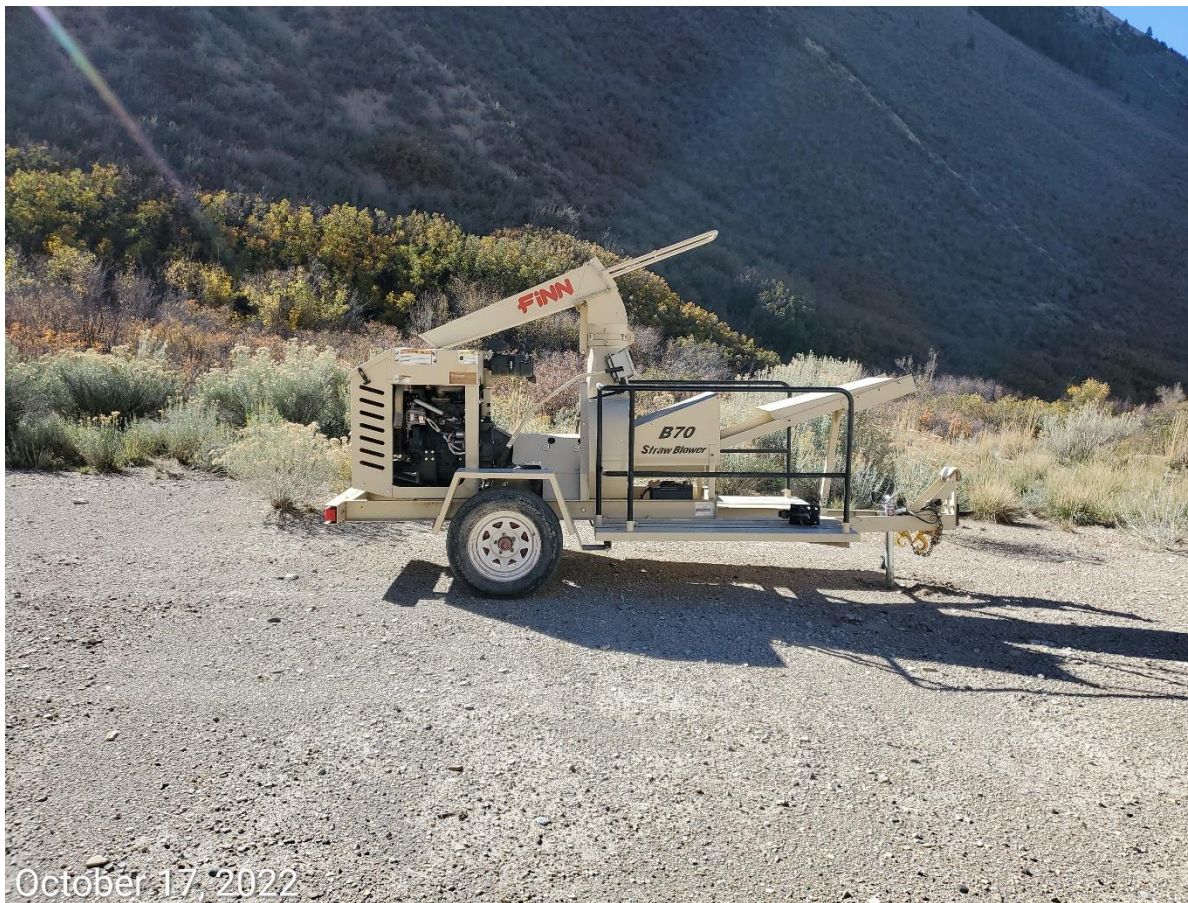
Photo 14: Unused equipment stored on south end of the Location. Equipment is not needed for production.

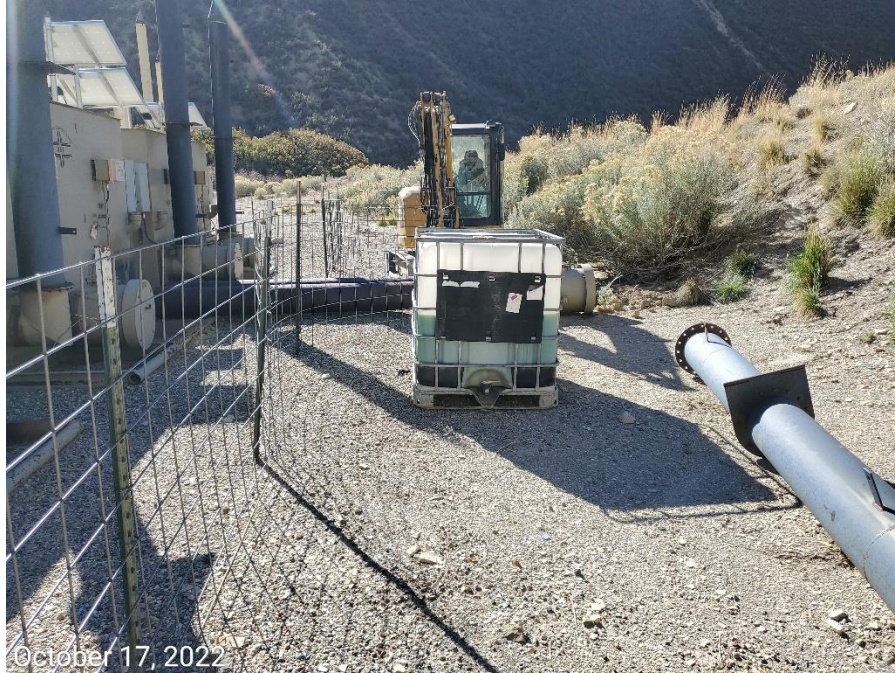
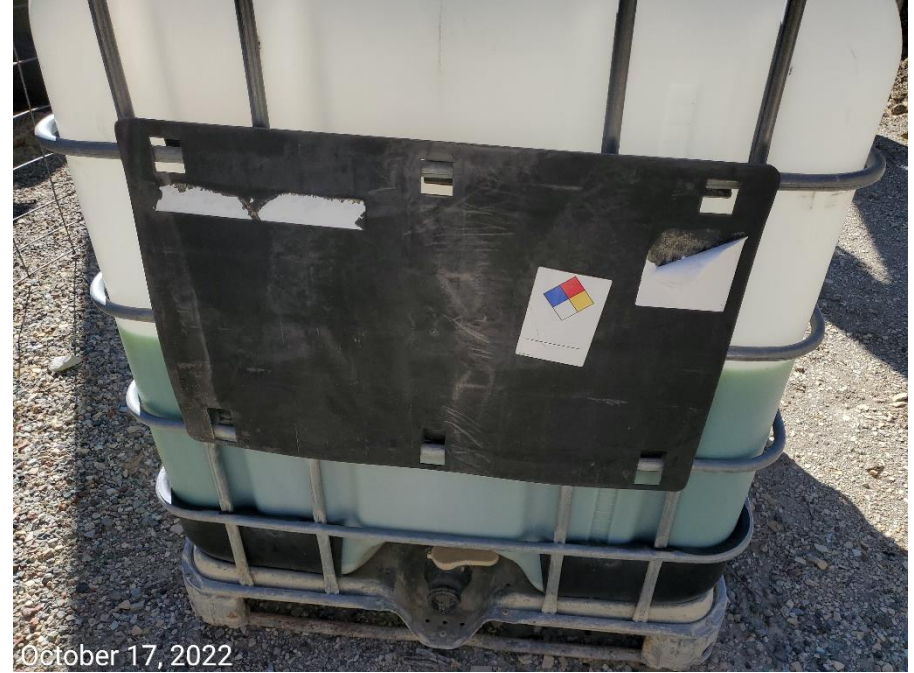
Photo 13: Tote container with unknown chemicals stored on west end of the Location; container lacking labeling as well as spill prevention and/or containment BMPs. NFPA label information observed on container blank or faded.

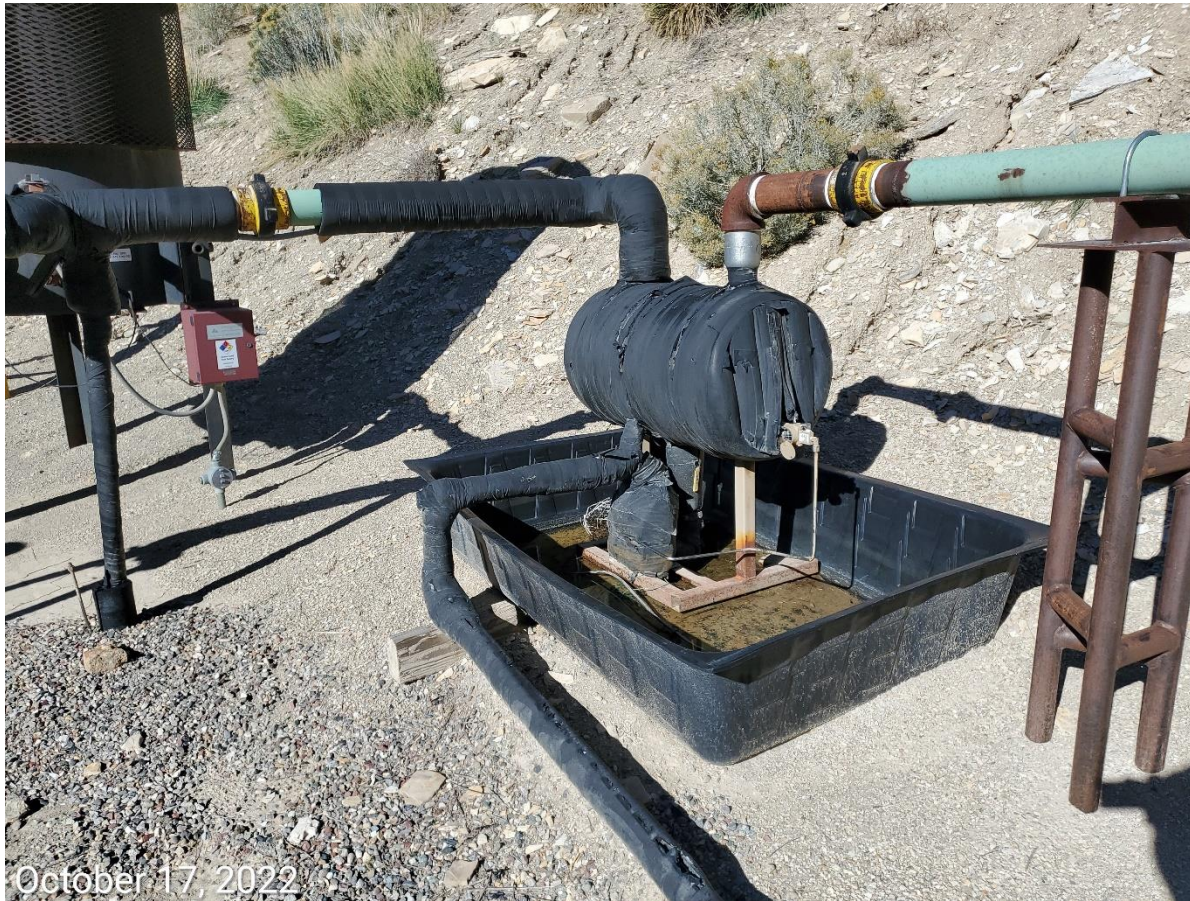
Photo 14: Secondary containment missing wildlife protection BMPs.
