Inspection
Photos
spill # 483023
Inspection Date:
10/6/2022
All Photos taken
by Kris Neidel

COLORADO
Oil & Gas Conservation
Commission
Department of Natural Resources

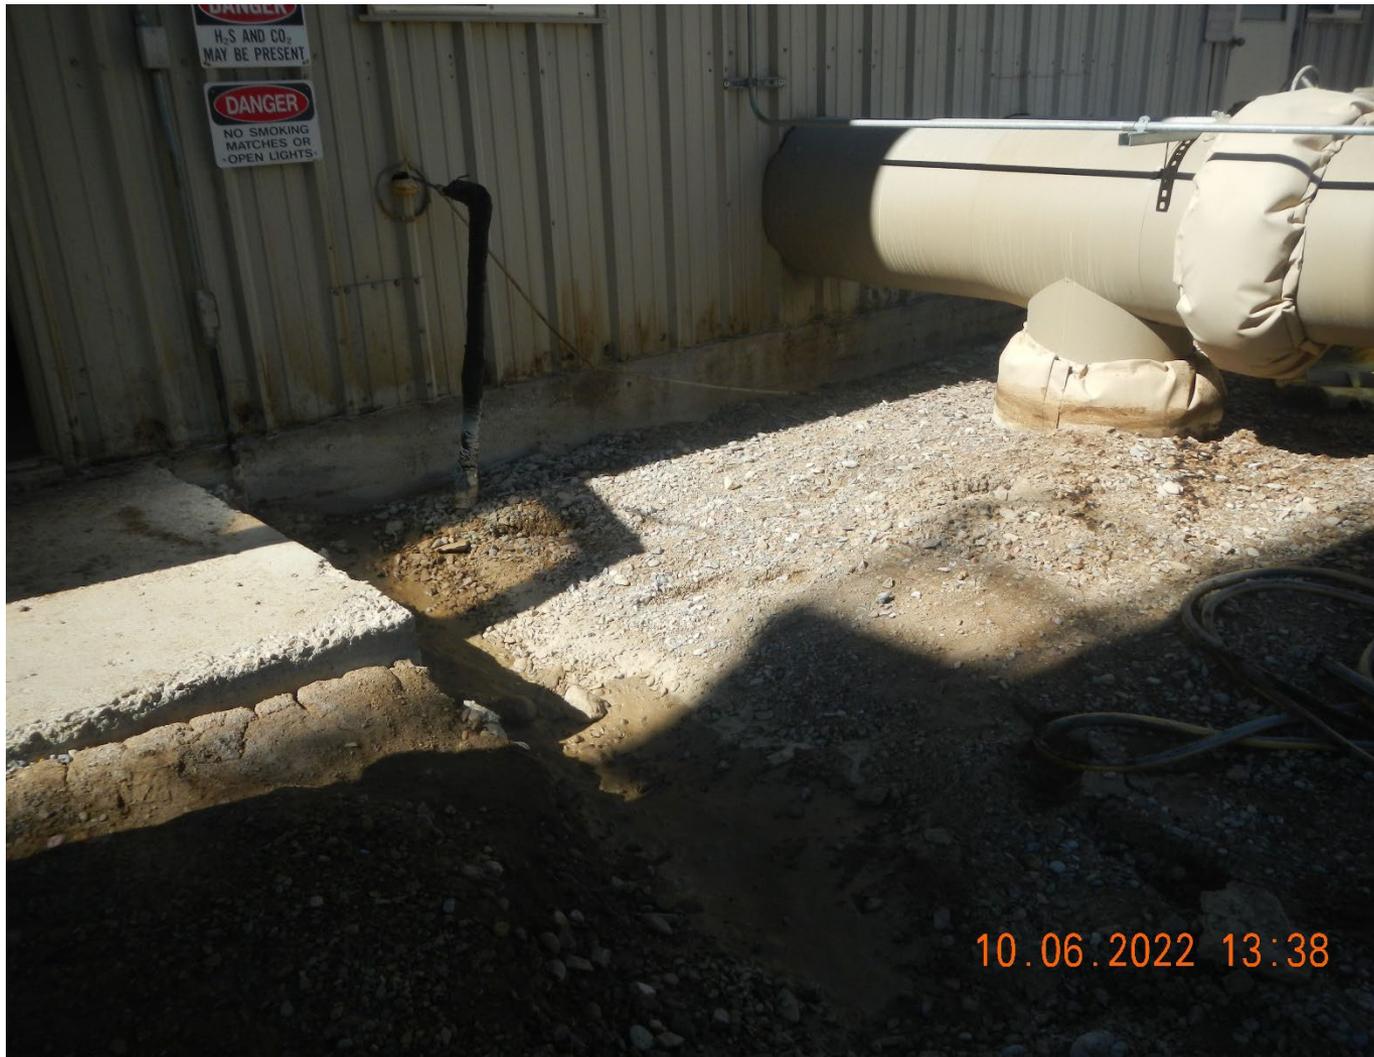
Photo #1 Area near spill origin. Note staining on pipe insulation.

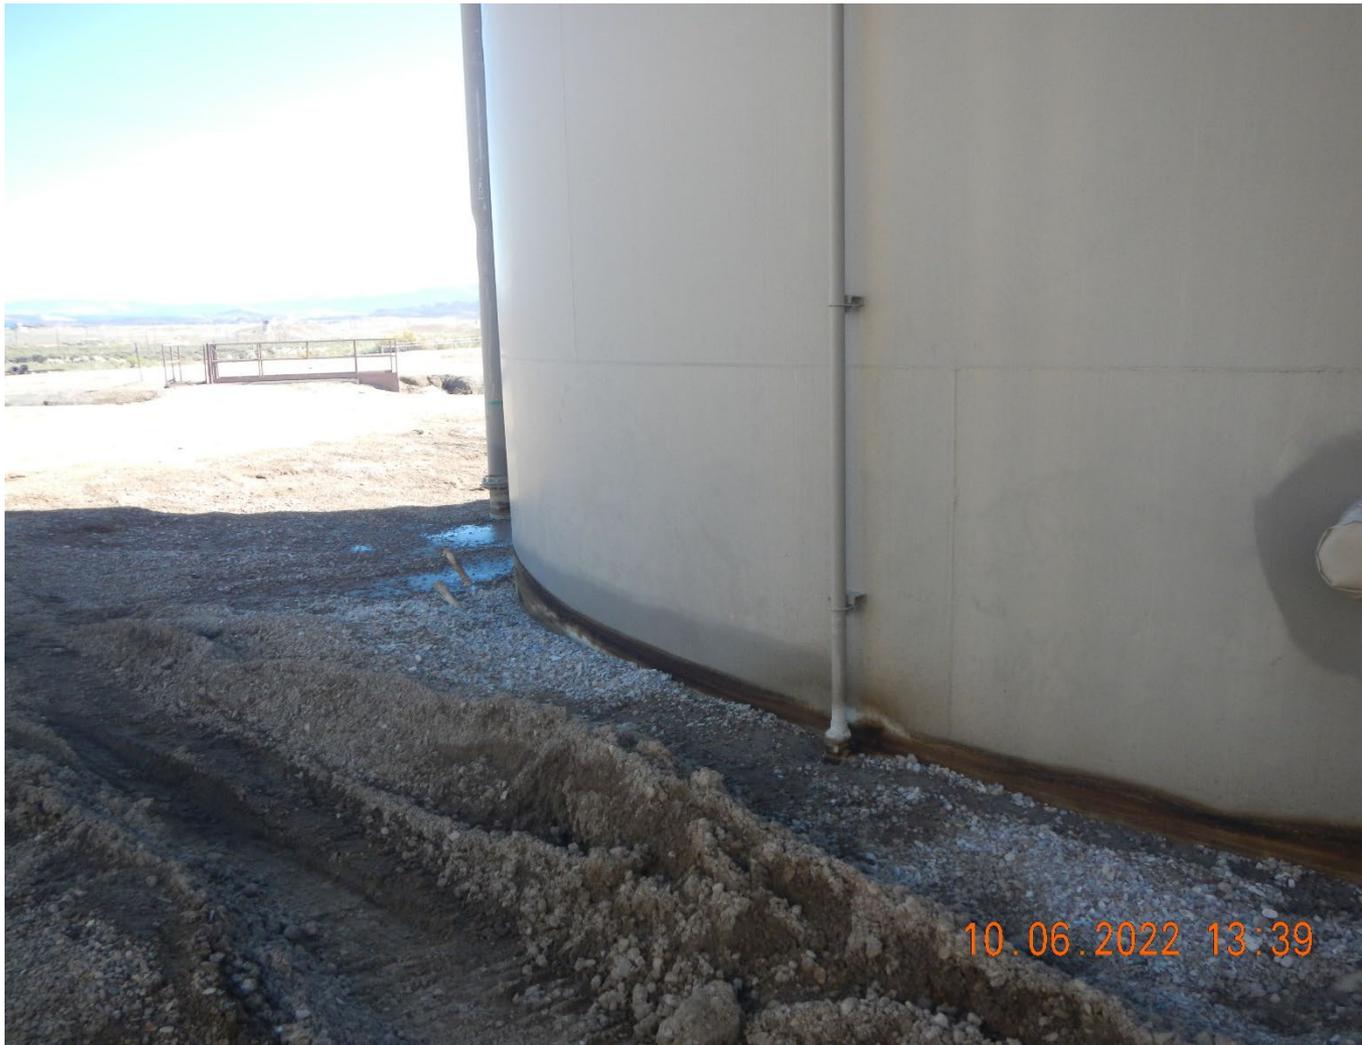
Photo #2 Tank that is directly across from spill origin. Tank is approximately 30 feet from spill origin. Photo taken looking south.

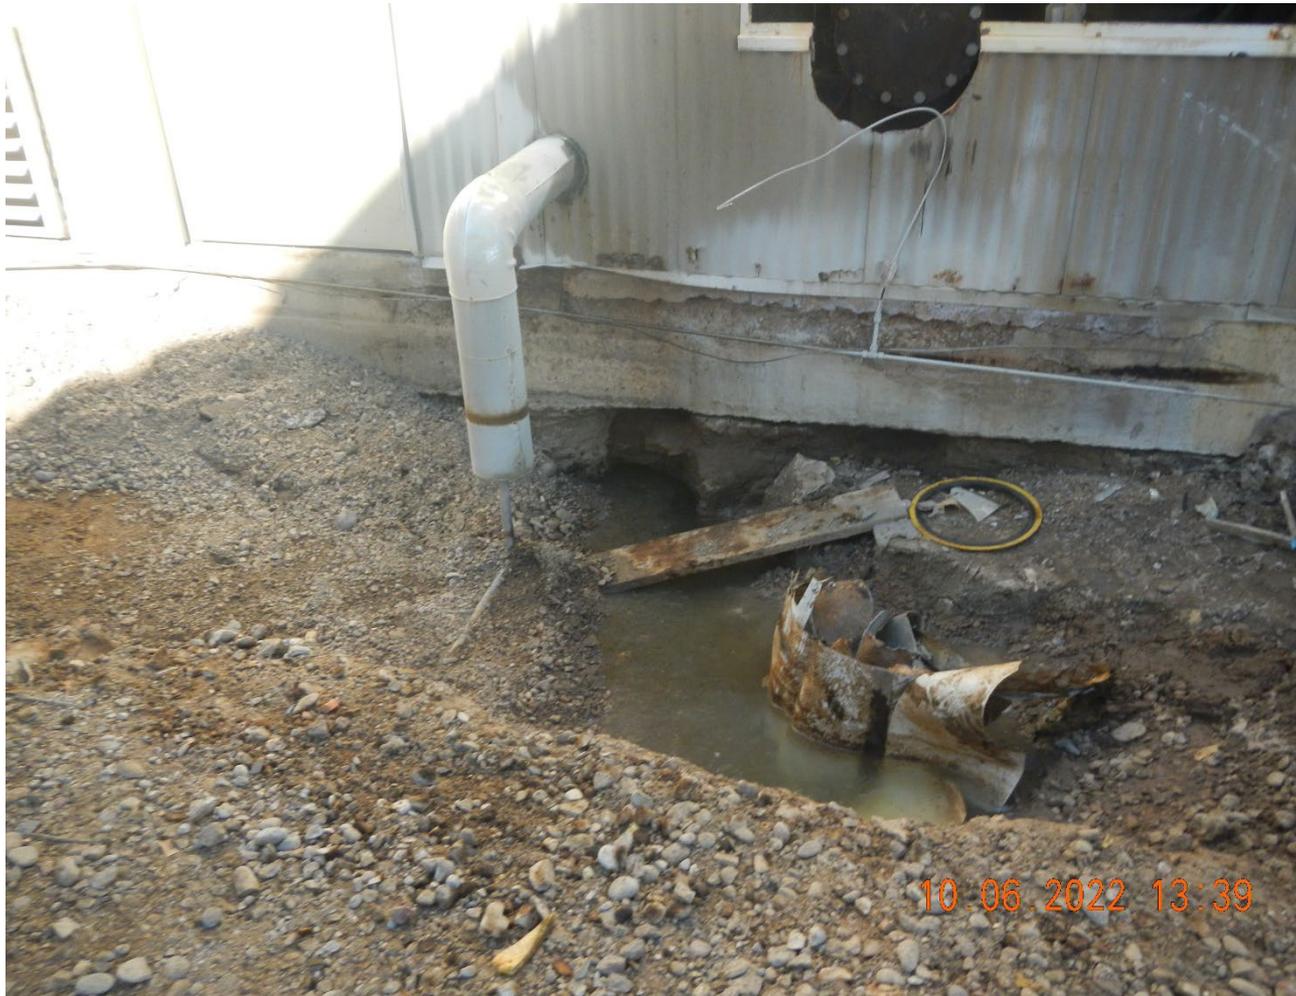
Photo #3 area of spill origin. Note: blind flange at top of photo, this was the area where the pipe failed. Photo is taken looking north.

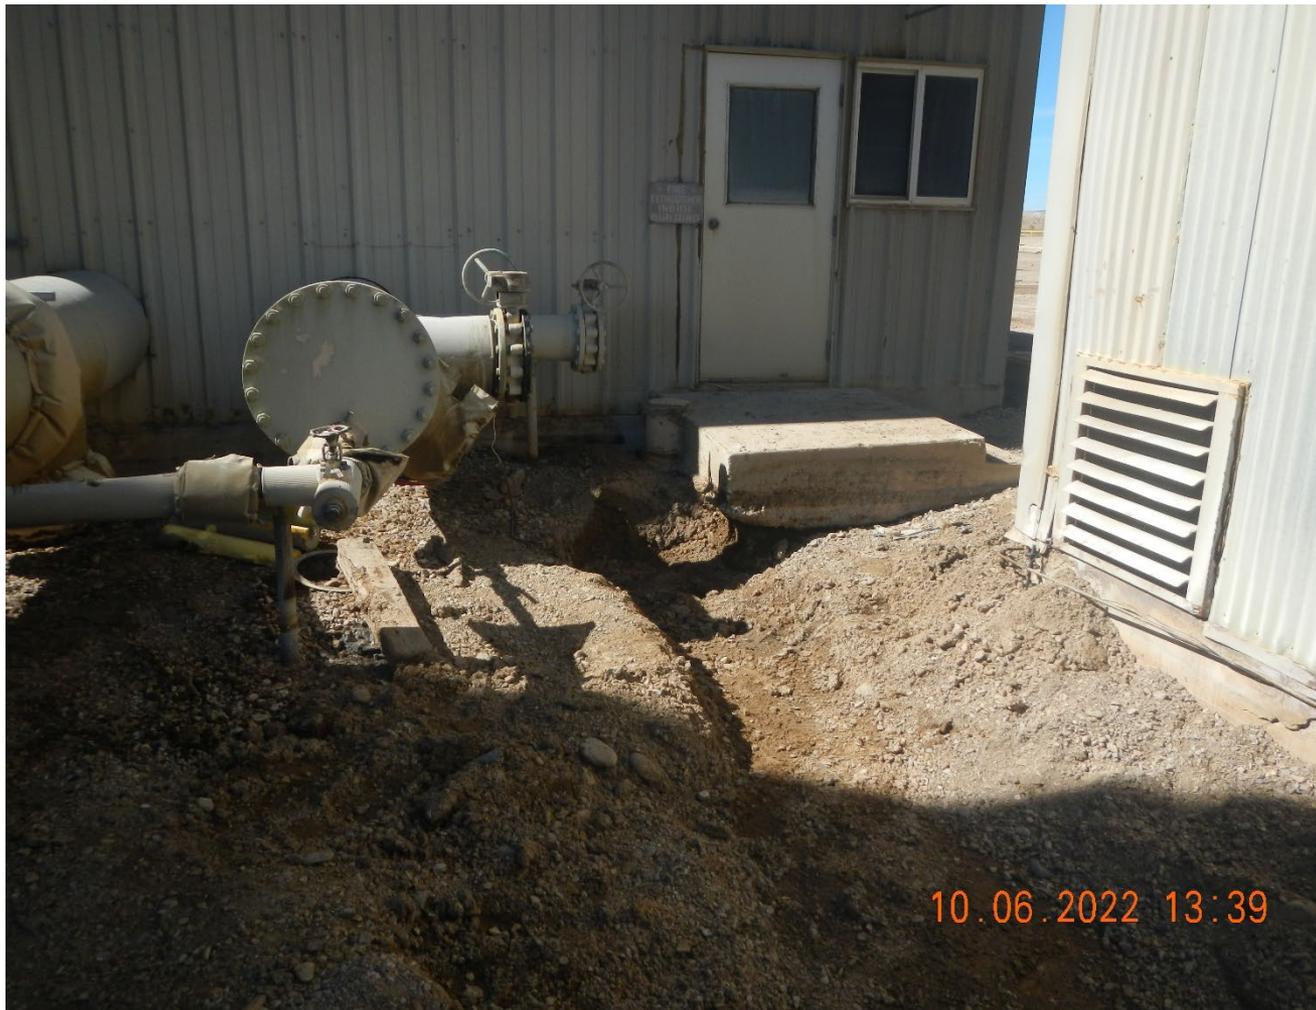
Photo #4 Spill origin is to the right and 10 feet behind camera. Photo is taken looking west.

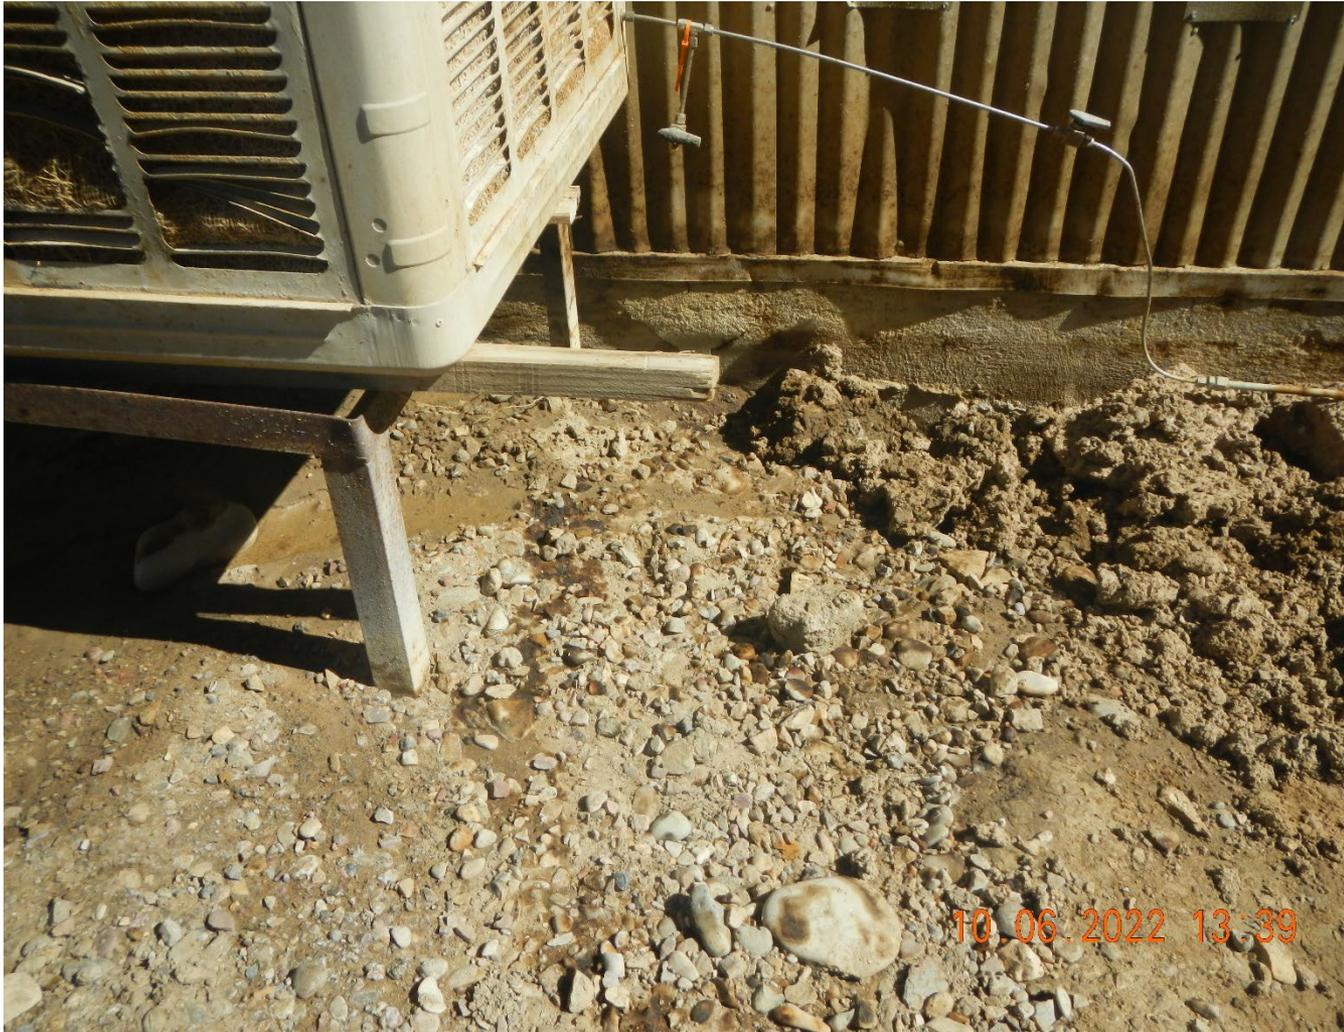
Photo #5 close up of Storage shed on the north side of location, that parallels the perimeter road. Note: high water mark of spill on building footer, some stained soil below the swamp cooler.

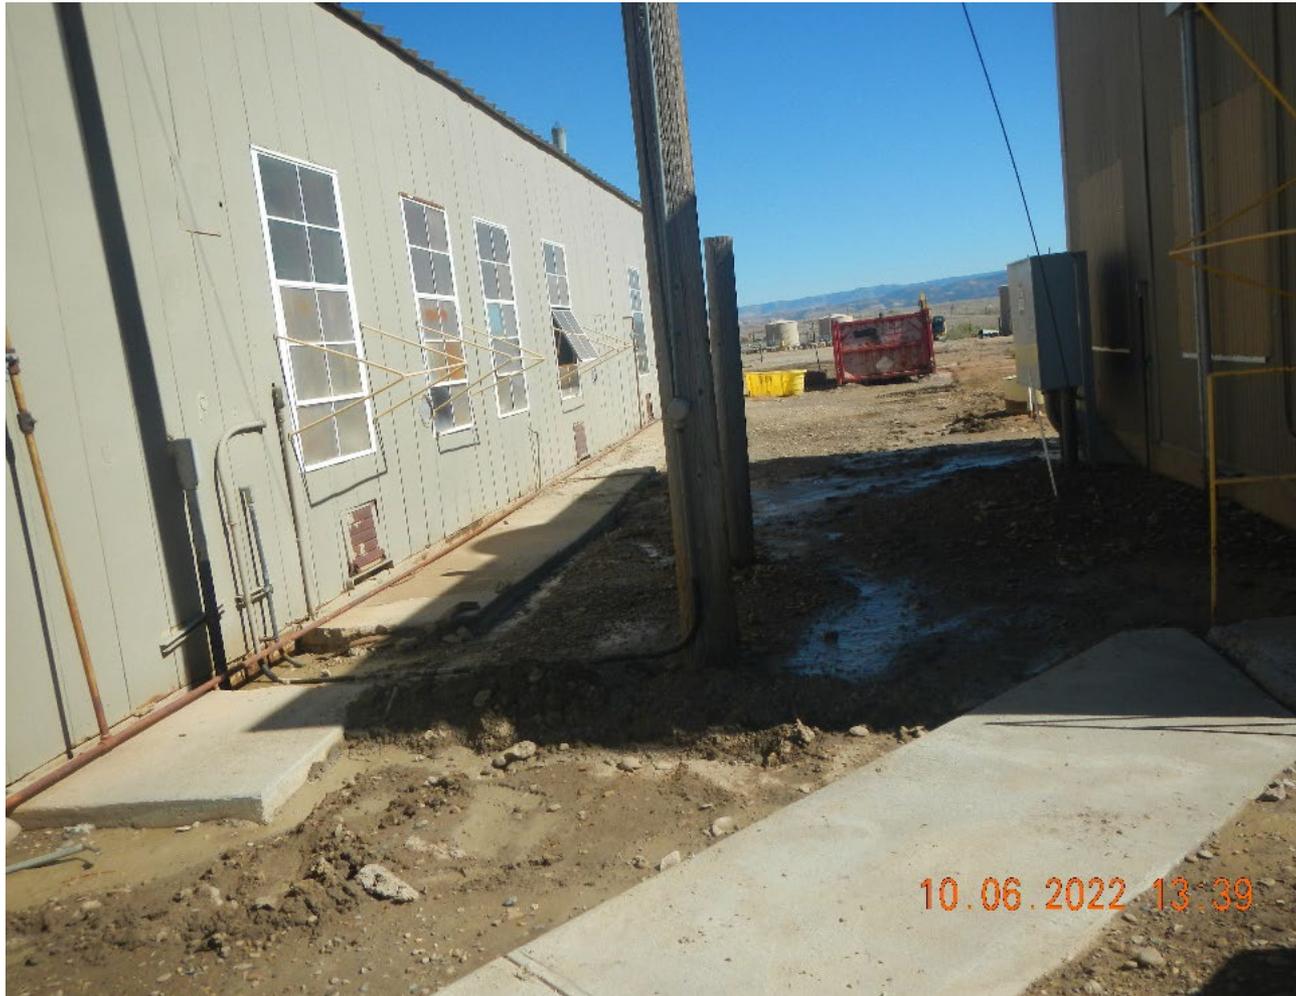
Photo #6 Building on the right contained the failed pipe. The Building on the left appeared to be used as a Storage shed it is on north side of the location, this building that parallels the perimeter road. Photo taken looking east.

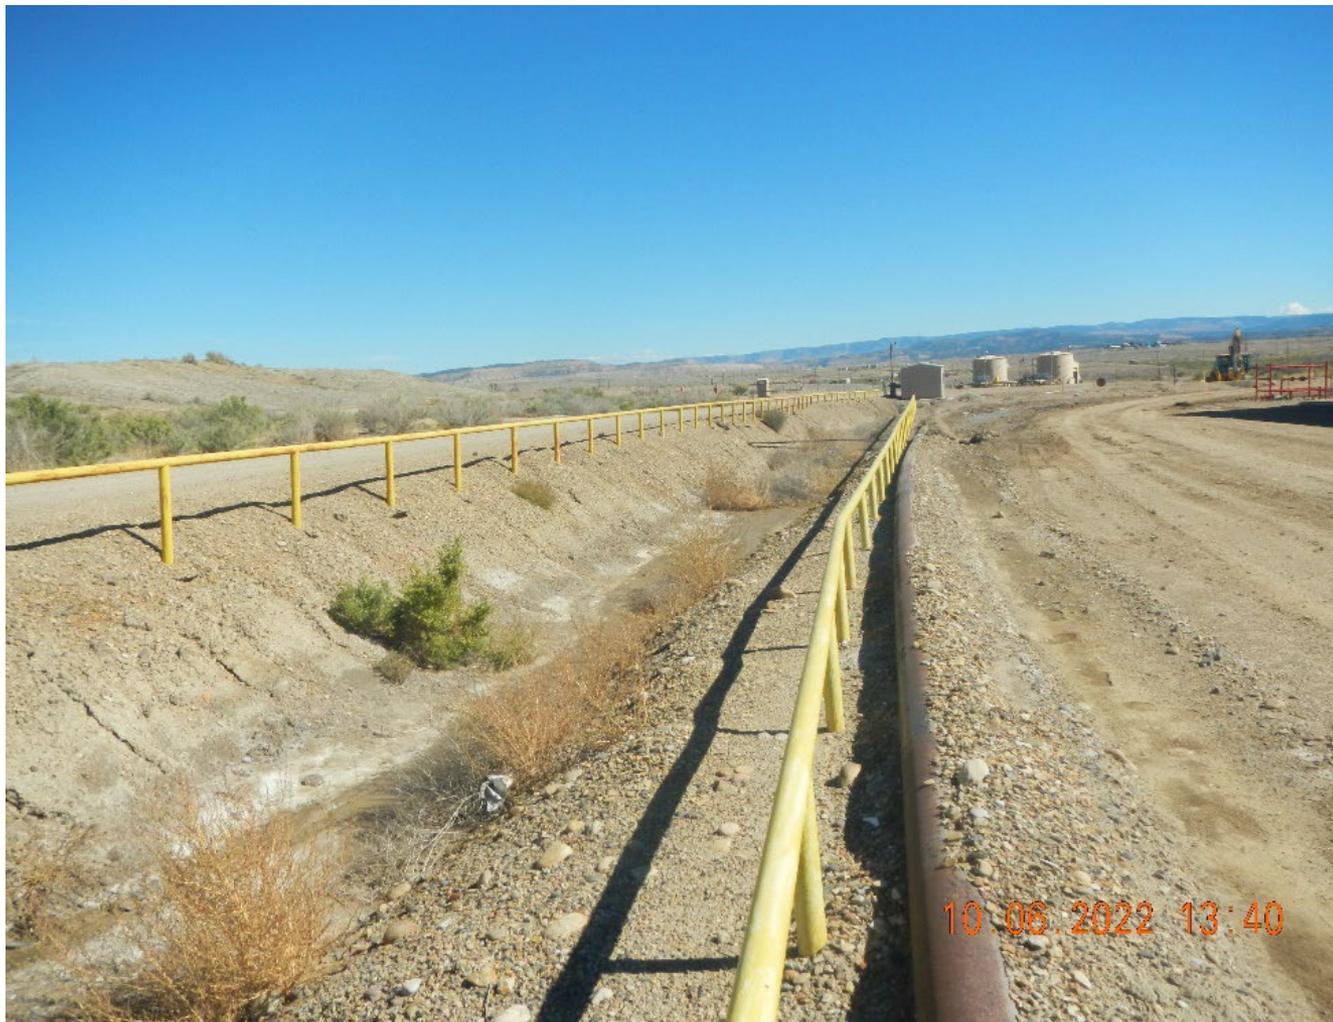
Photo #7 The surface water ditch captured some of the spilled fluid. It is believed, that water from ditch is directed through a culvert then to a ditch and ultimately to an emergency pit, Facility 102564.

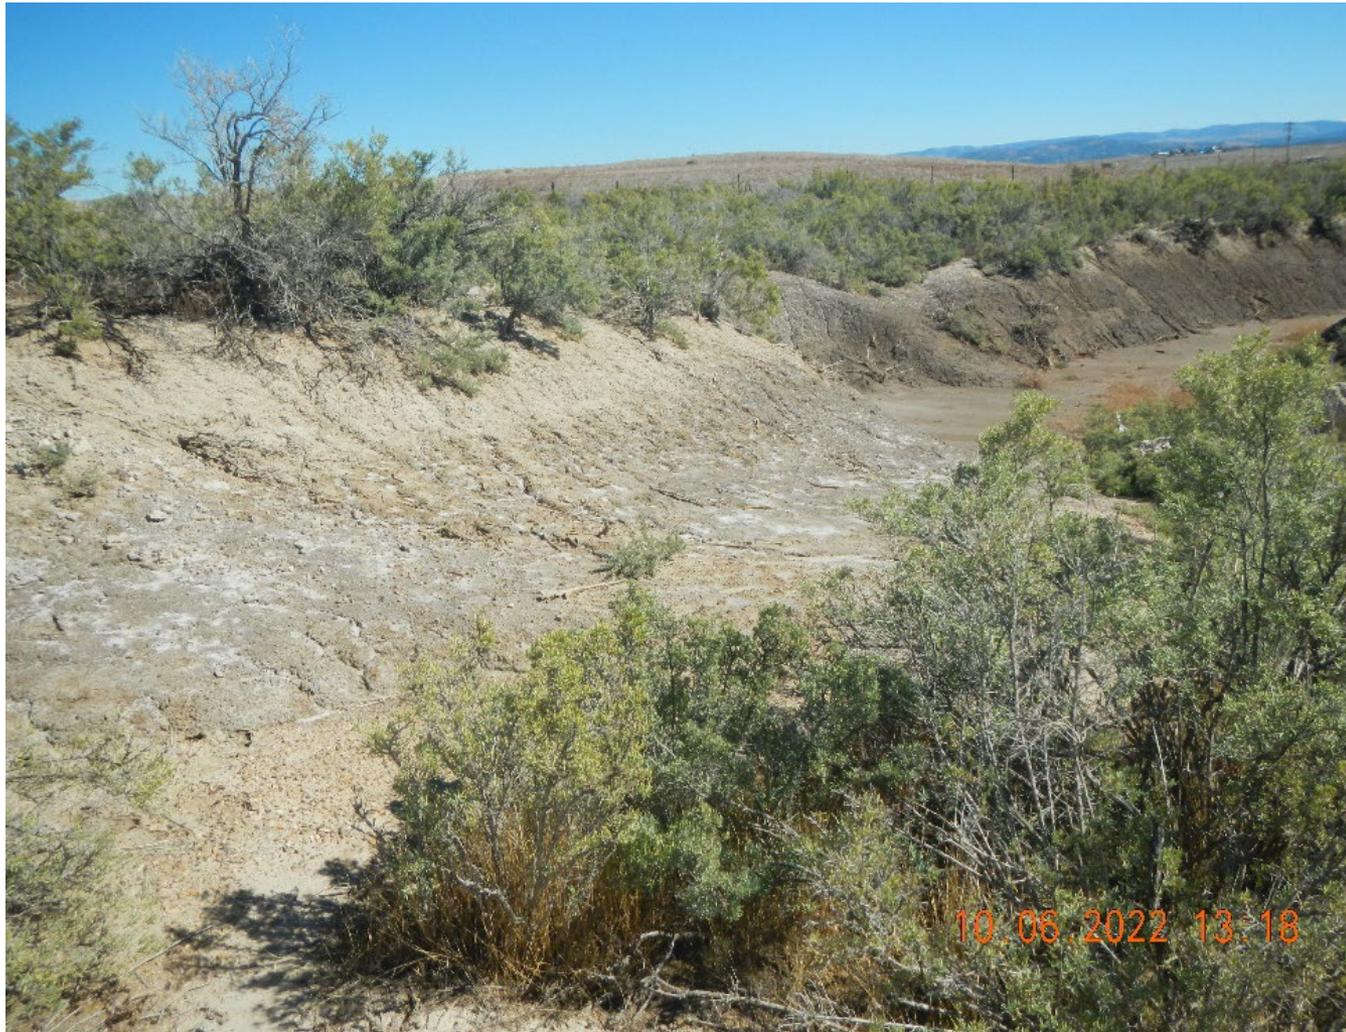
Photo #8 this ditch collected the spilled fluid and directed it to emergency pit. There was some salt staining observed, no hydrocarbon staining was observed in this portion of the spill path.

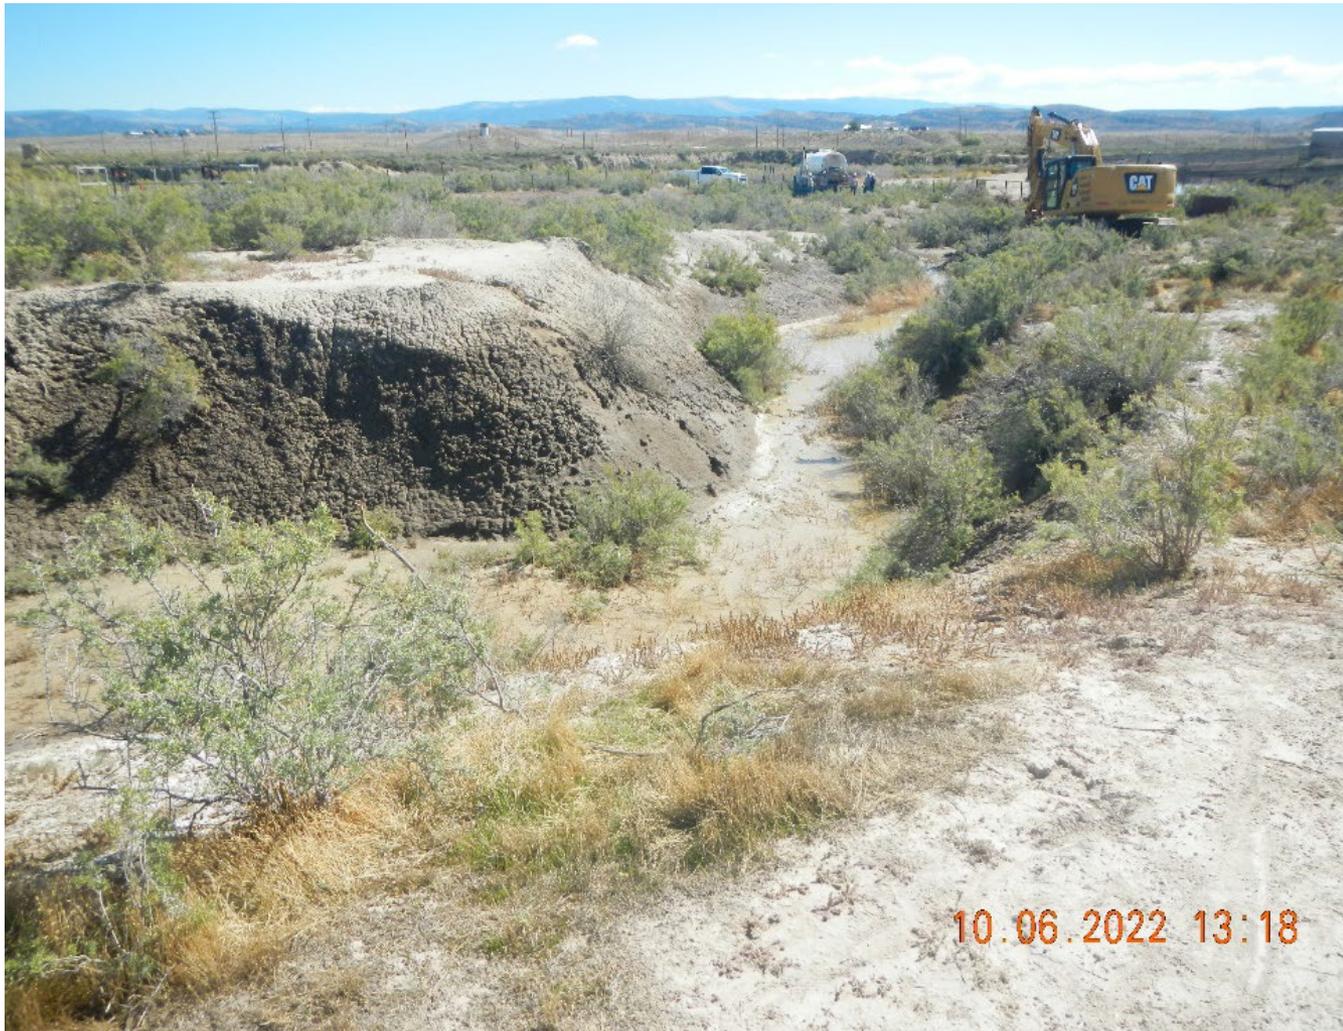
Photo #9 This ditch collected the spilled fluid and directed it to emergency pit. There was some salt staining observed, no hydrocarbon staining was observed in this portion of the spill path. Note: just to the lookers left of the excavator is a fence, this is the perimeter fence to the emergency Pit. The pump truck in photo was finishing collecting fluid from a water wash of the spill path.

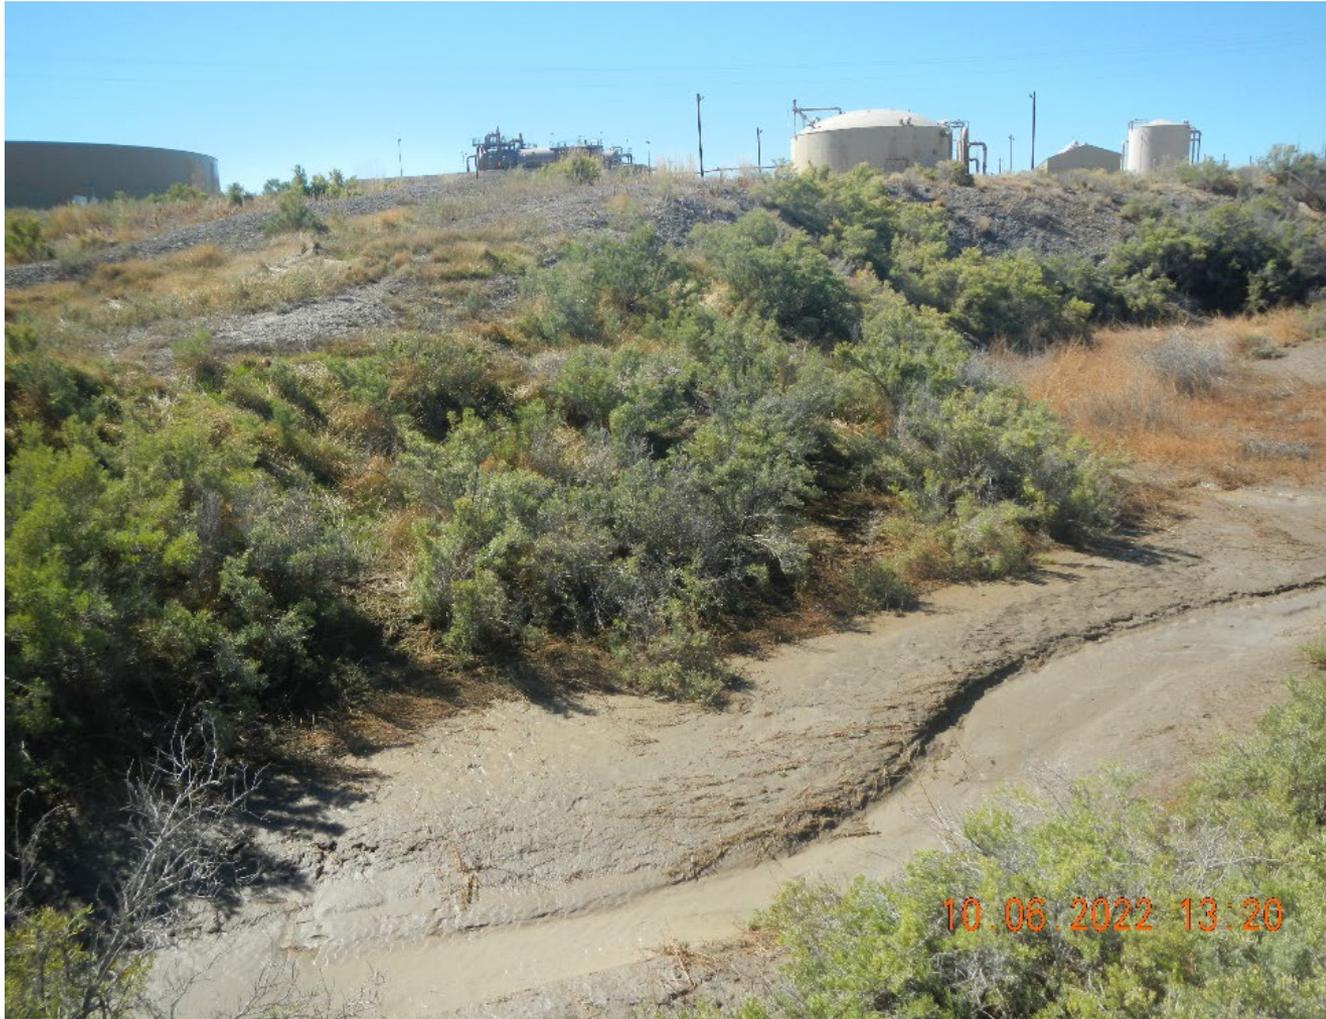
Photo #10 This ditch collected the spilled fluid and directed it to emergency pit. There was some salt staining observed, no hydrocarbon staining was observed in this portion of the spill path. Note: photo is looking east-southeast, taken between pit and Main Water Plant.

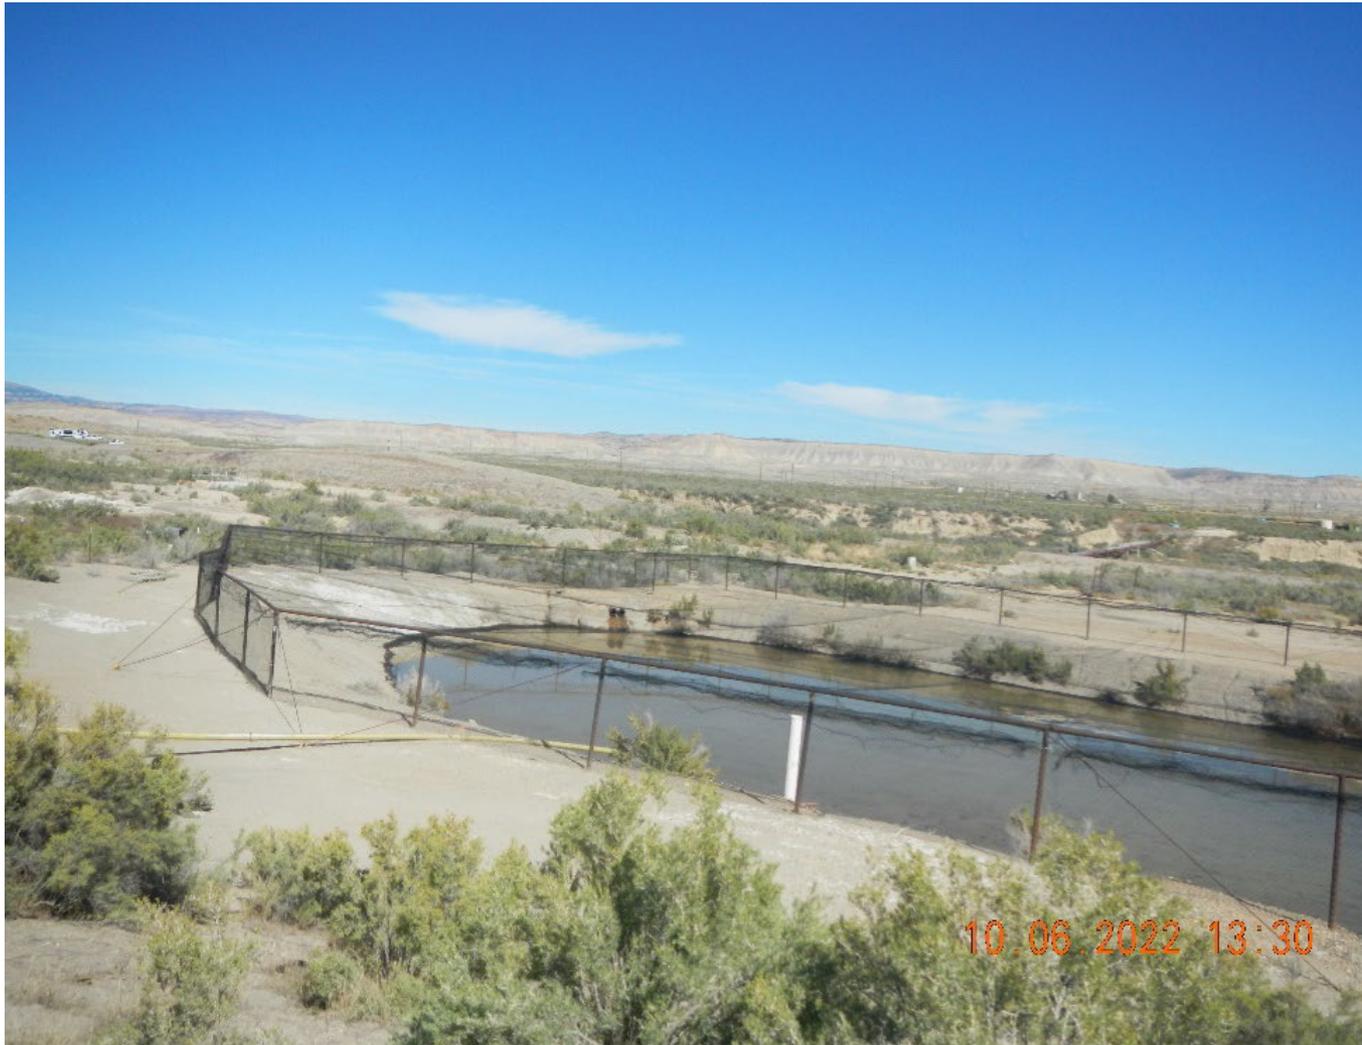
Photo #11 Emergency Pit at Main water Plant, Facility 102564

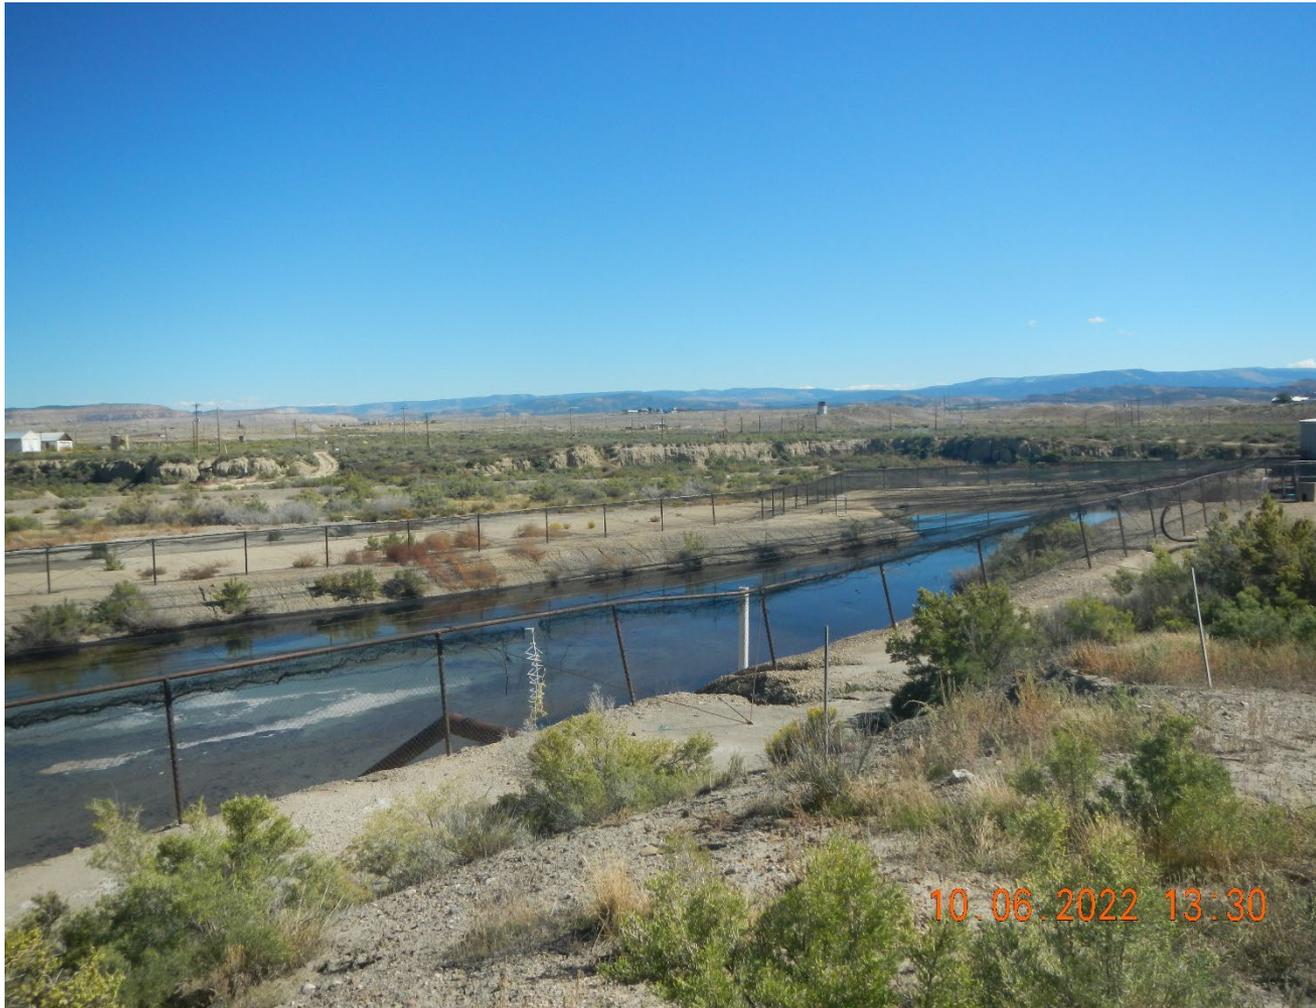
Photo #12 11 Emergency Pit at Main water Plant, Facility 102564

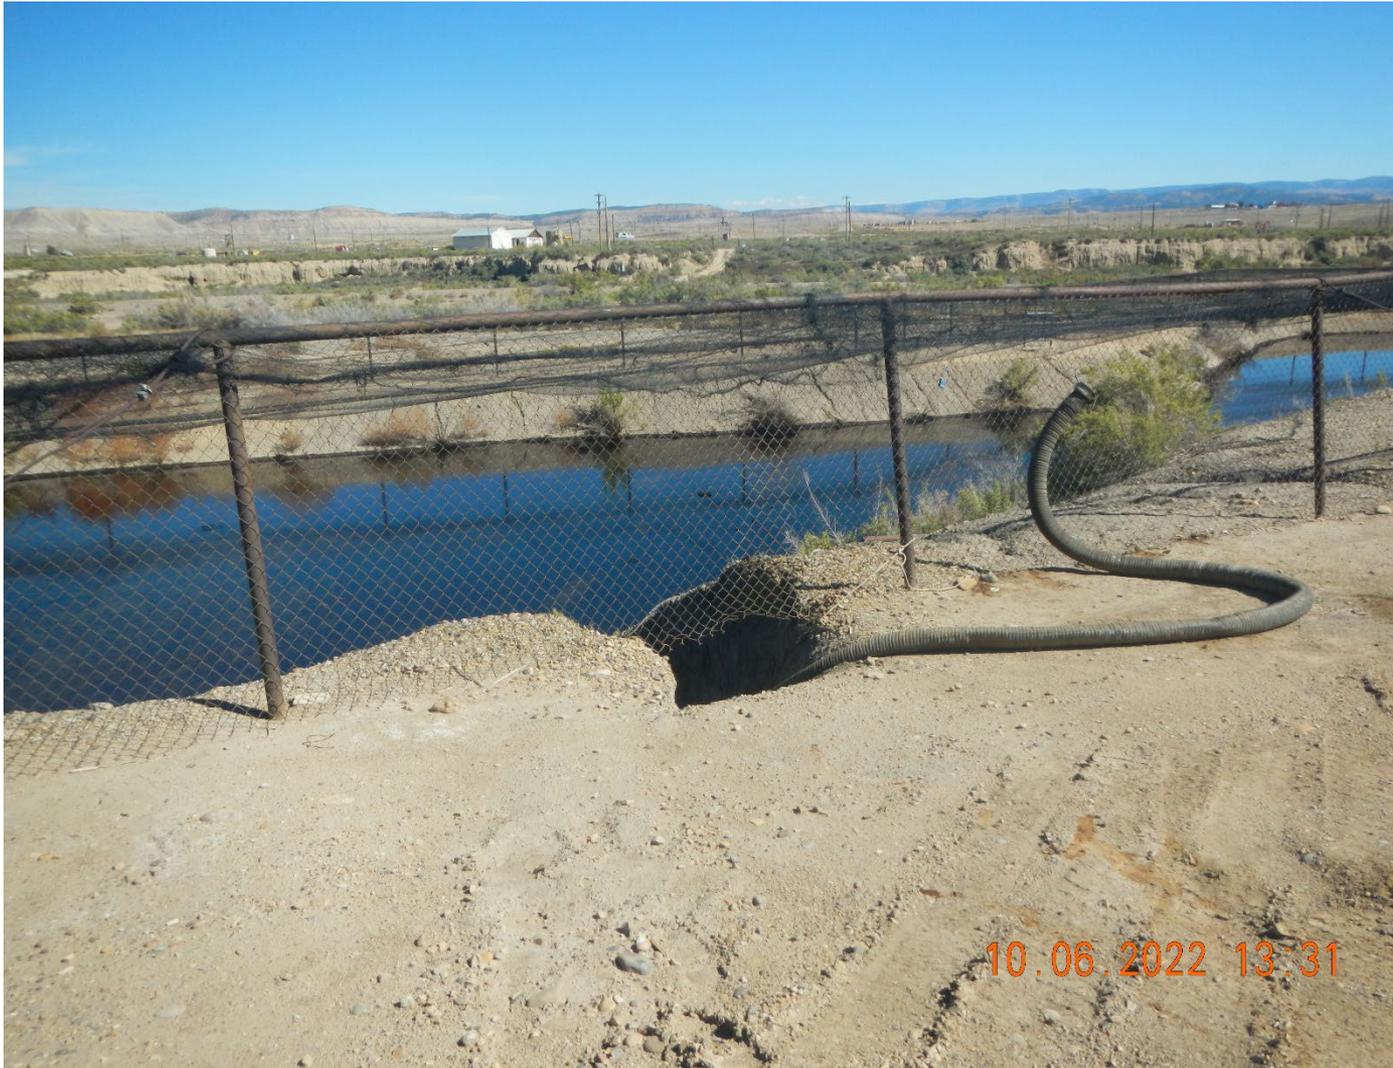
Photo # 11 Emergency Pit at Main water Plant, Facility 102564. Note: potential gap in fence.

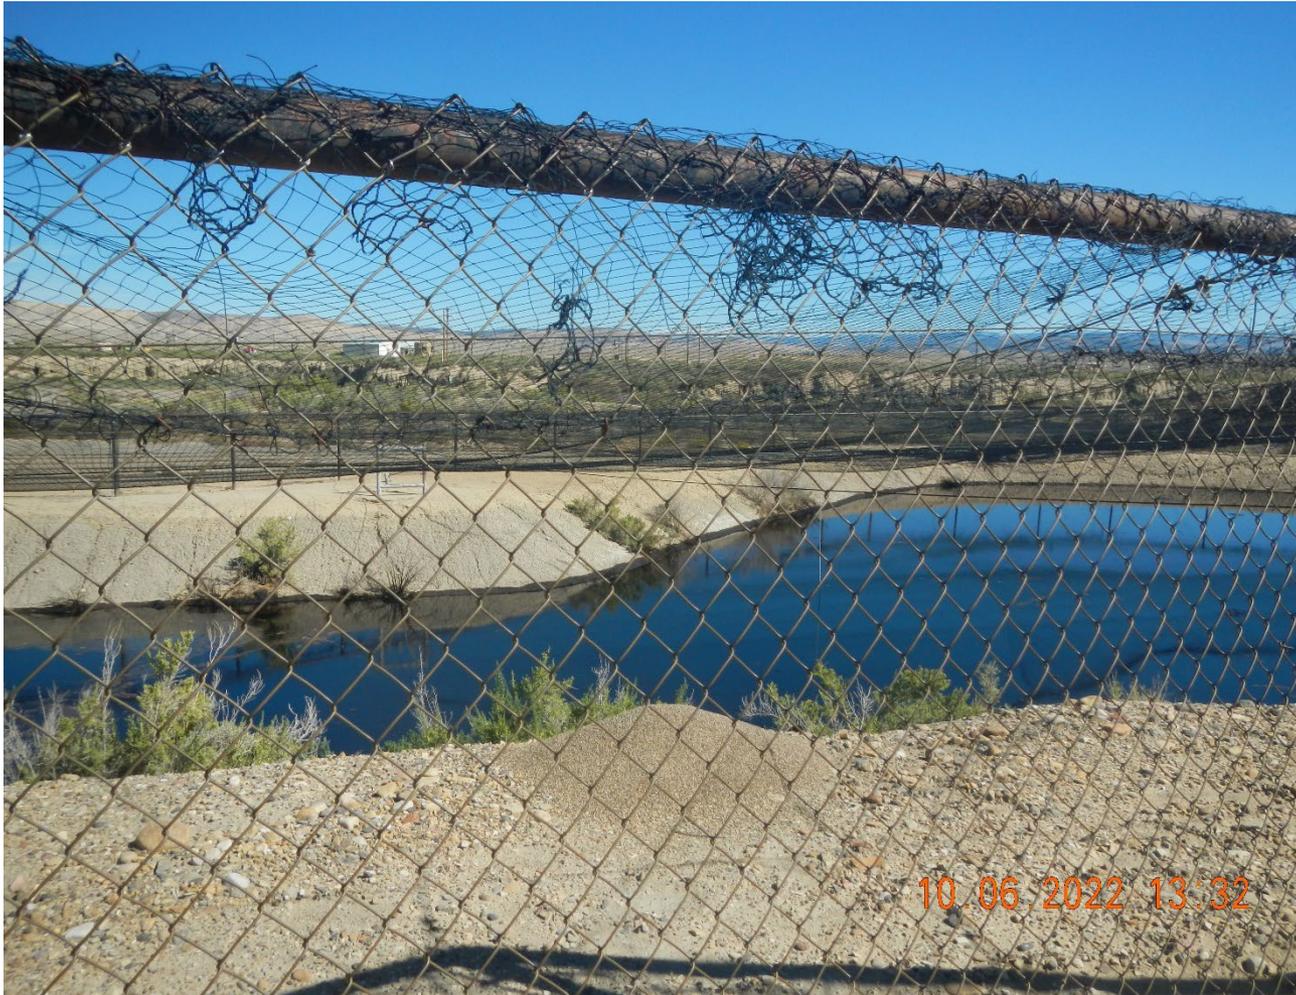
Photo #14 11 Emergency Pit at Main water Plant, Facility 102564

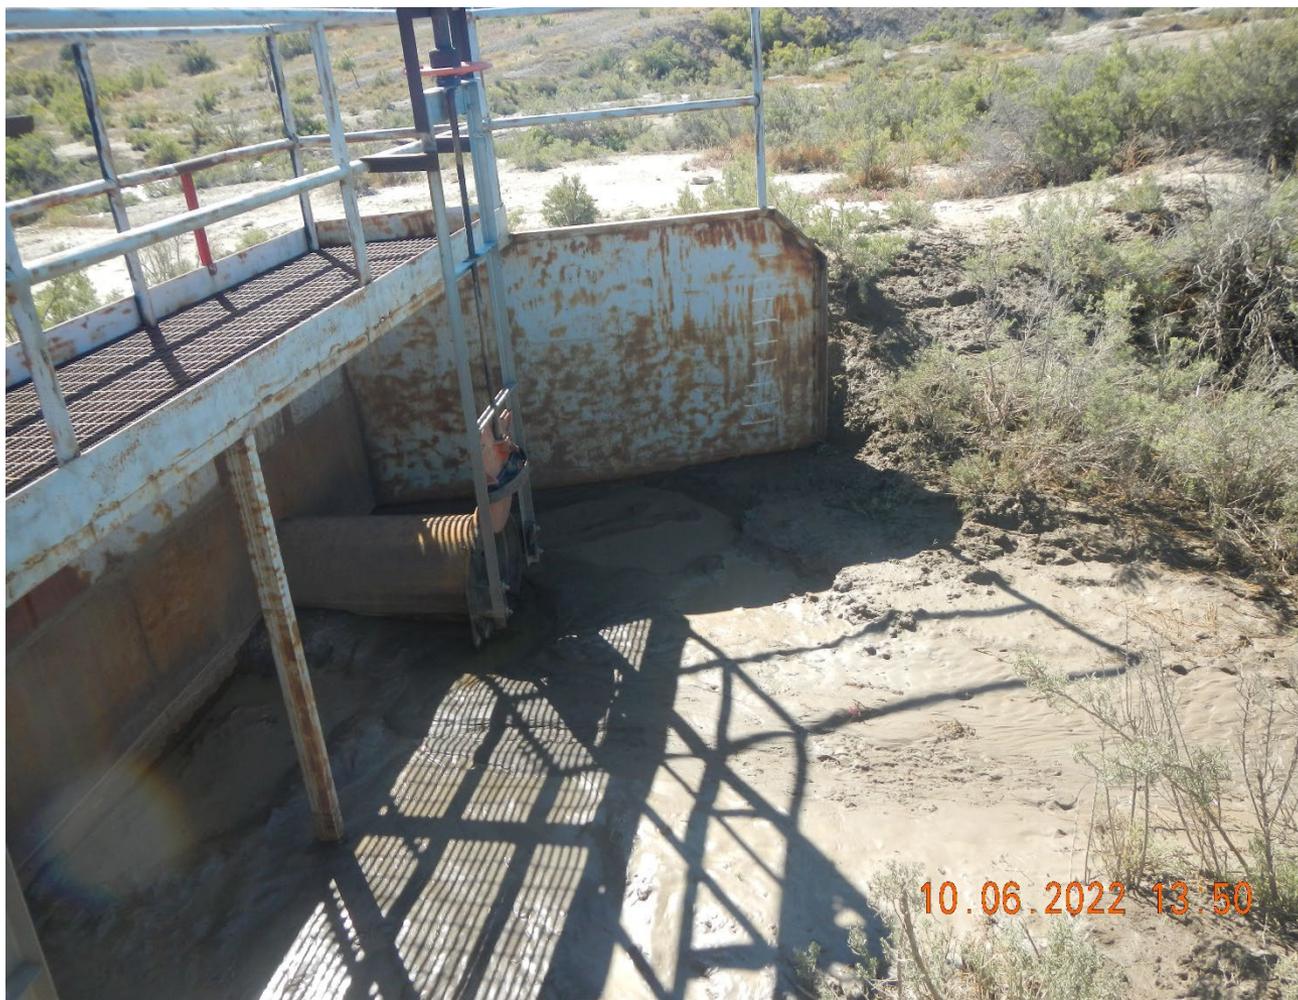
Photo #15 this gate is near the following lat/long that was recorded via camera; 40.099572,-108.859017. It is was told to COGCC that this gate was closed at the time of the spill, this directed water to the area behind the gate, in this photo and ultimately to the Pit. Behind this gate, was dry.

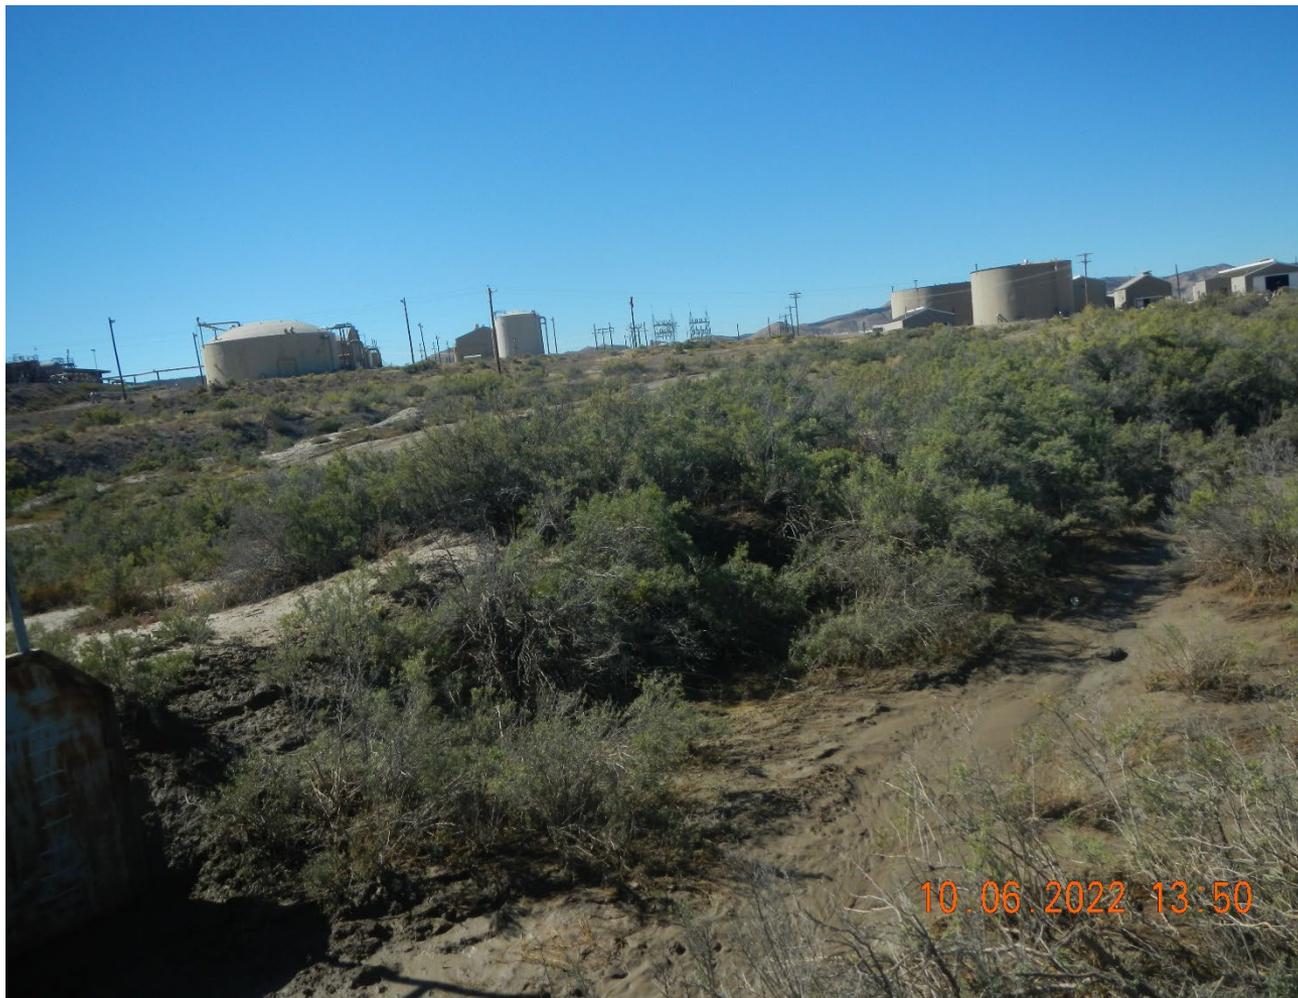
Photo #16 spill path between the facility and pit. NO hydrocarbon was observable in this portion of spill. This area was water washed.
