Inspection
Photos
spill # 483023
Inspection Date:
10/6/2022
All Photos taken
by Kris Neidel

COLORADO
Oil & Gas Conservation
Commission
Department of Natural Resources

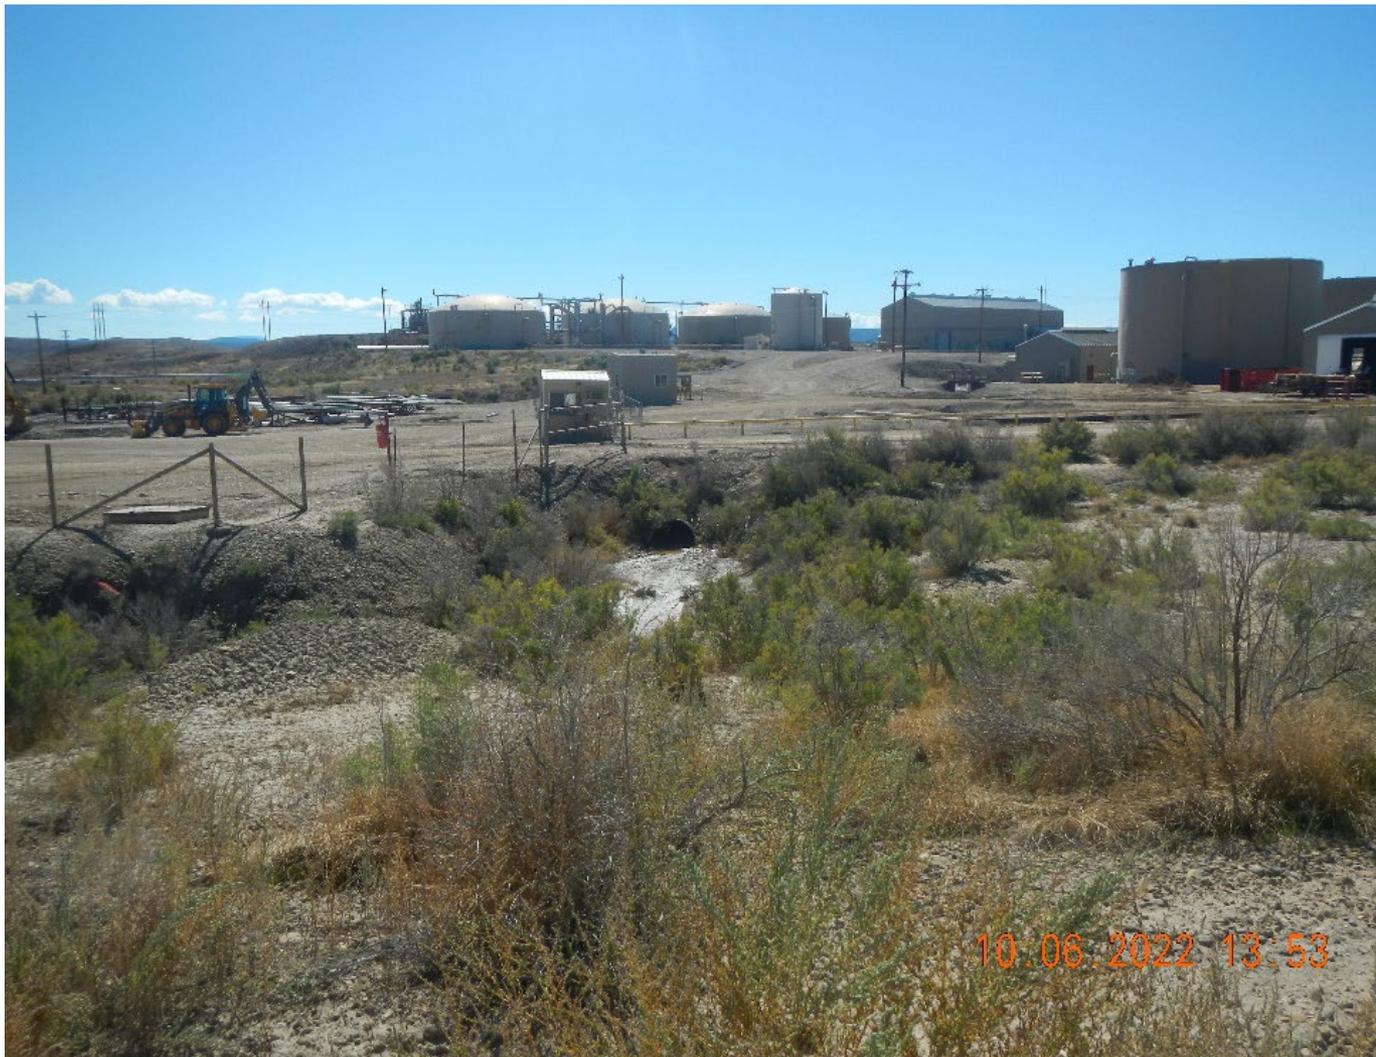
Photo #17 spill path between the facility and pit. NO hydrocarbon was observable in this portion of spill. This area was water washed.

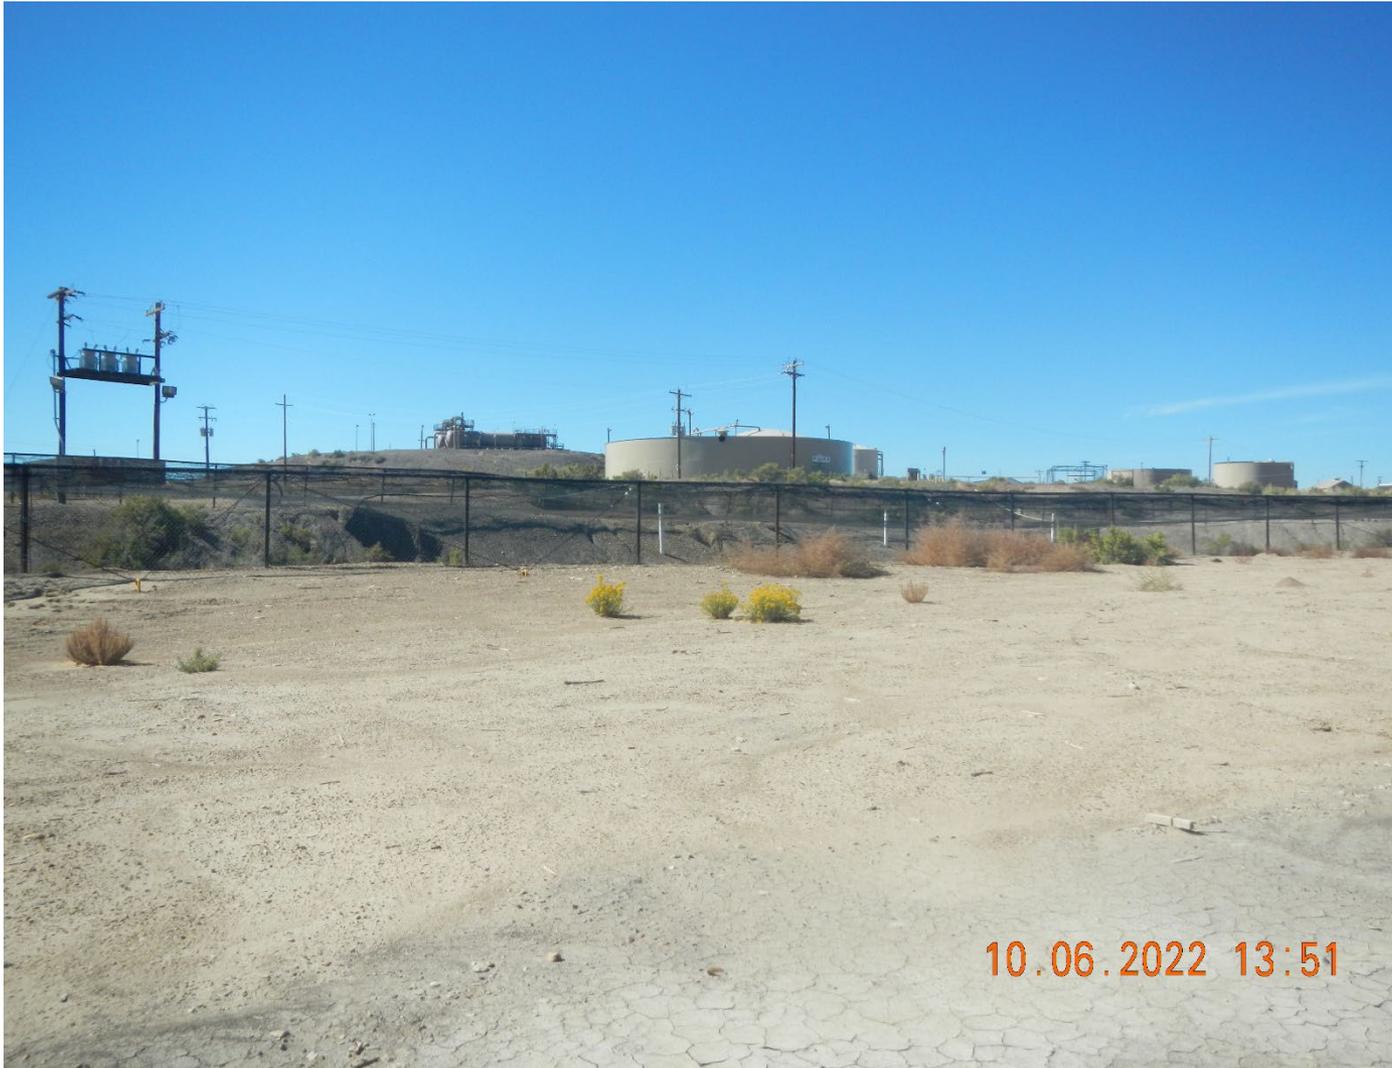
Photo #17 is taken on emergency access road for pit, on the northeast side of pit. It appears this side of the pit is not frequently used for maintaining the pit.

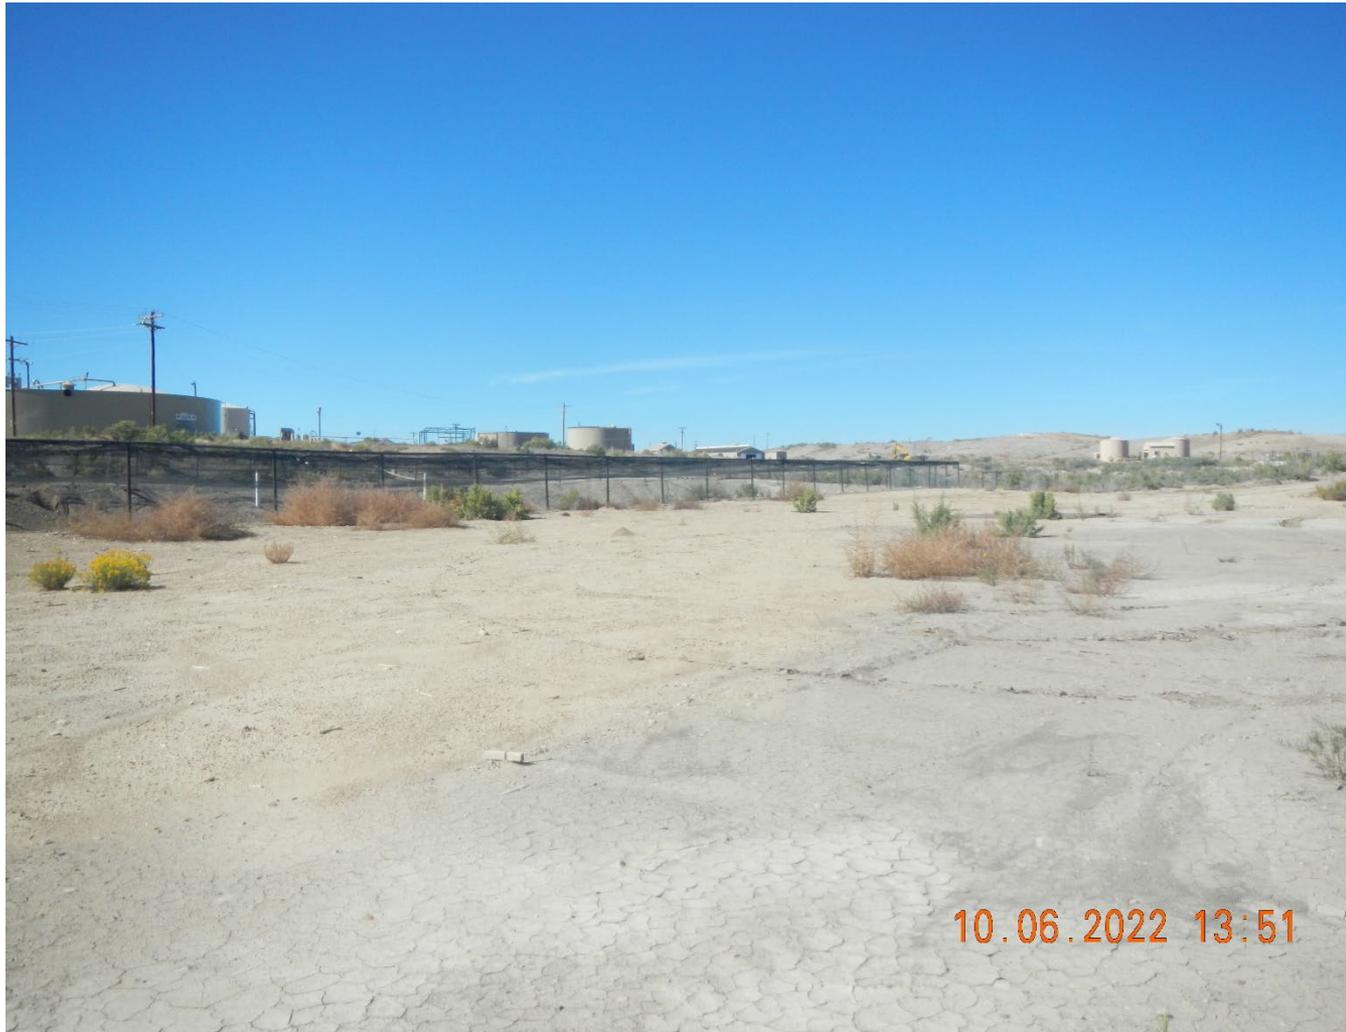
Photo #18 17 is taken on emergency access road for pit, on the northeast side of pit. It appears this side of the pit is not frequently used for maintaining the pit.
