Interim Reclamation and Stormwater Inspection

Operator: MALLARD EXPLORATION LLC - 10670

Location ID: 454414

Inspection Document #: 696105525

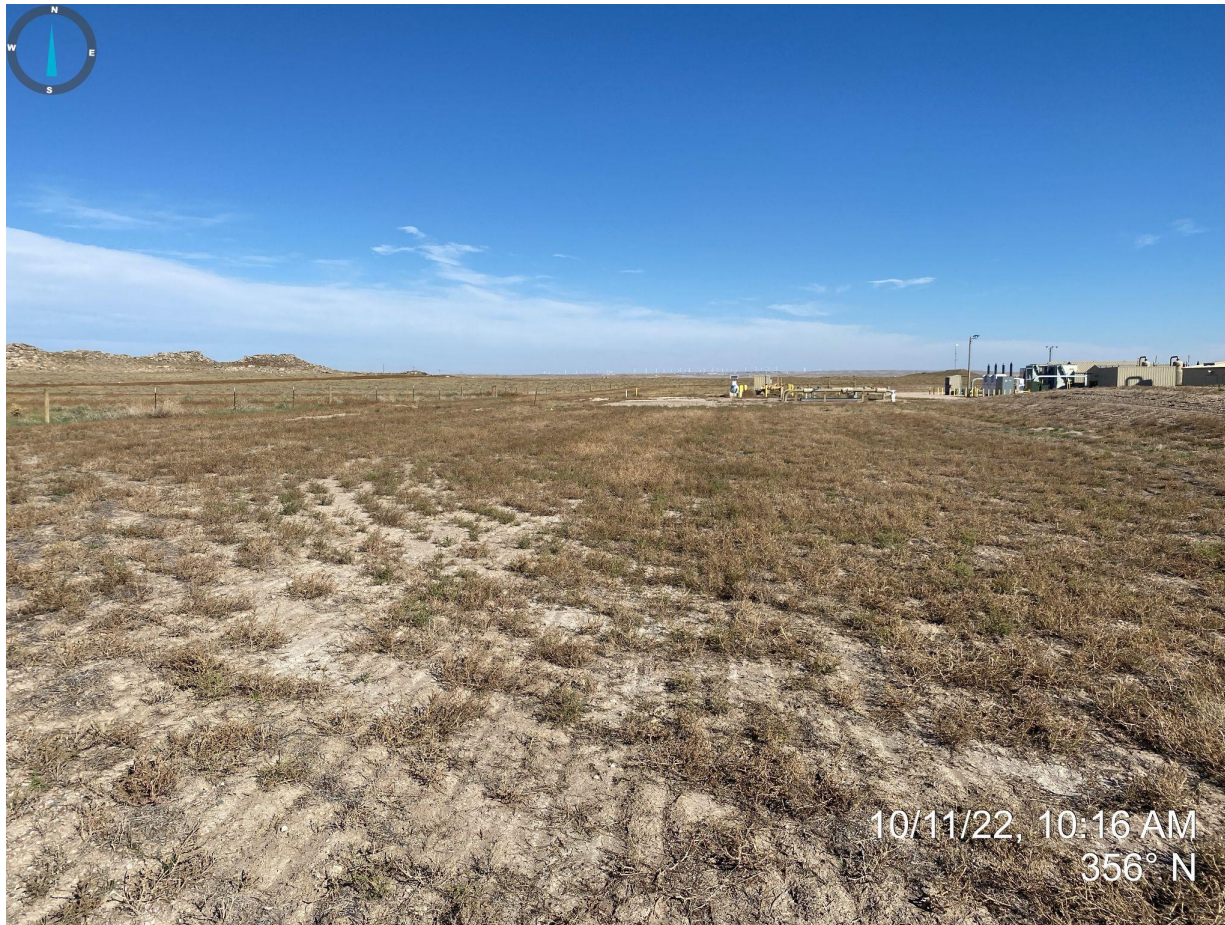
Photo 1. Taken from southwest portion of location, facing north. Photo illustrates annual weedy vegetation (e.g. kochia and russian thistle) was observed throughout the interim areas. Some desirable germination was observed in the drill rows (see Photo 9).

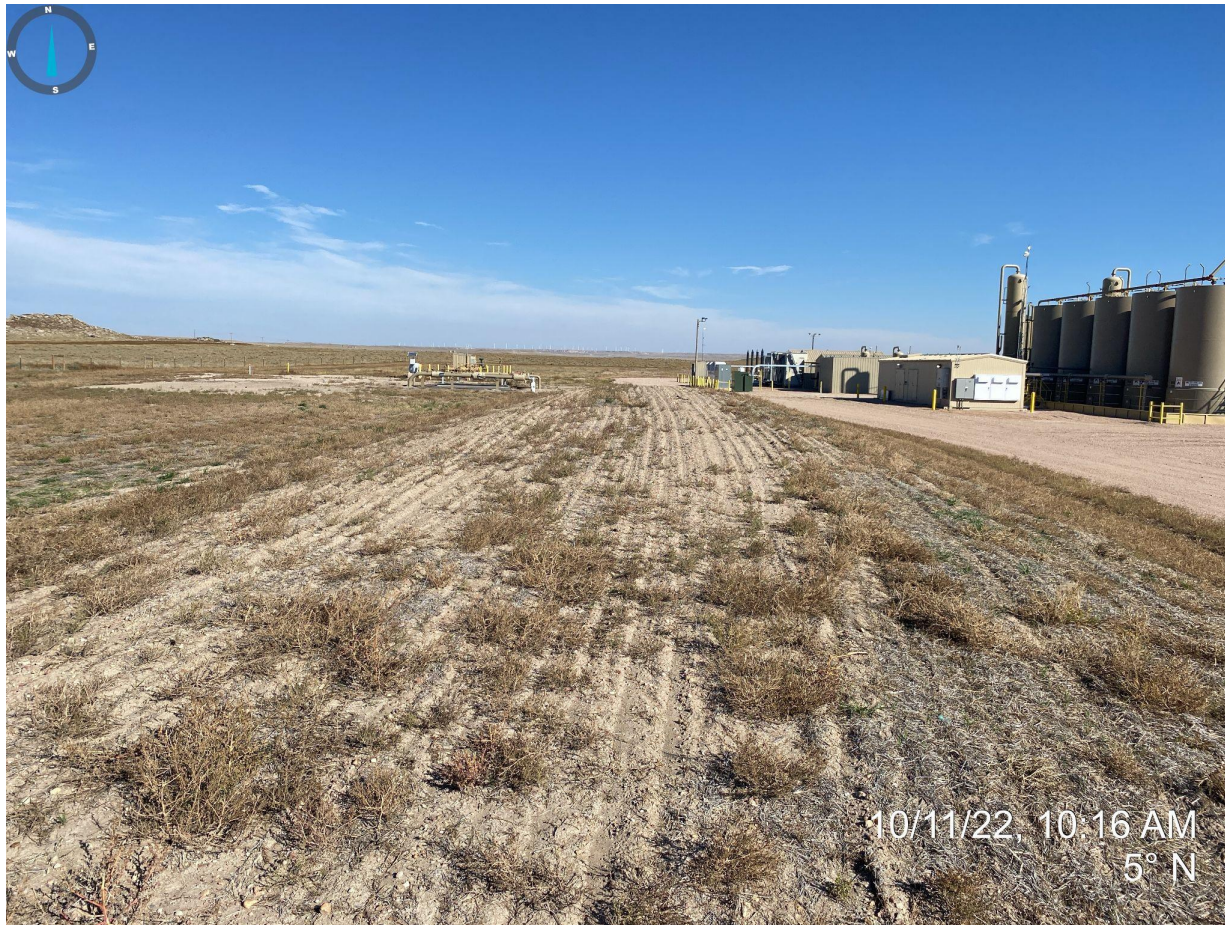
Photo 2. Taken from topsoil stockpile on the west end of location, facing north. See comments in Photo 1.

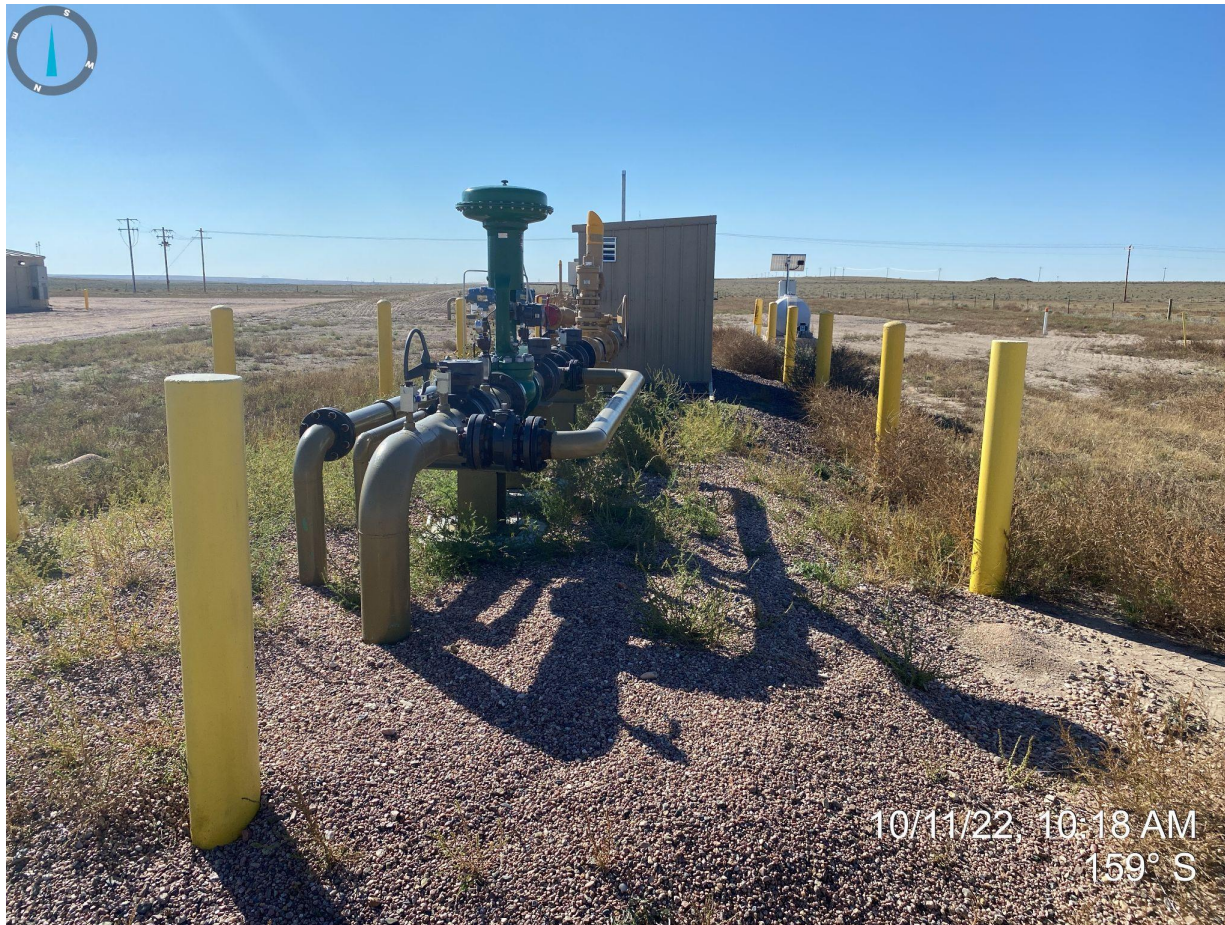
Photo 3. Taken from west portion of location, facing south. Annual weedy vegetation observed next to flowlines/meter shed location.

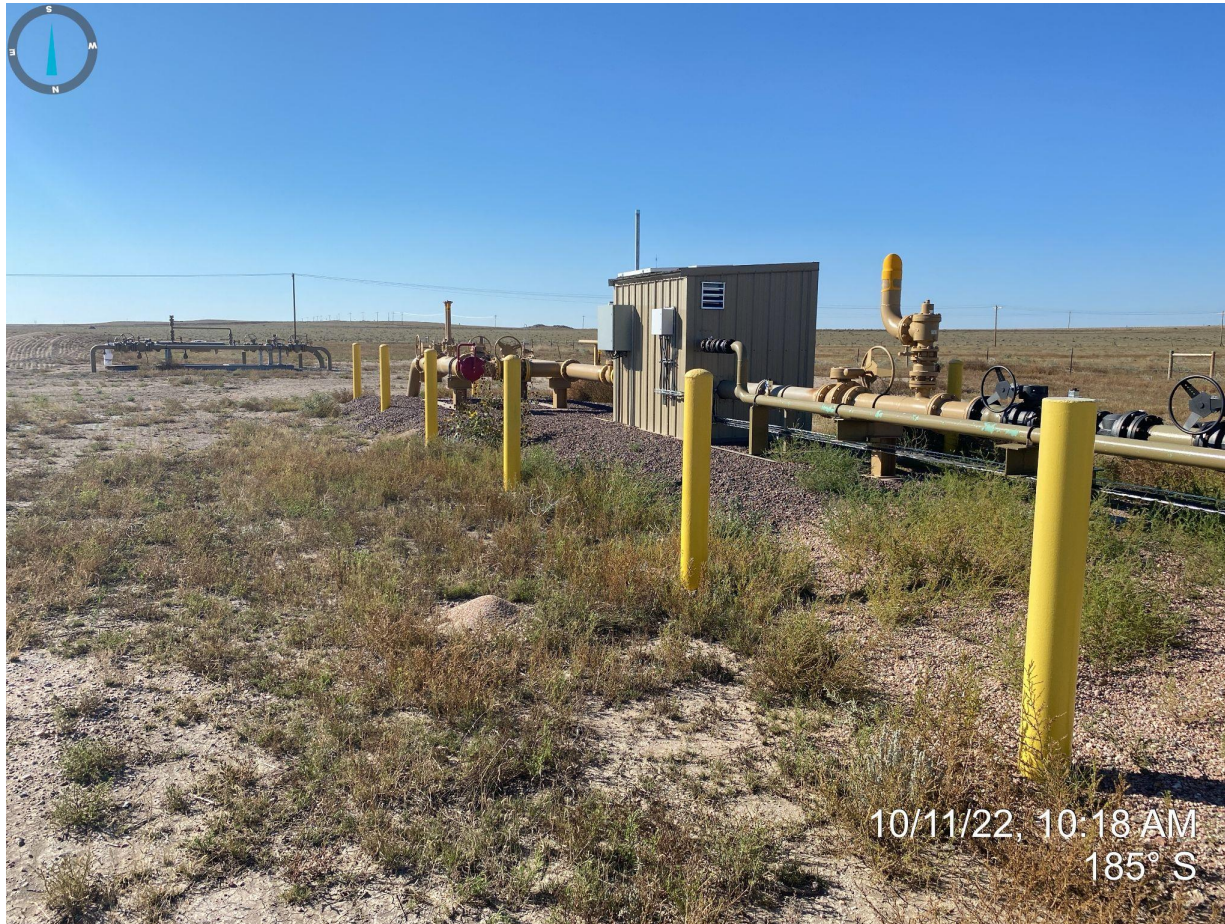
Photo 4. See comments in Photo 3.

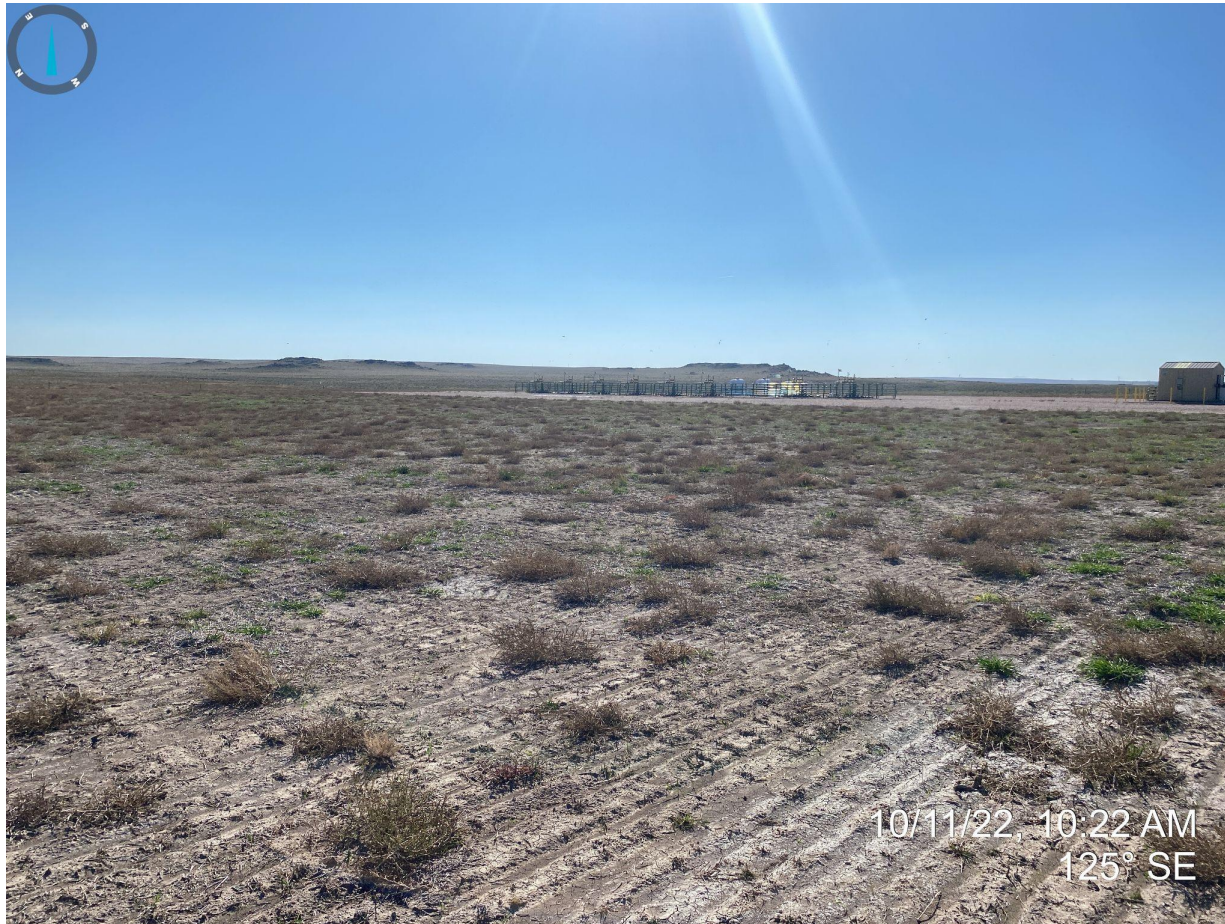
Photo 5. Taken from central, northern portion of location, facing southeast. See comments in Photo 1.

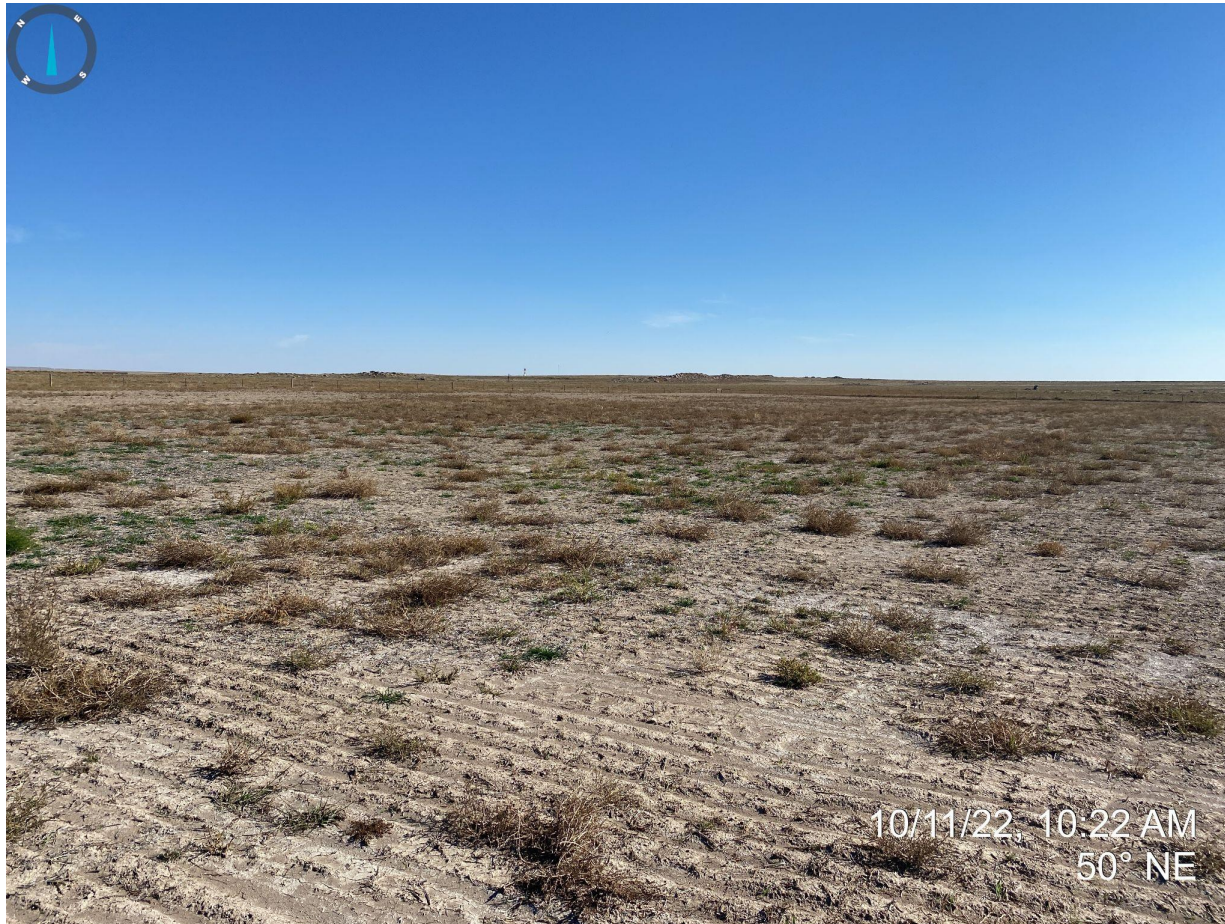
Photo 6. Taken from center portion of location, facing northeast. See comments in Photo 1.

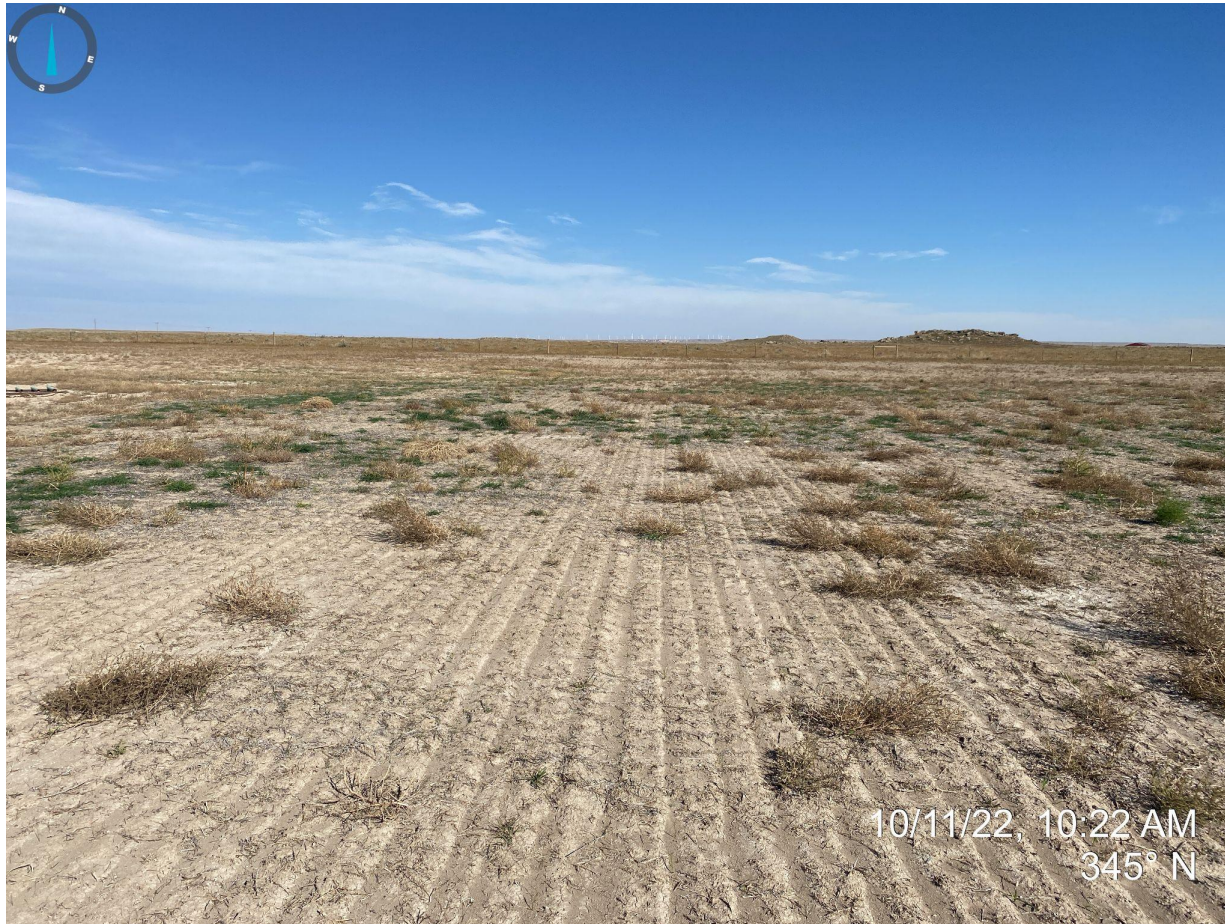
Photo 7. Taken from eastern portion, facing north. See comments in Photo 1.

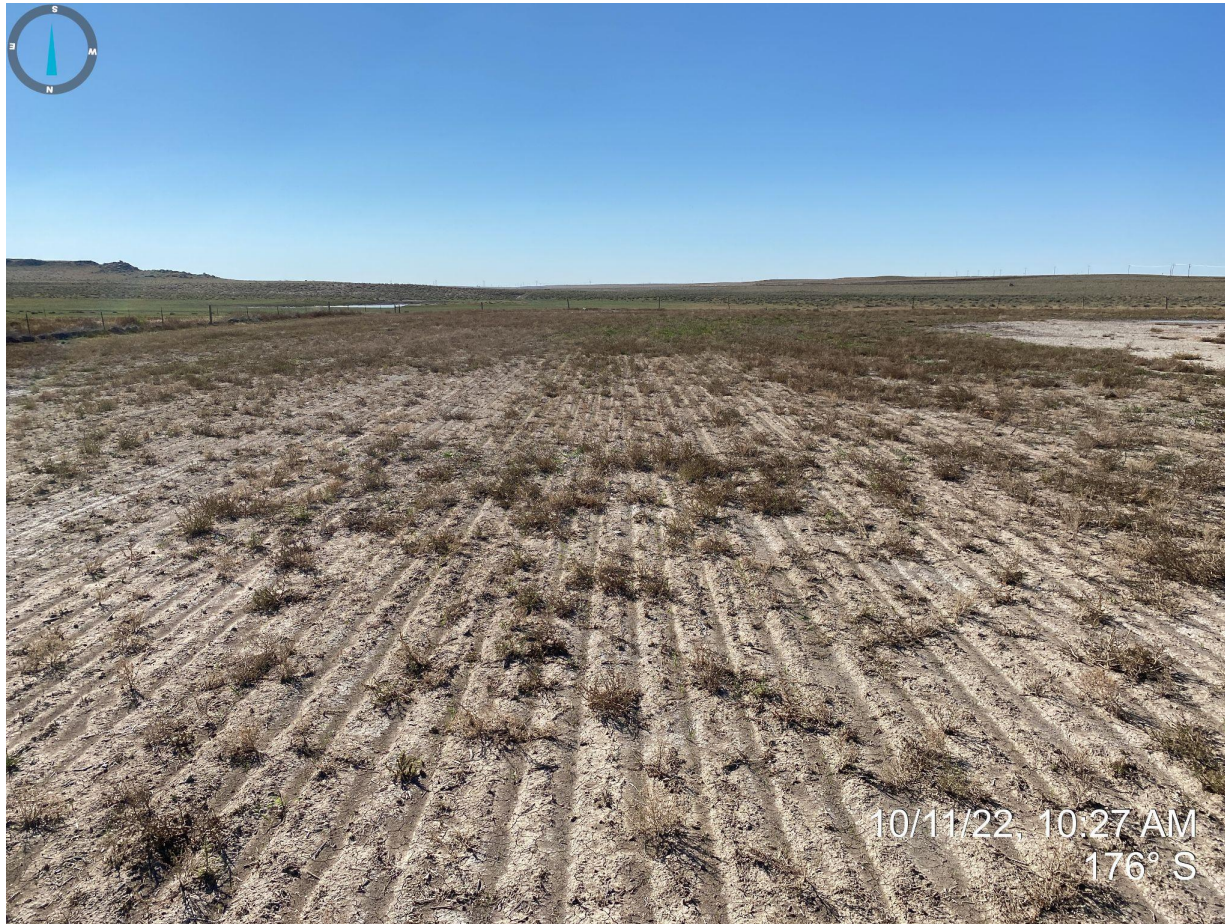
Photo 8. Taken from eastern portion , facing south. See comments in Photo 1.

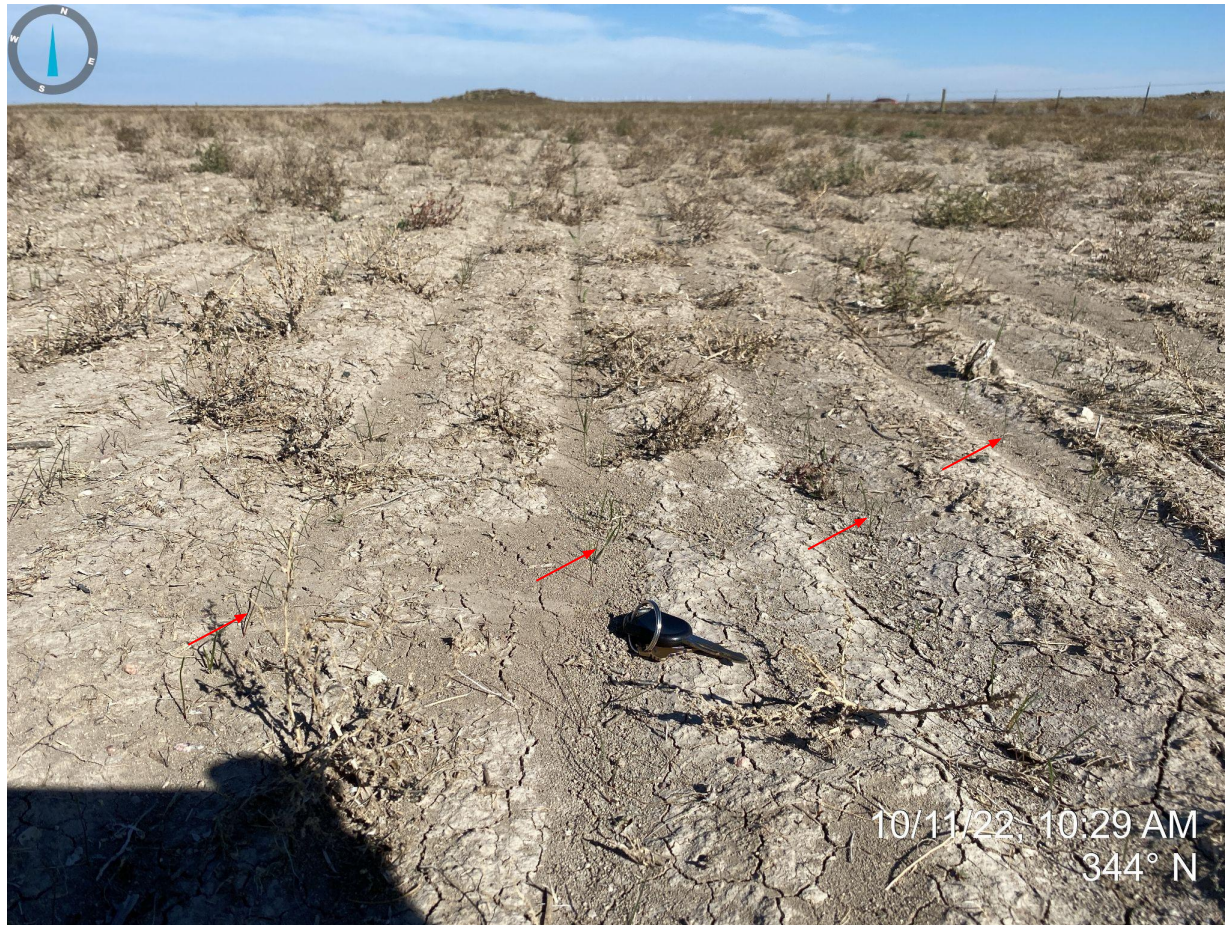
Photo 9. Close up photo of desirable germination observed in drill roads, taken on the eastern portion of the location. Key for reference scale; red arrows indicate germination.
