# Construction and Stormwater Inspection

Date: 10/11/2022

Operator: VERDAD RESOURCES LLC - 10651

Location ID: 466345

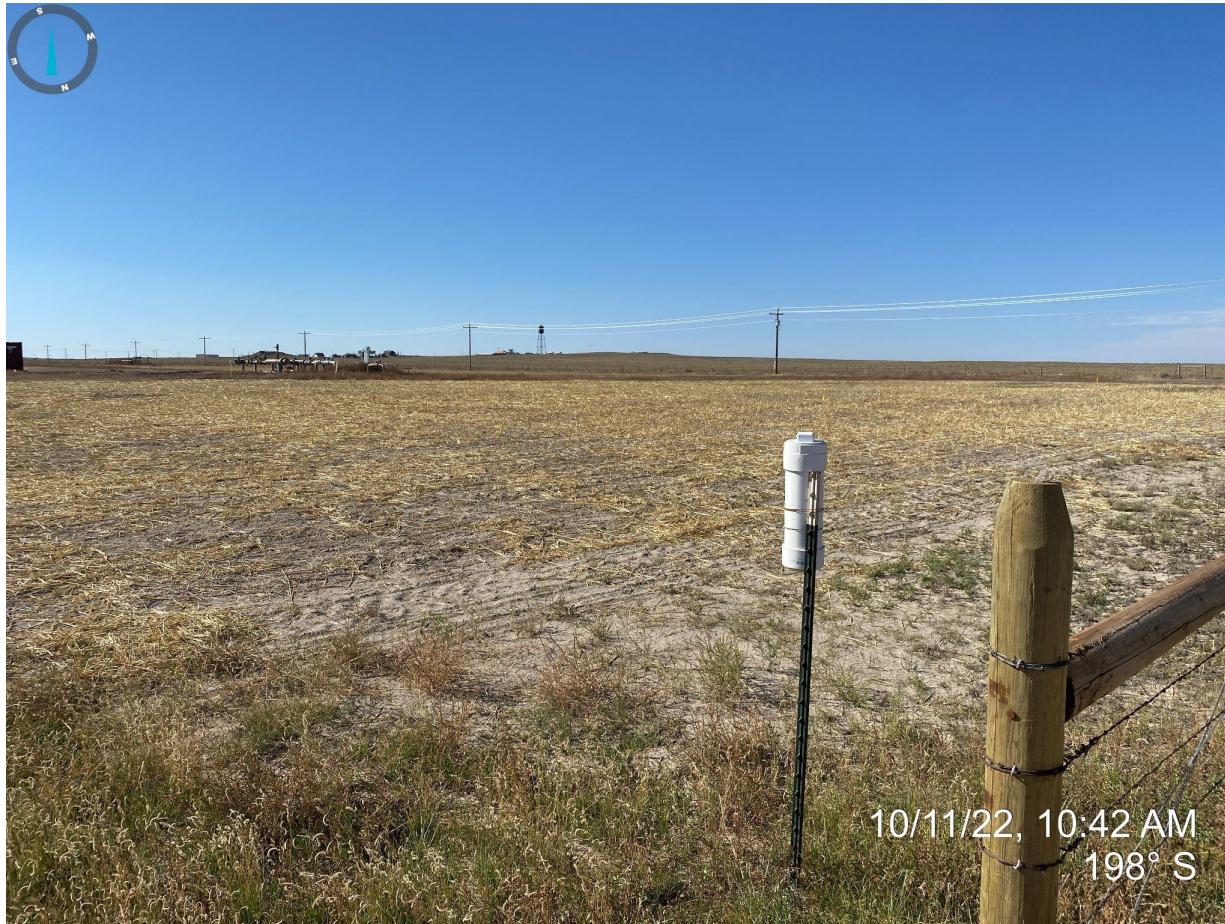
**Photo 1.** Taken from access road/location entrance, facing south. Photo depicts reclaimed area with evidence of straw crimped drill rows.

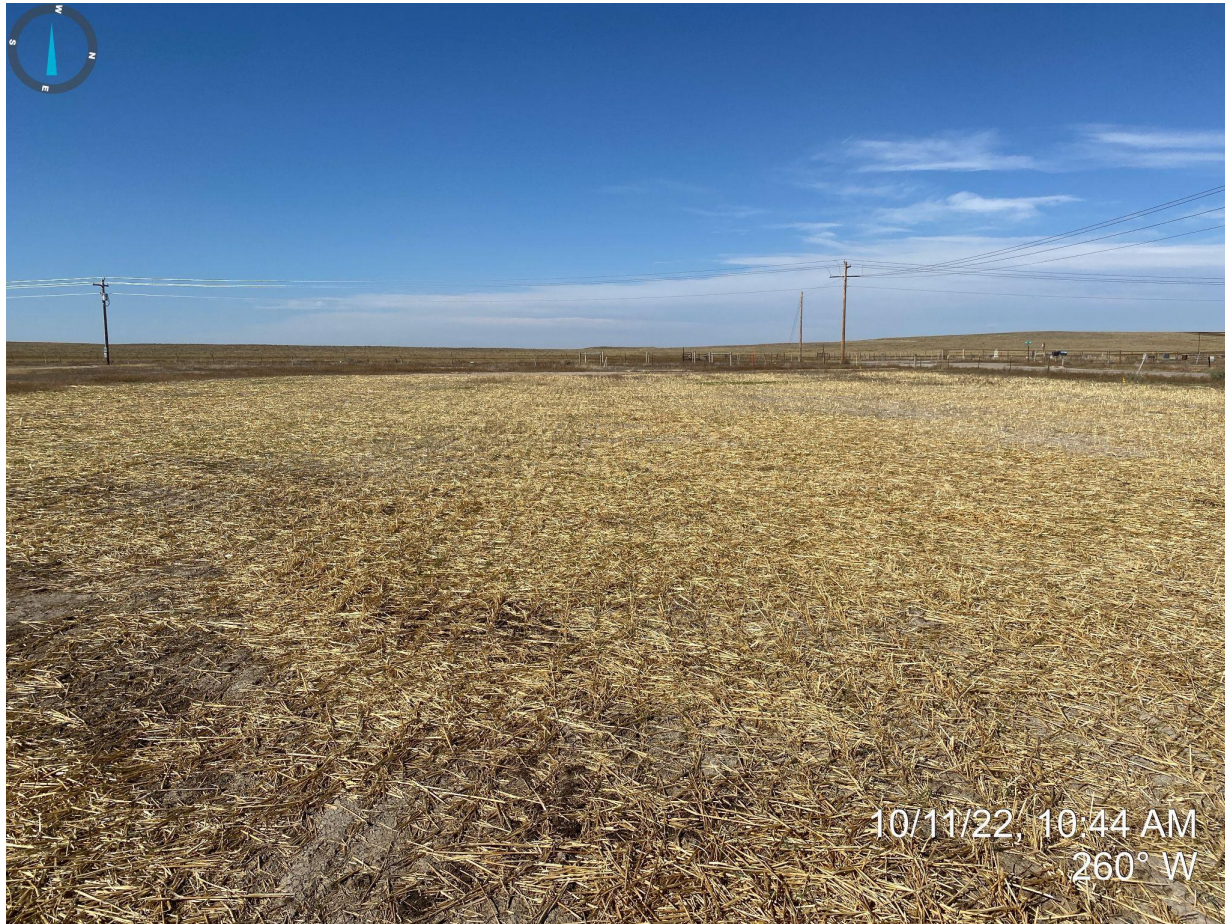
**Photo 2.** Taken from northwest portion, facing west. See comments in Photo 1.

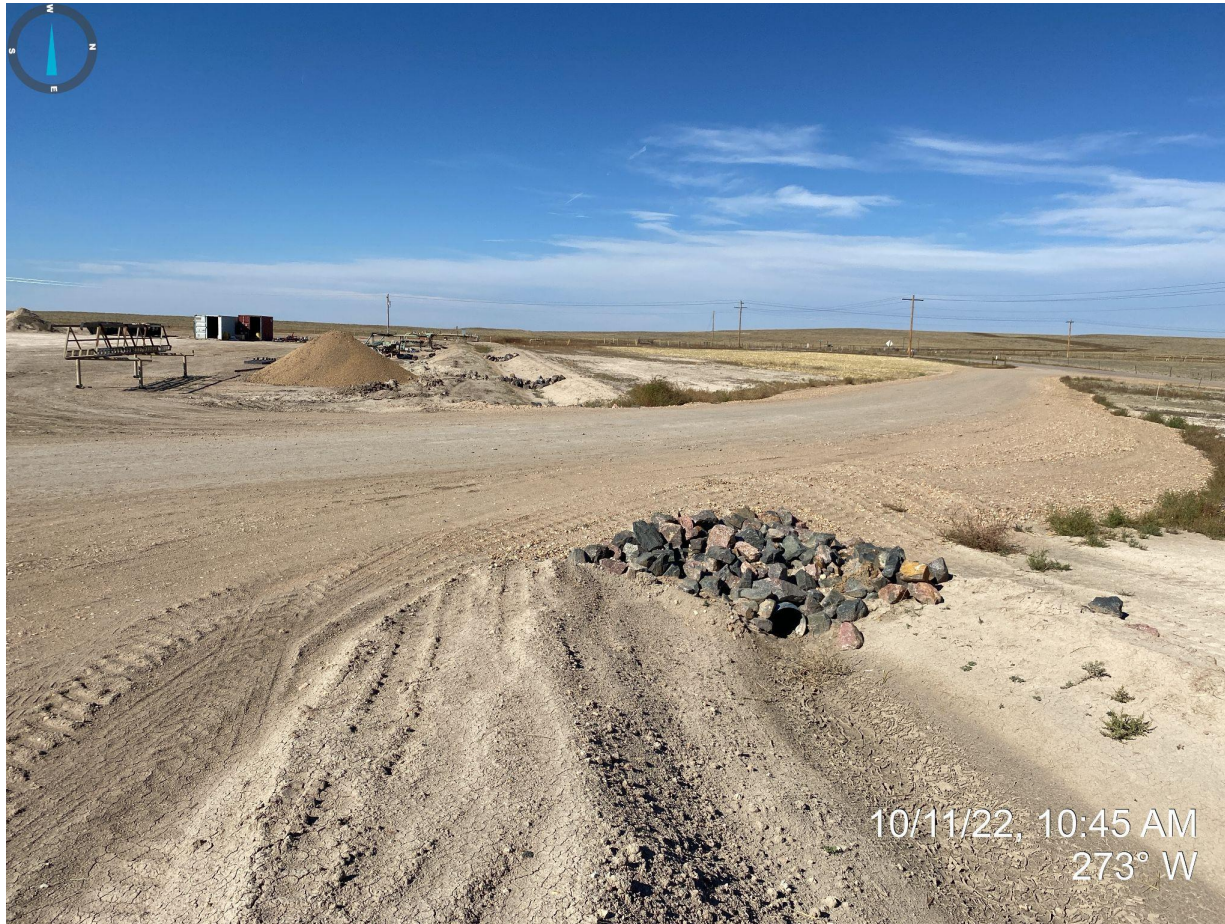
**Photo 3.** Taken near access road/location transition, facing west. Photo depicts rip-rap installed at inlet and outlet of culvert.

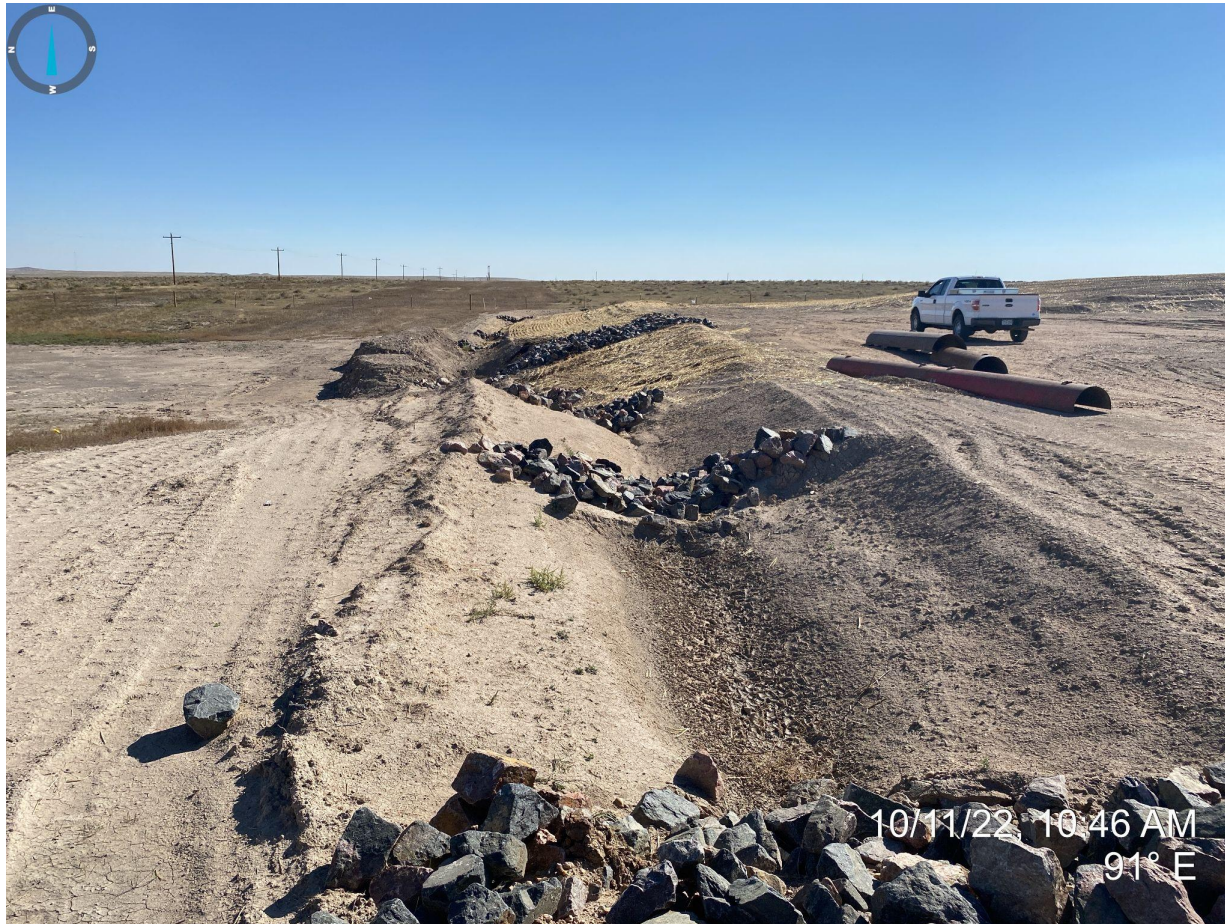
**Photo 4.** Taken near culvert, facing east. Photo depicts rip-rap has been installed in ditch.

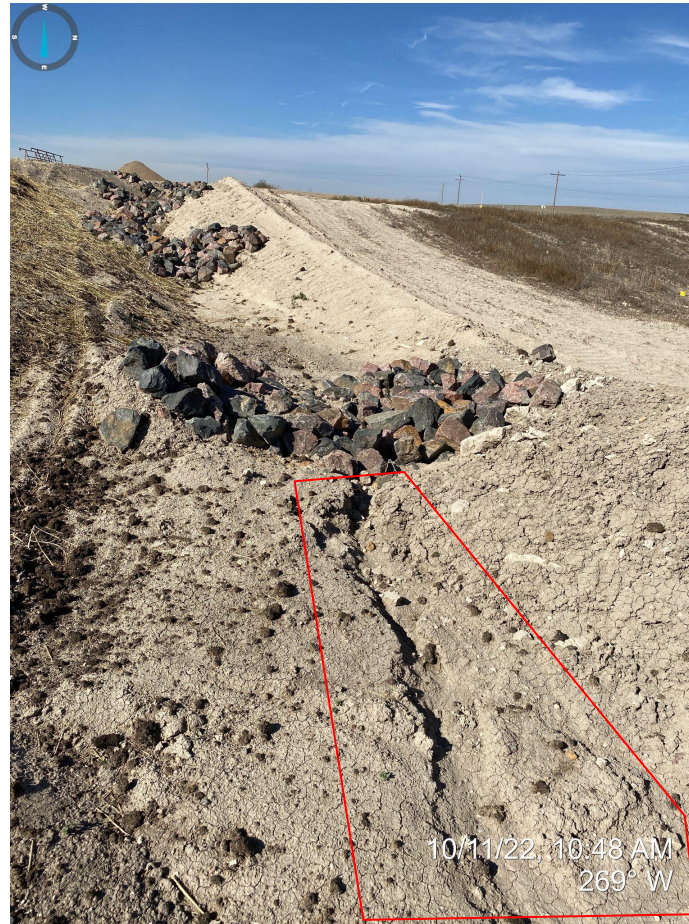
**Photo 5.** Taken from detention area, facing west. Photo depicts rill erosion in ditch, outlined in red.

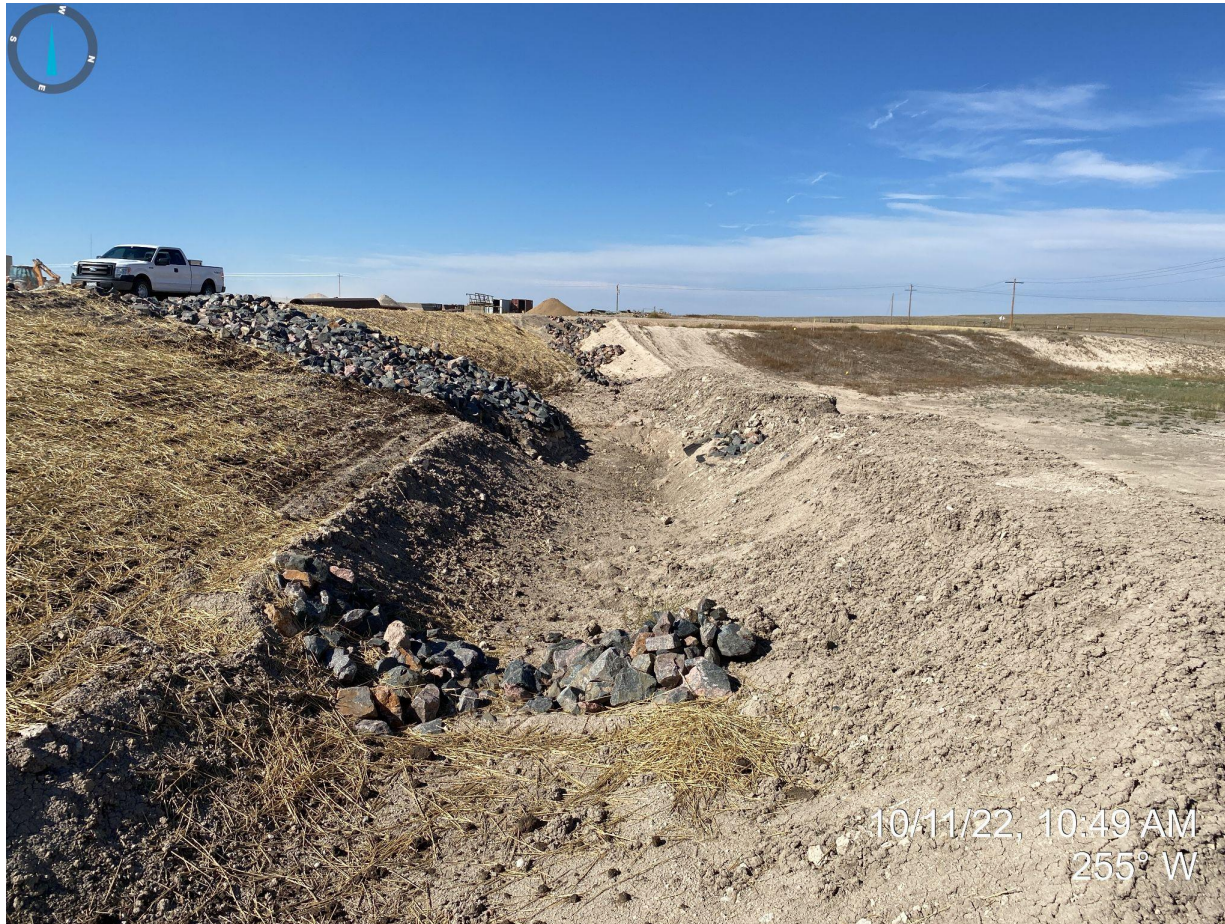
**Photo 6.** Taken east of detention area, facing west. Photo depicts rip-rap installed around inflows of BMPs.

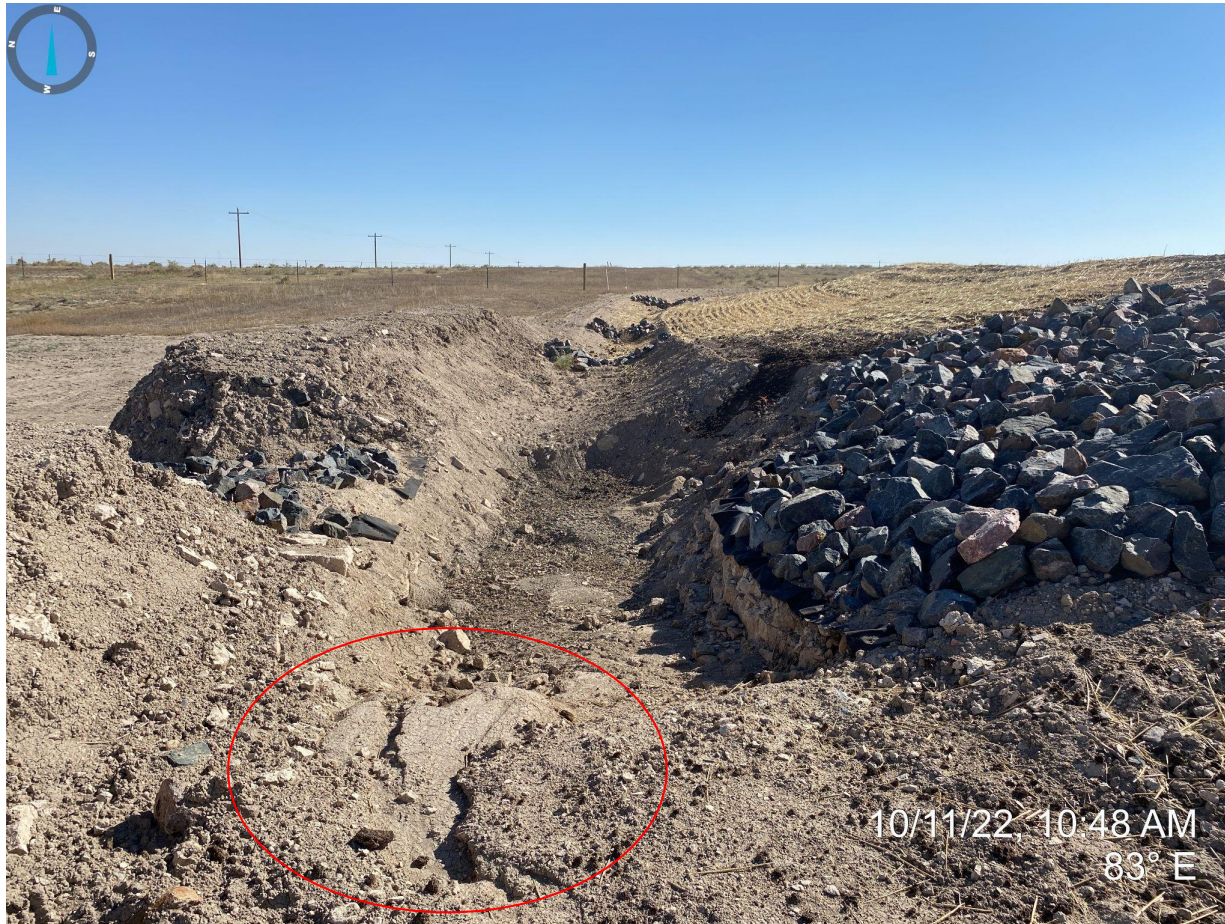
**Photo 7.** Taken west of detention area, facing east. Photo depicts rill erosion, outlined in red.

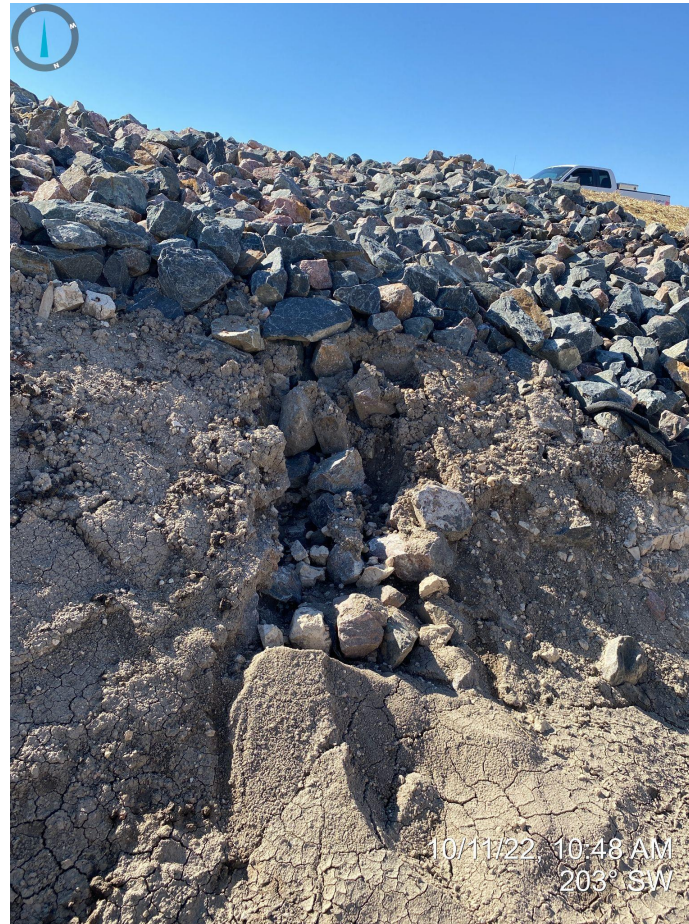
**Photo 8.** Close-up photo of rill erosion on inflow rip-rap area.

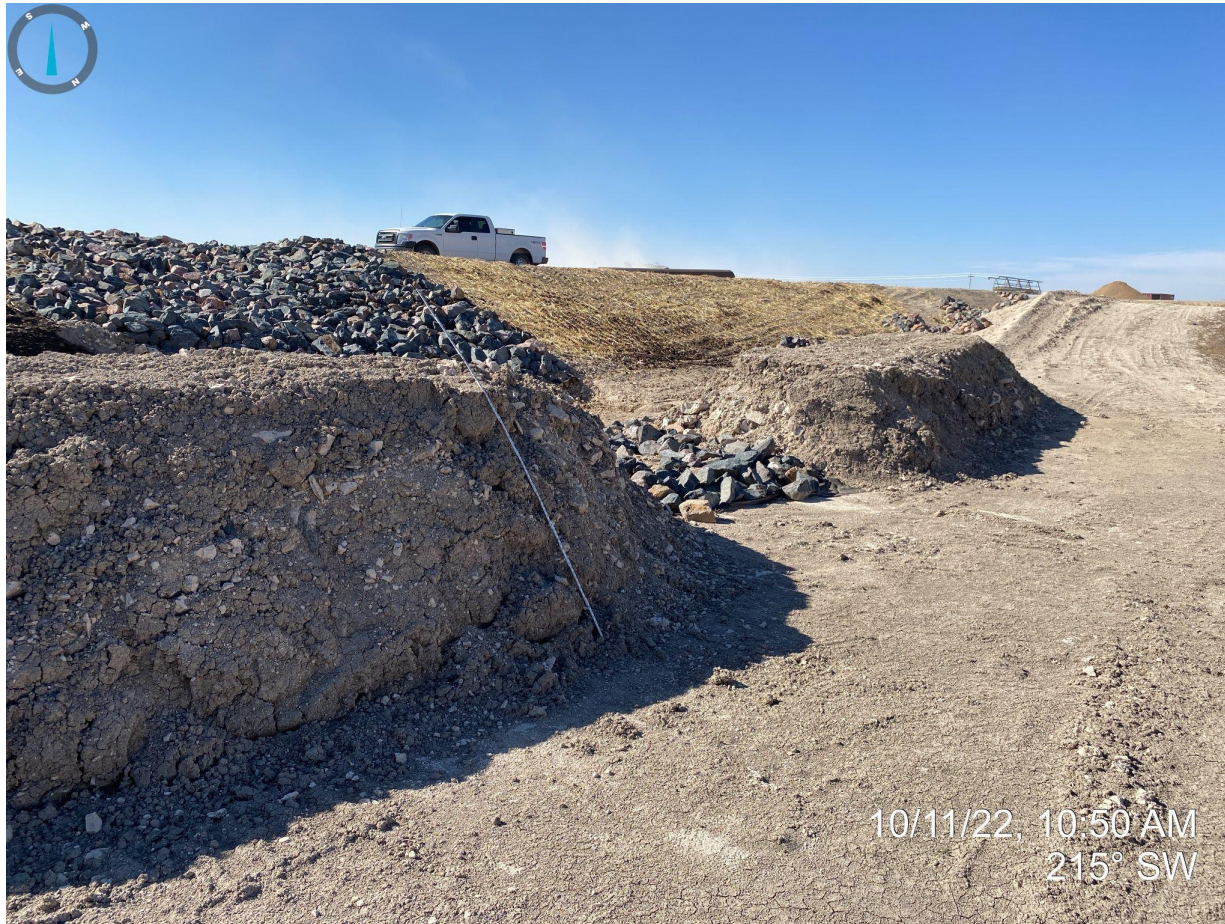
**Photo 9.** Taken north of detention area, facing west. Photo depicts unconsolidated material in berms; north walls of the berms appear vertical. 6.5' measuring stick for scale.

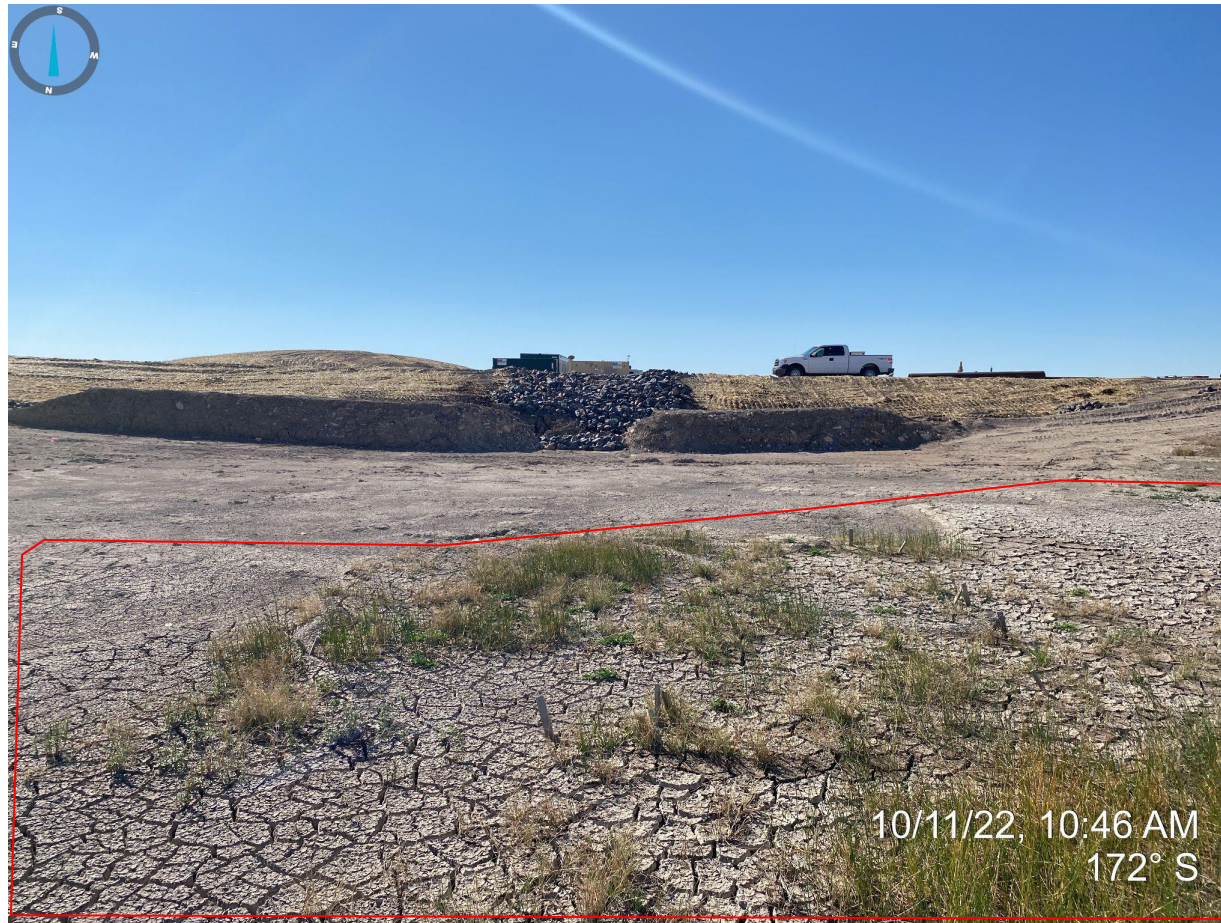
**Photo 10.** Taken north of detention area, facing south. Photo depicts deposited sediment that left detention area, identified in previous inspection.

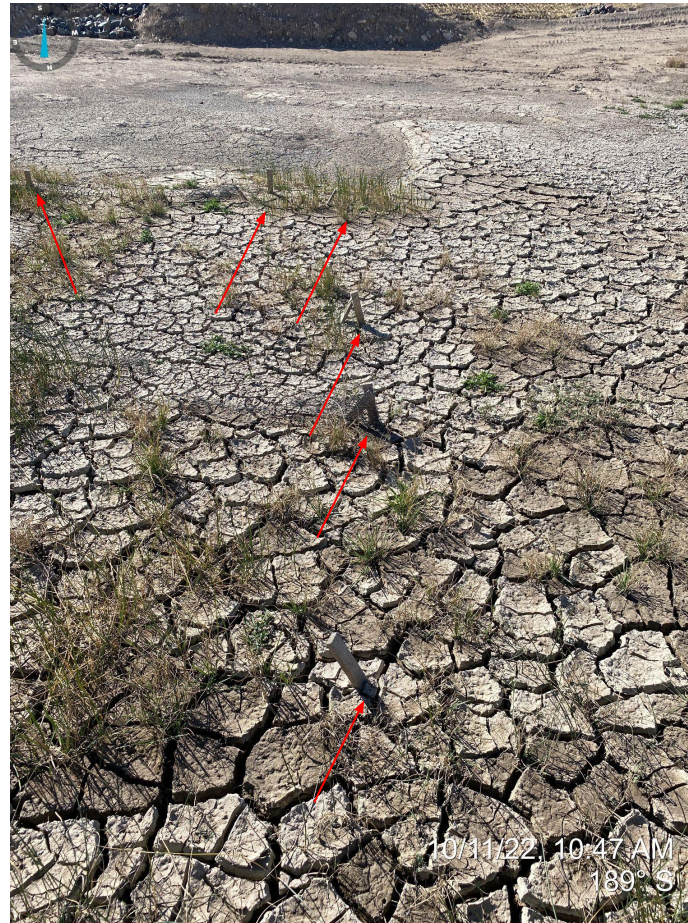
**Photo 11.** Close up photo of deposited sediment with buried straw wattles, indicated by red arrows.

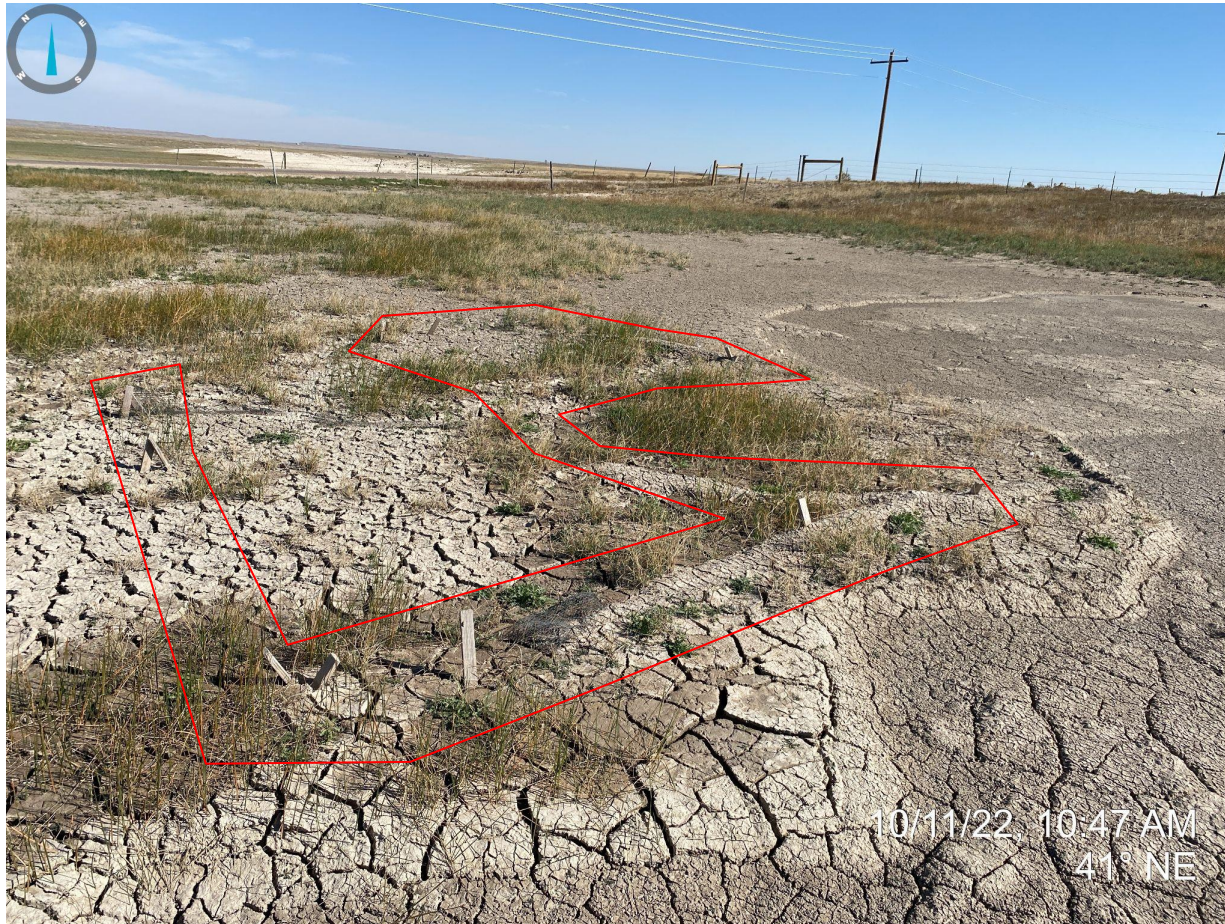
**Photo 12.** Facing northeast, see comments in Photo 11.

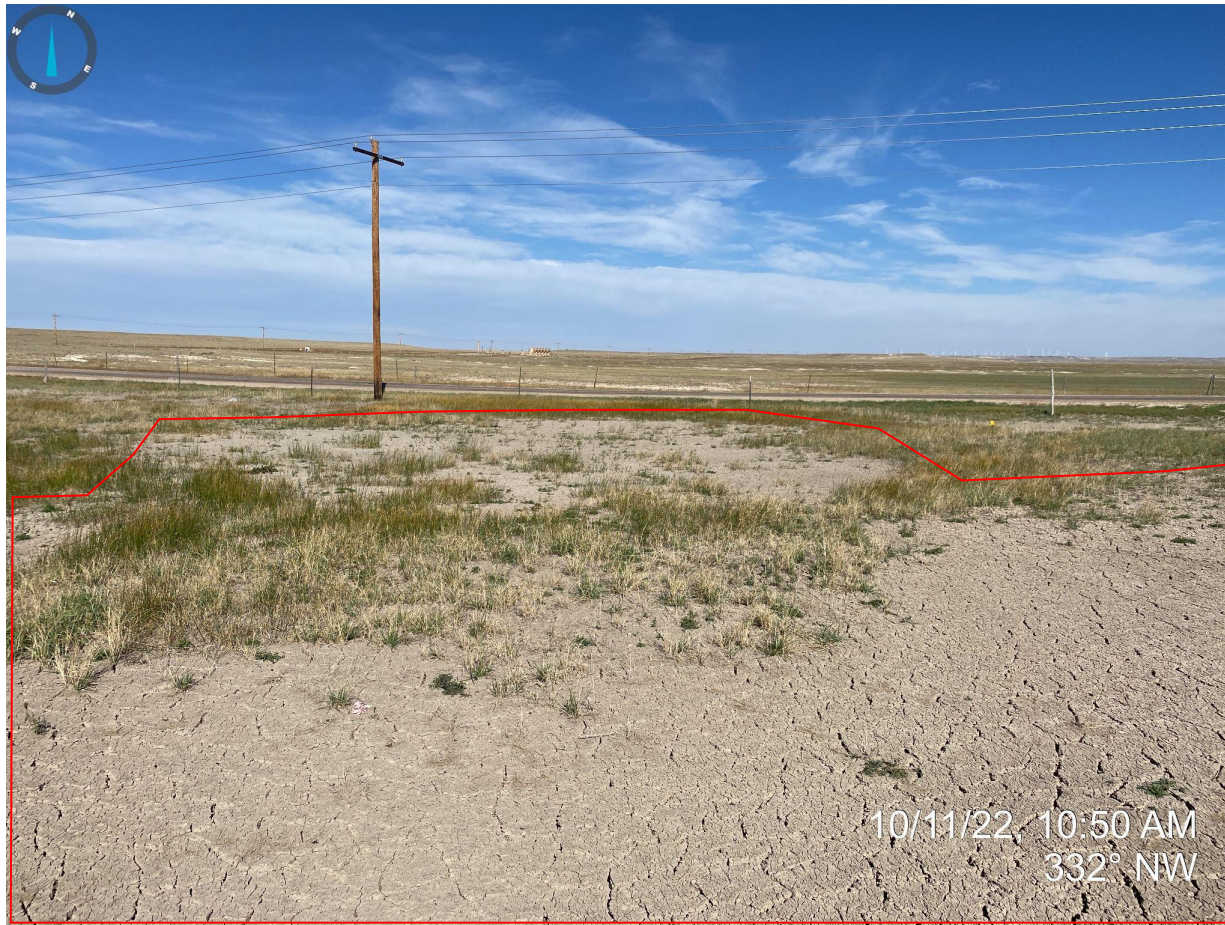
**Photo 13.** Taken north of detention area, facing northwest. Photo depicts extent of sediment deposition that has not been placed back to its' relative position. This area will need to be reclaimed.

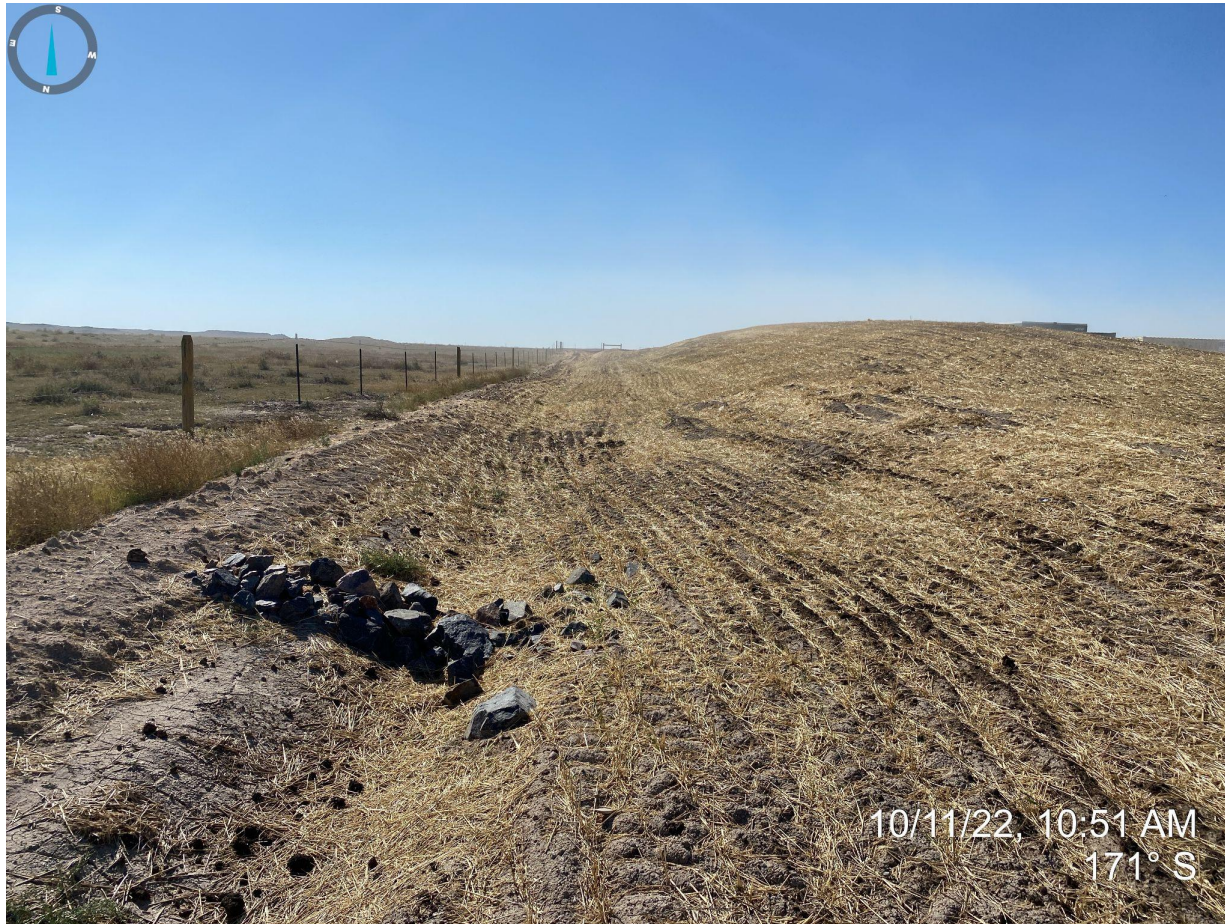
**Photo 14.** Taken from northeast portion near stockpile, facing south. Photo depicts topsoil stockpile has been stabilized with evidence of straw crimped into drill rows.

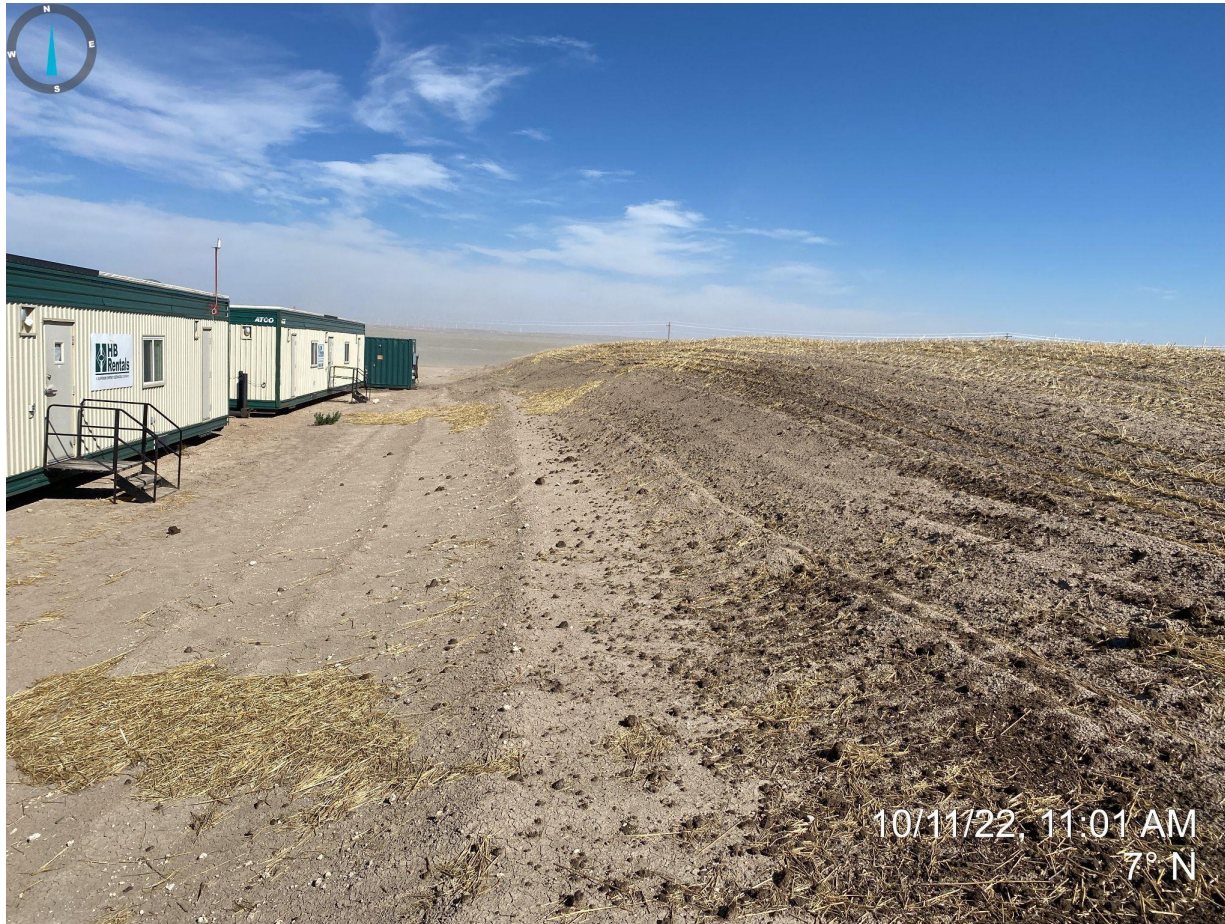
**Photo 15.** Taken near topsoil stockpile, facing north. Photo depicts western portion of stockpile is not stabilized and is susceptible to wind and water erosion.

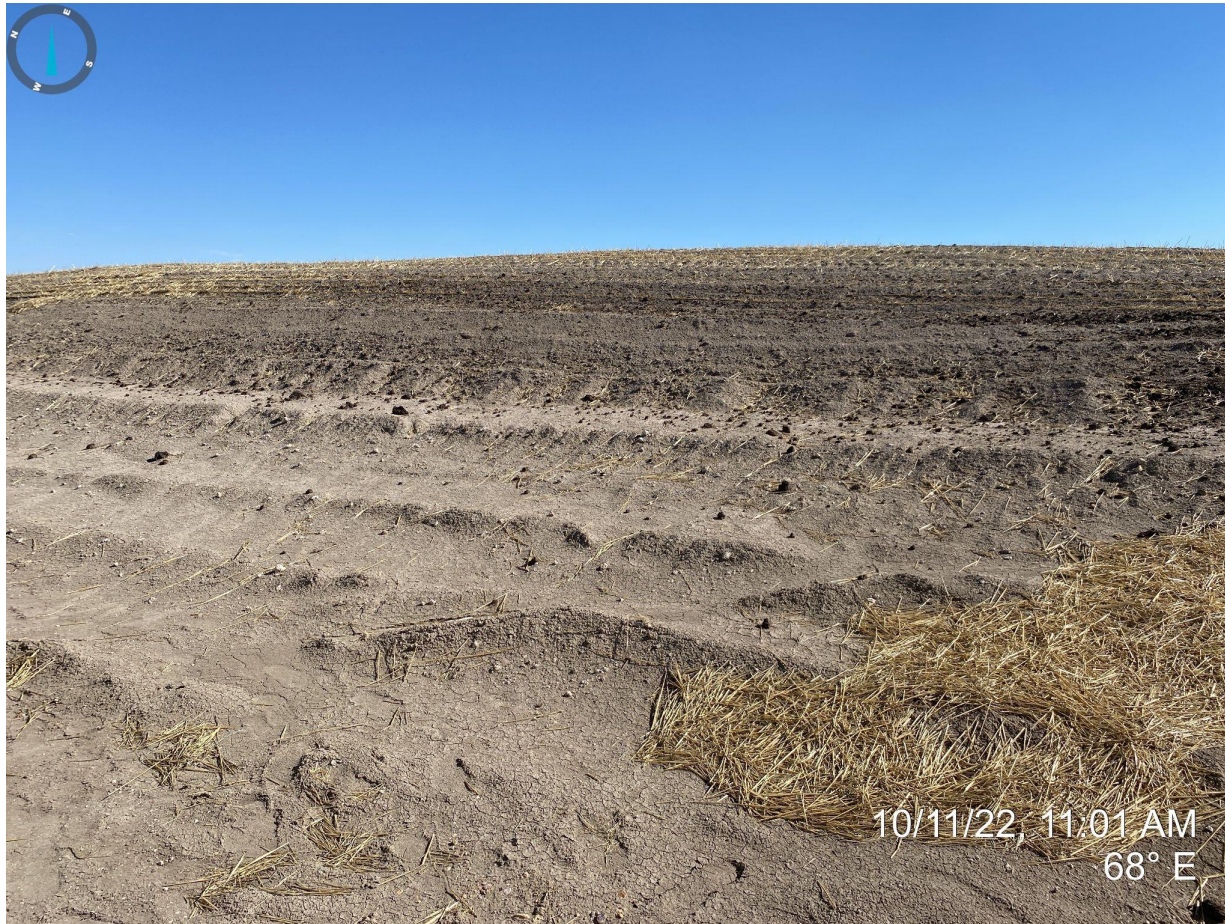
**Photo 16.** Facing east, see comments in Photo 15.

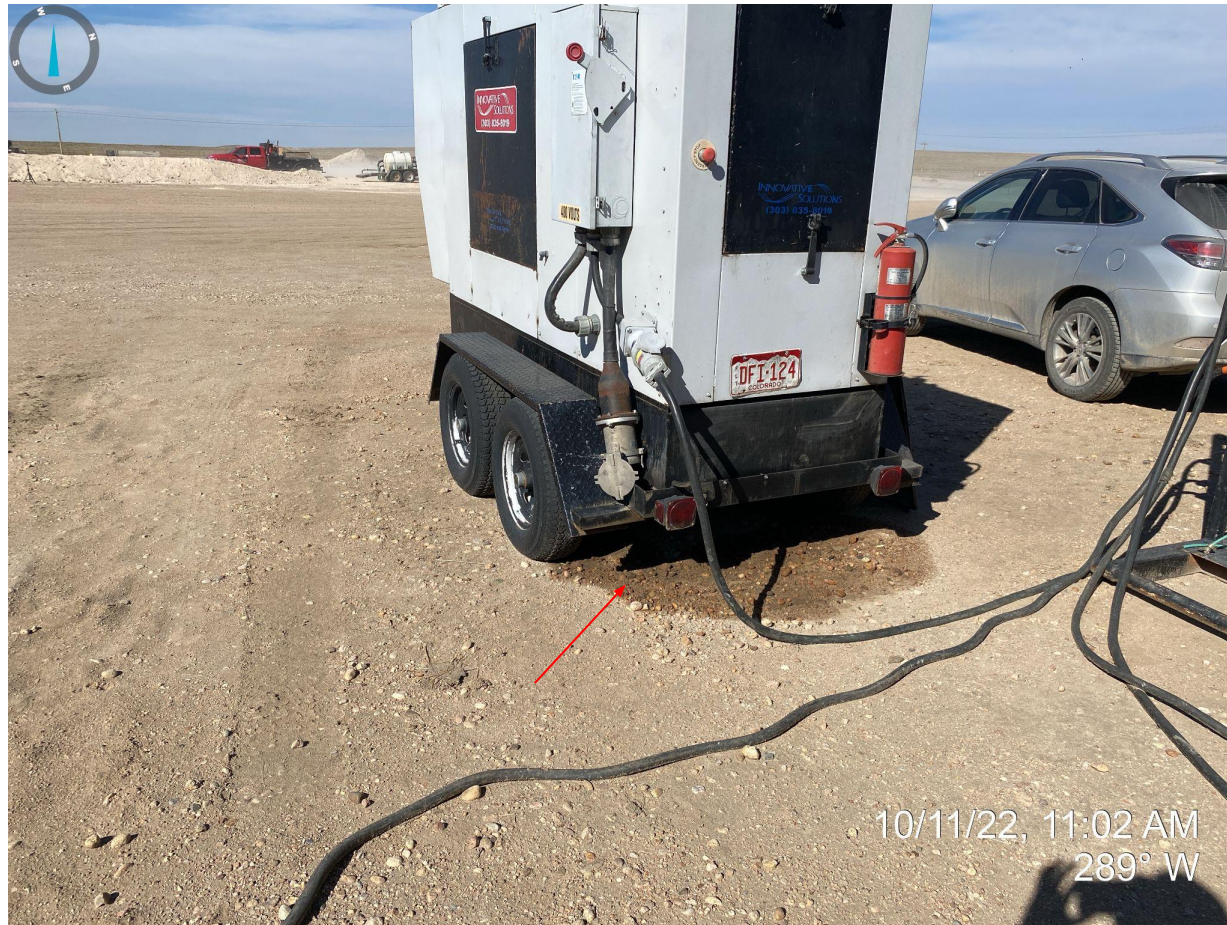
**Photo 17.** Taken near work trailers, facing west. Photo depicts stained soil underneath diesel generator, indicated by red arrow.

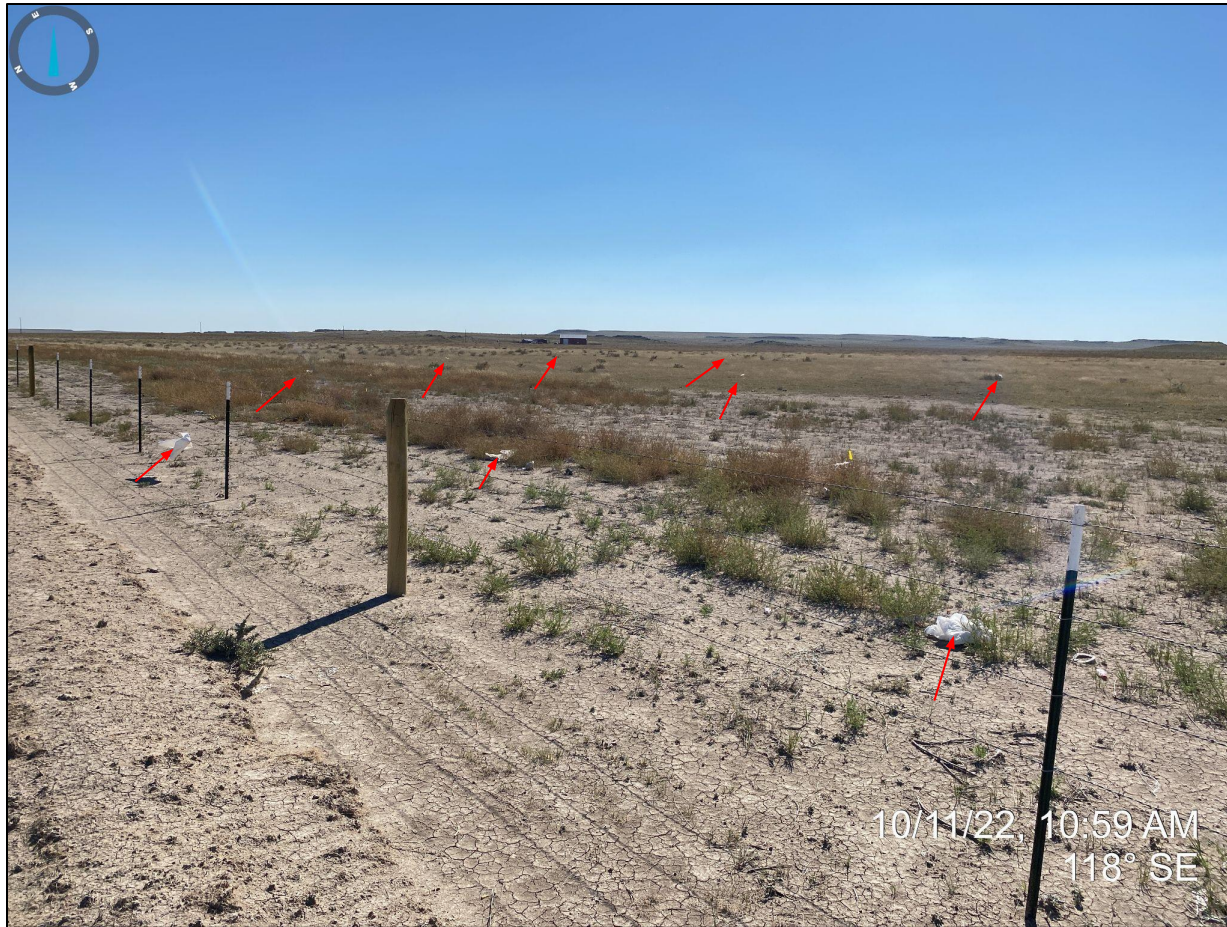
**Photo 18.** Taken near southern portion of location, facing southeast. Photo depicts trash that has blown off location and need to be collected and properly disposed of, indicated by red arrows.

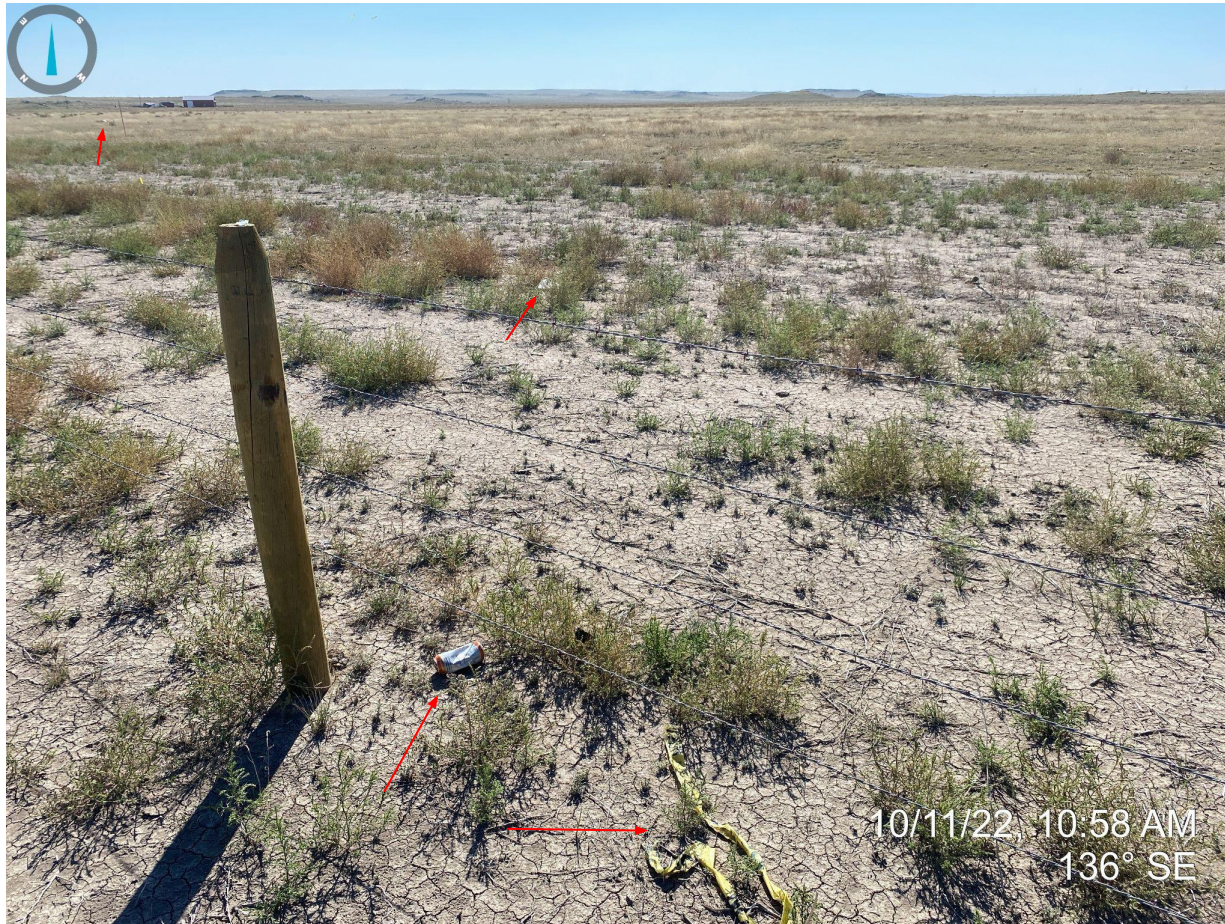
**Photo 19.** Facing southeast, see comments in Photo 18.

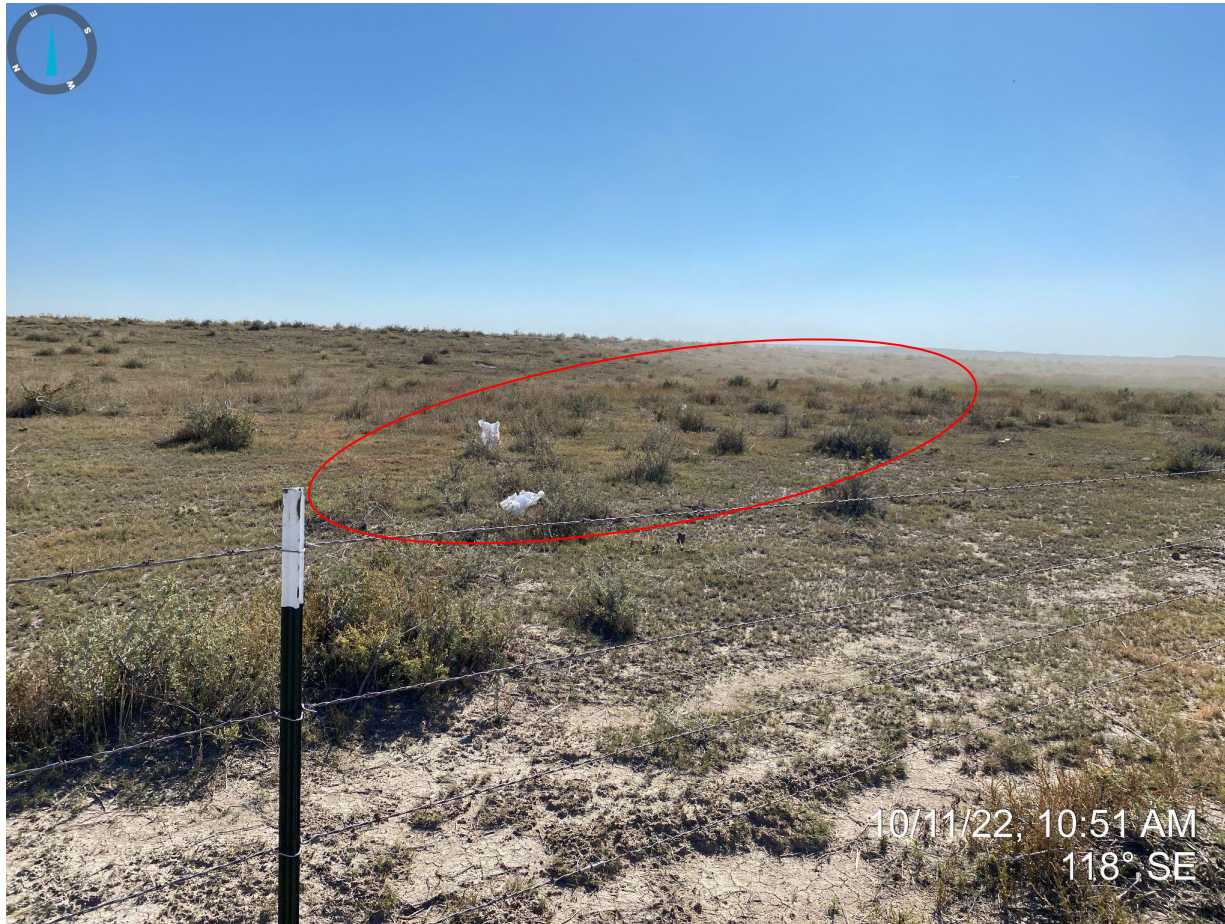
**Photo 20.** Facing southeast, see comments in Photo 18.

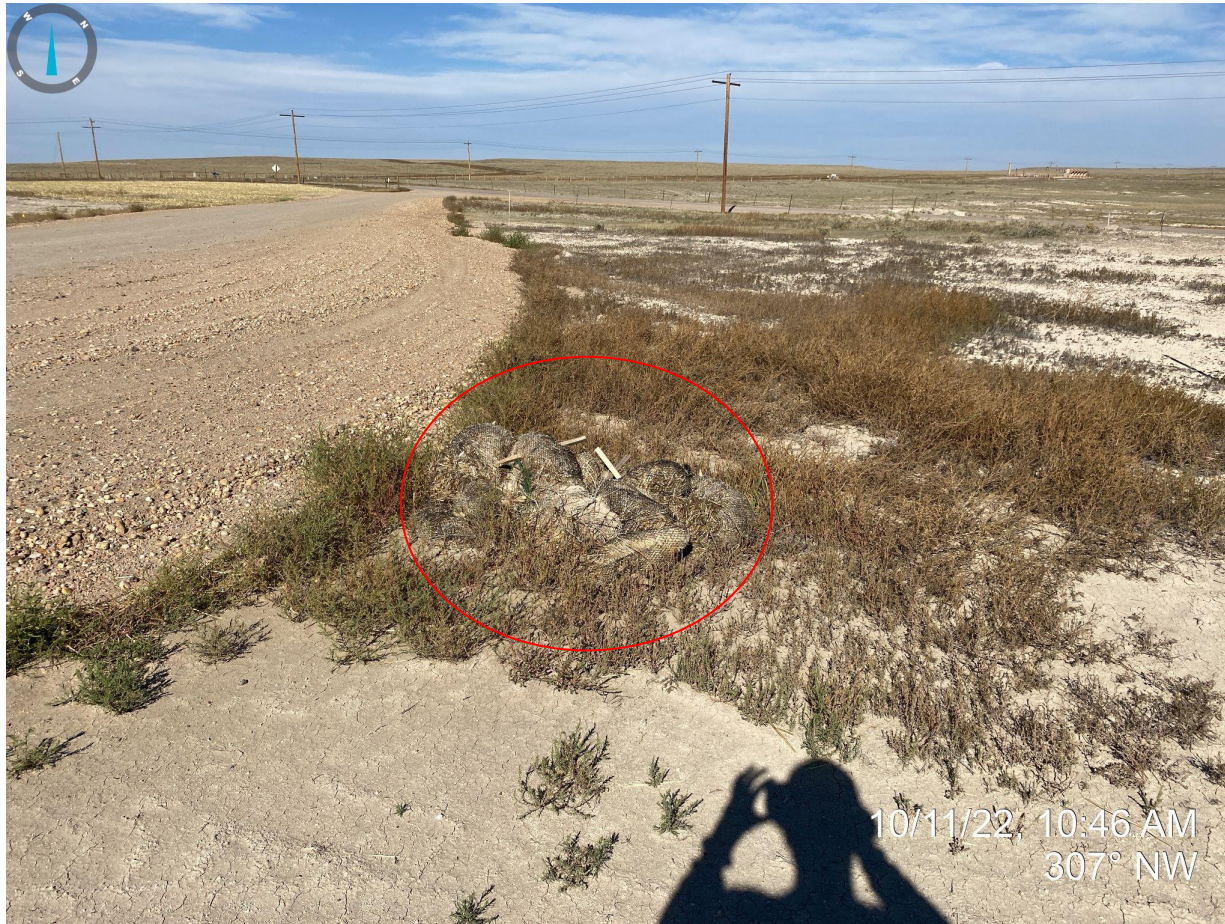
**Photo 21.** Taken from access road portion of location, facing northwest. Straw wattle debris observed and needs to be disposed of.
