# Construction and Stormwater Inspection

Date: 10/11/2022

Operator: VERDAD RESOURCES LLC - 10651

Location ID: 466345

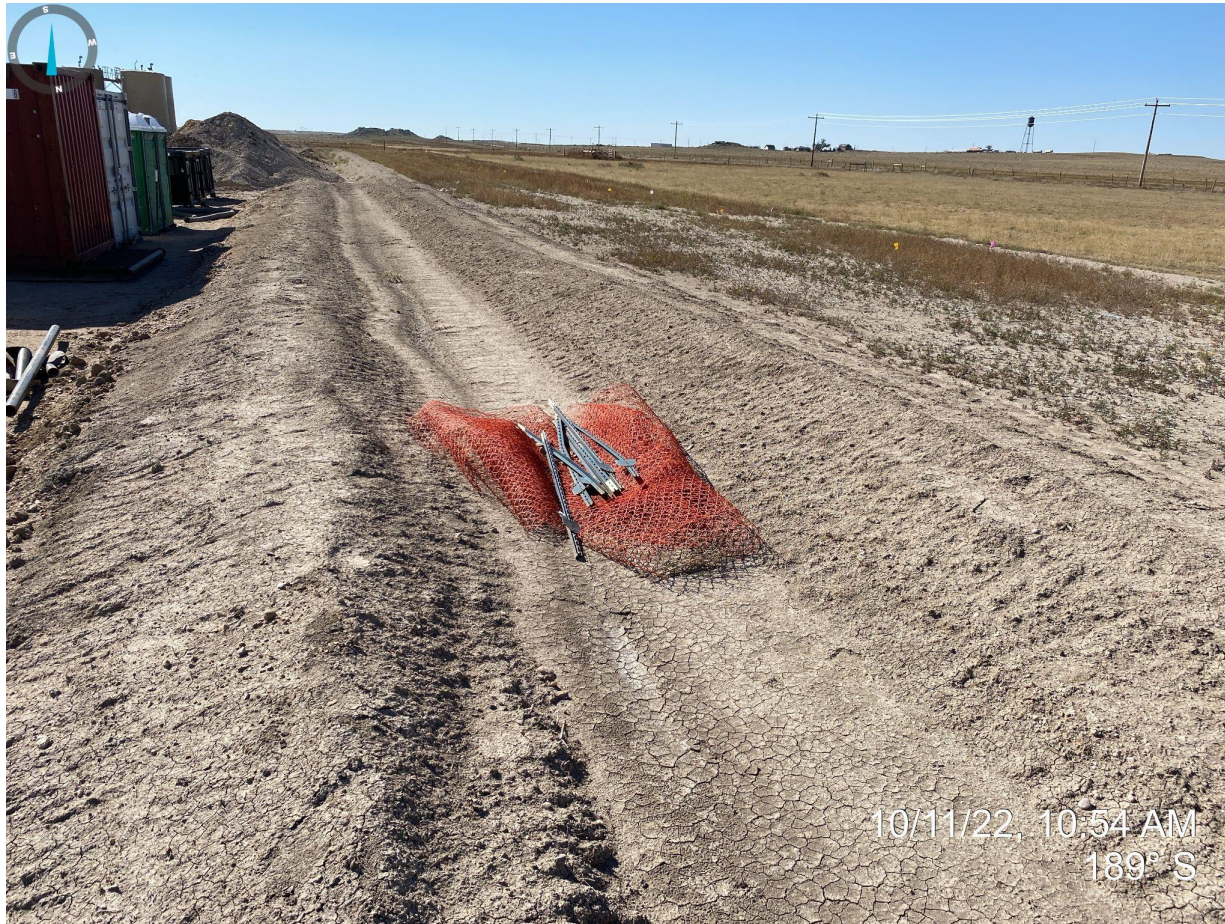
**Photo 22.** Taken from western portion of location, facing south. Fencing material observed in ditch and berm BMP.

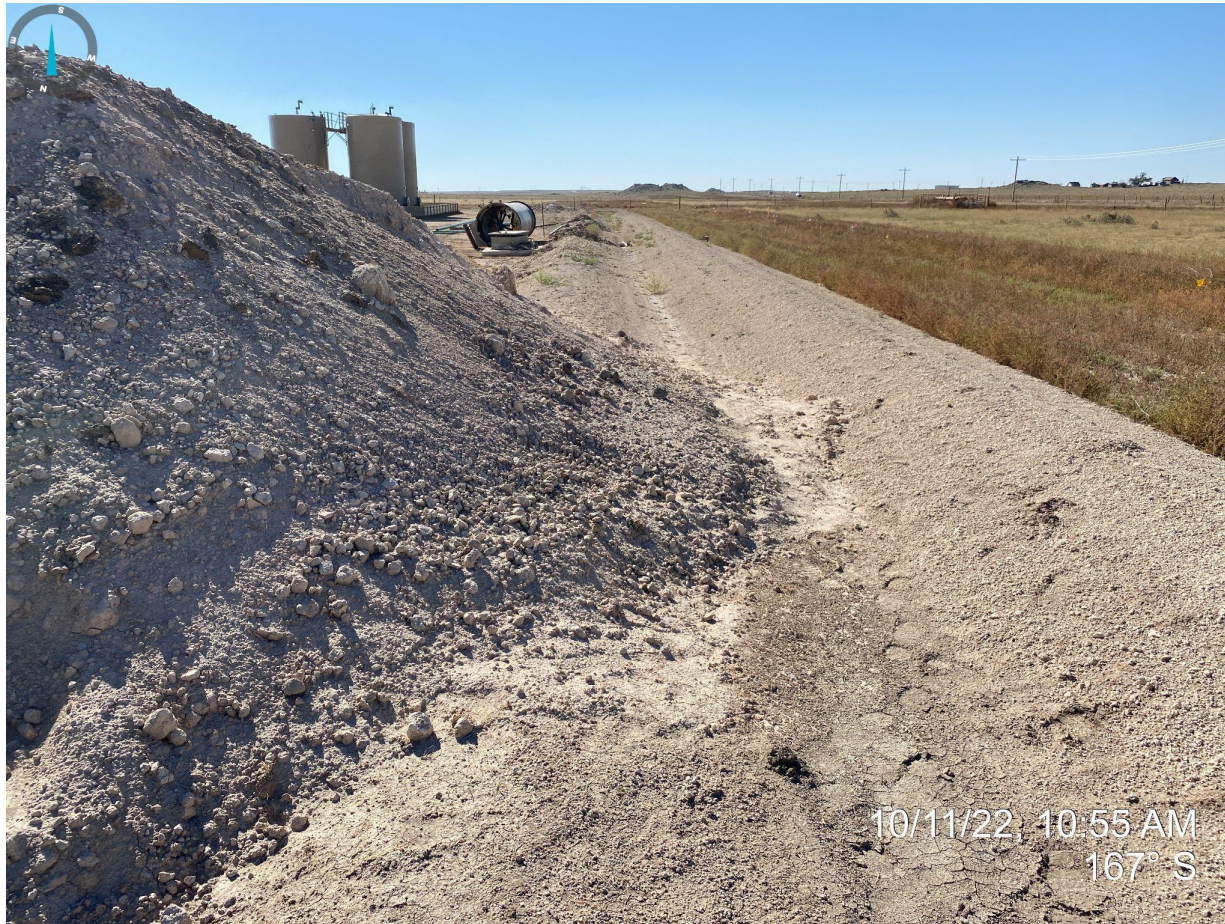
**Photo 22.** Taken from western portion of location, facing south. Photo depicts soil deposition in ditch and berm BMP.

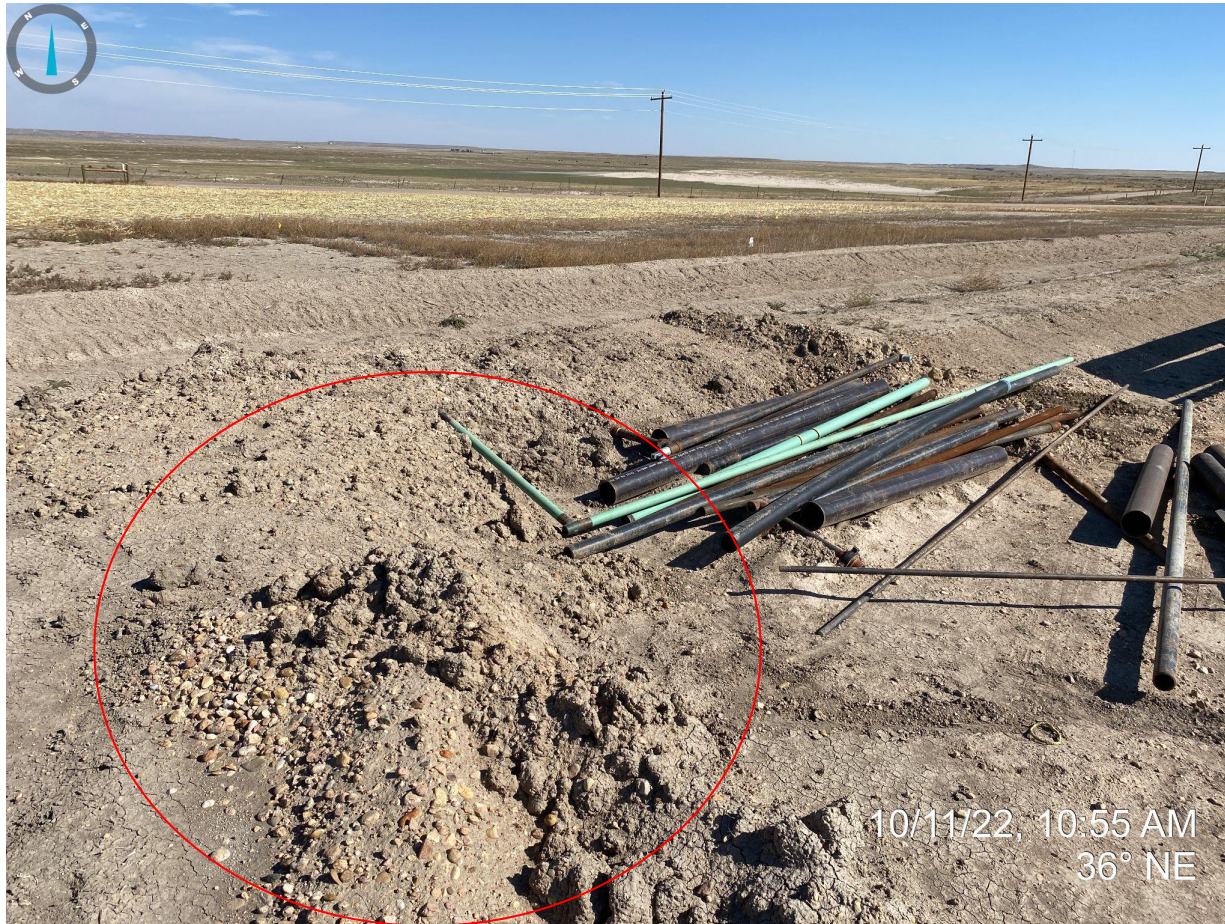
**Photo 24.** Taken from northwest portion of location, facing northeast. Photo depicts piping placed on ditch and berm and unconsolidated material, outlined in red.

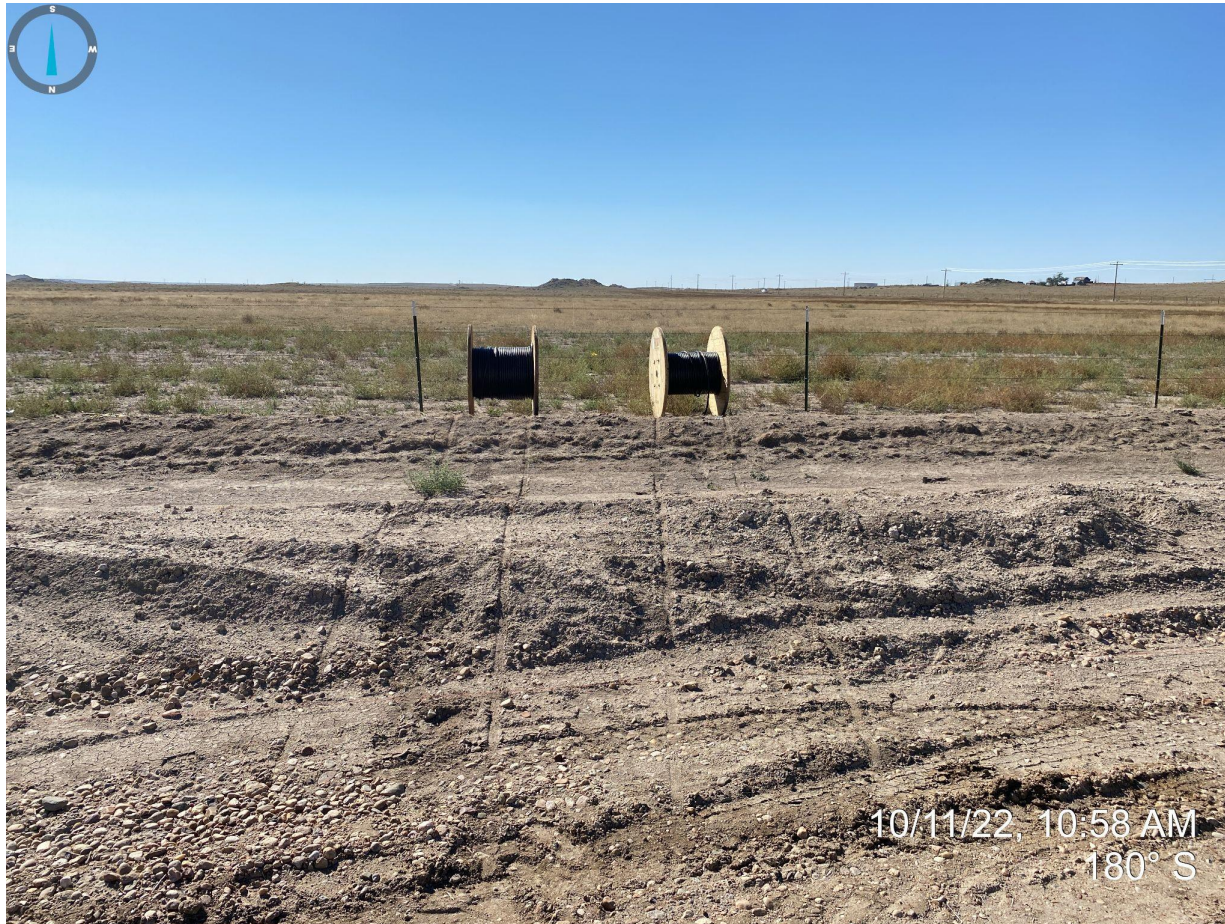
**Photo 25.** Taken from southern, central portion of location, facing south. Photo depicts equipment was not properly stored/secured and moved towards locations perimeter fencing.
