Inspection Photos
Location Name: Marjo #M2
Location ID: 322261

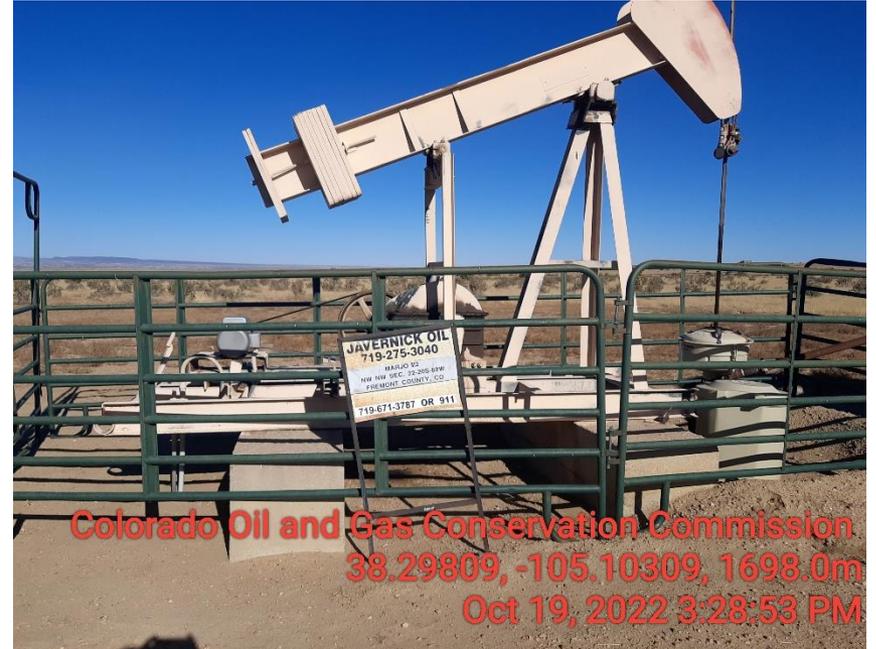
Photo 2 Well head

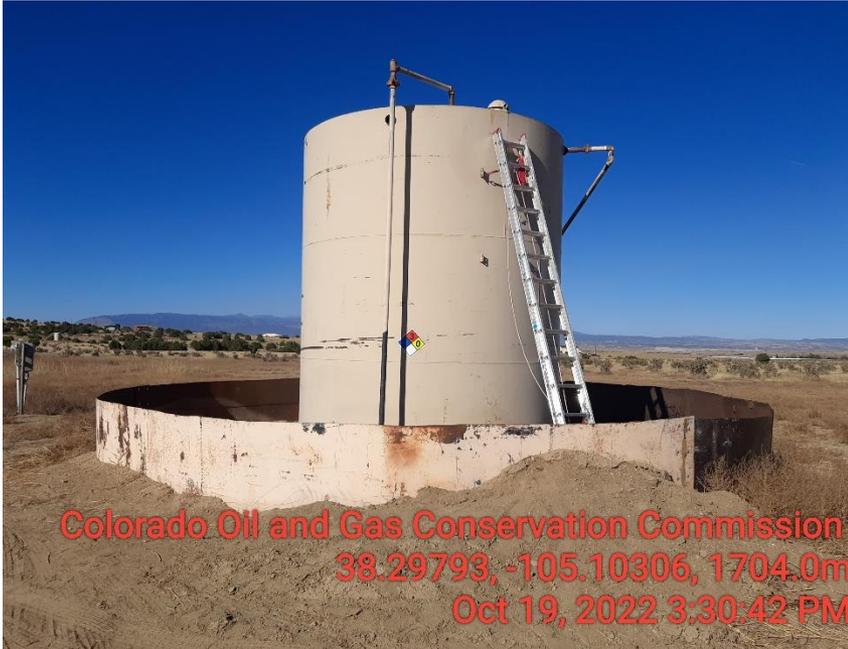
Photo 3 No volume or tank lable

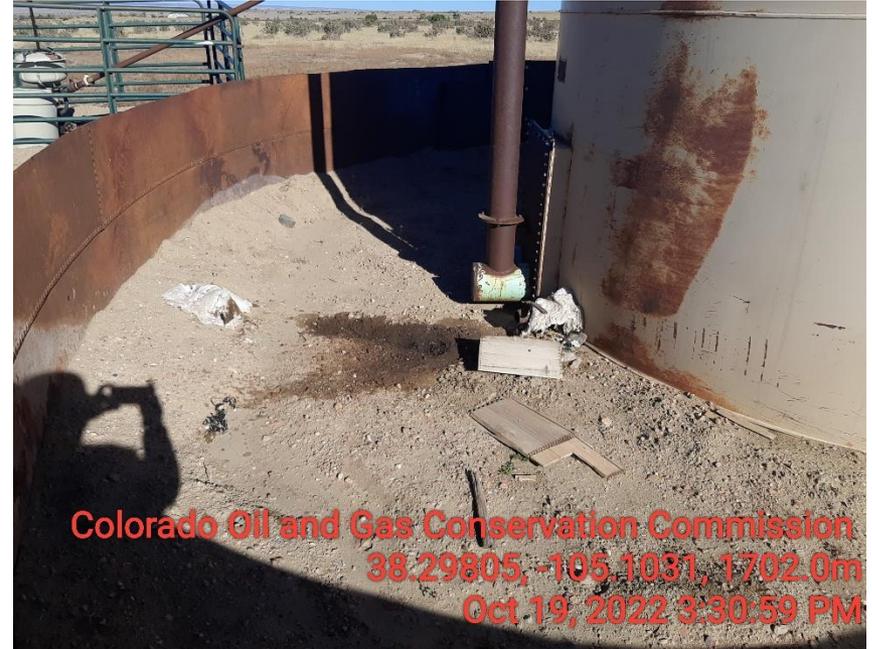
Photo 4 Stained soil Crude oil load out line. Mechanical issue

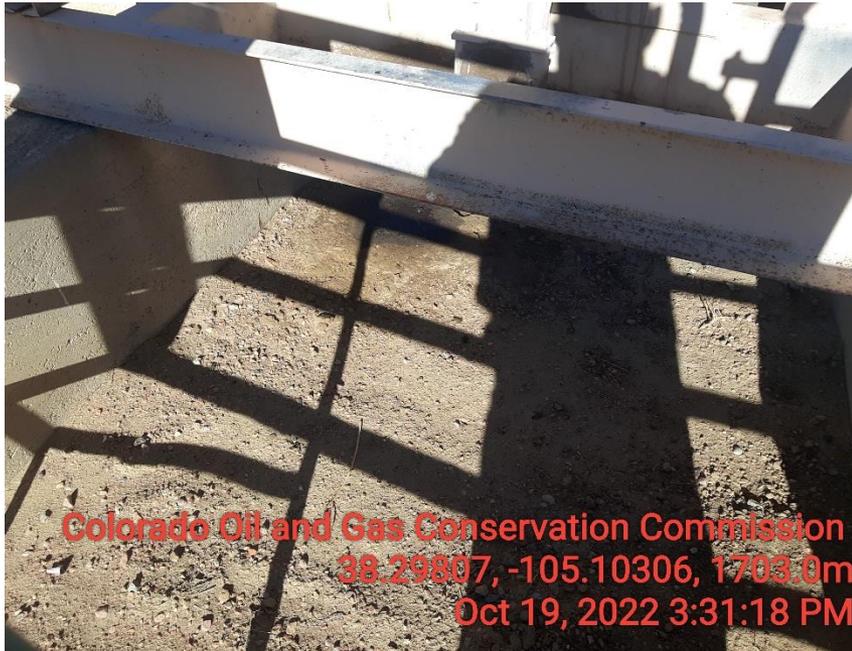
Photo 5 stained soil under Pumping unit. Mechanical issue
