**Inspection Photos**  
**Location Name: Draper #2**  
**Location ID: 322233**

**Photo 1 Unused equipment tank is not connected to anything**

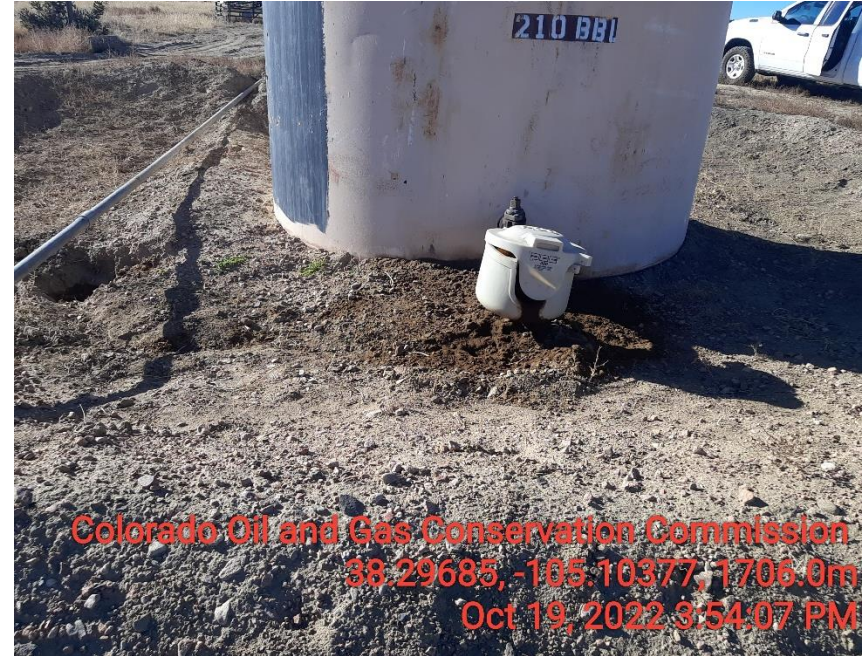
**Photo 2 Stained soil around unused crude oil tank holes dug in containment it appears to be a historical spill contact EPS**

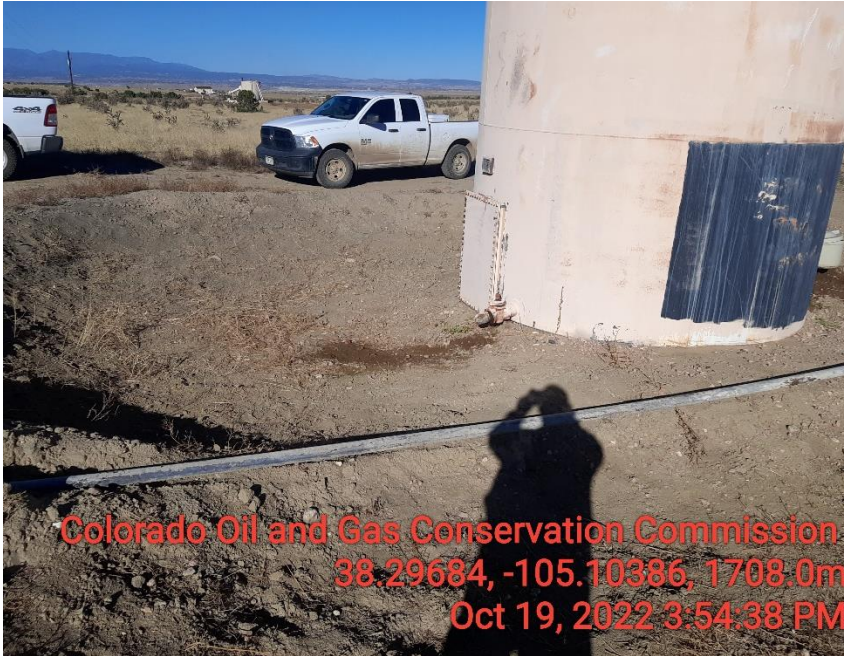
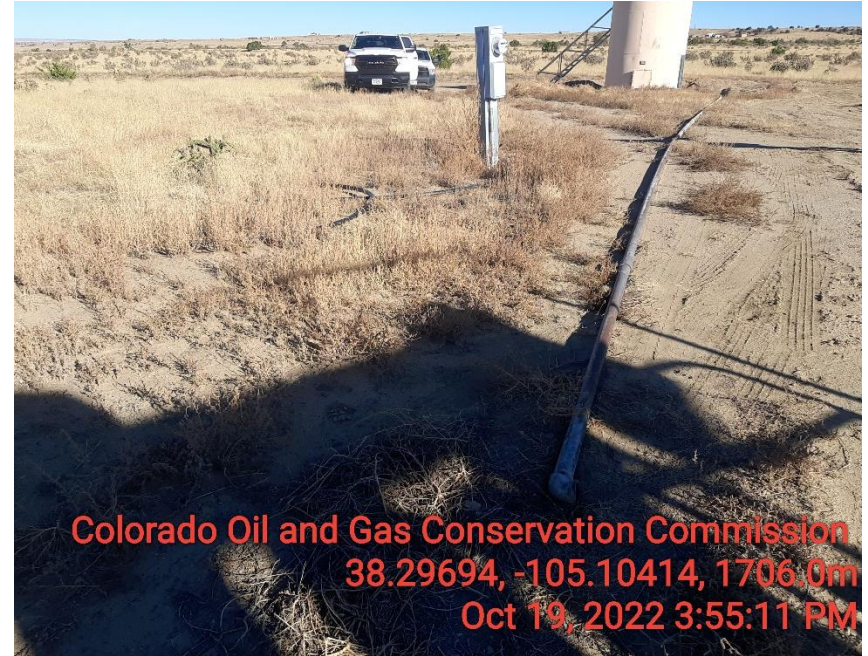
**Photo 3 unused equipment 2" line and crude oil tank.**

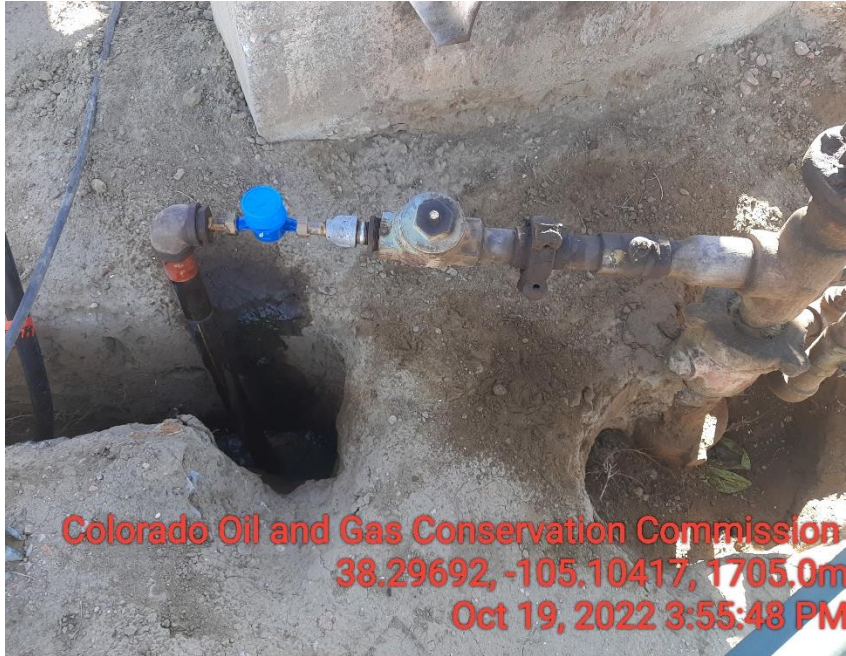
Photo 5 Flow line leaking crude oil from ½ line to well head.  
Stained soil around well head

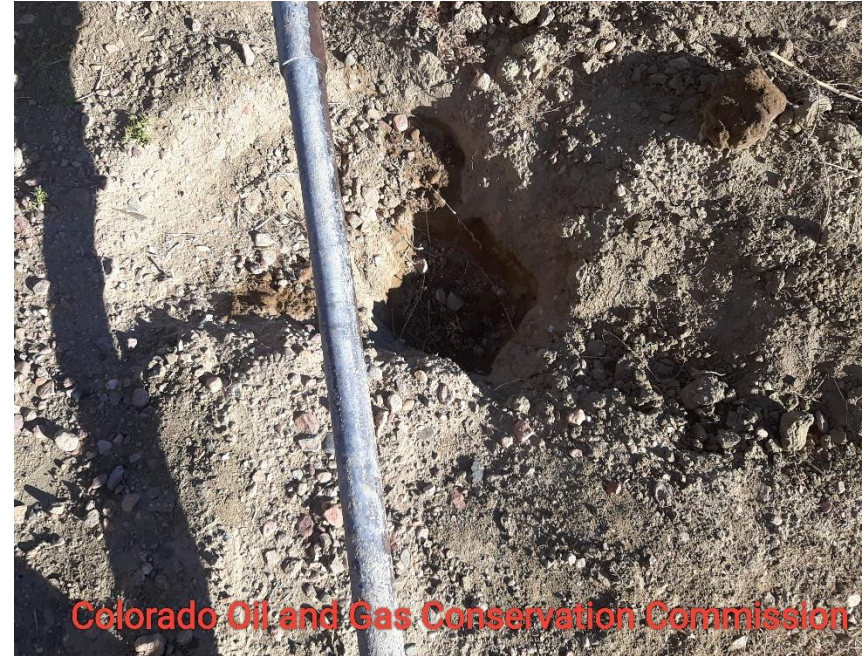
Photo 6 open hole inside unused crude oil tank containment  
it appears the hole is 10 deep and has stained soil .

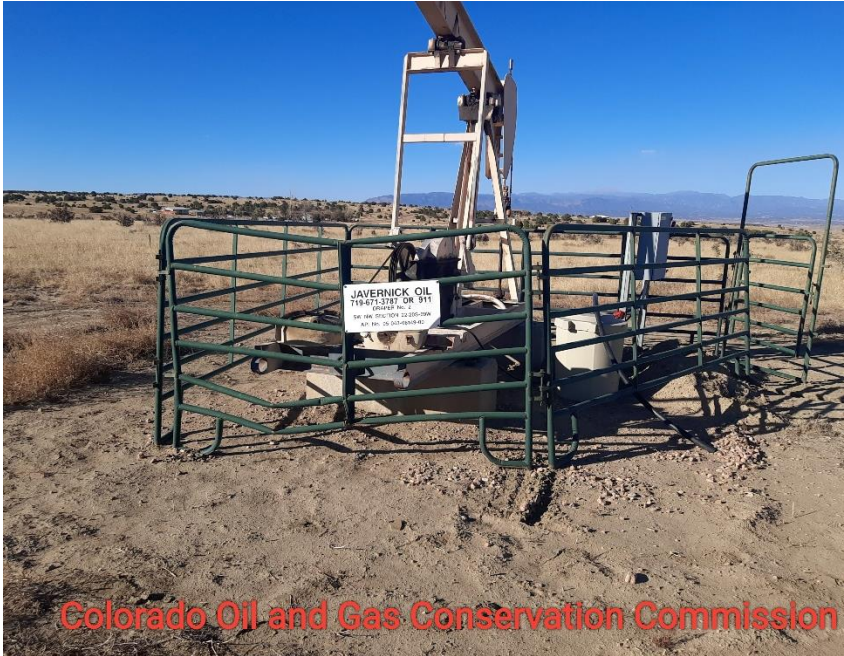
Photo 7 Well head sign
