Stormwater Inspection Report

Operator:	Laramie Energy, LLC
Project:	Cascade Creek
Location:	Shell 797-03B Pad
Date:	Wednesday, October 19, 2022
Weather:	Clear, Calm, 74°, Lo 40°

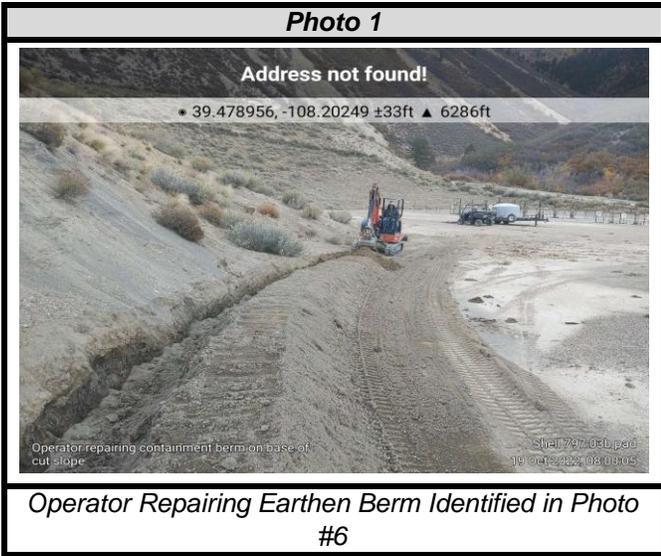
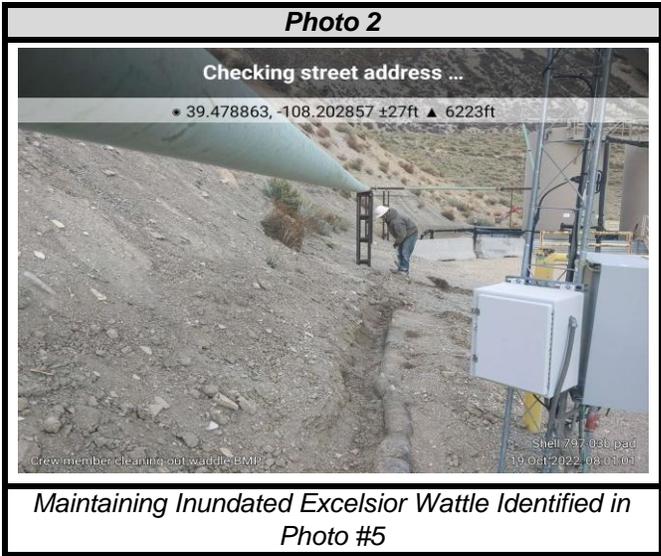
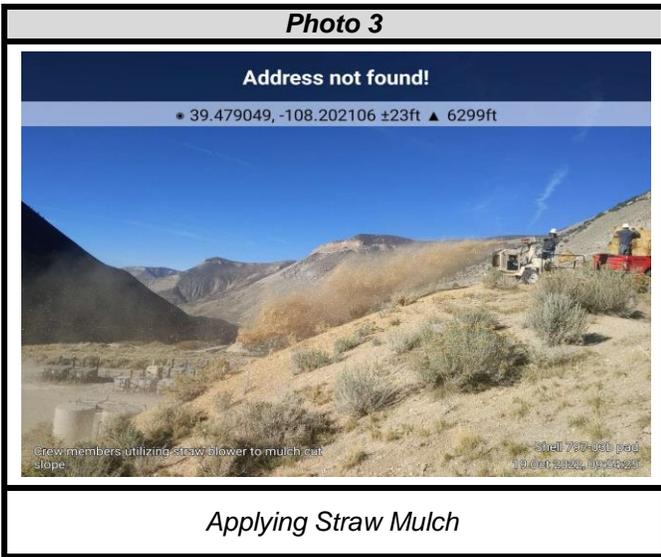
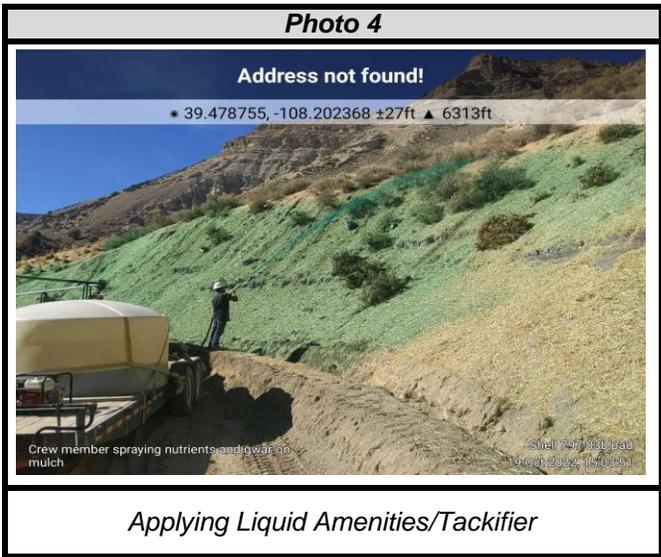
Comments / Descriptions / Explanations
<p>One BMP crew continued repairing erosion damage and impacted BMPs on the Shell 797-03B pad. EI received COGCC Document #696204259 this morning which identifies specific issues to be addressed, many of which were previously identified in the routine 30-day stormwater inspection and were already scheduled for repair. The mulch blower identified in Photo #12 (Labeled Photo #14) was recently staged on the Shell 797-03B pad to apply straw mulch to the Shell 797-03B pad. It has been on location for less than one week and will be removed from the location as soon as all straw mulch applications have been made. The BMP crew began addressing issues identified in Photos #1 through #7 yesterday. These photos identify large scale erosion across much of the Shell 797-03B cut and fill slopes. It will be a multi-day effort to correct all of these issues and work may extend into next week. A mini-ex was used to begin making repairs to the damaged containment berm identified in Photo #6. Excess material that was washed down the cut slope into the containment berm is being removed and repurposed as fill for repairing erosion features, and/or, improving/repairing BMPs. A mini-ex was also used to maintain the upper containment trench located on the upper end of the Shell 797-03B cut slope. The mini-ex was also used to repair deeper erosion features. A mulch blower was used to apply 100 certified, weed-free straw bales as mulch to the cut slope. 1,000 of liquid amenities and tackifier was applied to portions of the straw mulch to help hold the material in place and provide nutrients to weak soils. An additional 45 pounds of QuickGuard and six pounds of Lower Cascade Seed Mix were broadcast over areas experiencing erosion, prior to hand raking or harrowing to remove erosion and incorporate seed.</p>
