Interim Reclamation Inspection

October 11, 2022

Location ID: 480698

Inspection Photos
Location Name: Martin J Schaefer #2 Flowline
Location ID: 480698

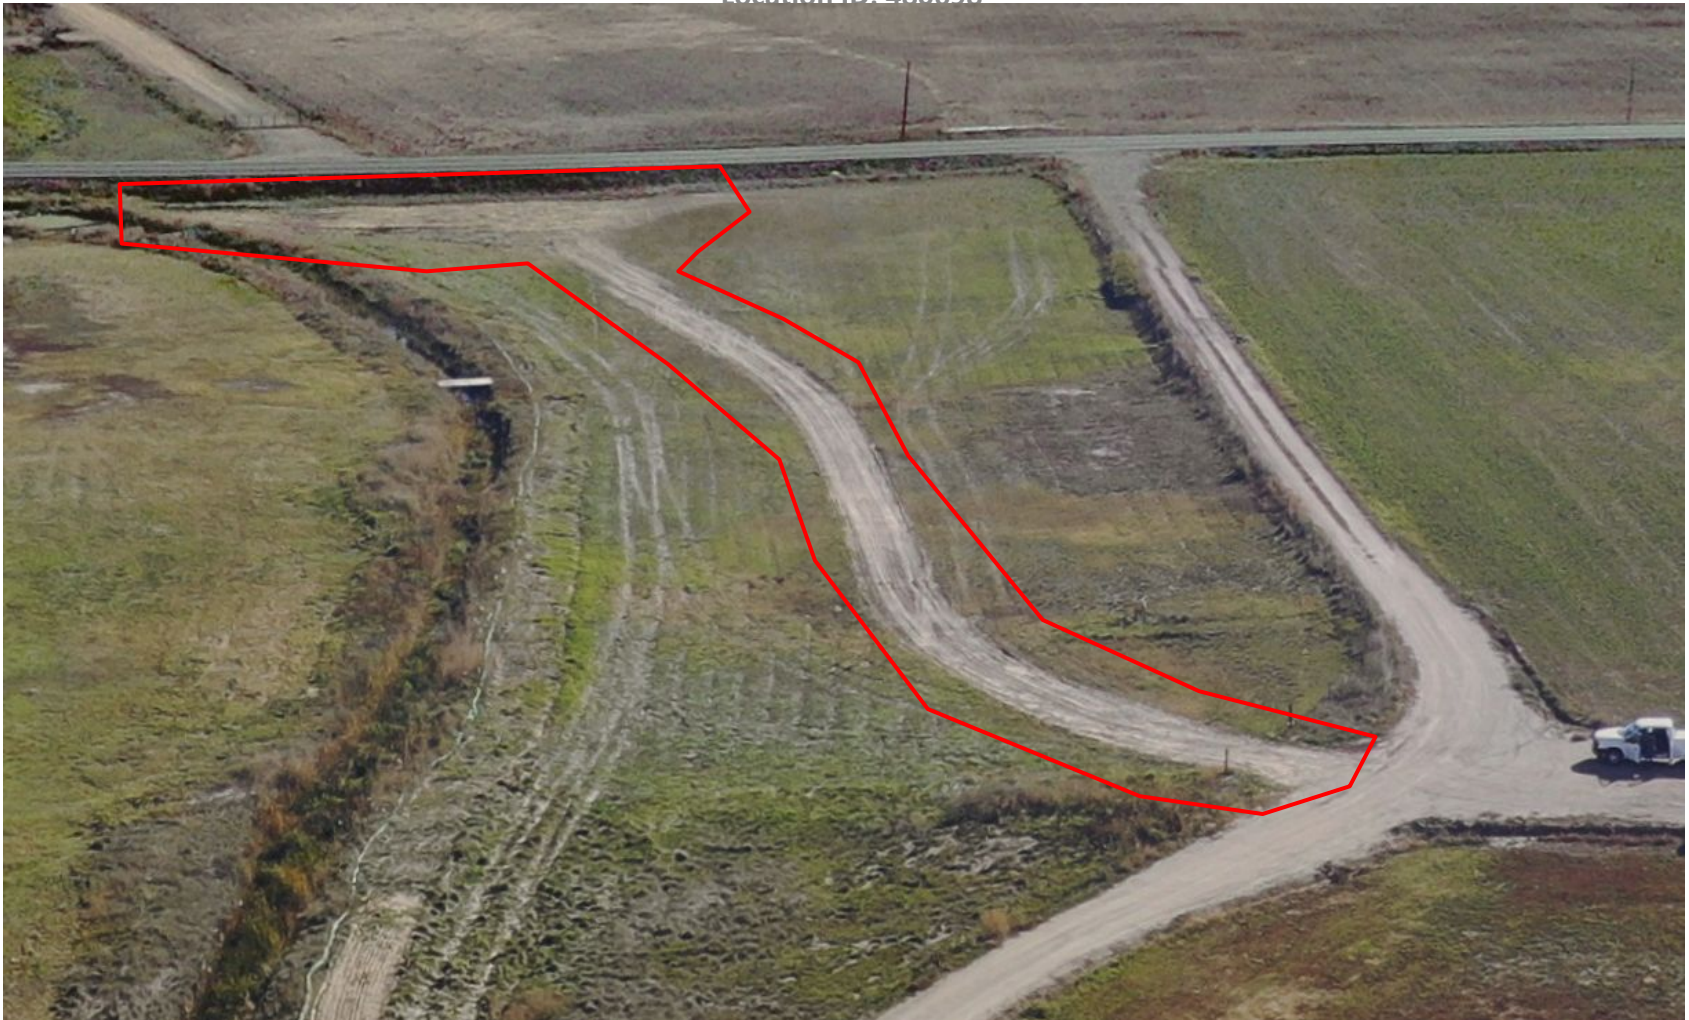
Photo 1. COGCC drone aerial imagery taken on October 11, 2022 documenting the scope of reclamation work that has been performed. The red polygon has been seeded and hydromulched.

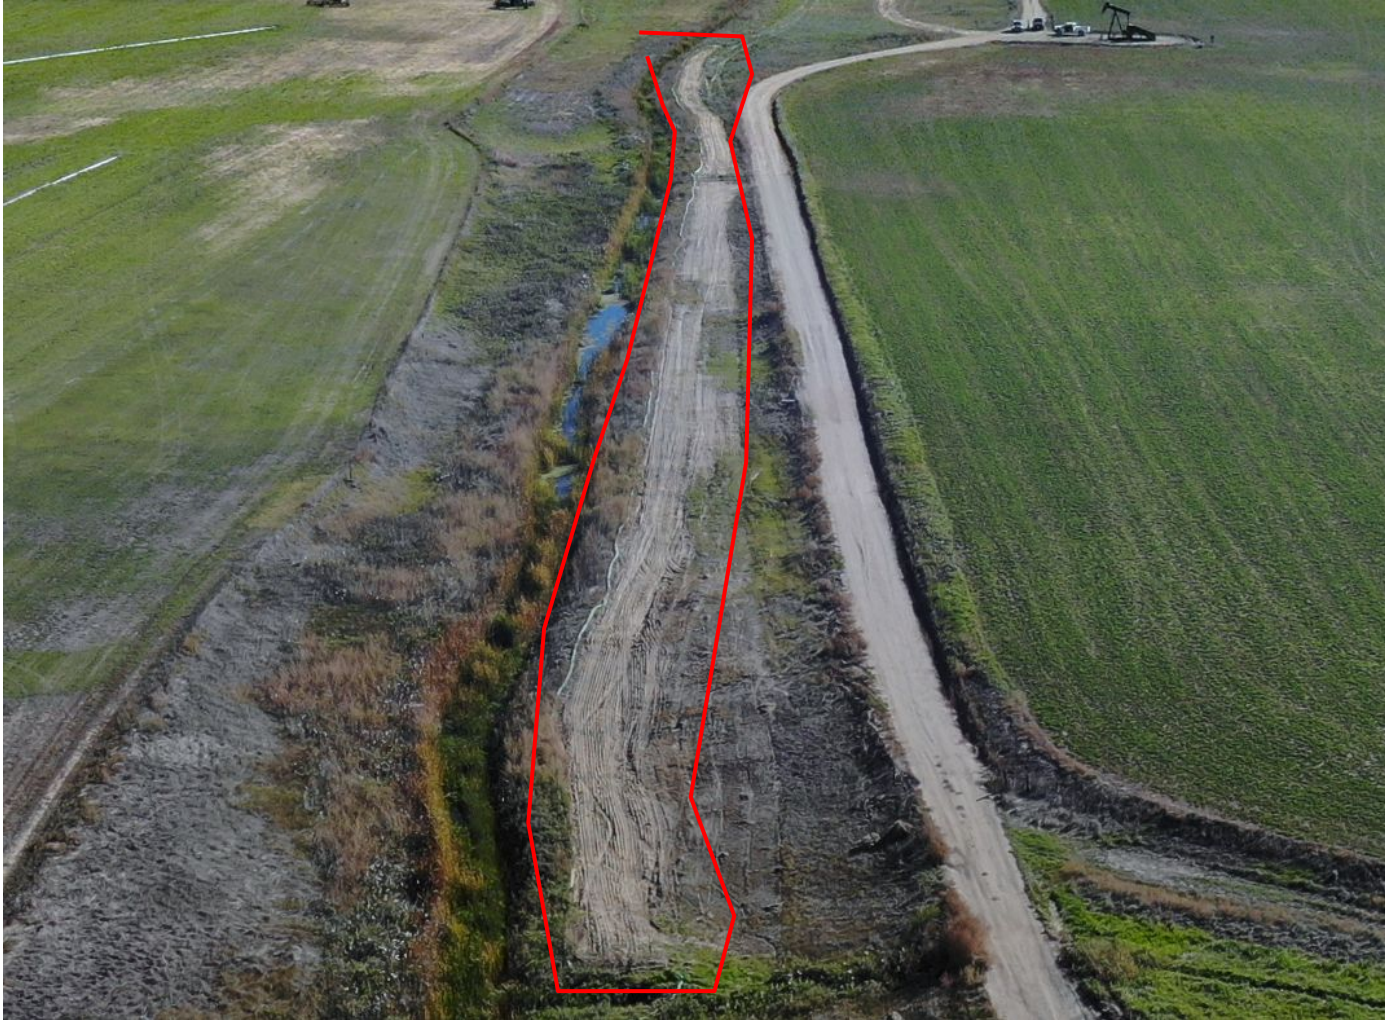
Photo 2. COGCC drone aerial imagery taken on October 11, 2022 documenting the scope of reclamation work that has been performed. The red polygon has been seeded and hydromulched.

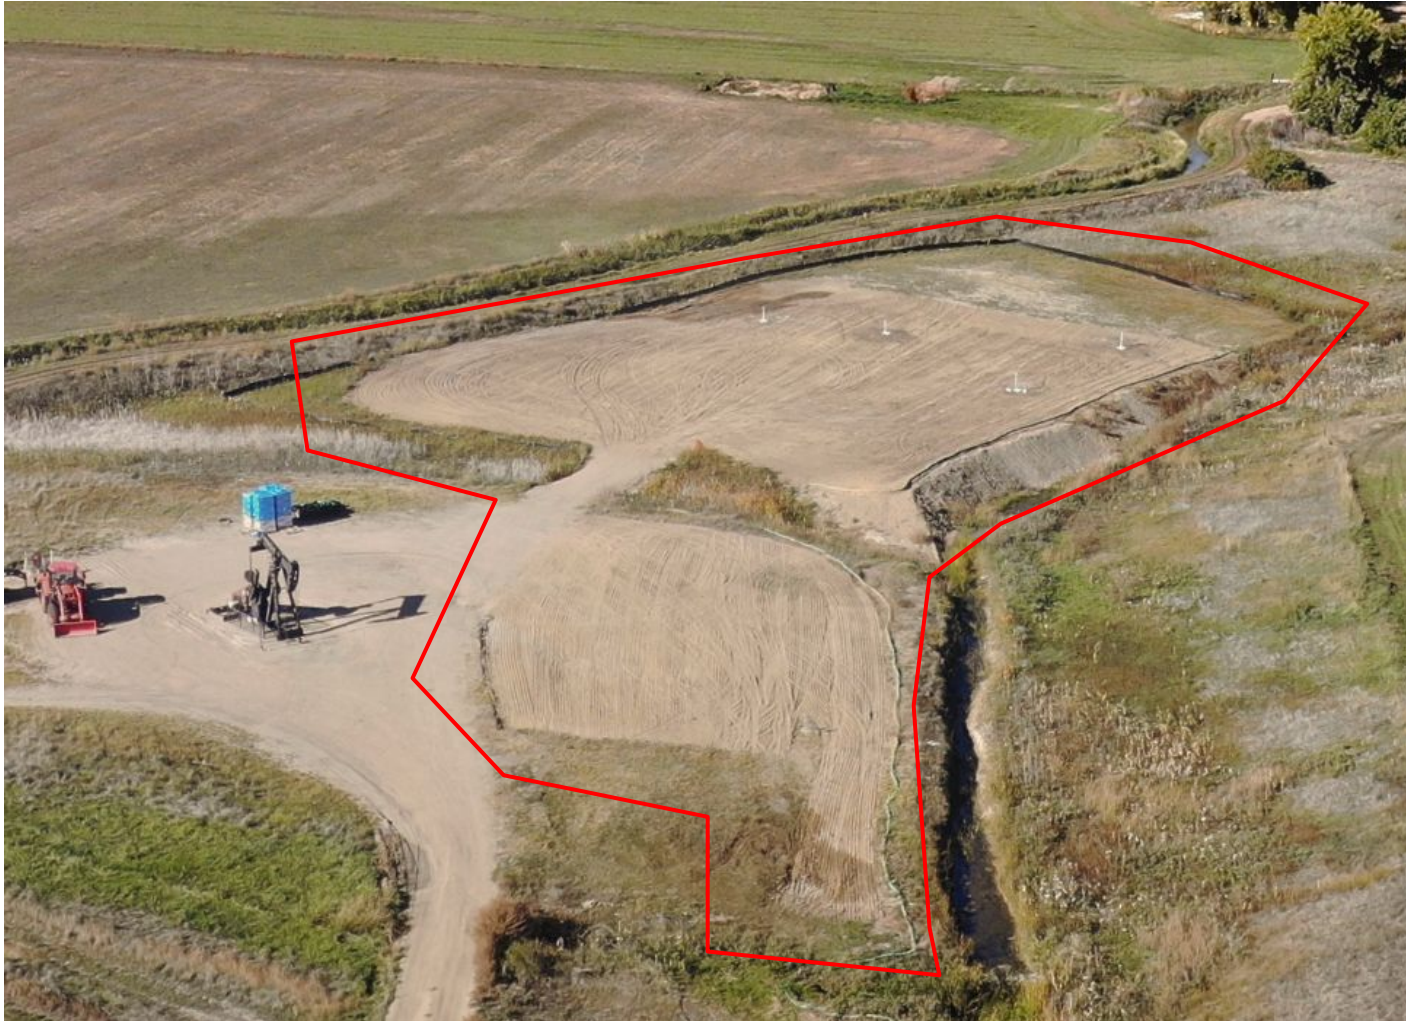
Photo 3. COGCC drone aerial imagery taken on October 11, 2022 documenting the scope of reclamation work that has been performed. The red polygon has been seeded and hydromulched. Note- the north-facing fill slope is going to require additional stabilization and the Operator is addressing that.

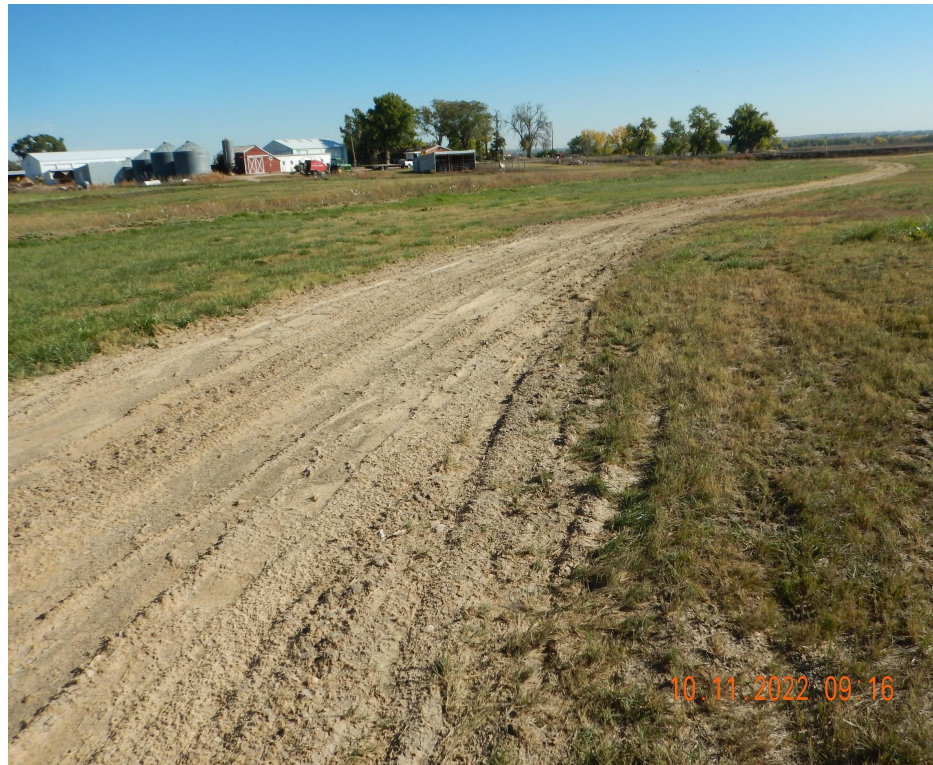
Photo 4. Photo taken from the eastern access road, facing East. Photo illustrates the access road has been seeded and hydromulched. Germination of desirable plant species was observed.

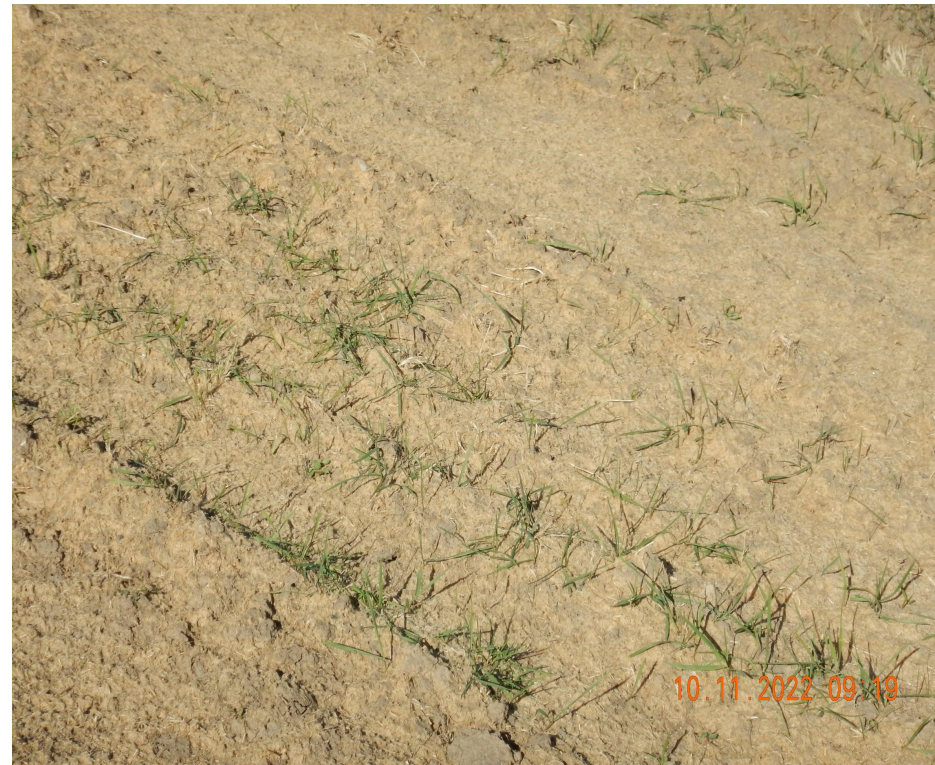
Photo 5. Close up photo illustrating germination of desirable plant species.

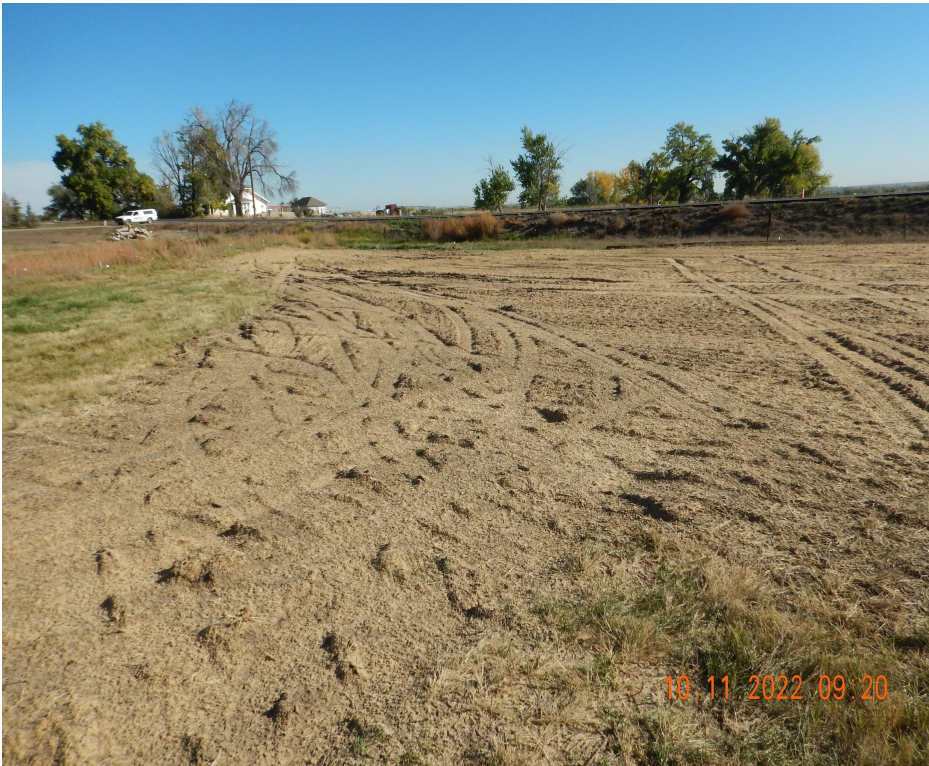
Photo 6. Photo taken from the eastern staging area, facing Northeast. See comments under Photo 4.

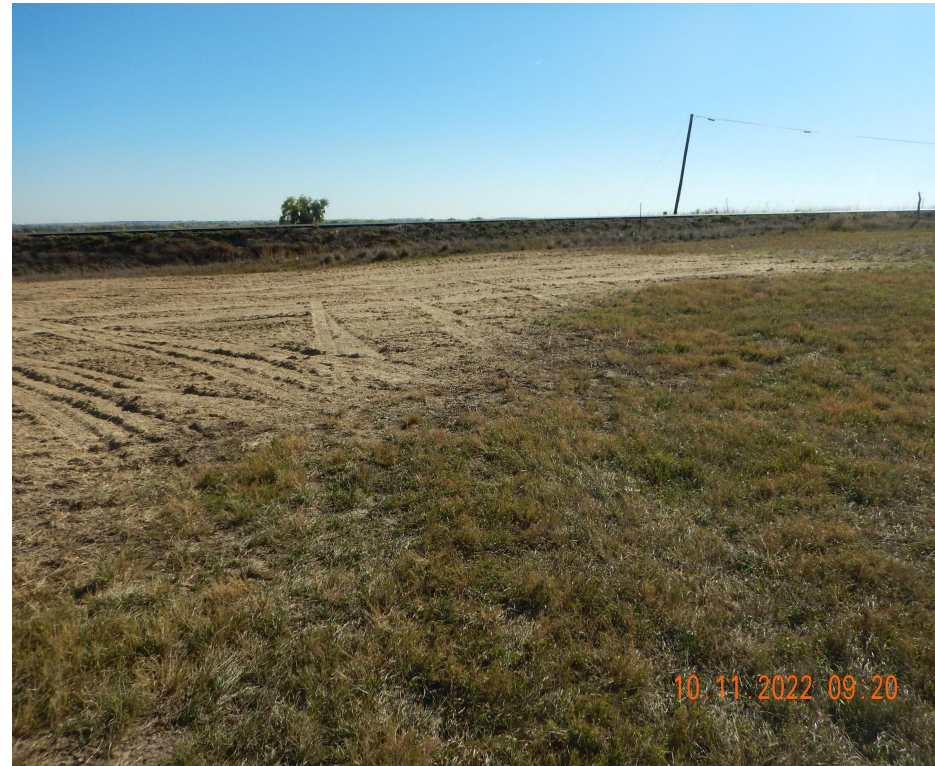
Photo 7. Photo taken from the eastern staging area, facing East. See comments under Photo 4.

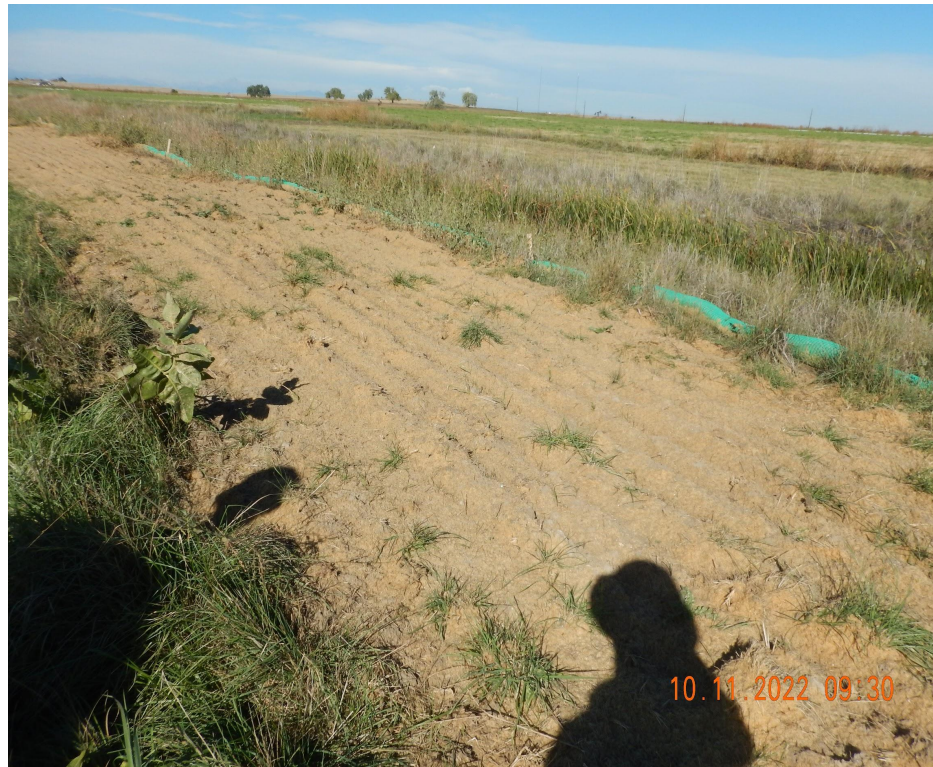
Photo 8. Photo taken from the central access road, facing West. See comments under Photo 4.

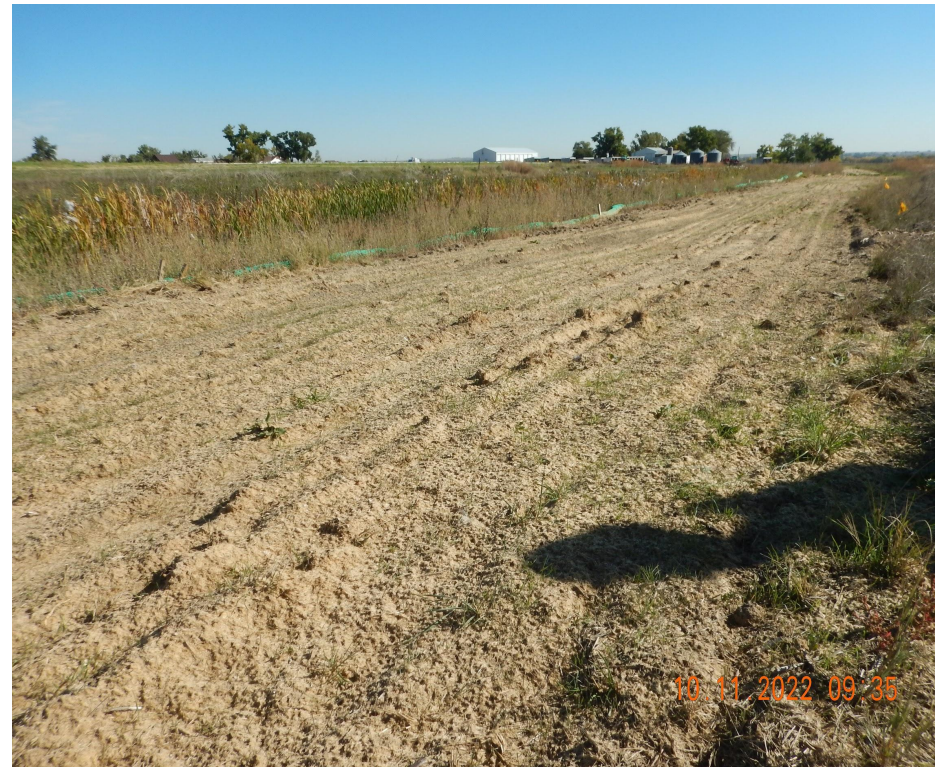
Photo 9. Photo taken from the western access road, facing East. See comments under Photo 4.

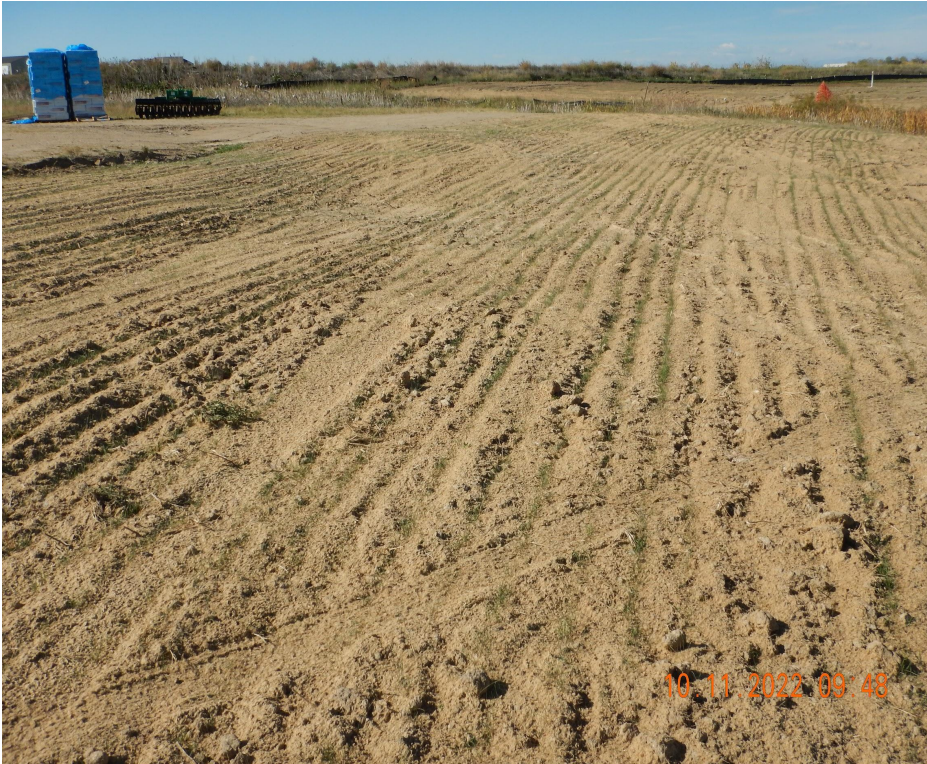
Photo 10. Photo taken from the western staging area, facing West. See comments under Photo 4.

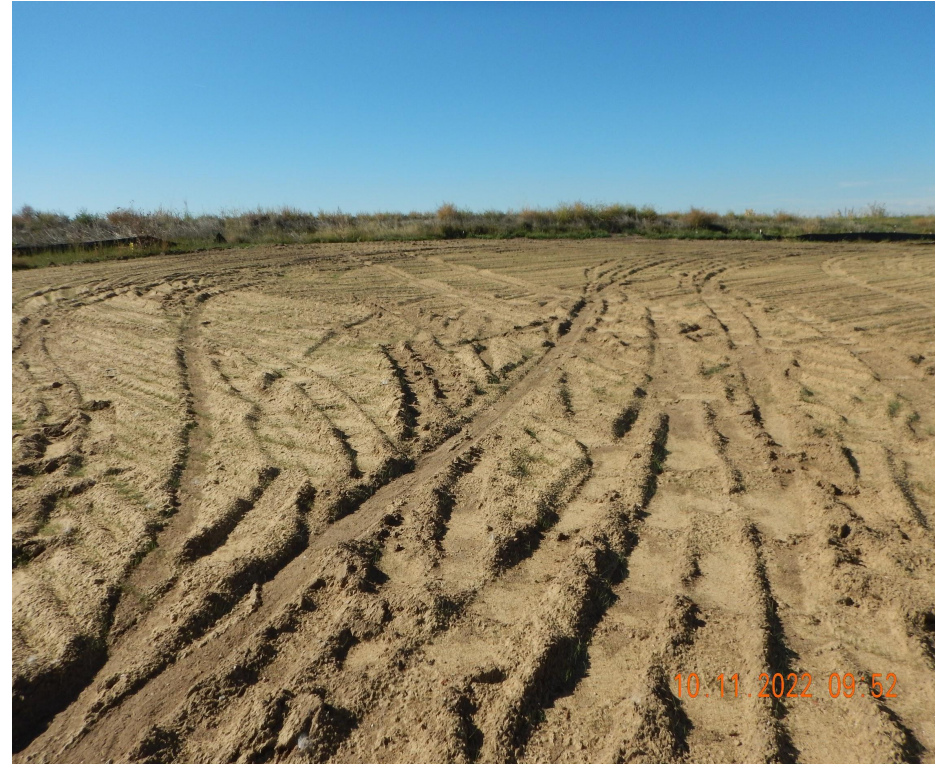
Photo 11. Photo taken from the western excavation area, facing West. See comments under Photo 4. Note- vehicle traffic appears to be driving over reclamation area. Operator will work to keep vehicle traffic off while reclamation is in progress.

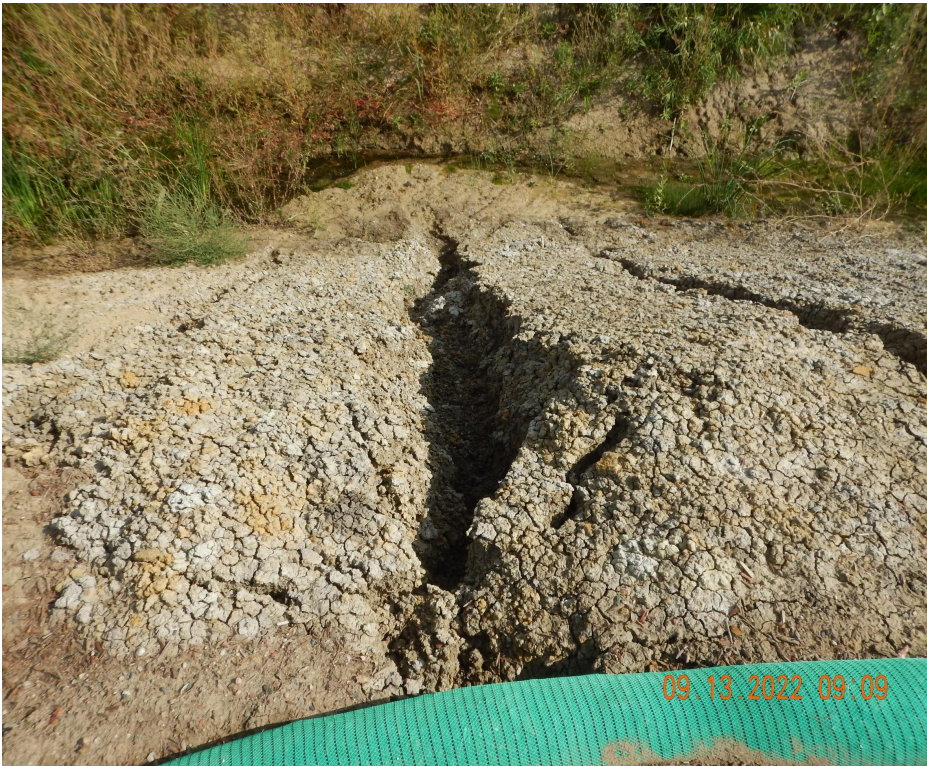
Photo 12. Photo taken from the western fill slope on 9/13/2022, facing North. Photo illustrates erosion along the fill slope that needs to be repaired during reclamation. The erosion is believed to be from a recent irrigation event by the surface owner.

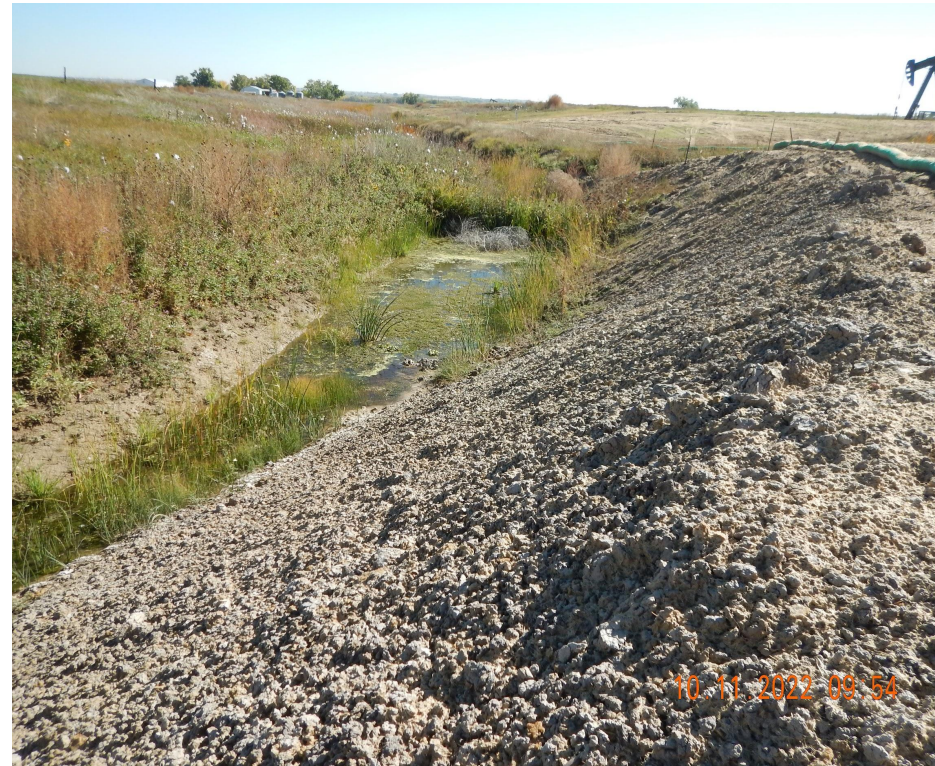
Photo 13. Photo taken from the western fill slope on 10/11/2022, facing East. Photo illustrates erosion along the fill slope has been repaired but there appears to be movement of the slope. Operator is planning to implement additional BMPs to better stabilize the fill slope for long-term stabilization.
