Interim Reclamation and Stormwater Inspection

Date: 10/11/2022

Operator: MALLARD EXPLORATION LLC - 10670

Location ID: 445657

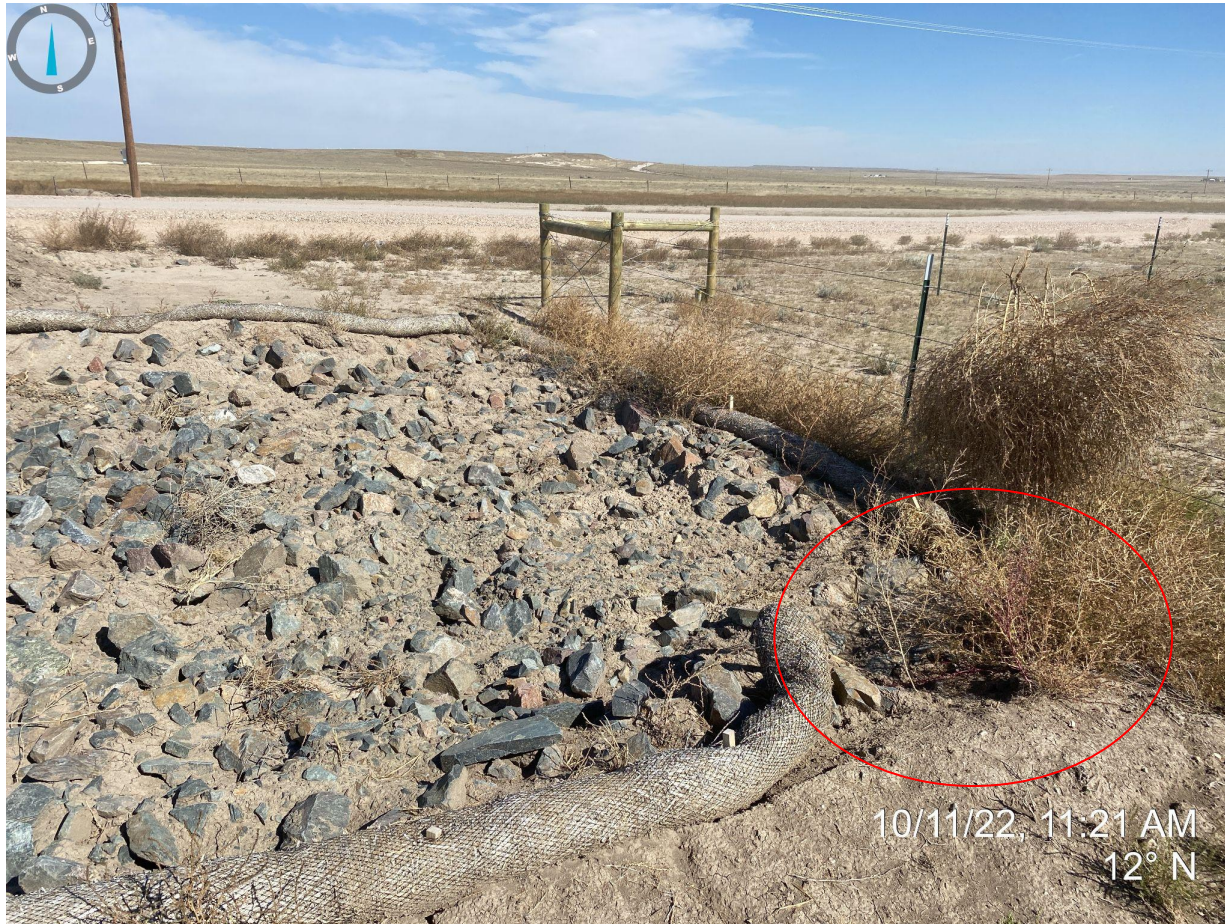
Photo 1. Taken near entrance, facing north. Photo illustrates straw wattles are not properly installed or missing. Rip-rap material is partially covered with sediment.

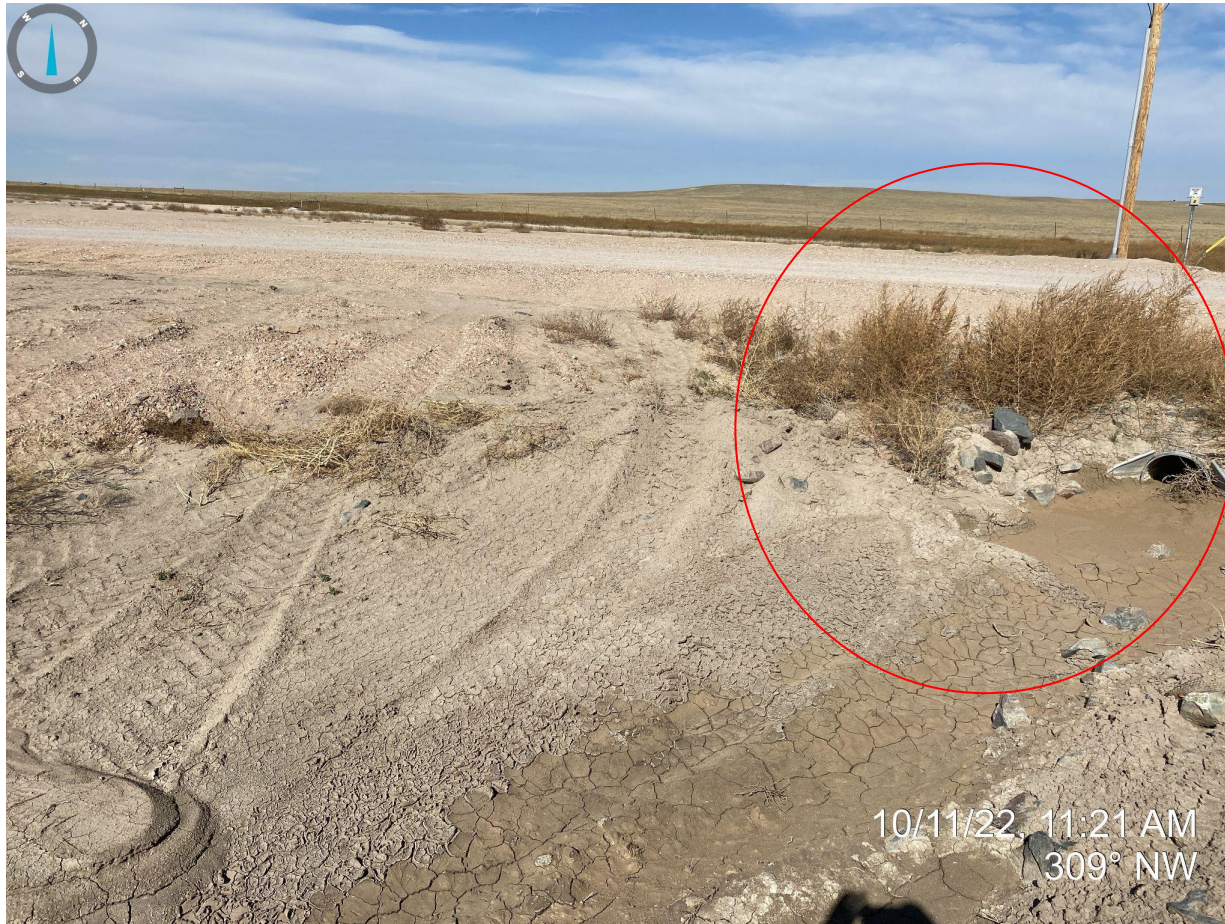
Photo 2. Taken near entrance, facing northwest. Photo illustrates outlet portion of culvert is partially buried with sediment. Annual weedy vegetation (kochia) also pictured.

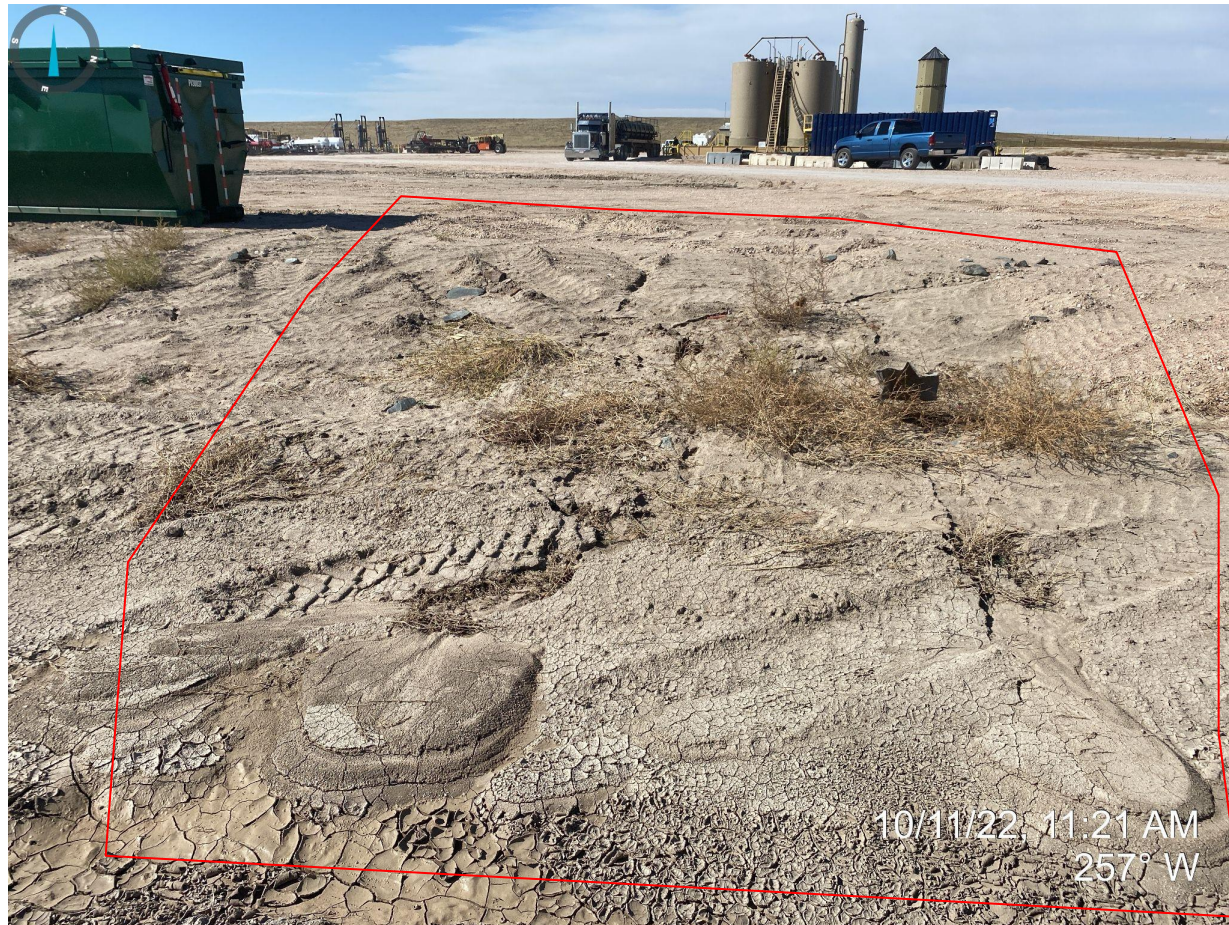
Photo 3. Taken near entrance, facing west. Photo illustrates rill erosion.

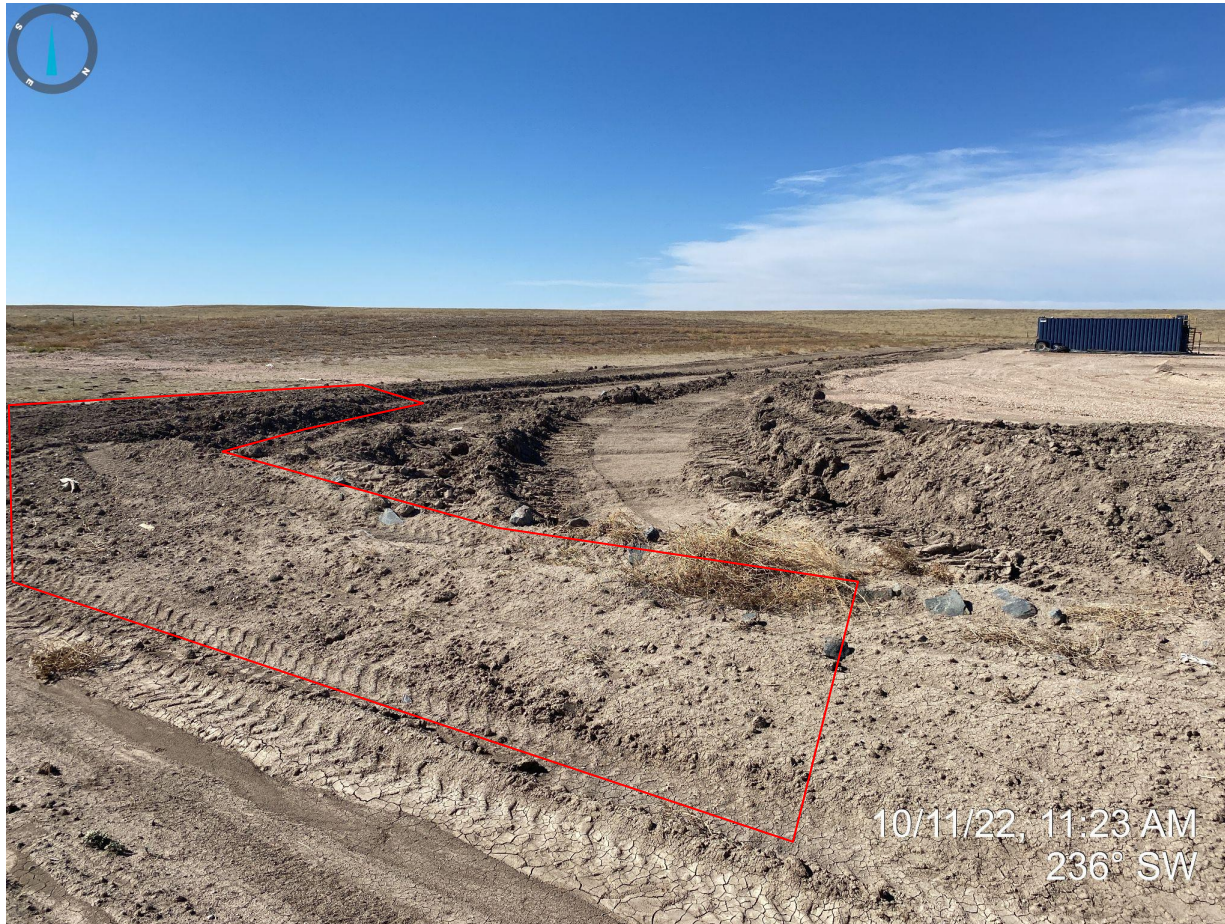
Photo 4. Photo taken from eastern portion, facing southwest. Photo illustrates ditch and berm BMP consisting of unconsolidated material, outlined in red.

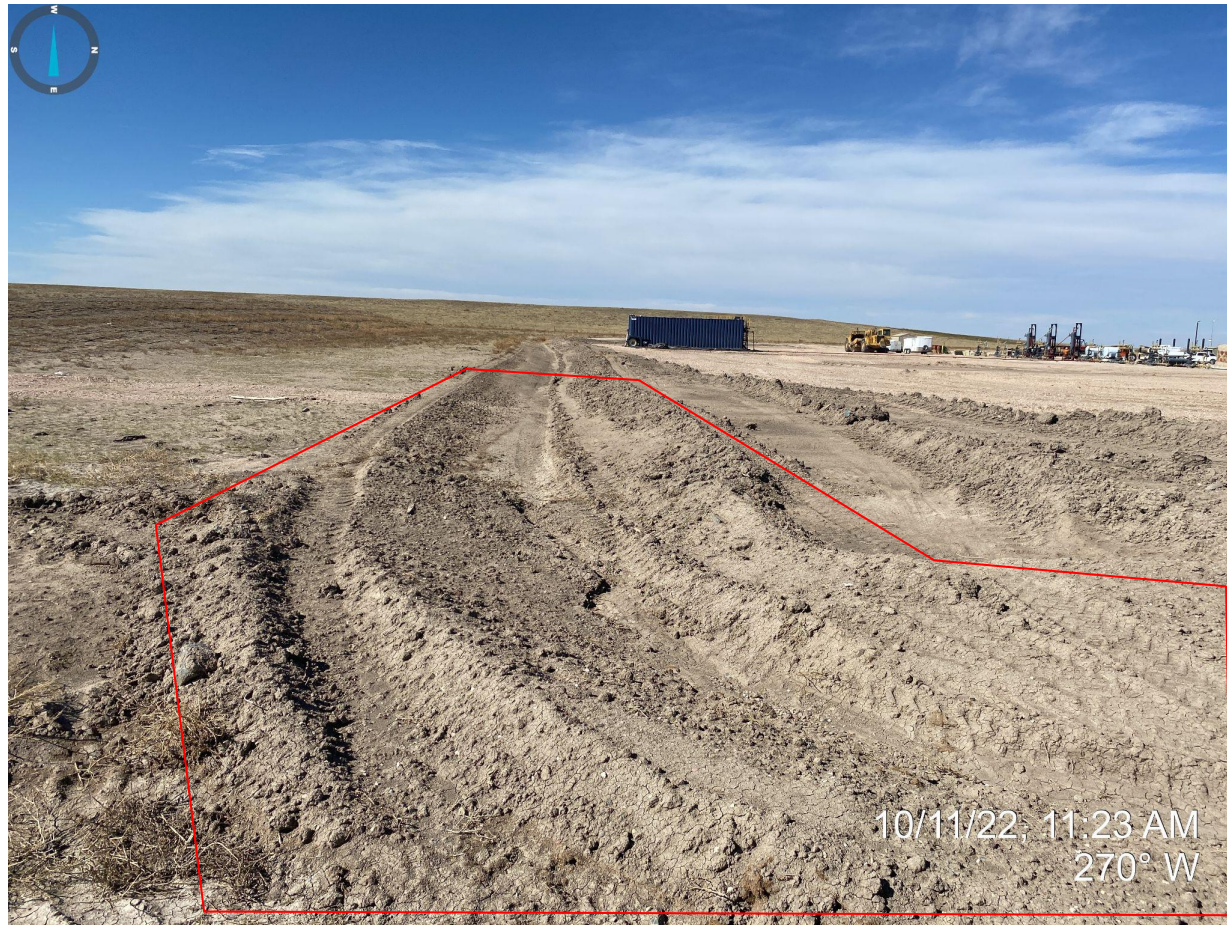
Photo 5. Taken near southeast corner of location, facing west. See comments in photo 4.

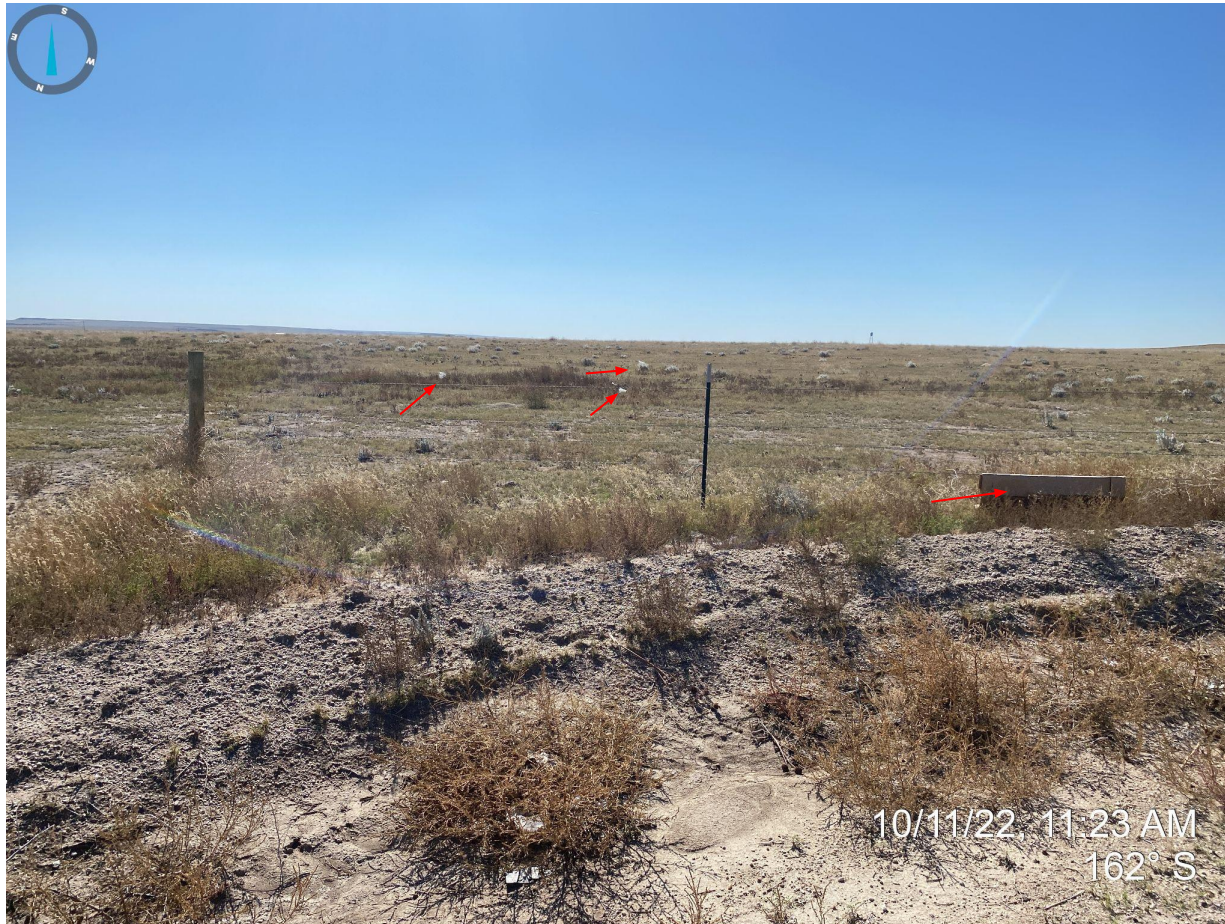
Photo 6. Taken from southeast corner, facing south. Photo illustrates trash that has blown off location, indicated by red arrows.

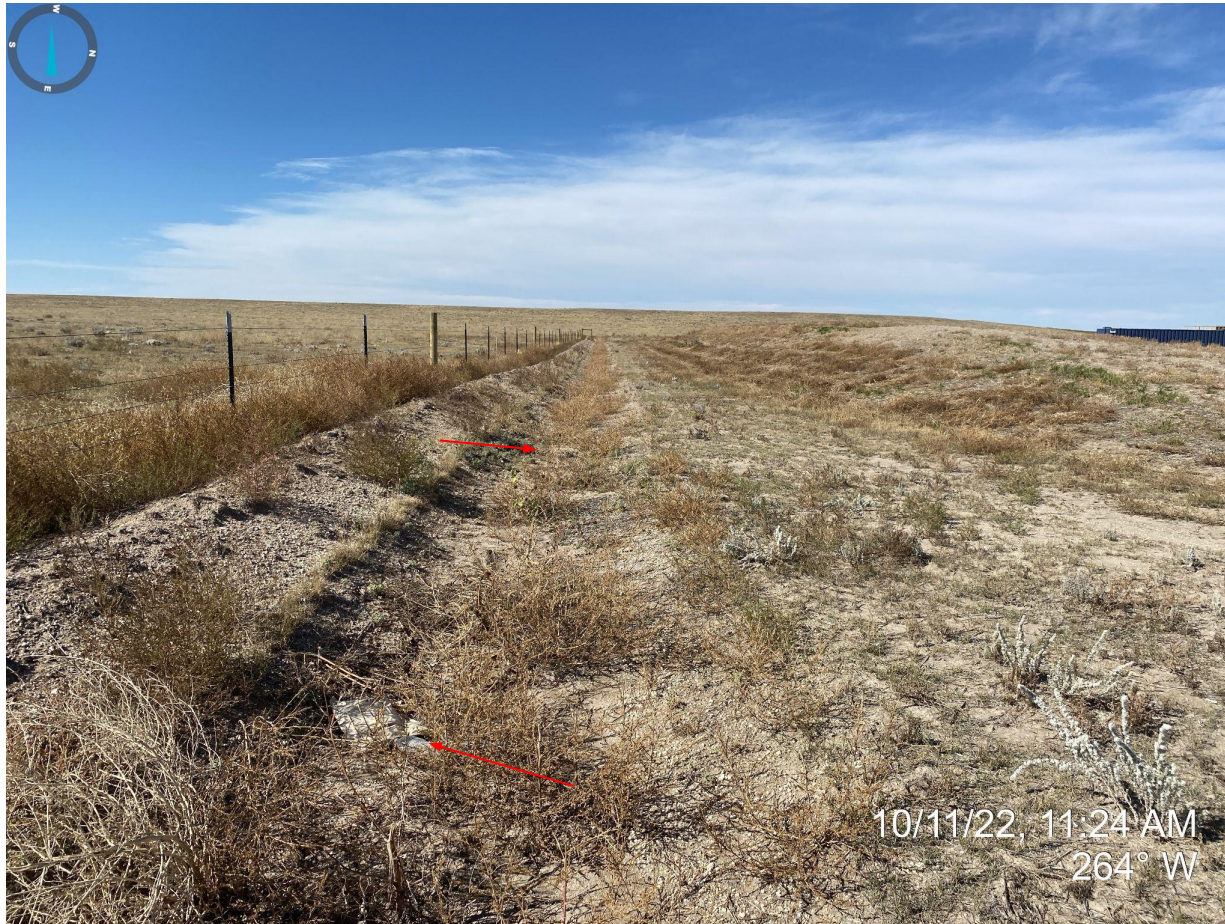
Photo 7. Taken from southeast corner, facing west. Photo illustrates perimeter ditch BMP has annual weedy vegetation growth and trash.

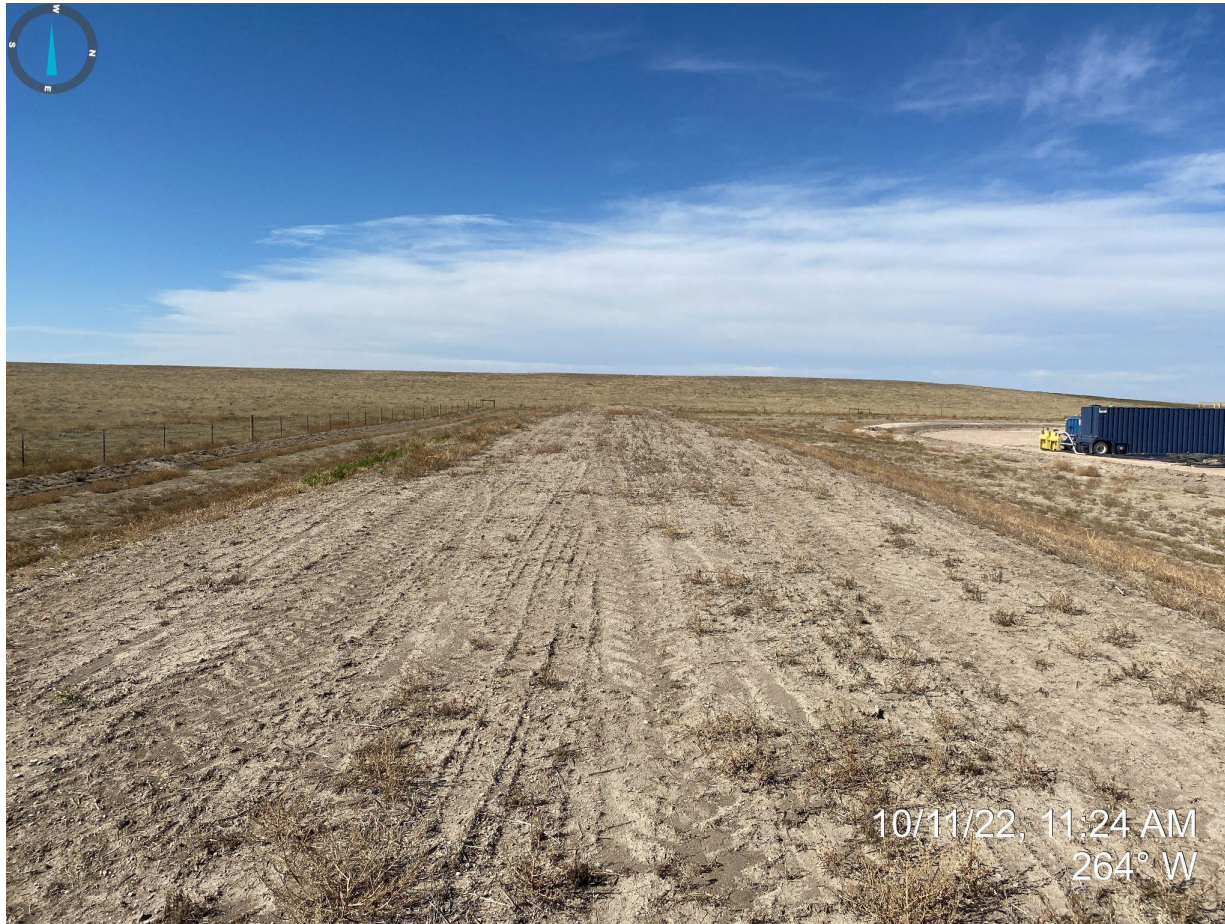
Photo 8. Taken on top of topsoil stockpile, facing west. Photo illustrates topsoil has not been revegetated to comply with 1003 rules; annual weedy vegetation and bare soil observed.

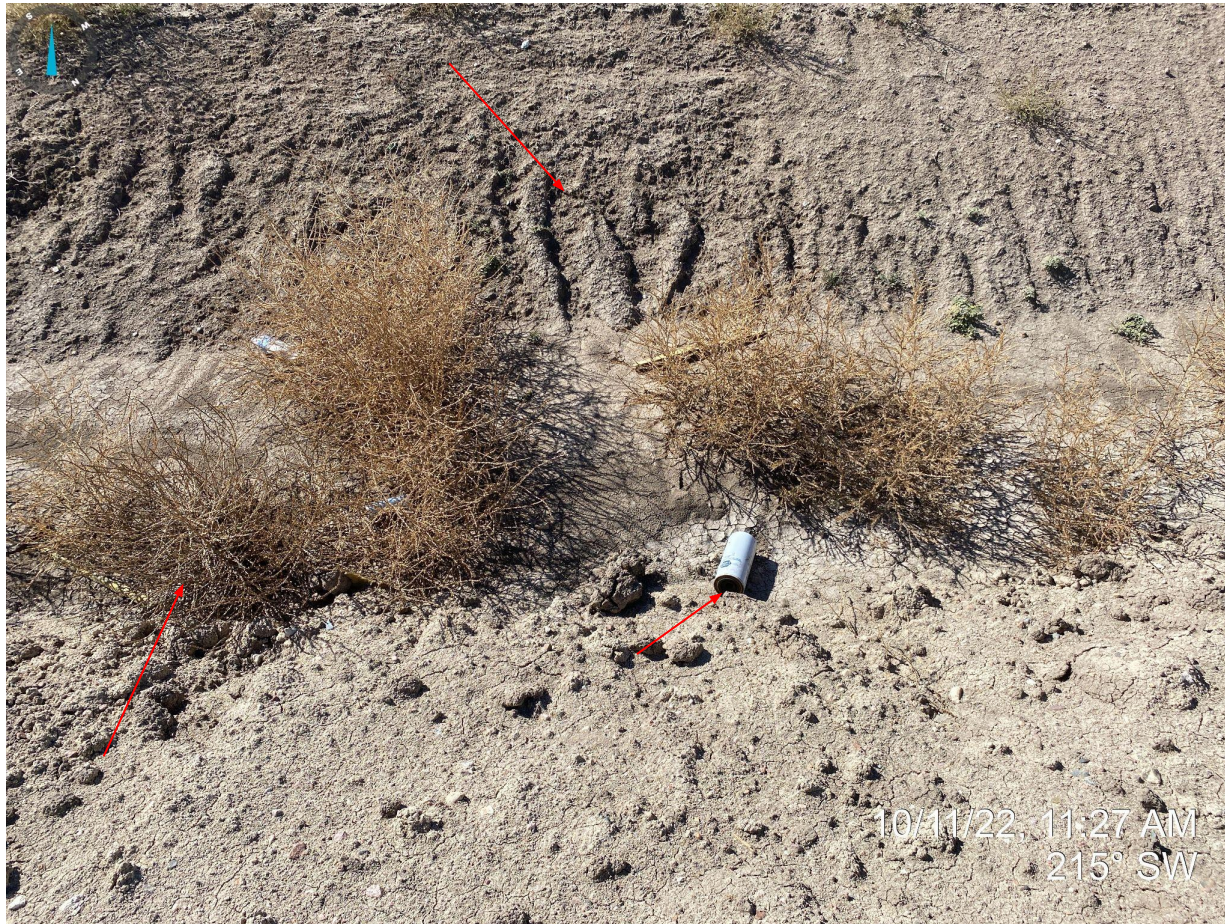
Photo 9. Taken from southwest portion of location, facing southwest. Close up photo of ditch BMP illustrating trash, annual weedy vegetation, unconsolidated material, and rill erosion.

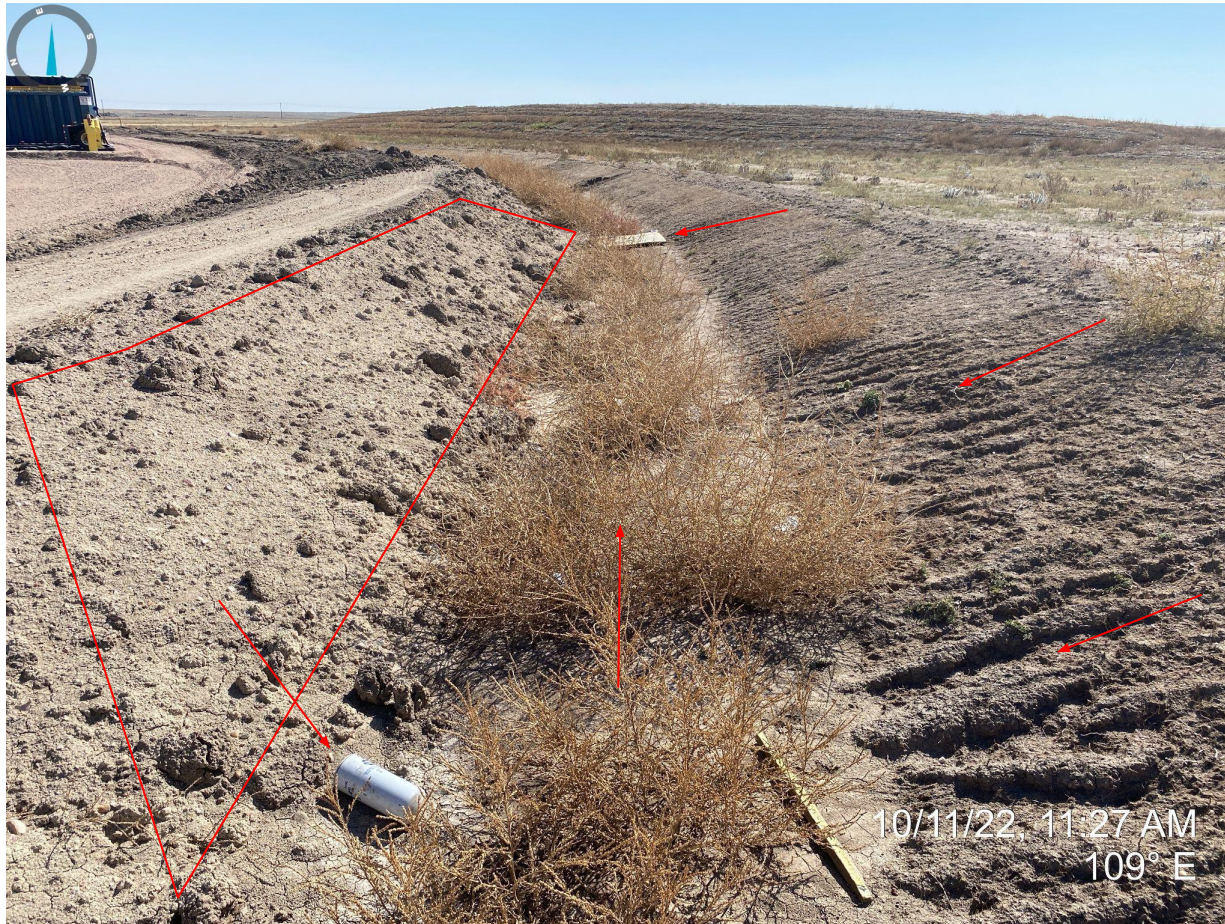
Photo 10. Taken from southwest portion of location, facing east. See comments in photo 9.

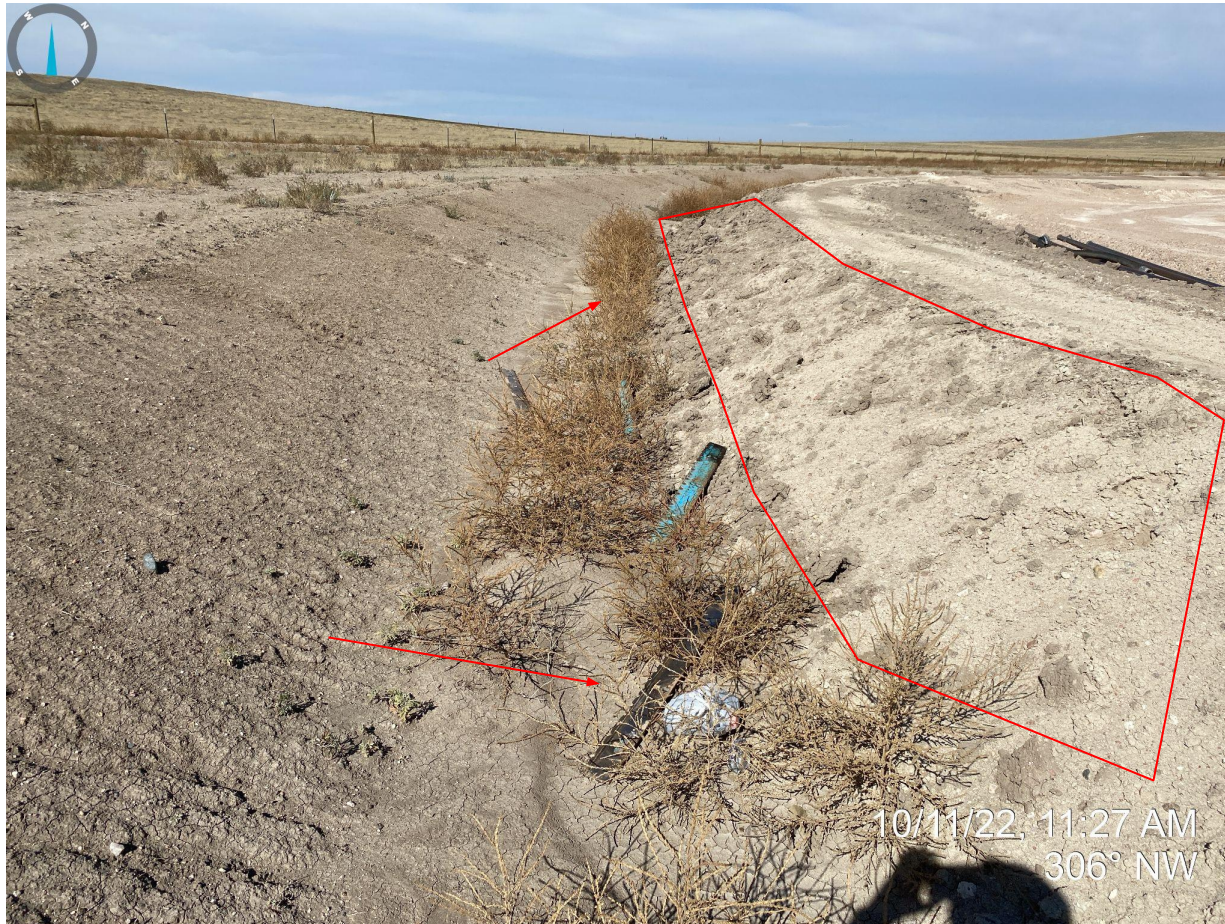
Photo 11. Taken from southwest portion of location, facing northwest. See comments in photo 9.

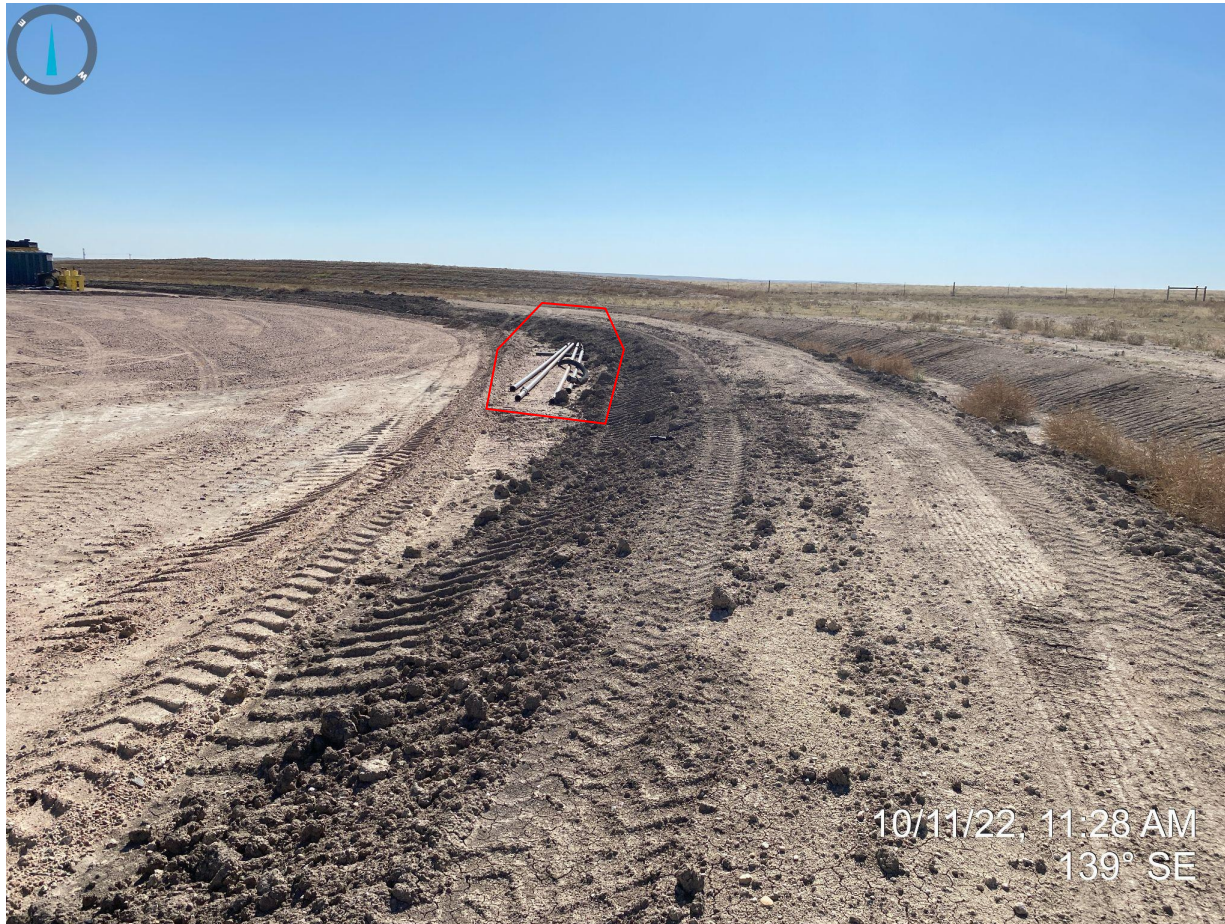
Photo 12. Taken from southwest portion of location, facing southeast. Unused pipe stored on location.

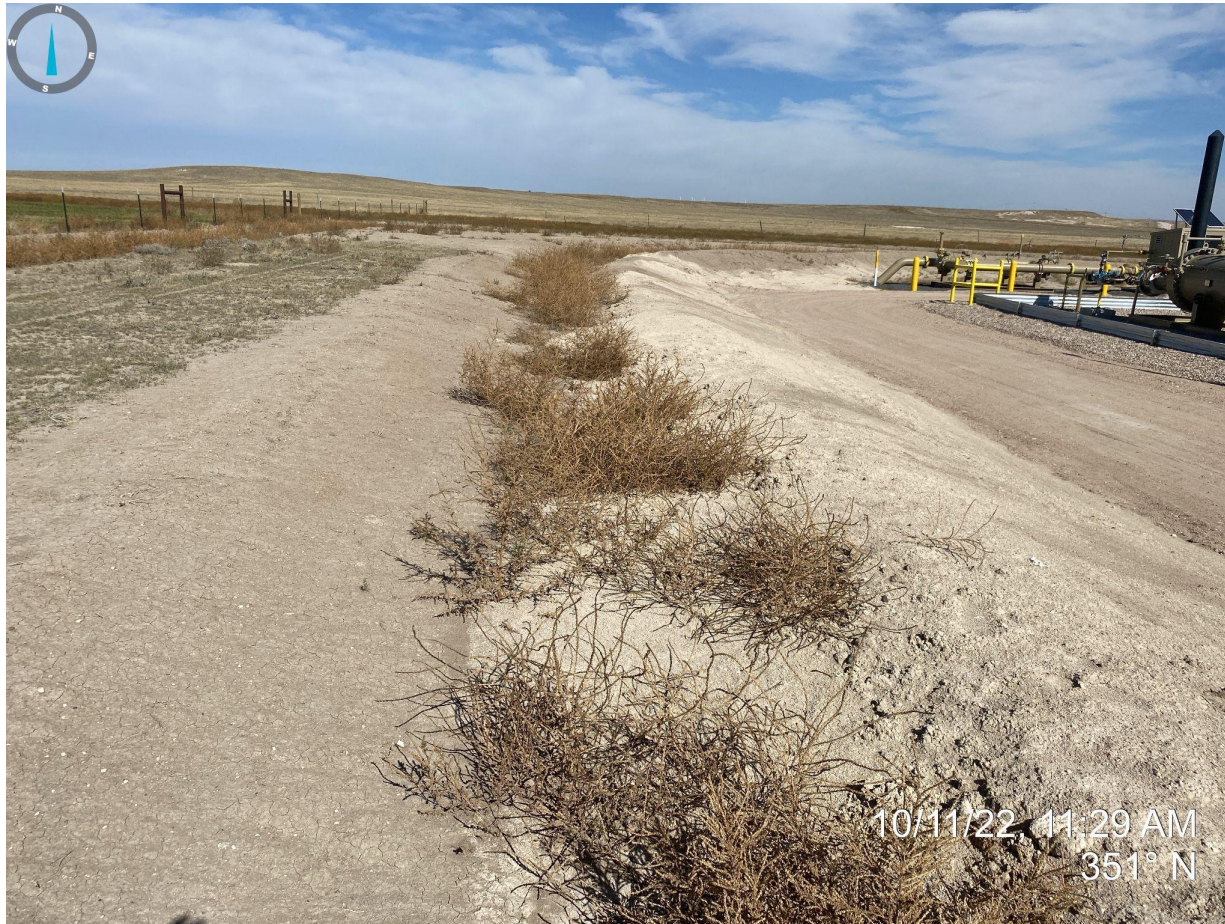
Photo 13. Taken from the western portion of location, facing north. Photo illustrates ditch BMP is filled with sediment and annual weedy vegetation.

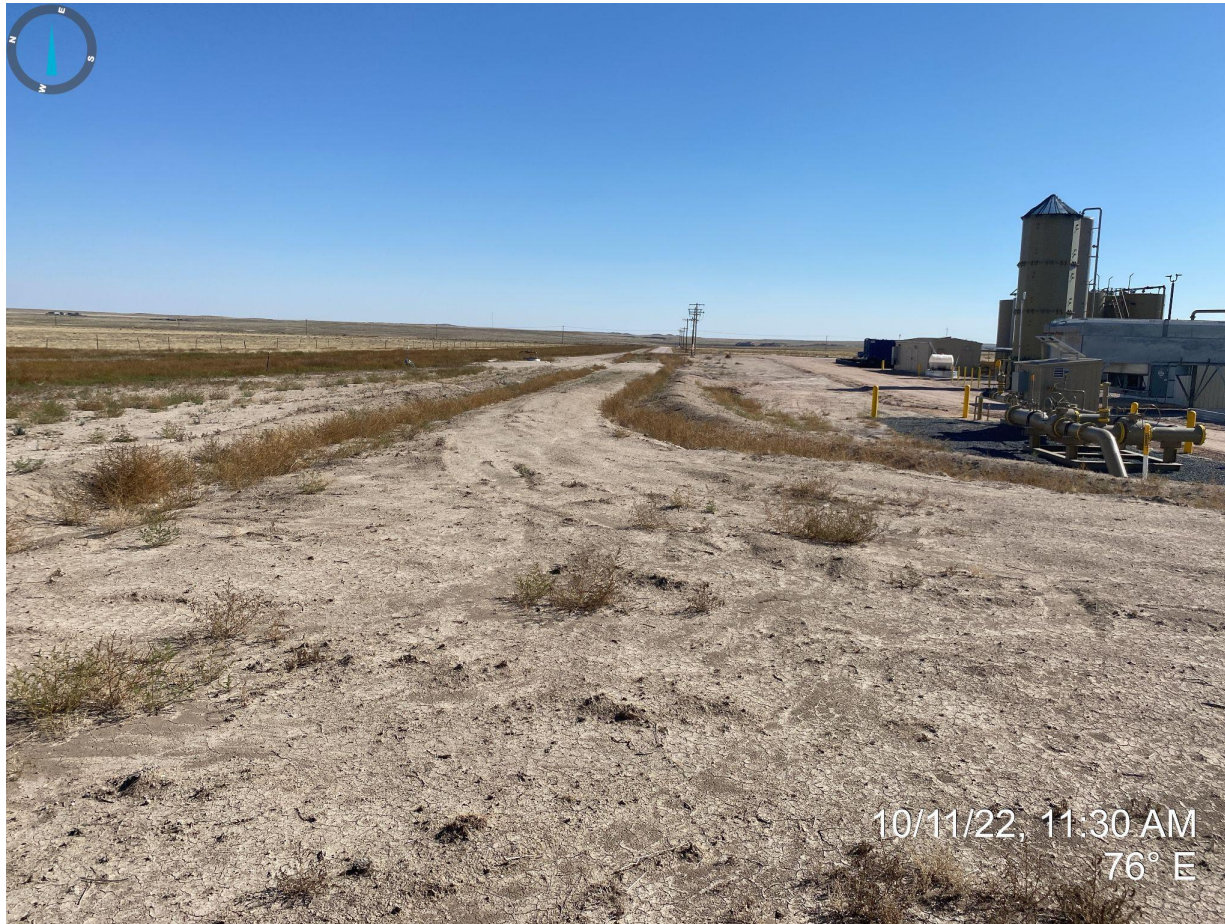
Photo 14. Taken from northwest corner, facing east. Photo illustrates interim areas have failed to revegetate with bare soil and annual weedy vegetation observed.

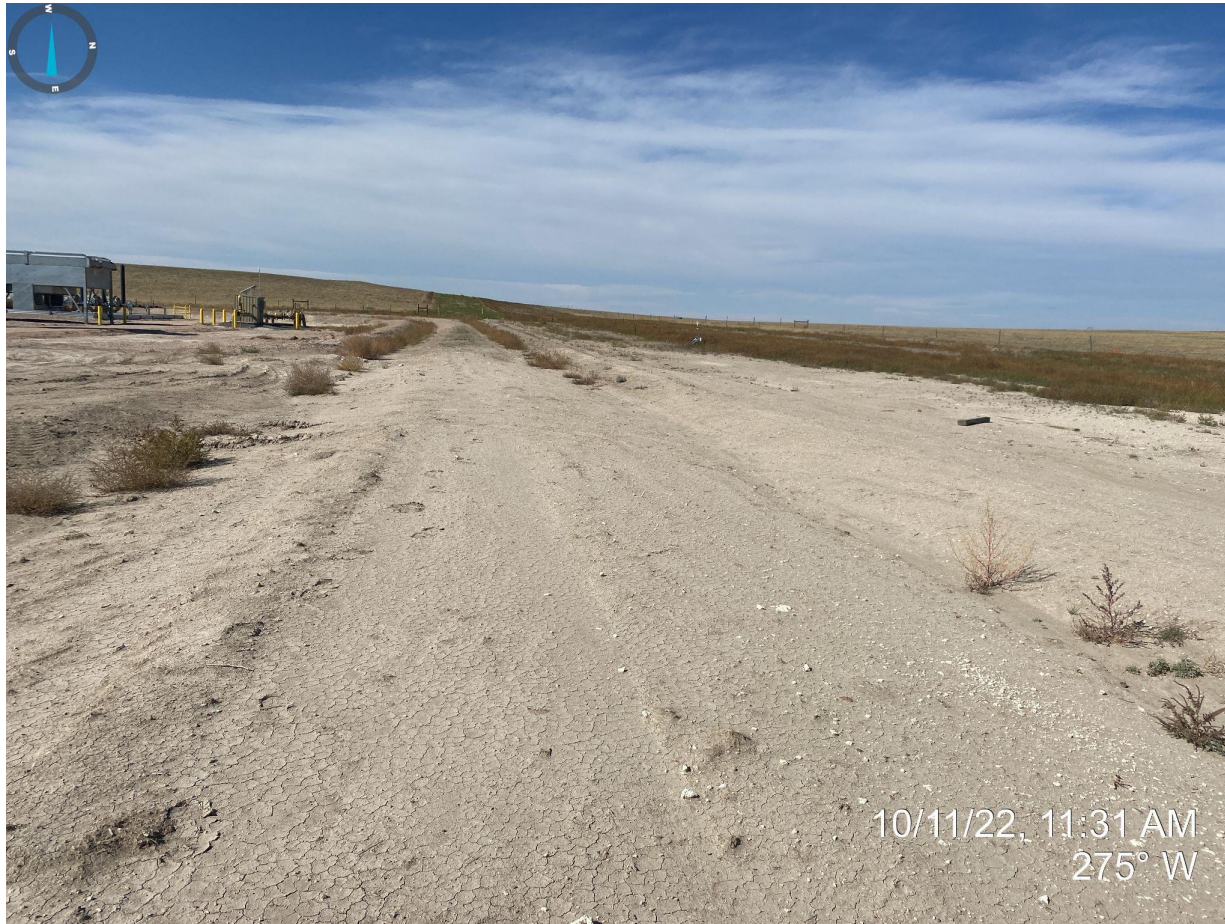
Photo 15. Taken from northeast corner, facing west. See comments in photo 14.
