Inspection Photos

Operator: Crowheart Energy LLC - #10776

Location Name: Bakers Peak Unit-611N91W /12SWSE

Inspection Document #: 702800836

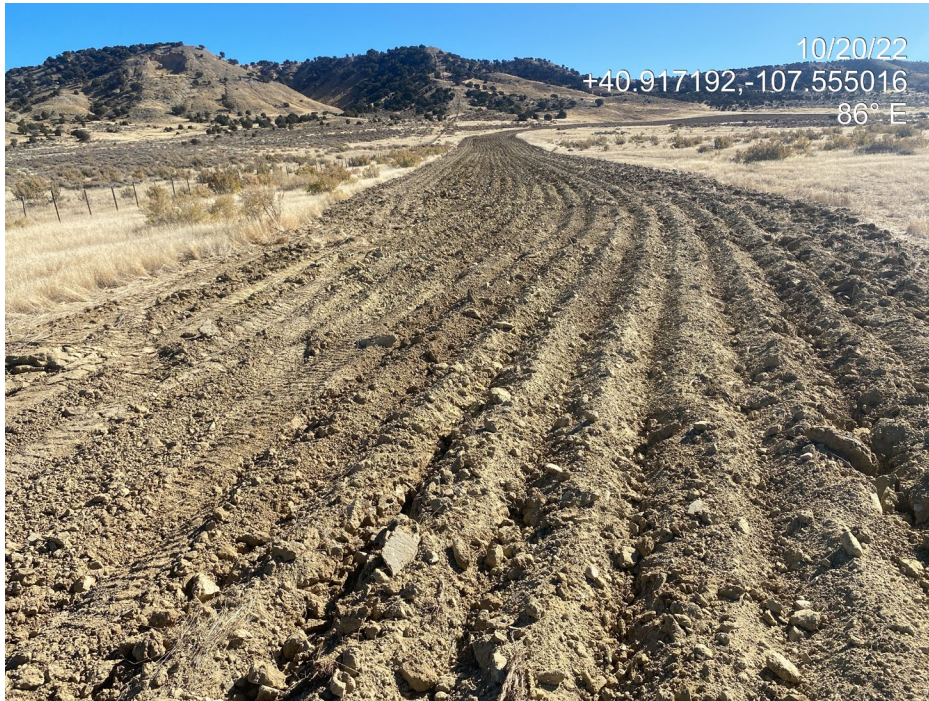
Photo 1. Photo taken from the northwest of the Location shows the access road has been ripped. Soil pits and shovel penetration tests throughout the road indicated a maximum ripping depth of 12 inches, sometimes less. 1004 Rules require ripping to a depth of 18 inches.

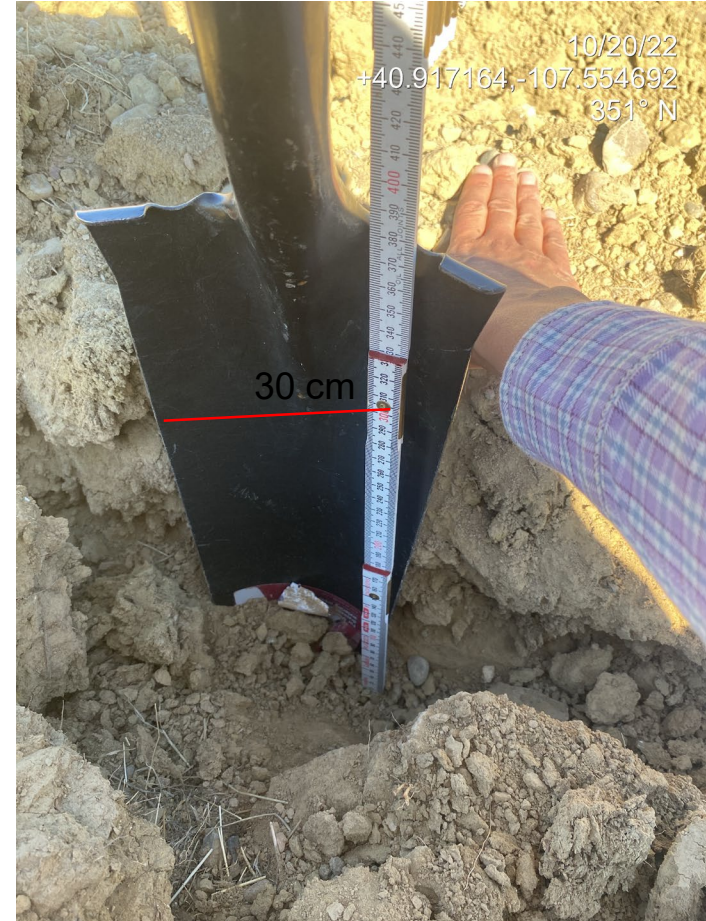
Photo 2. Photo shows the depth of shovel penetration on the ripped access road is 30 cm (12 inches). Other areas appeared to be ripped shallower.

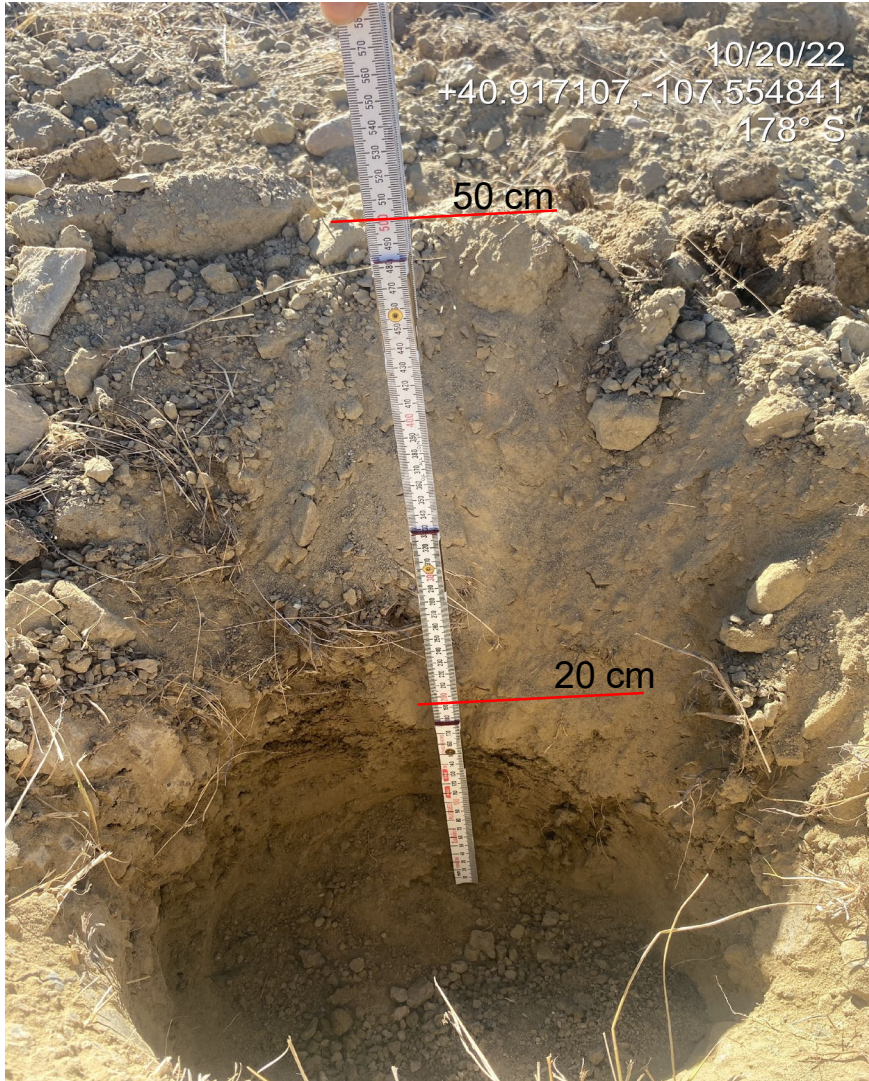
Photo 3. Photo shows a soil pit dug on the ripped access road. Ripped soil in photo is approximately 30 cm (12 inches). Below 12 inches the soil does not appear to be ripped.

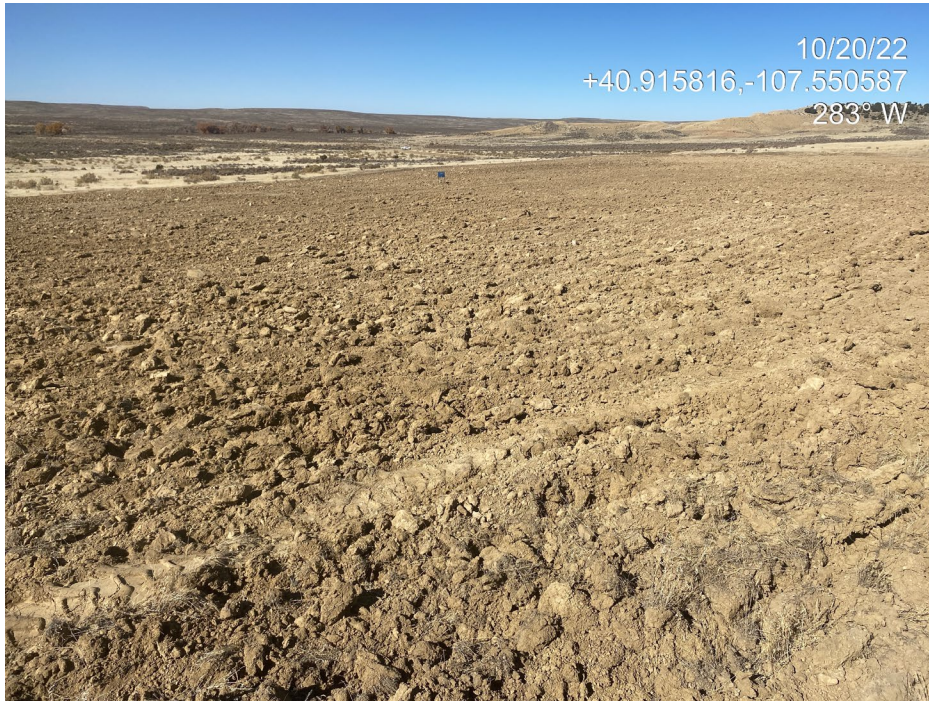
Photo 4. Photo taken from the southeast shows an overview of the Location.

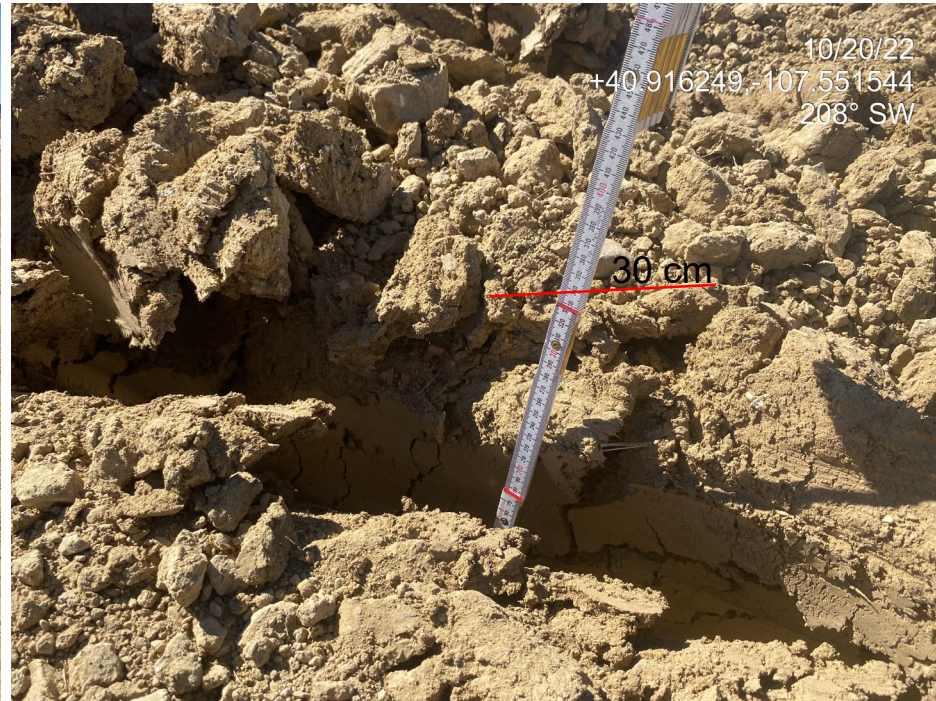
Photo 5. Photo shows the Location appears to have been ripped to approximately 30 cm (12 inches).

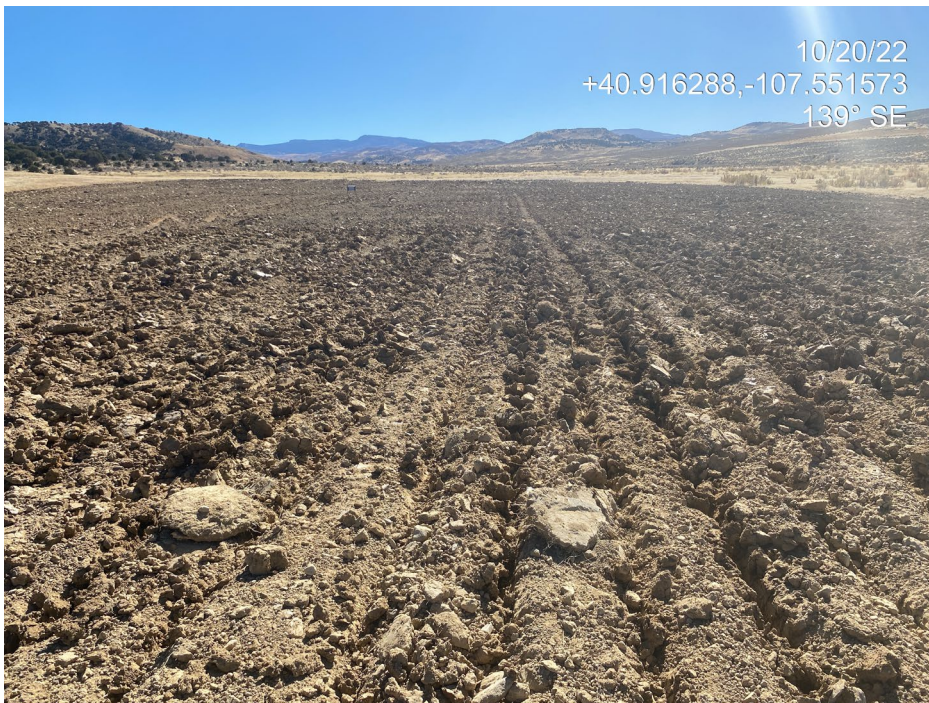
Photo 6. Photo shows the Location has been ripped in one direction. Soils have not been “cross-ripped” with overlapping passes.

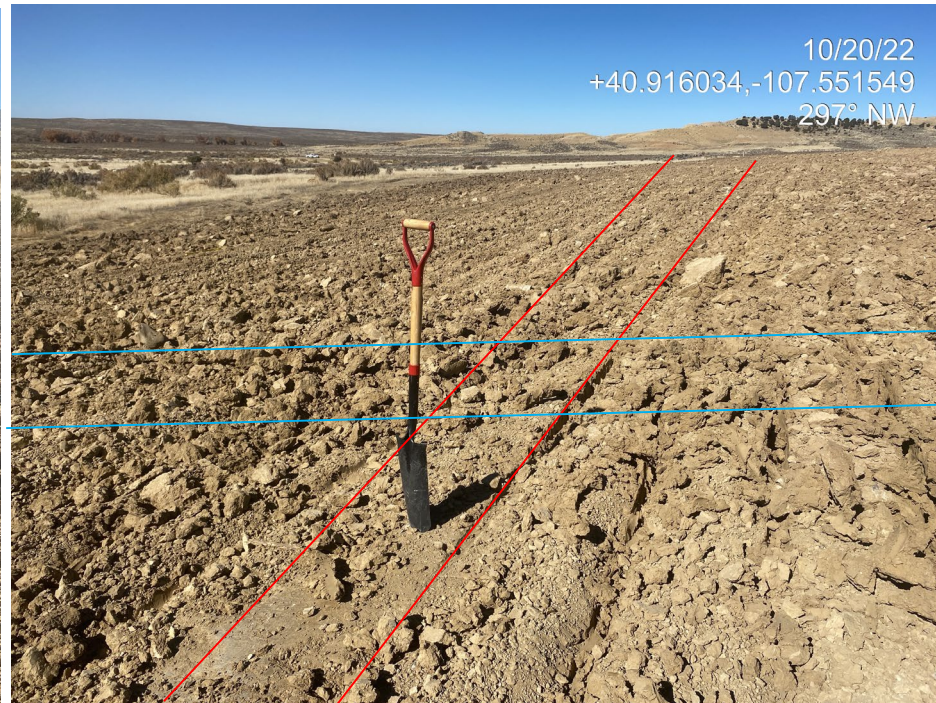
Photo 7. Photo shows a the Location has been ripped in one direction. Shovel was unable to penetrate a continuous strip of unripped soil. “Cross-ripping” means passes should be overlapping. Red line indicates direction of rip. Blue line indicates additional rip direction needed.

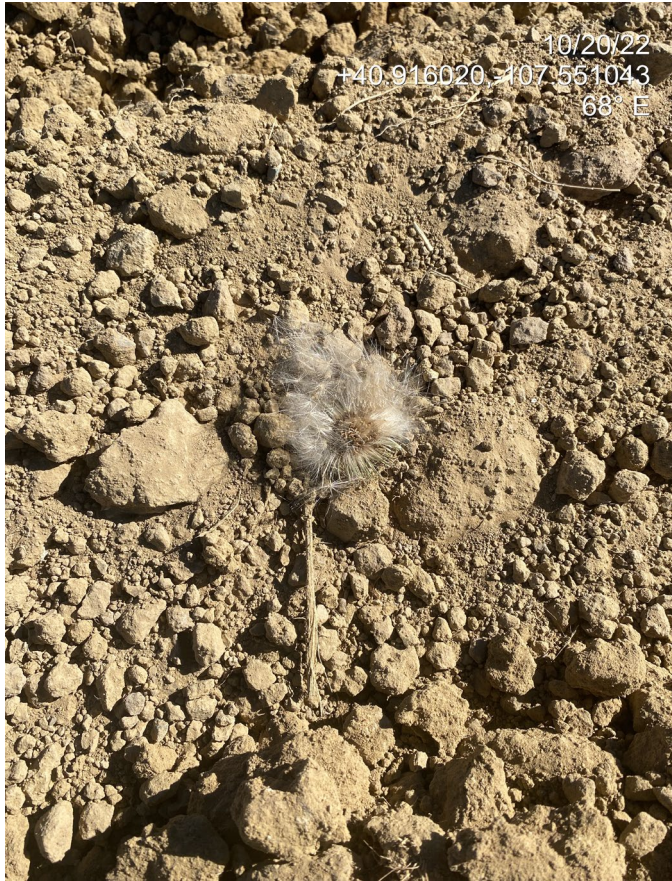
Photo 8. Photo shows bull thistle (noxious weed) seed in recently ripped soil. Ongoing weed management will be required.

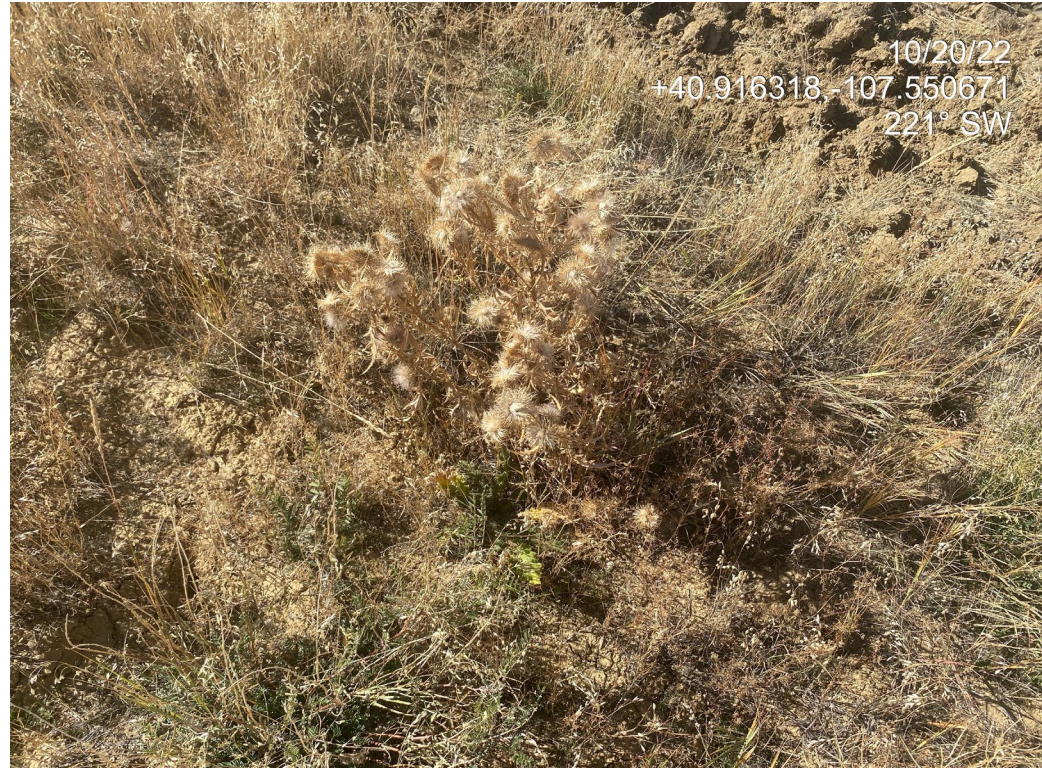
Photo 9. Photo shows a bull thistle (noxious weed) plant going to seed adjacent to recently ripped soil. Ongoing weed management will be required.
