Inspection Photos

Location Name: CAERUS PICEANCE LLC SHAEFFER-67S93W /12SENW

Location ID: 311608

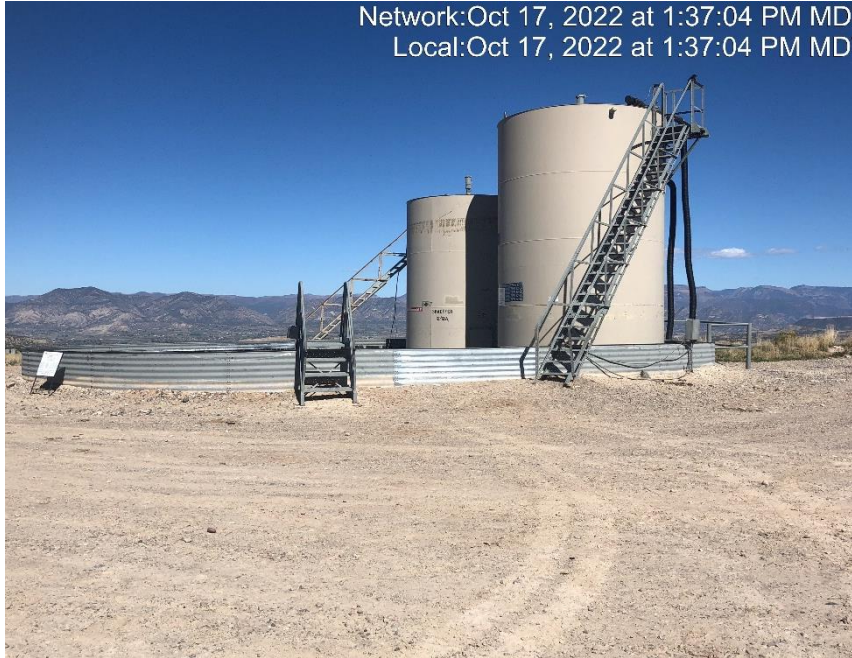
Photo #8089 From entrance to location.

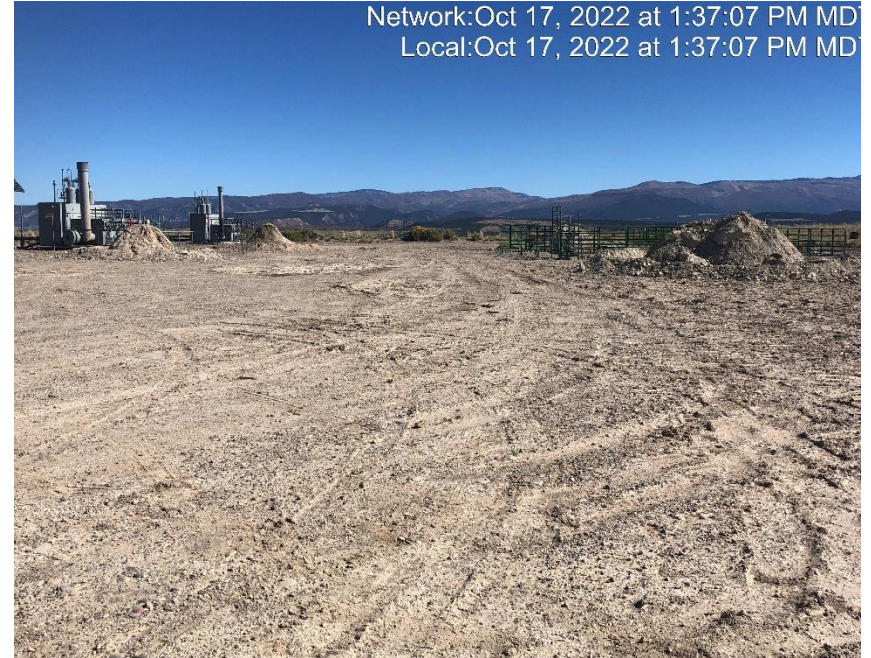
Photo #8090 From entrance to location.

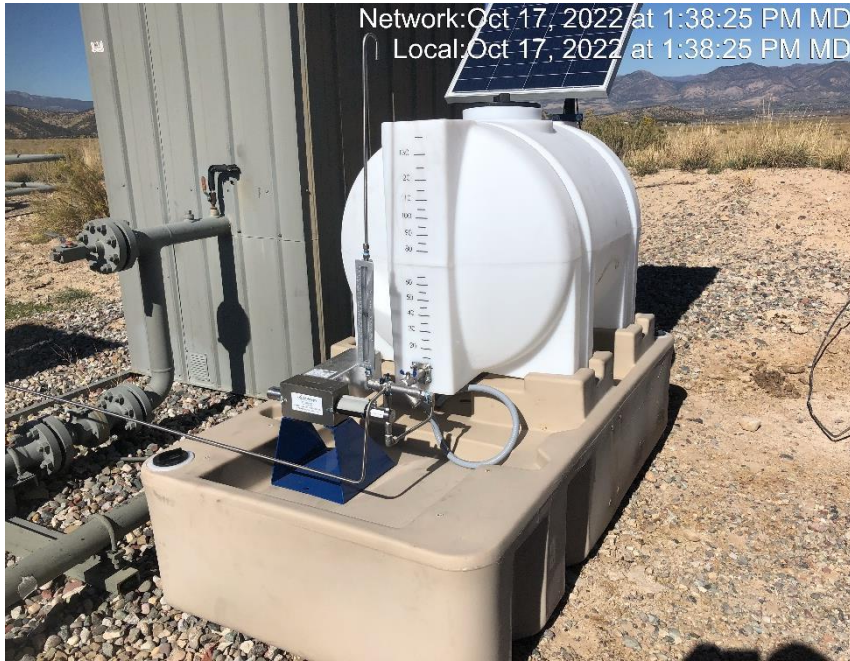
Photo #8092 Chemical tank missing required information.

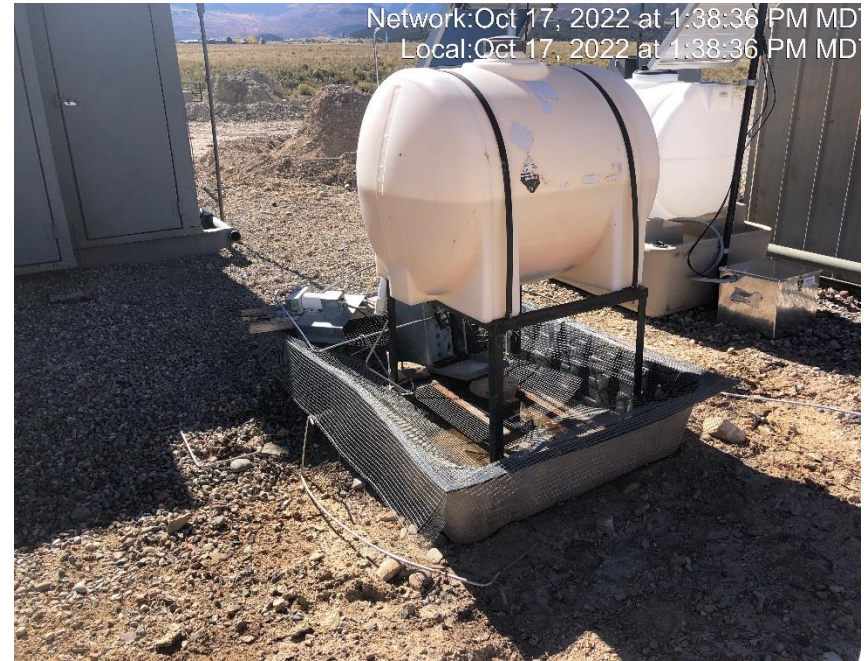
Photo #8093 Unused Chemical tank.

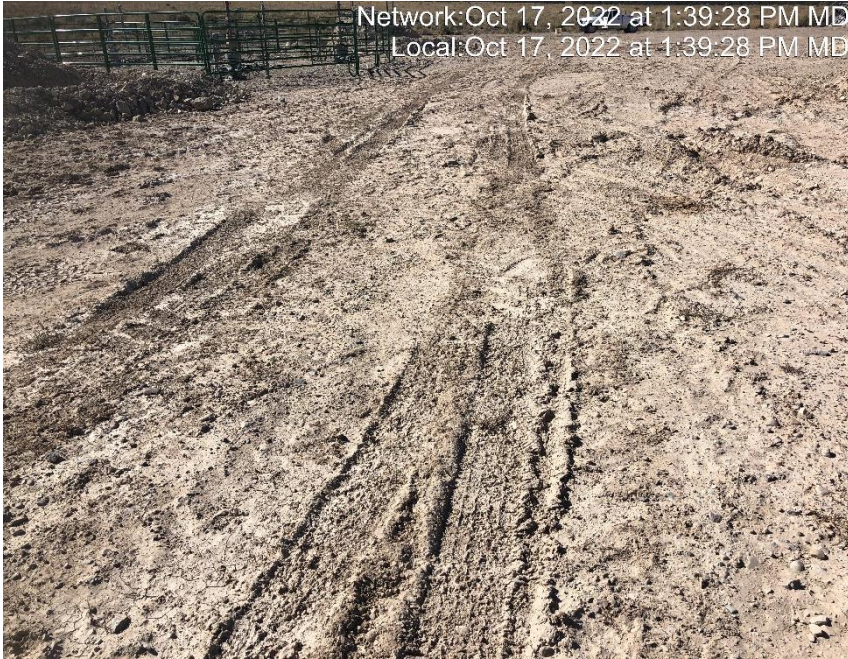
Photo #8095 Location lacks stabilization.

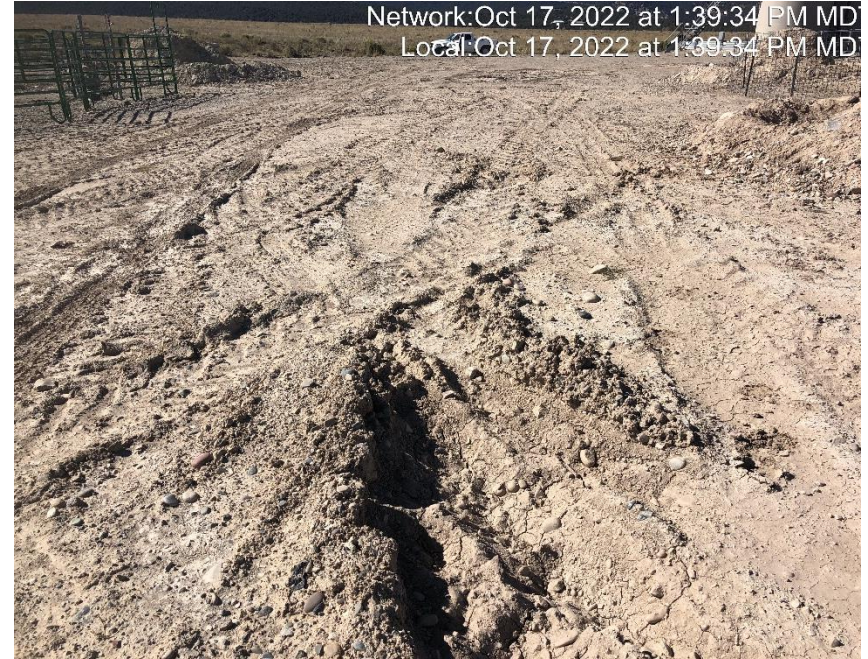
Photo #8096 Location lacks stabilization.

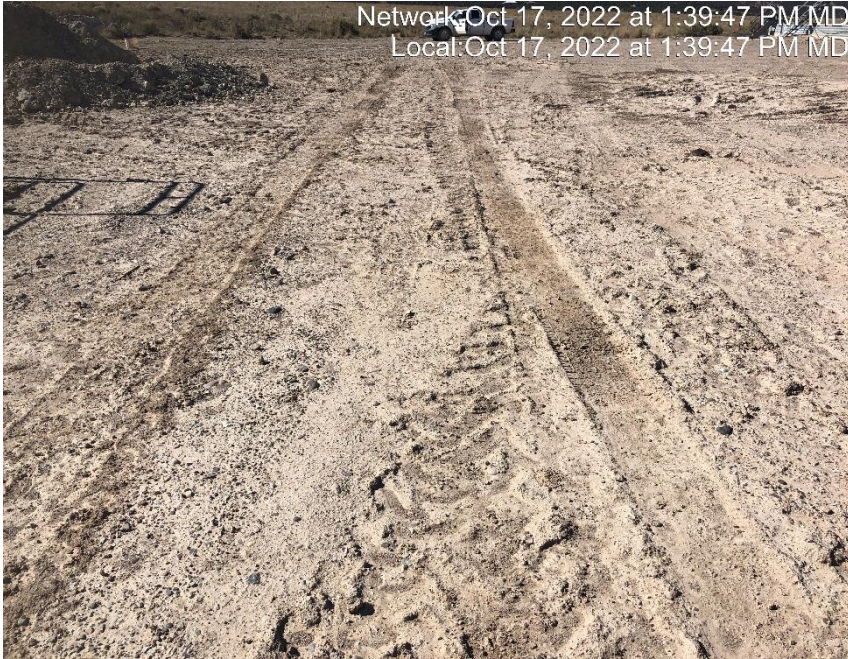
Photo #8098 Location lacks stabilization.

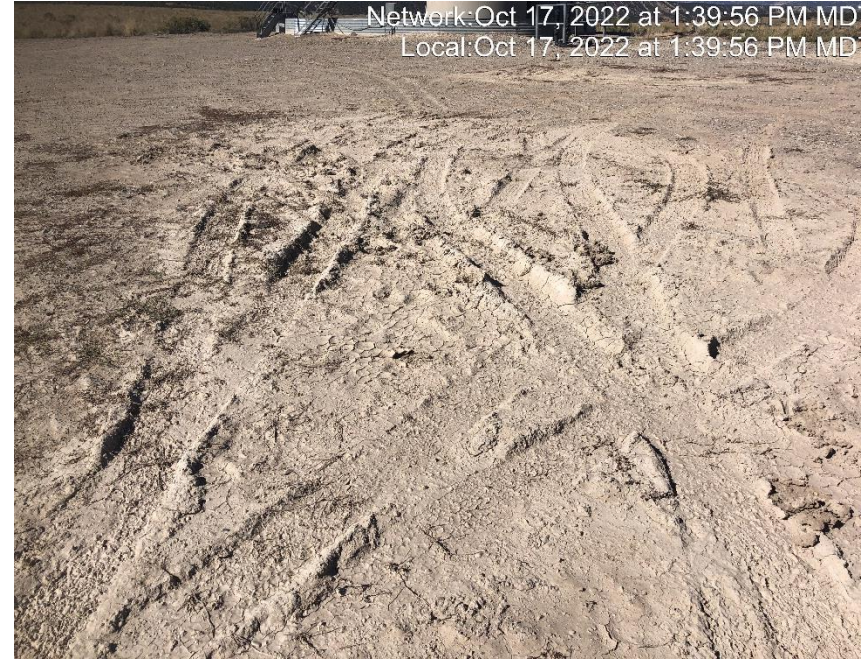
Photo #8099 Location lacks stabilization.

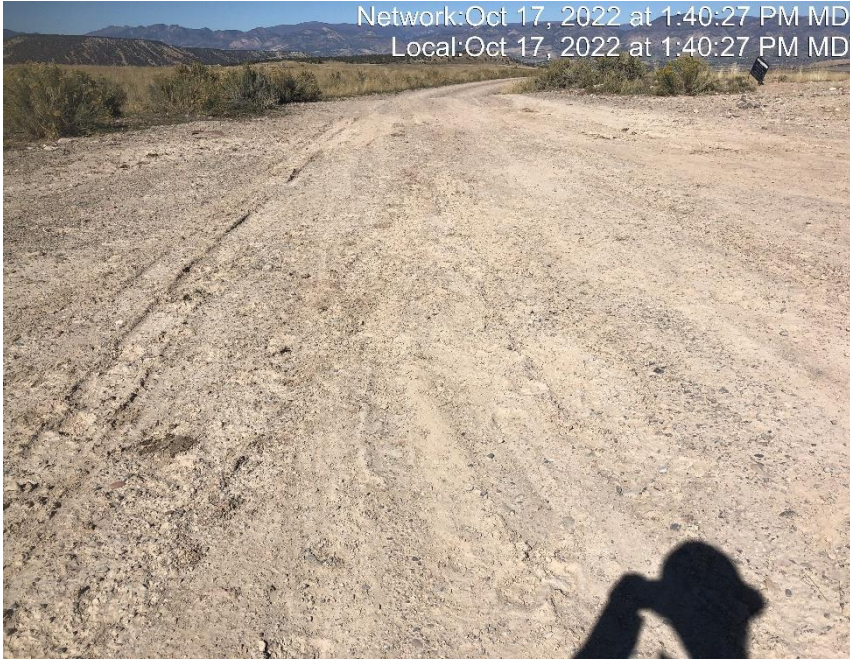
Photo #8100 Insufficient tracking BMP at entrance to location.
