Construction and Stormwater Inspection

Date: 10/11/2022

Operator: VERDAD RESOURCES LLC - 10651

Location ID: 441041

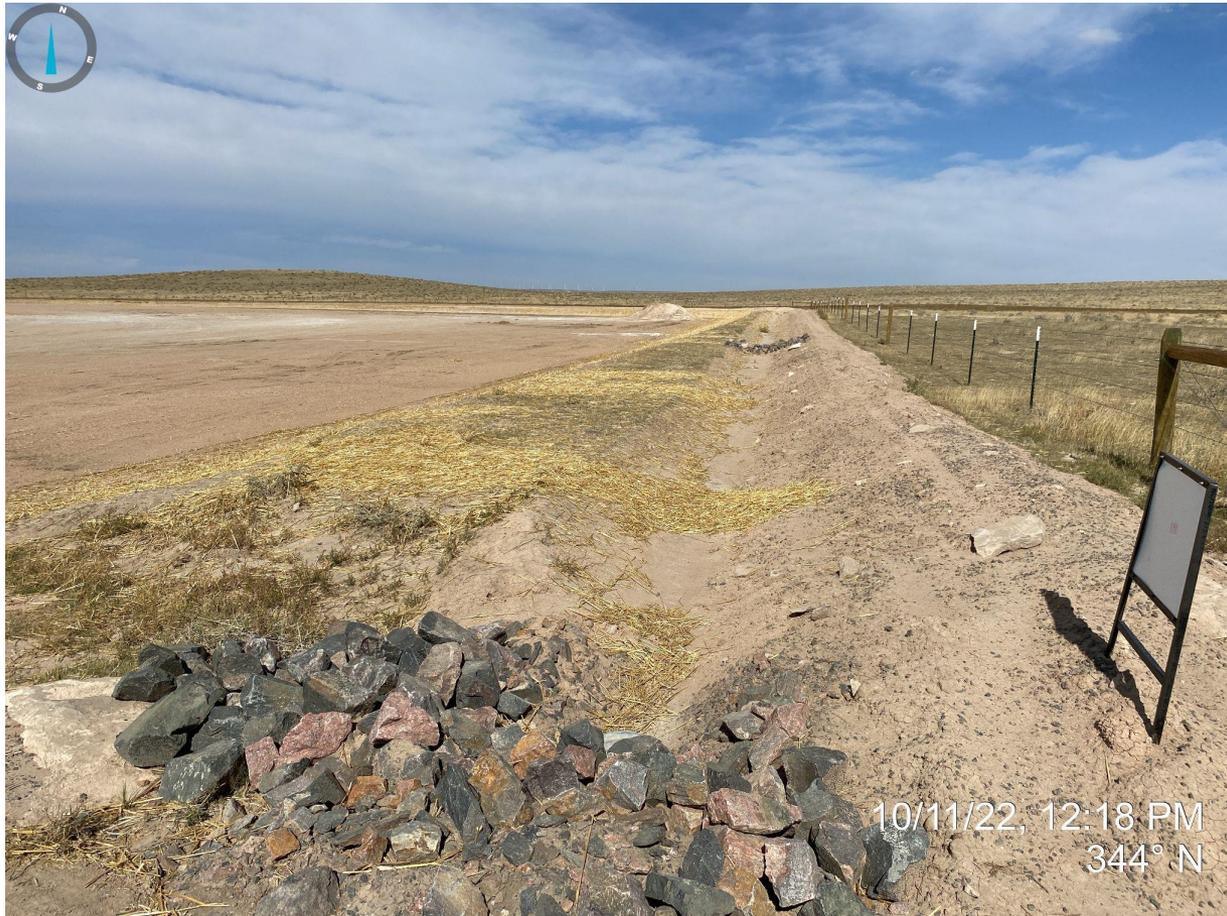
Photo 1. Taken near entrance, facing north. Photo illustrates operator has performed corrective actions and has stabilized inlet and outlets of culverts.

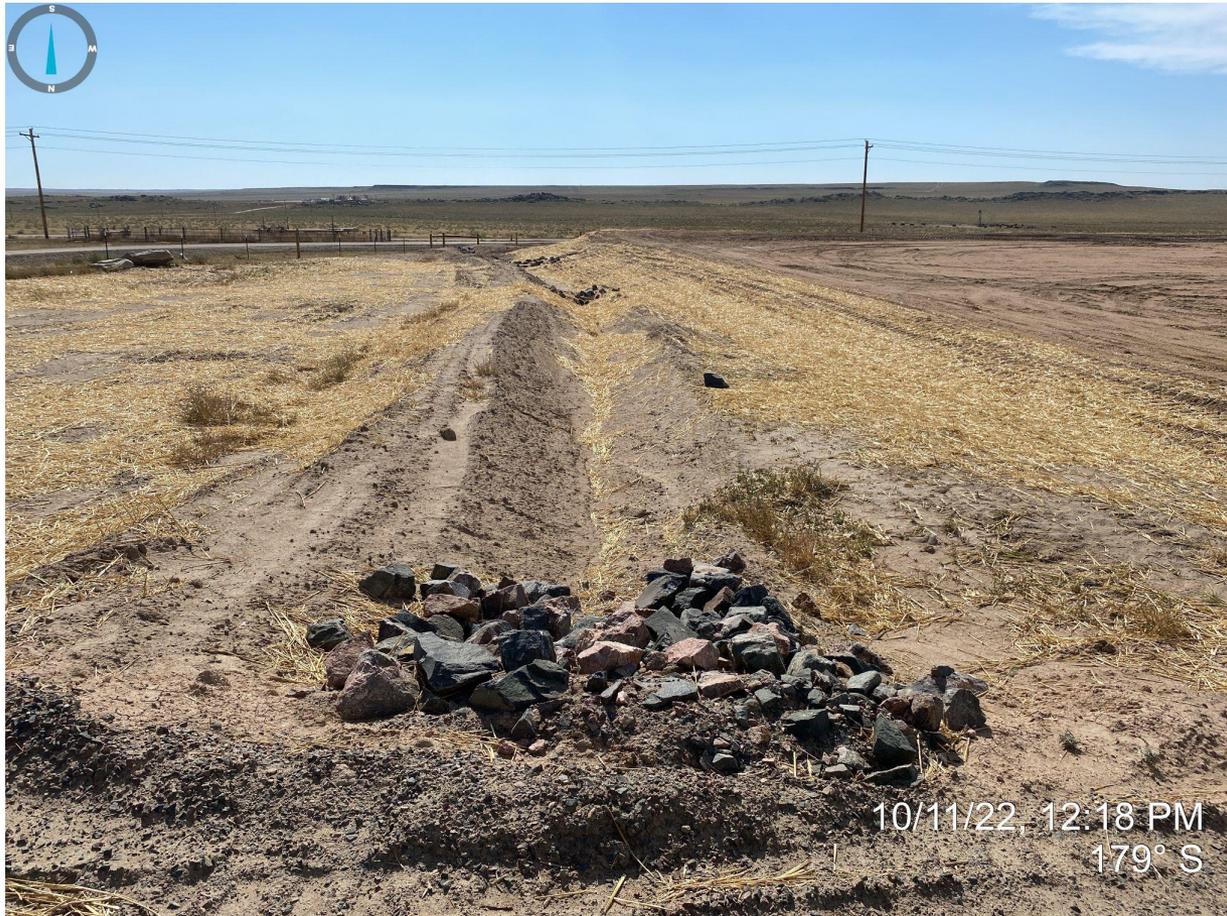
Photo 2. Taken near entrance, facing south. Photo illustrates operator has performed corrective actions and has stabilized inlet and outlets of culverts.

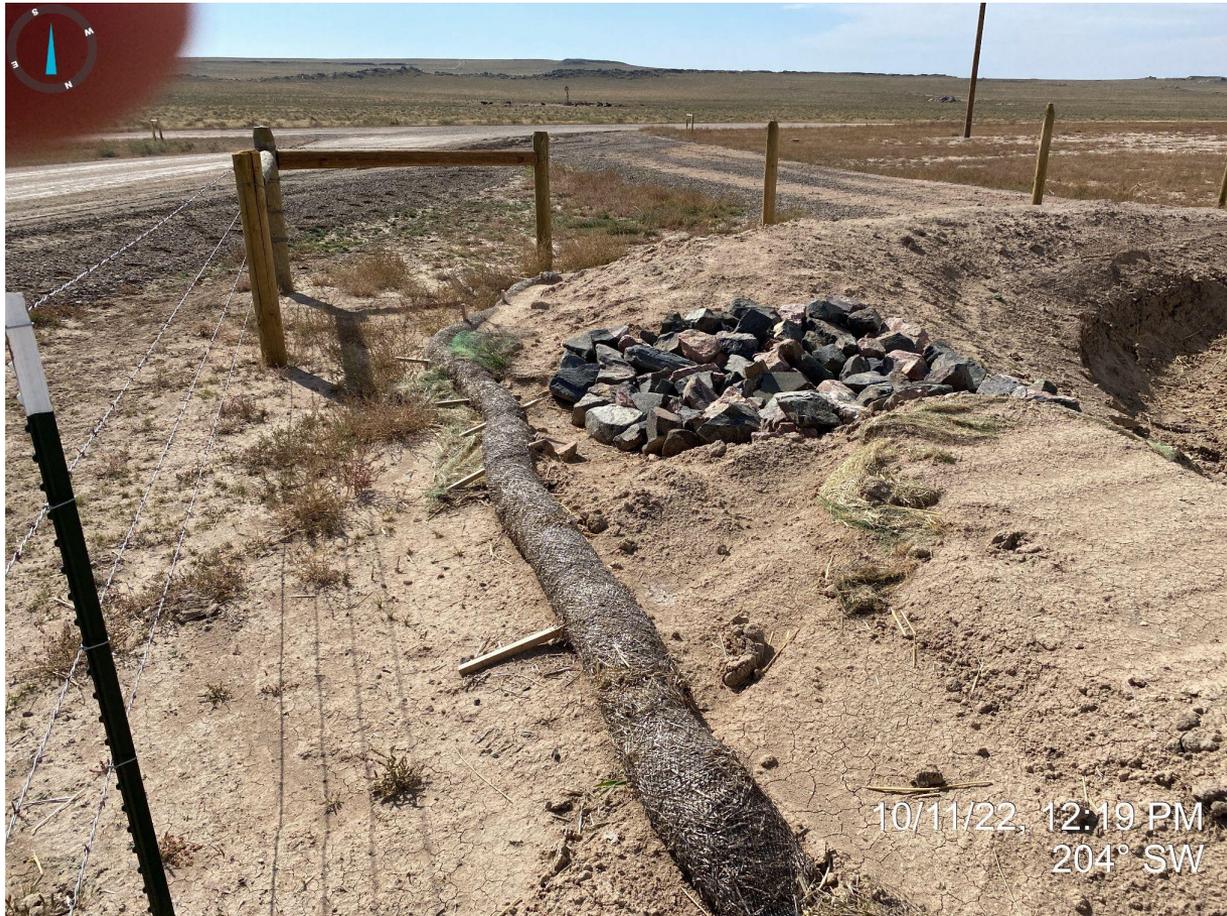
Photo 3. Taken from southeast corner of location, facing southwest. Photo illustrates straw wattles are not installed per good engineering practices (e.g. not staked, not trenched).

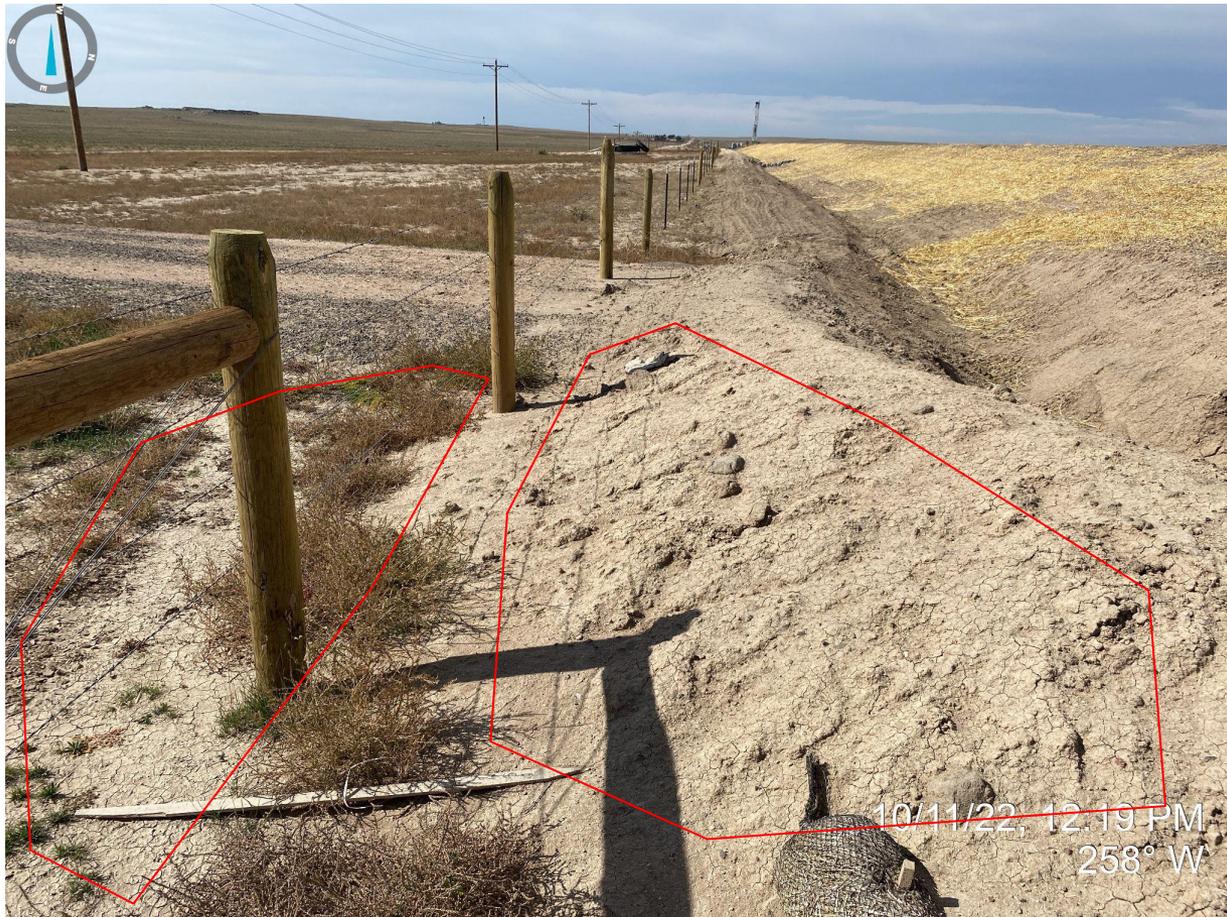
Photo 4. Taken from southeast corner of location, facing west. Photo illustrates rill erosion occurring on south slope of berm and sediment laden stormwater discharging off location.

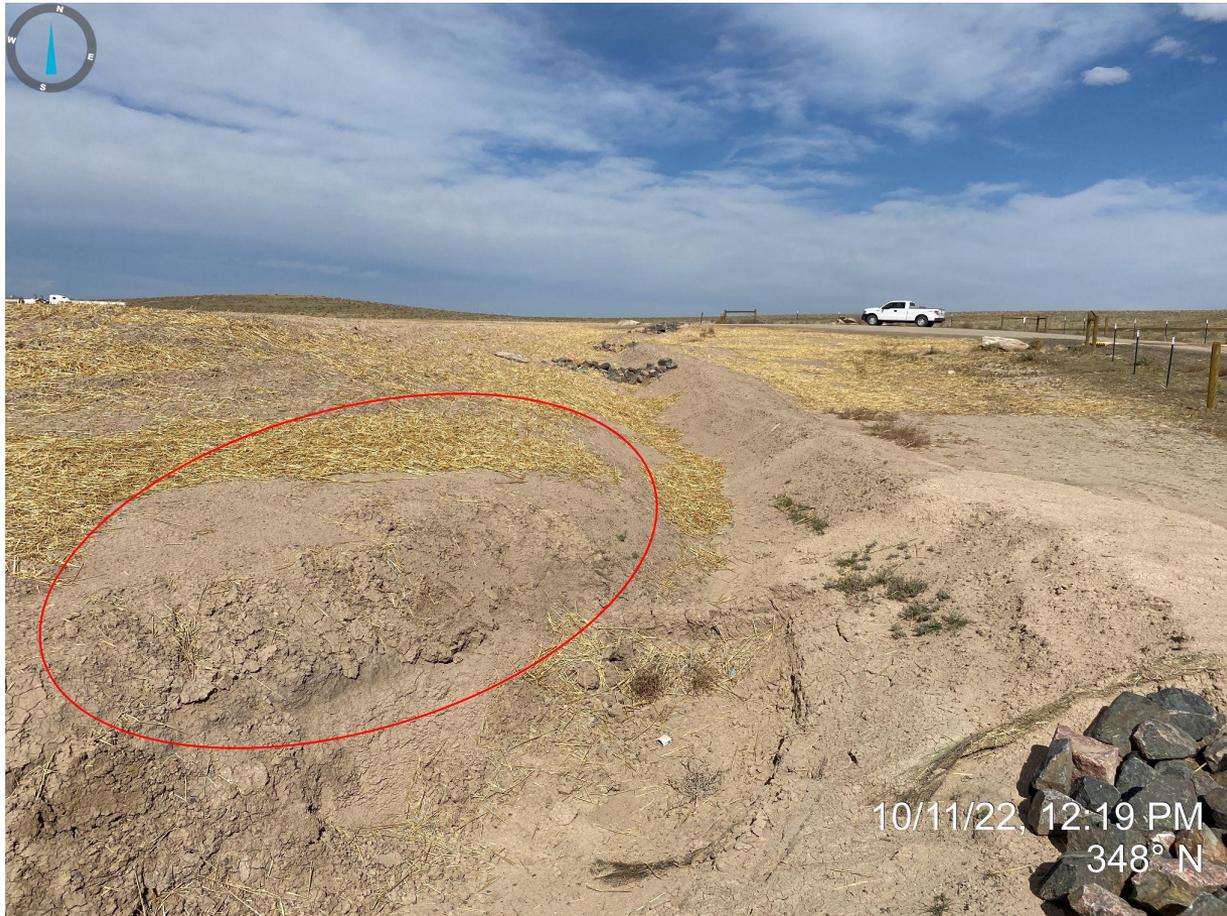
Photo 5. Taken from southeast corner of location, facing north. Photo illustrates Operator has performed corrective actions with no evidence of unconsolidated material on the berm portion of BMP.

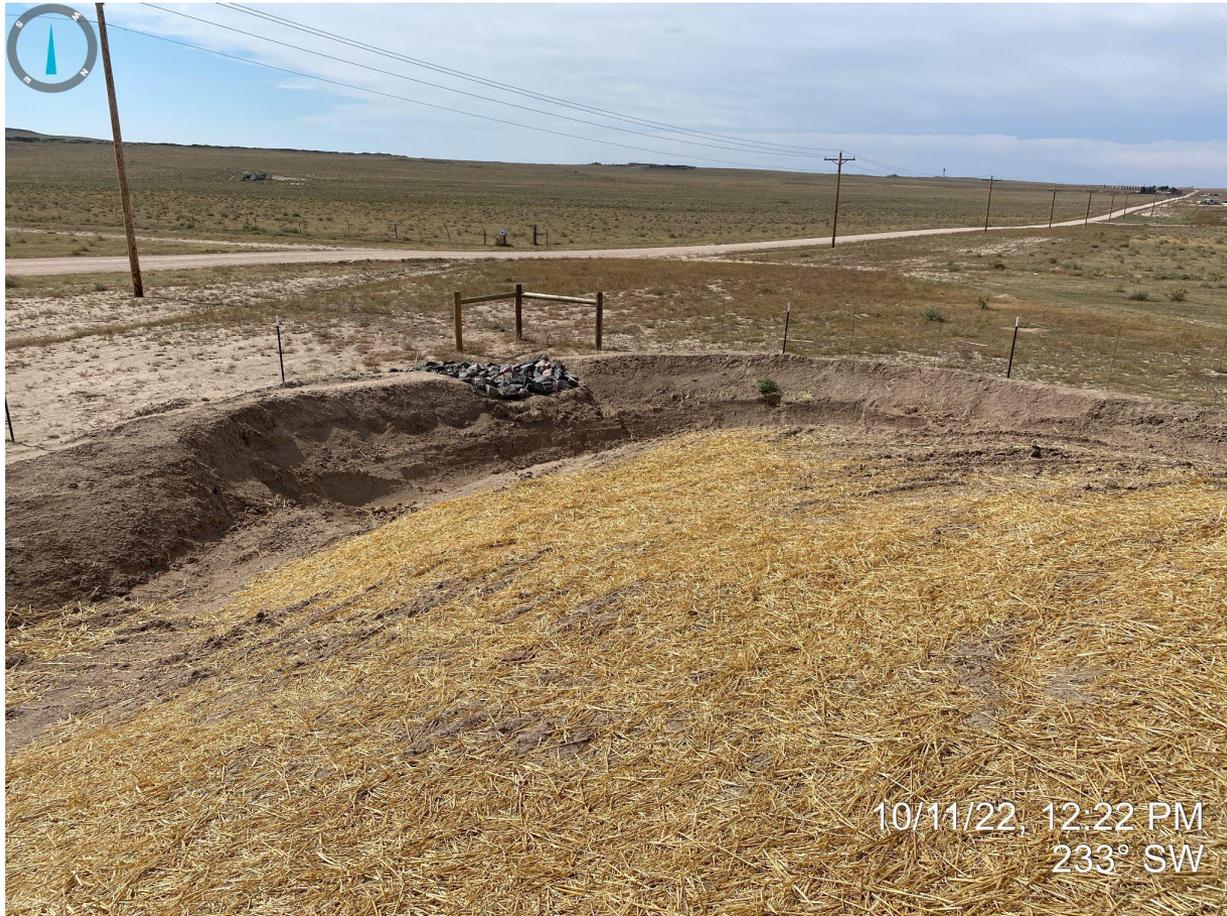
Photo 6. Taken from southwest portion of location, facing southwest. Photo illustrates detention area and stabilized slopes.

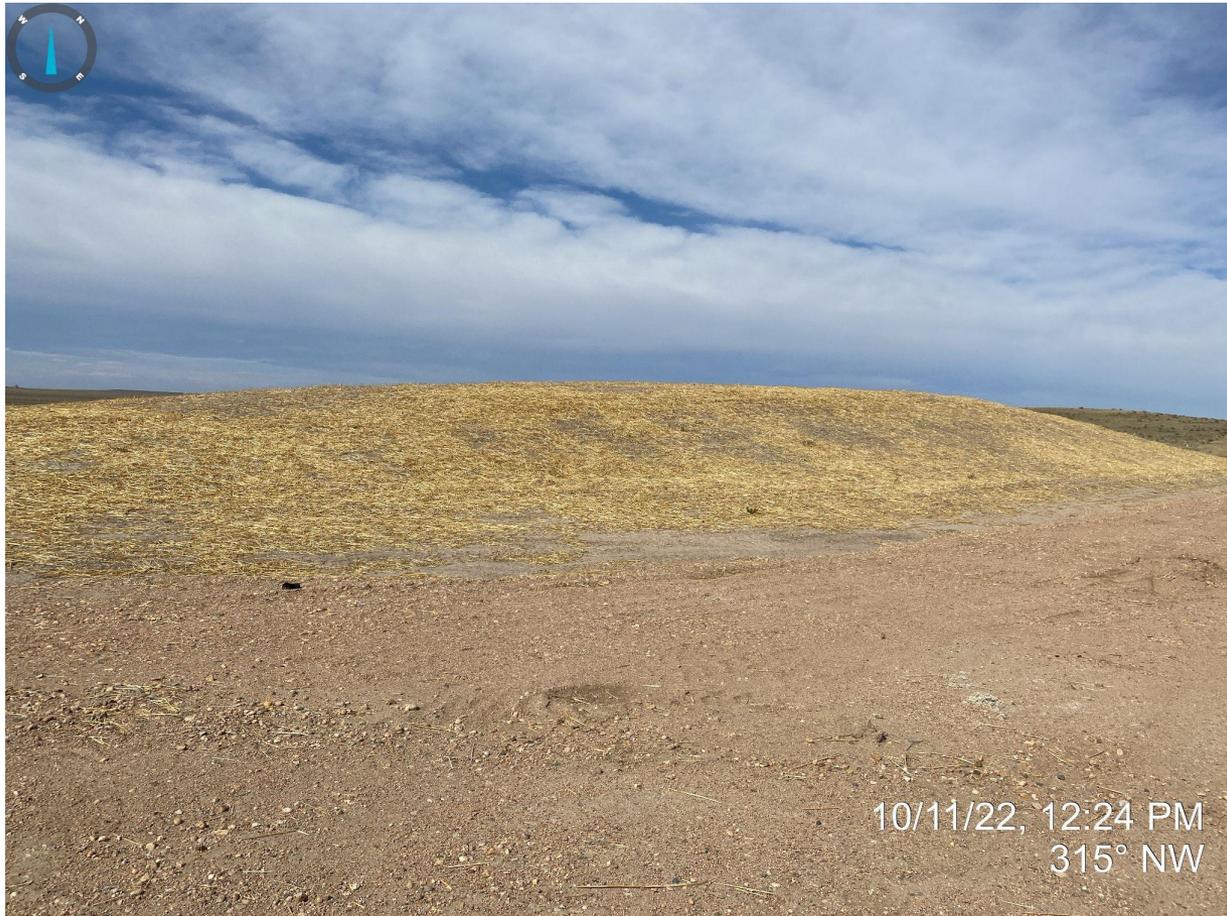
Photo 7. Taken from center of location, facing northwest. Photo illustrates topsoil stockpile has been stabilized with evidence of seeding and straw crimped mulch.

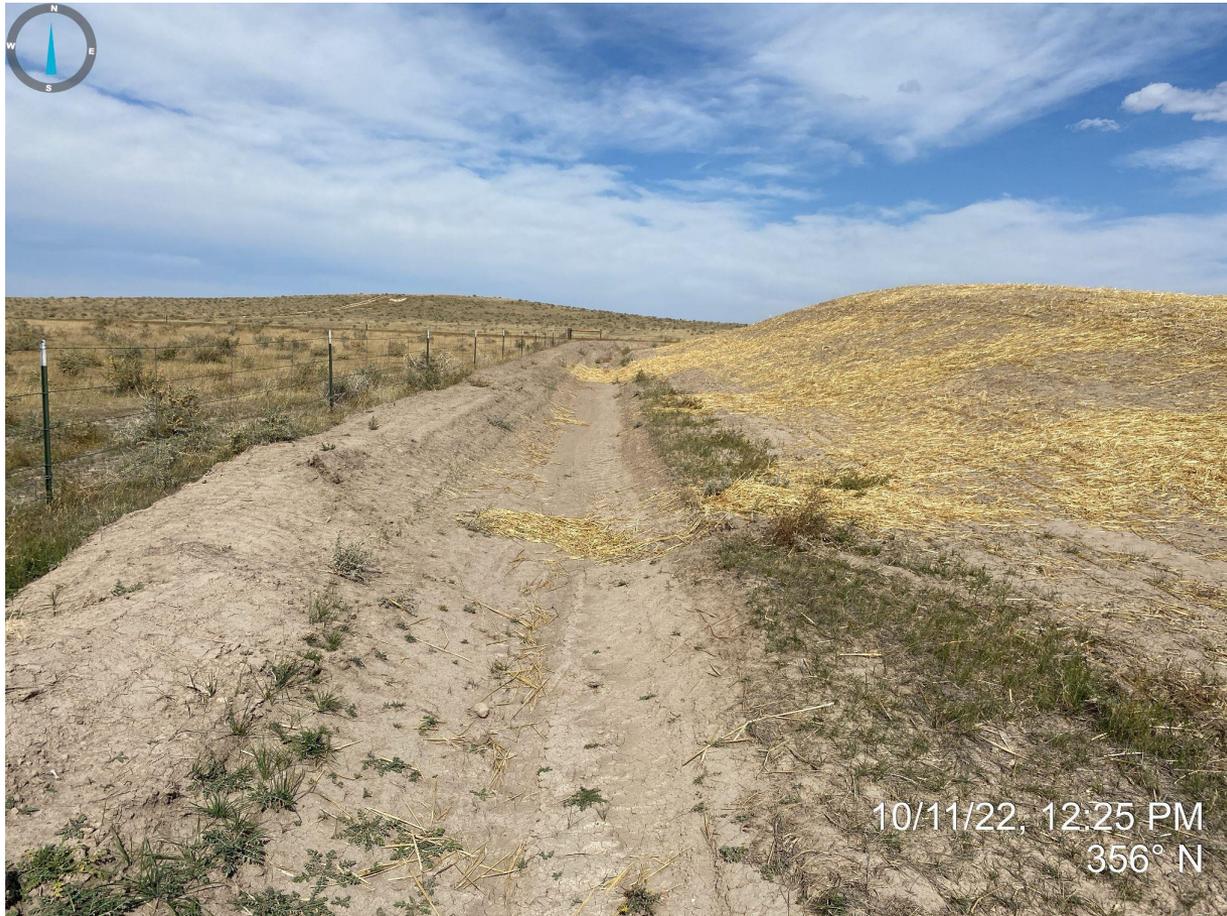
Photo 8. Taken from western portion, facing north. See comments in photo 7.

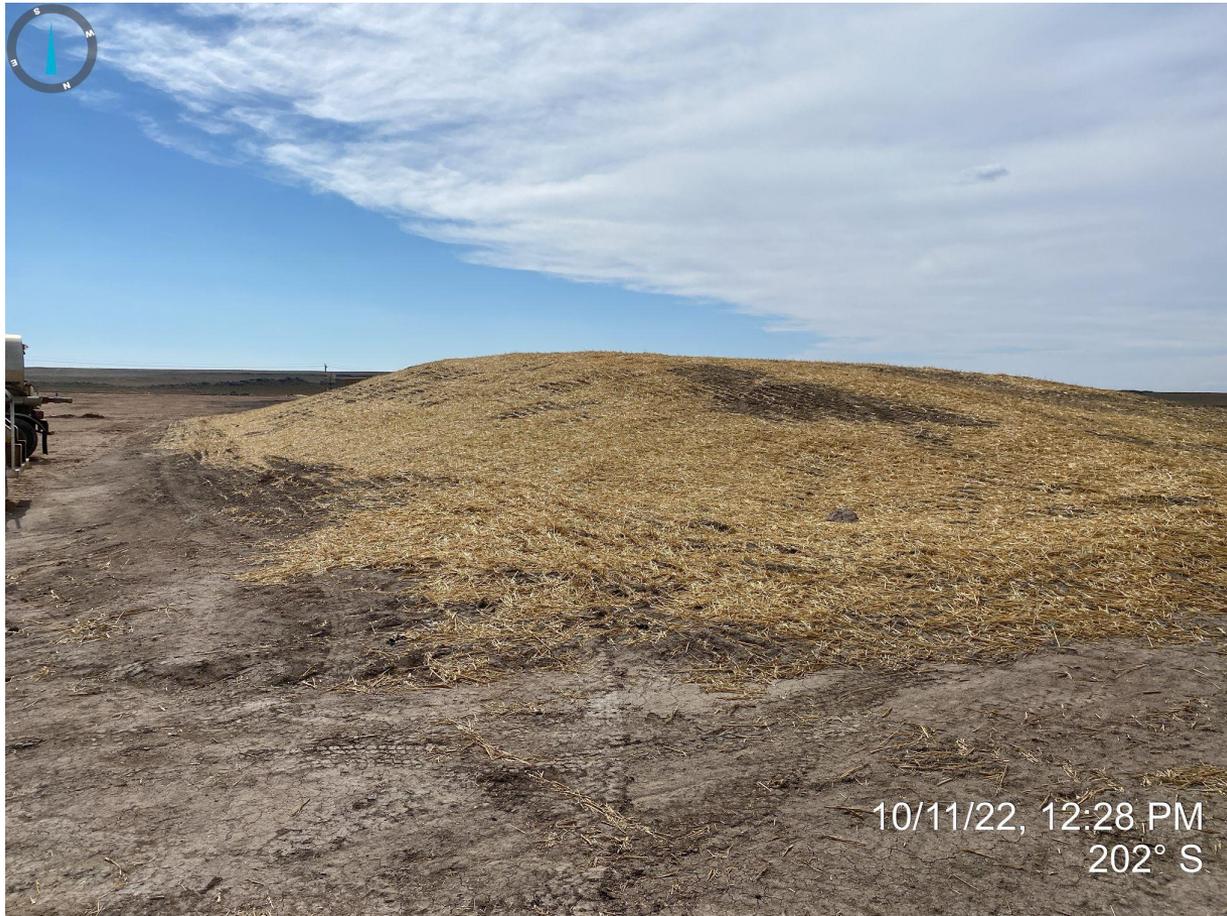
Photo 9. Taken from northwestern corner of location, facing south. See comments in photo 7.

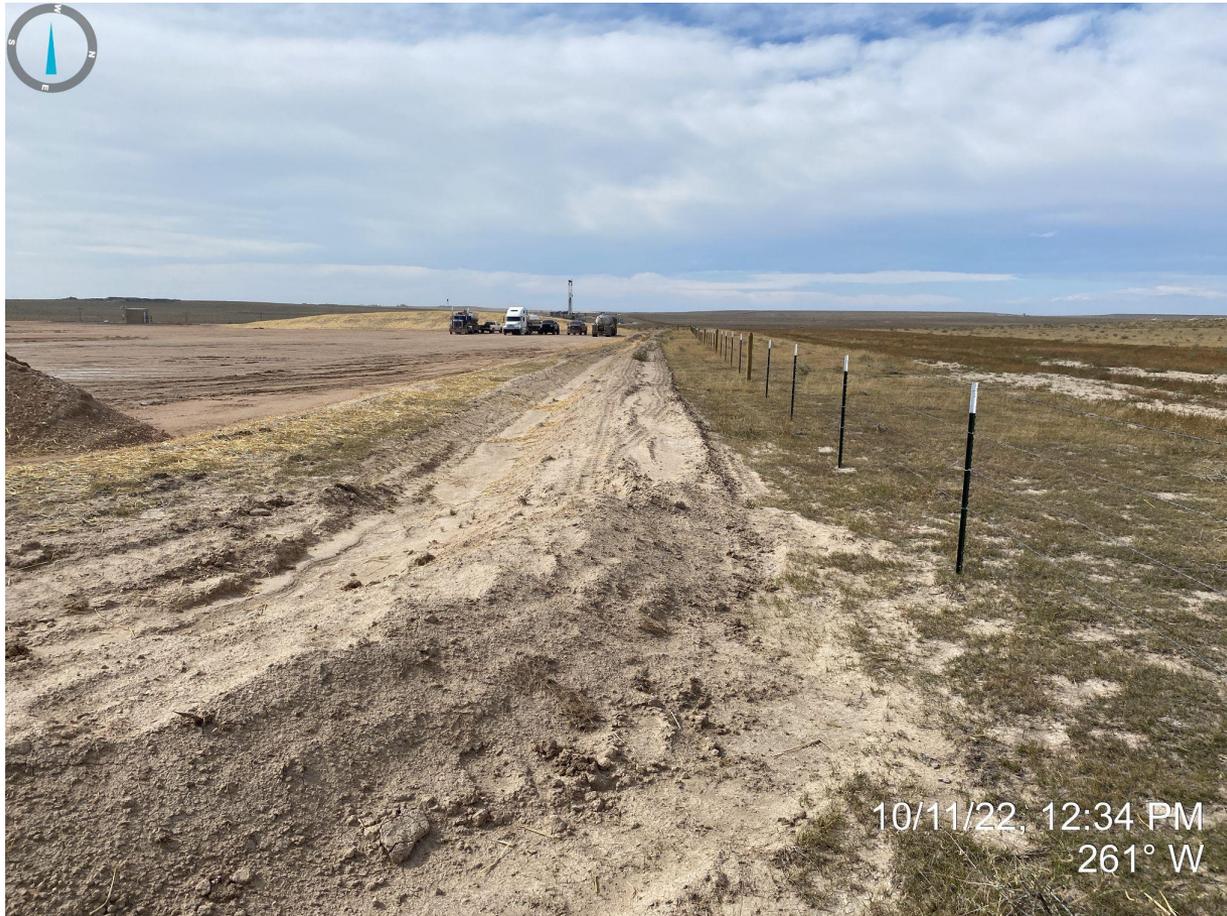
Photo 10. Taken from northeast corner of location, facing west. Photo illustrates Operator has performed corrective actions with no evidence of unconsolidated material on the berm portion of BMP; material seems to have been compacted.

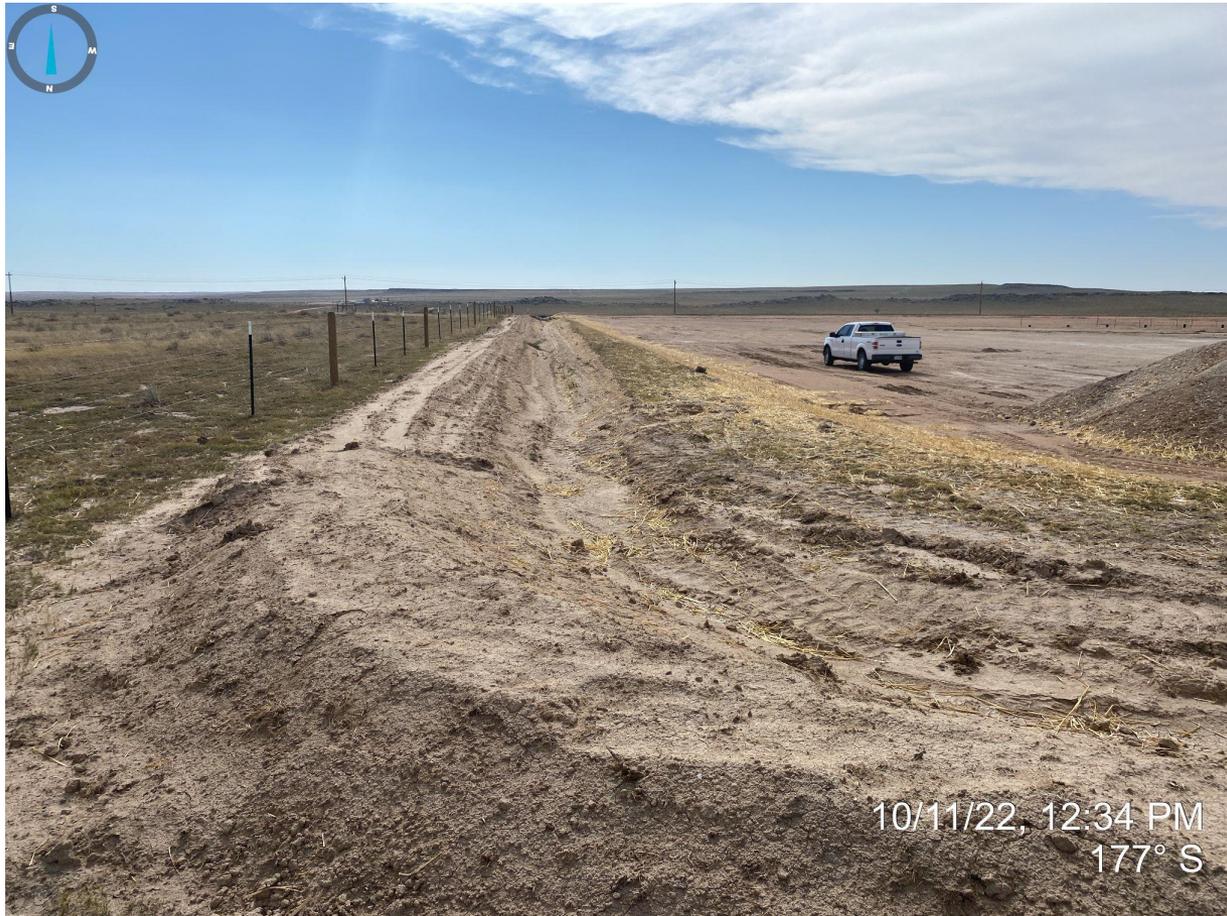
Photo 11. Taken from northeast corner of location, facing south. See comments in photo 10.

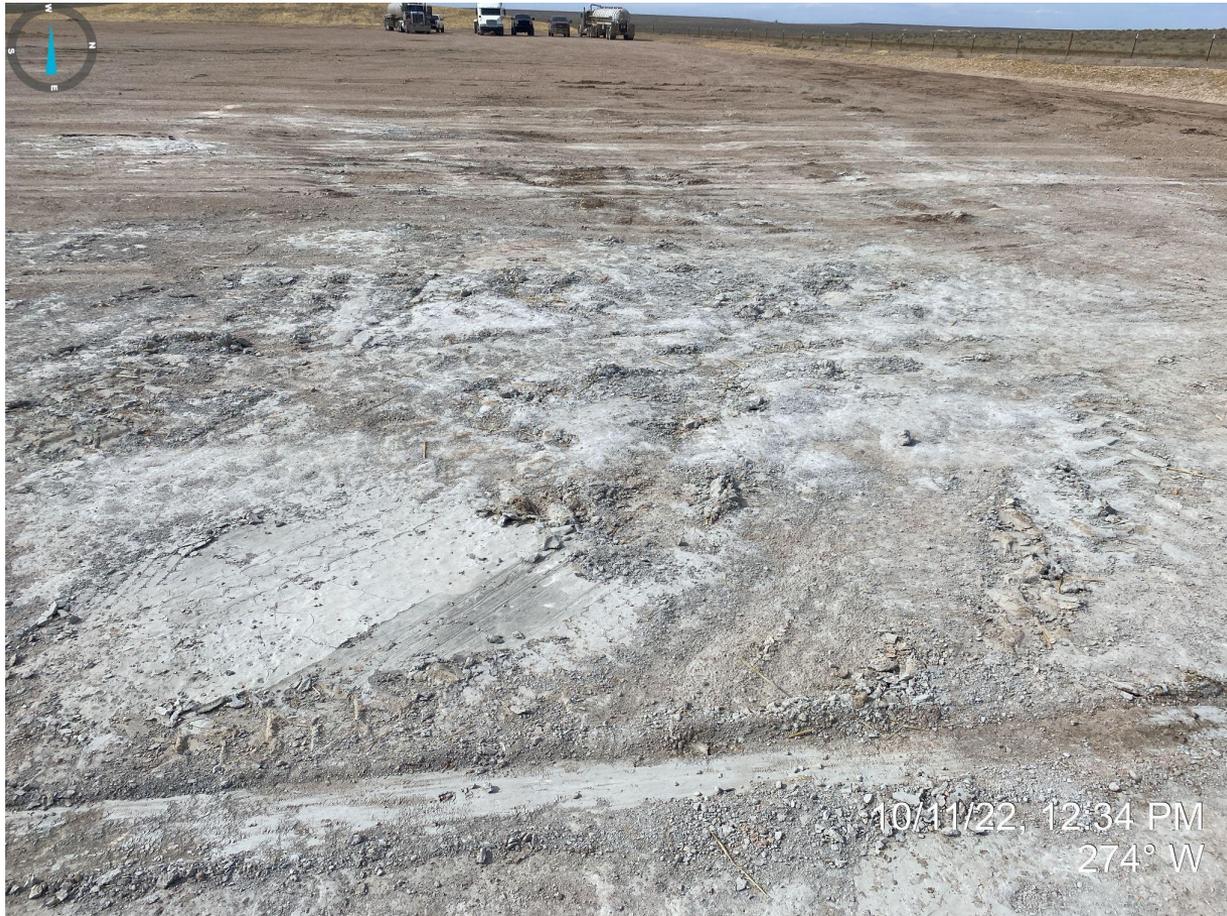
Photo 12. Taken near northeast corner of location, facing west. Photo illustrates approximate 20' x 20' area of concrete washout. This need to be cleaned and properly disposed of.

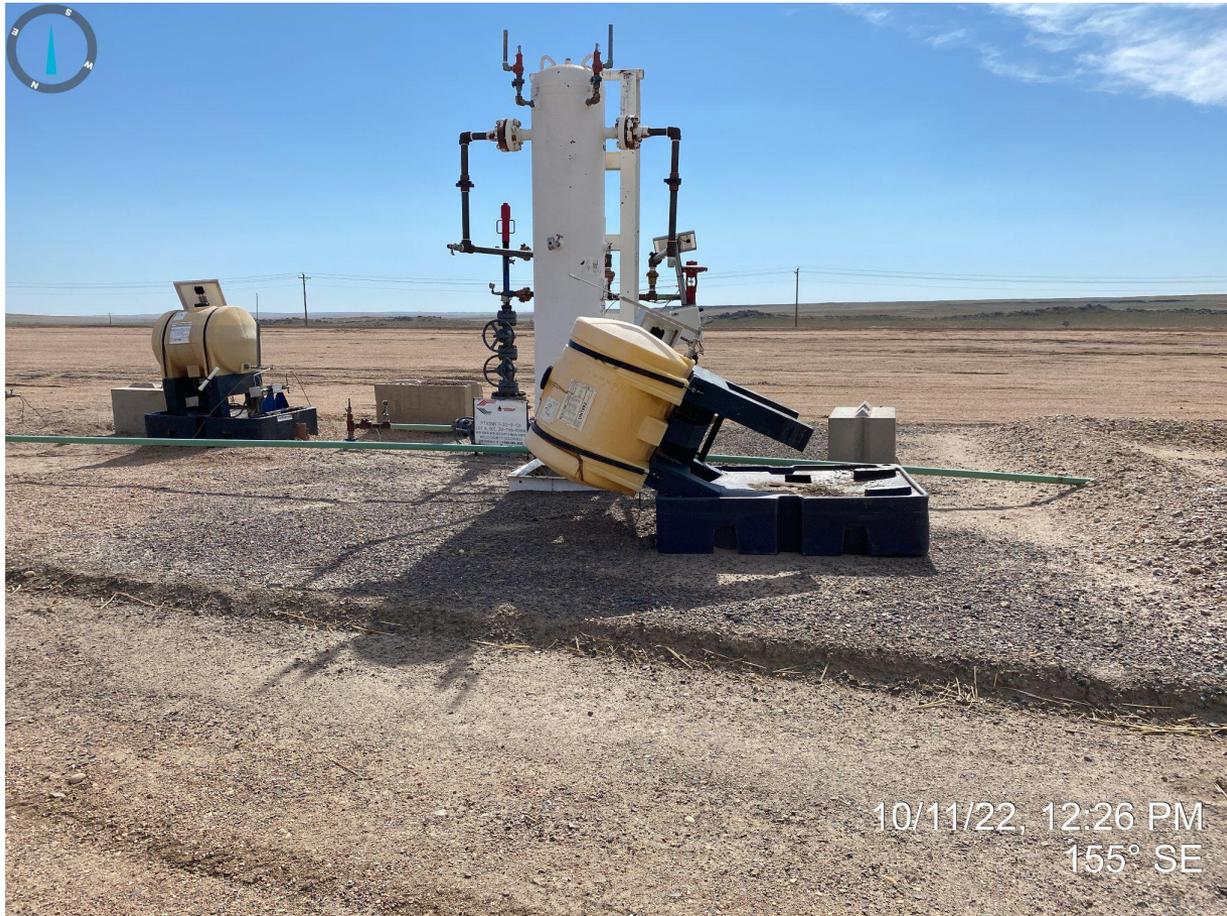
Photo 13. Taken near center of location, facing southeast. Tank has shifted and needs to be uprighted. No apparent fluid/material in tank, and no visible leaks on ground during time of inspection.
