# Inspection Photos and Issue Report

Operator: LARAMIE ENERGY LLC - 10433

Location #335889

Garfield County, CO

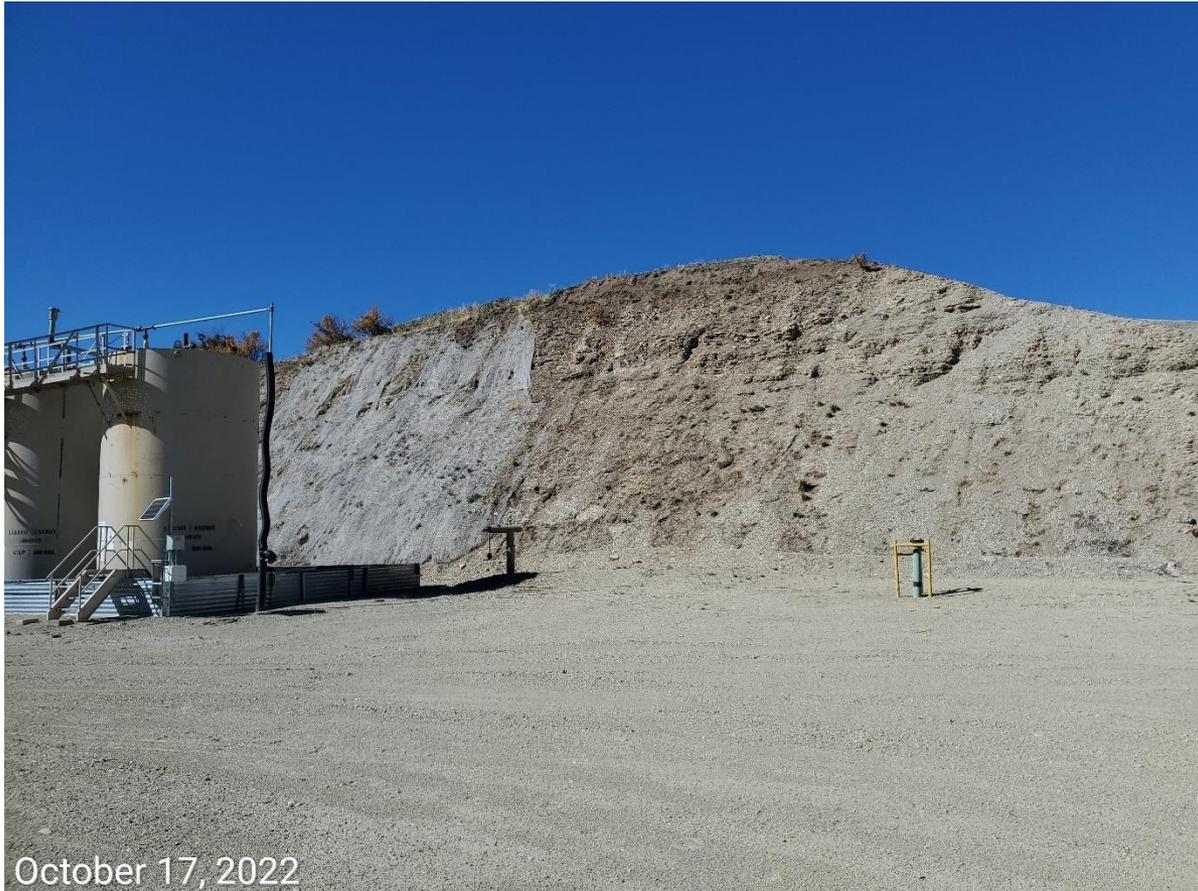
**Photo 1:** Photo taken from the Location, facing north. Photo shows large areas where control measures to protect, stabilize, as well as to minimize erosion and degradation at the cut slopes of the Location remain missing or insufficient.

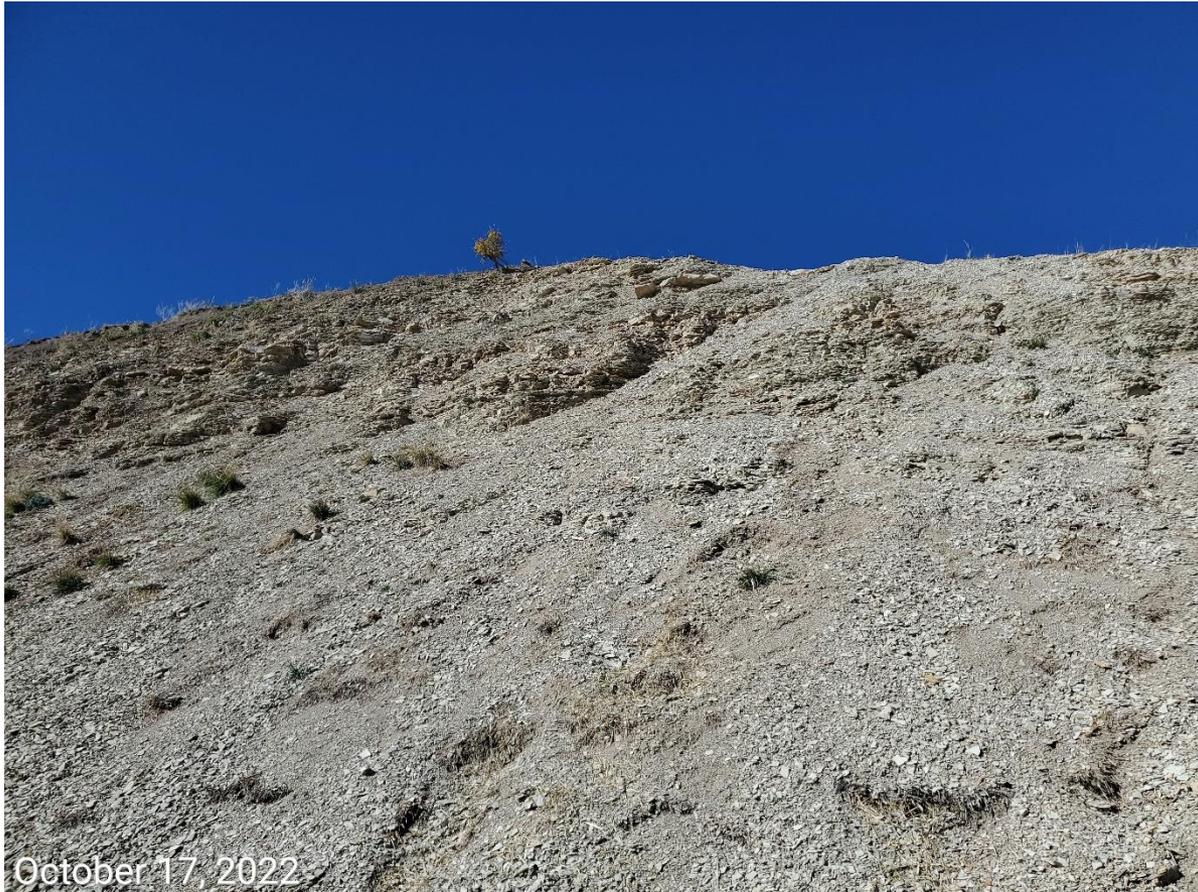
**Photo 2:** Photo shows large areas where control measures to protect, stabilize, as well as to minimize erosion and degradation at the cut slopes of the Location remain missing or insufficient.

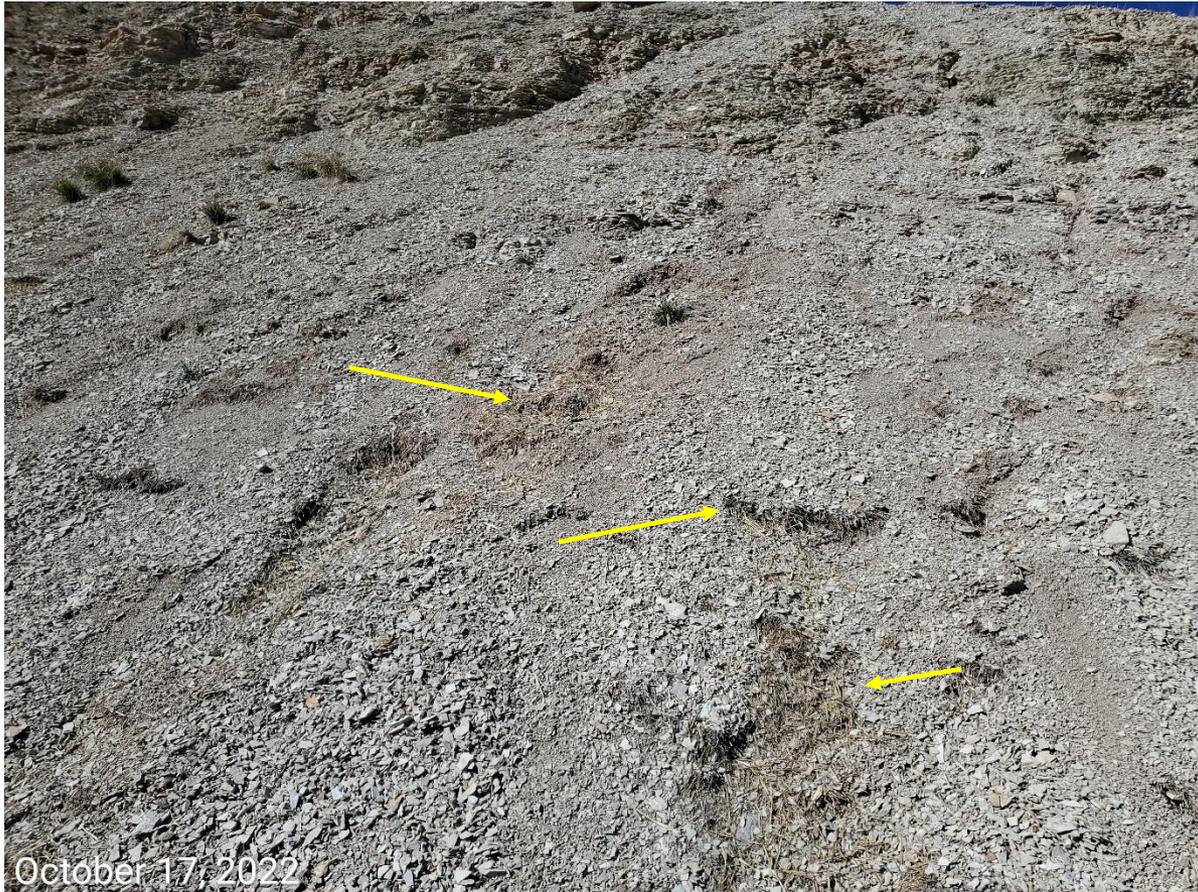
**Photo 3:** Continued from photo 2. Photo shows sediment/material eroding from the slopes have covered what appears to have be straw mulch applied to the slopes. BMP observed inadequate to protect, stabilize, as well as to minimize erosion and degradation at the cut slopes; erosion degradation has persisted.

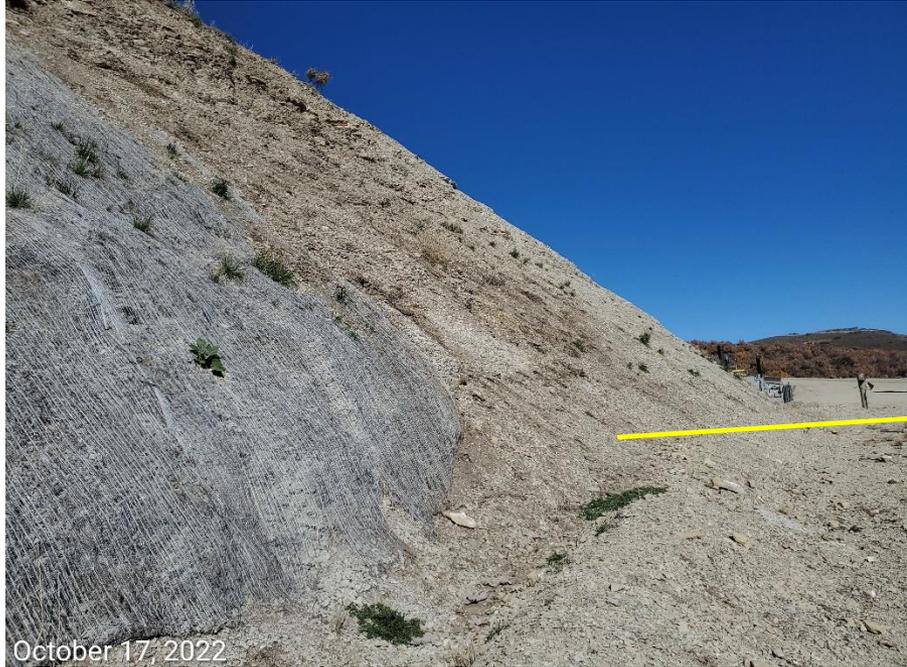
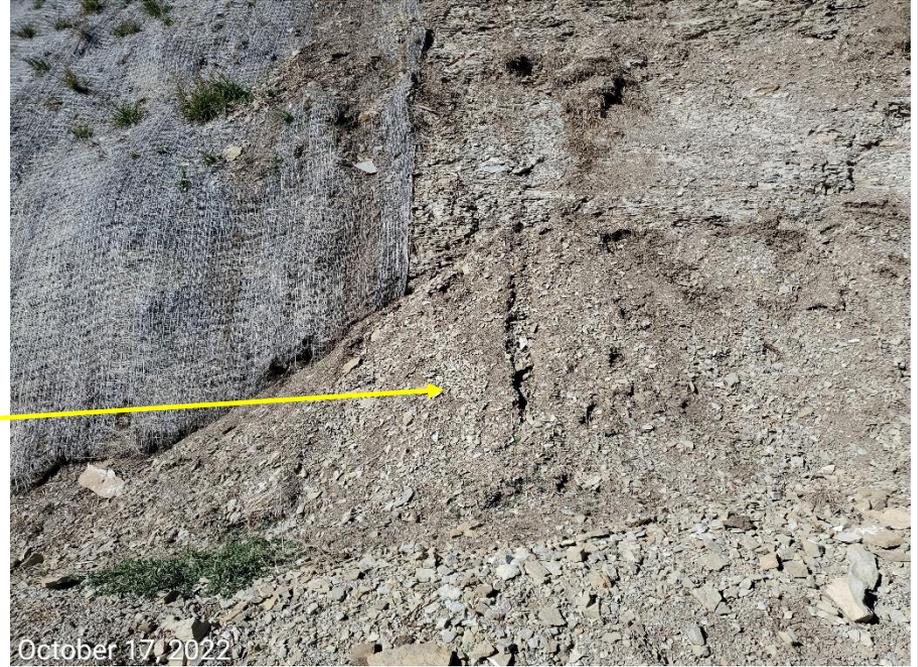
**Photo 4:** Photo taken from the toe of the cut slopes. Photo shows sediment deposition due to erosion degradation at the cut slopes.

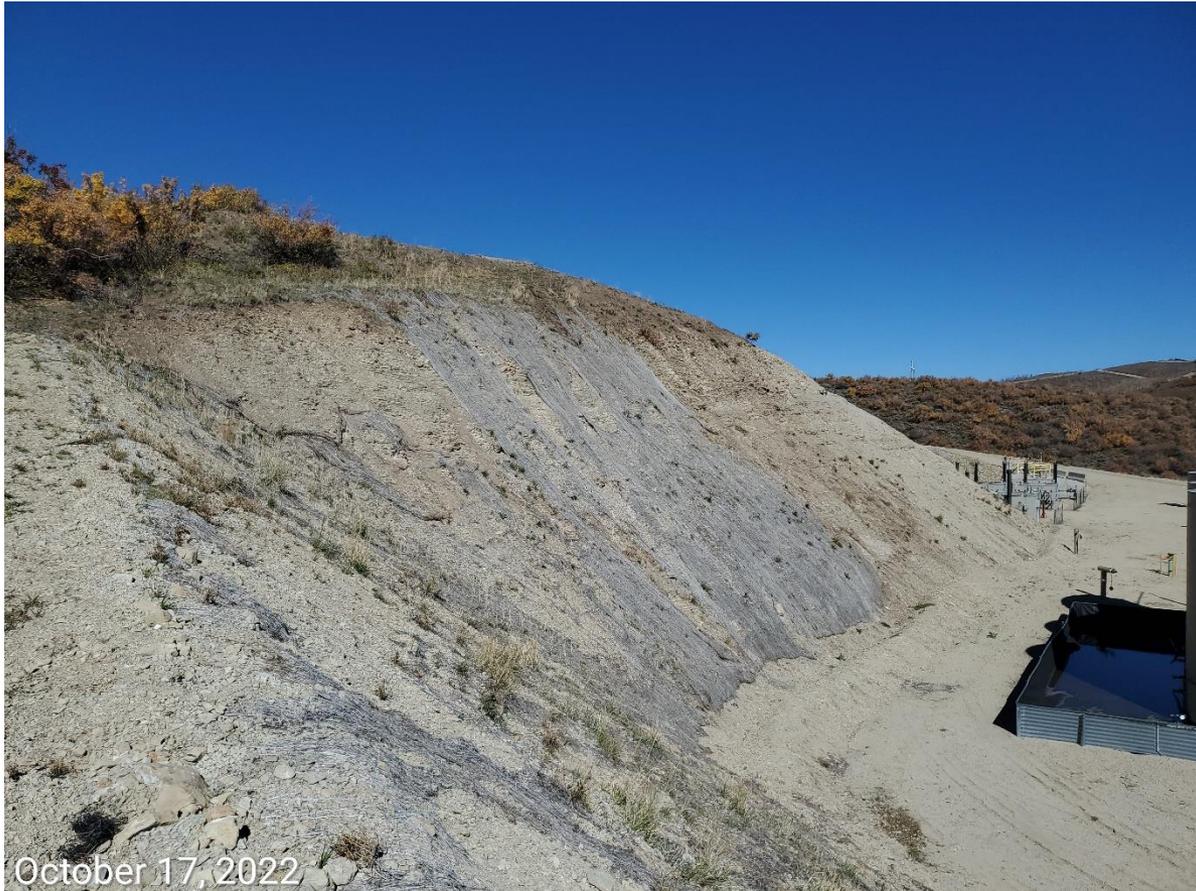
**Photo 5:** Photo taken from the cut slopes. Photo shows the erosion control blankets previously implemented have not been maintained in a proper functioning condition per good engineering practices. Erosion degradation has persisted.

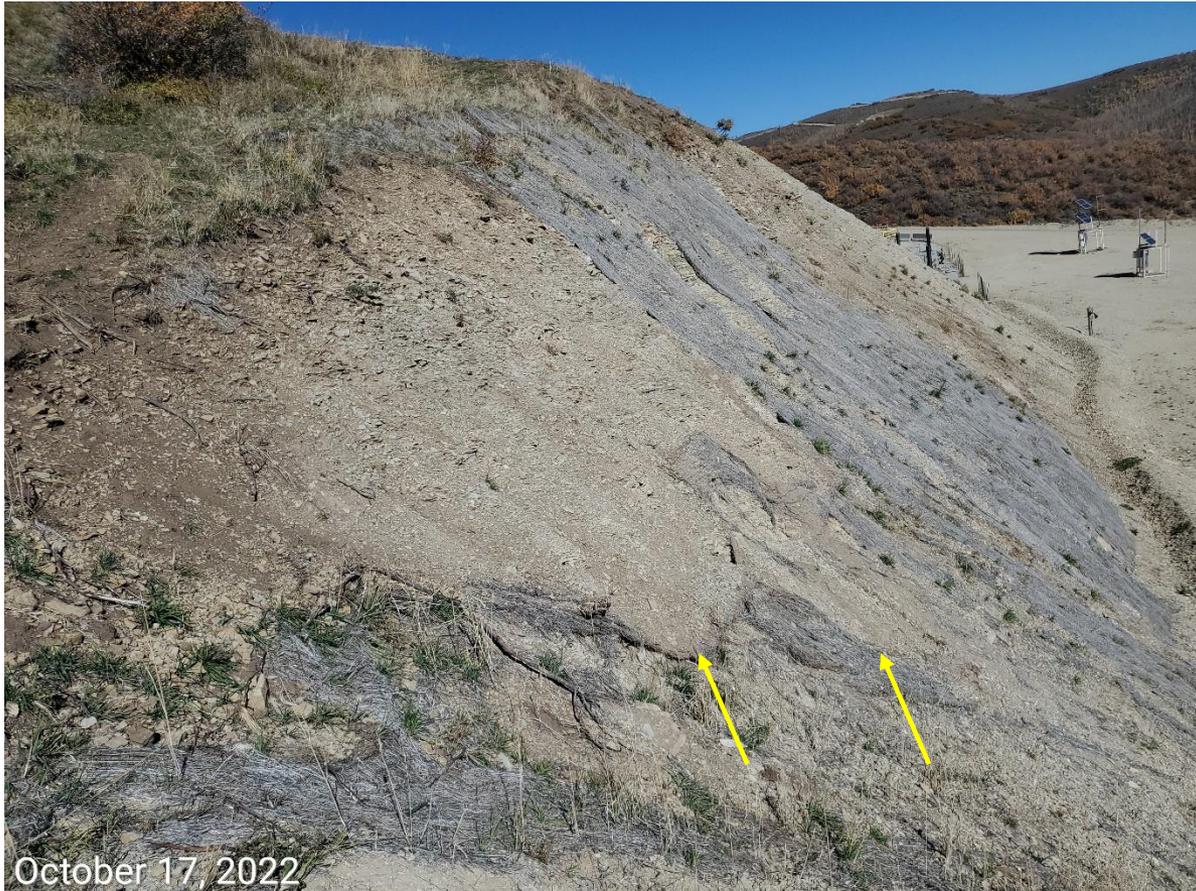
**Photo 3:** Photo taken from the cut slopes. Photo shows the erosion control blankets previously implemented have not been maintained in a proper functioning condition per good engineering practices. Erosion degradation has persisted. Arrow shows blanket in disrepair, as well as sediment/material eroding from the slopes covering remaining erosion blankets.

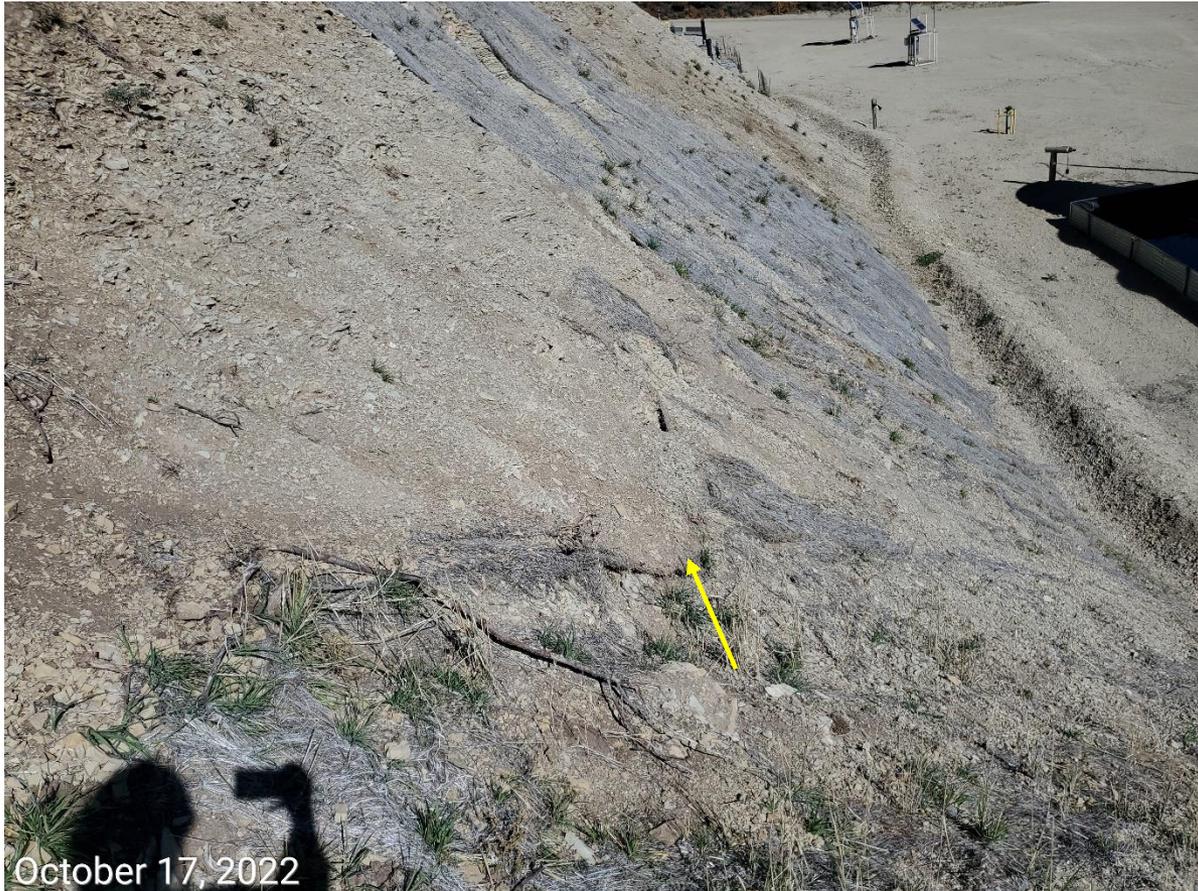
**Photo 7:** See comments under photo 6.
