Interim Reclamation and Stormwater Inspection

Operator: VERDAD RESOURCES LLC #10651

Location ID: 417324

Inspection Photos
Location Name: State 16-11-9-60H
Location ID: 417324

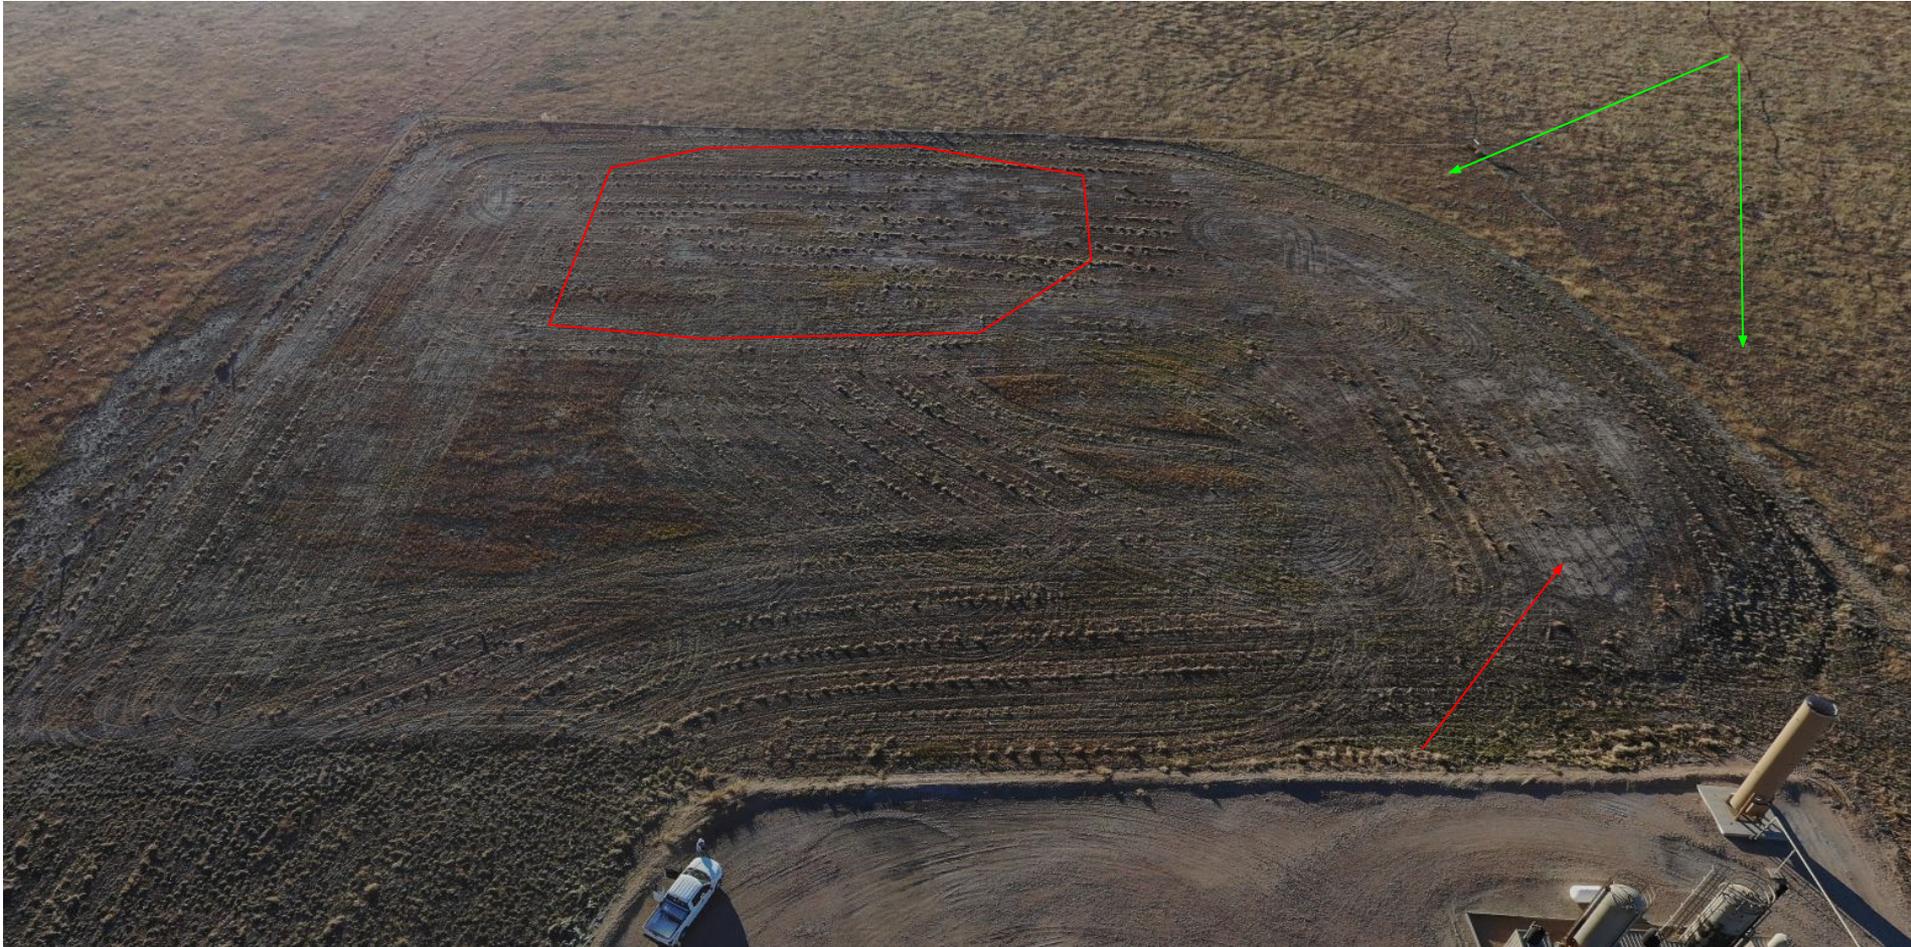
Photo 1. Drone aerial imagery illustrates the pit area. Bare patches were observed throughout (red arrow and polygon show examples of some of the bare patches) and weedy, annual vegetation was observed that is not reflective of reference areas. Desirable establishment was observed but introduced plant species were observed along the eastern interim and pit areas. Photo also illustrates the location has been recently mowed.

Green arrow indicates where COGCC Staff located reference area vegetation.

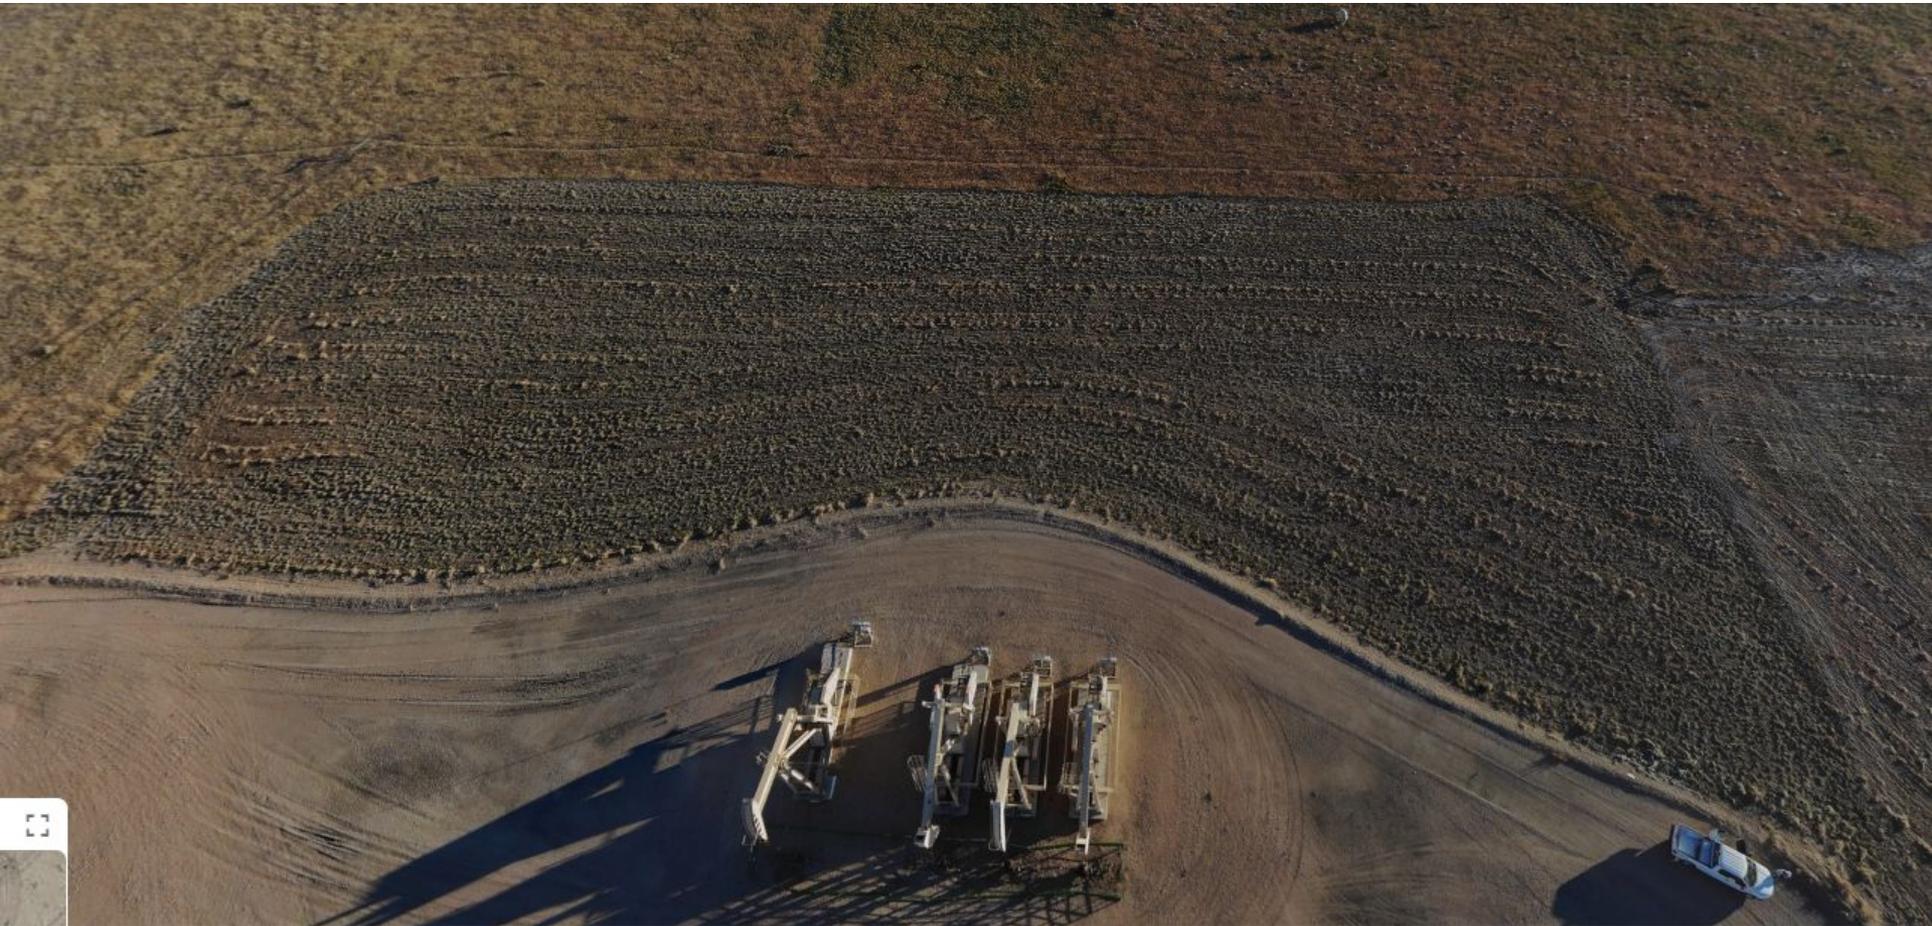
Photo 2. Drone aerial imagery illustrates the eastern interim reclamation area. The majority of the eastern interim reclamation area was established with an introduced plant species, likely Crested wheatgrass, which is not reflective of reference areas. Vegetation was mowed so there were no seedheads, only basal leaves.

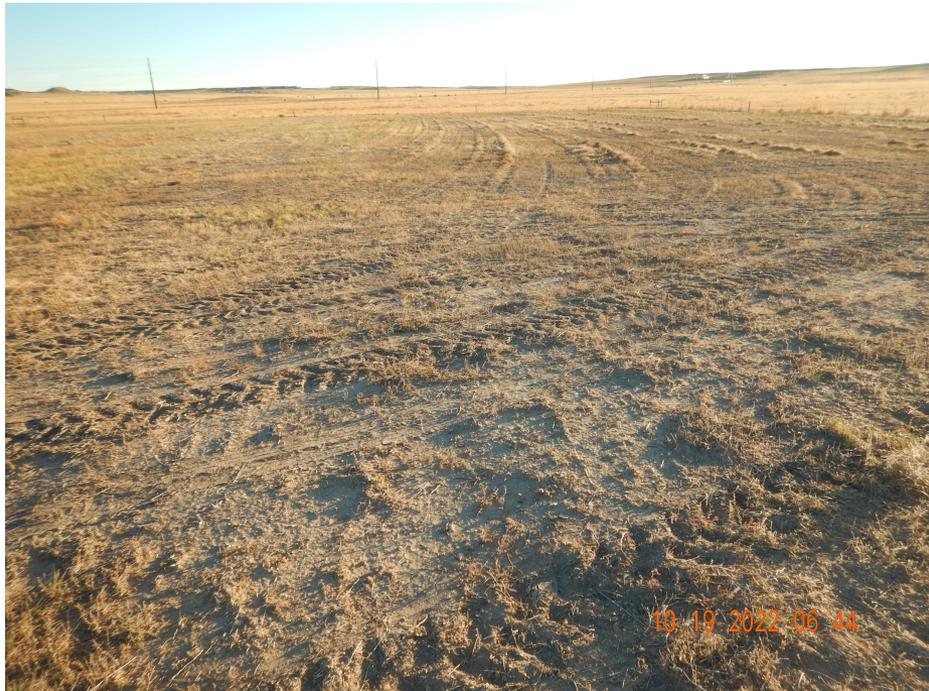
Photo 3. Photo taken from the southwestern pit area, facing East. Photo illustrates a bare patch with no vegetation establishment, which is not reflective of reference areas.

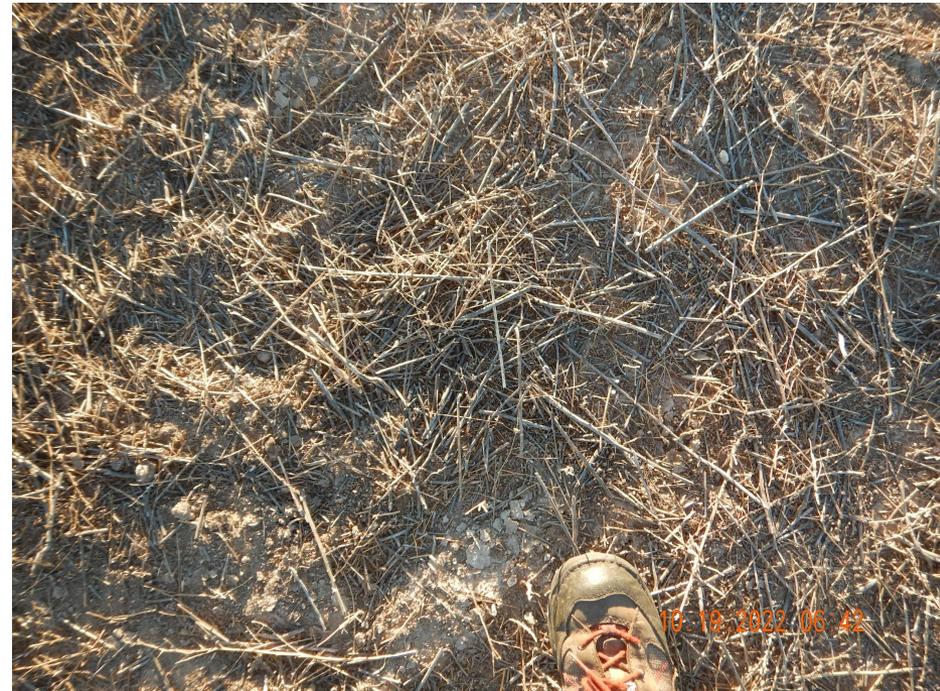
Photo 4. Close up photo taken from the bare patch in Photo 3.

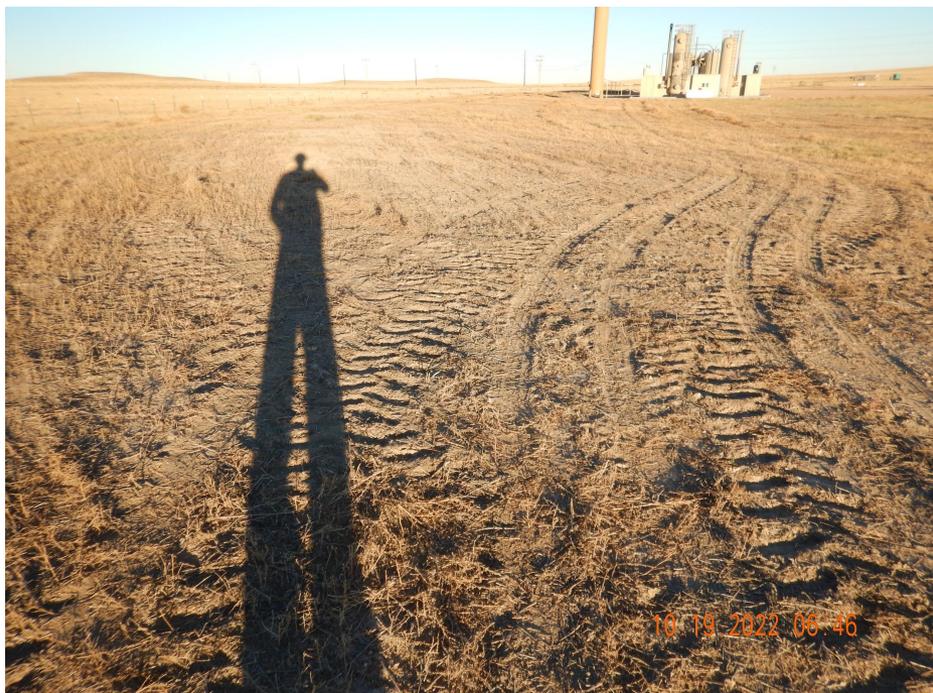
Photo 5. Photo taken from the southwestern pit area, facing North. See comments under Photo 3 and 4.

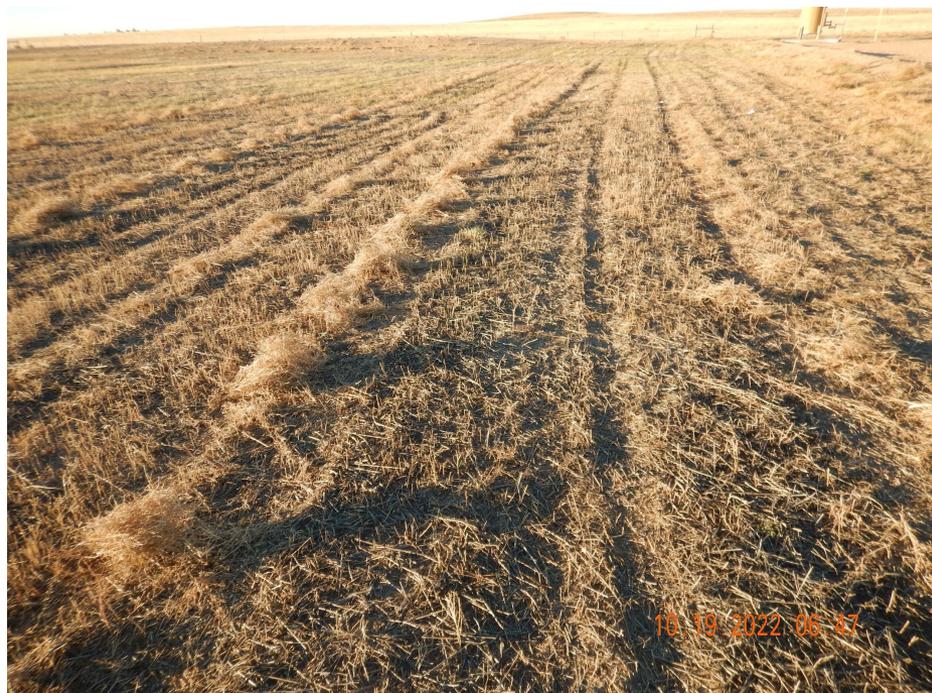
Photo 6. Photo taken from the northern pit area, facing West. Photo illustrates mostly annual, weedy vegetation has established that was recently mowed.

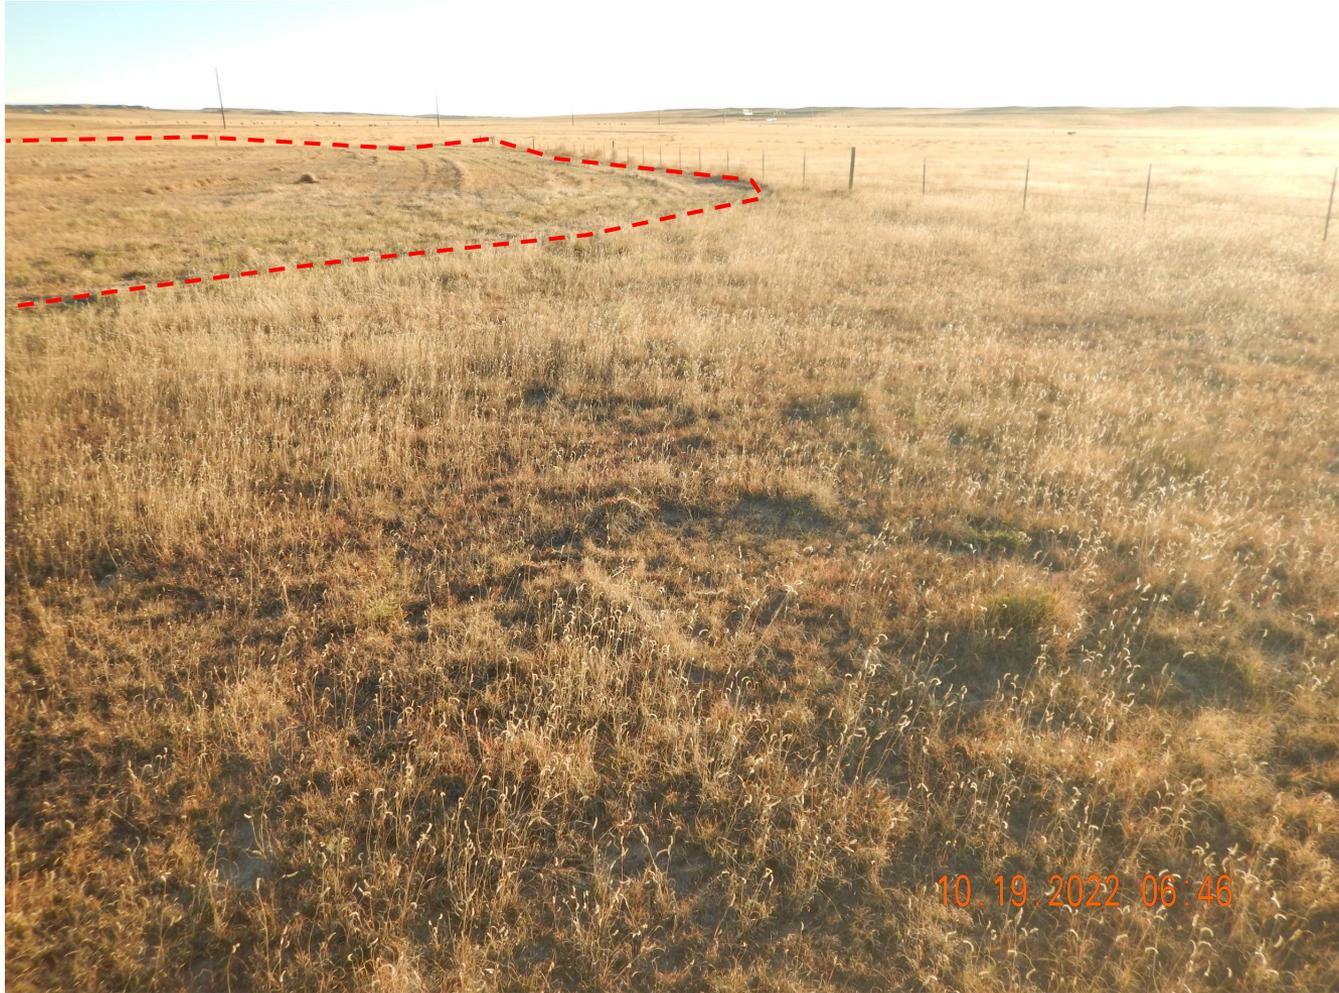
Photo 7. Reference photo taken from a southwestern area, facing East. Photo illustrates reference area vegetation consists mostly of uniform Blue grama.
Note- the area within the red-dashed line is the pit area and everything outside is reference areas.

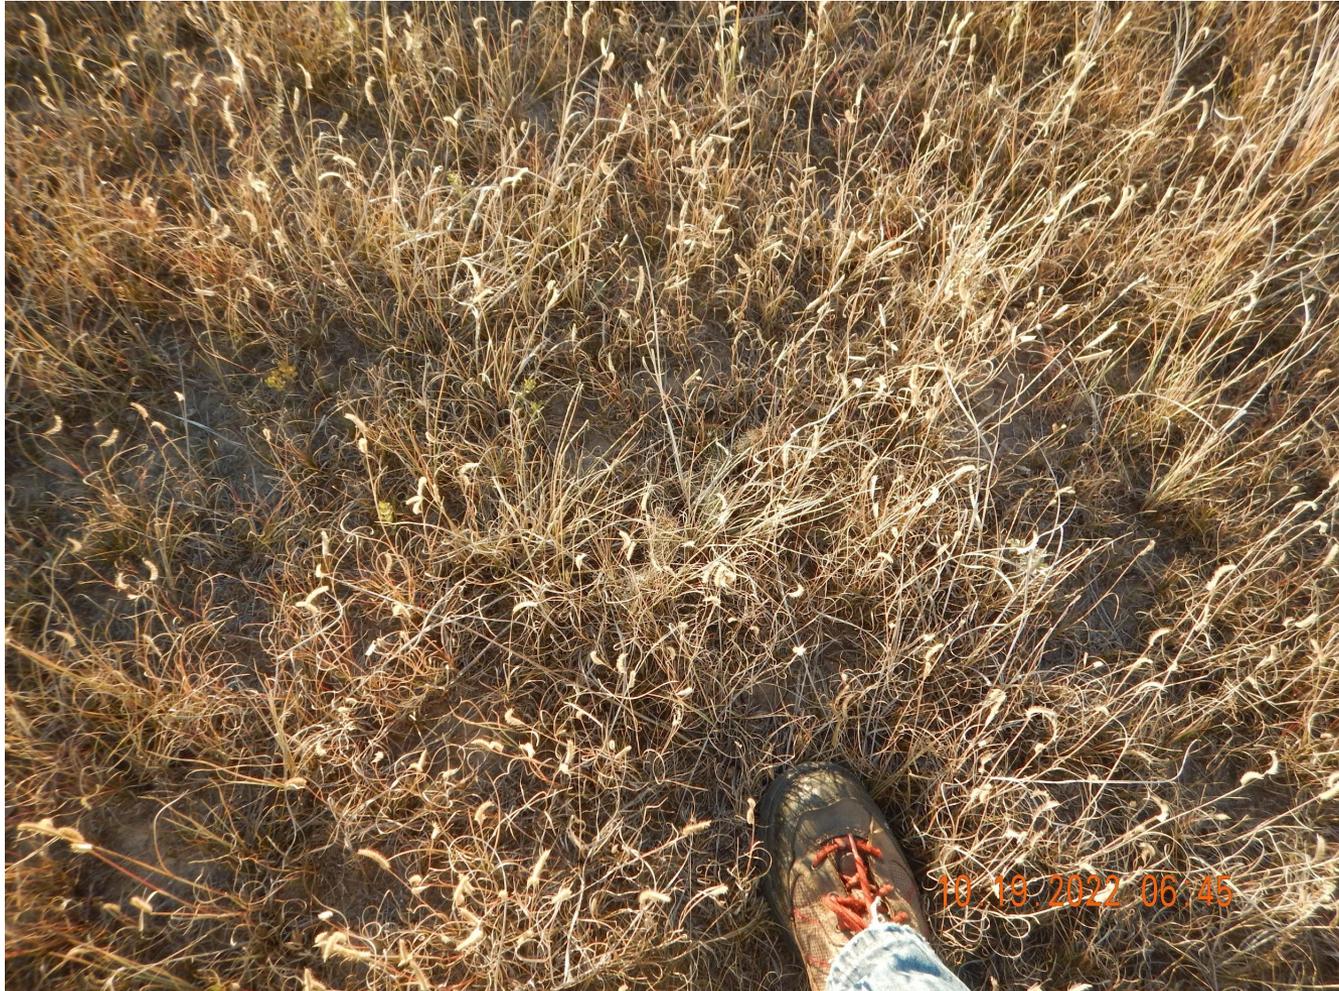
Photo 8. Close up reference photo taken from Photo 7 illustrating the uniform Blue grama establishment.

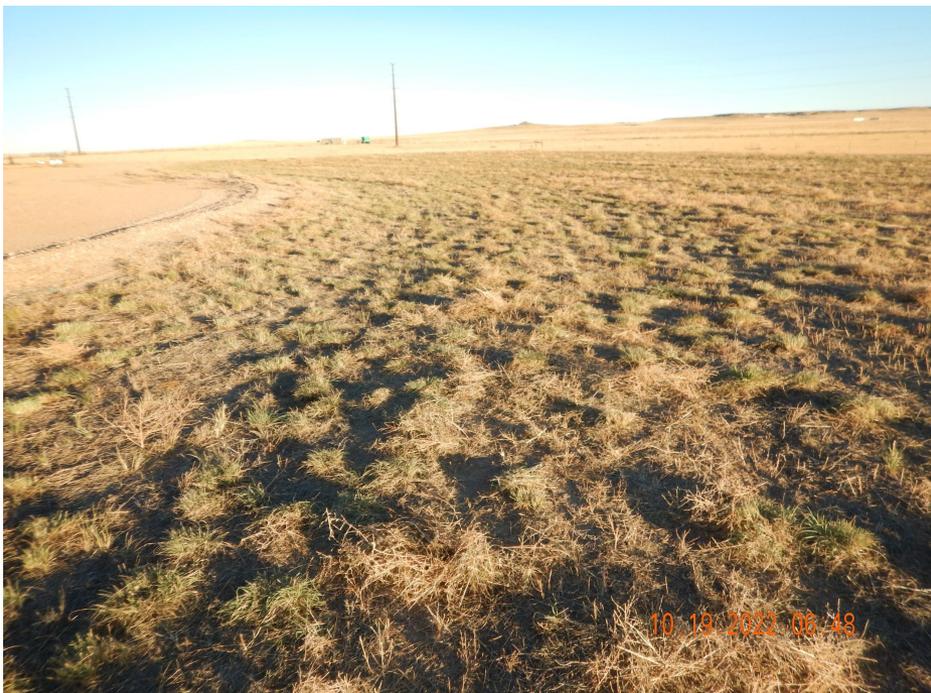
Photo 9. Photo taken from the southeastern interim reclamation area, facing North. Photo illustrates what appears to be Crested wheatgrass which is not reflective of reference area vegetation.

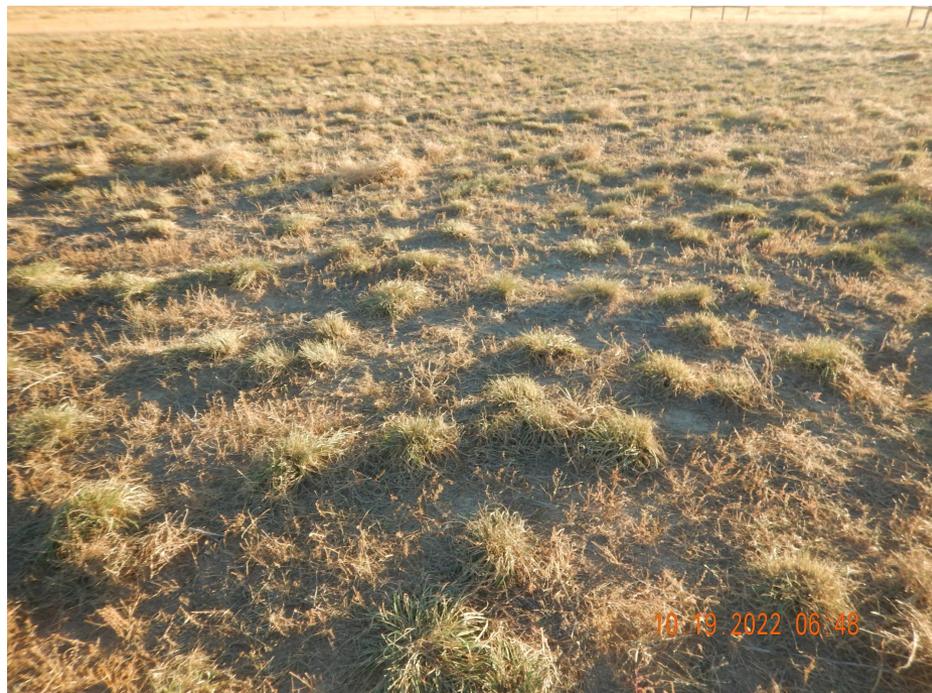
Photo 10. Photo taken from the southeastern interim reclamation area, facing East. See comments under Photo 9.

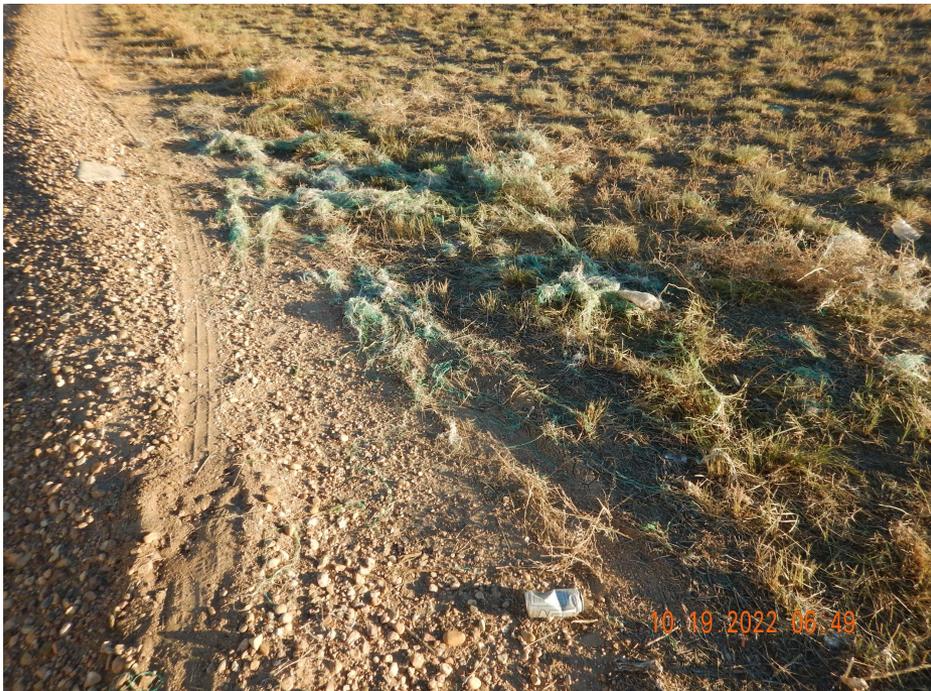
Photo 11. Photo taken from the eastern interim reclamation area, facing North. Photo illustrates trash from reclamation activities- string that has been mowed over.

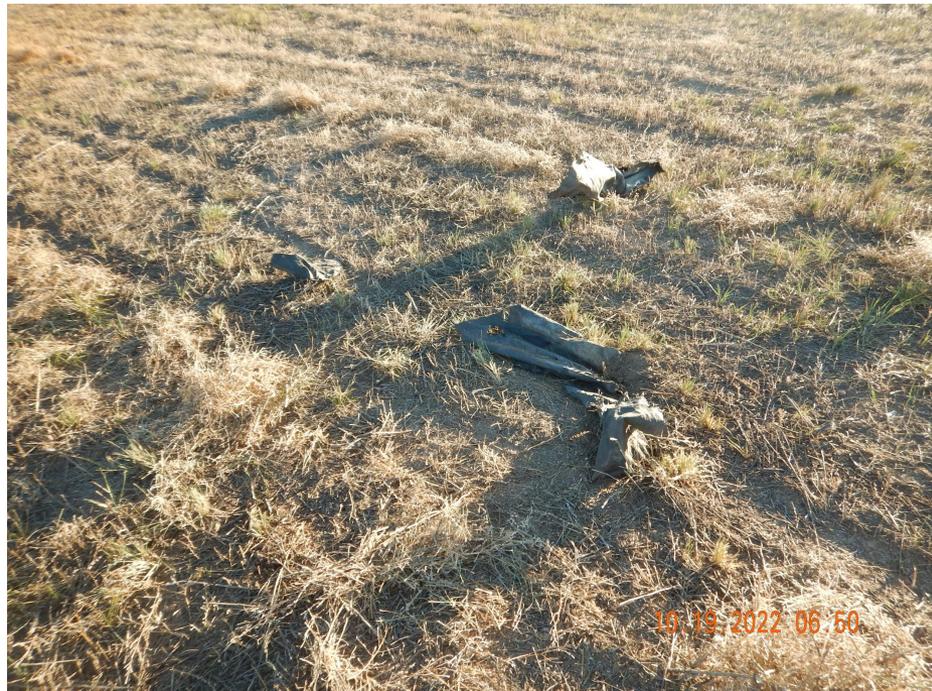
Photo 12. Photo taken from the eastern interim reclamation area, facing East. See comments under Photo 11.
