Interim Reclamation and Stormwater Inspection

Operator: VERDAD RESOURCES LLC #10651

Location ID: 425475

Inspection Photos
Location Name: Hemberger 25-34-8-60
Location ID: 425475

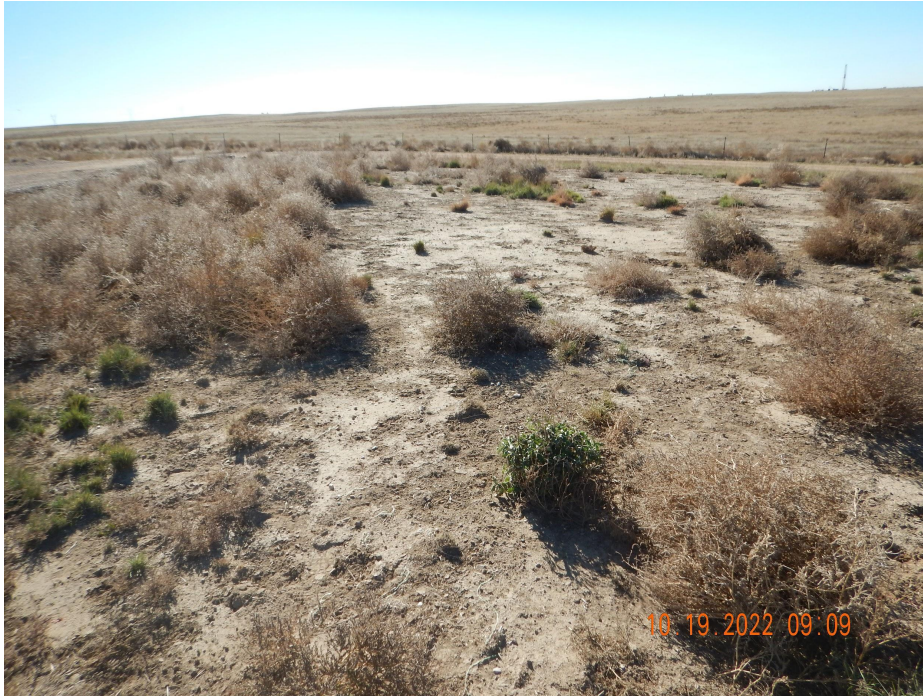
Photo 1. Photo taken from the southwestern interim reclamation area, facing South. Photo illustrates unmanaged annual, weedy Kochia vegetation and bare ground with some desirable vegetation establishment. Note- introduced grass species were observed which is not reflective of reference area vegetation.

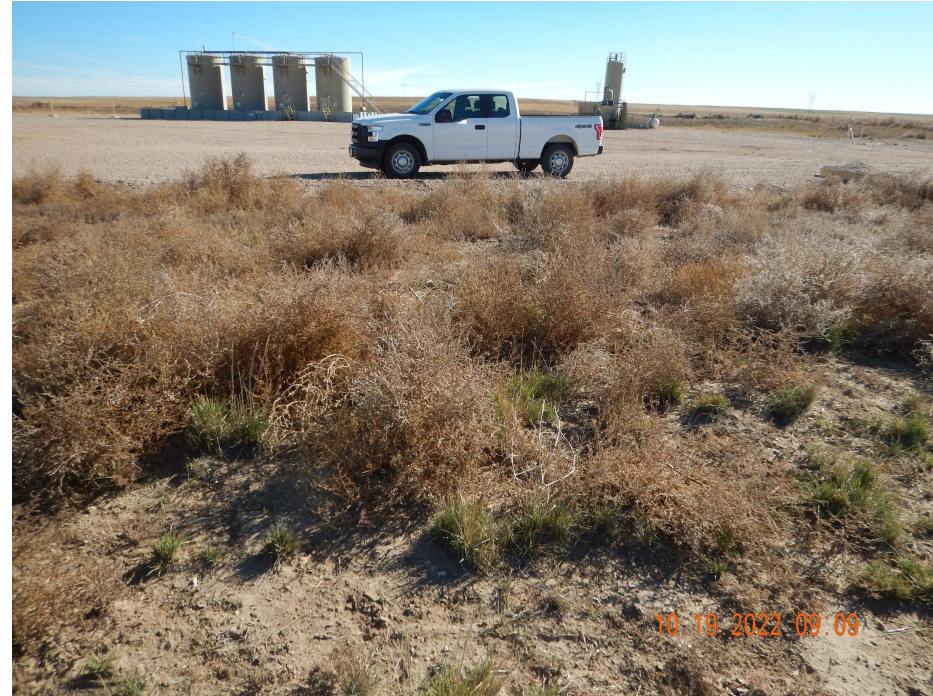
Photo 2. Photo taken from the southwestern interim reclamation area, facing East. See comments under Photo 1.

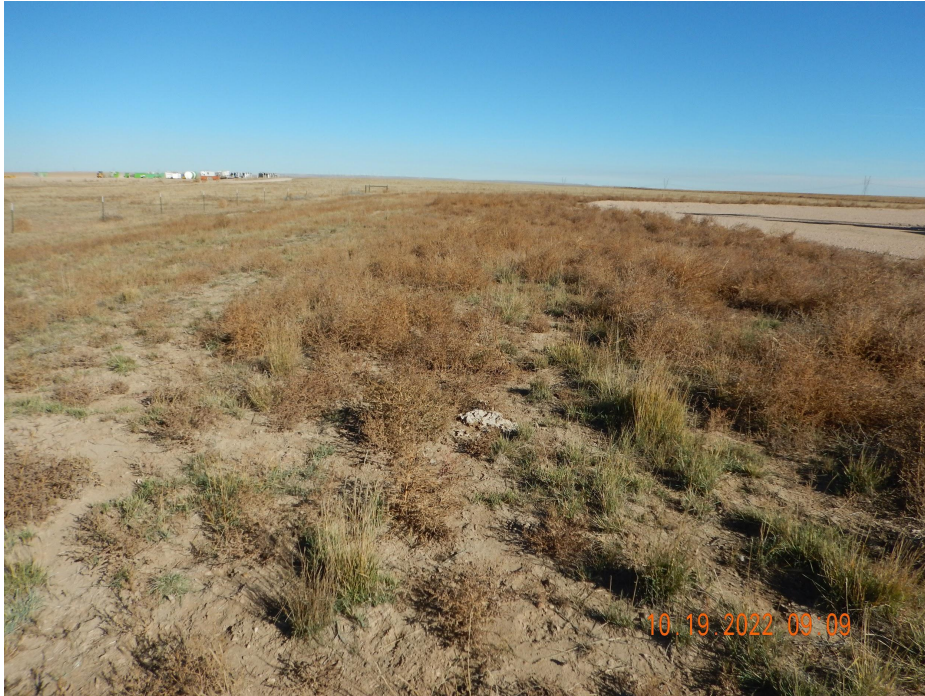
Photo 3. Photo taken from the southwestern interim reclamation area, facing North. See comments under Photo 1.

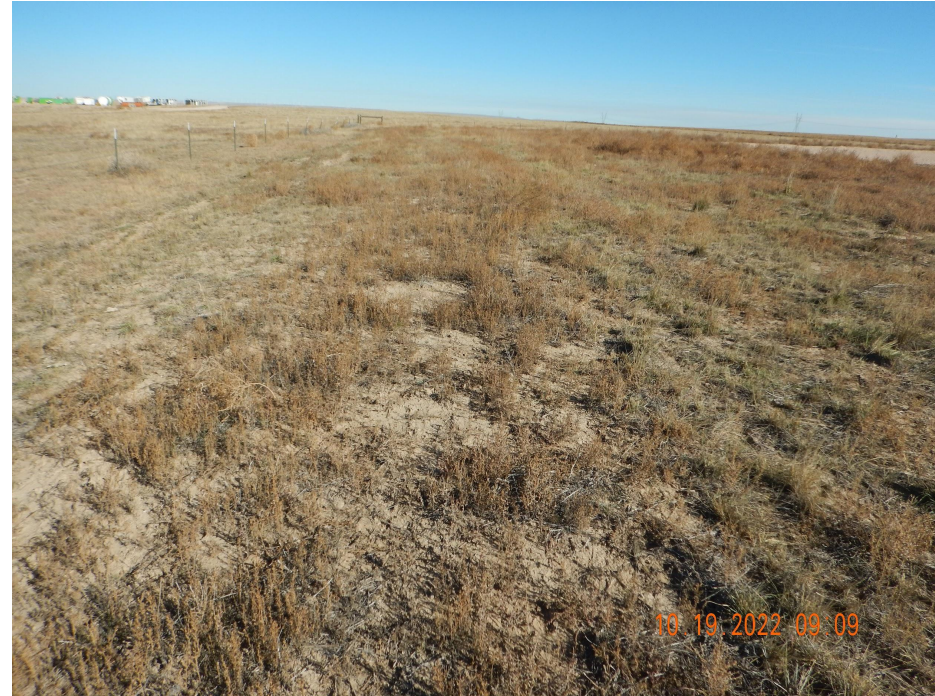
Photo 4. Photo taken from the western interim reclamation area, facing North. See comments under Photo 1.

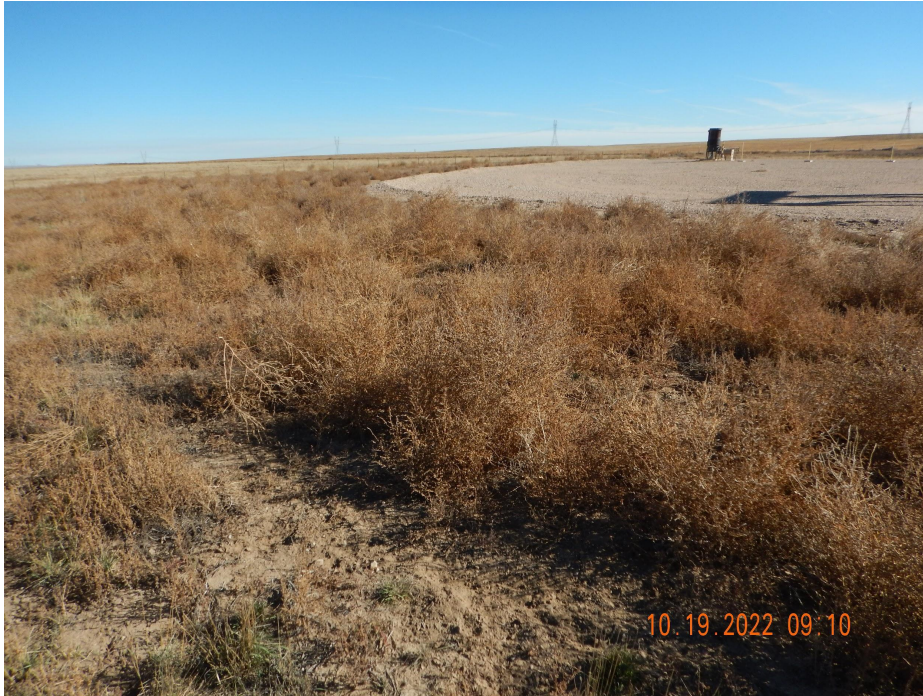
Photo 5. Photo taken from the northwestern interim reclamation area, facing Northeast. See comments under Photo 1.

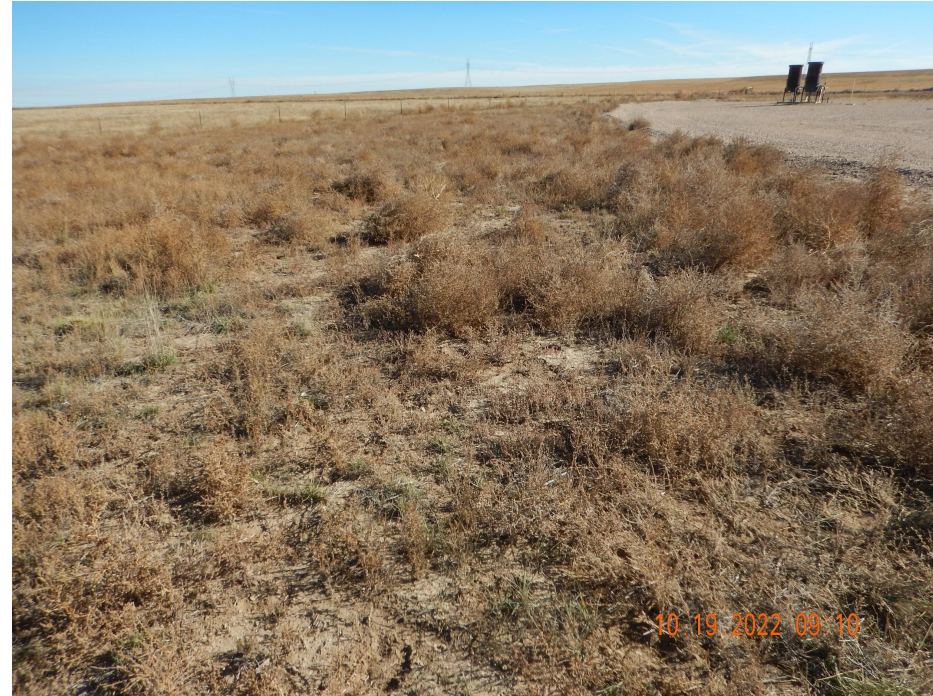
Photo 6. Photo taken from the northwestern interim reclamation area, facing East. See comments under Photo 1.

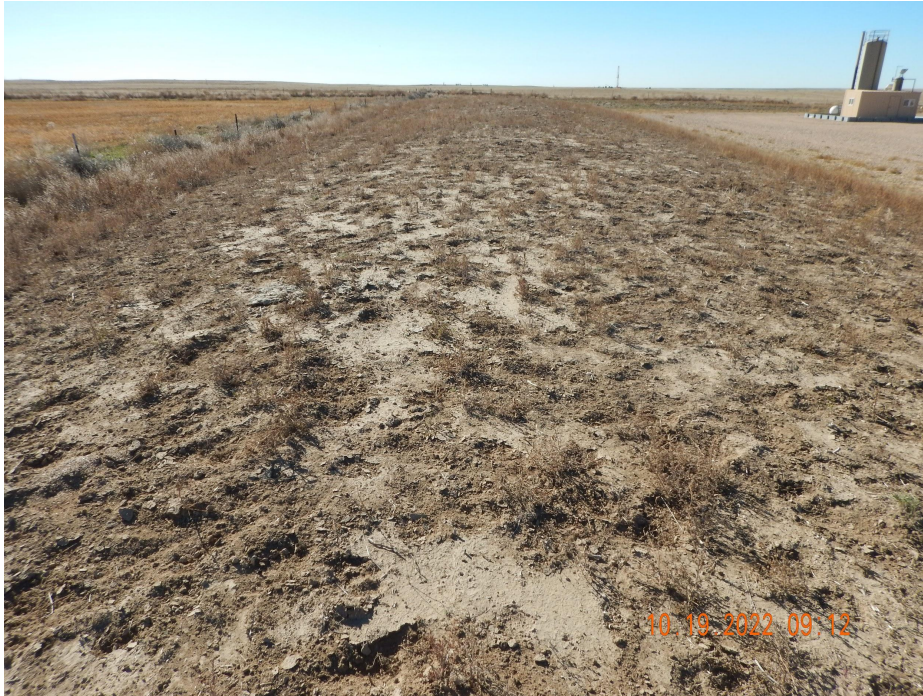
Photo 7. Photo taken from the northeastern interim reclamation area, facing South. Photo illustrates what appears to be a potential topsoil stockpile lacking vegetative growth and is not stabilized.

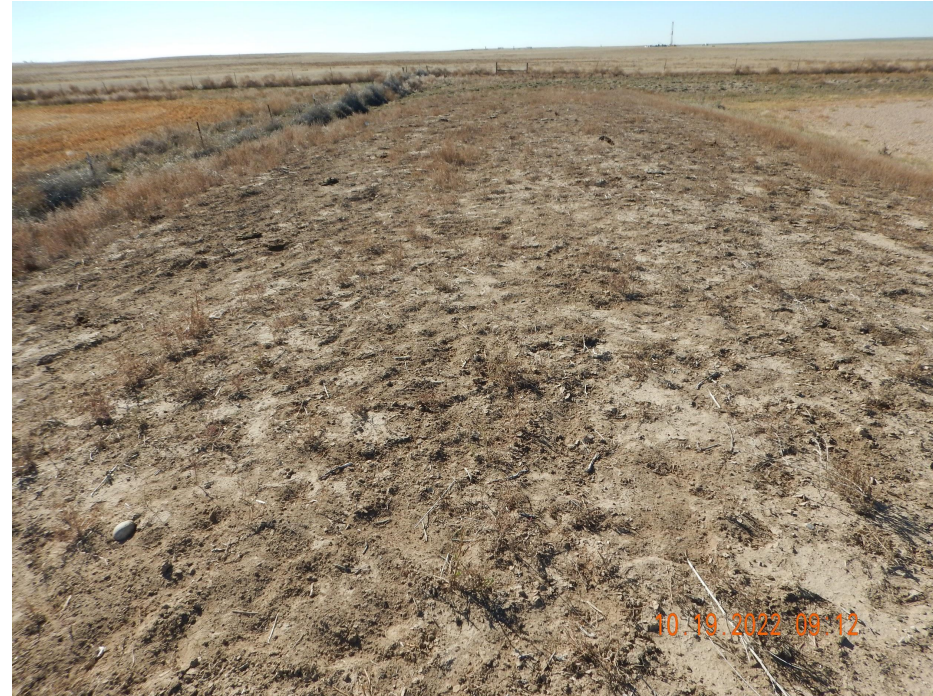
Photo 8. Photo taken from the eastern interim reclamation area, facing South. See comments under Photo 7.

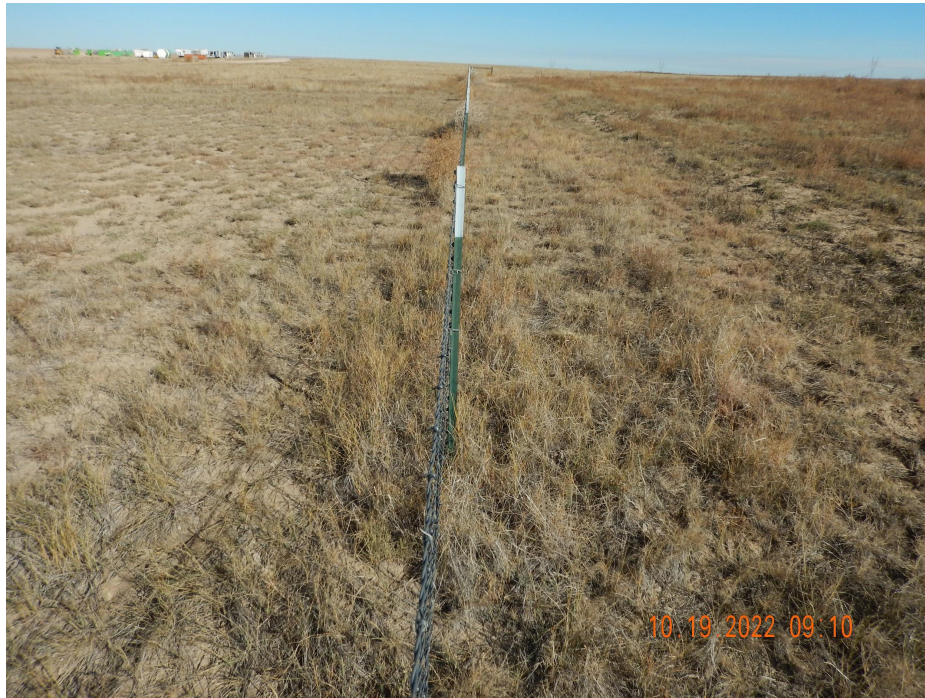
Photo 9. Reference photo taken from the western interim reclamation area, facing North. Photo illustrates desirable perennial vegetation.

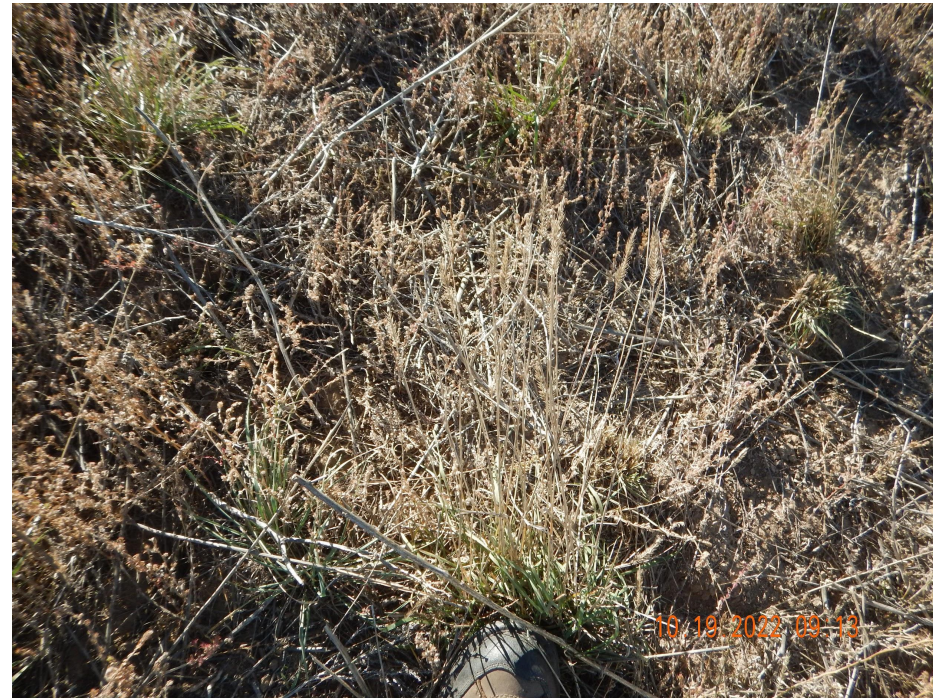
Photo 10. Photo taken from the southeastern interim reclamation area. Photo illustrates an introduced grass species, Crested wheatgrass.
