Interim Reclamation and Stormwater Inspection

Operator: VERDAD RESOURCES LLC #10651

Location ID: 437190

Inspection Document #: 697504297

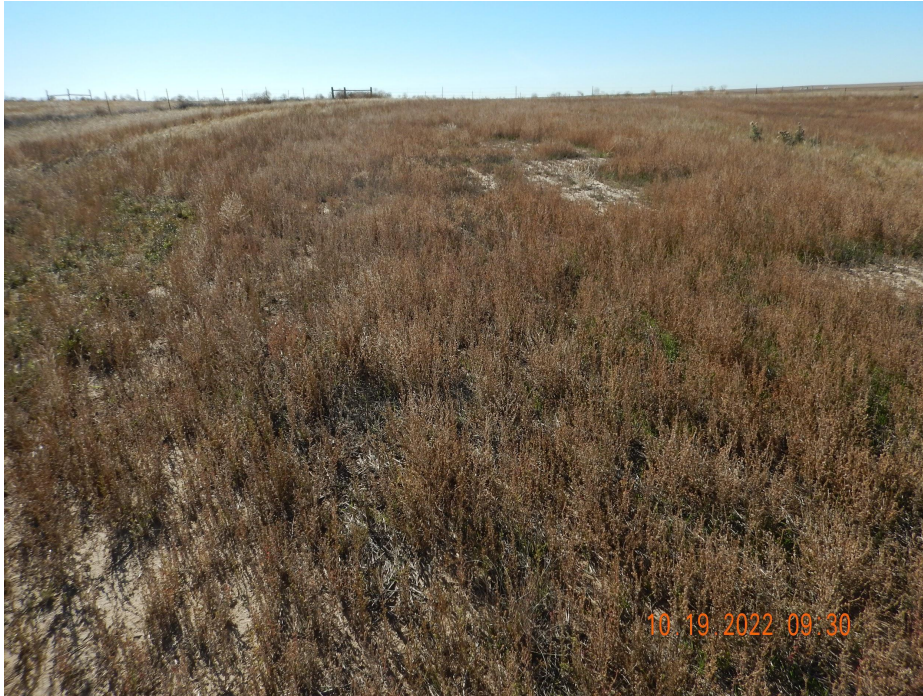
Photo 1. Photo taken from the southeastern interim reclamation area, facing South. Photo illustrates unmanaged annual, weedy Kochia vegetation and bare ground with some desirable vegetation establishment. Note- introduced grass species were observed which is not reflective of reference area vegetation.

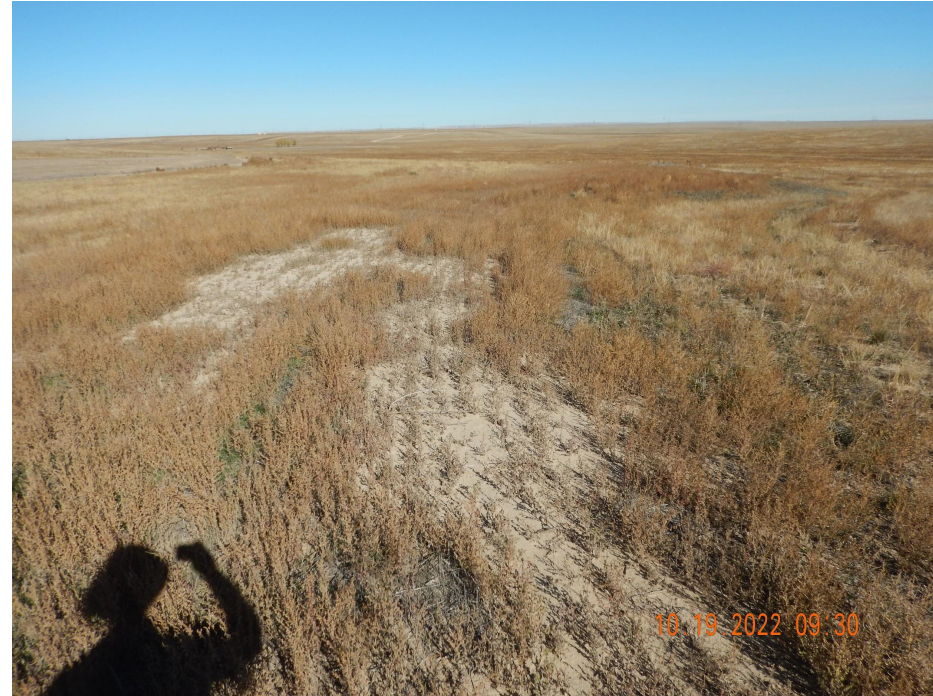
Photo 2. Photo taken from the southeastern interim reclamation area, facing North. See comments under Photo 1.

Note- it is unclear whether there is topsoil stockpile along the eastern location or whether the location has been properly contoured.

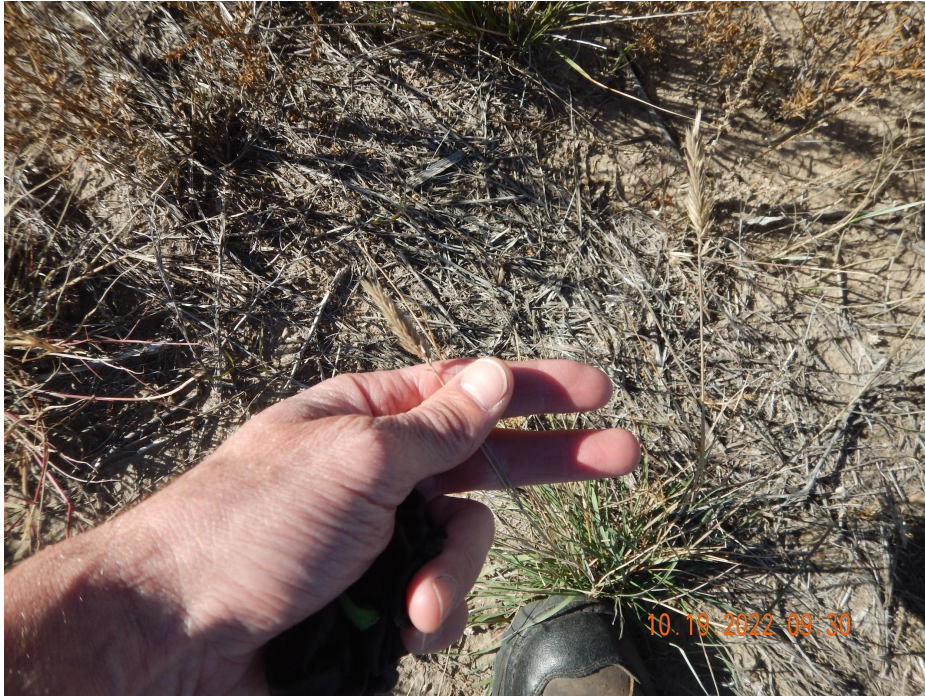
Photo 3. Close up photo taken from within the interim reclamation area. Photo illustrates Crested wheatgrass, introduced grass species, that was seeded as part of interim reclamation.

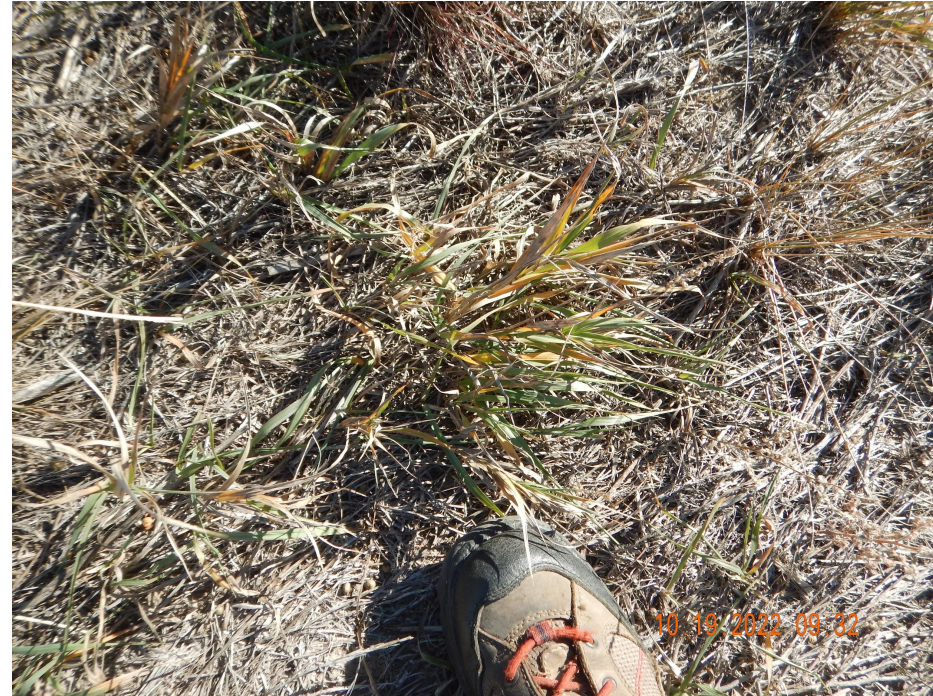
Photo 4. Close up photo taken from within the interim reclamation area. Photo illustrates Smooth brome, introduced grass species, that was seeded as part of interim reclamation.

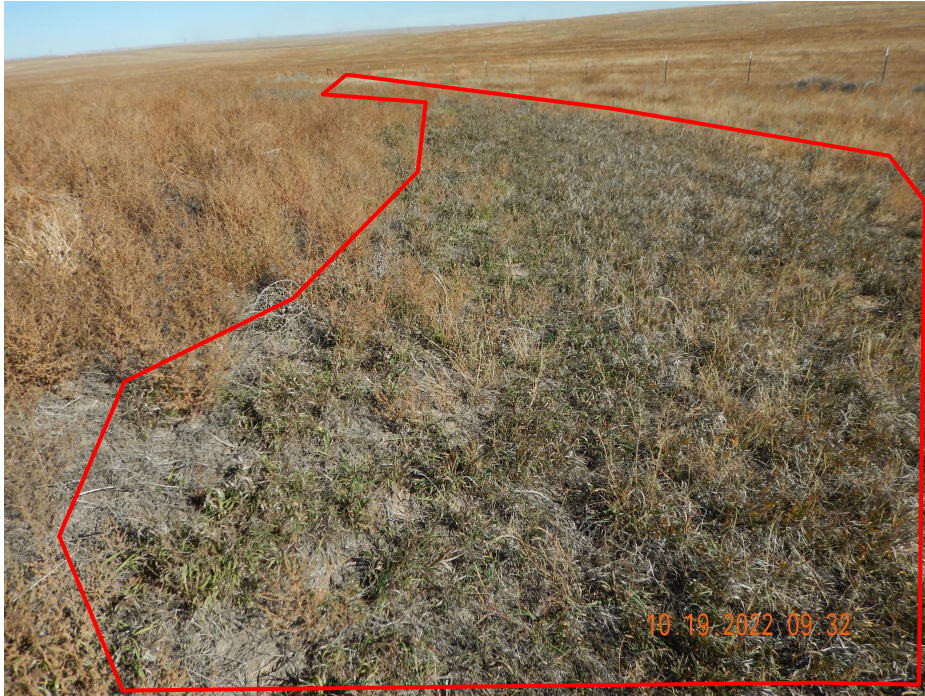
Photo 5. Photo taken from the eastern interim reclamation area, facing North. Photo illustrates Smooth brome establishment within the red polygon. Photo also illustrates unmanaged Kochia to the interior.

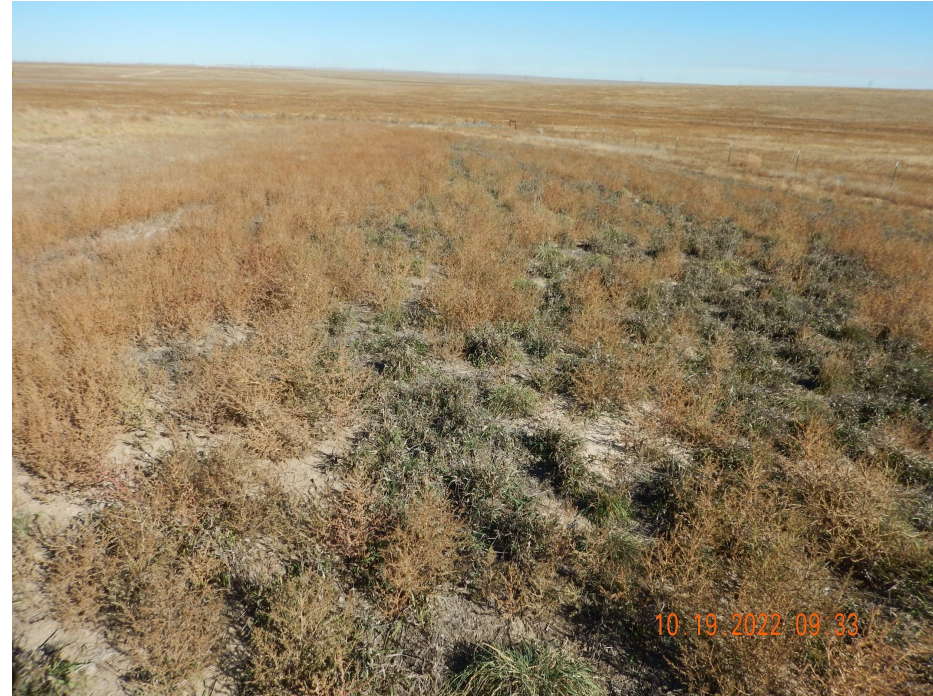
Photo 6. Photo taken from the eastern interim reclamation area, facing North. Photo illustrates a mix of introduced grass species and Kochia as the main vegetation with some establishment of natives.

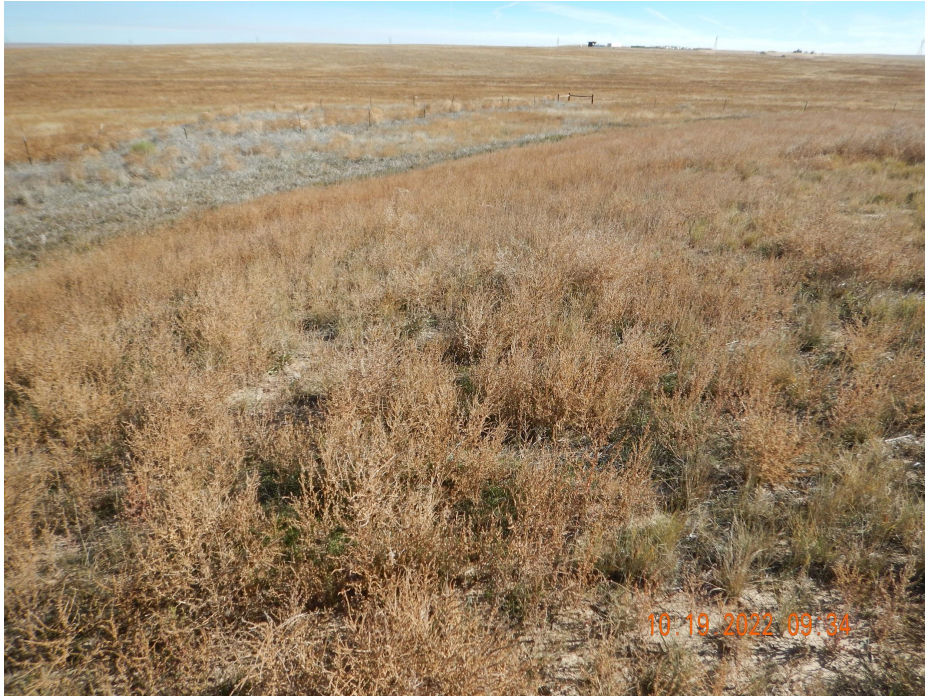
Photo 7. Photo taken from the northeastern interim reclamation area, facing Northeast. Photo illustrates similar vegetative condition to Photo 6, except with a higher density of Kochia.

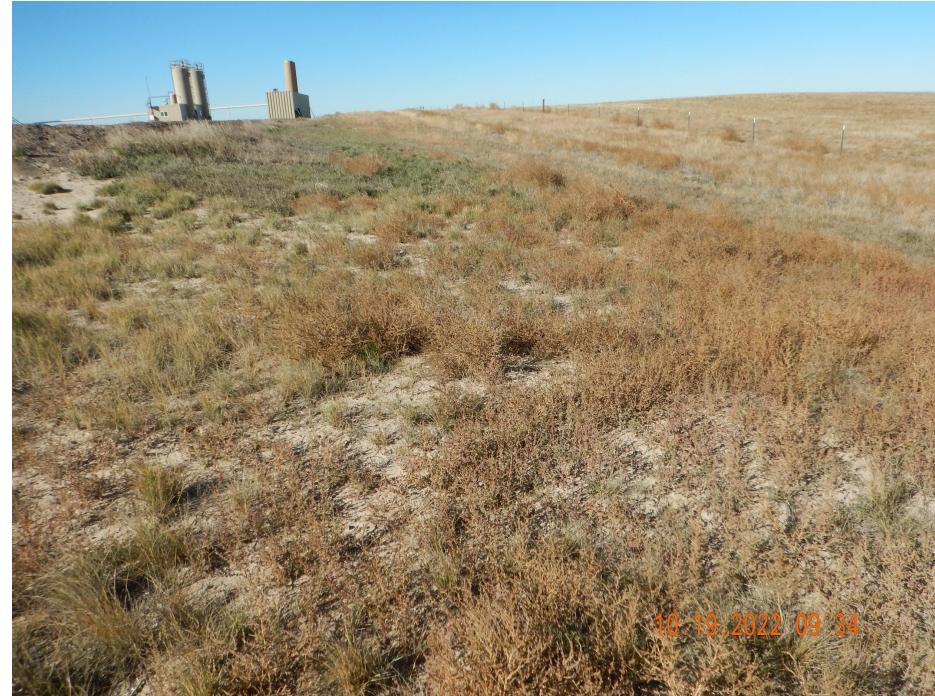
Photo 8. Photo taken from the northeastern interim reclamation area, facing West. See comments under Photo 6.

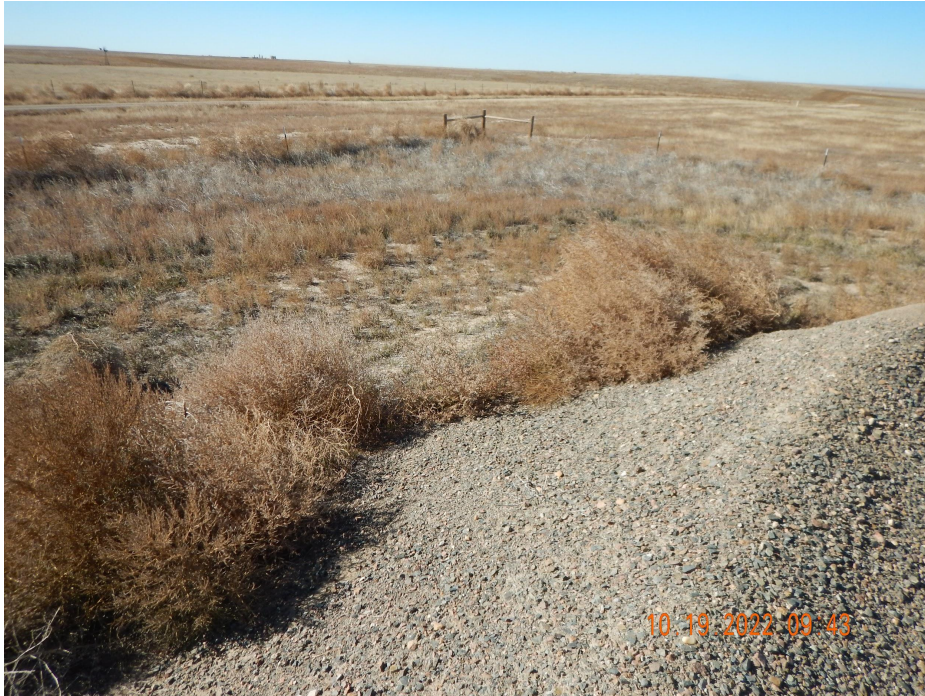
Photo 9. Photo taken from the southwestern interim reclamation area, facing Southwest. Photo illustrates unmanaged Kochia along the southern fill slope.

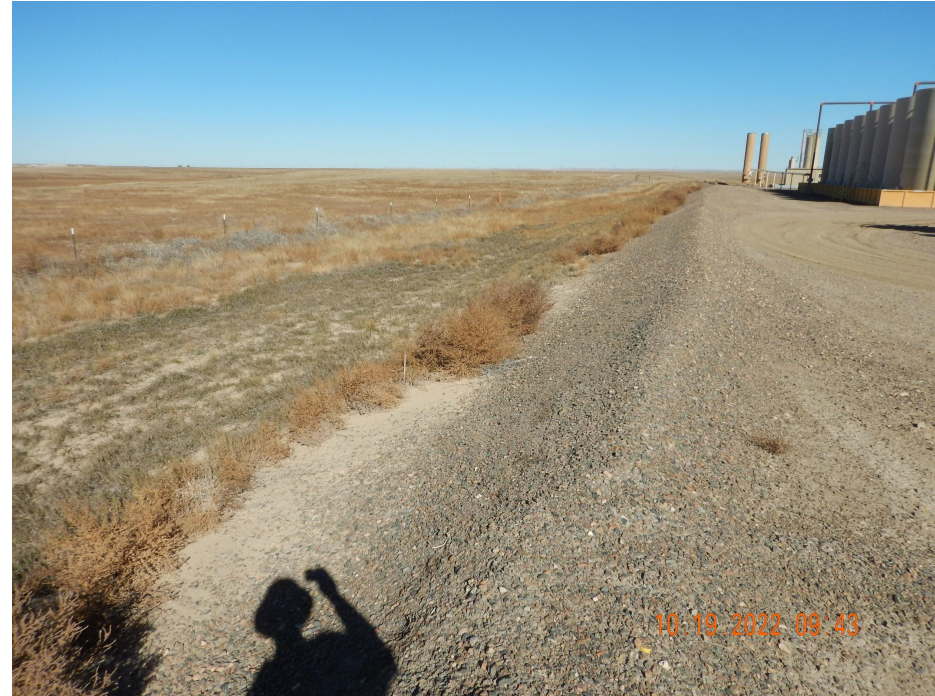
Photo 10. Photo taken from the southwestern interim reclamation area, facing North. Photo illustrates unmanaged Kochia along the base of the western fill slope.

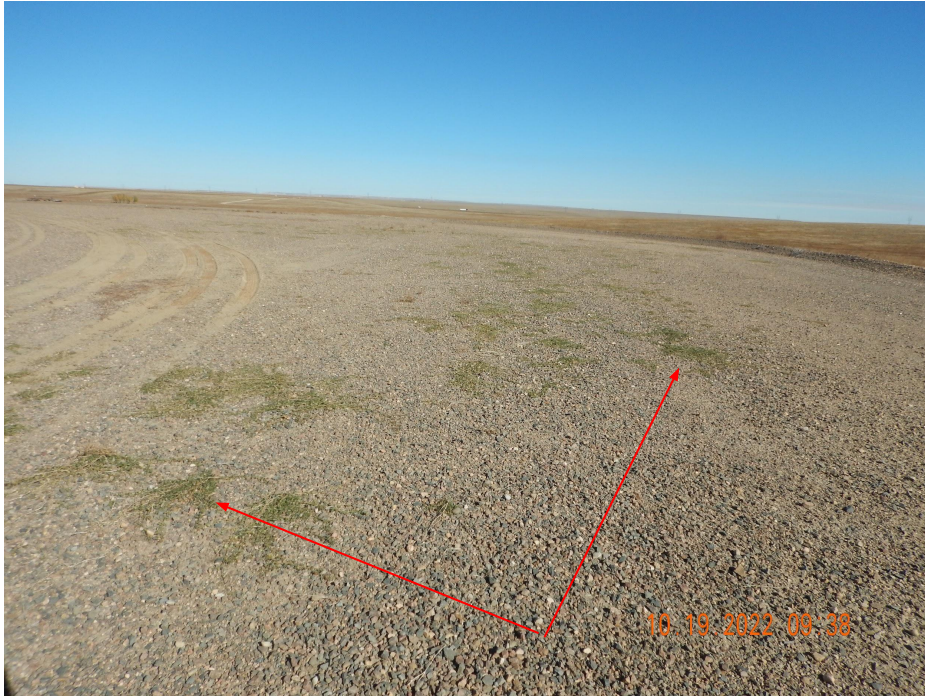
Photo 11. Photo taken from the northeastern interim reclamation area, facing North. Photo illustrates unmanaged Puncturevine, a List C Colorado noxious weed. Also, the photo illustrates areas not needed for production operations along the northeastern location can be further reduced. Refer to Photo 13 for more information.

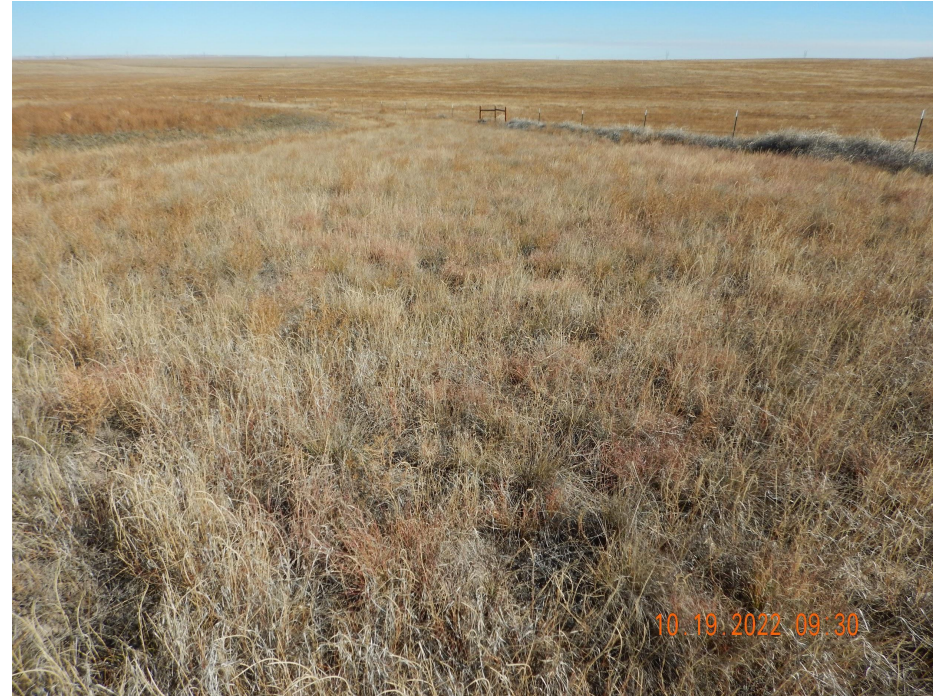
Photo 12. Reference photo taken from the eastern location, facing North. Photo illustrates native grass species and no introduced grass species were observed.

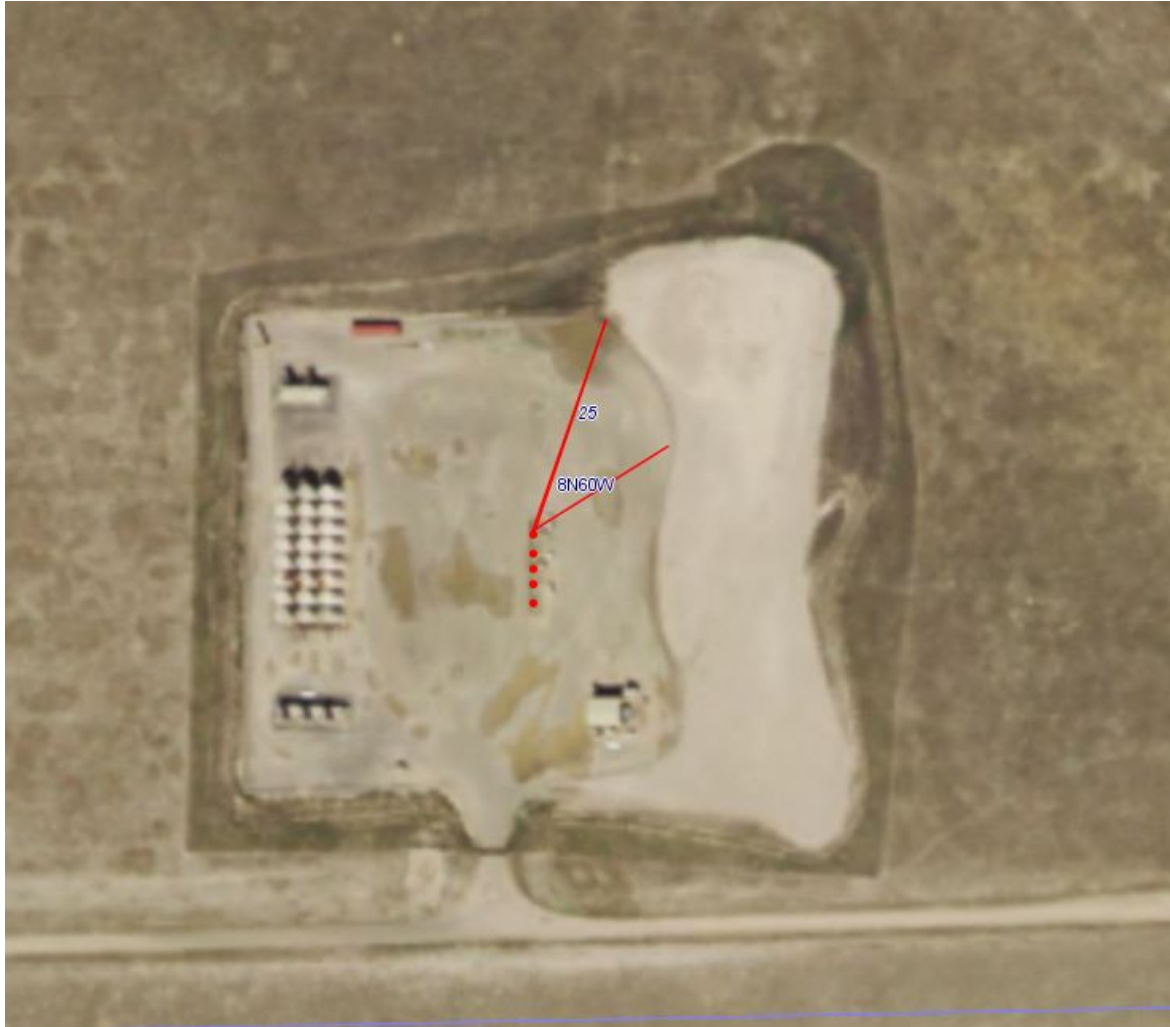
Photo 13. COGCC GISOnline aerial imagery from 2019 illustrates two red lines: shorter= ~140' and longer= ~200'. Operator does not appear to need portions of this northeastern area and shall further reduce the location per Rule 1003.
