Interim Reclamation and Stormwater Inspection

October 19, 2022

Operator: VERDAD RESOURCES LLC #10651

Location ID: 436809

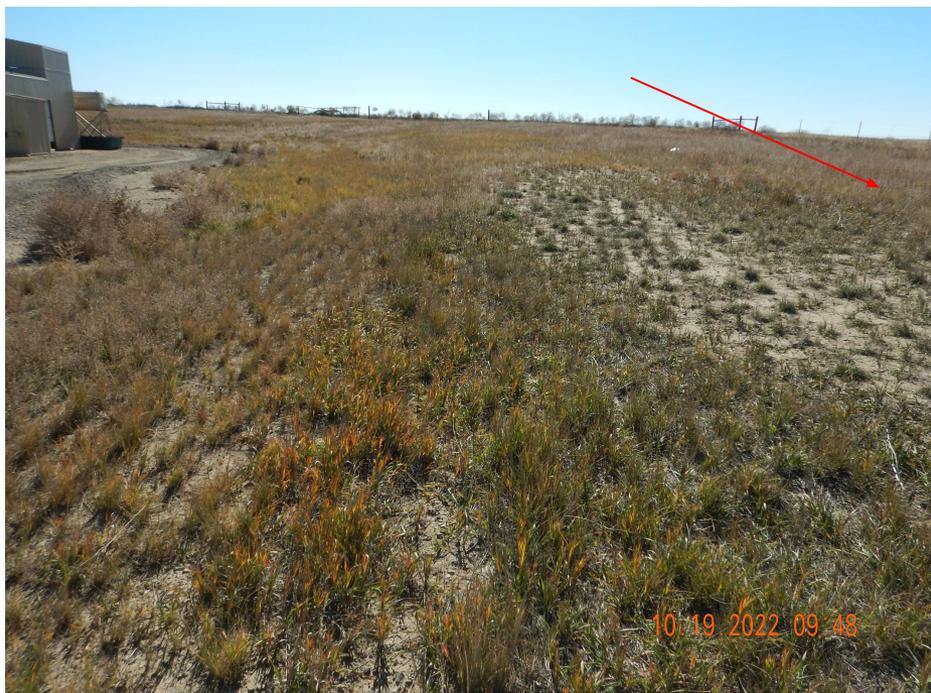
Photo 1. Photo taken from the southwestern interim reclamation area, facing Southeast. Photo illustrates the establishment of mixed native and introduced grass mix. Introduced grass species are establishing more than natives.

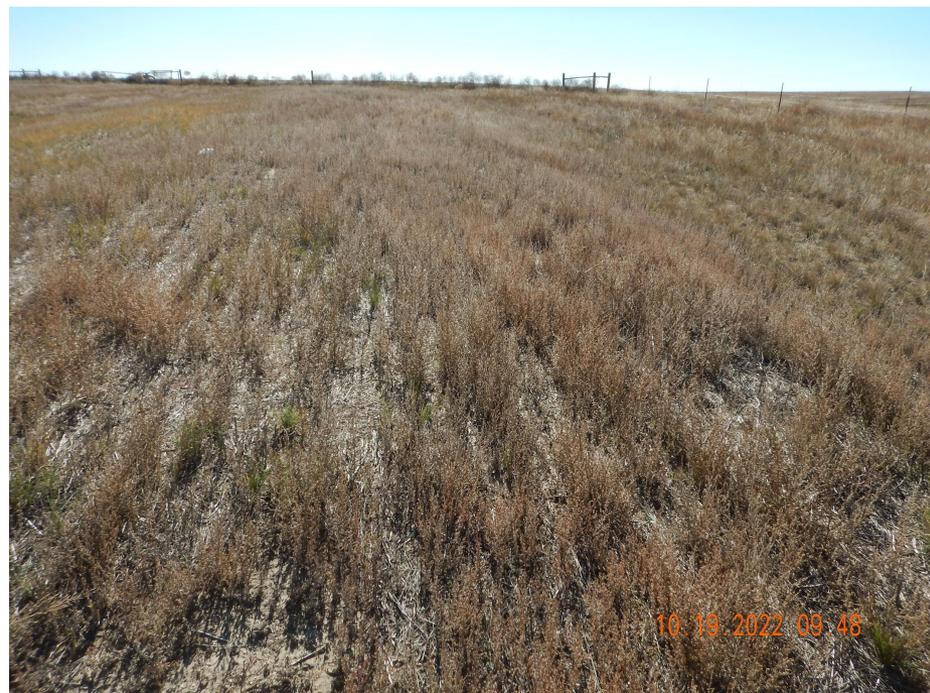
Photo 2. Photo taken from the southwestern interim reclamation area, facing Southeast. Photo illustrates an area of annual, weedy Kochia establishment.

Photo 2 taken from the red arrow.

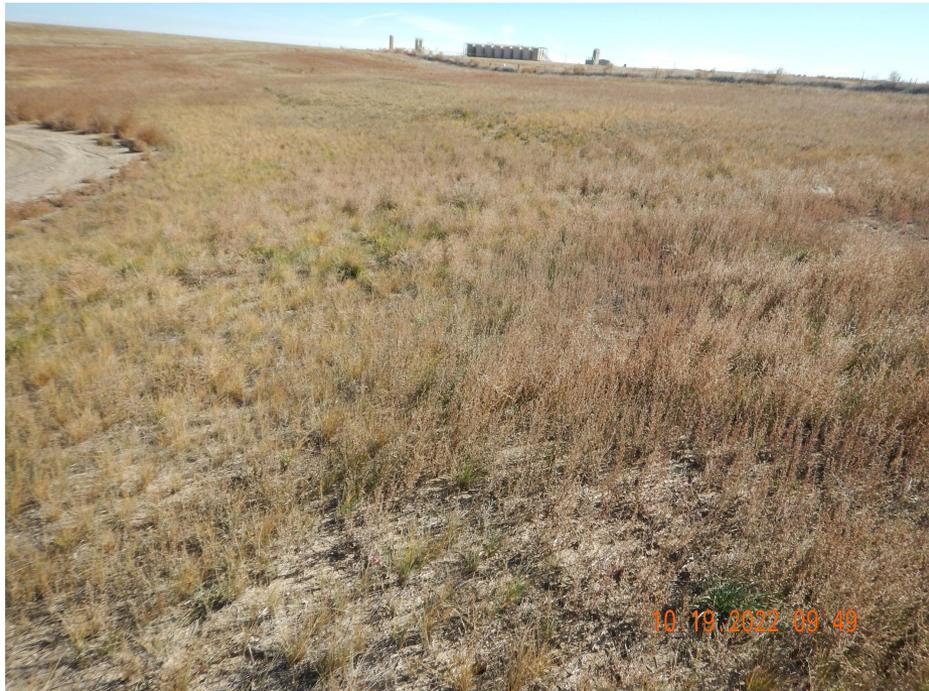
Photo 3. Photo taken from the southwestern interim reclamation area, facing Northeast. Photo illustrates a mix of introduced/native grasses with Kochia.

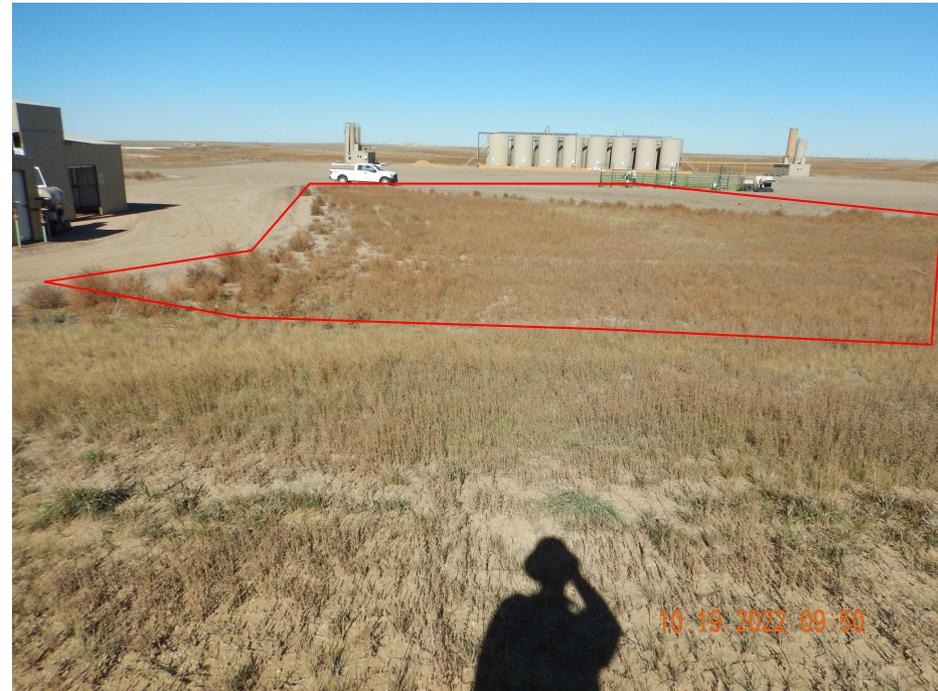
Photo 4. Photo taken from the southwestern interim reclamation area, facing Northwest. See comments under Photo 3.

The red polygon illustrates an area of Kochia establishment.

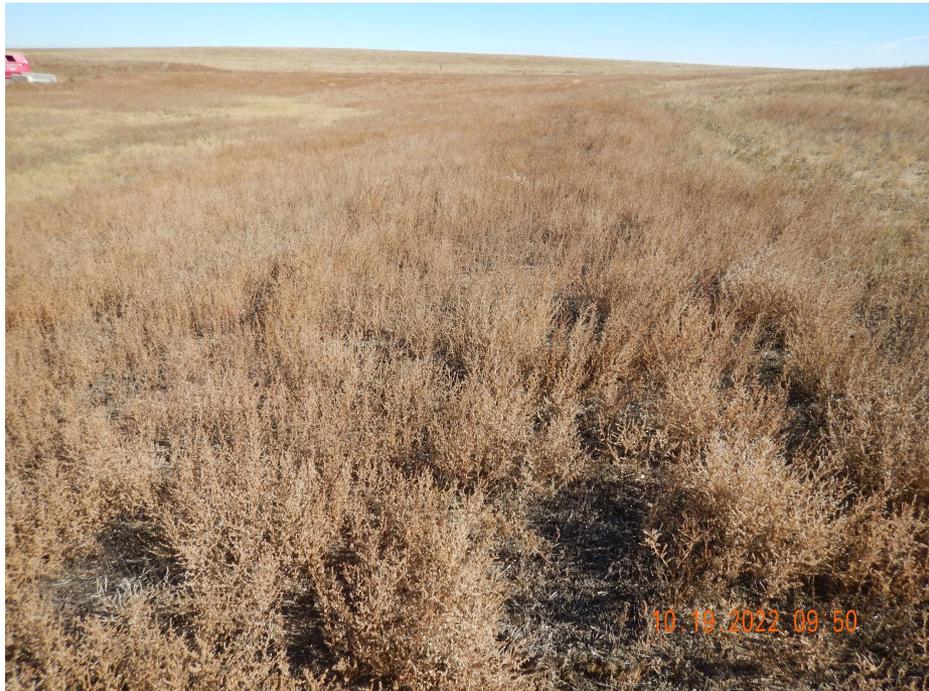
Photo 5. Photo taken from the southern interim reclamation area, facing Northeast. See comments under Photo 2.

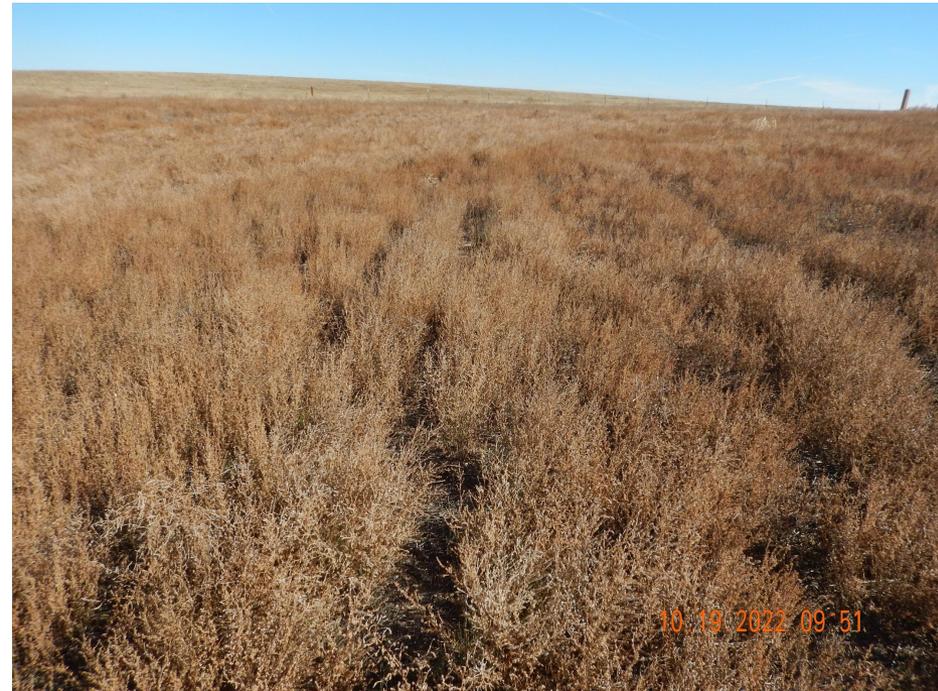
Photo 6. Photo taken from the southeastern interim reclamation area, facing Northeast. See comments under Photo 2.

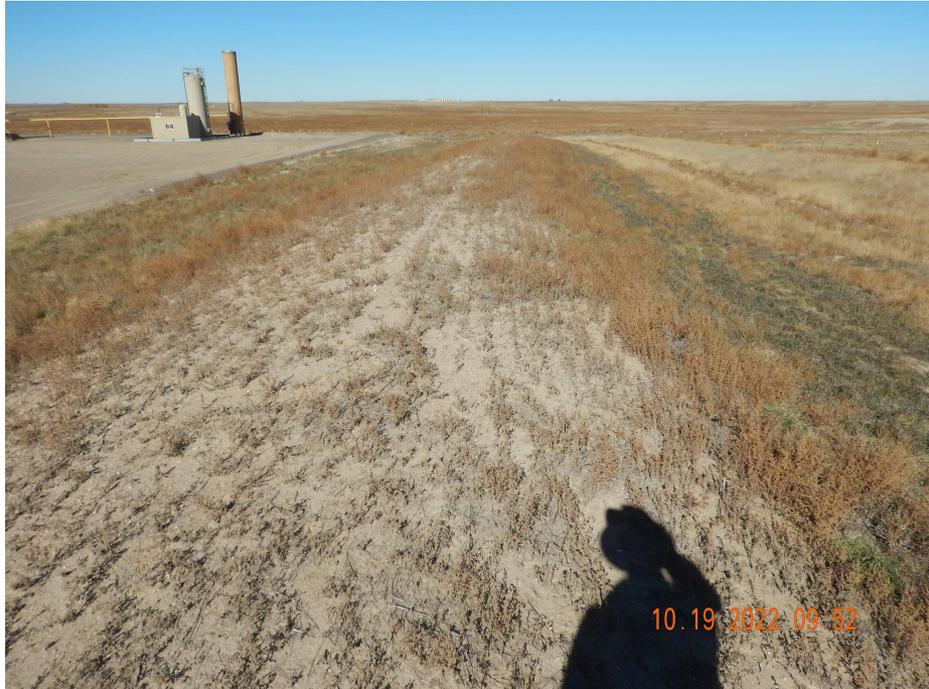
Photo 7. Photo taken from the southeastern interim reclamation area, facing Northwest. Photo illustrates a topsoil stockpile with annual, weedy Kochia establishment.

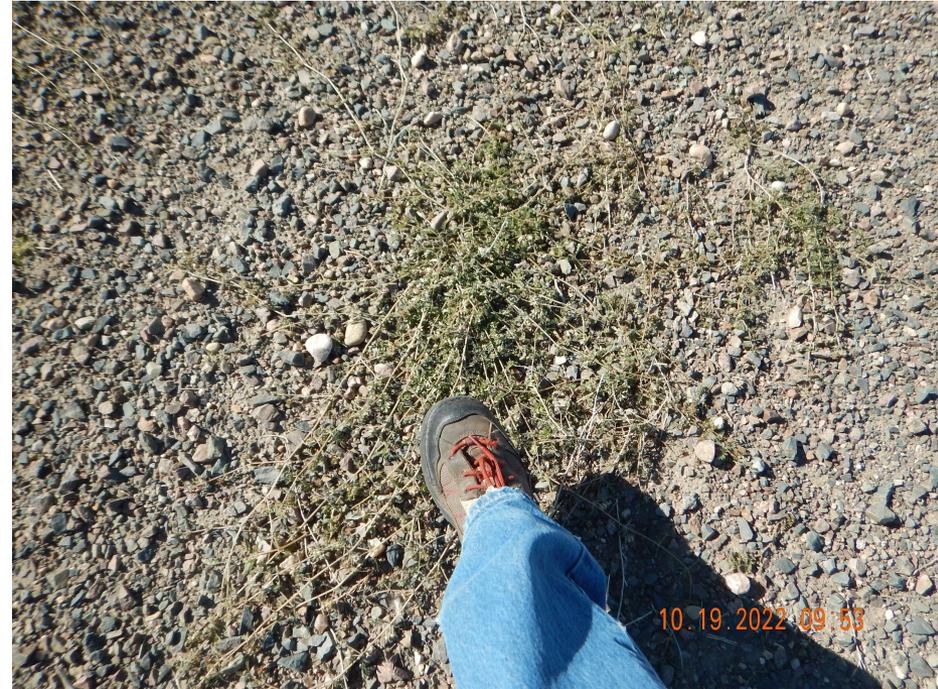
Photo 8. Photo taken from the well pad area. Photo illustrates unmanaged Puncturevine, a List C Colorado noxious weed.

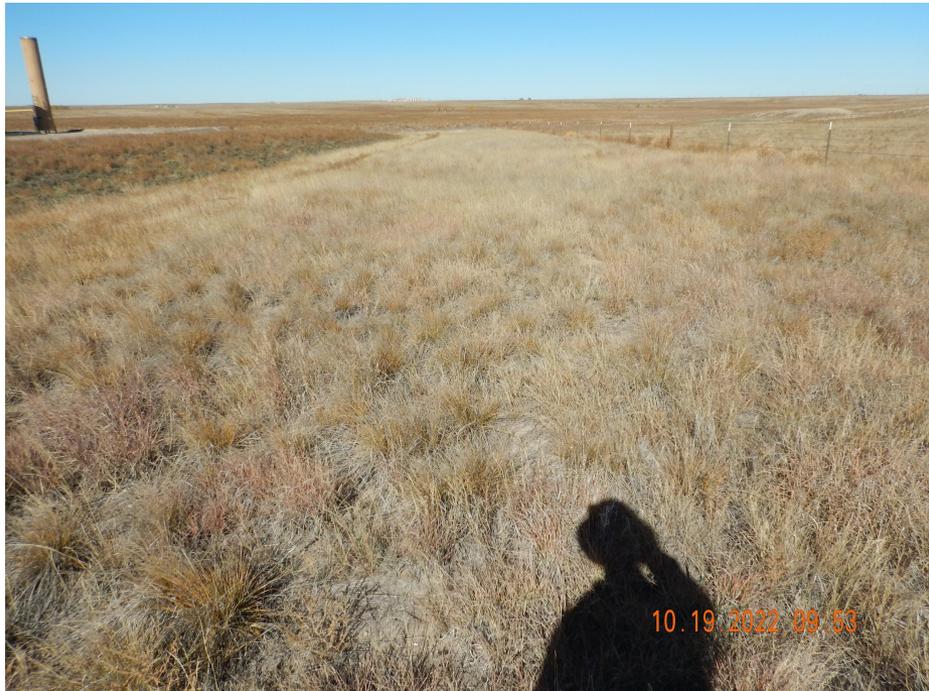
Photo 9. Reference photo taken from the northeastern interim reclamation area, facing Northwest. Photo illustrates native grass species and no introduced grass species were observed.

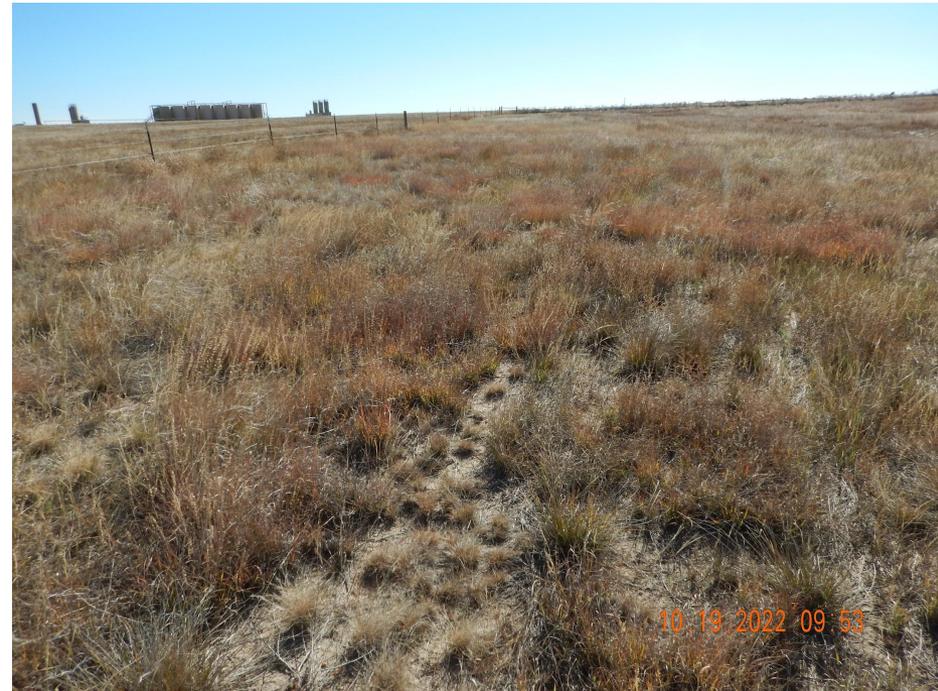
Photo 10. Reference photo taken from the northeastern interim reclamation area, facing Southeast. See comments under Photo 9.
