Interim Reclamation and Stormwater Inspection

October 19, 2022

Operator: VERDAD RESOURCES LLC #10651

Inspection Photos
Location Name: HEMBERGER/26-34-8-60
Location ID: 425541

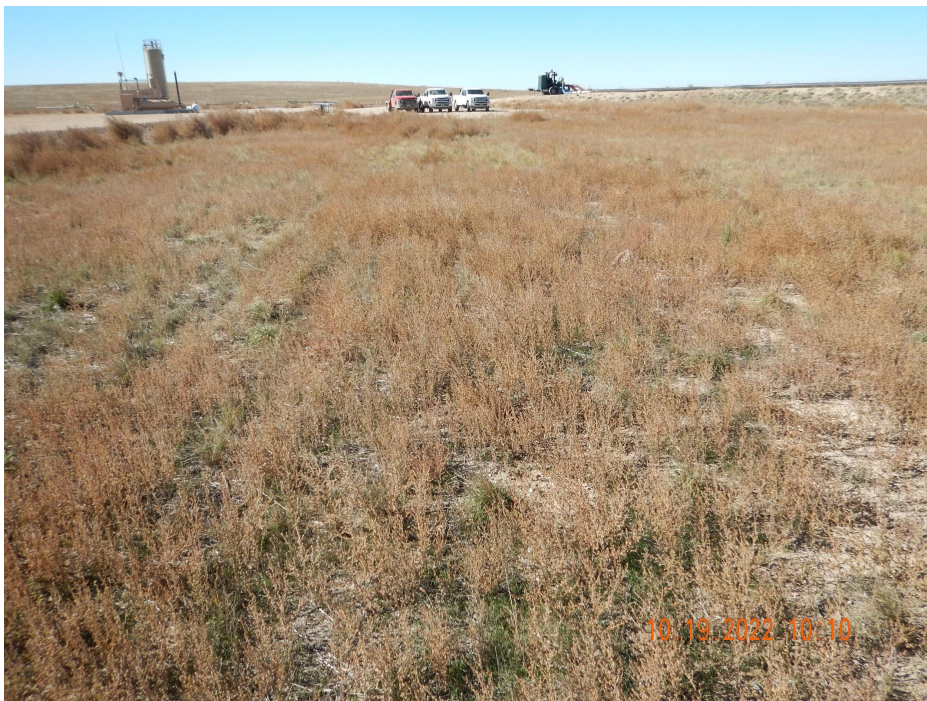
Photo 1. Photo taken from the northern interim reclamation area, facing Southwest. Photo illustrates the establishment of annual, weedy Kochia with mostly introduced grass species with some natives.

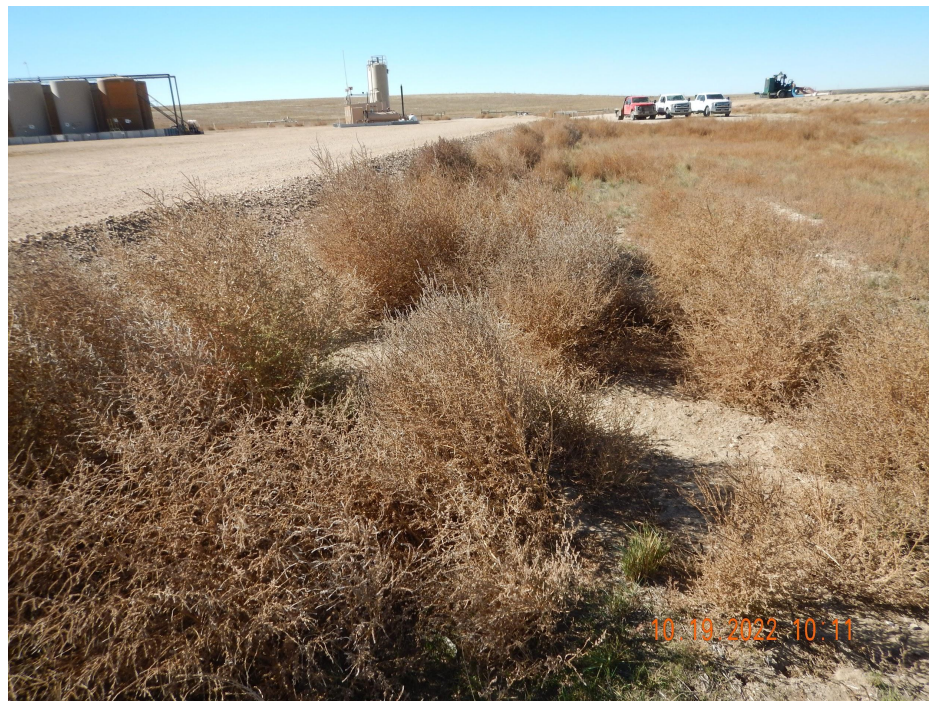
Photo 2. Photo taken from the northern interim reclamation area, facing Southwest. Photo illustrates unmanaged Kochia.

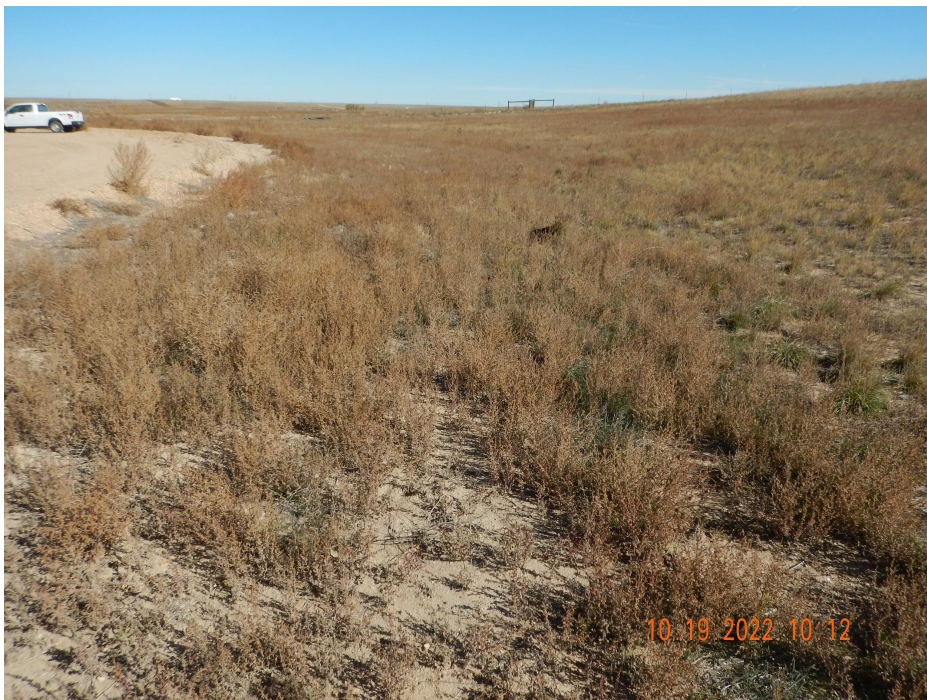
Photo 3. Photo taken from the southwestern interim reclamation area, facing Northeast. See comments under Photo 1.

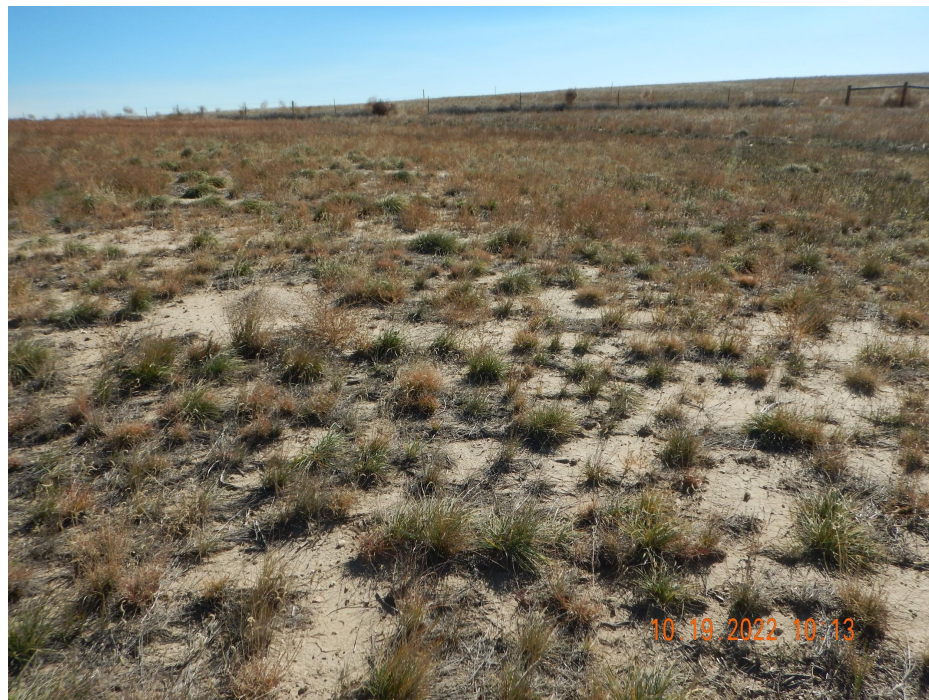
Photo 4. Photo taken from the south/southeastern interim reclamation area, facing South. Photo illustrates the establishment of mostly introduced grass species with some natives.

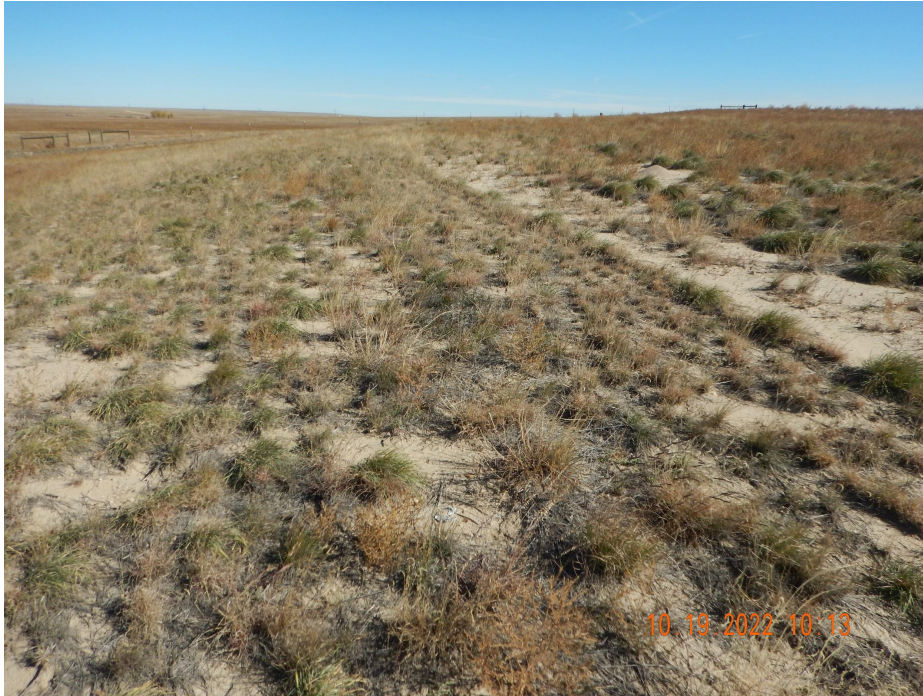
Photo 5. Photo taken from the south/southeastern interim reclamation area, facing Northeast. See comments under Photo 4.

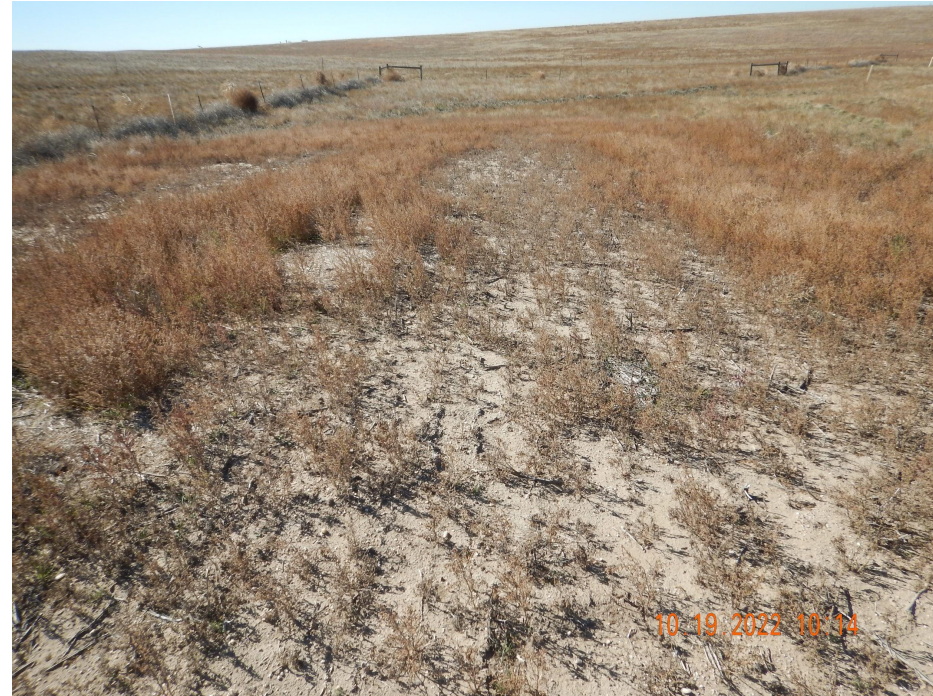
Photo 6. Photo taken from the south/southeastern interim reclamation area, facing Southwest. Photo illustrates an area of annual, weedy Kochia establishment.

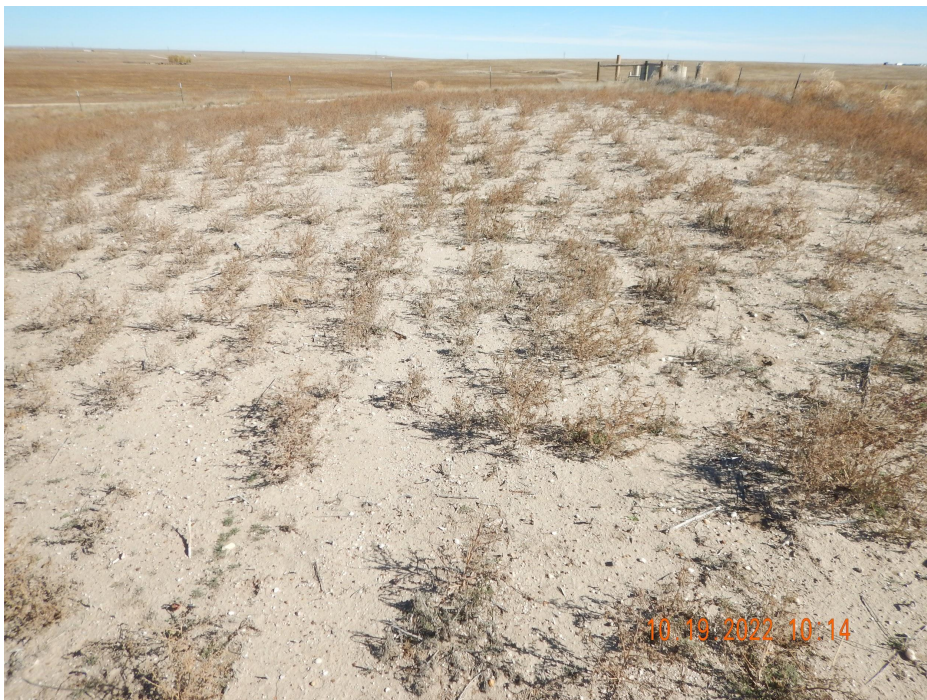
Photo 7. Photo taken from the southeastern interim reclamation area, facing Northeast. Photo illustrates bare ground with some Kochia.

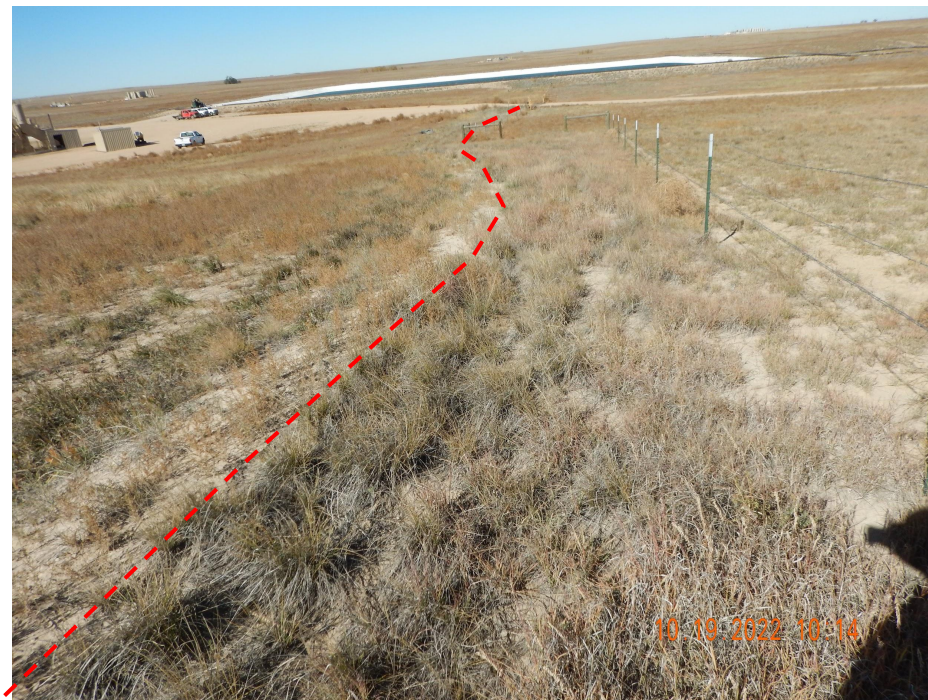
Photo 8. Reference photo taken from the southeastern interim reclamation area, facing Northwest. Photo illustrates native grass species and no introduced grass species were observed.

Interim reclamation areas are to the left of the red-dashed line and reference areas to the right.

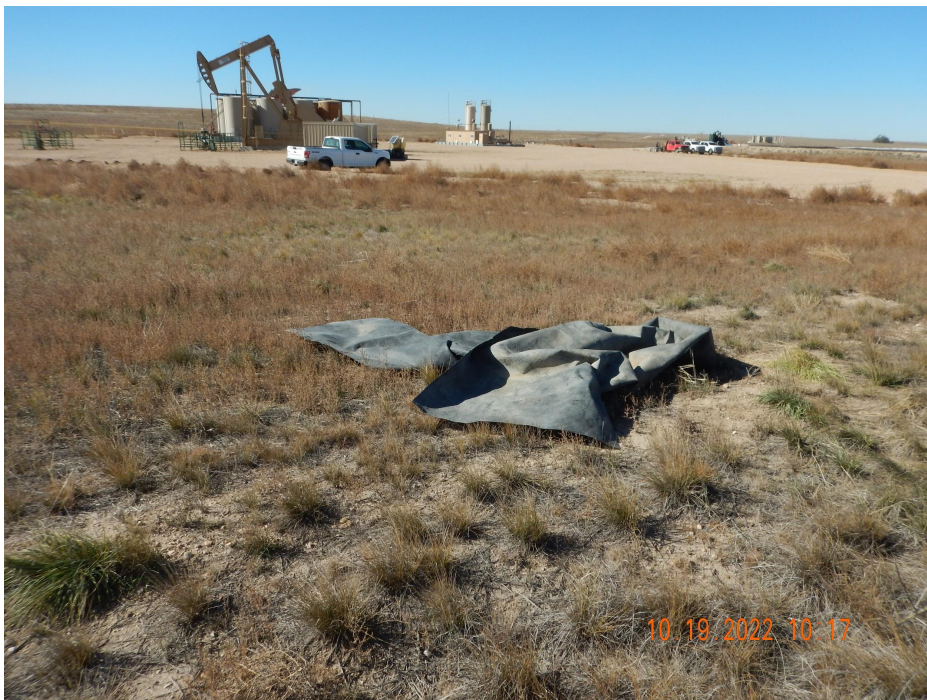
Photo 9. Photo taken from the eastern interim reclamation area, facing West. Photo illustrates trash/debris from the pit liner.

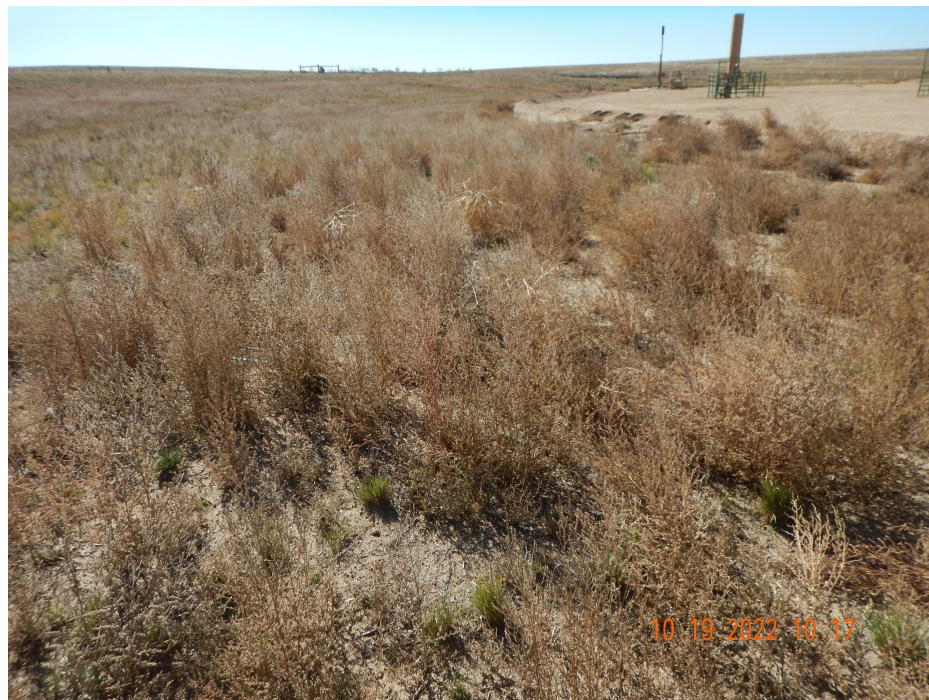
Photo 10. Photo taken from the eastern interim reclamation area, facing South. See comments under Photo 2.

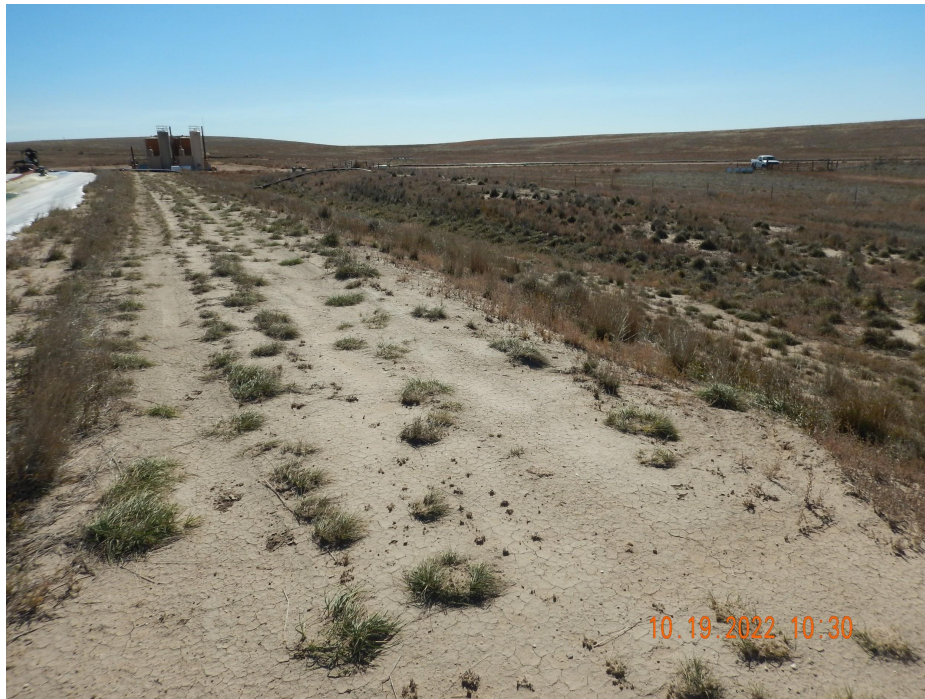
Photo 11. Photo taken from the southern pit, facing Southeast. Photo illustrates the establishment of mostly introduced grass species with some natives and bare ground.

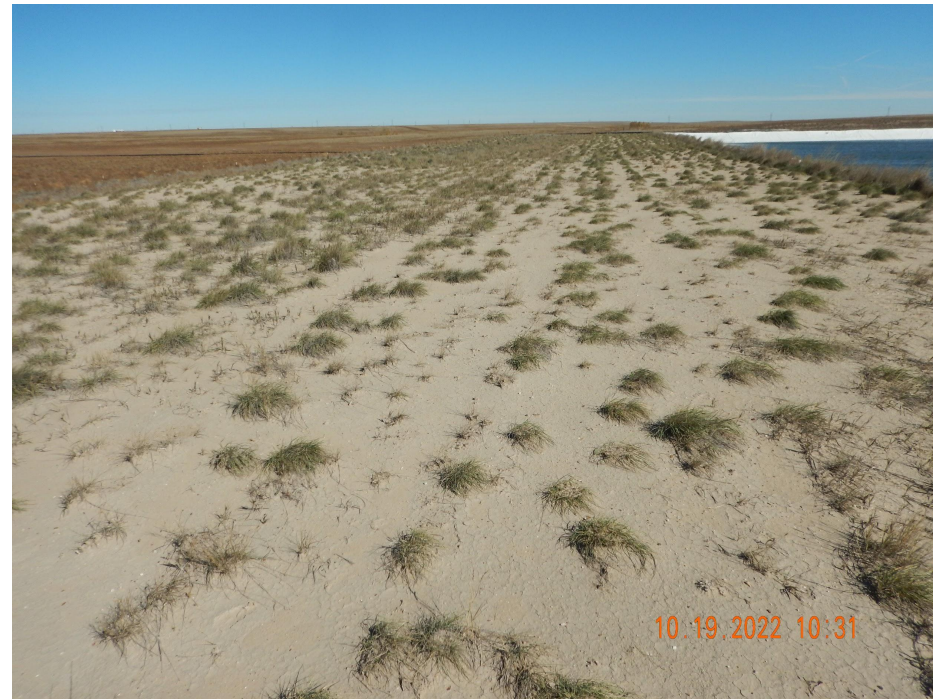
Photo 12. Photo taken from the southern pit, facing Northeast. See comments under Photo 11.

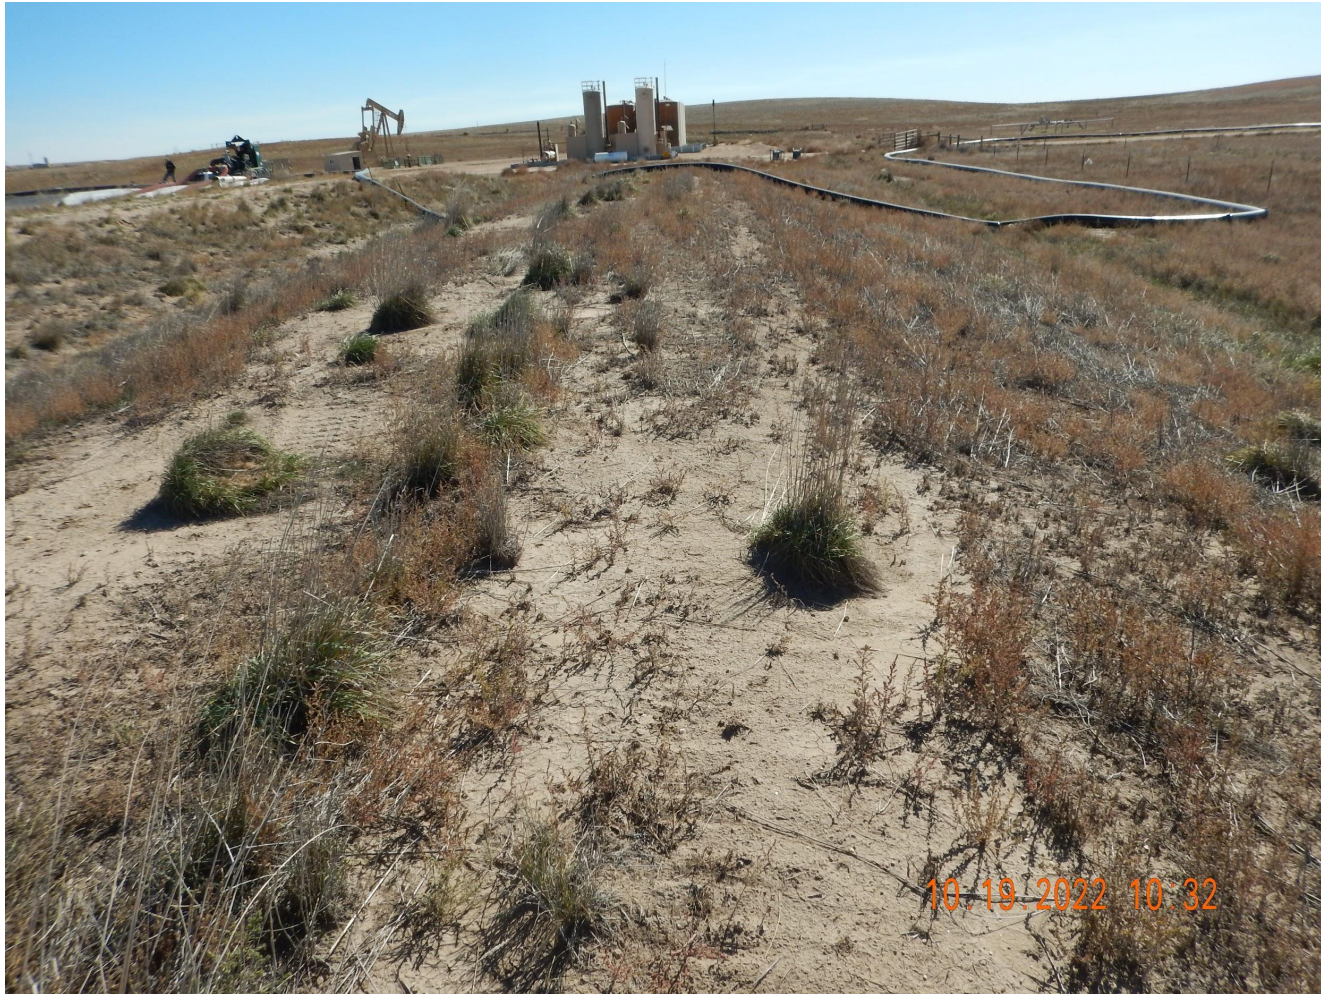
Photo 13. Photo taken from the pit topsoil stockpile, facing Southeast. Photo illustrates the establishment of mostly introduced grass species and Kochia.
