Inspection Photogs
Location Name: Huntington A 1
Location ID: 325737

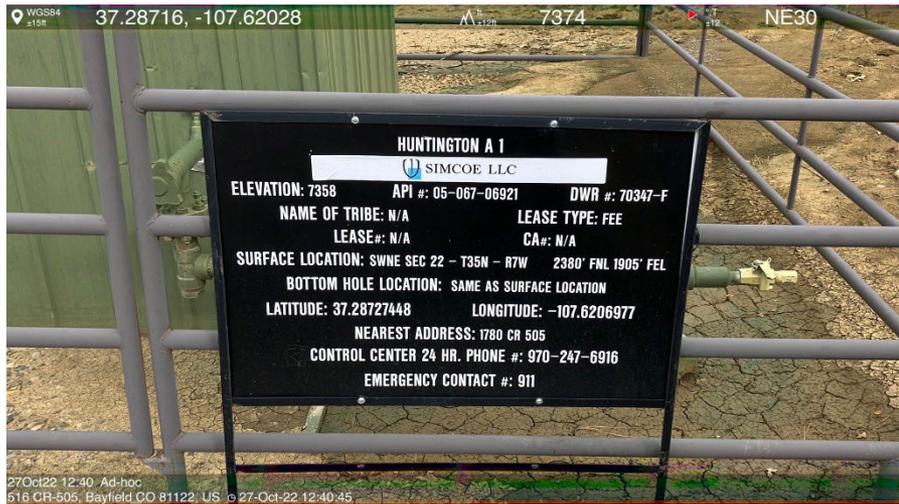
IMG 01
Well sign

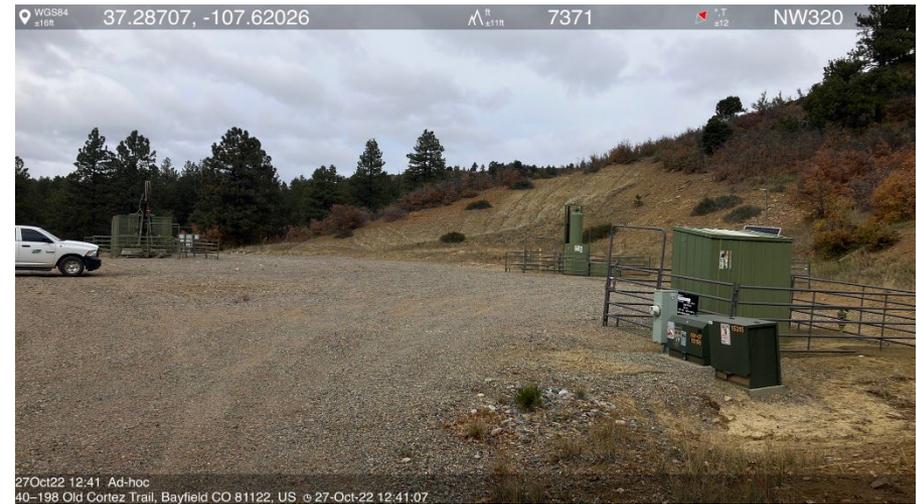
IMG 02
Location overview

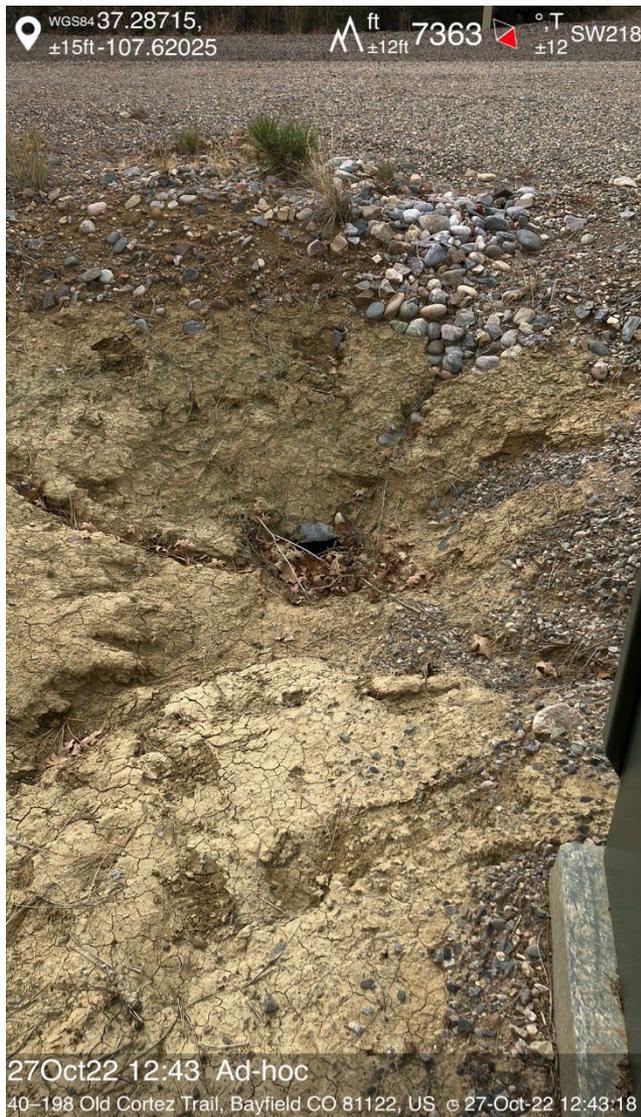
IMG 03

Culvert inlet is filled with sediment.

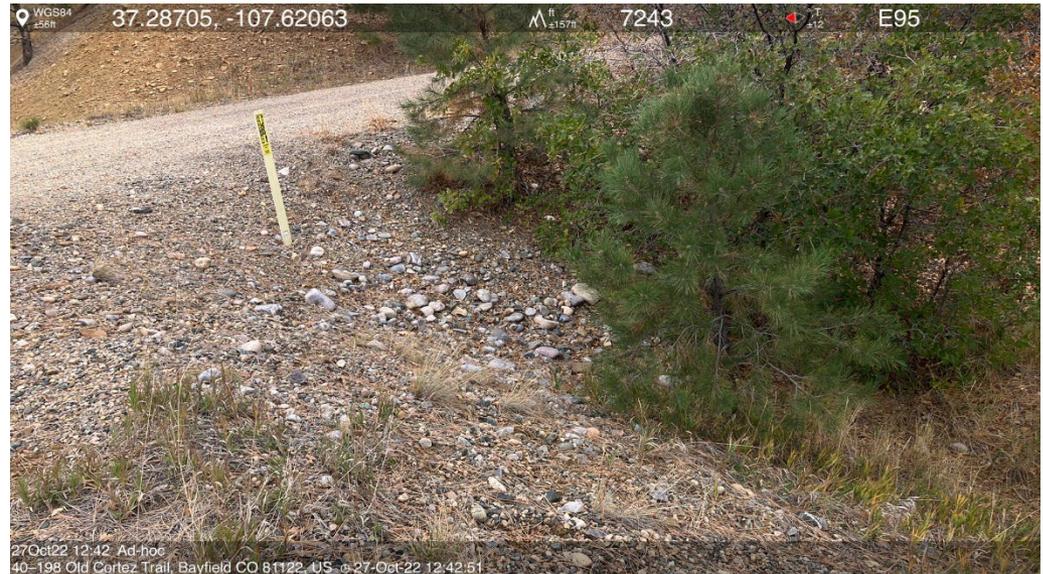
IMG 04

Culvert outlet is covered with sediment.

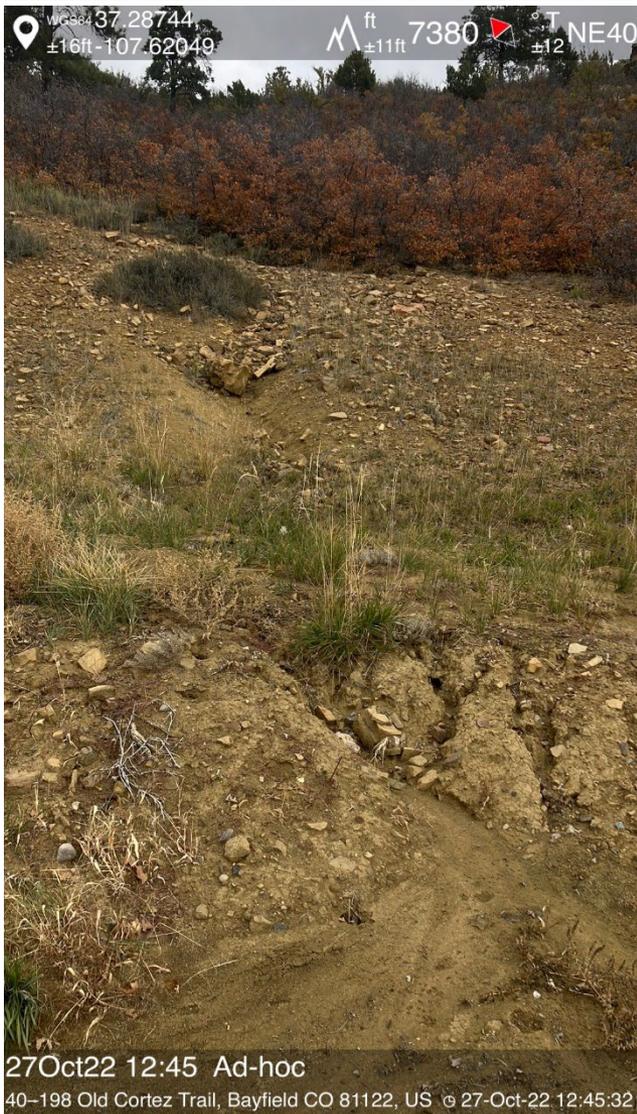
IMG 05
Erosion channel on cut slope

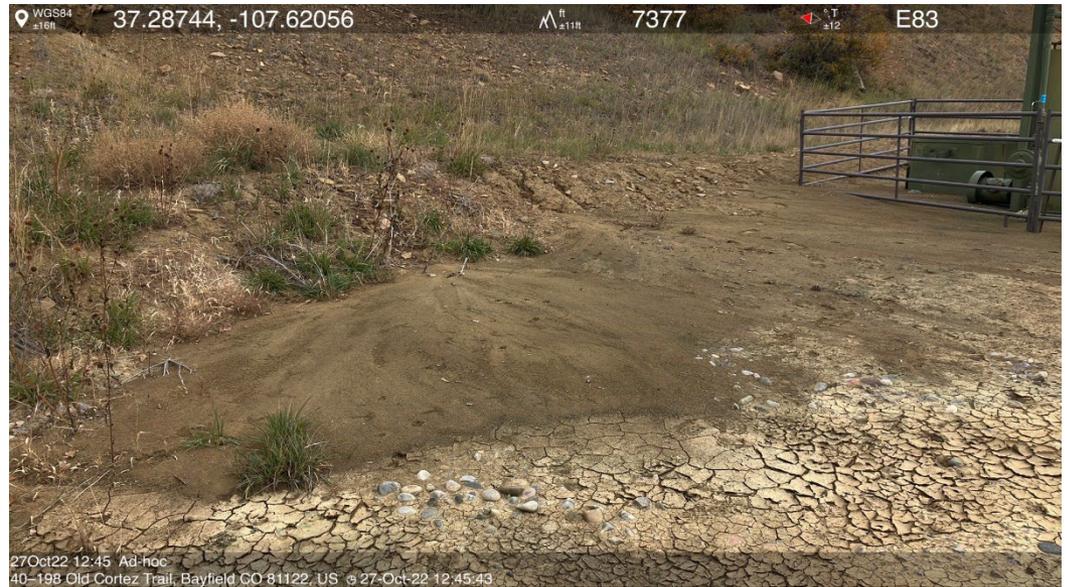
IMG 06
Sediment on location from erosion channel

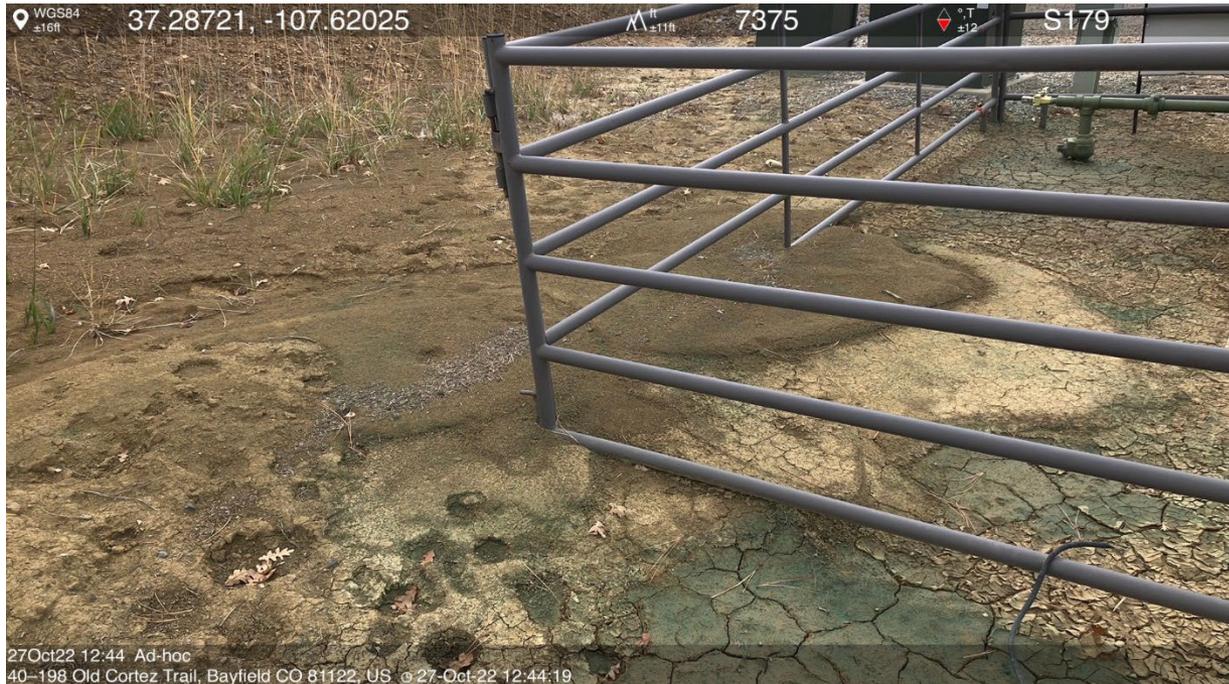
IMG 07

Sediment on location from upgradient, near gas meter run
