Inspection Photos

API: 073-06189

Operator: MAGPIE OPERATING INC

Inspection Date: 10/25/2022

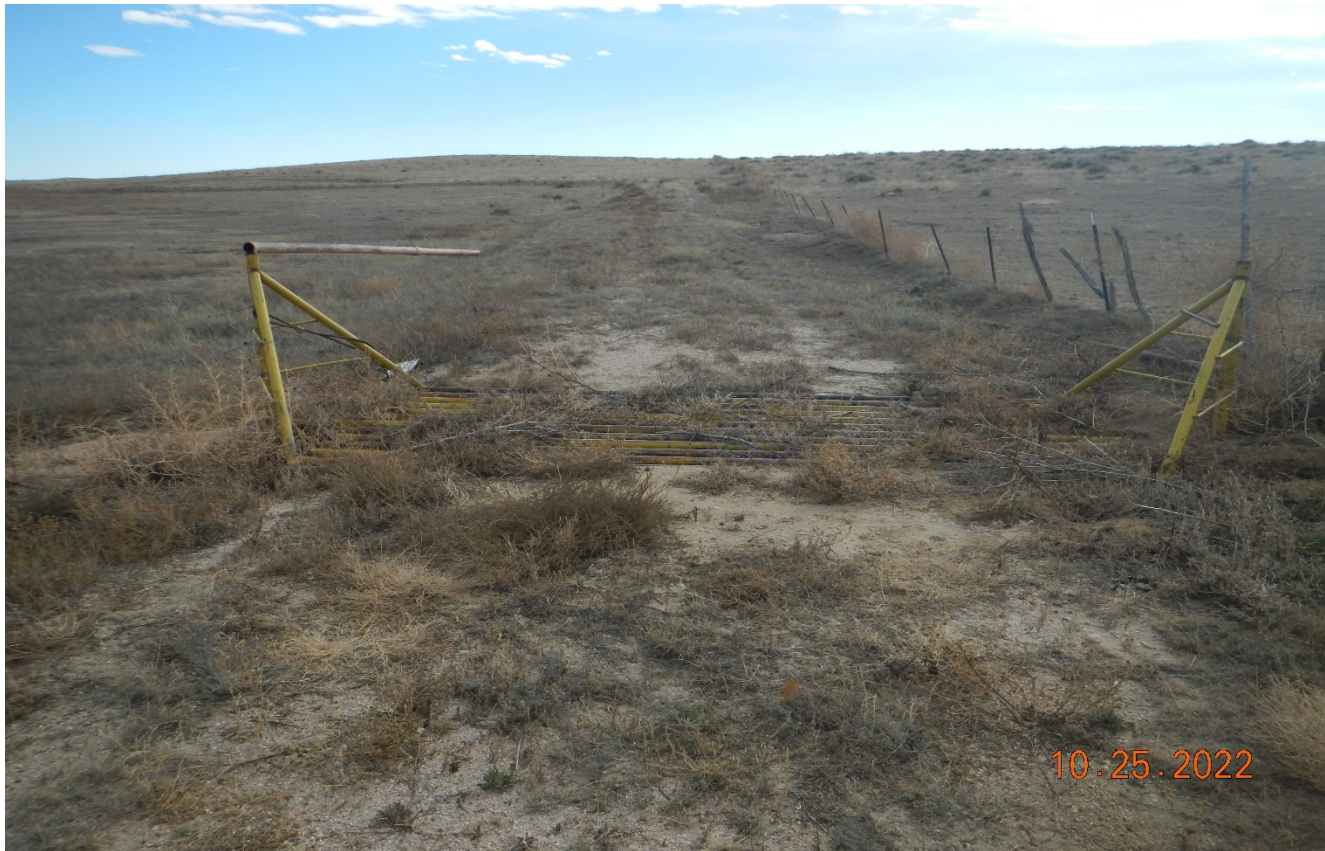
Photo 1. Facing south toward the access road. The cattleguard has not been removed and is filled in with sediment. Previous corrective action was not completed.

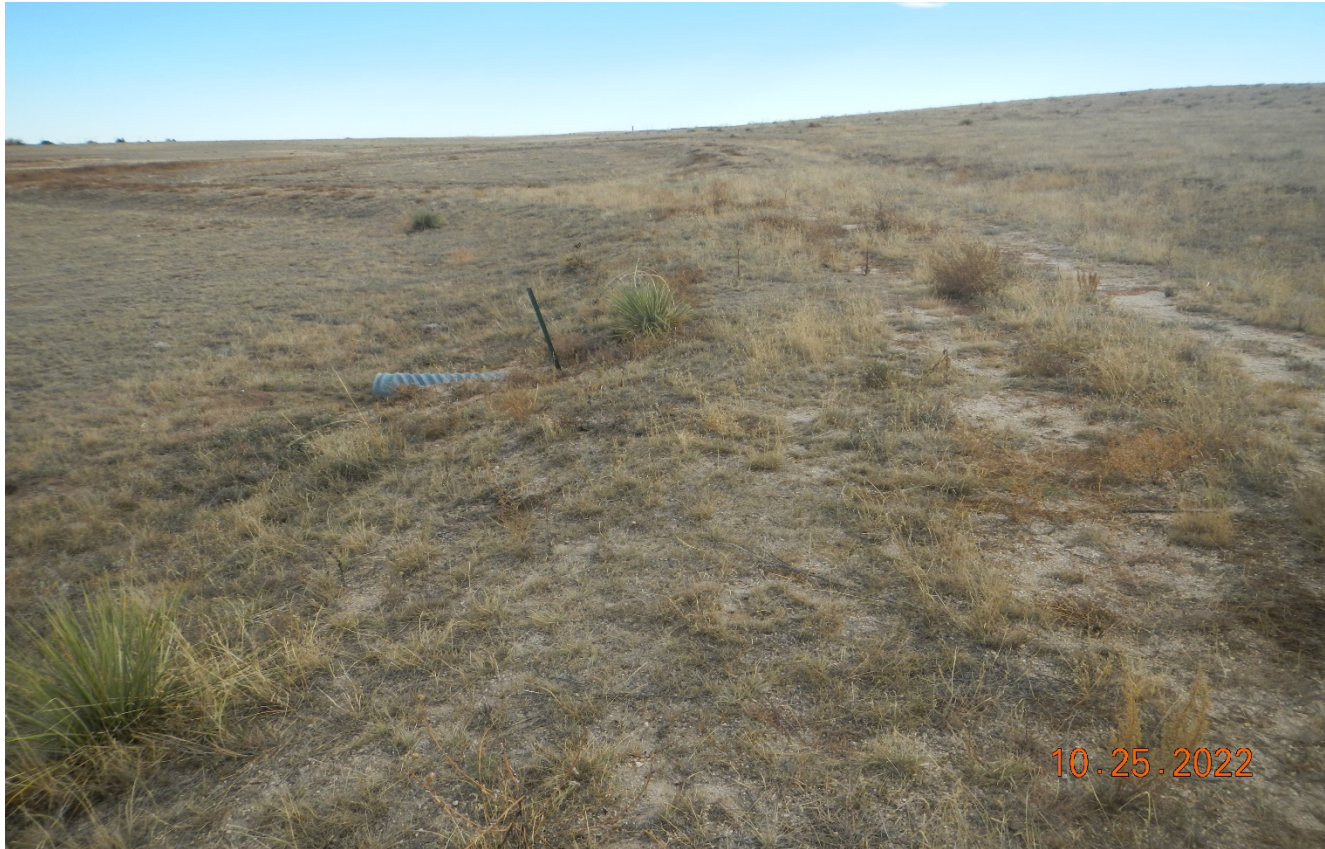
Photo 2. Facing southeast along the access road . The road has not been recontoured and culverts remain. Previous corrective action was not completed.

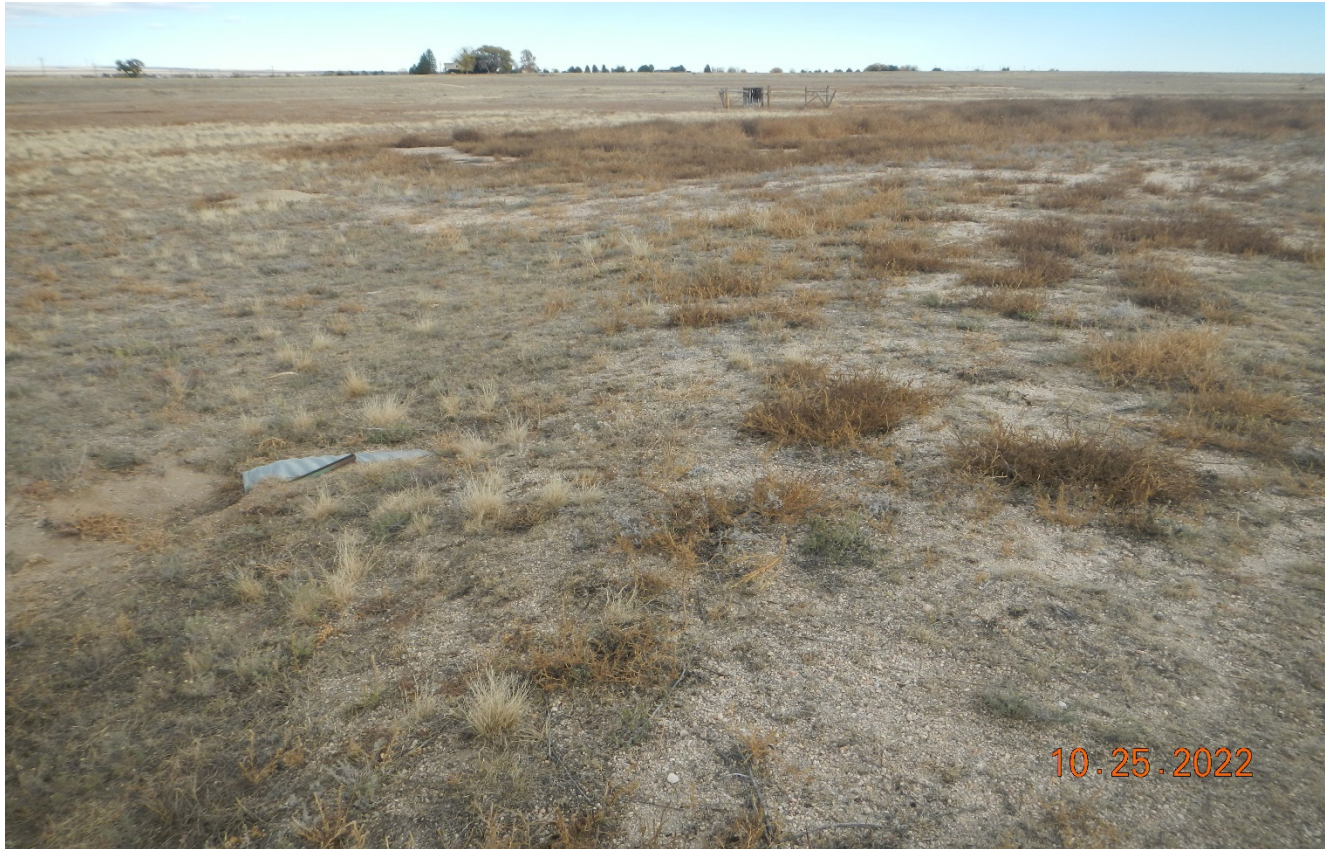
Photo 3. Facing east along the access road toward the location. The road has not been recontoured and culverts remain. Previous corrective action was not completed.

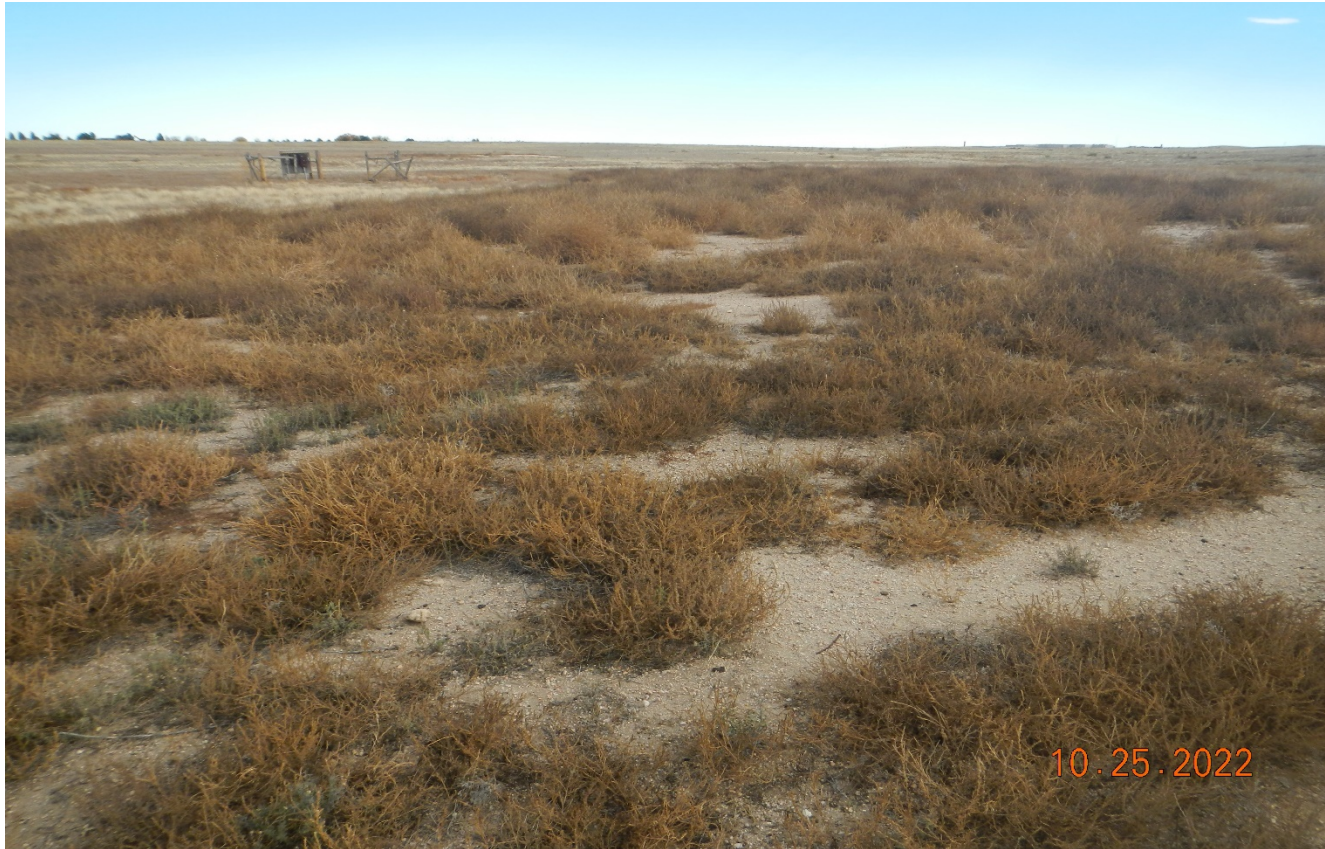
Photo 4. Facing east at the location. The location has not been reclaimed and there is undesirable weed throughout the location. (brown veg. → Russian thistle)

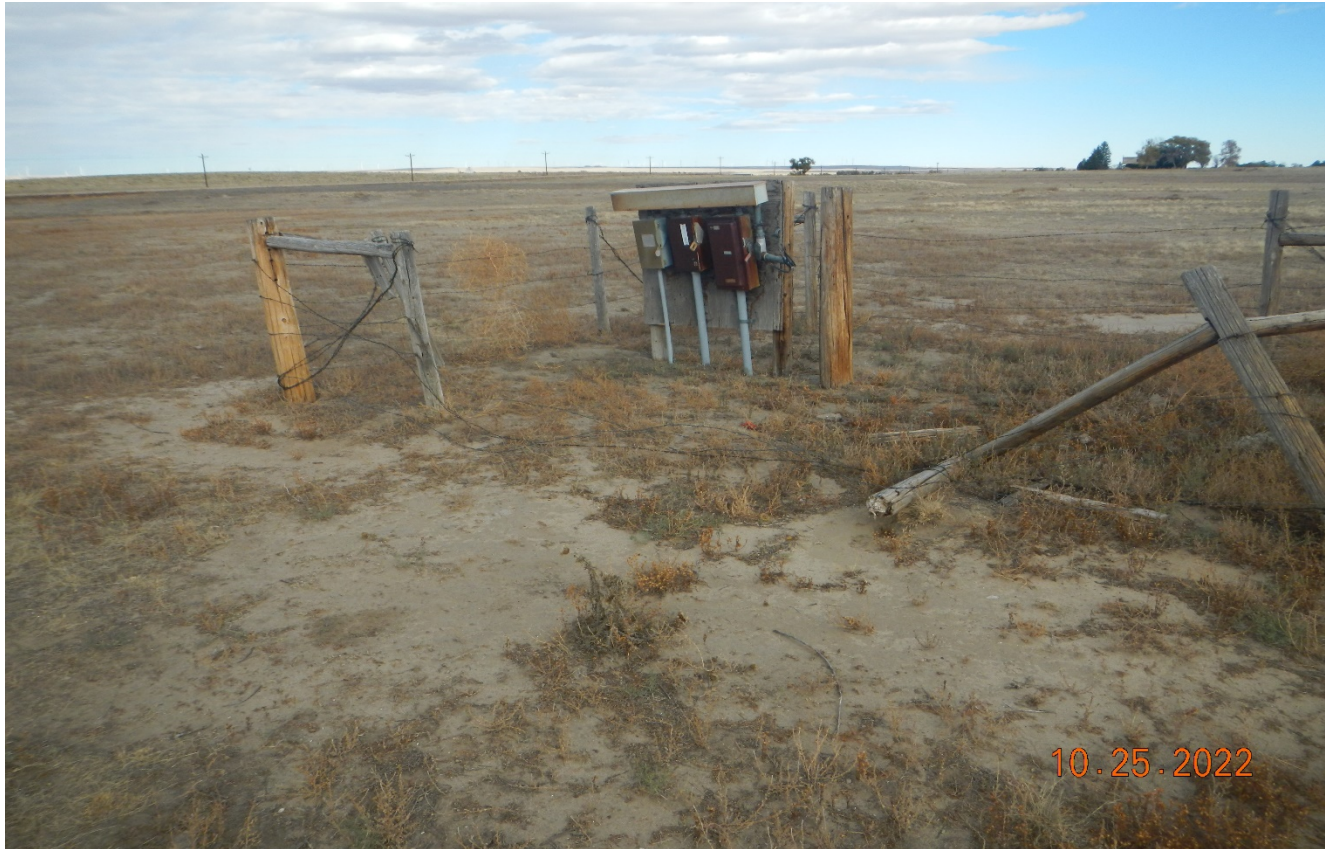
Photo 5. There is electric utilizes and a fence in disrepair that remain at the location. All equipment should have been removed within 3 months of abandonment. Previous corrective action was not completed.

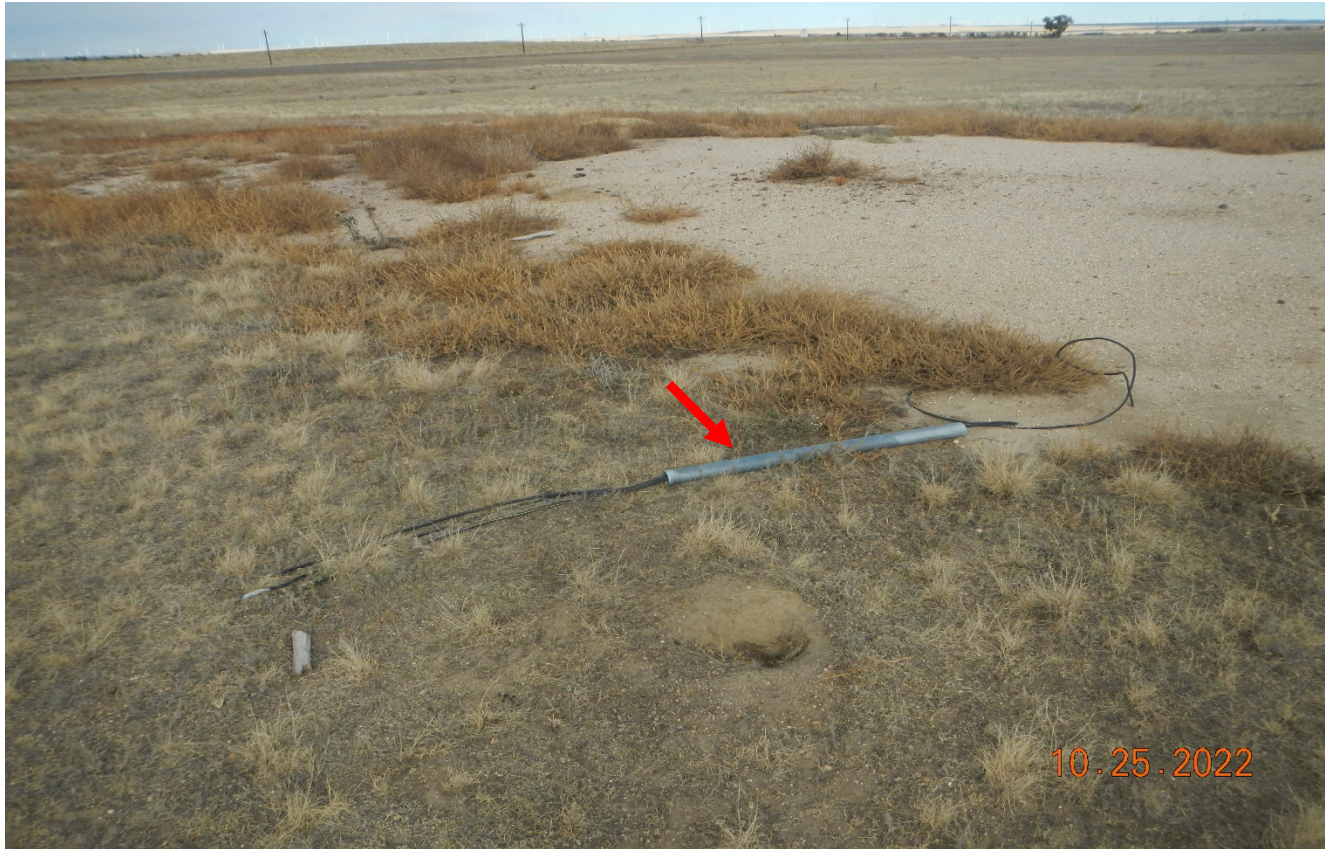
Photo 6. Facing northeast abandoned wellsite location. There are electric utility wires that have not been removed and the location has not been reclaimed.

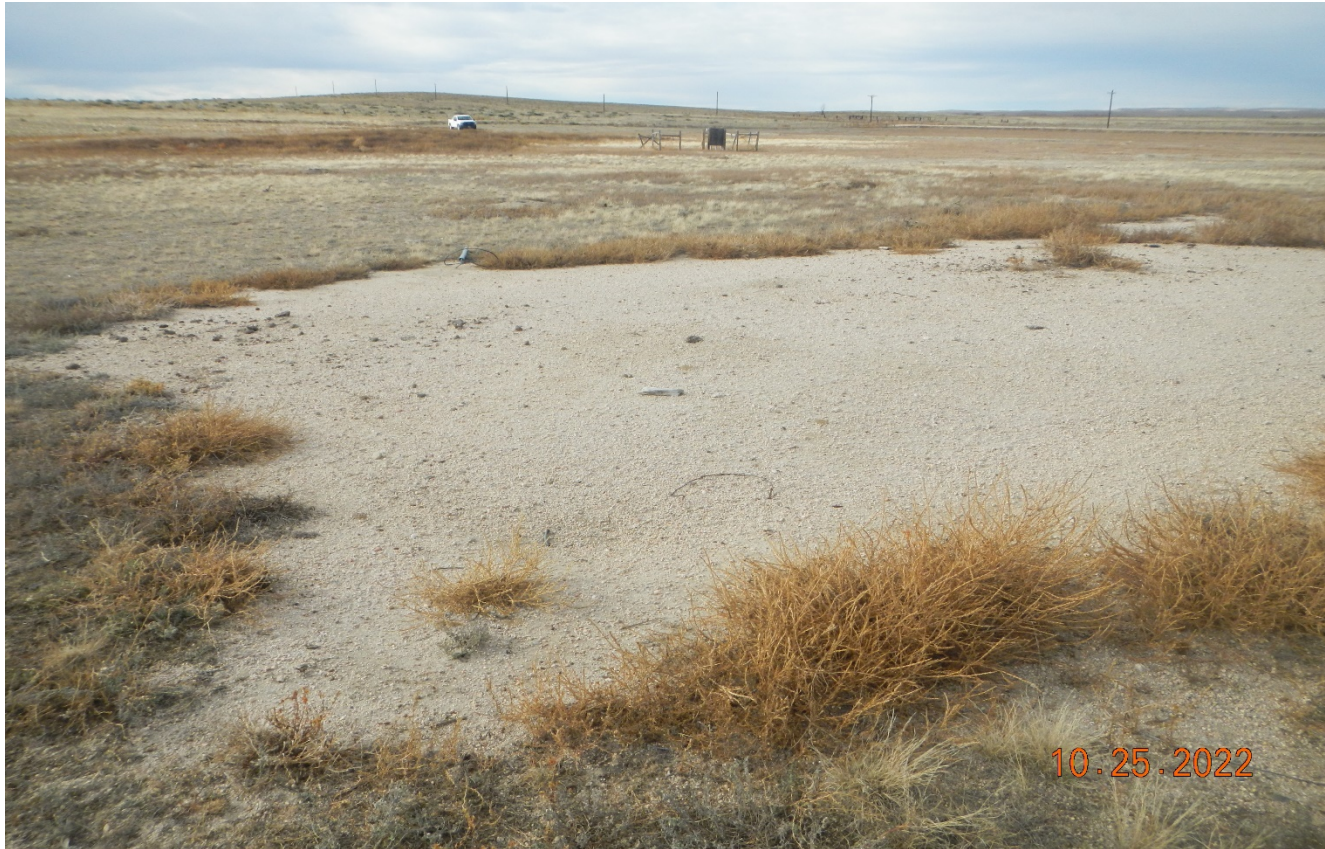
Photo 7. Facing northwest at the abandoned wellsite location. This area approximately 50'x50' is bare of vegetation. The location has not been reclaimed.

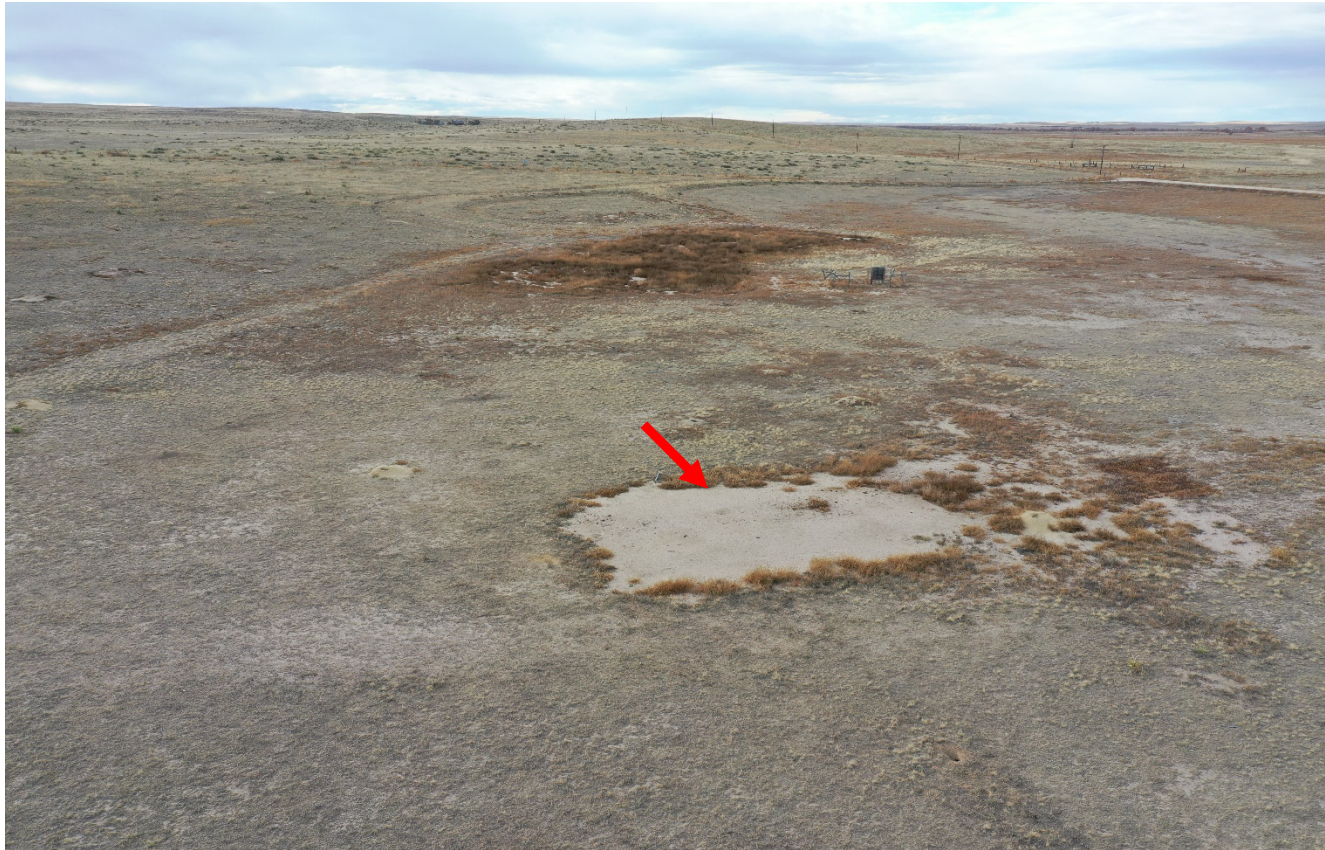
Photo 8. Drone aerial photo facing northwest toward the location. The red arrow points to the abandoned wellsite shown in photo 6-7.

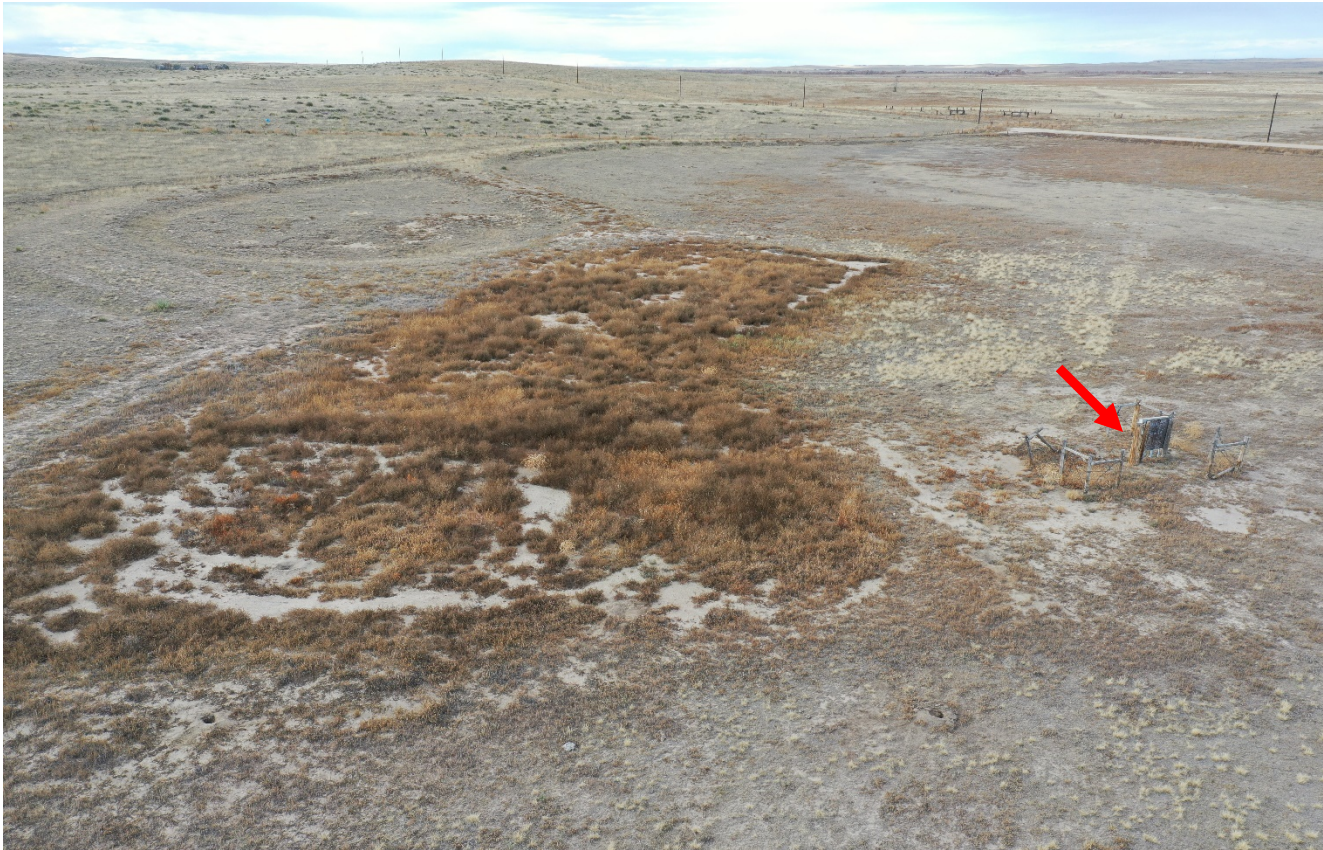
Photo 9. Drone aerial photo facing northwest toward the location. The brown vegetation is undesirable weeds → Russian thistle. The electric utilities shown in photo 5 are located at red arrow. This area appears to be the former tank battery site.

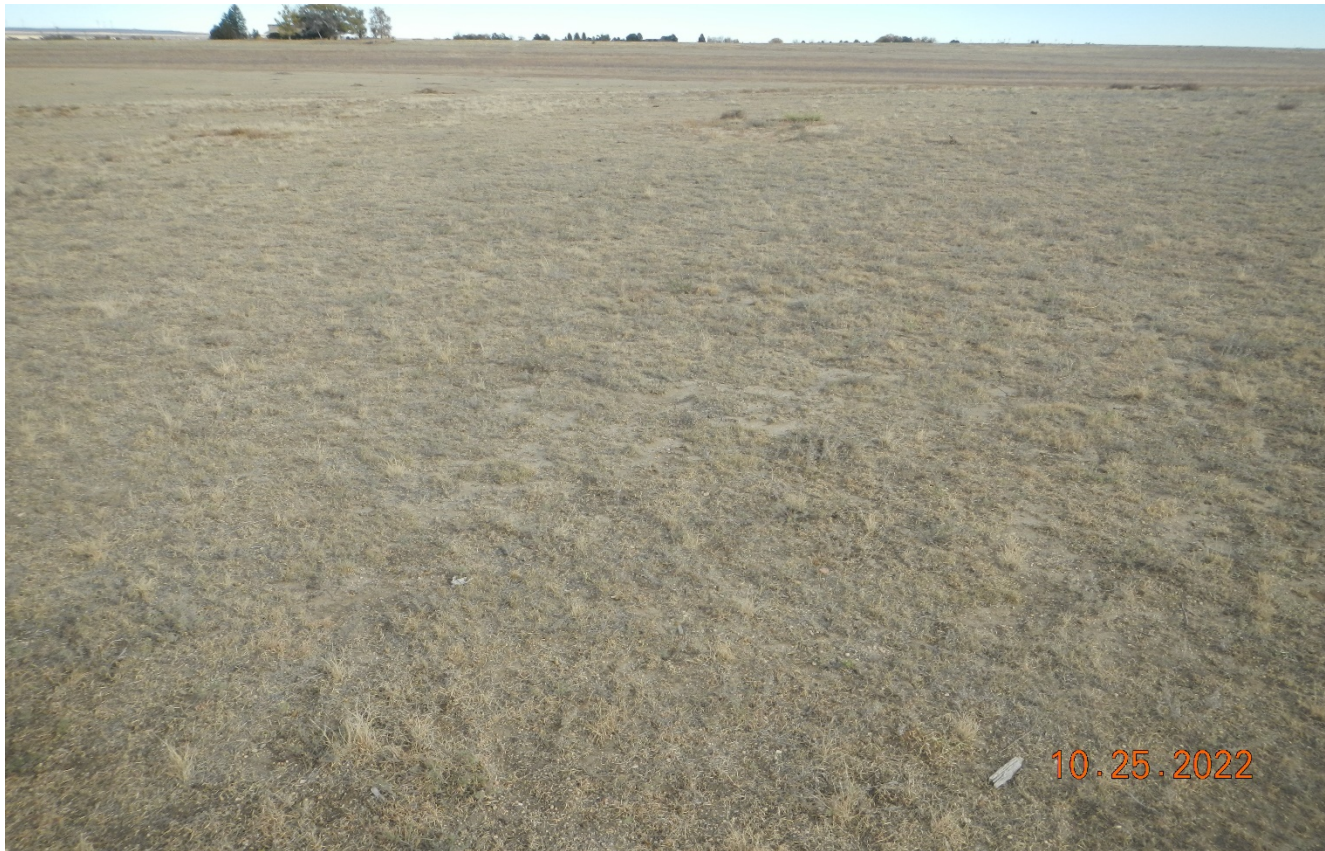
Photo 10. Facing toward the surrounding reference area consisting of Blue grama, Sand dropseed, among other native species.
