Colton Limited Liability CO, Cookie Jar 1
005-07005

Inspection #688313300

10/28/2022

PA Inspection, day 2

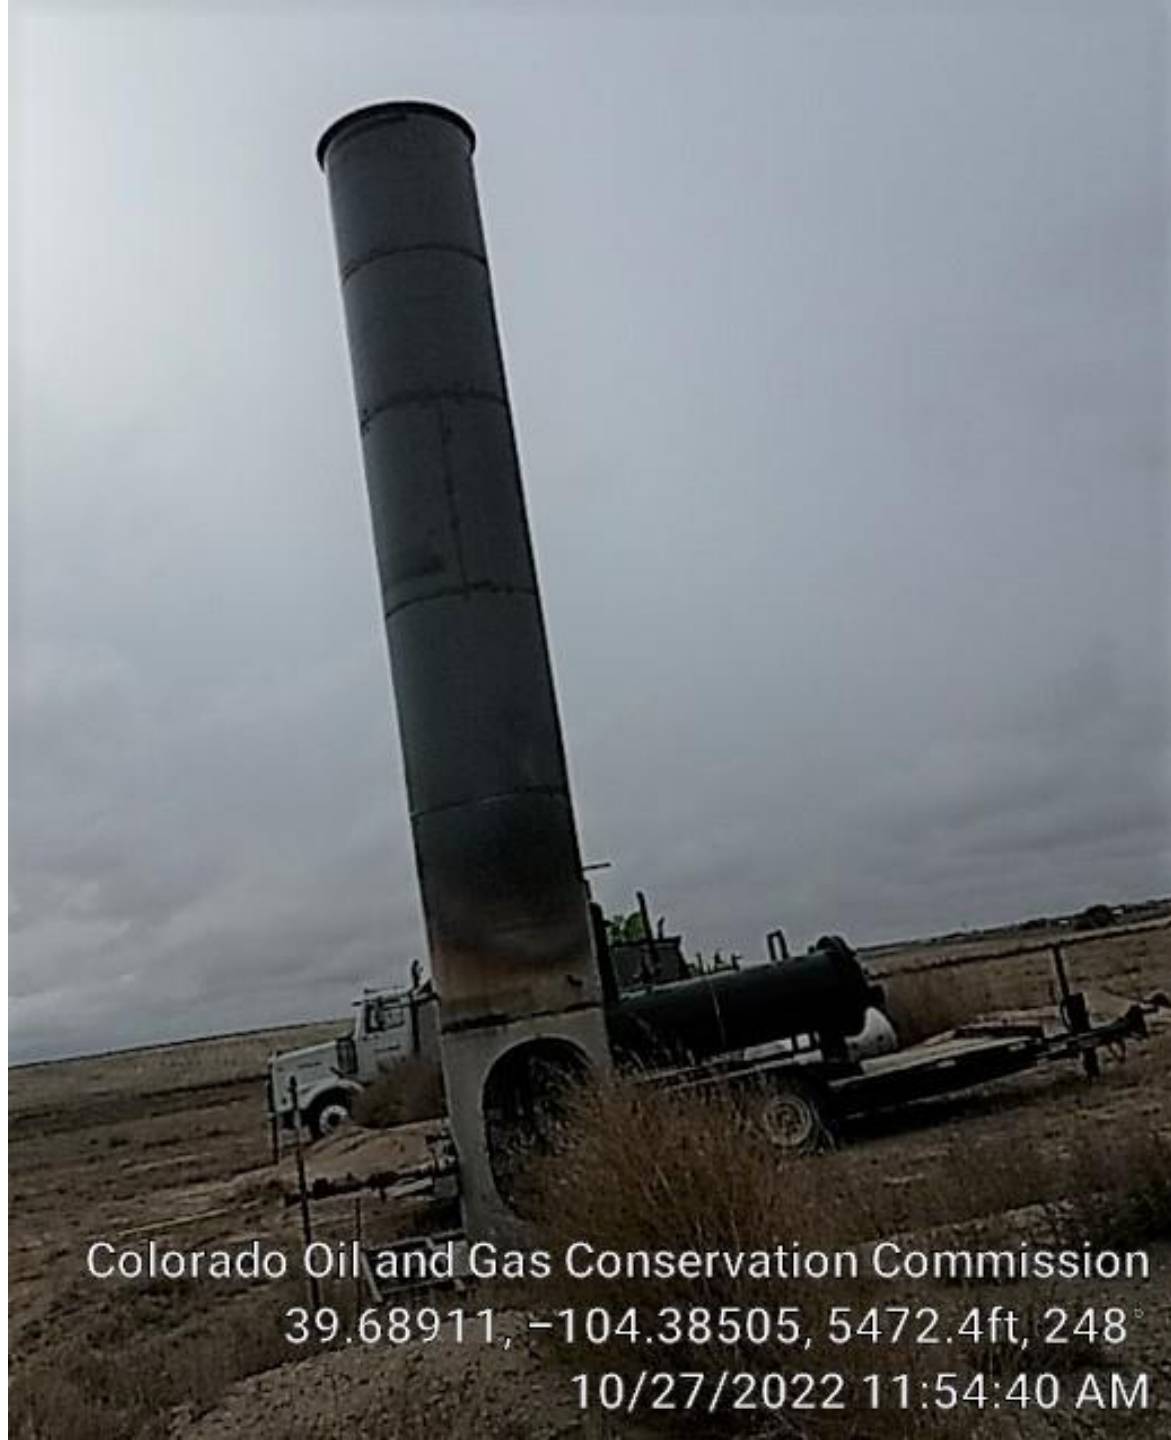
ECD not used for PA

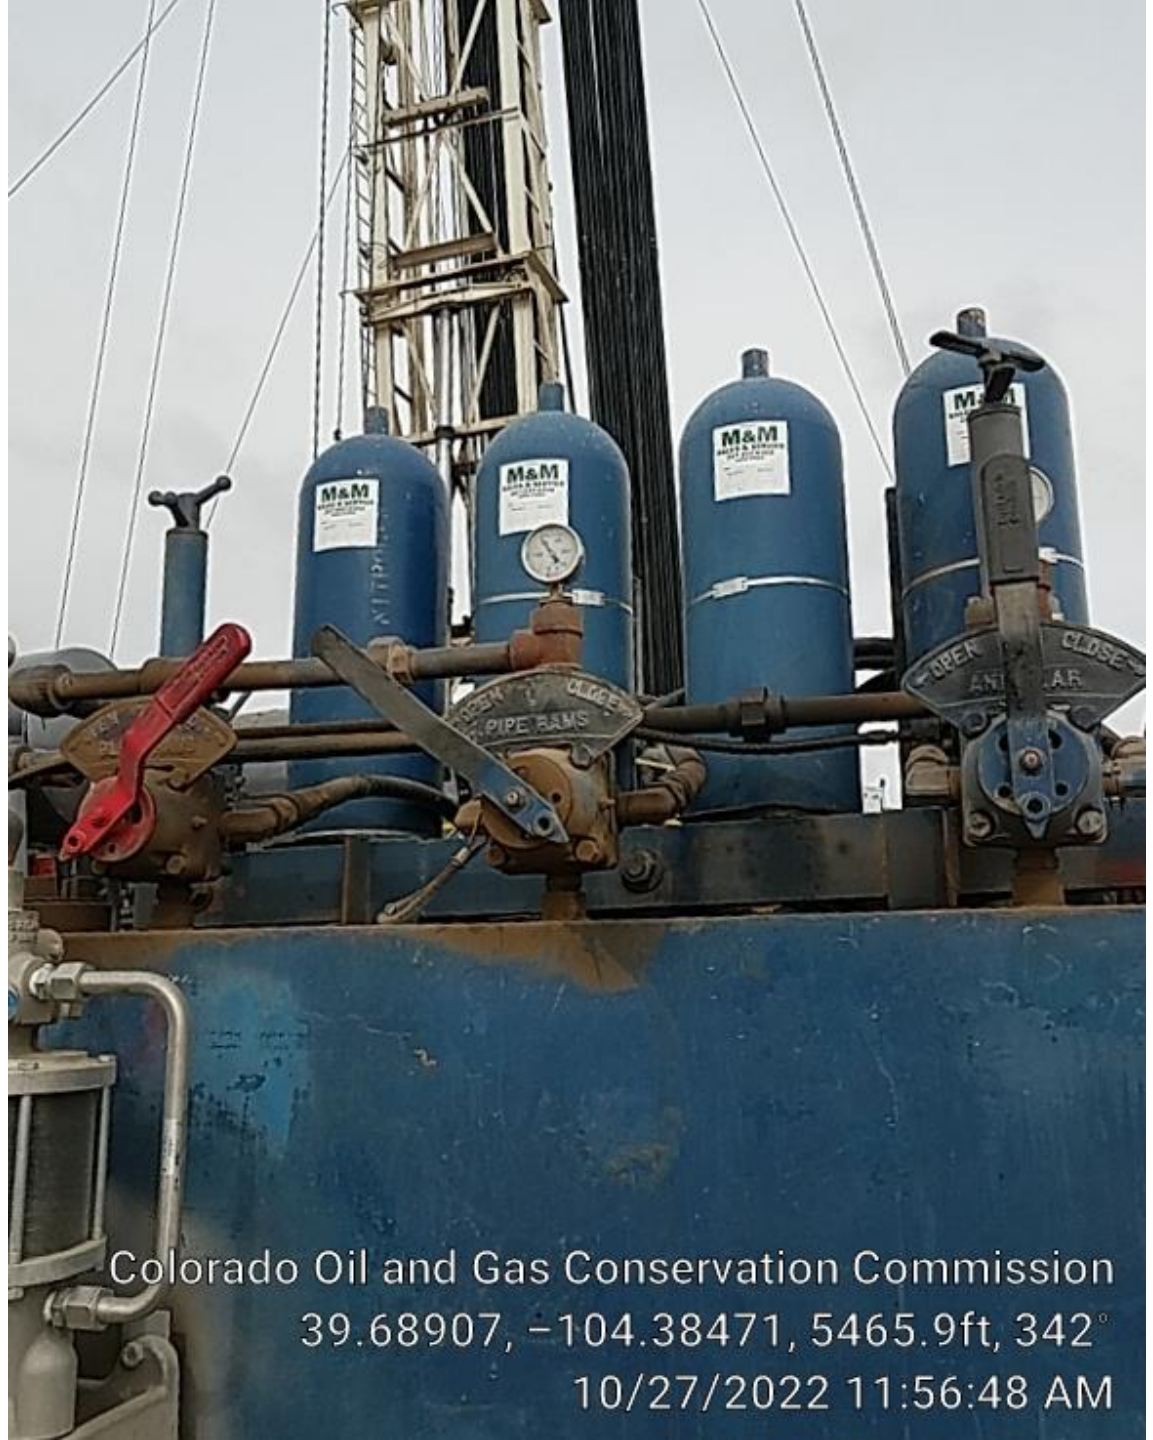
Accumulator/pipe
rams at 2000 psi

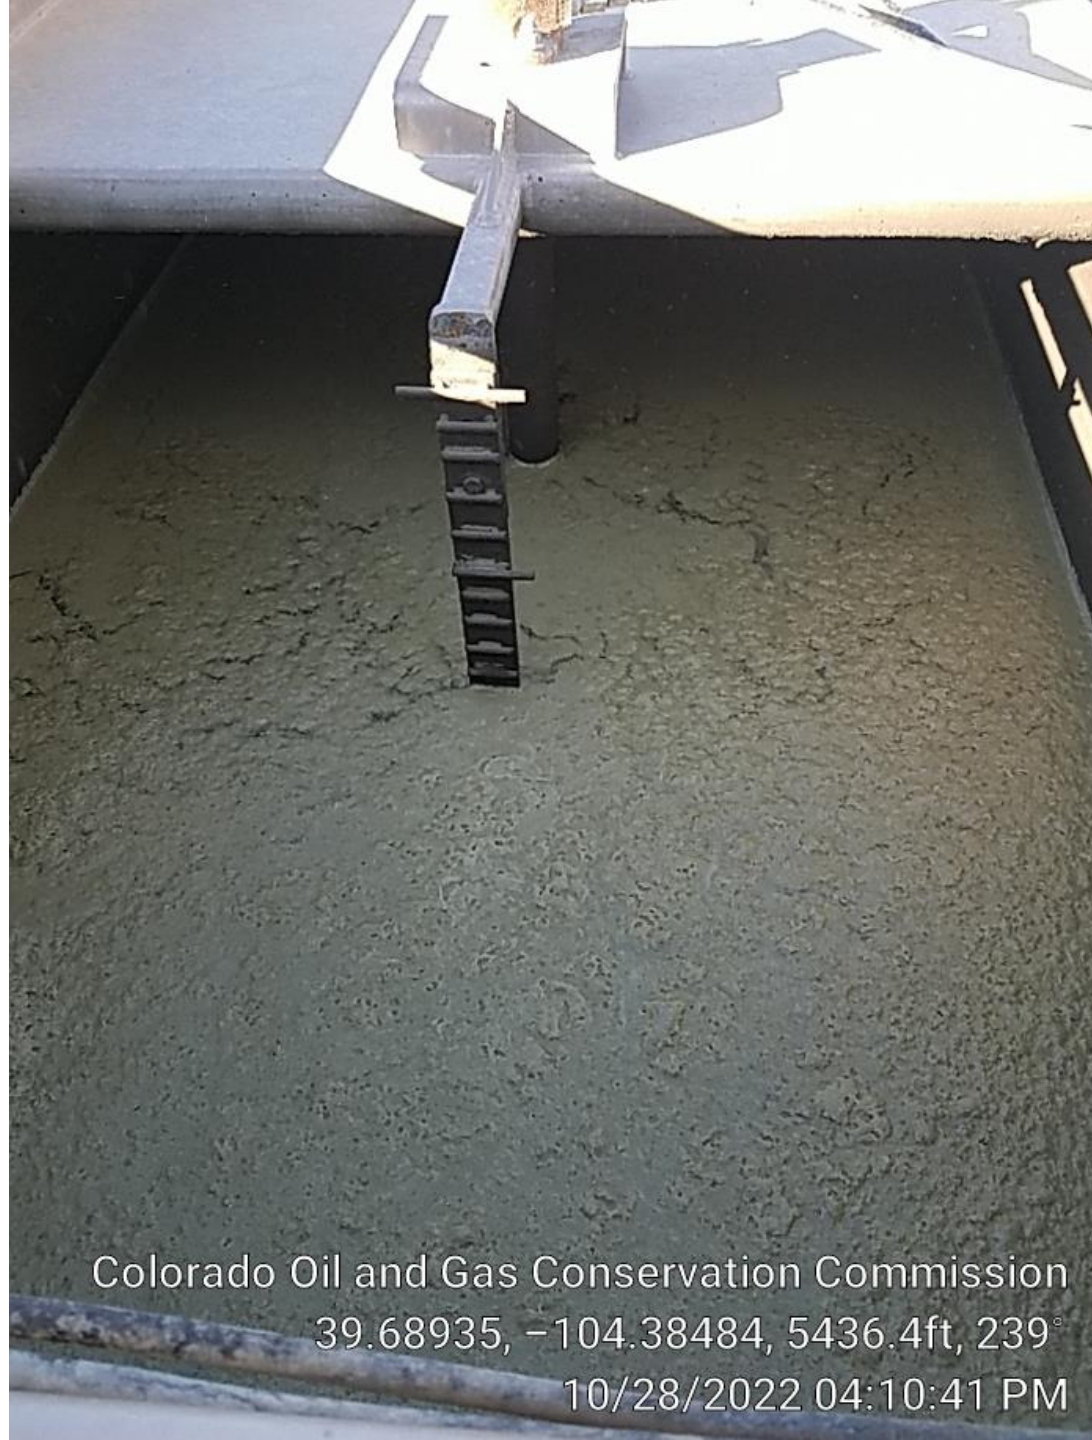
Water in cement pump truck tanks had algae for the water zone plugs.

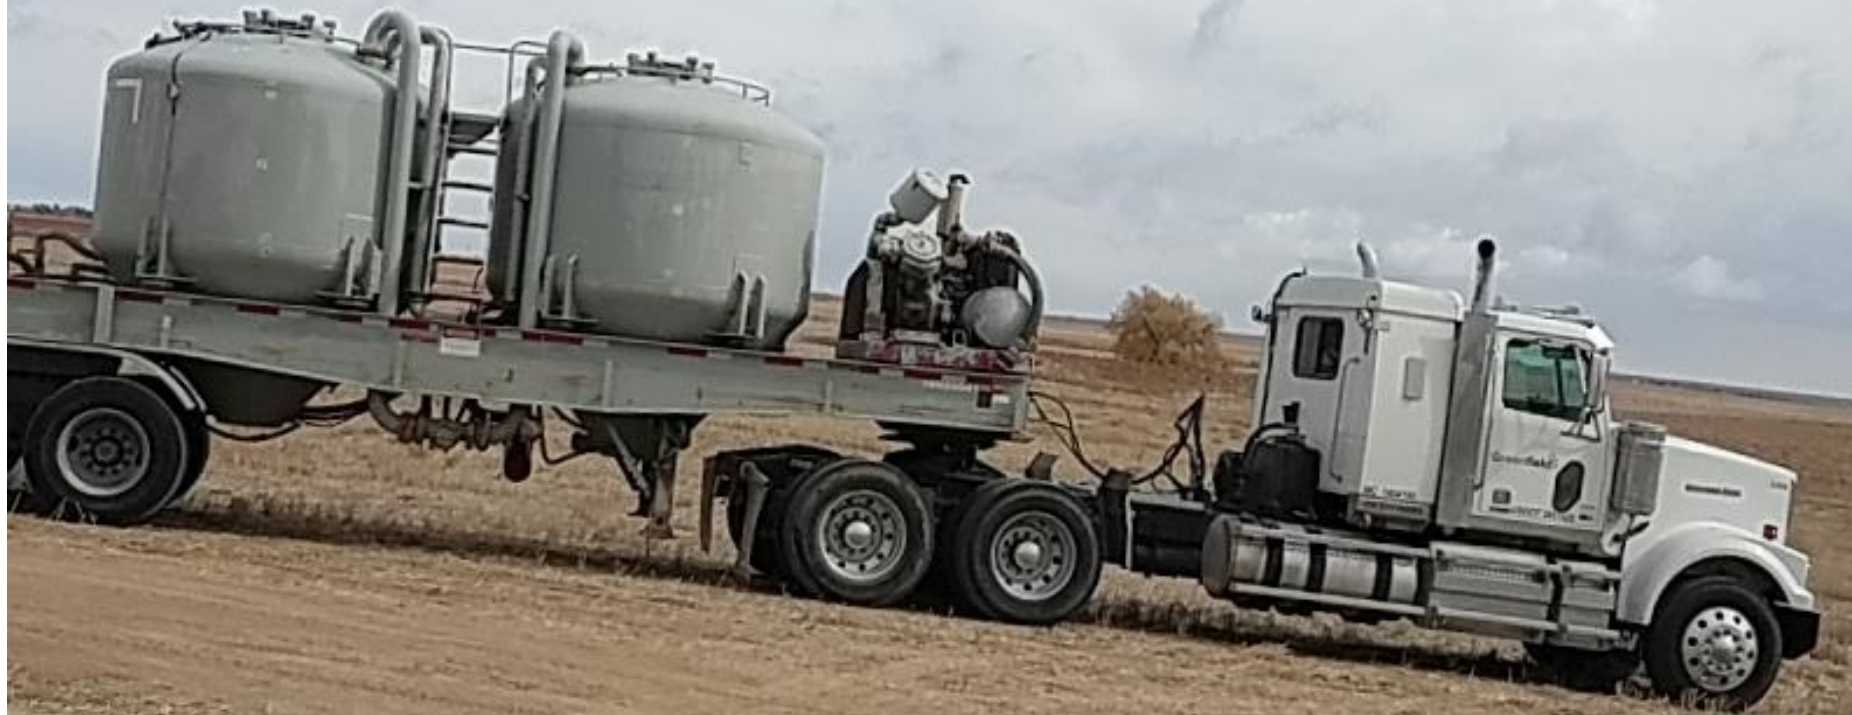
Greenfield cement
bulk truck. Not used.
