Interim Reclamation and Stormwater Inspection

October 27, 2022

Operator: CONFLUENCE DJ LLC #10518

Location ID: 466977

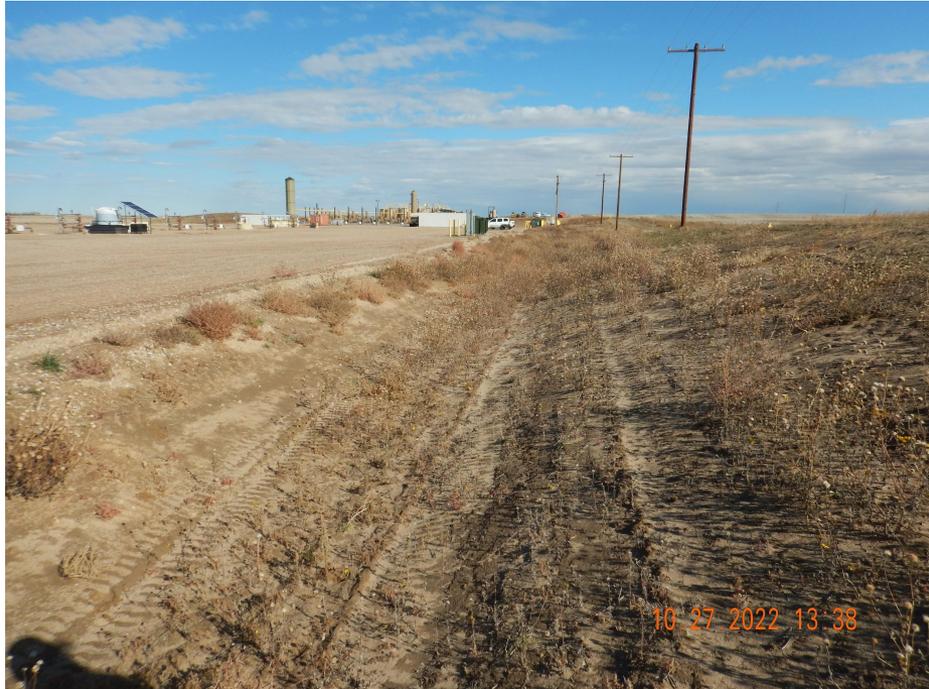
Photo 1. Photo taken from the southwestern stormwater BMP area, facing East. Photo illustrates weedy, annual growth. Operator will need to reseed to achieve long-term stabilization.

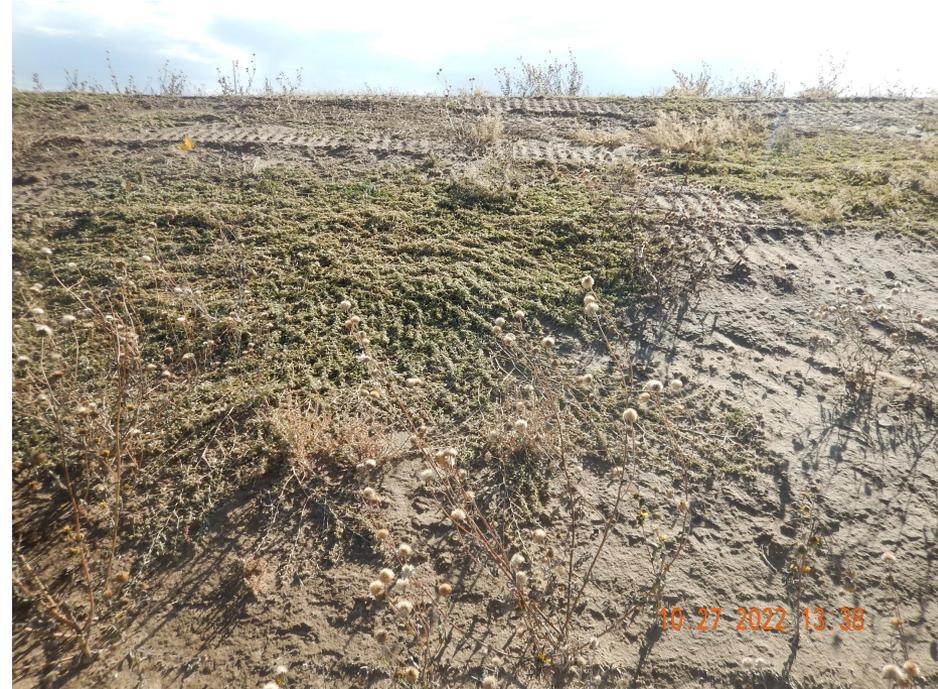
Photo 2. Photo taken from the southwestern stormwater BMP area, facing South. Photo illustrates a List C Colorado noxious weed, Puncturevine.

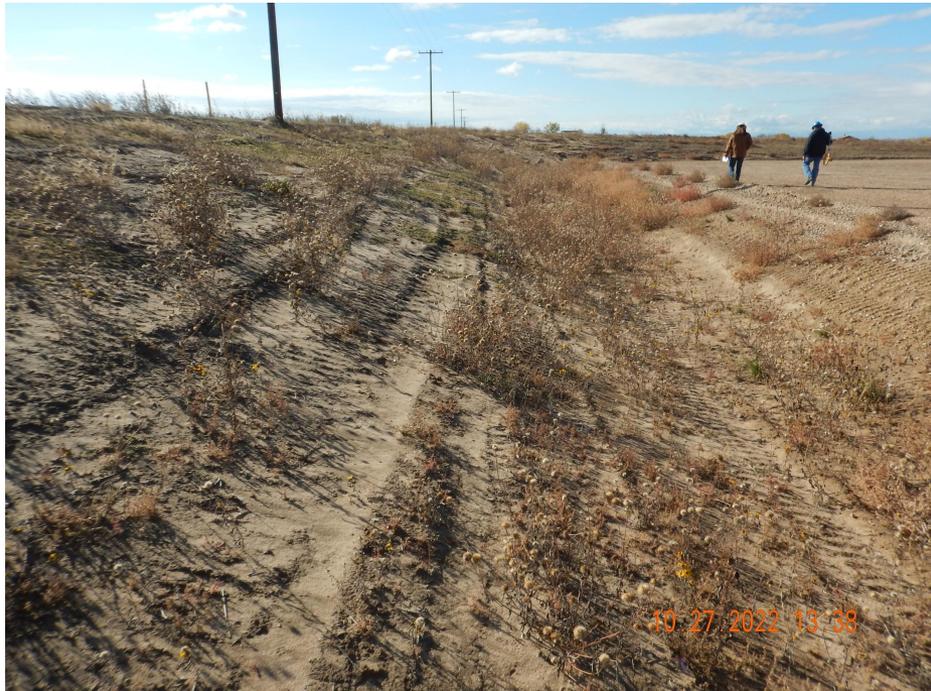
Photo 3. Photo taken from the southwestern stormwater BMP area, facing West. See comments under Photos 1 and 2.

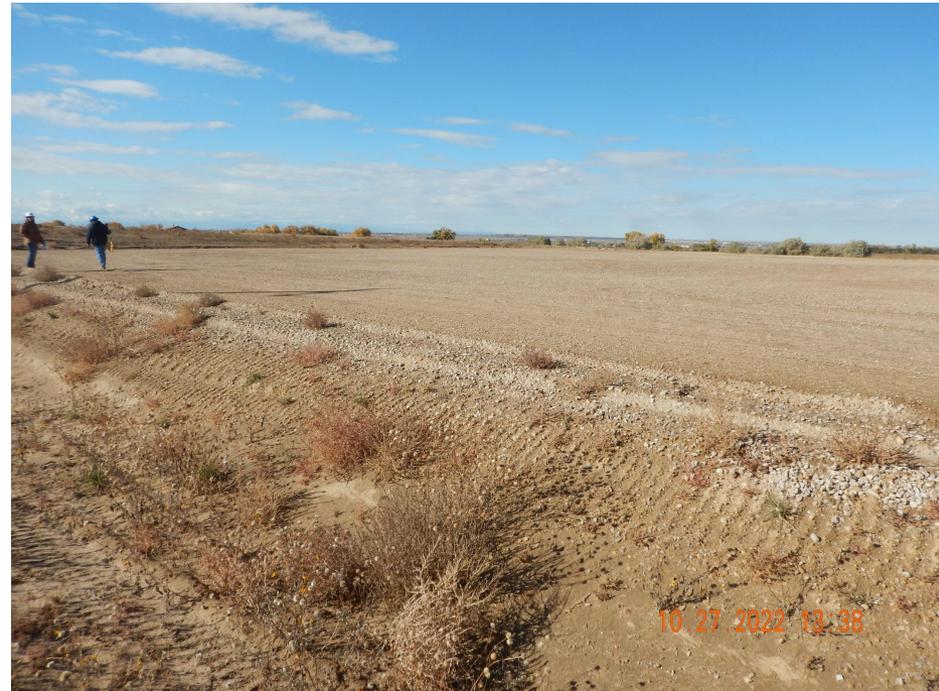
Photo 4. Photo taken from the southwestern stormwater BMP area, facing Northwest. Photo illustrates portions of the western location needing to be reclaimed.

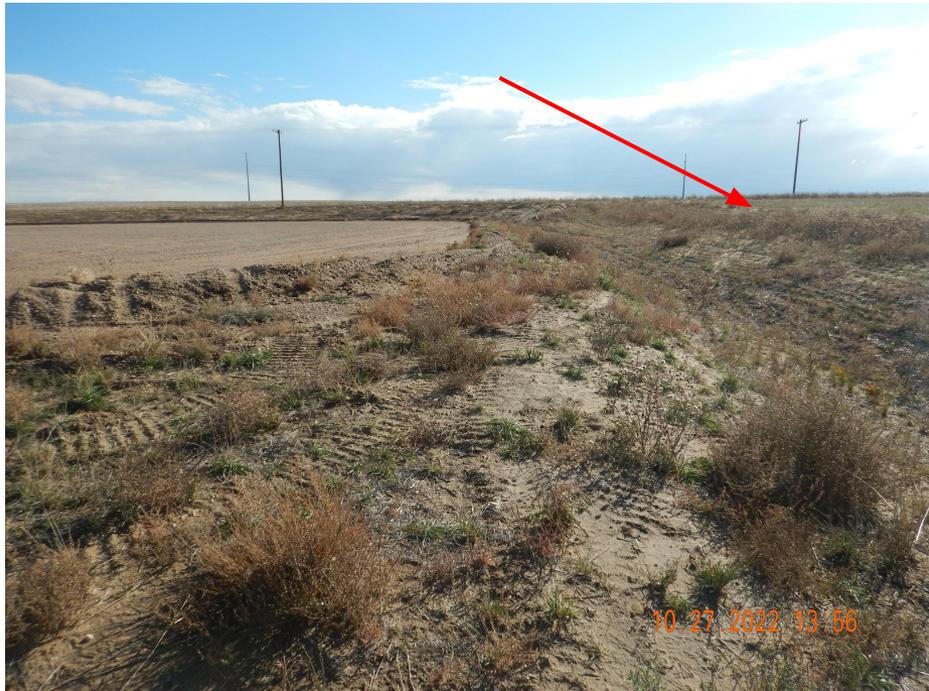
Photo 5. Photo taken from the northwestern stormwater BMP area, facing South. Photo illustrates portions of the western location needing to be reclaimed and Weld County stormwater BMPs have to be revised for the interim reclamation phase.

Red arrow is pointing towards the agricultural field to the West.

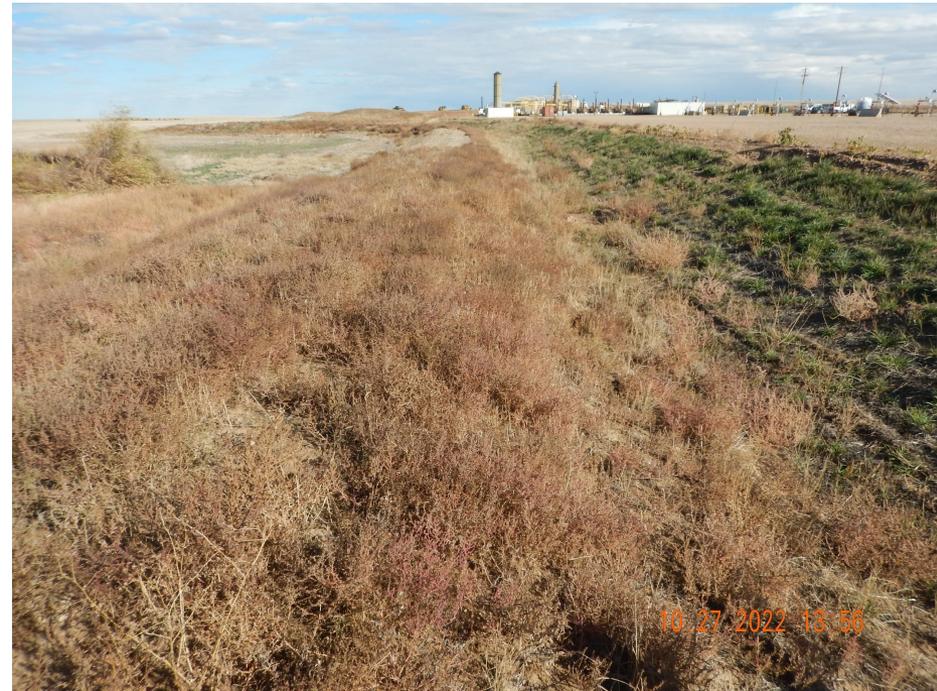
Photo 6. Photo taken from the northwestern stormwater BMP area, facing East. Photo illustrates portions of the northwestern location needing to be reclaimed and Weld County stormwater BMPs have to be revised for the interim reclamation phase.

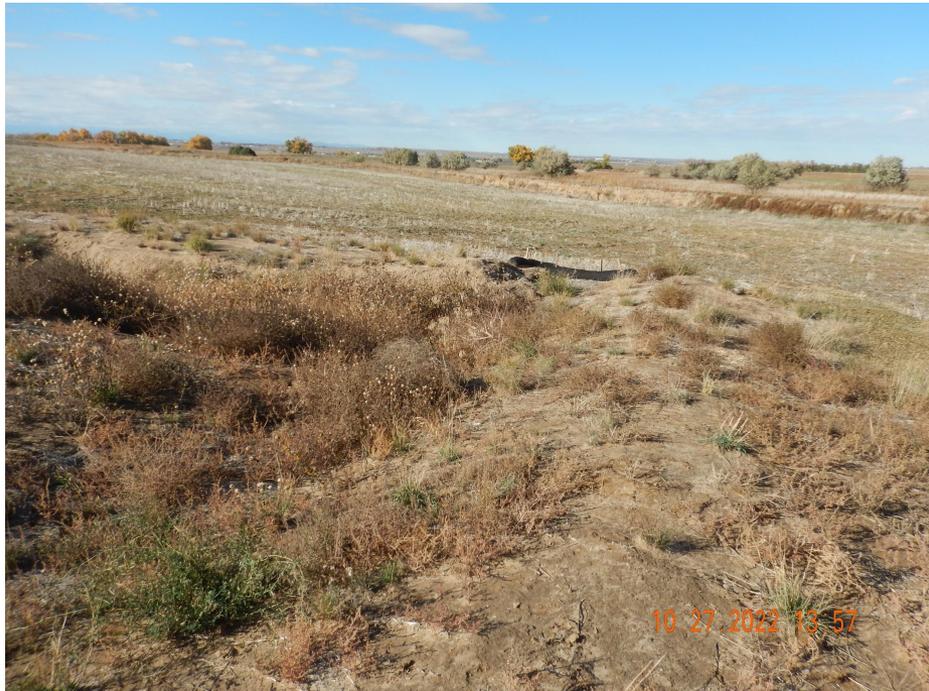
Photo 7. Photo taken from the northwestern stormwater BMP area, facing Northwest. Photo illustrates the end point for the diversion ditch with the agricultural field in the background.

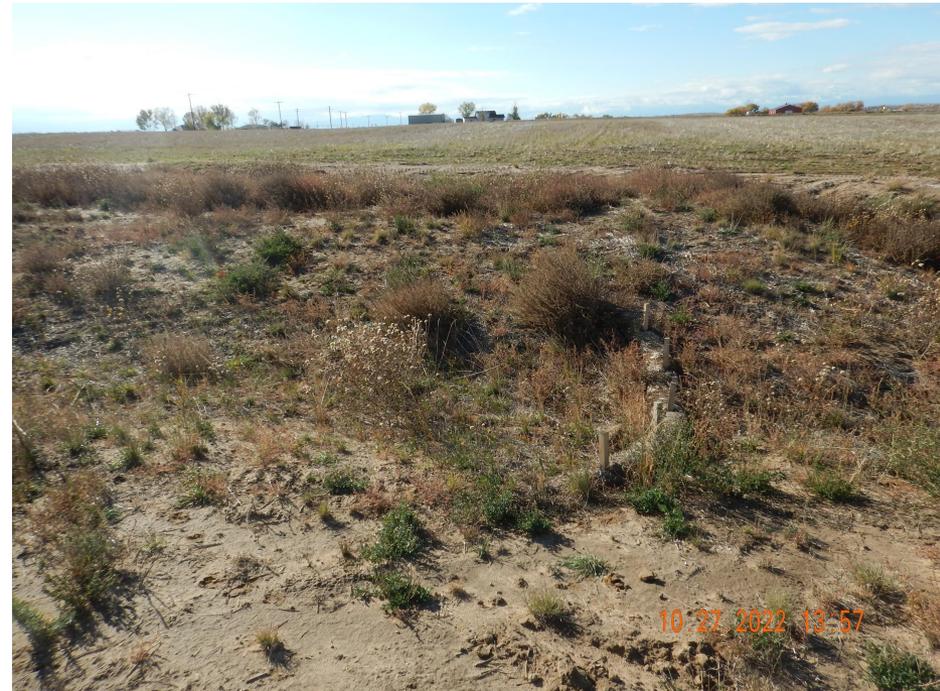
Photo 8. Photo taken from the northwestern stormwater BMP area, facing West. Photo illustrates the agricultural field in the background.

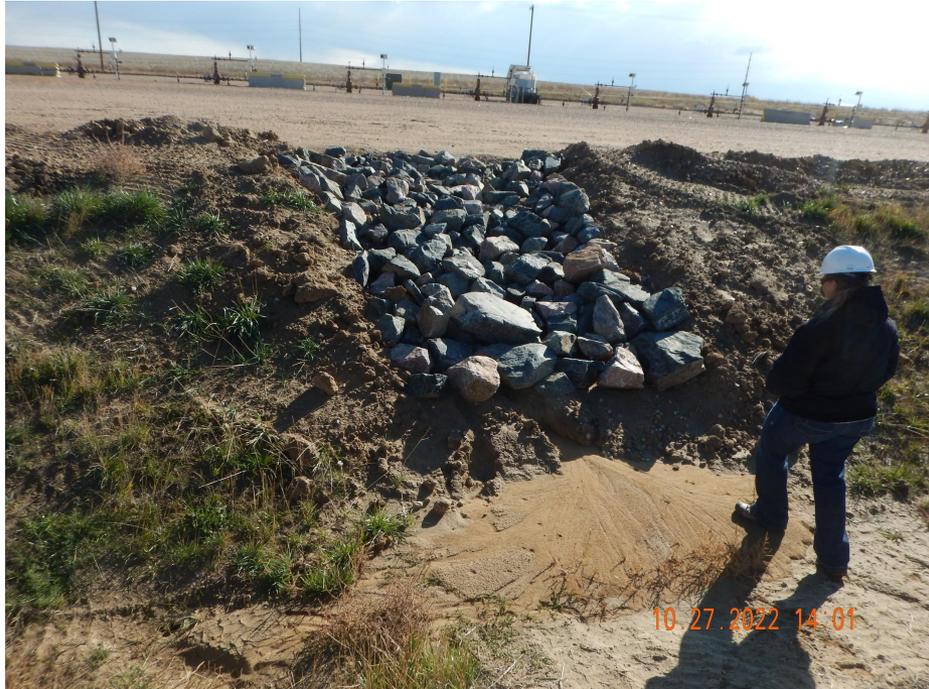
Photo 9. Photo taken from the northern stormwater BMP area, facing South. Photo illustrates erosion undercutting the riprap because there is no liner.

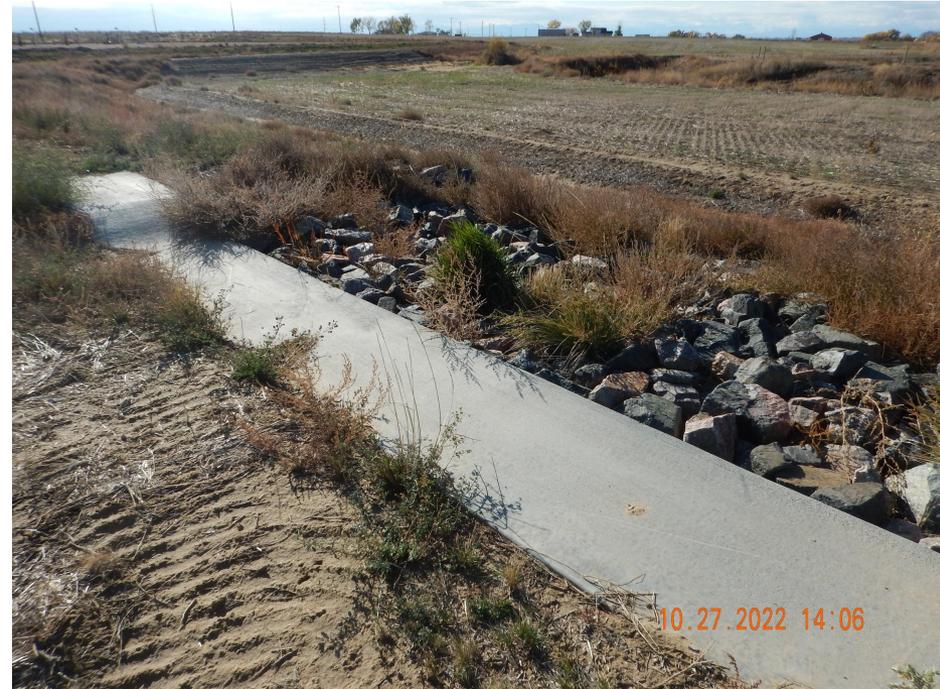
Photo 10. Photo taken from the emergency spillway, facing West. Photo illustrates the Denver Hudson Canal.

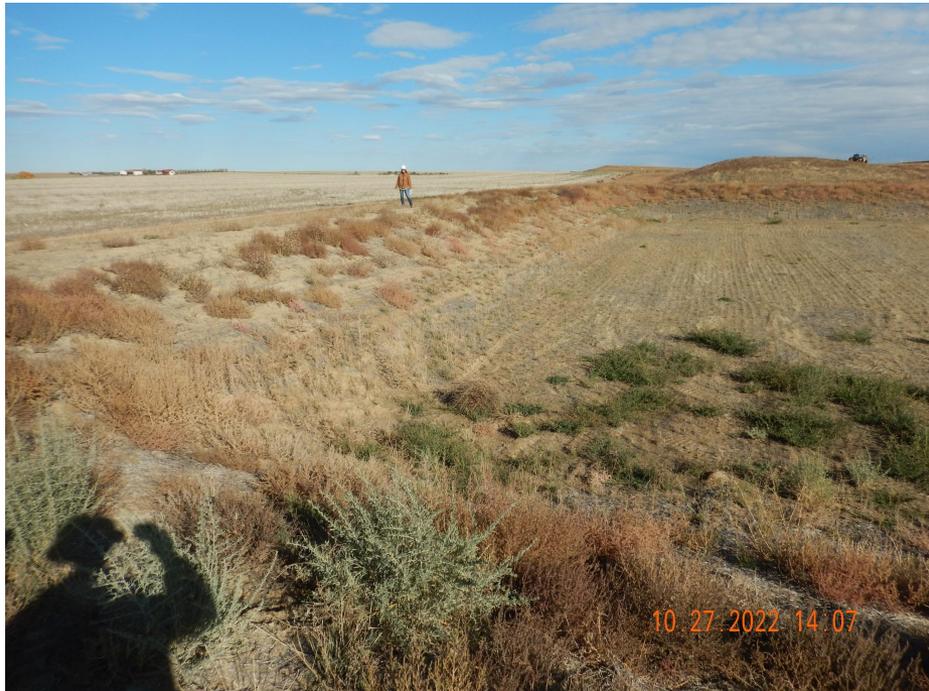
Photo 11. Photo taken from the emergency spillway, facing East. Photo illustrates the retention pond. Desirable vegetation was observed along the base of the pond but weedy outside of that.

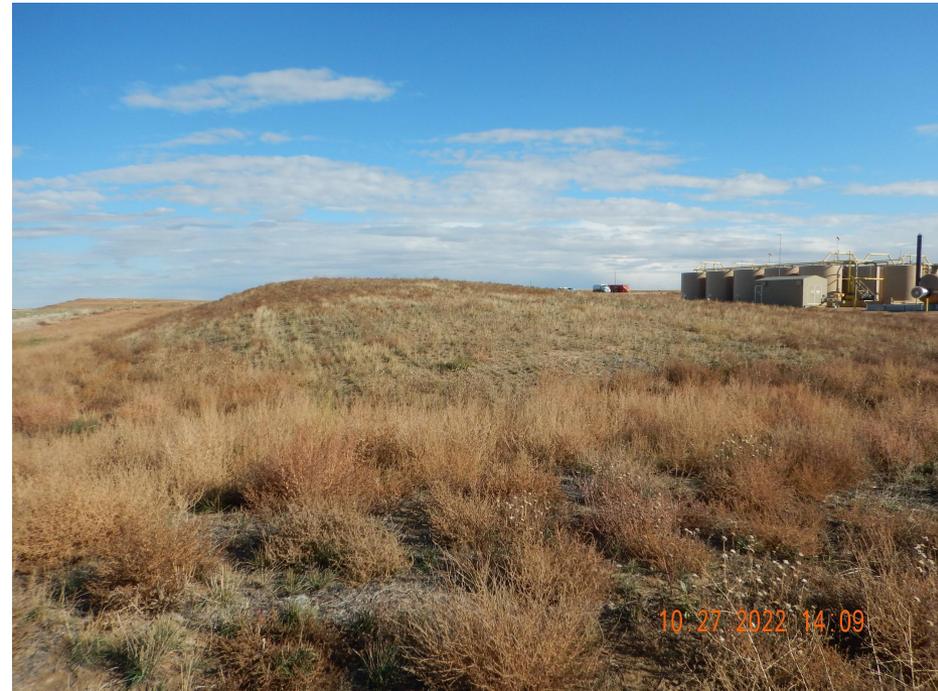
Photo 12. Photo taken west of the topsoil stockpile, facing East. Photo illustrates weedy, annual growth with some establishment of perennial grasses.

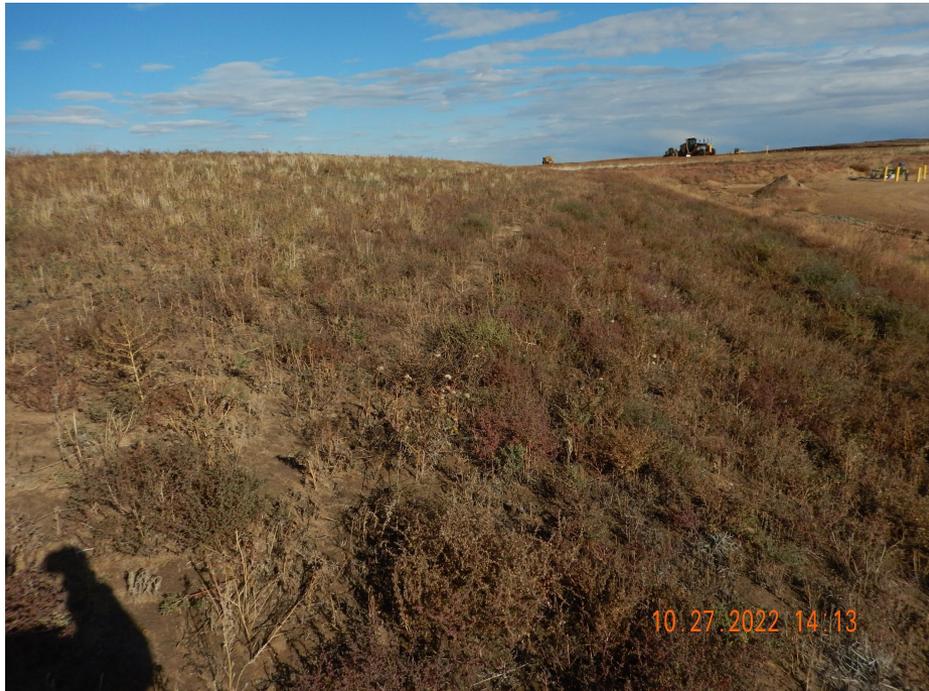
Photo 13. Photo taken from the western topsoil stockpile, facing East. Photo illustrates the establishment of both weedy, annuals and perennial grasses with more density of weeds.

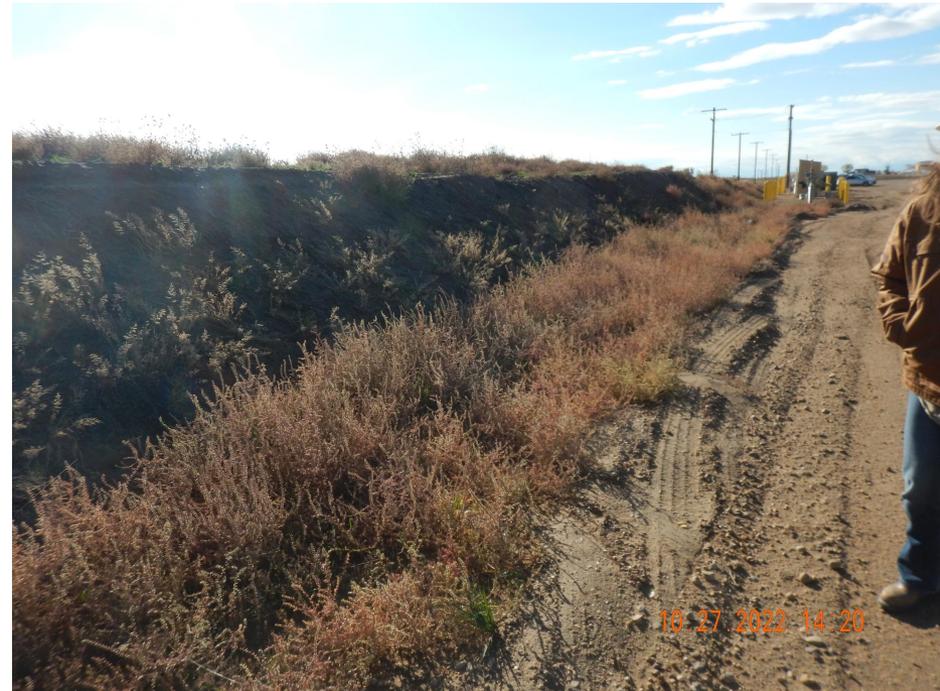
Photo 14. Photo taken southeastern location, facing West. Photo illustrates a cut slope needing weed maintenance and stabilization.
