Inspection Photos

Location Name: CAERUS PICEANCE LLC BOULTON-66S92W /33SESE

Location ID: 334857

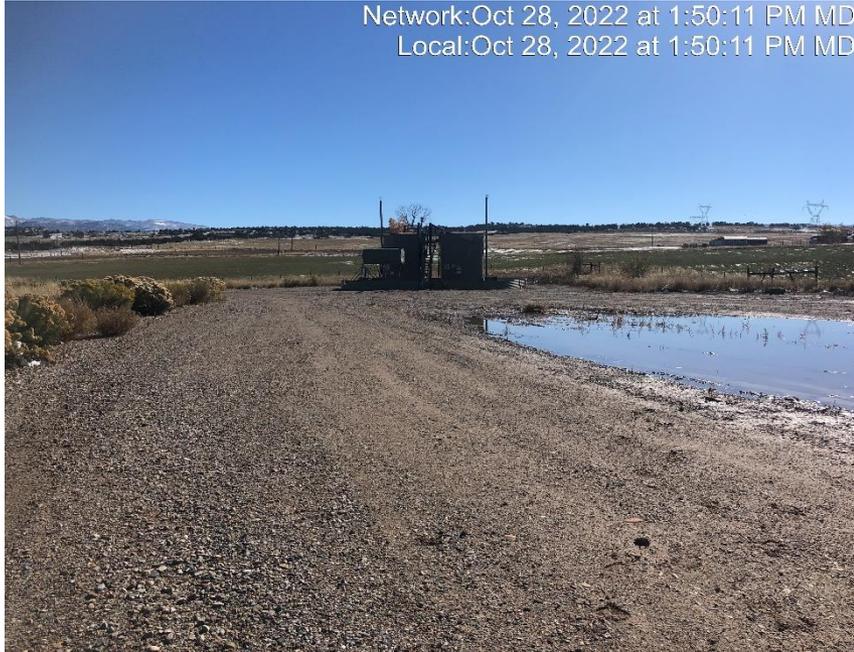
Photo #8225 From entrance to location.

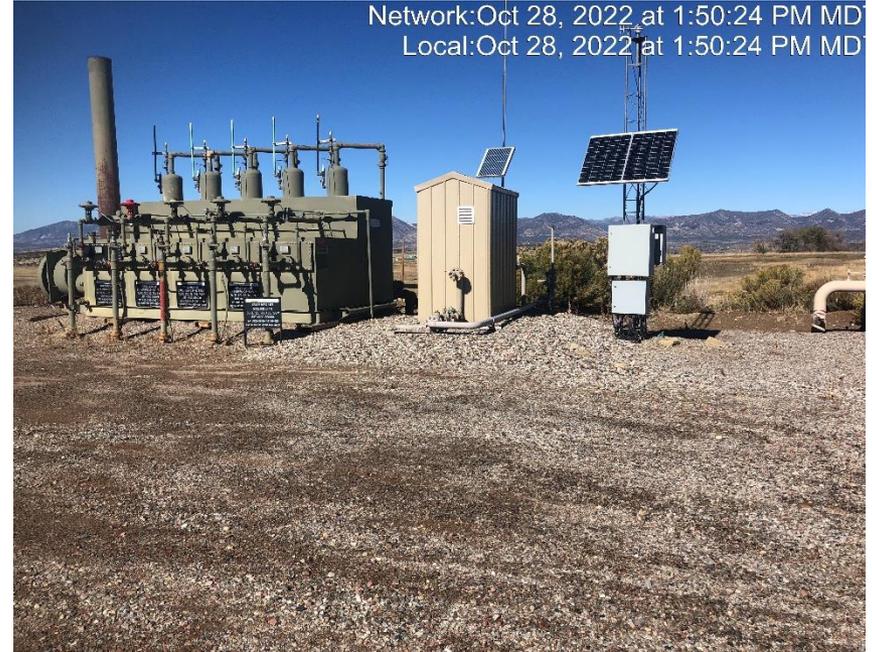
Photo #8226 From entrance to location.

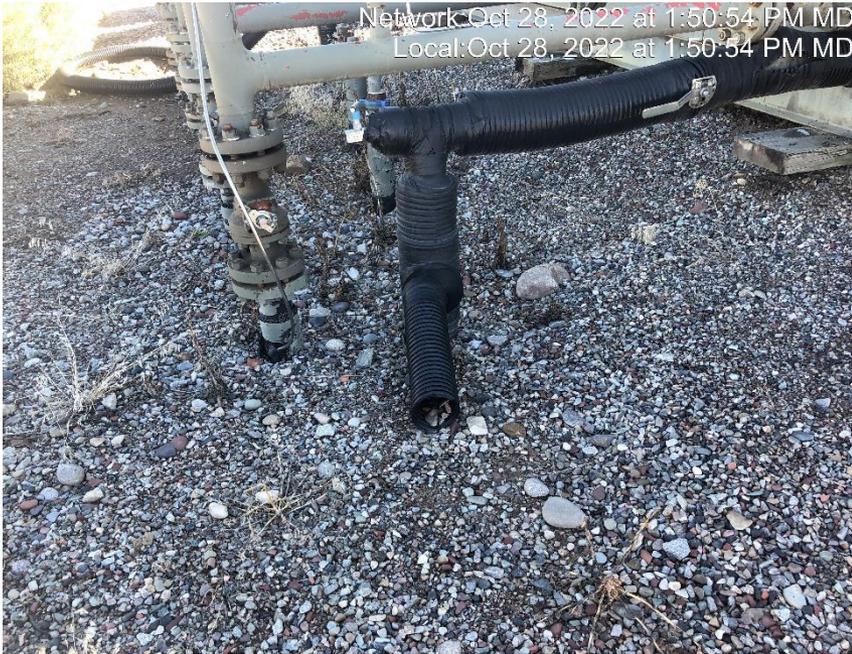
Photo #8228 Flowline insulation open ended and not capped.

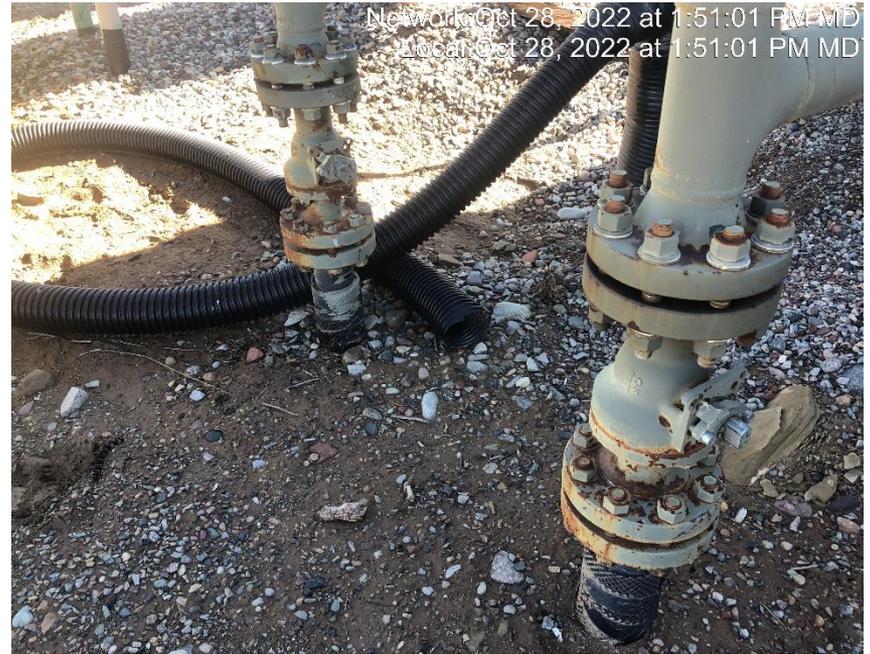
Photo #8229 Flowline insulation open ended and not capped.
