Final Reclamation and Stormwater Inspection

Operator: MAGPIE OPERATING INC - 52530

Location ID: 312143

Location Name: WARNECKE- 68N53W 30 SESE

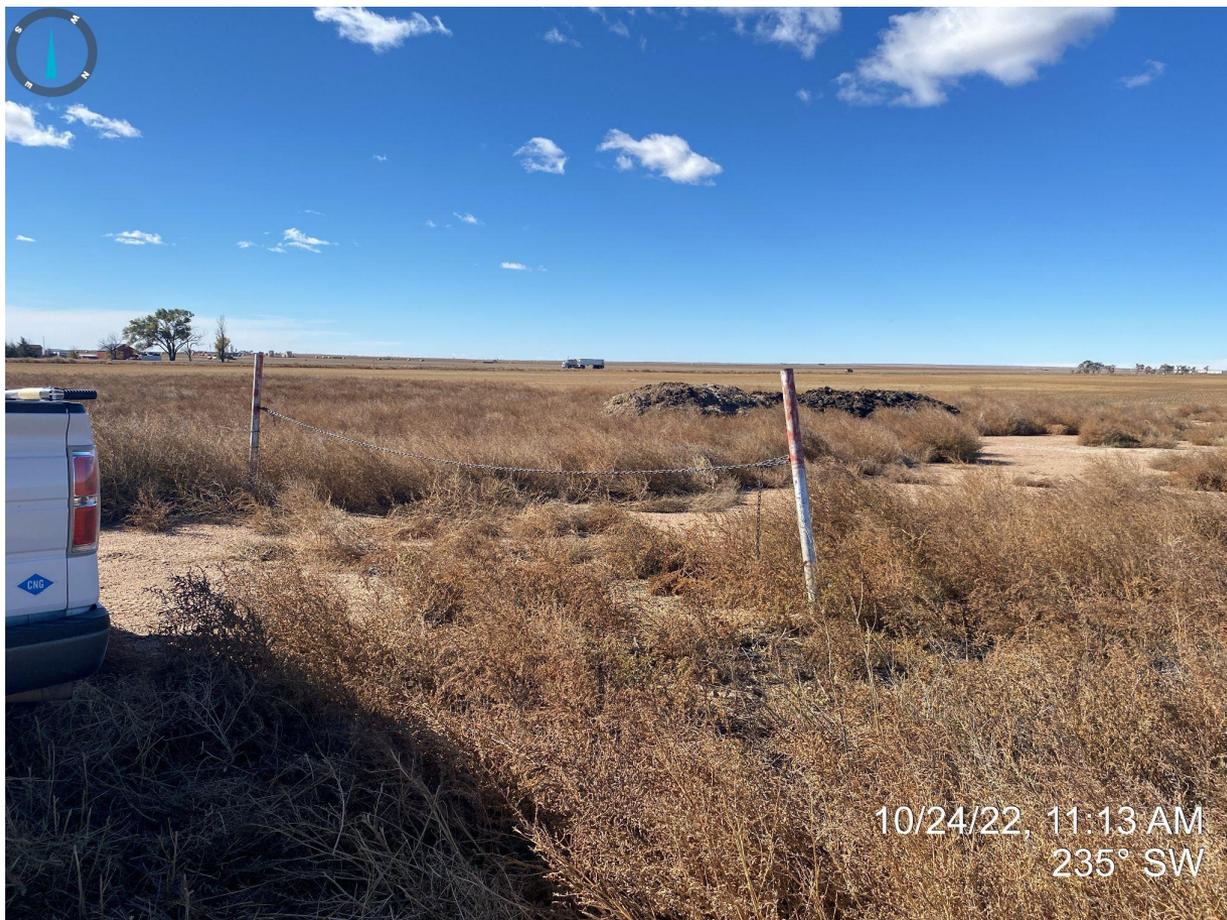
Photo 1. Taken from county road near access point, facing southwest. Photo shows presence of undesirable vegetation (e.g. kochia) and gate/fence that remains on location. The undesirable vegetation needs to be managed and the fencing/gate material needs to be properly disposed of.

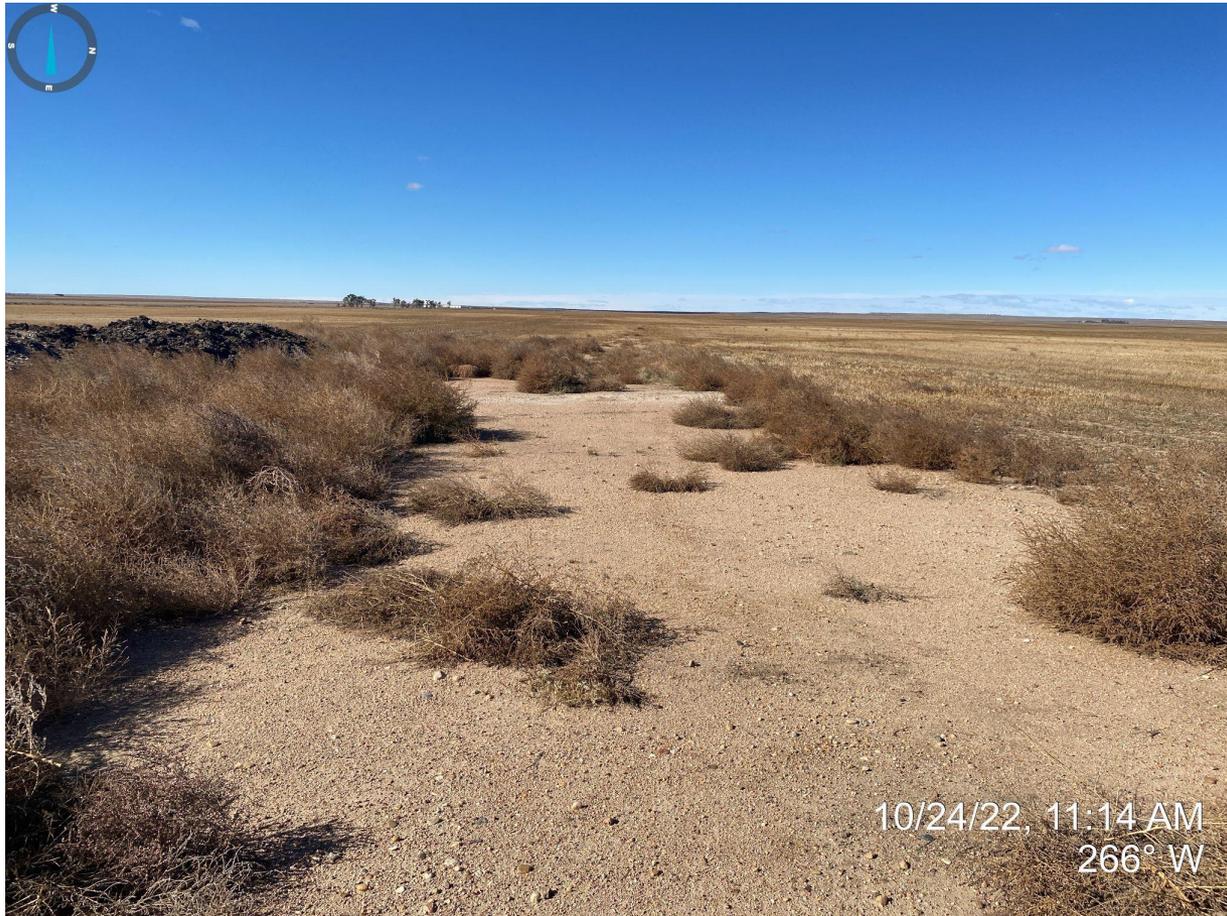
Photo 2. Taken from entrance to location, facing west. Photo show that the access road and location have not been properly decompacted with the presence of road base/gravel evident. Undesirable vegetation (e.g. kochia) was observed throughout the location and access roads.

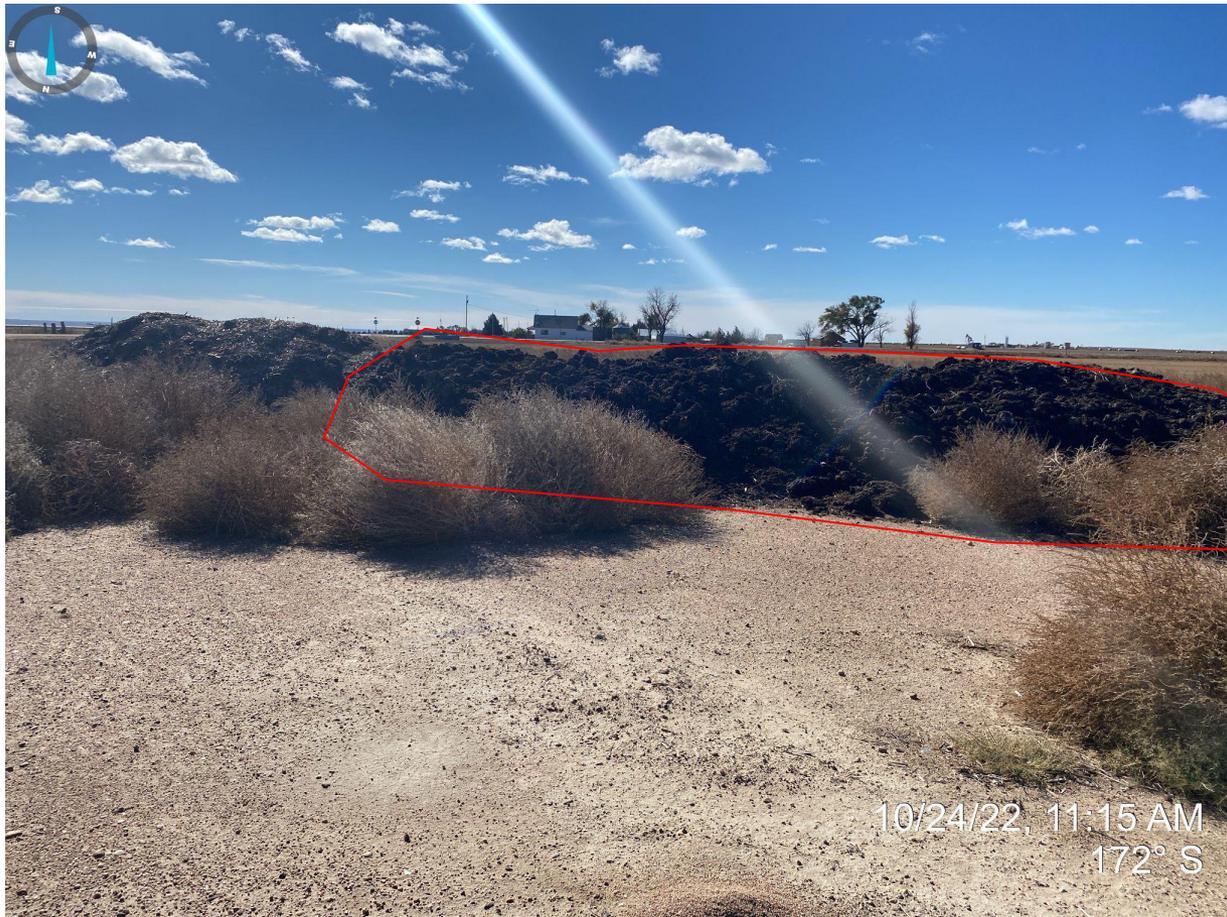
Photo 3. Taken near entrance to location, facing south. Photo shows pile of unidentified material (outlined in red) and crop residue/debris (left in picture) that remain on location.

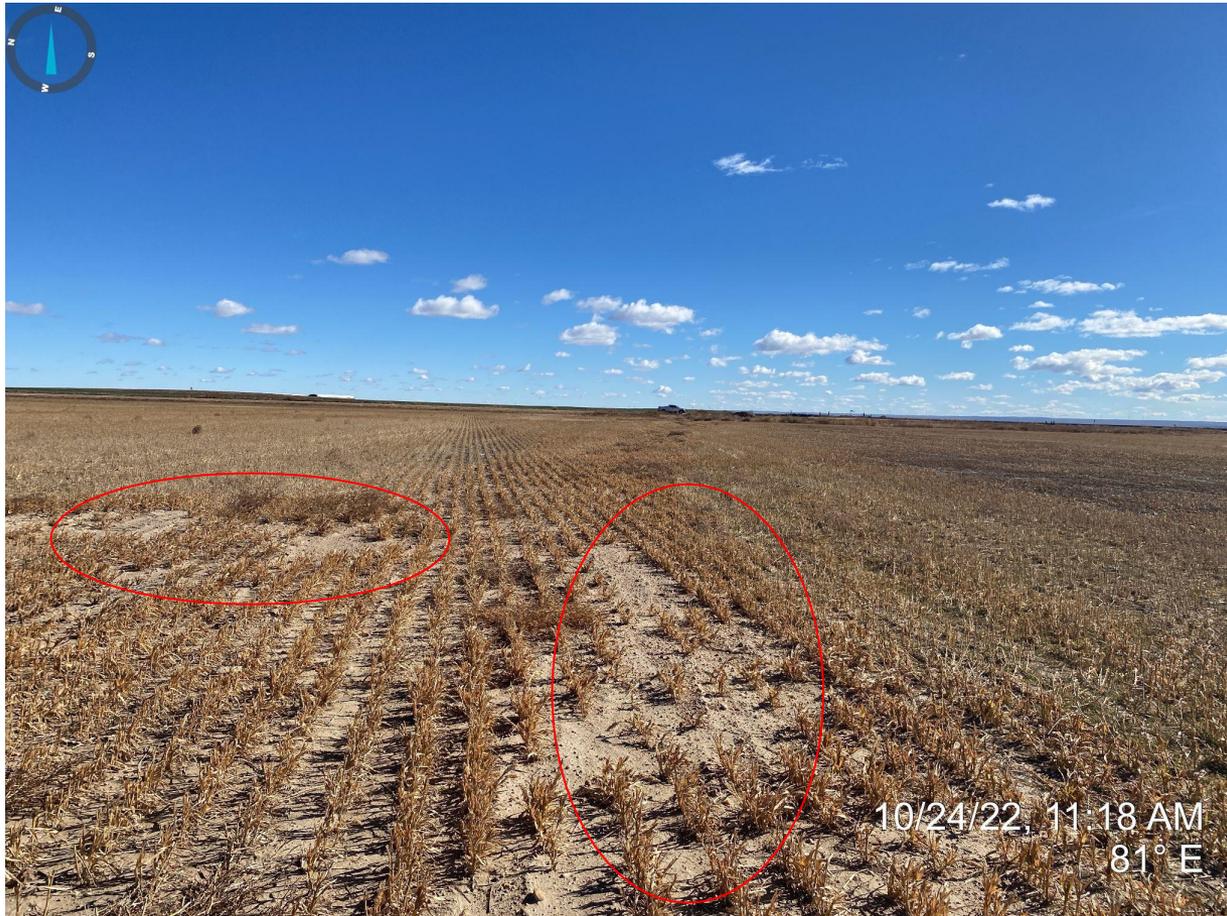
Photo 4. Taken from southern portion of well location, facing east. Photo shows non-uniform crop coverage resulting in areas of bare soil.

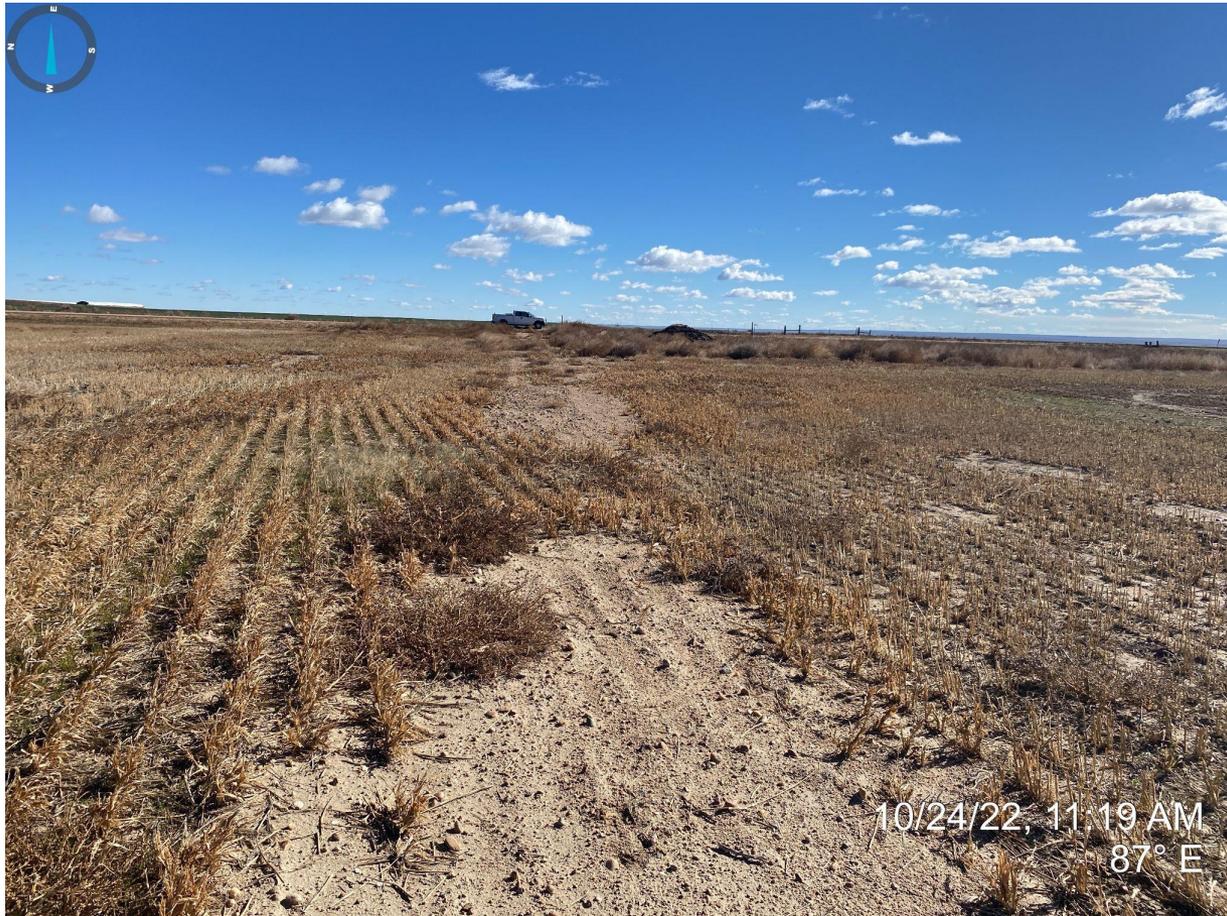
Photo 5. Taken between well and location, facing east. Photo shows access road has not been reclaimed with no evidence of decompaction, gravel/road base present, and non-uniform vegetation cover.

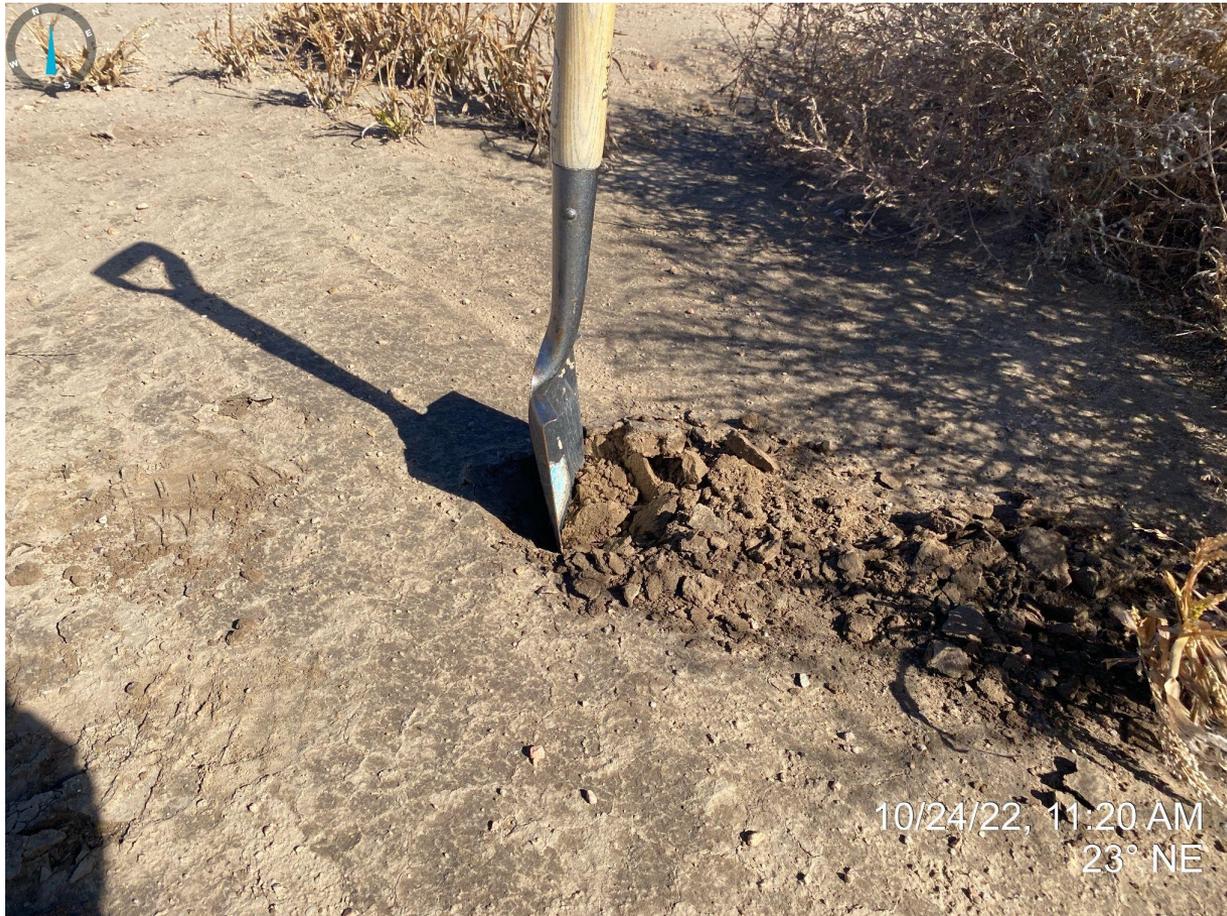
Photo 6. Close up photo taken from pit area. Photo shows the location was not properly decompacted.

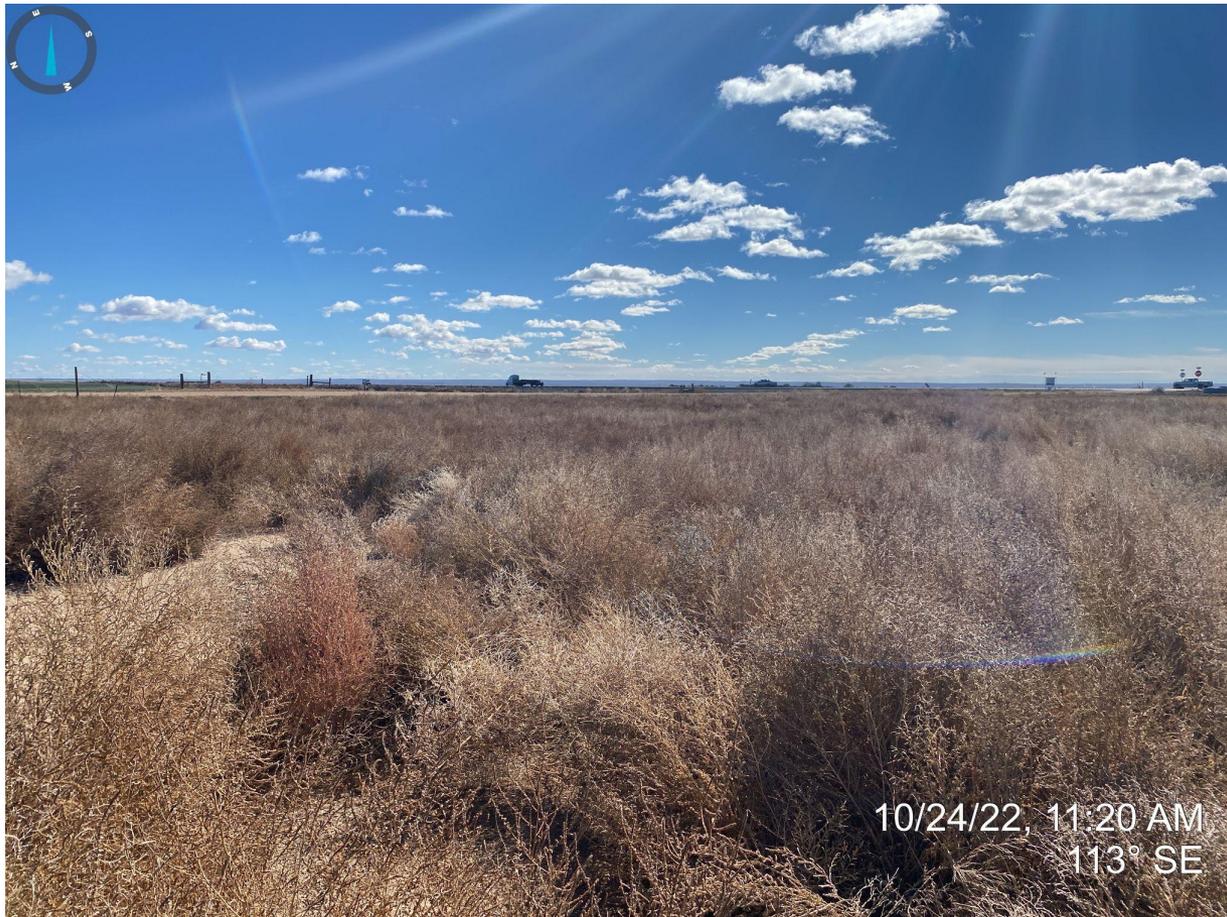
Photo 7. Taken from northern portion of the Pit, facing southeast. Photo shows undesirable vegetation (e.g. kochia) throughout the majority of the location.

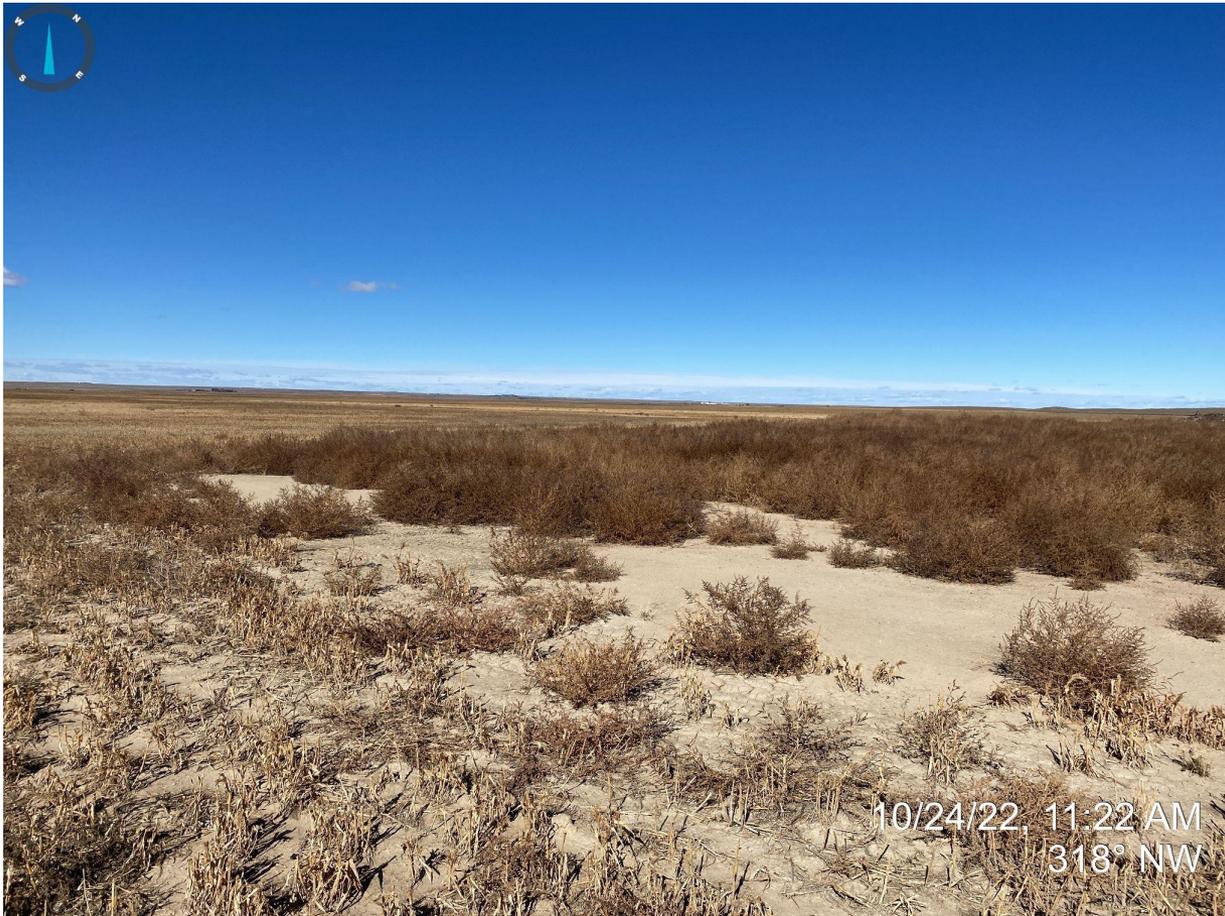
Photo 8. Taken from the southern portion of the pit, facing northwest. See comments in photo 7.

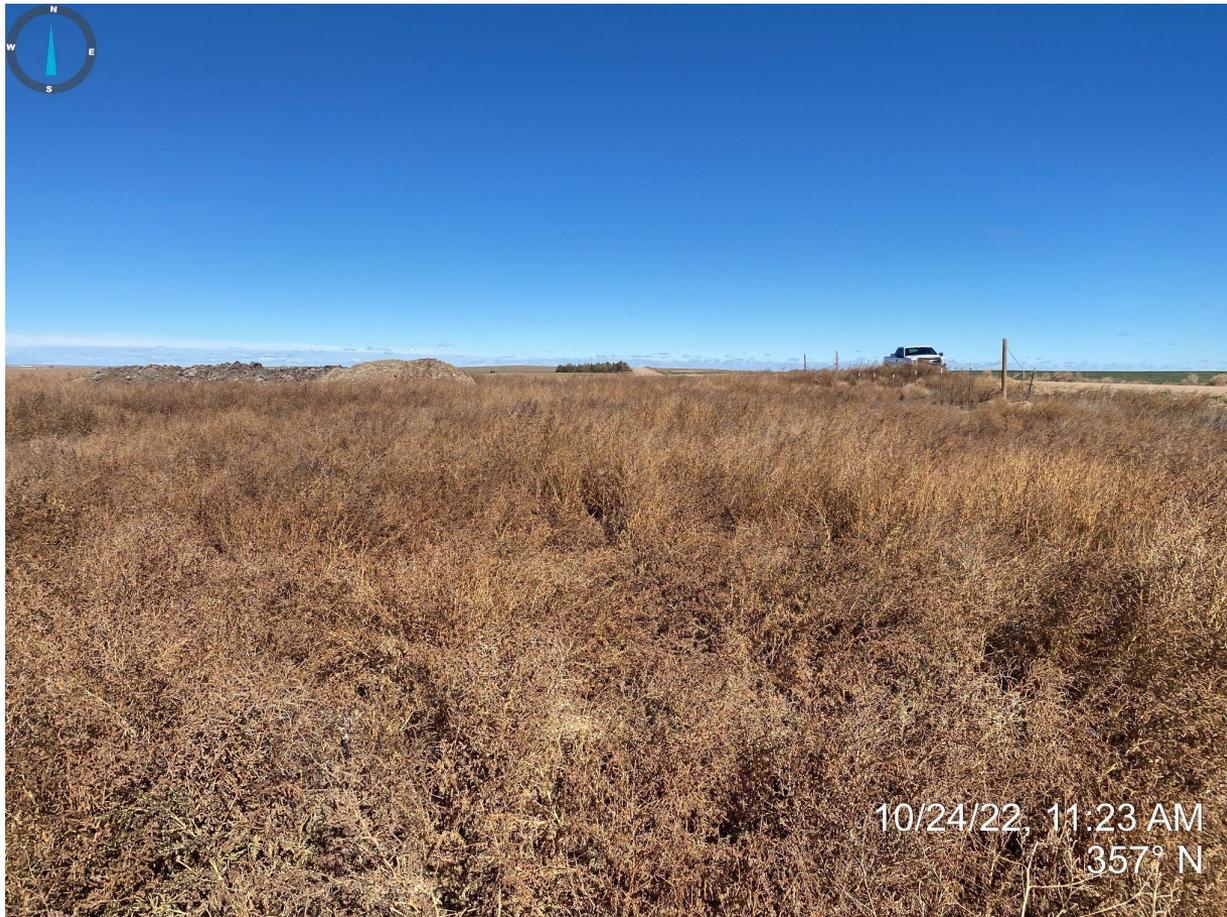
Photo 9. Taken from the southern portion of the pit, facing north. See comments in photo 7.

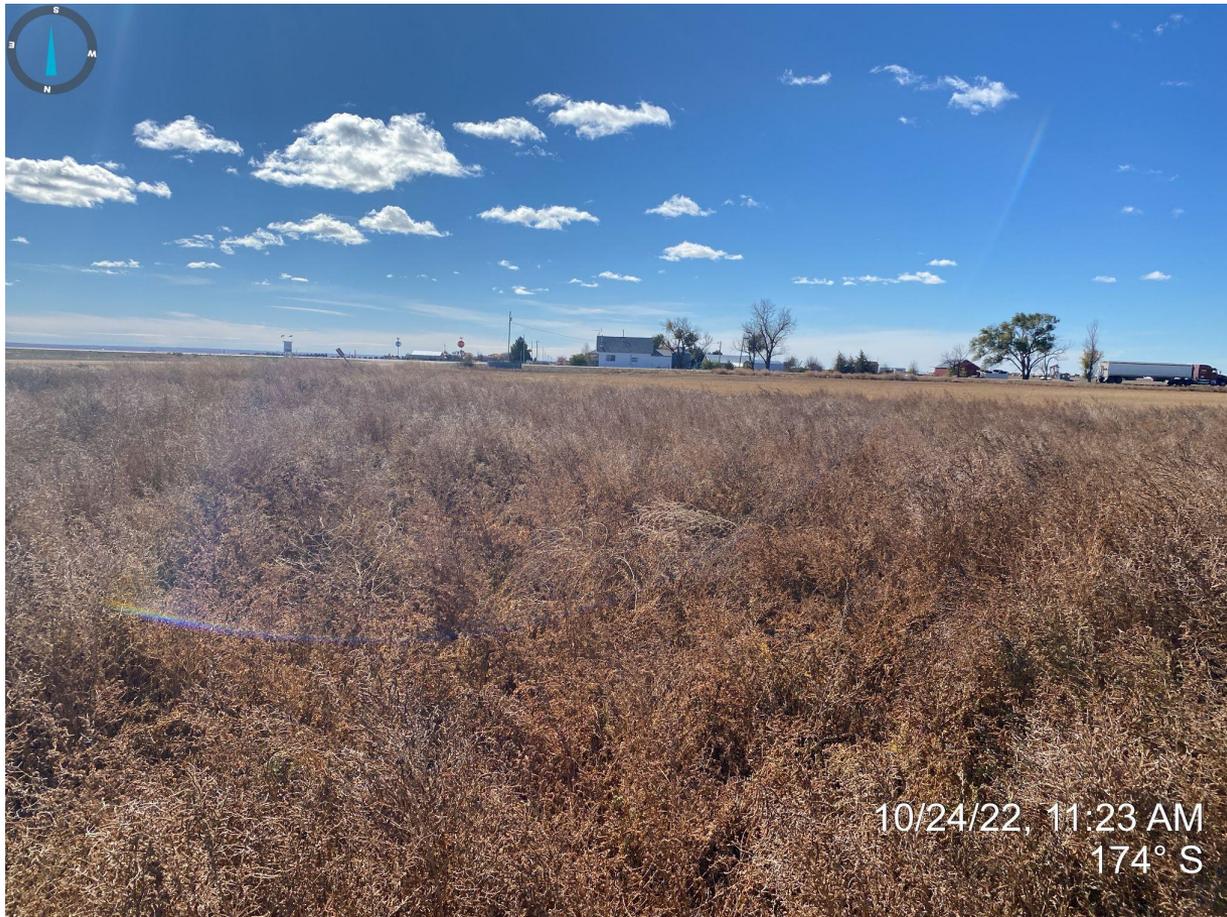
Photo 10. Taken from the northern portion of the pit, facing south. See comments in photo 7.

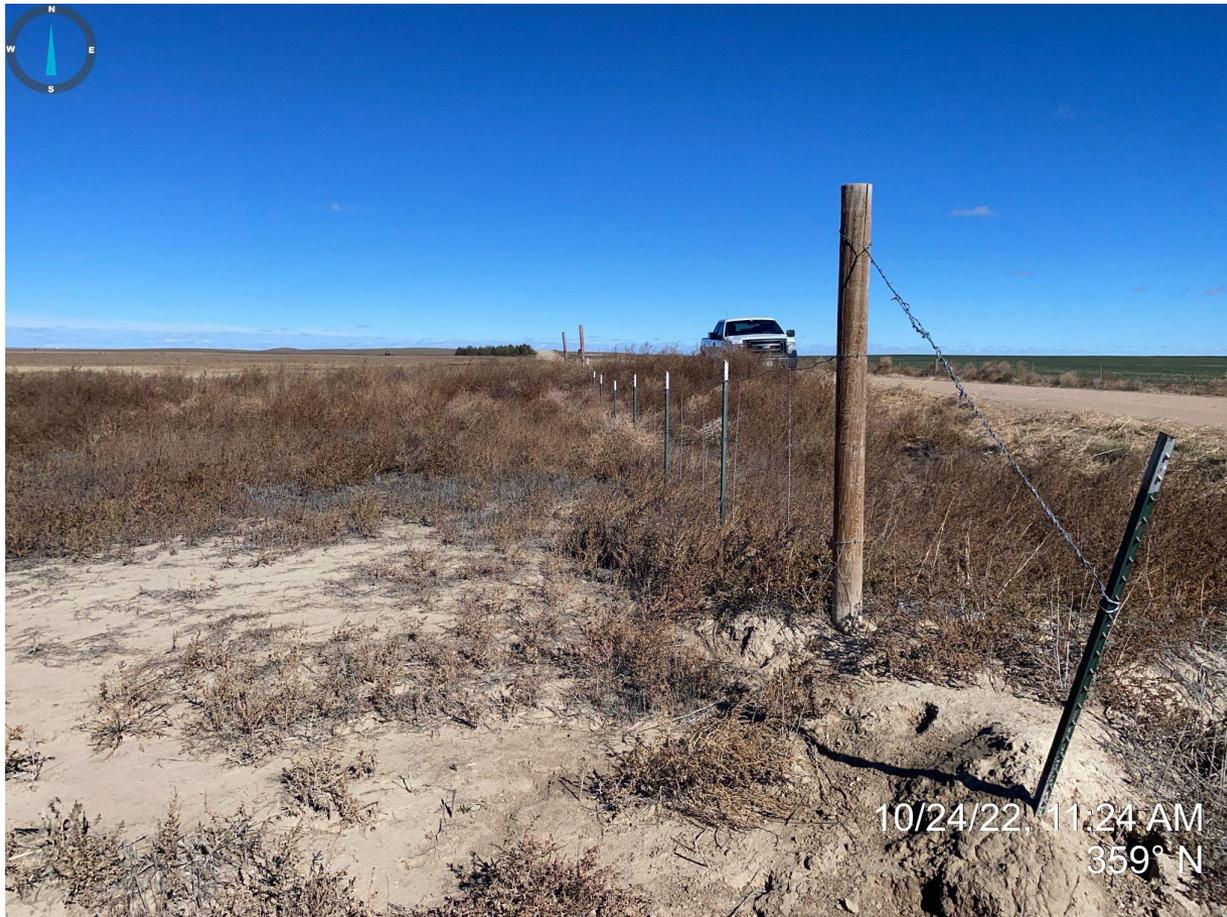
Photo 11. Taken from the southeastern portion of the location, facing north. Photo shows fence installed along east side of location. This is considered debris and needs to be removed.

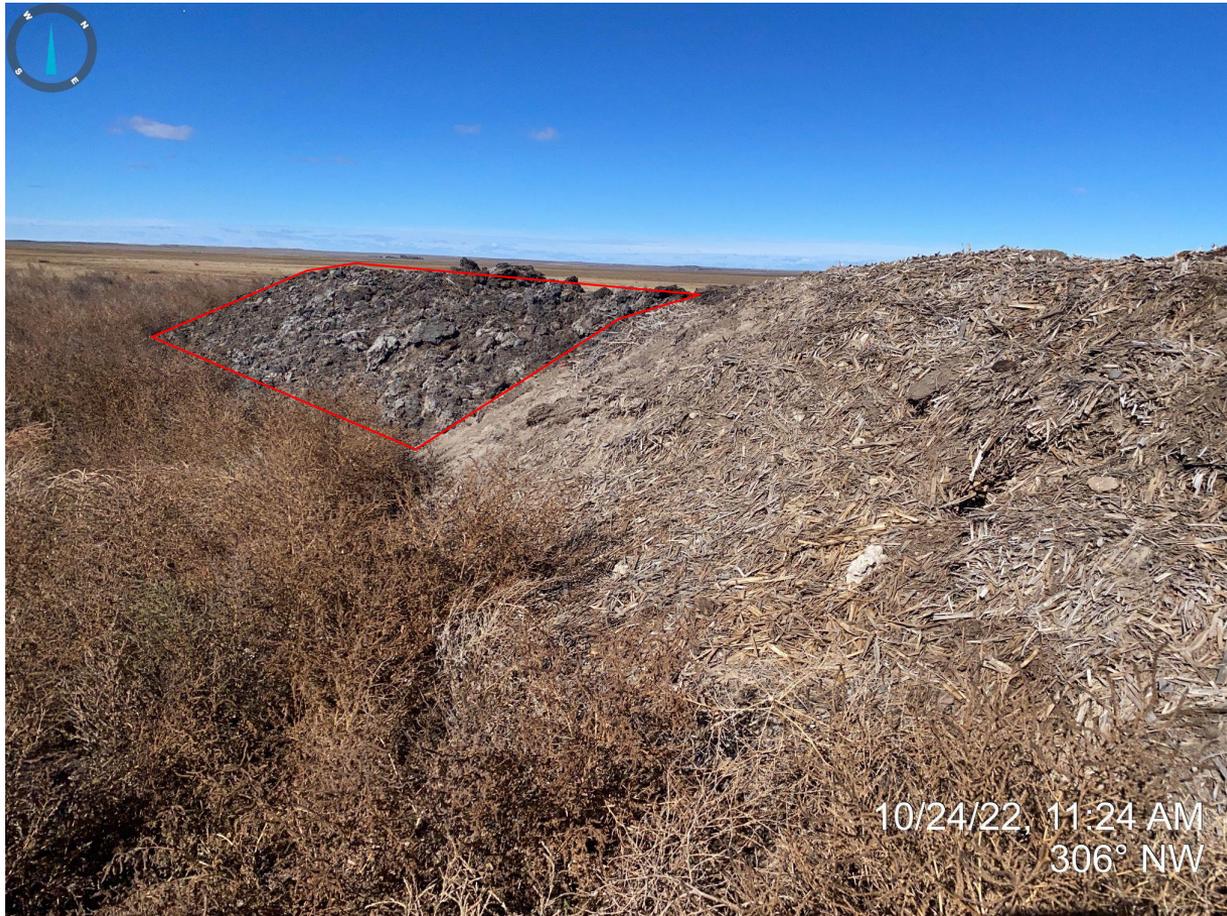
Photo 12. Close up photo taken of unidentified material (background, red outline) and crop residue/debris pile that remain on location.

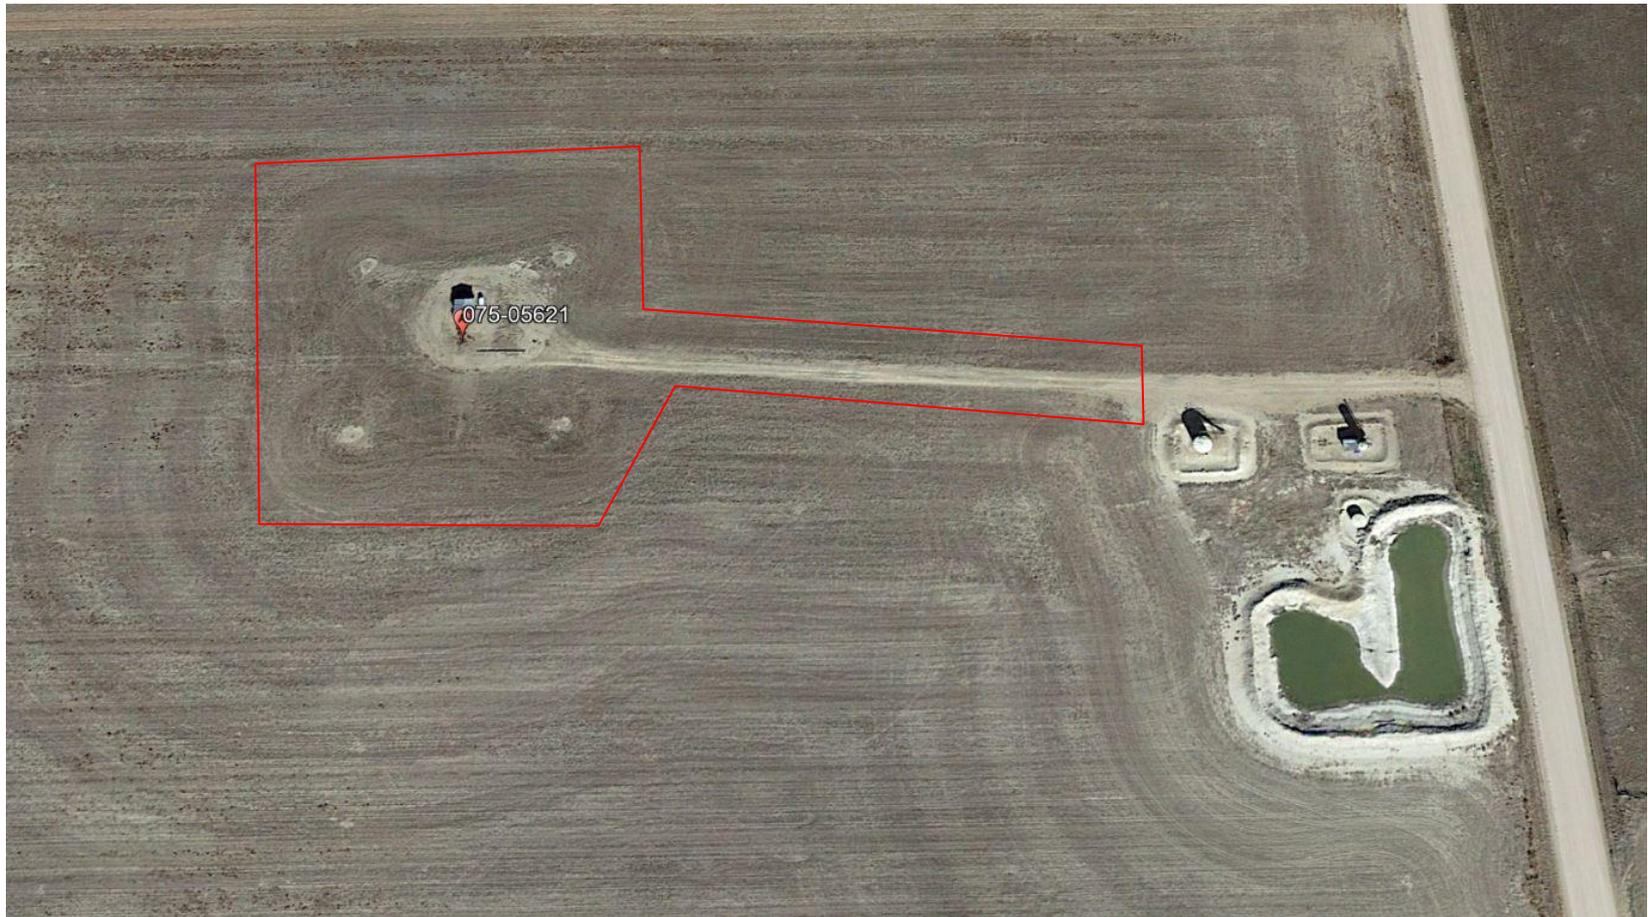
Photo 14. Google Earth aerial imagery illustrates area (outlined in red) that needs to be reclaimed ASAP. Refer to inspection report for additional details.
