Inspection Photos and Issue Report

11/1/2022

Operator: GUNNISON ENERGY LLC - 10515

Location #324485

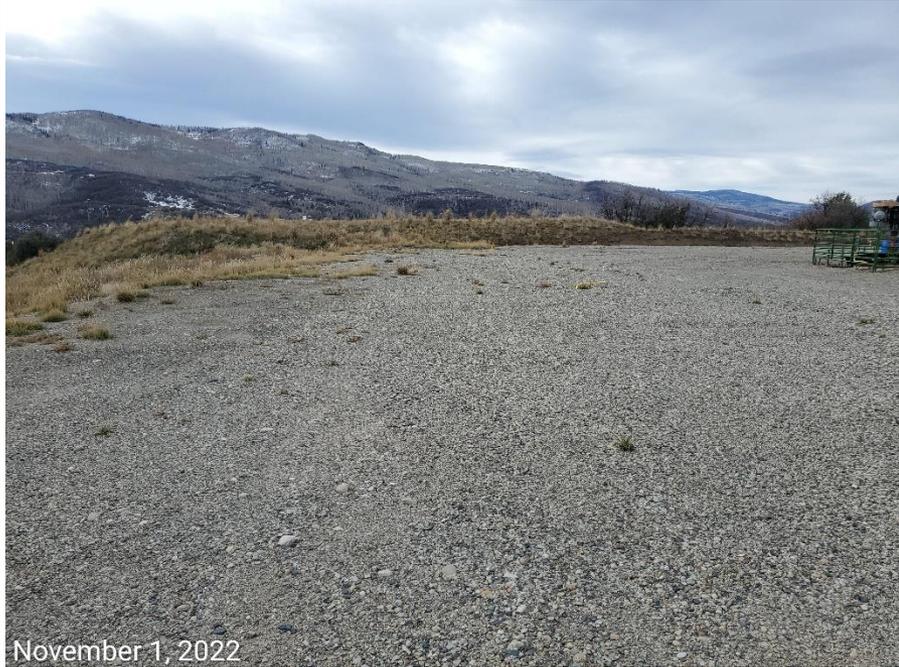
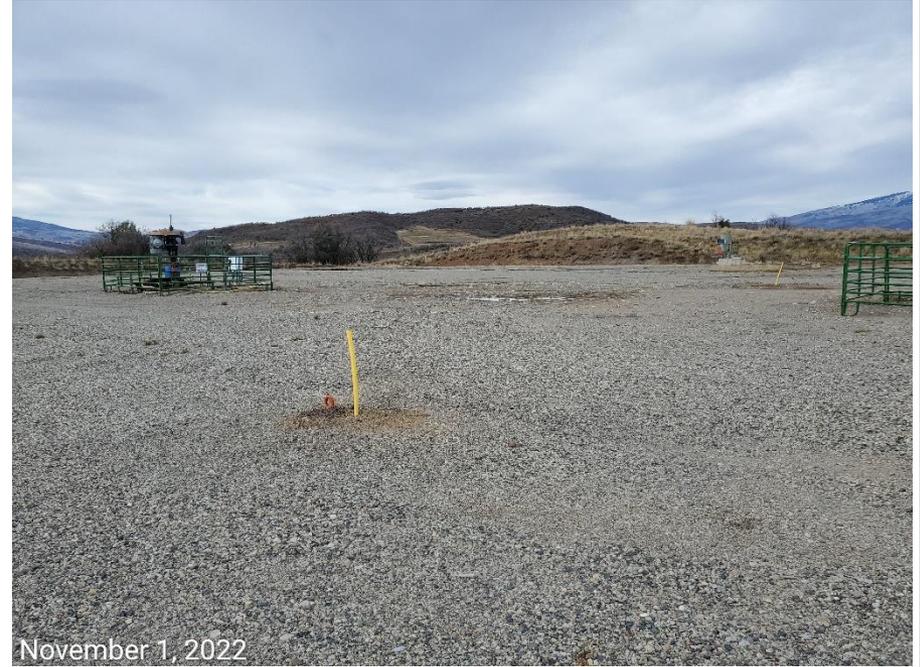
Photo 1: Photos 1-2 taken from the south end of the Location. Photos provide an overview of the Location from west, northeast, northeast to east.

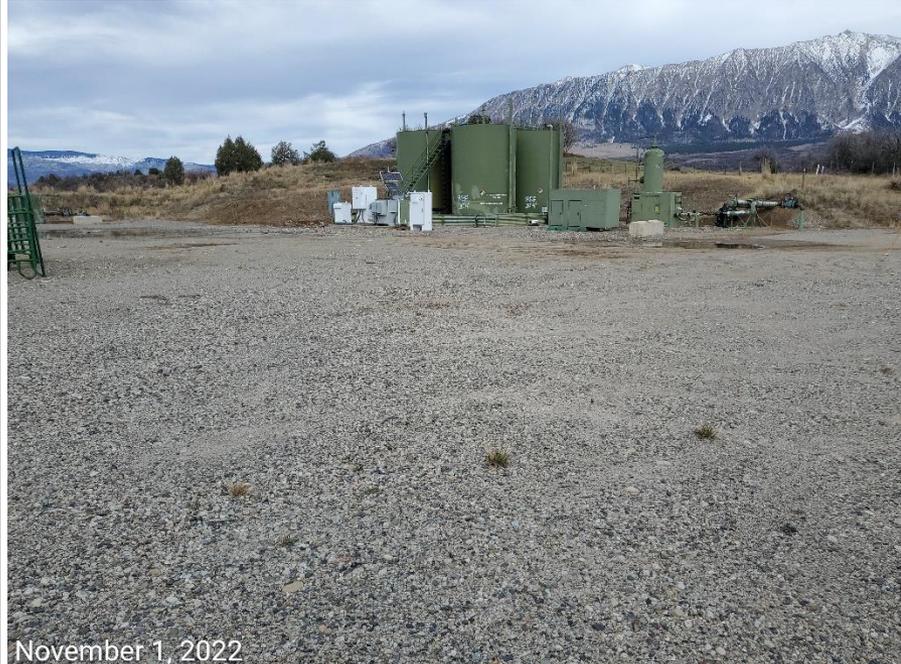
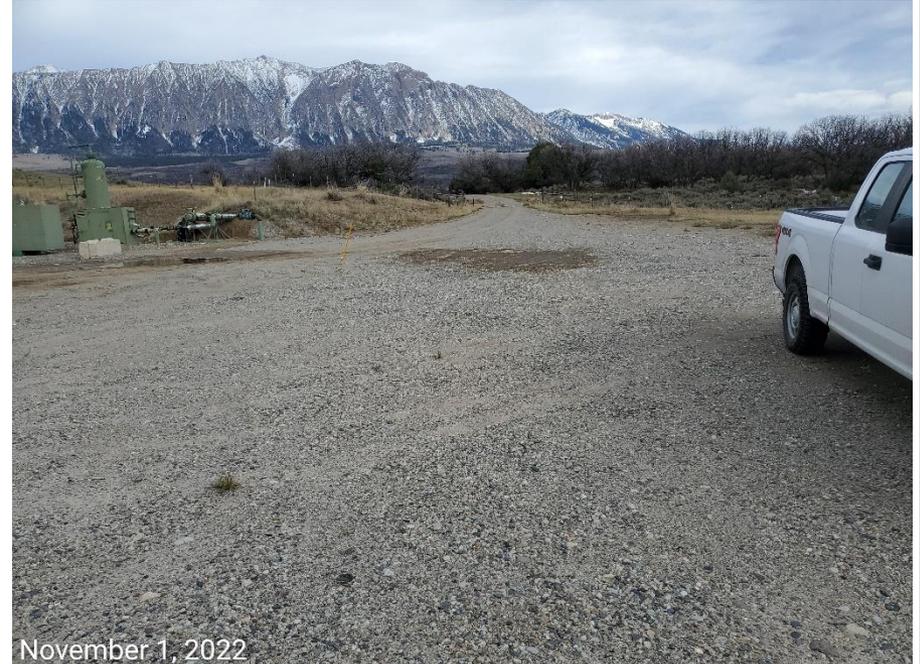
Photo 2: See comments under photo 1.

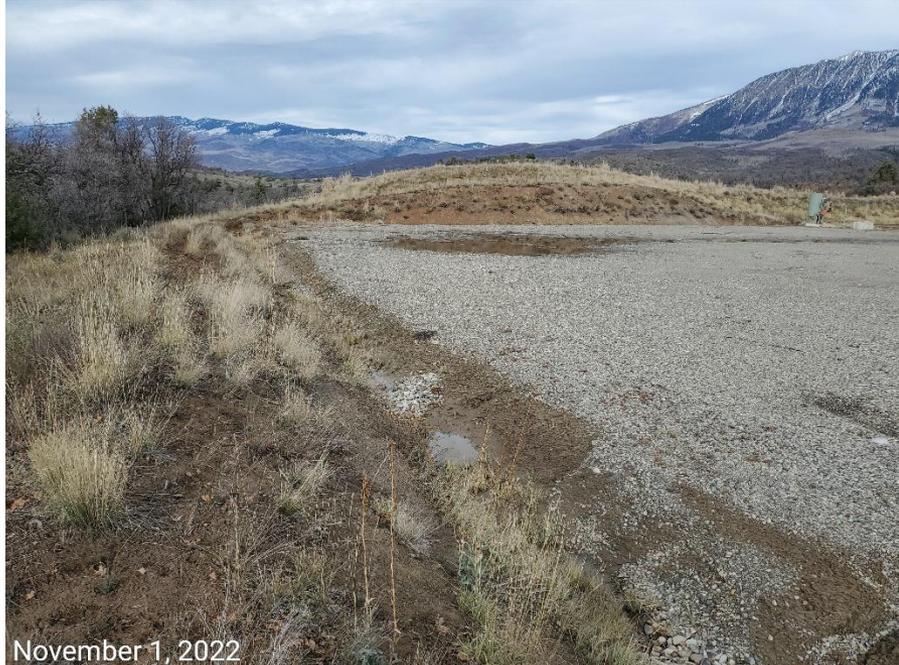
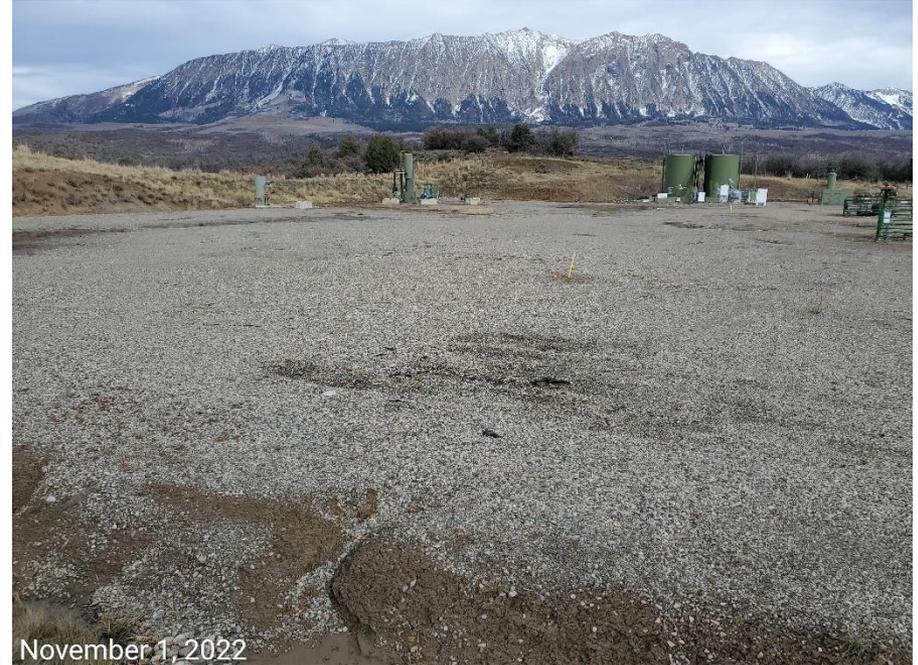
Photo 3: Photos 3-4 taken from the west end of the Location. Photos provide an overview of the Location from north, northeast, southeast to east. Photos also show areas of the Location not needed for production have not been reclaimed in accordance with 1003 requirements. Additionally, per Form 2A #400537258, the permitted size of disturbance are during construction is 2.79 acres, reduced to 1.21 acres after interim reclamation. The total disturbance area is 4 acres, and the current production areas are 2 acres; Location exceeds permitted disturbance area.

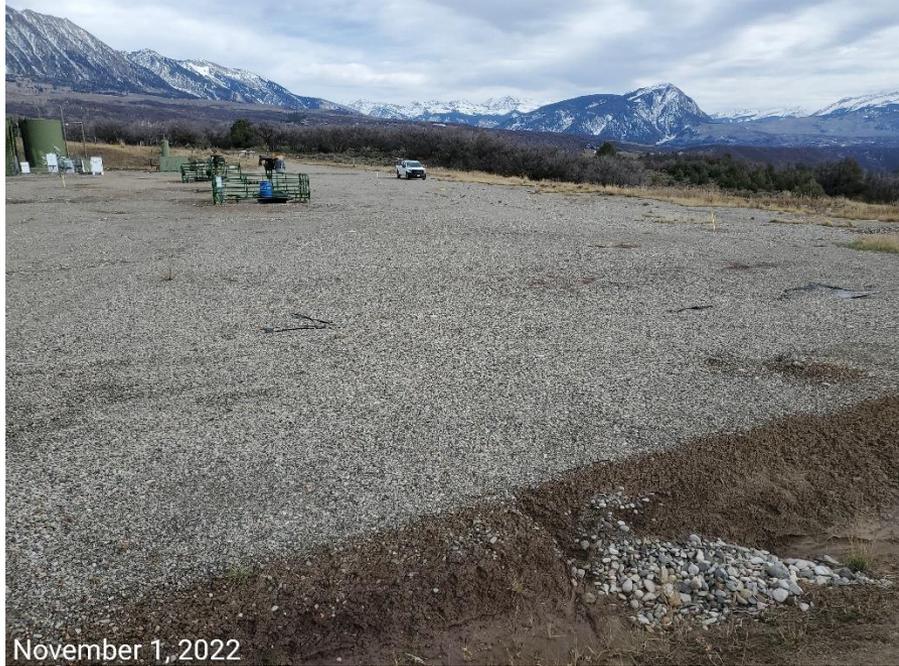
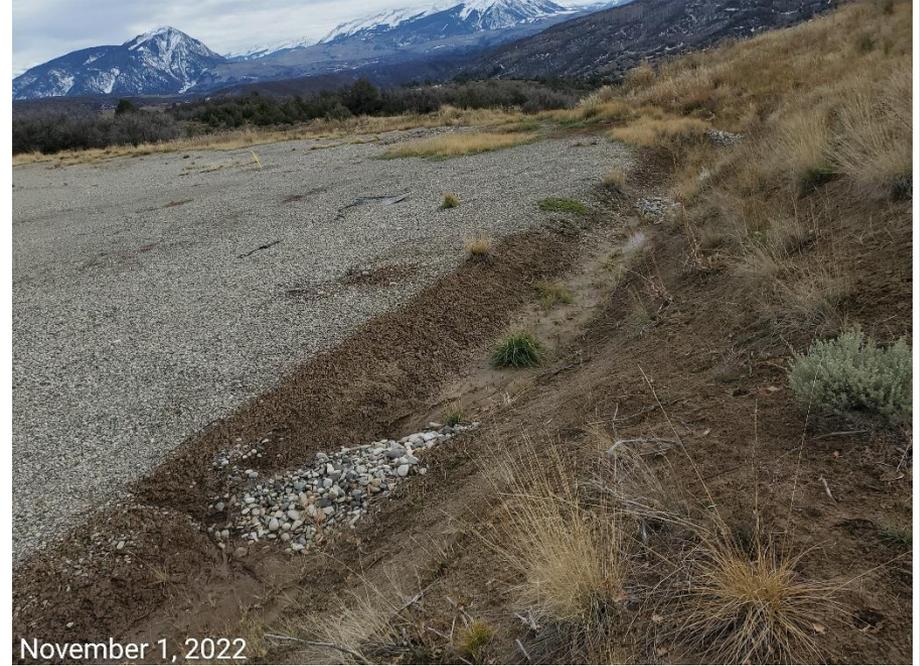
Photo 4: See comments under photo 3.

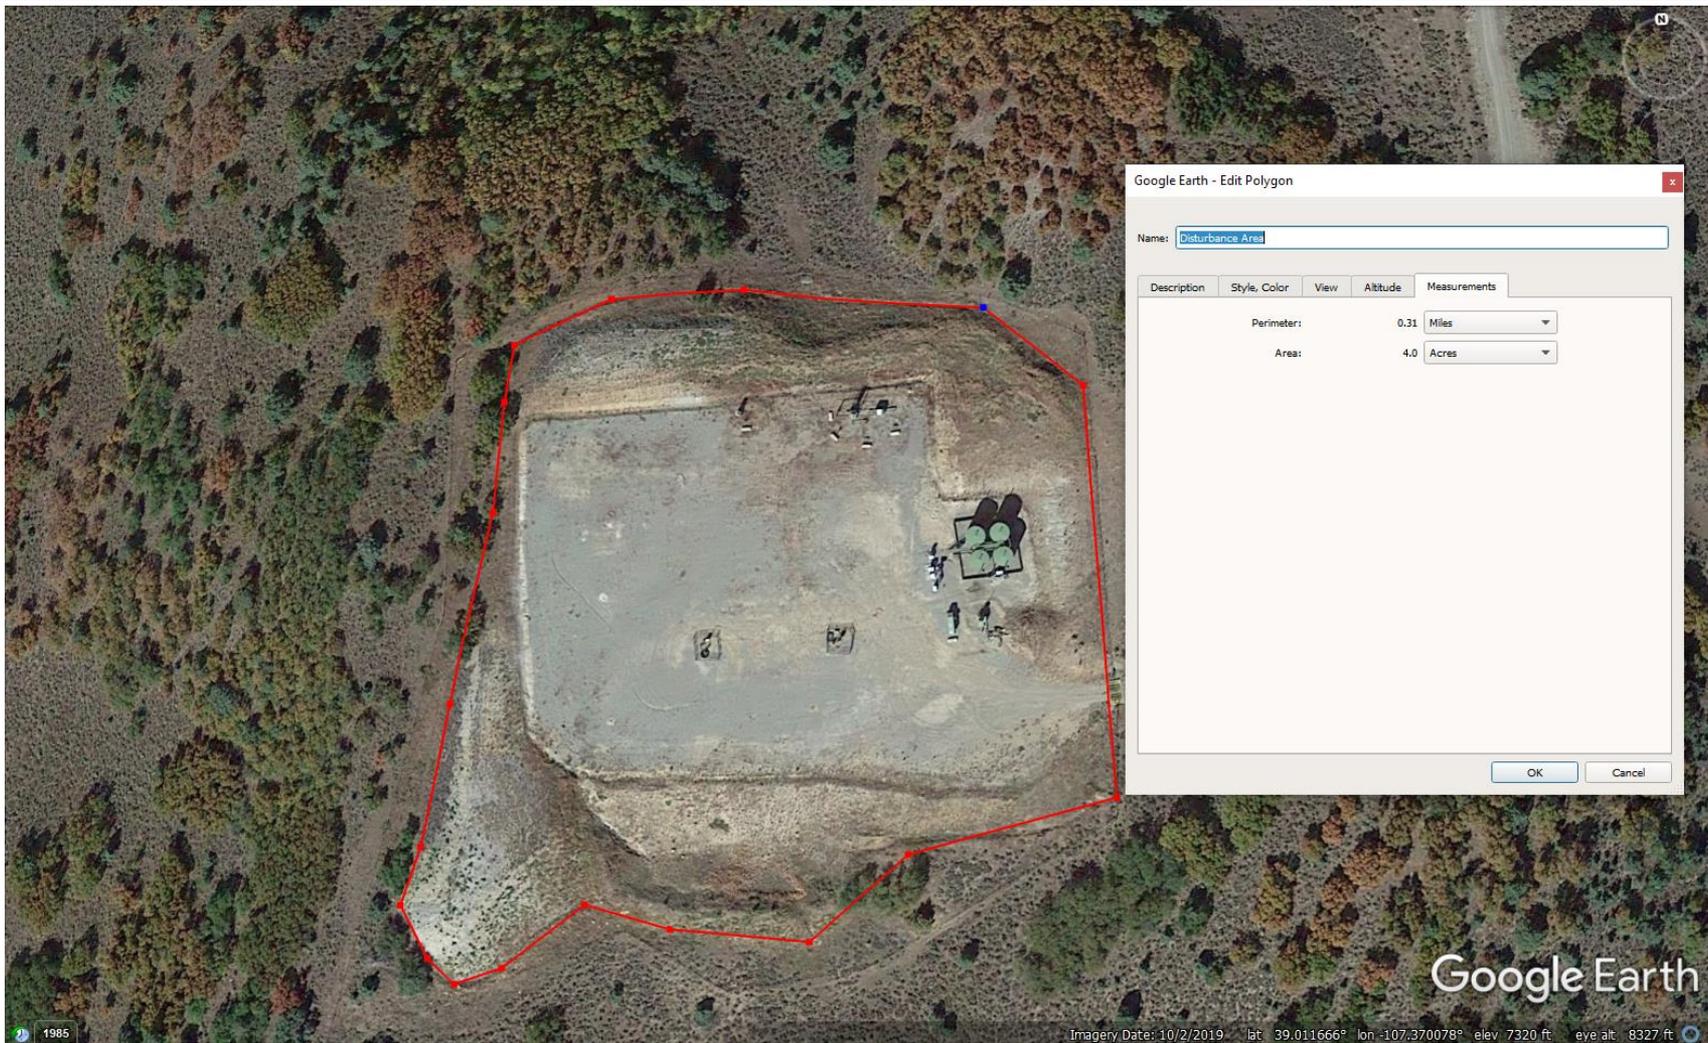
Photo 5: Photo shows a Google Earth Aerial image of the Location. Per Form 2A #400537258, the permitted size of disturbance area during construction is 2.79 acres, reduced to 1.21 acres after interim reclamation. The total disturbance area is 4 acres, and the current production areas are 2 acres; Location exceeds permitted disturbance area. Measurement and polygon does not include the perimeter fence constructed around Location.

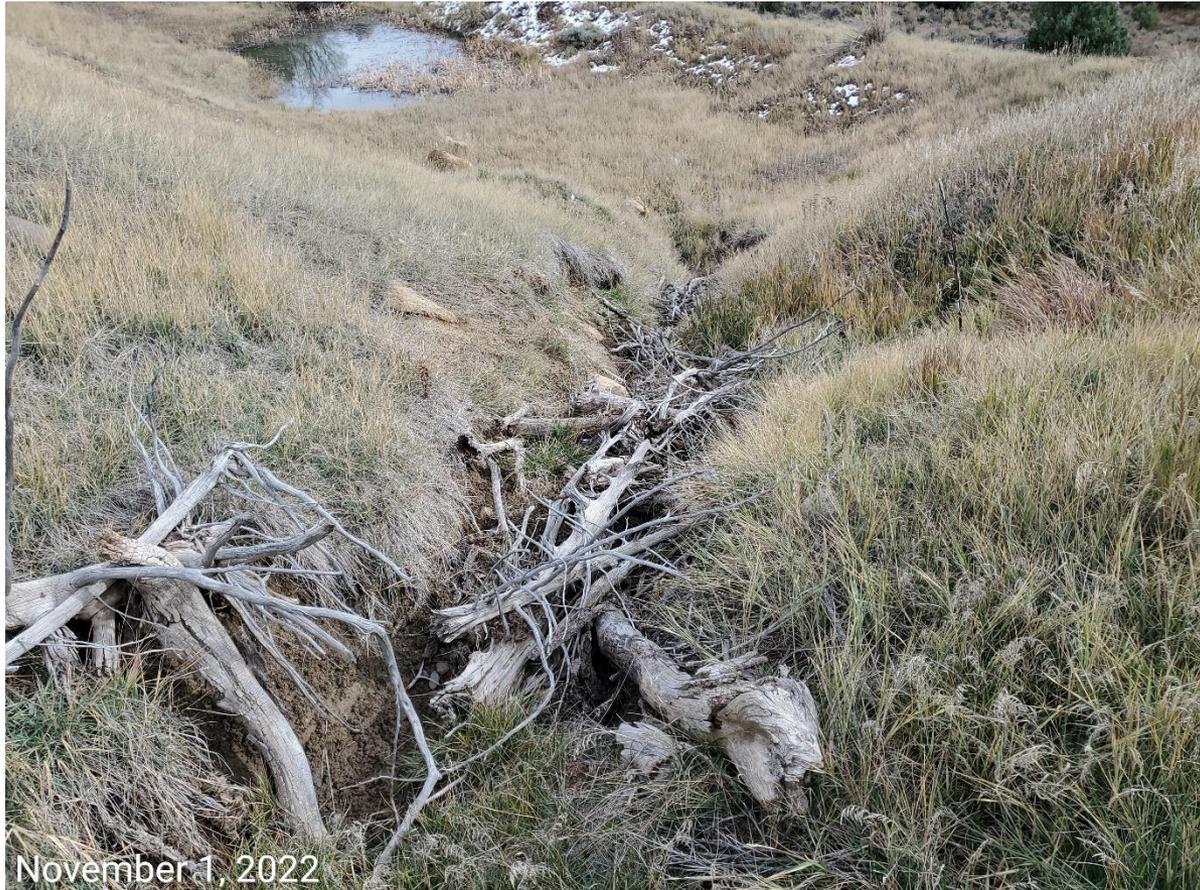
Photo 6: Photo taken from the northern inlet at the sediment trap on the east end of the Location. Photos shows sediment trap has not been constructed with a properly engineered inlet per corrective actions; gully erosion due to stormwater runoff into trap remains evident.

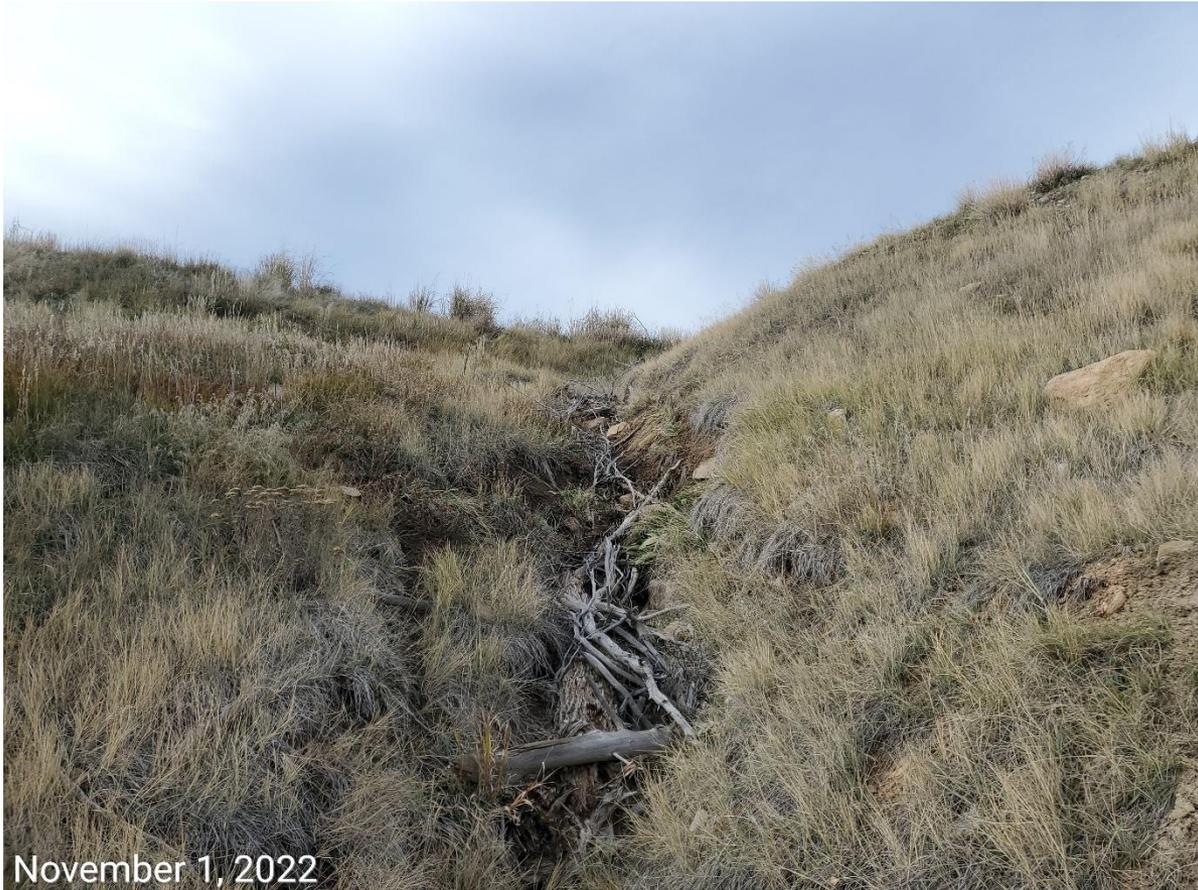
Photo 7: Photo taken from the northern inlet at the sediment trap on the east end of the Location. Photos shows sediment trap has not been constructed with a properly engineered inlet per corrective actions; gully erosion due to stormwater runoff into trap remains evident.

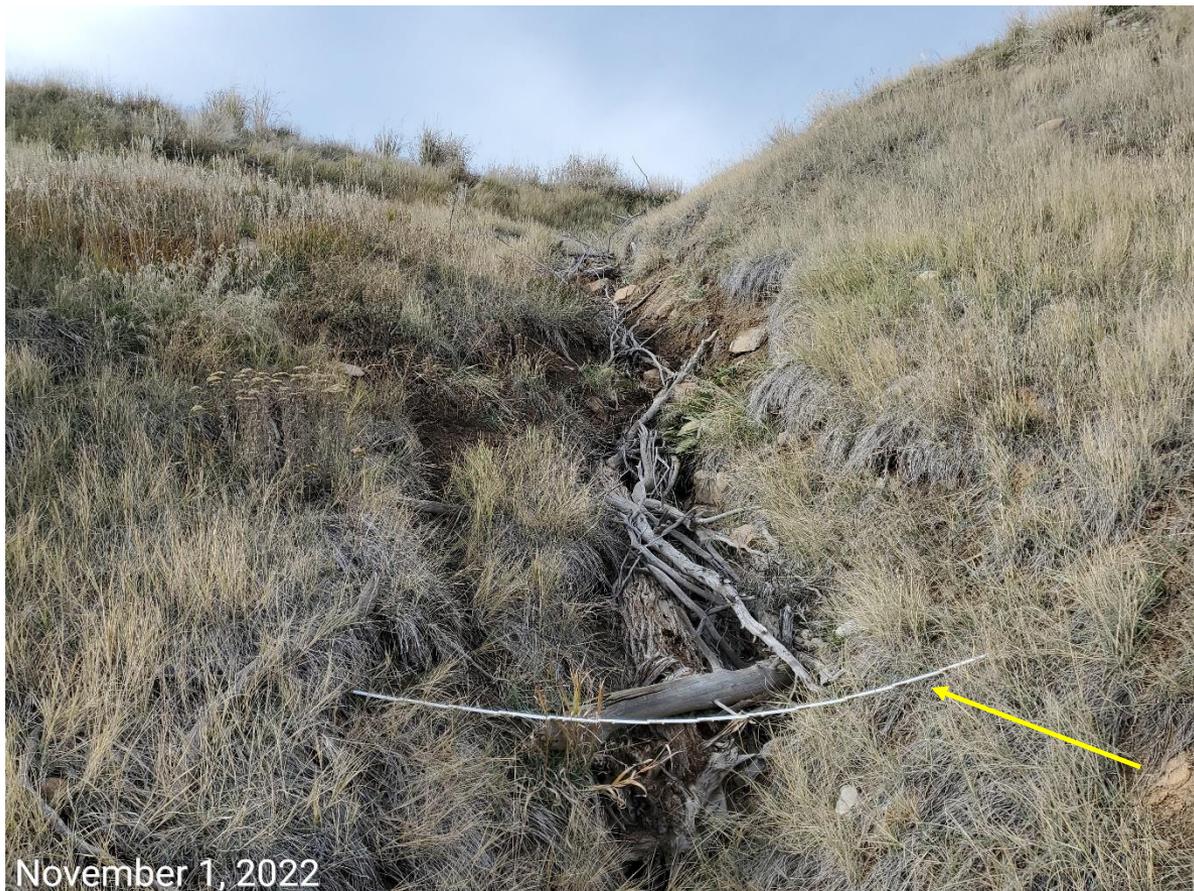
Photo 8: Photo taken from the northern inlet at the sediment trap on the east end of the Location. Photos shows sediment trap has not been constructed with a properly engineered inlet per corrective actions; gully erosion due to stormwater runoff into trap remains evident. 6 and ½ foot measuring stick used for scale (arrow).

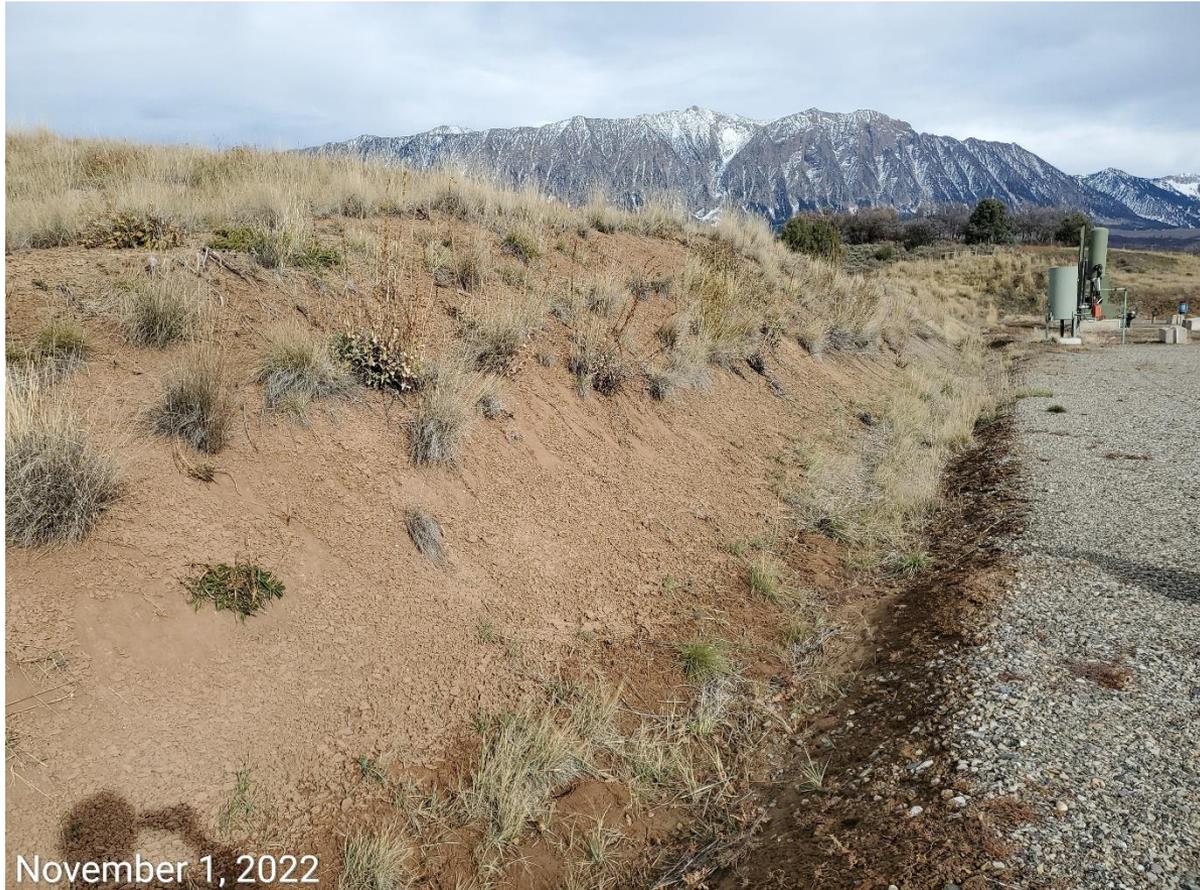
Photo 9: Photo taken from the soil stockpile on the northwest end of the Location. Photo shows BMPs to minimize erosion, degradation and sediment transport remain missing or insufficient- soils remain bare and at risk to wind and water erosion; this does not comport with Rules 1002.f and 1002.c.

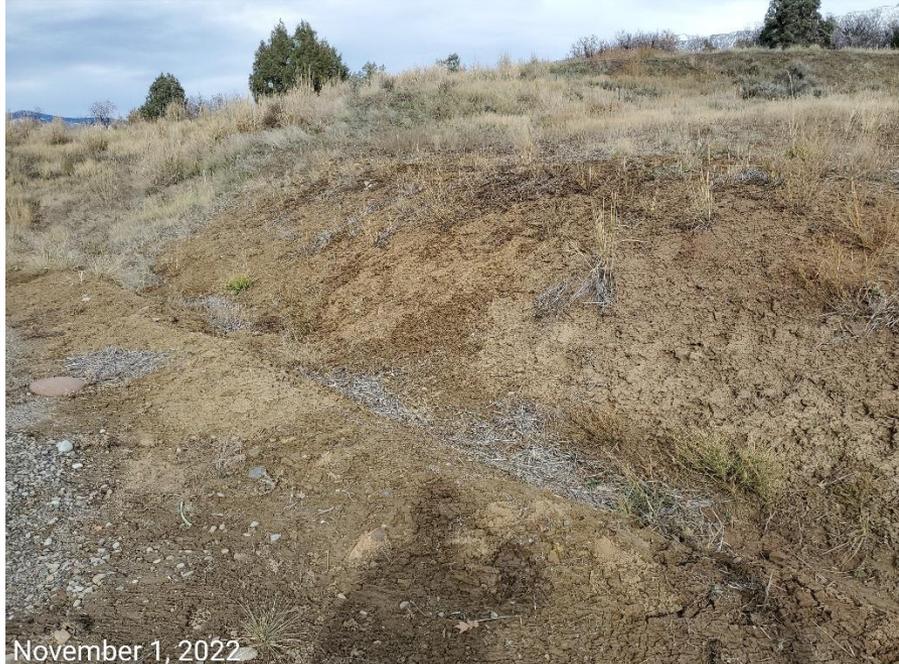
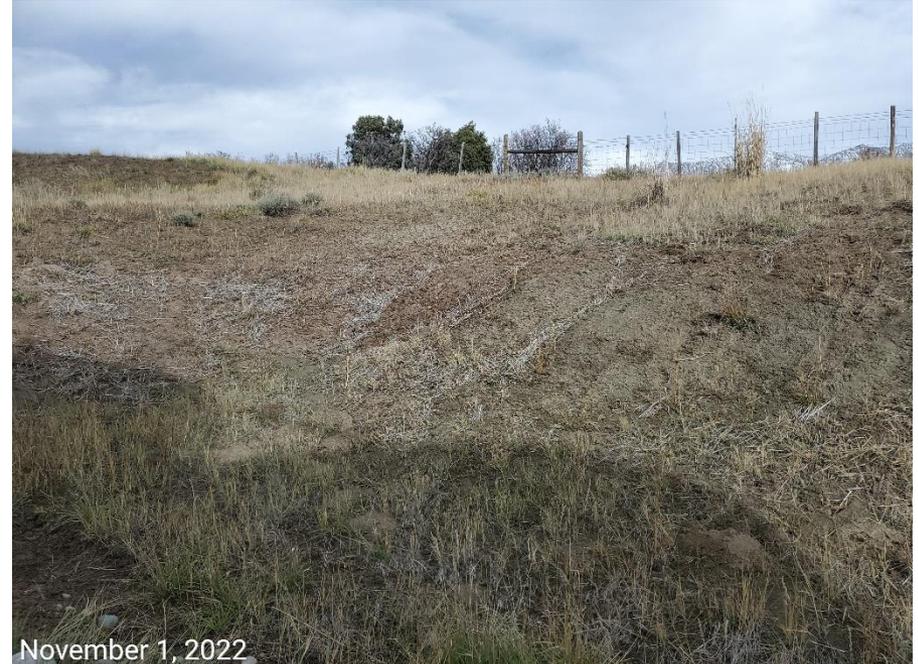
Photo 10: Photos taken from the cut slopes on the east end of the Location. Photo shows BMPs to minimize erosion, degradation and sediment transport remain missing or insufficient- erosion degradation remains evident.

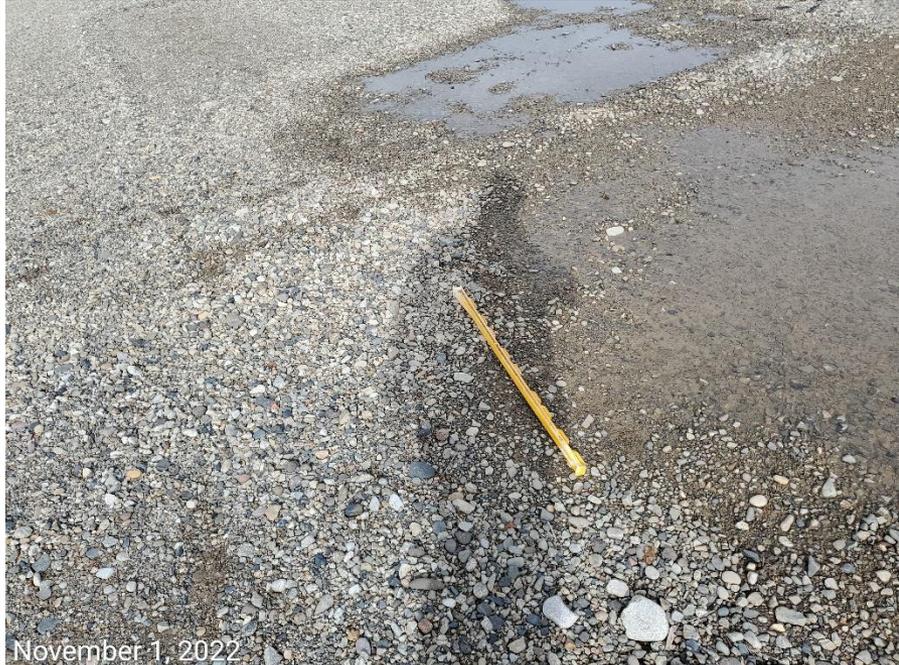
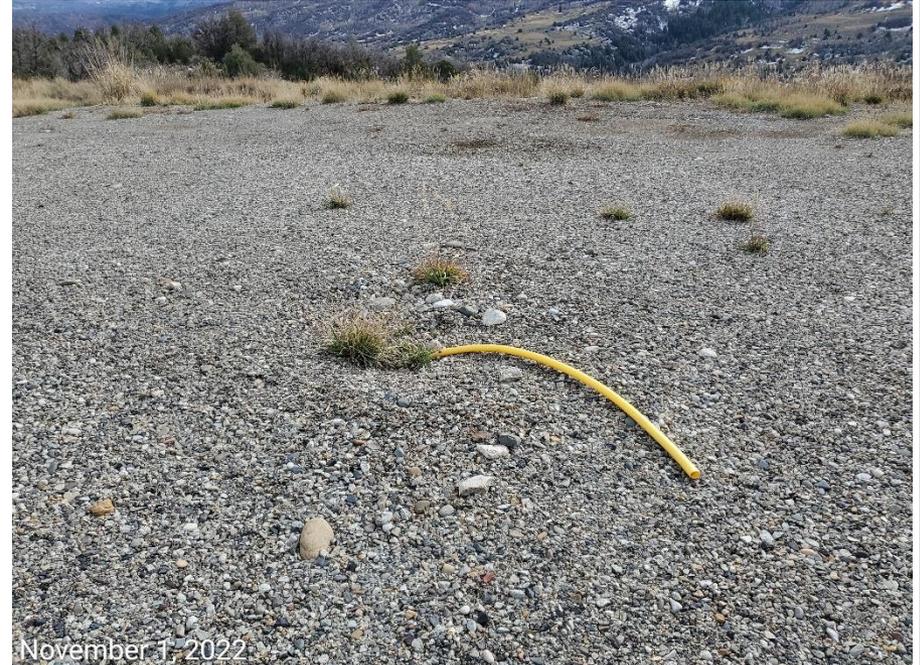
Photo 11: Photos examples showing markers at anchors not in proper functioning condition. Maintenance required. Unable to find anchor associated with marker observed in left photo.
