# Inspection Photos and Issue Report

11/1/2022

Operator: GUNNISON ENERGY LLC #10515

Location #427218

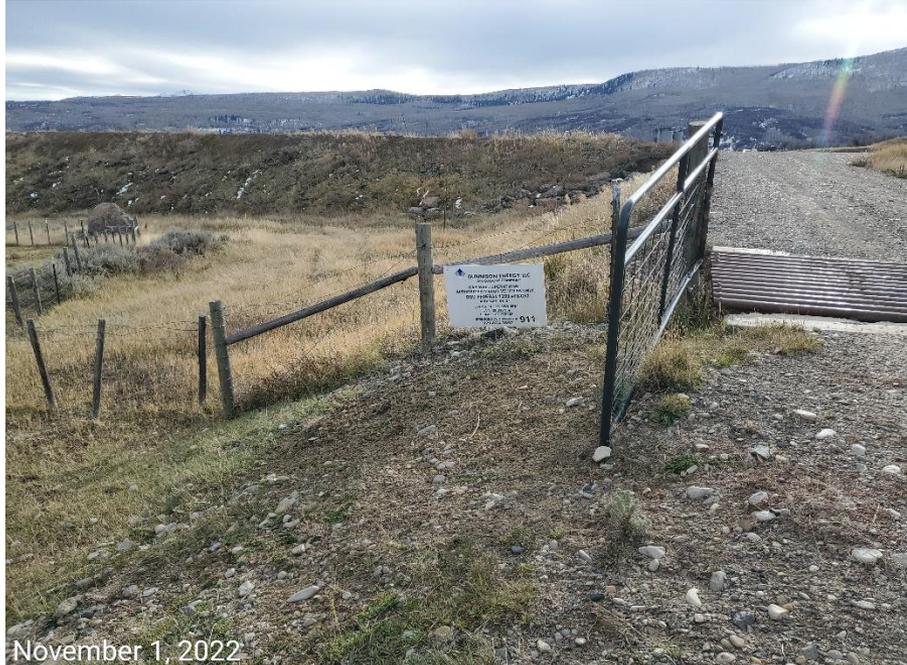
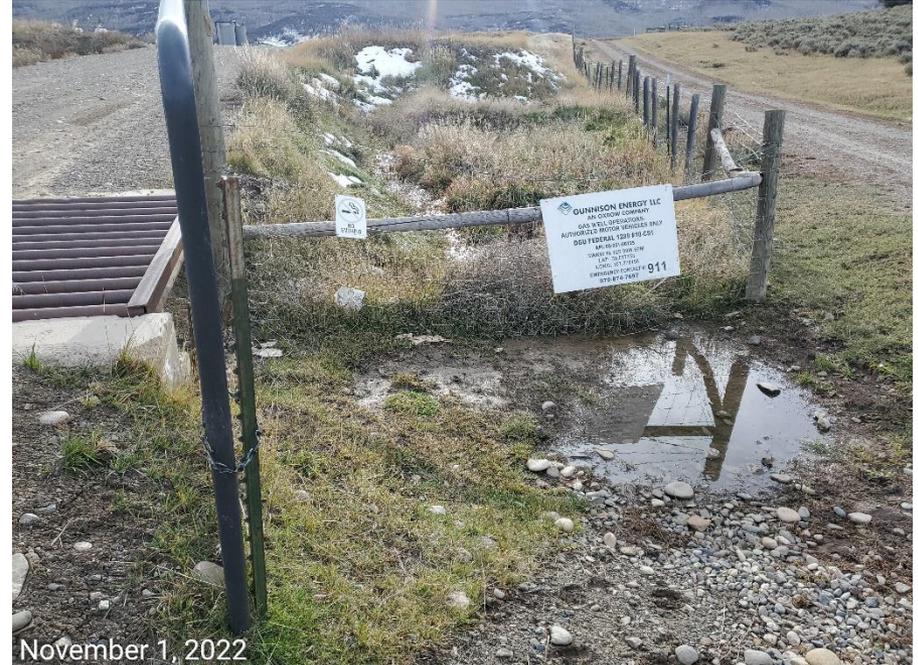
**Photo 1:** Photos taken from the Location entrance. Photo shows required delayed IR variance signage per Form 4 #401463099 conditions of approval has not been posted at the Location entrance. Signs observed in photo is required Location signage.

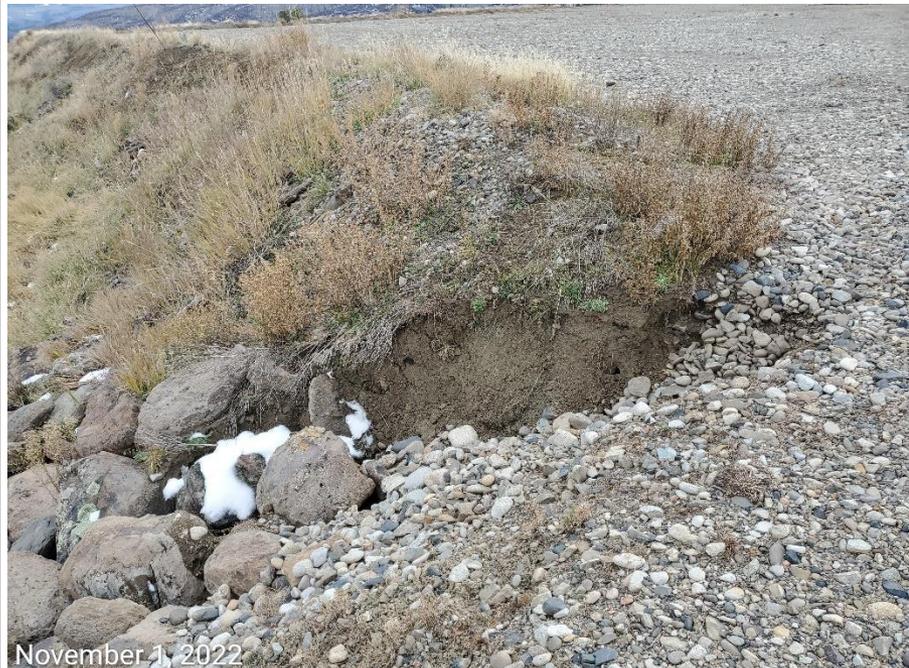
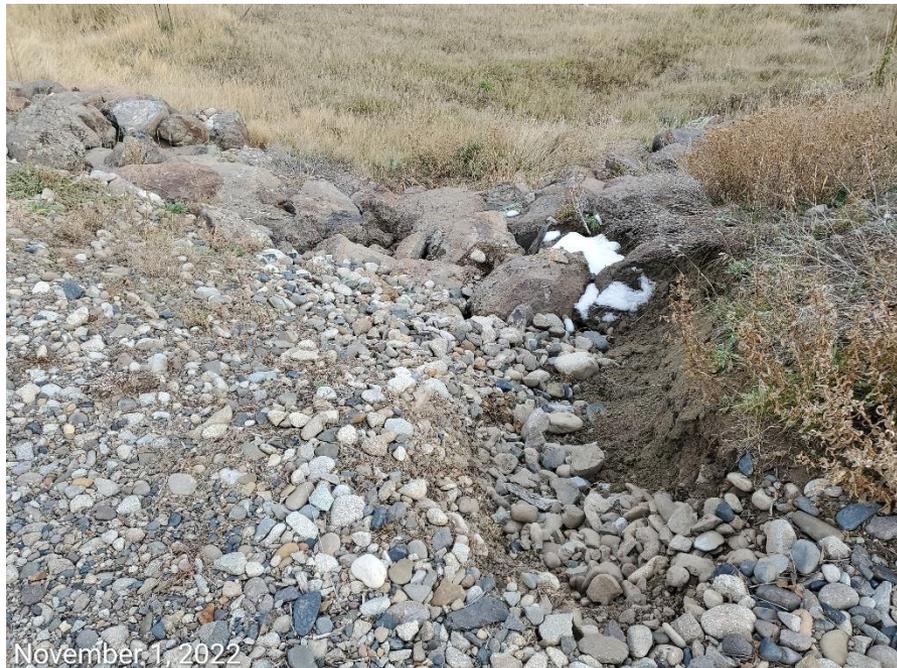
**Photo 2:** Photos taken from the north end of the Location, at the location entrance. Photo shows stormwater runoff has resulted in erosion degradation to the slopes. BMPS missing or insufficient.

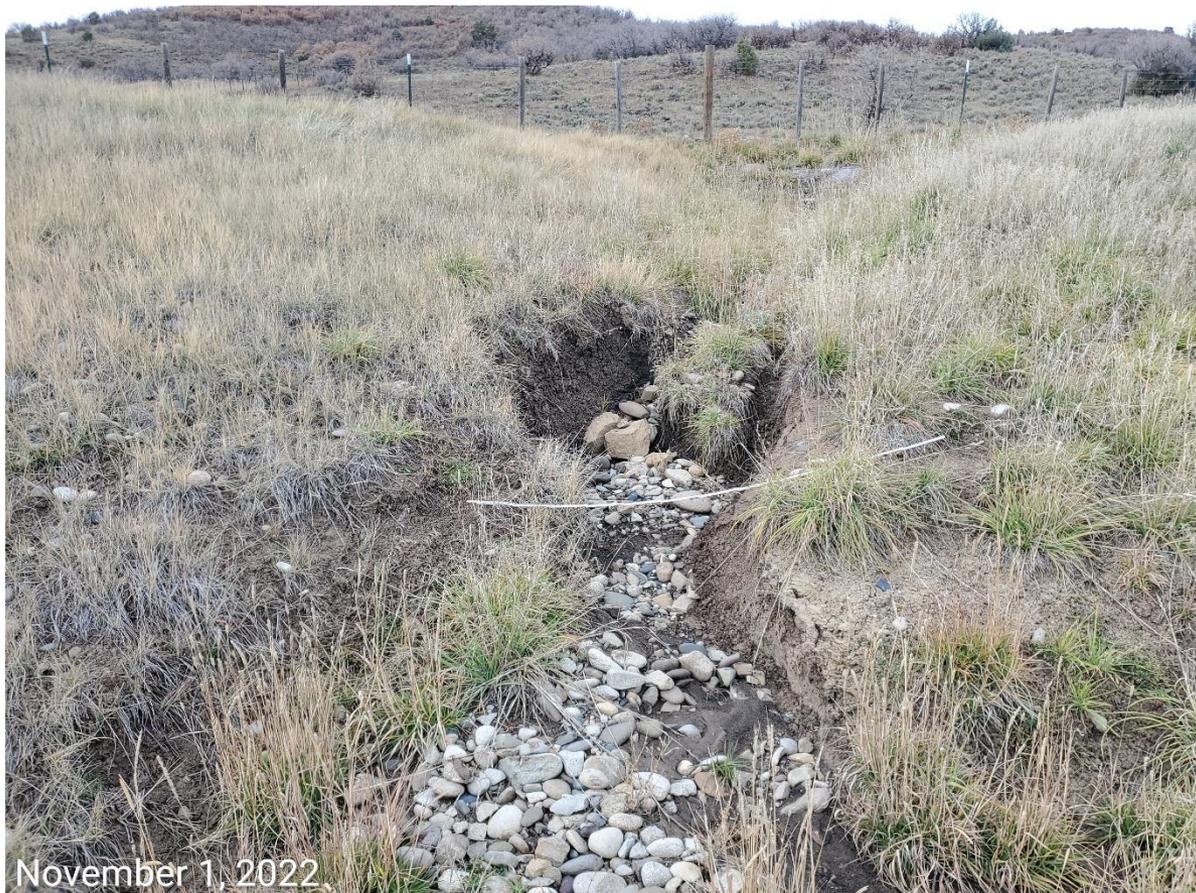
**Photo 3:** Photo taken from the northwest end of the Location. Photo shows stormwater runoff has resulted in a gully erosion and degradation. 6 and ½ foot measuring stick used for reference.

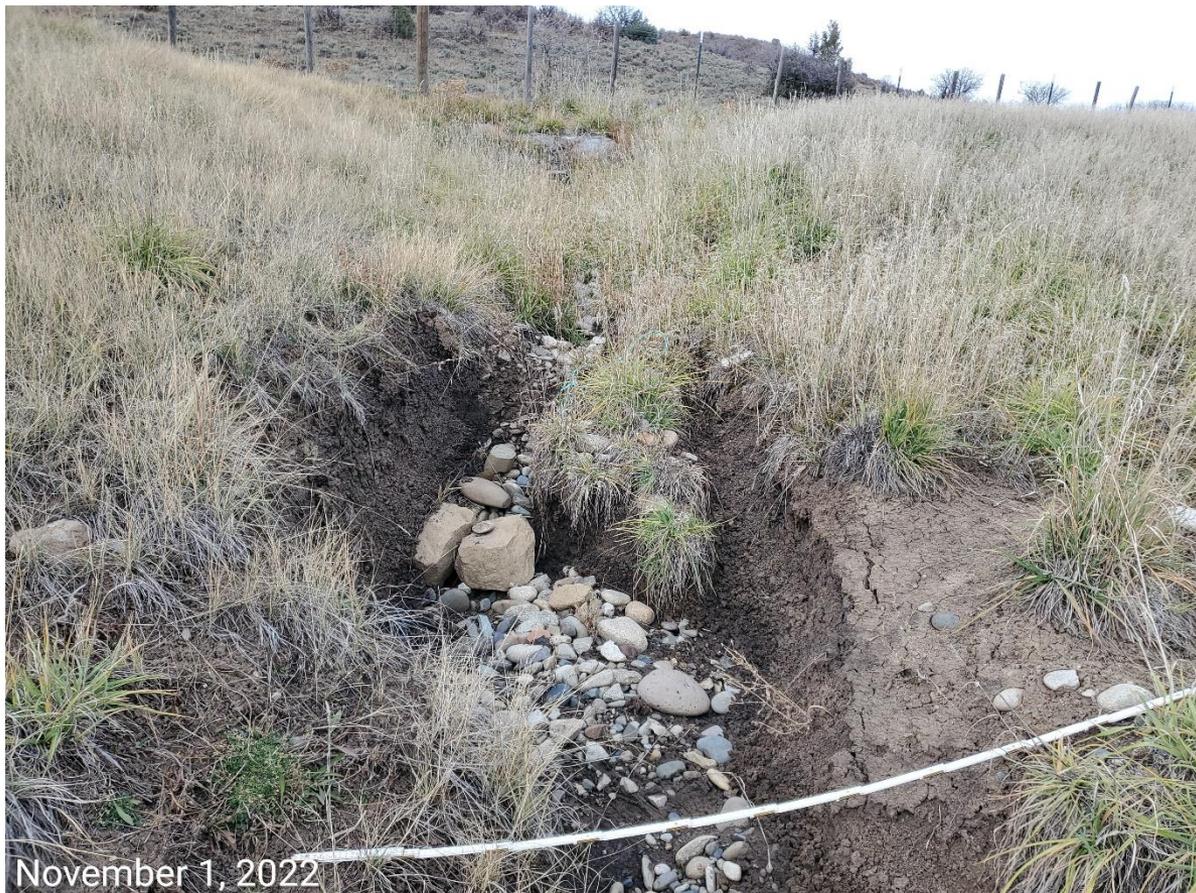
**Photo 4:** Photo taken from the northwest end of the Location. Photo shows stormwater runoff has resulted in a gully erosion and degradation. 6 and ½ foot measuring stick used for reference.

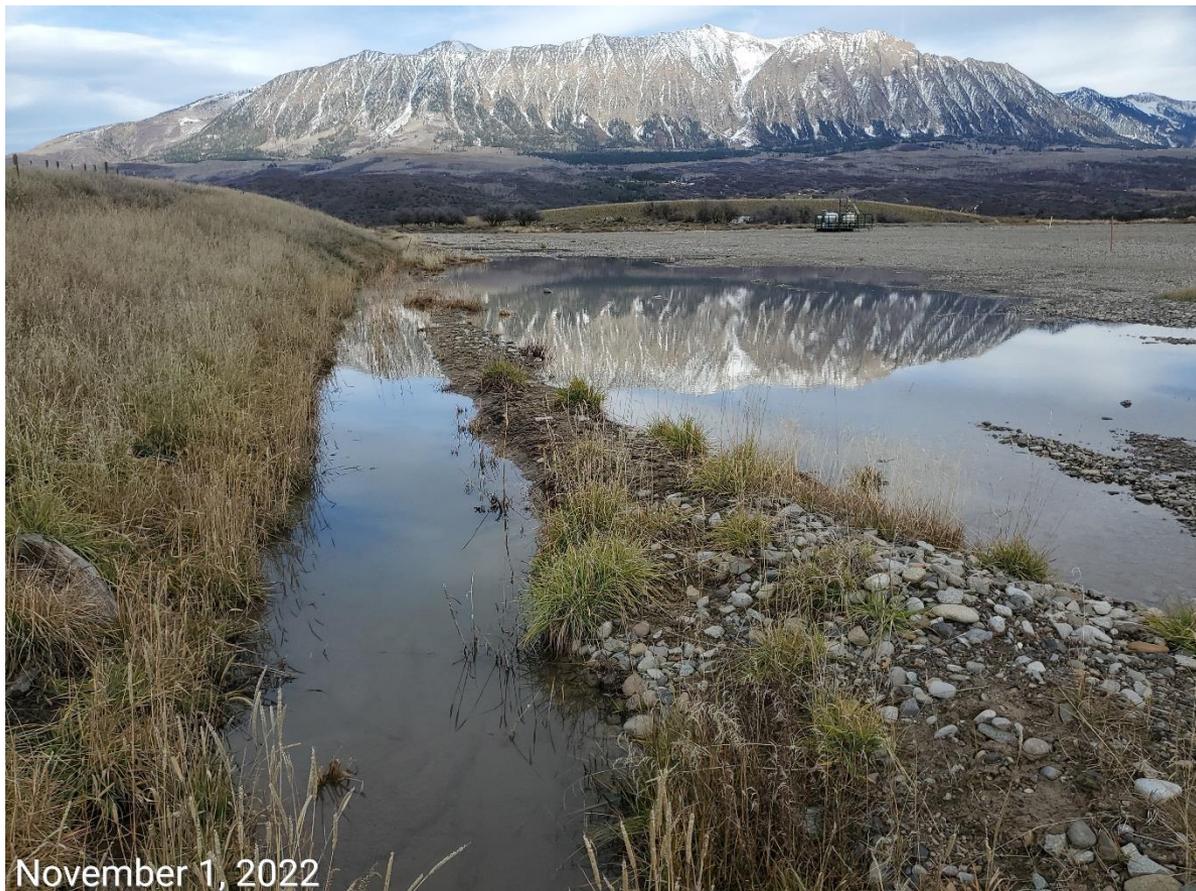
**Photo 5:** Photo taken from the northwest end of the Location. Photo shows the stormwater diversion ditch is not in proper functioning condition; stormwater runoff appears to be either being diverted and discharging onto the working pad areas of the Location, rather than off-location, or area and ditch/berm has not been properly engineered to facilitate stormwater discharge to leave the pad.
