Inspection Photos

Location Name: CAERUS PICEANCE LLC DUNN-67S92W /9NWNE

Location ID: 334833

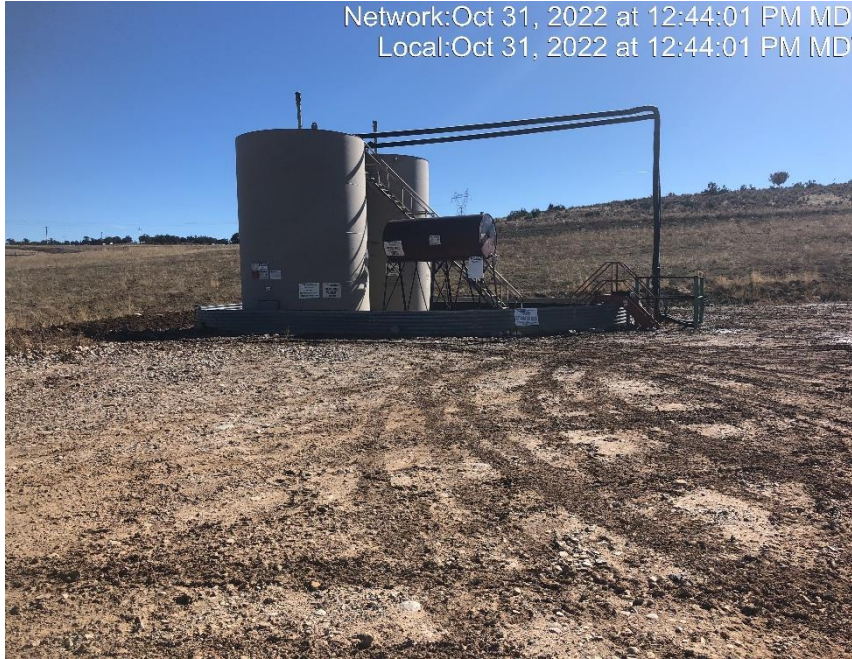
Photo #8266 From entrance to location.

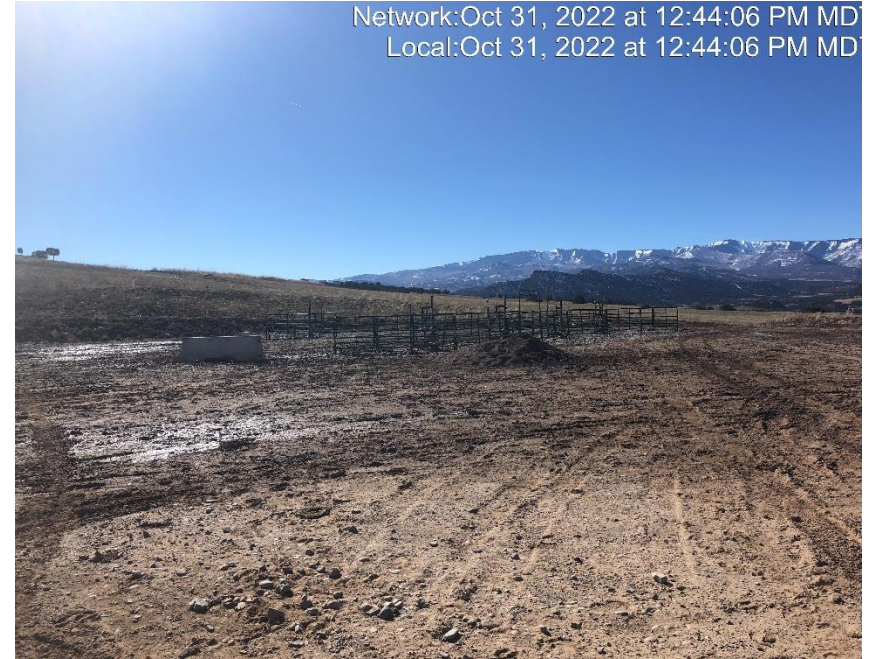
Photo #8267 from entrance to location.

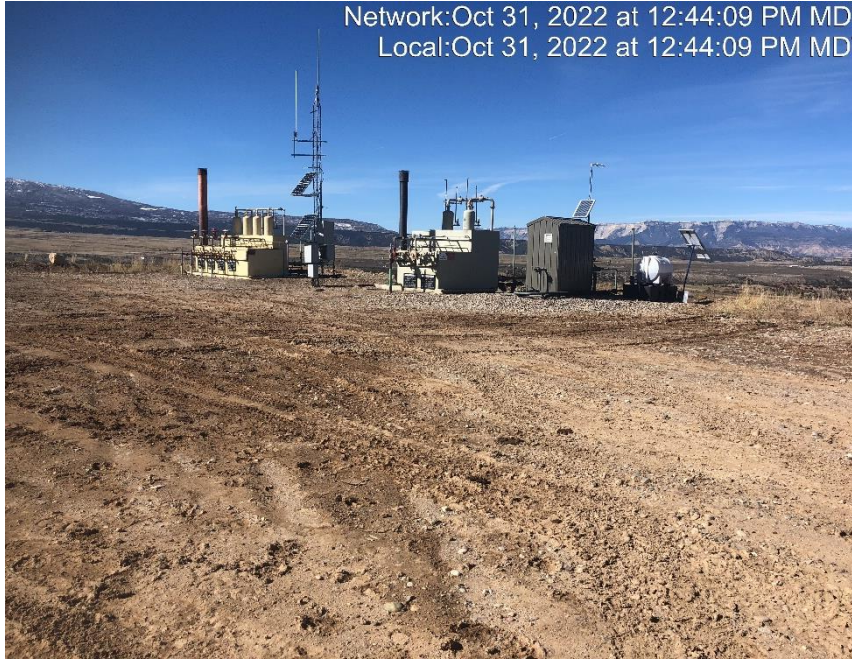
Photo #8268 From entrance to location.

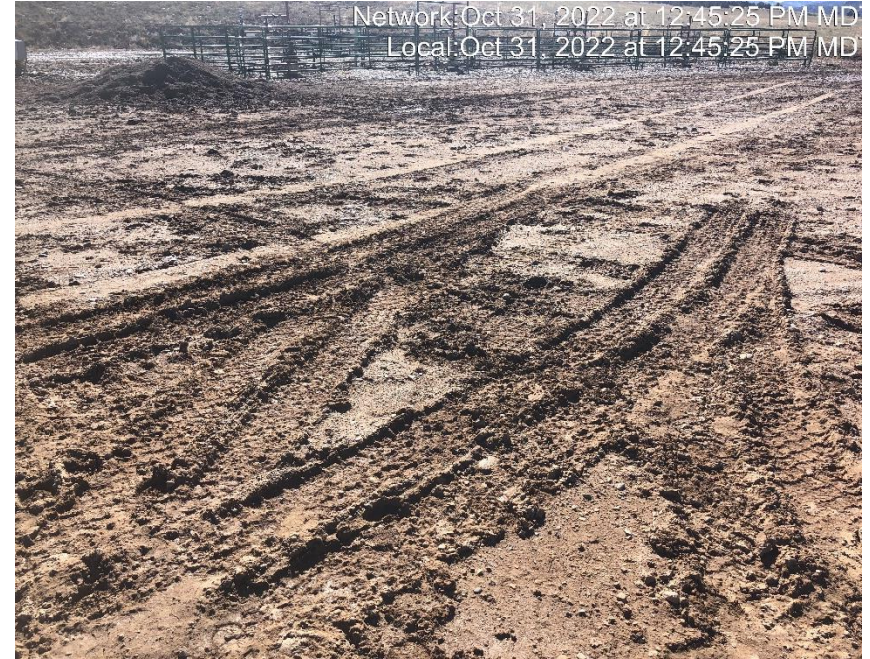
Photo #8269 Location lacks stabilization.

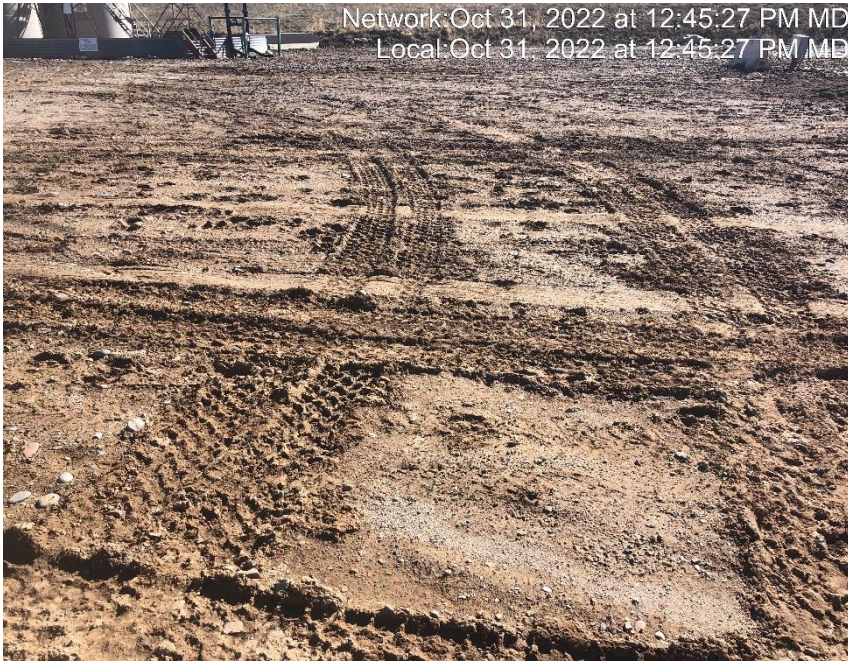
Photo #8270 Location lacks stabilization.

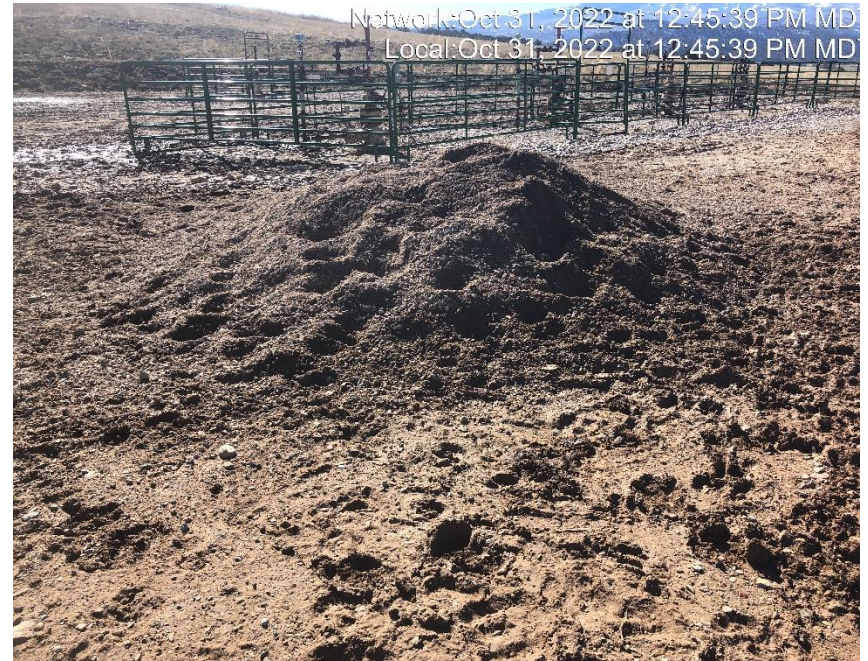
Photo #8271 BMP's have not been implemented around stockpiled soils.

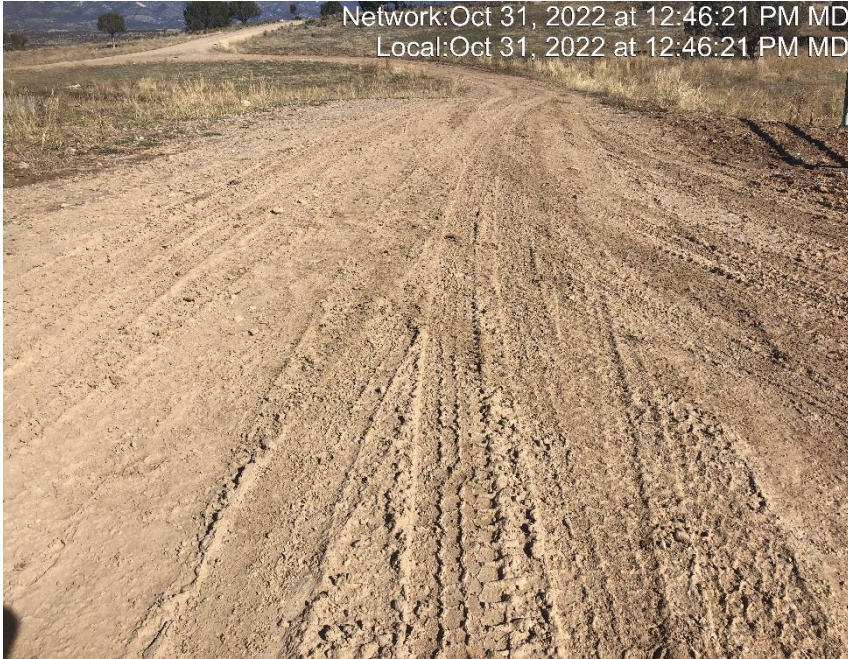
Photo #8272 Insufficient tracking BMP at entrance to location.
