Inspection Photogs
Location Name: Miller Mesaverde Unit 1
Location ID: 325165

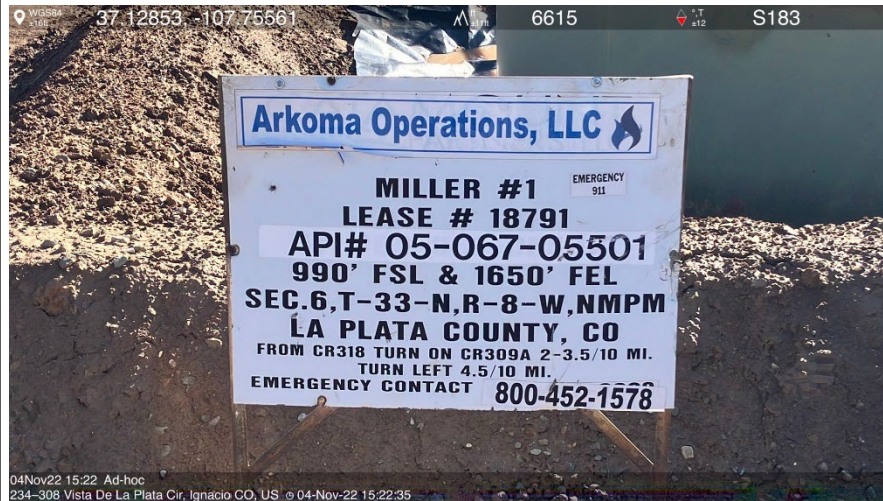
IMG 01
Well sign

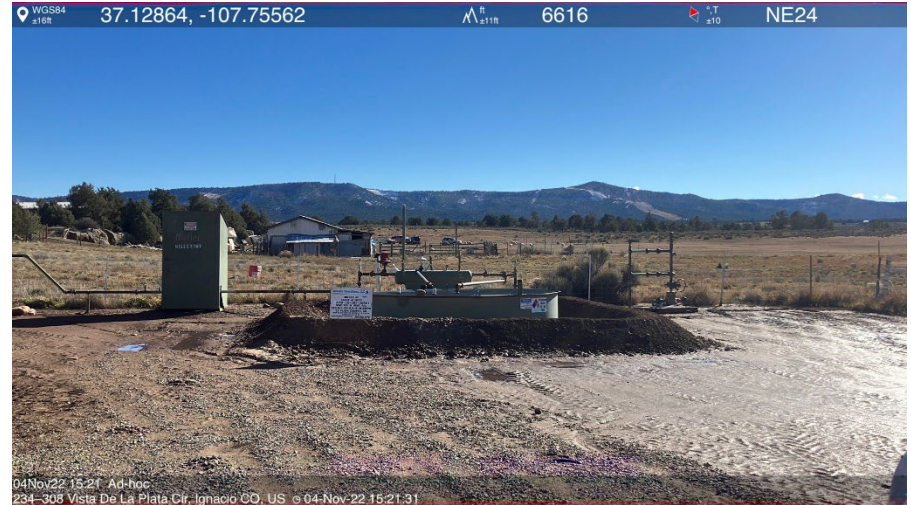
IMG 02
Location overview
