Stormwater Inspection Report

Operator:	Laramie Energy, LLC
Project:	Cascade Creek
Location:	Shell 797-03A Pad
Date:	Wednesday, November 2, 2022
Weather:	Partly Cloudy, Windy, 64°, Lo 46°

Operator:	Laramie Energy, LLC
Project:	Cascade Creek
Location:	Shell 797-03A Pad
Date:	Monday, November 7, 2022
Weather:	Mostly Sunny, Windy, 65°, Lo 36°

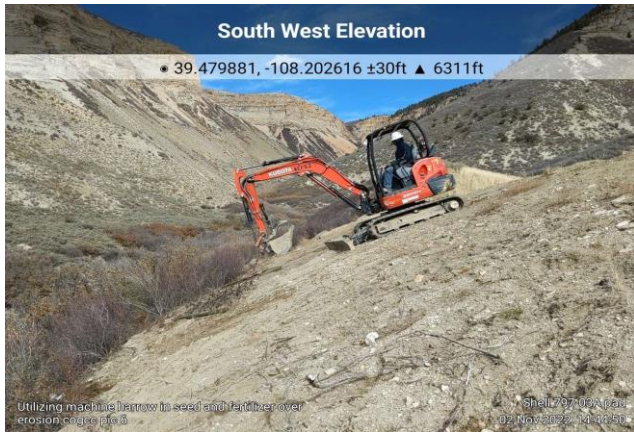
Photo 1

Removing Erosion Features Identified in Photo #6

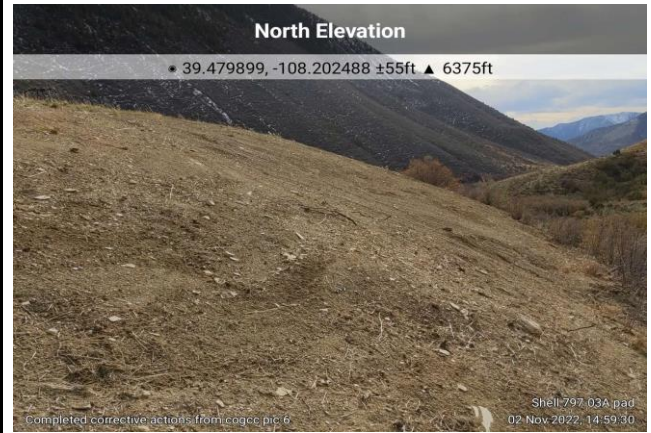
Photo 2

Corrective Action Completed for Photo #6

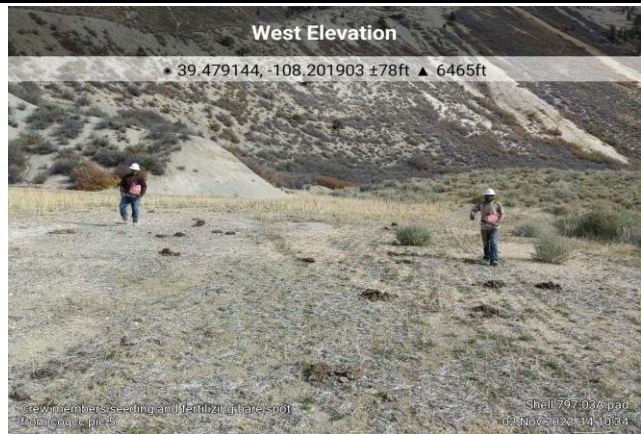
Photo 3

Seeding Bare Areas Identified as Photo #5

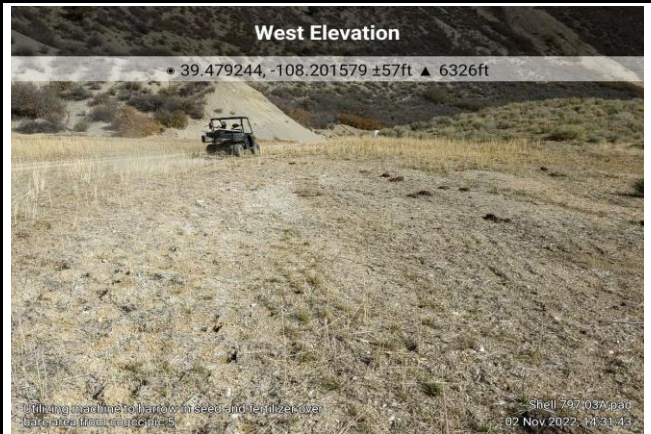
Photo 4

Harrowing Areas Identified in Photo #5

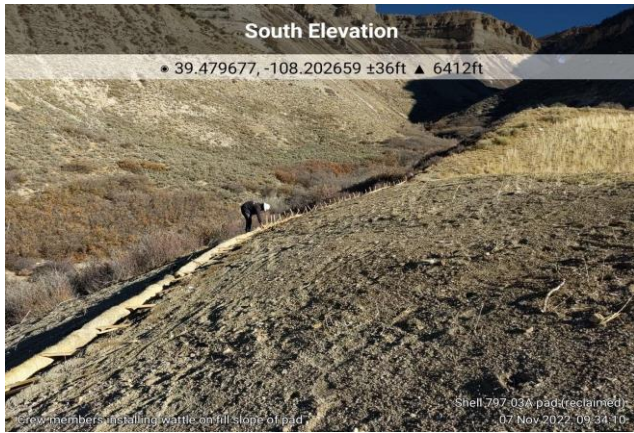
Photo 1

Installing Excelsior Wattle

Comments / Descriptions / Explanations	
<p>BMP crews completed repairs to issues identified by COGCC in Document #696204257. Areas with weak stands of vegetation called out in Photo #5 were seeded and harrowed last week. Today, 20 weed-free certified straw bales were applied as mulch over this location. 250 feet of excelsior wattle was installed perpendicularly, midslope to provide additional protection to areas identified in Photos #6 and #7.</p>

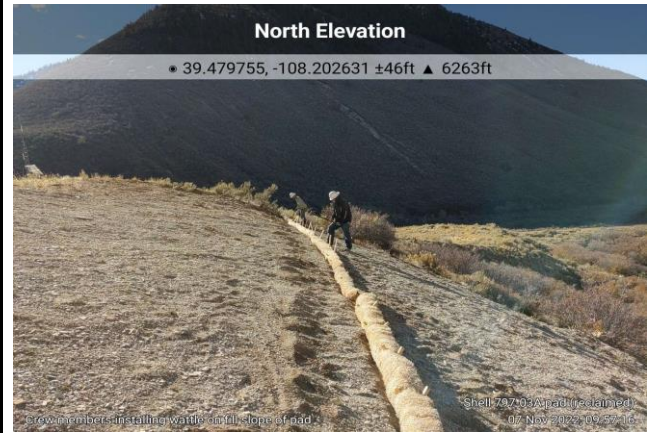
Photo 2

Installing Excelsior Wattle

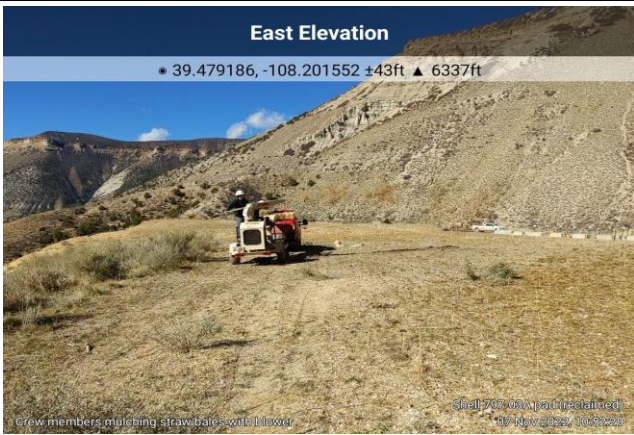
Photo 3

Applying Straw Mulch

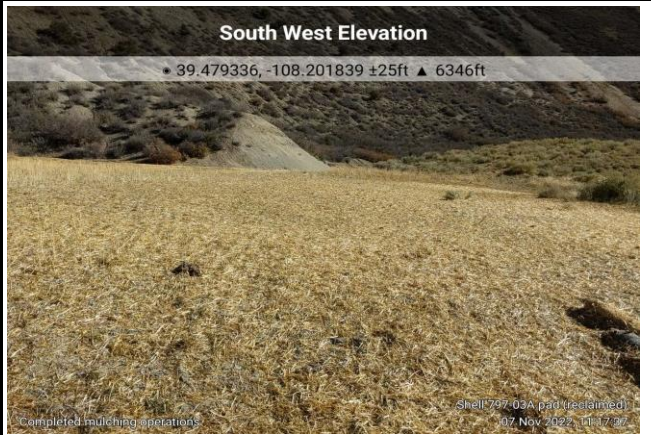
Photo 4

Straw Mulch Applied
