Prospect Energy - COGCC Inspection Photos
MSSU 19-5 Injection Well Flowline
Spill ID #483137 Date 11/02/2022

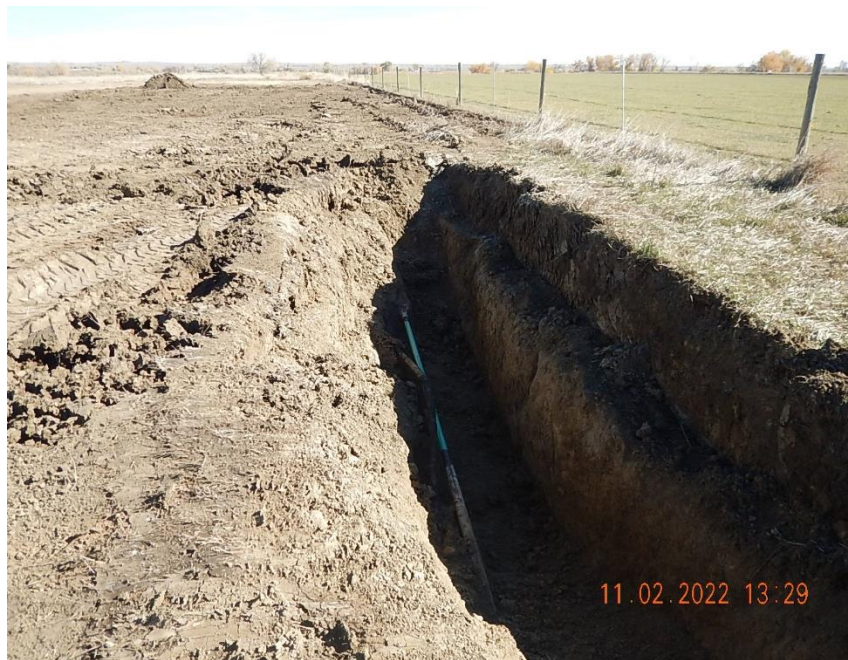
Flowlines exposed in excavation; repair completed on produced water injection flowline. View east toward MSSU 19-5 injection well. Located at approx 40.648722, -105.049226

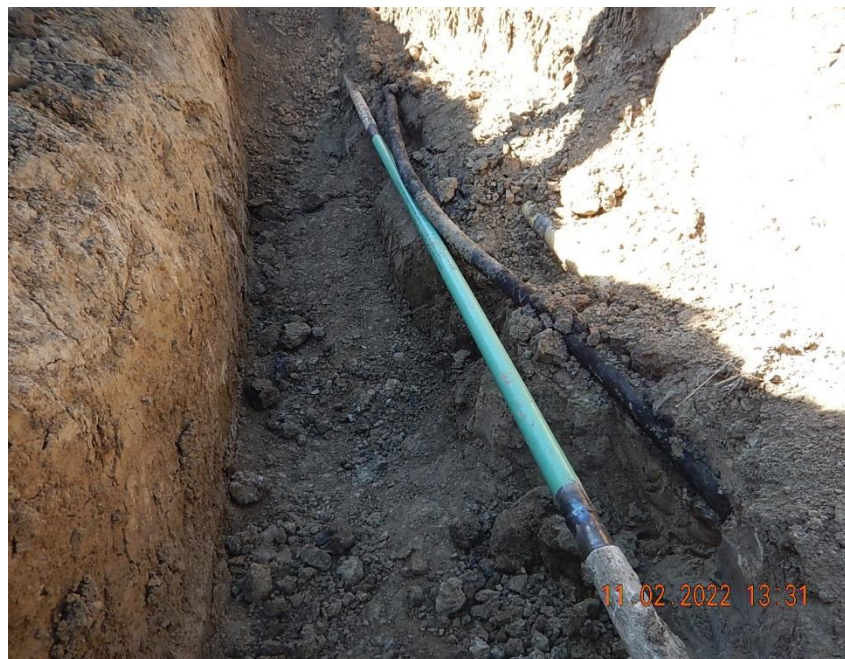
View of flowlines exposed in excavation at release point. (1) 2" carbon steel flowline repaired; approximately 15' of 2" CS FBE coated pipe welded into place (welds to be coated) in area of failure. (1) poly natural gas flowline running tandem in same trench.

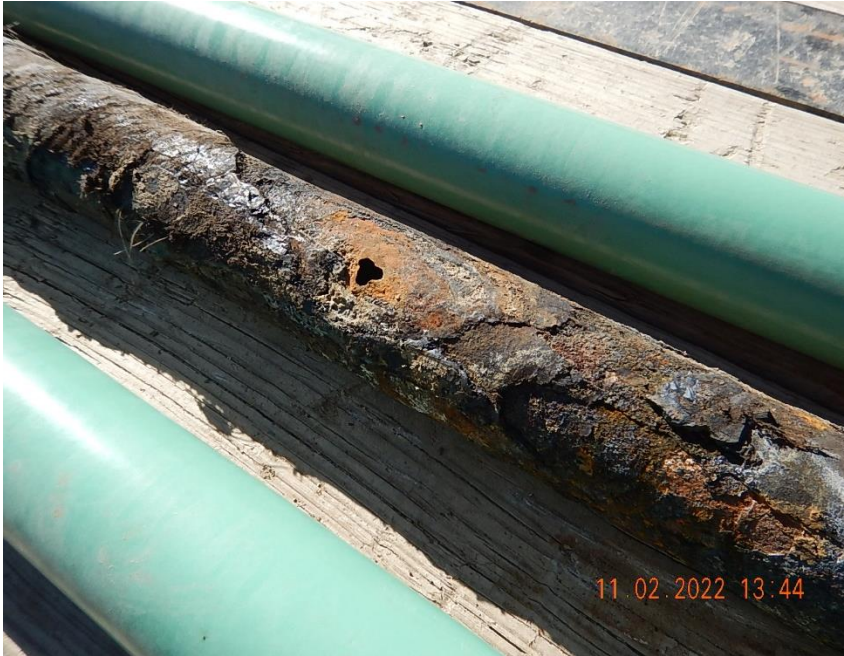
Corrosion hole identified on flowline pipe; MSSU 19-5 PW Injection flowline (off location). Coating damage observed in area of failure.

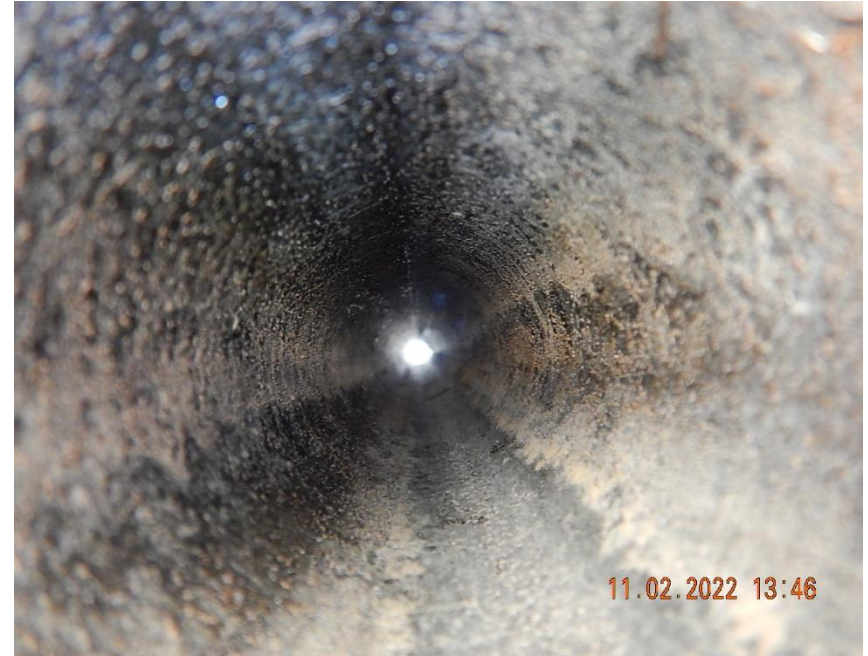
Internal photo of failed section of MSSU 19-5 flowline pipe.

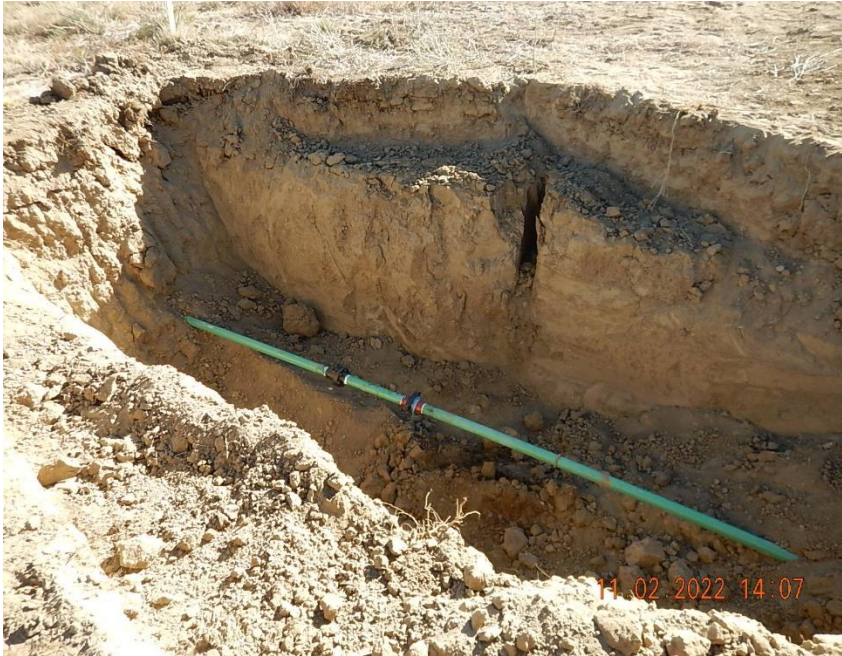
Isolation valve installed on MSSU 19-5 flowline adjacent to/ west of Krauss Battery. Valve can to be installed for access.

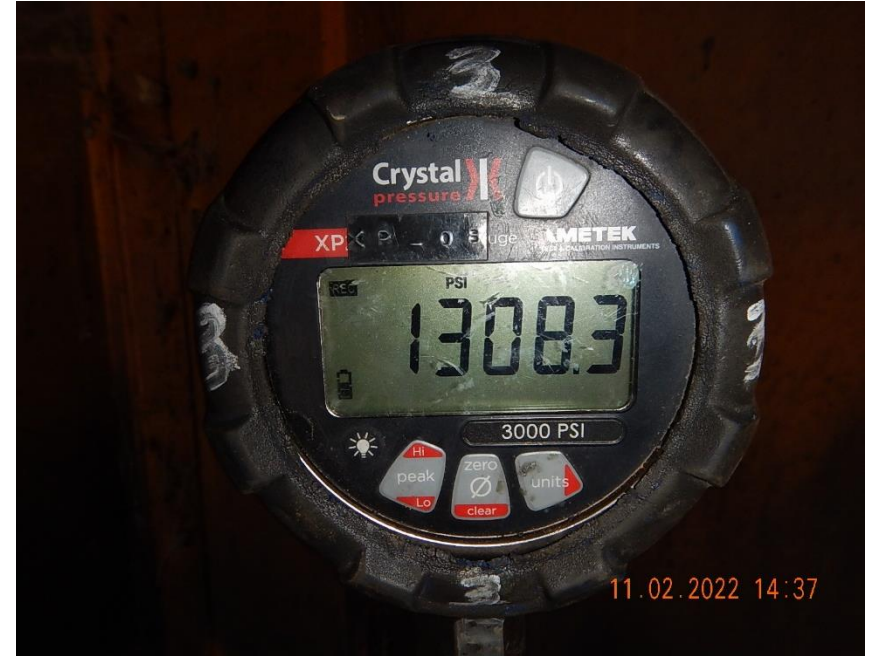
Flowline pressure test witnessed; crystal gauge reading near end of pressure test (verification of repairs completed).
