# Final Reclamation and Stormwater Inspection

Operator: KERR MCGEE OIL & GAS ONSHORE LP - 47120

Location ID: 320397

Inspection Photos  
Location Name: HSR EPPINGER #1-1  
Location ID: 320397

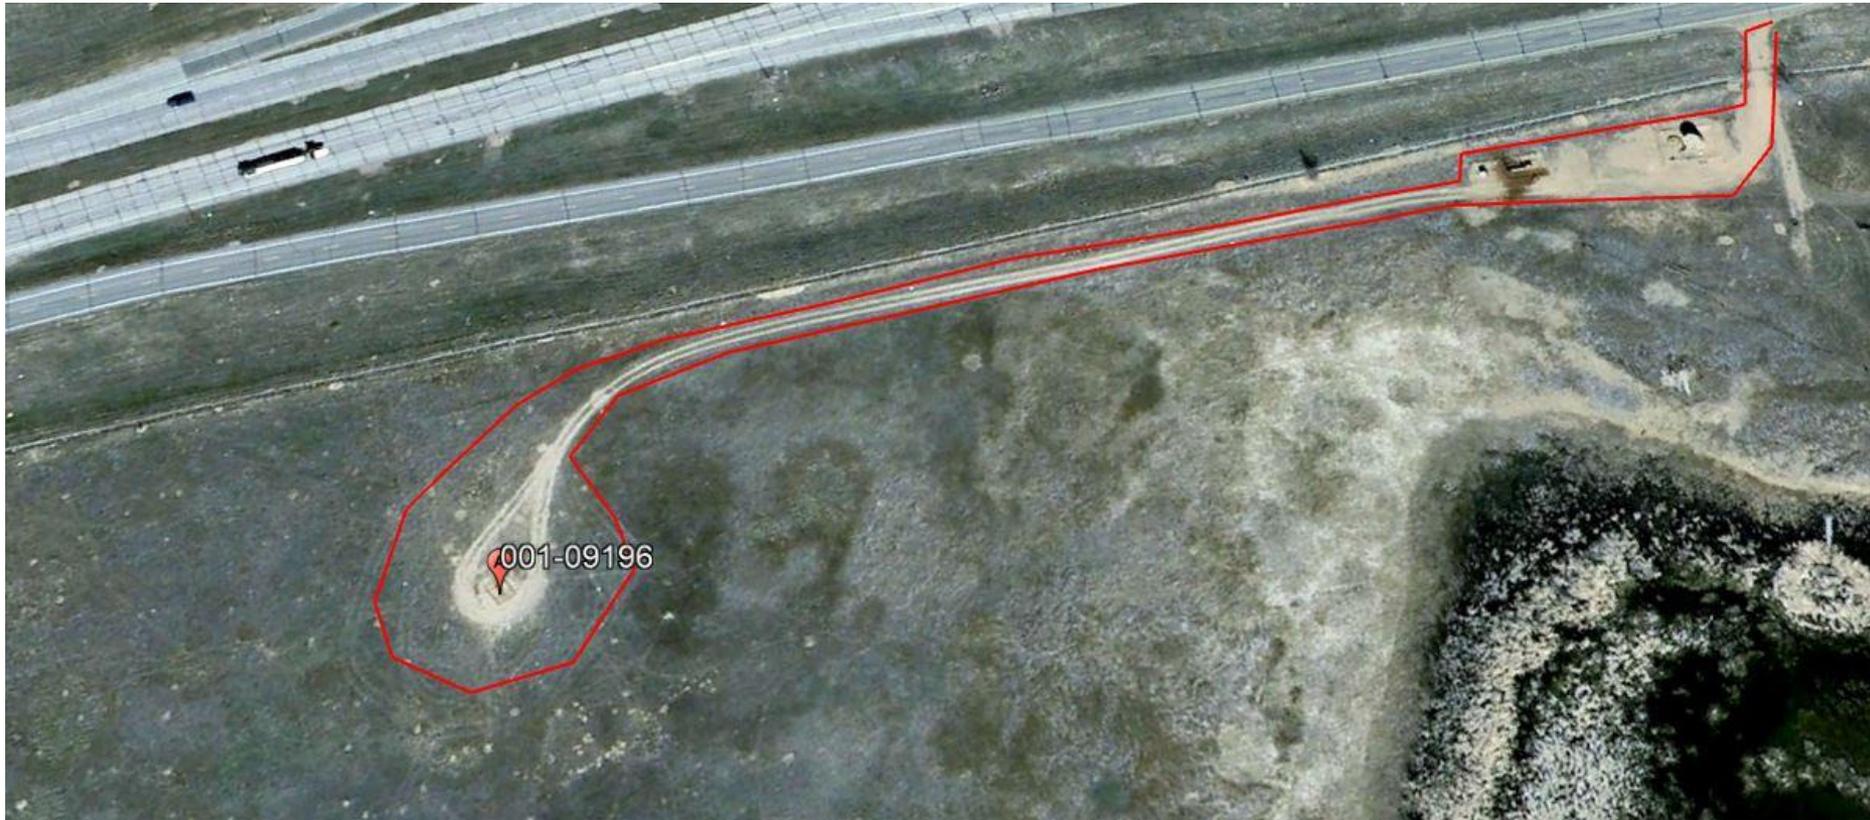
**Photo 1.** Google Earth aerial imagery taken circa 2006 illustrates the access road and location that need to be reclaimed.

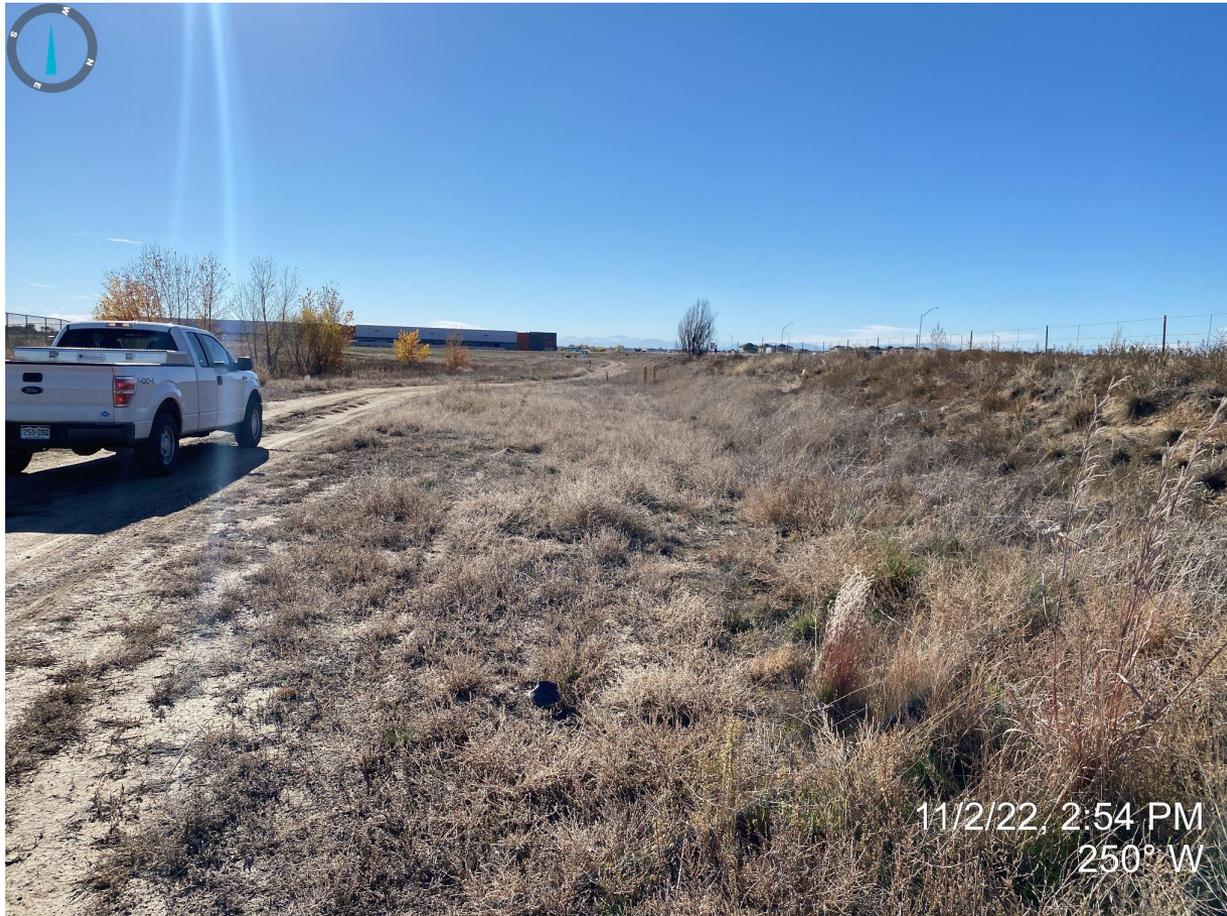
**Photo 2.** Taken near the entrance of the access road, facing west. Photo shows tank battery location is predominantly undesirable vegetation (e.g. kochia) and access road has not been reclaimed.

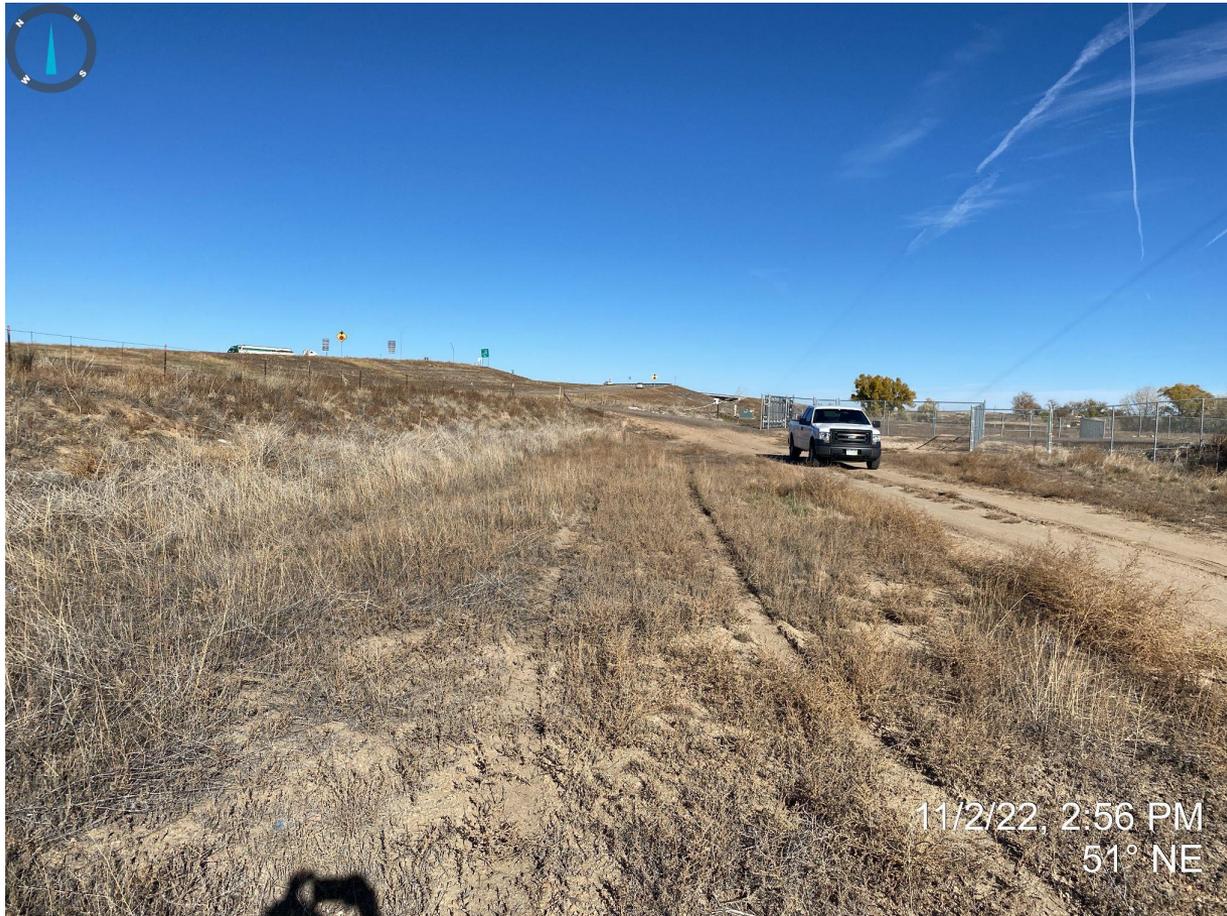
**Photo 3.** Taken from southern portion of tank battery location, facing northeast. Photo illustrates vehicle tracks through the disturbance area.

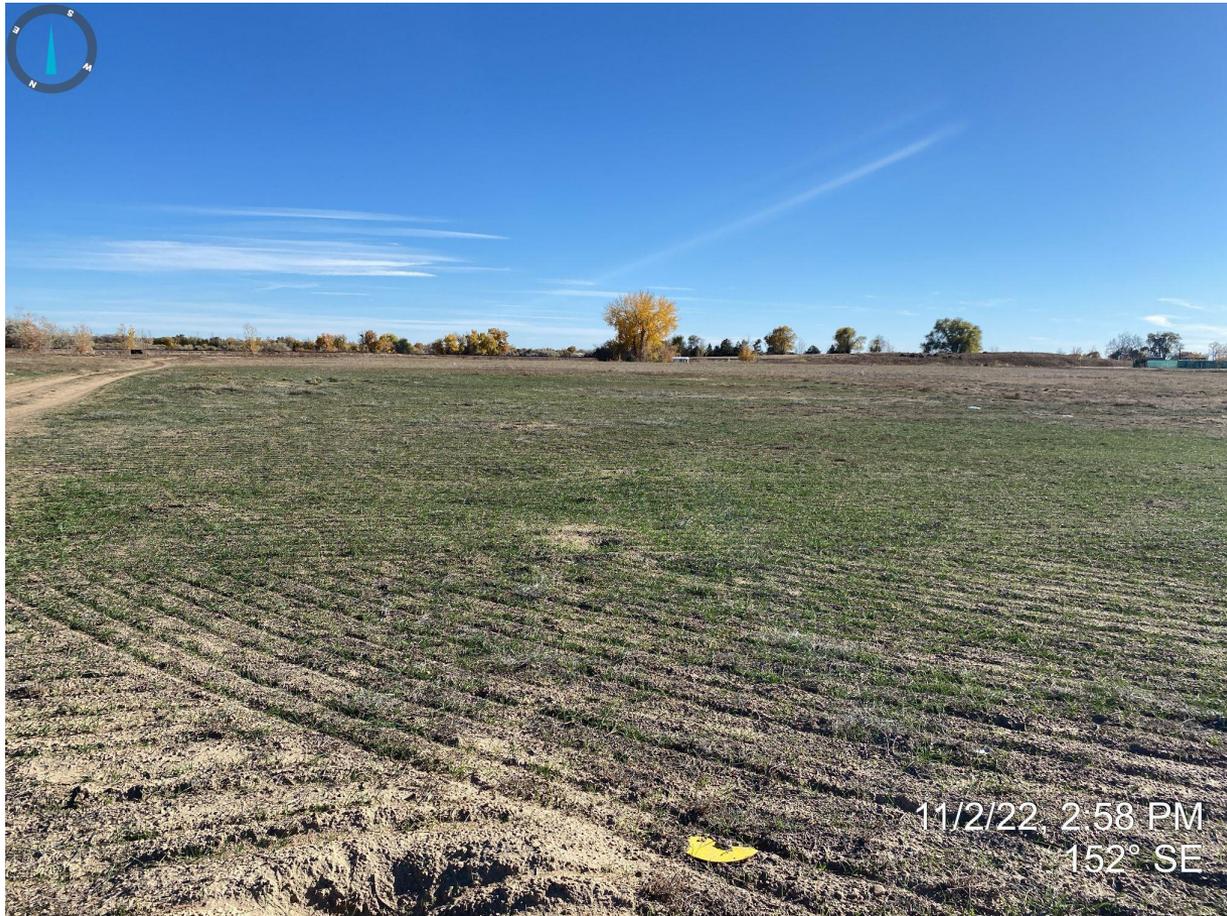
**Photo 4.** Taken from the well location, facing southeast. Photo illustrates the location appears to have been revegetated. A follow-up inspection will need to be performed at a later date to verify revegetation.

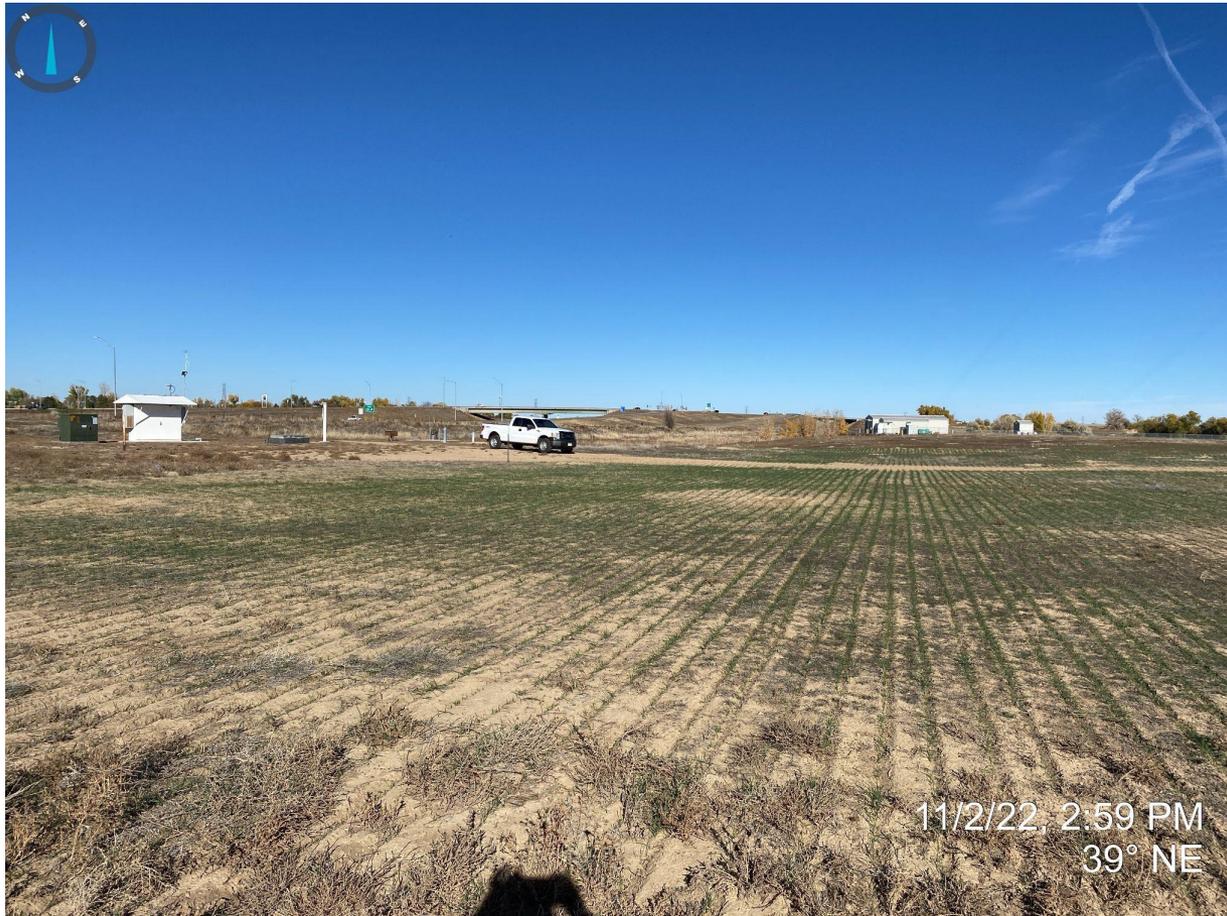
**Photo 5.** Taken from the southern portion of the location, facing northeast. See comments in Photo 4.

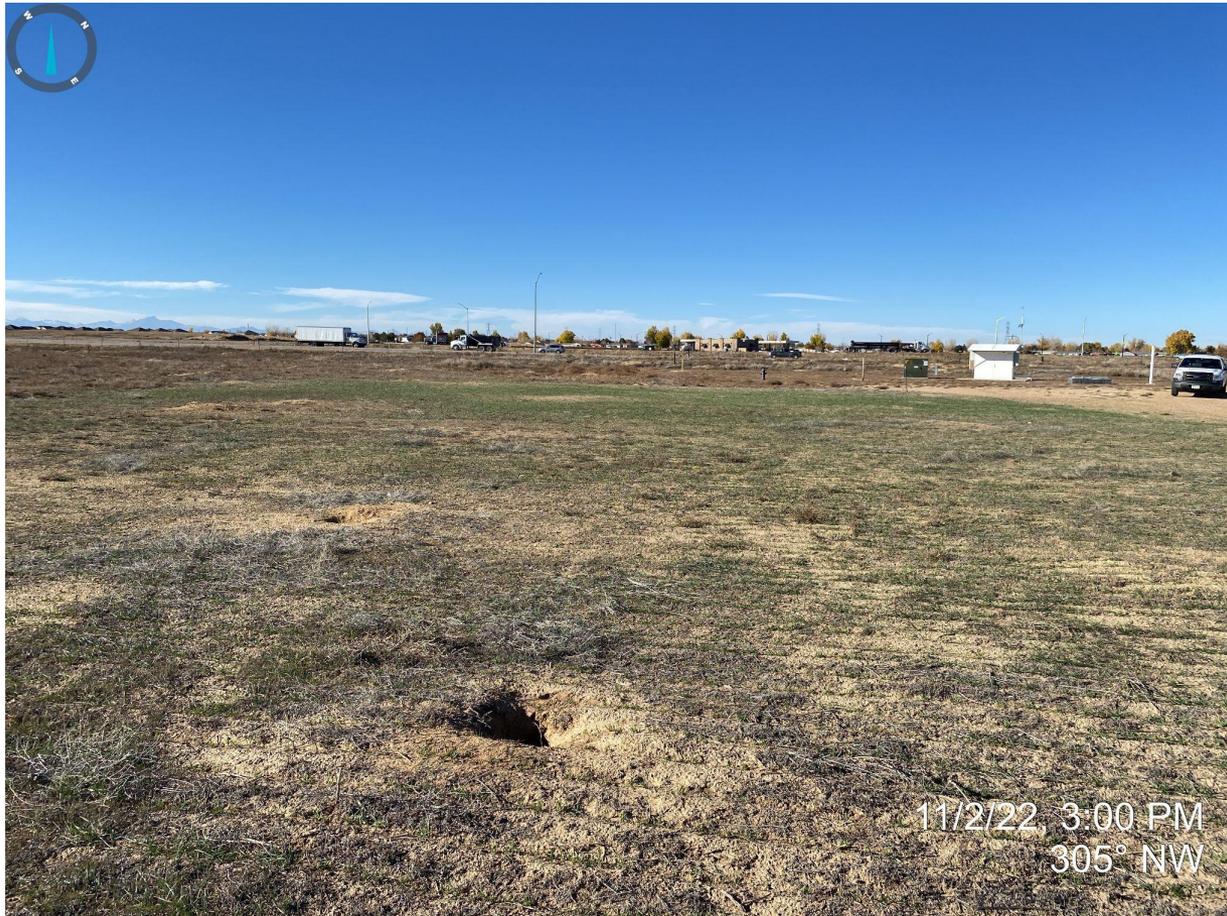
**Photo 6.** Taken from the eastern portion of the location, facing northwest. See comments in Photo 4.

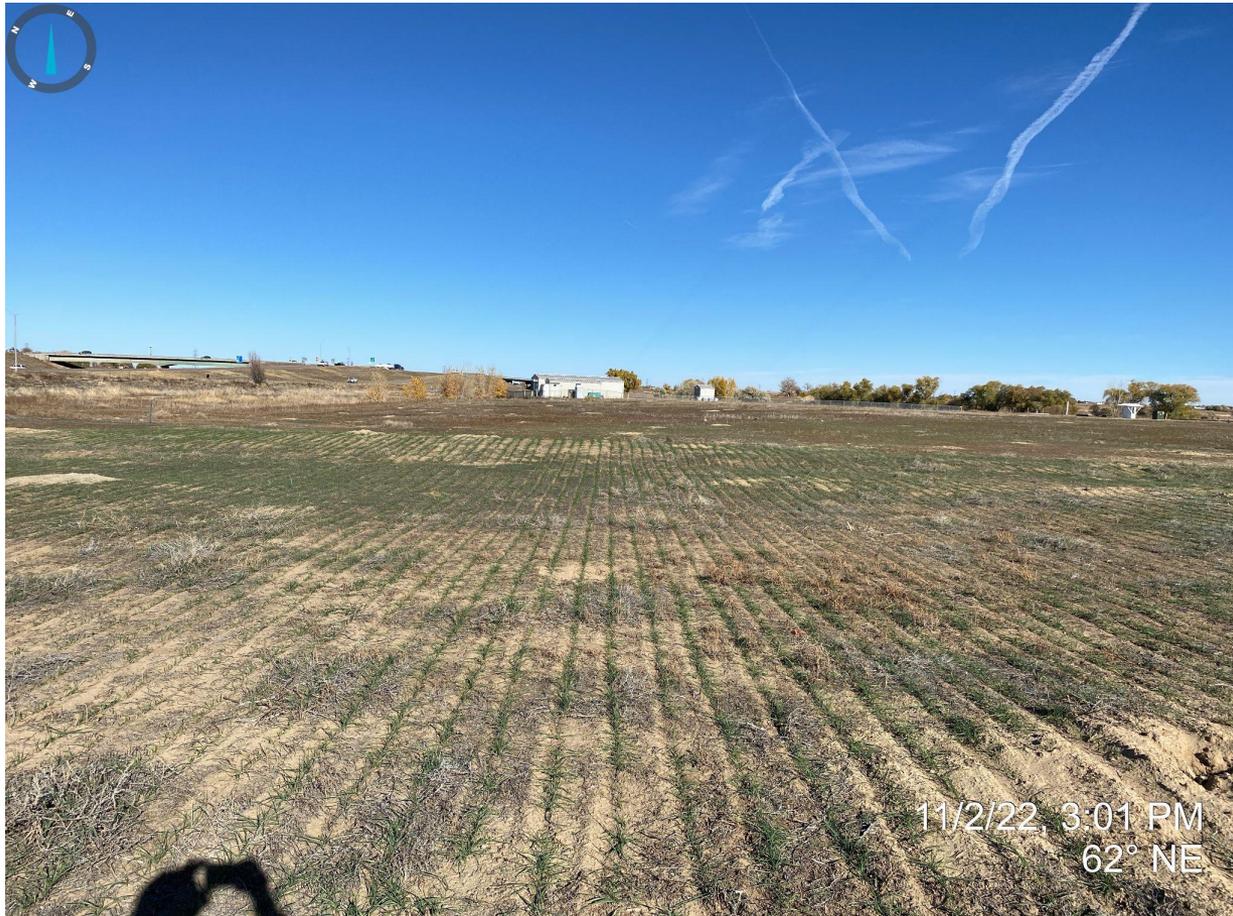
**Photo 7.** Photo taken from across the access road, north of the reclaimed location, facing northeast. Photo illustrates reference area appears to have been revegetated.

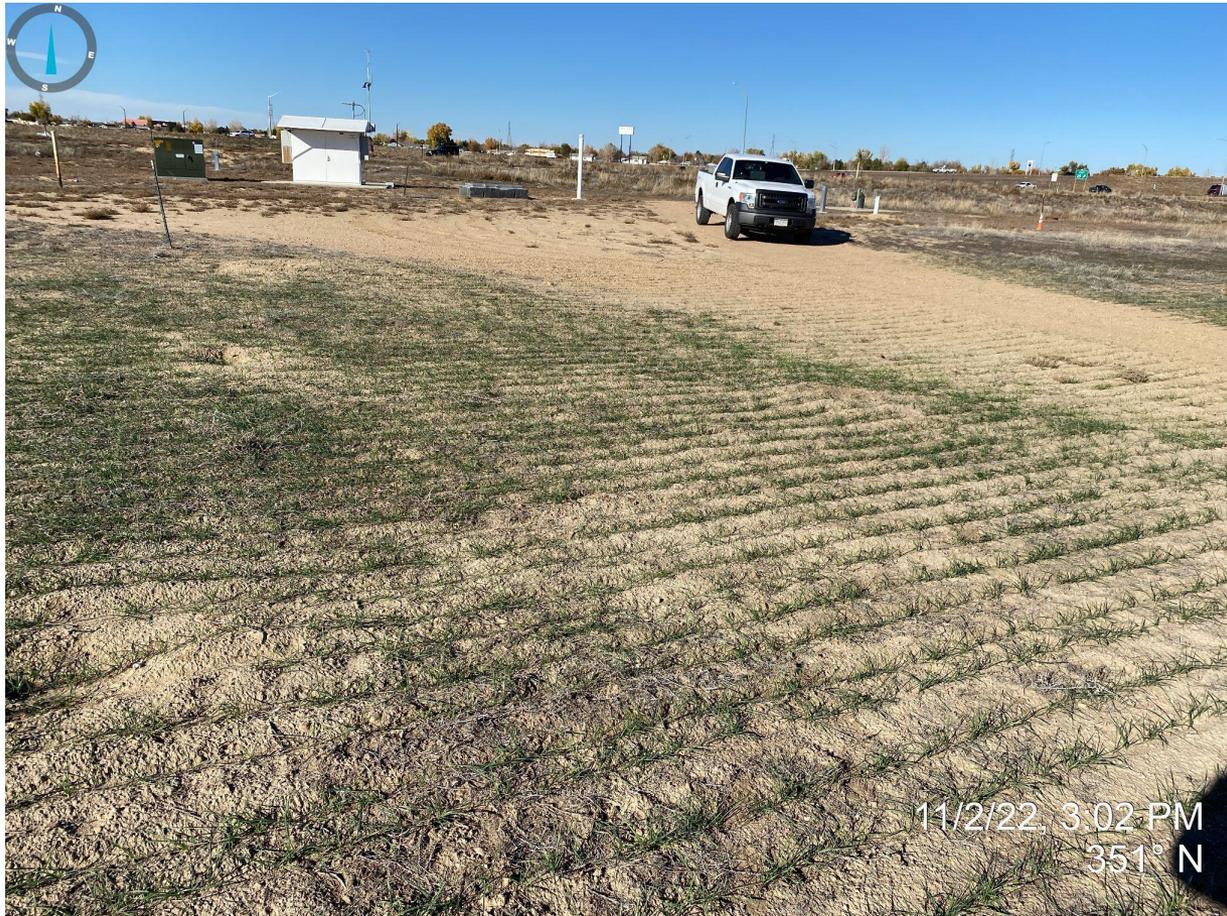
**Photo 8.** Taken from the location, facing north. Photo illustrates water supply equipment located north of the location. It appears the access road is being used by the water district; the access road will need to be reclaimed in order to reach final reclamation standards.
