**APPENDIX A**

**SITE PHOTOS**

#1 - Phelps 11-32CHZ AST Release Site

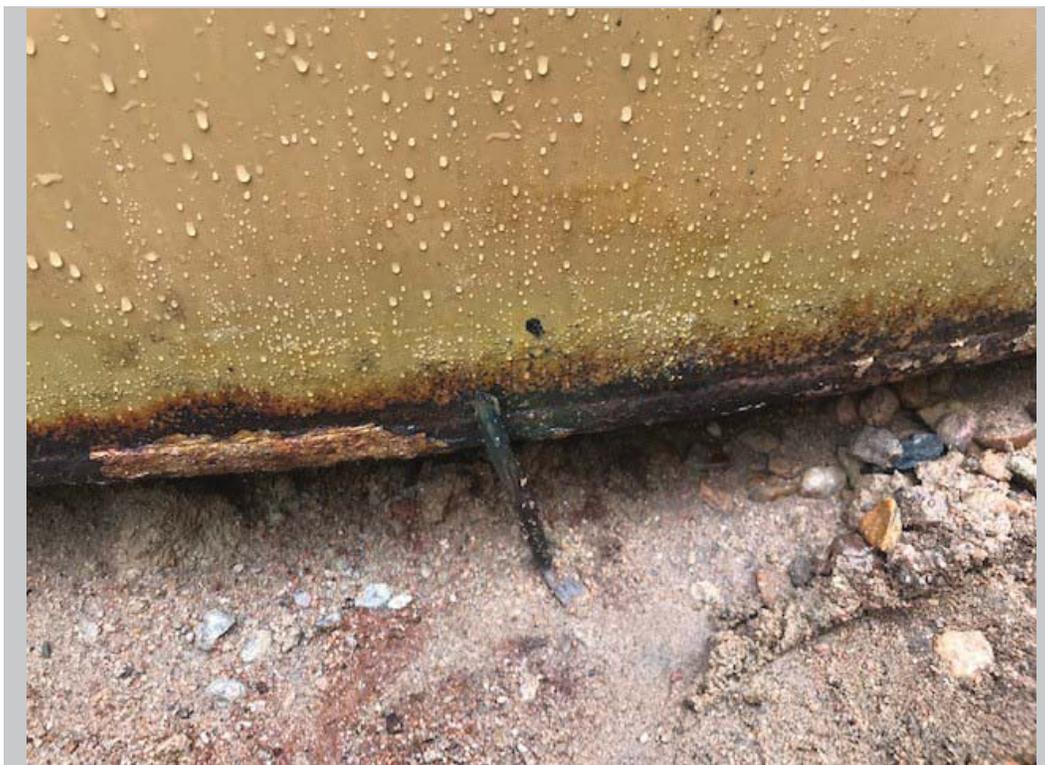
#2 - A Pinhole Failure in the AST Shell Caused the Release

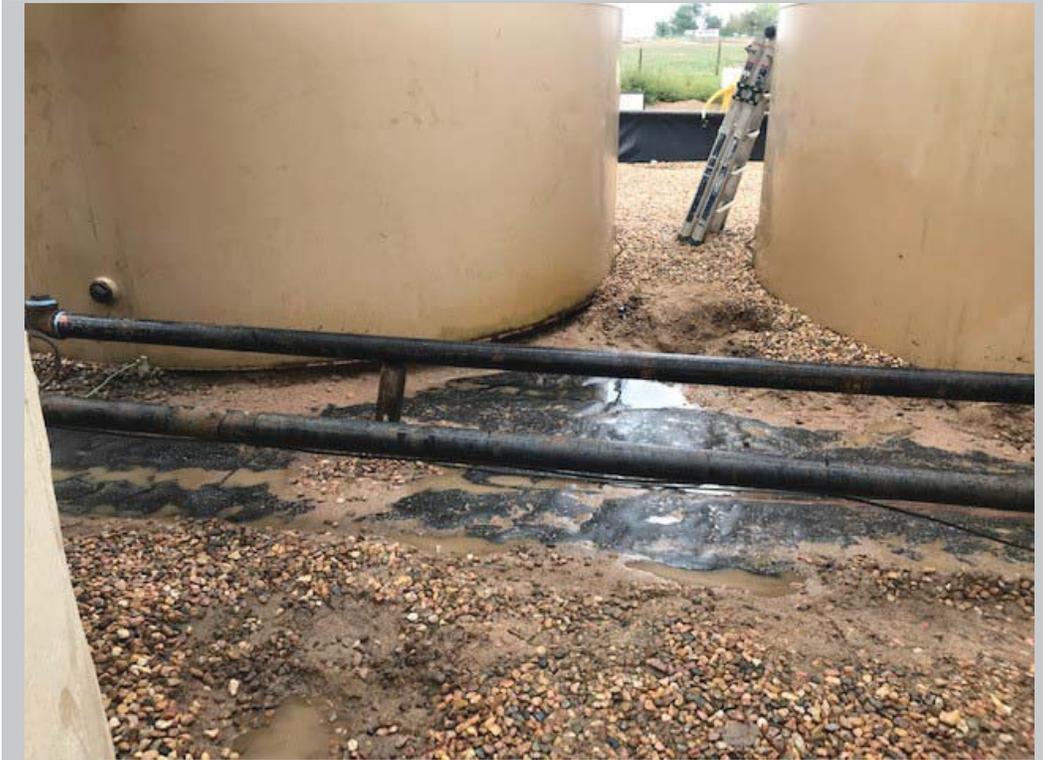
#3 - Looking North at AST that Failed. Note Synthetic Liner Beneath ASTs.

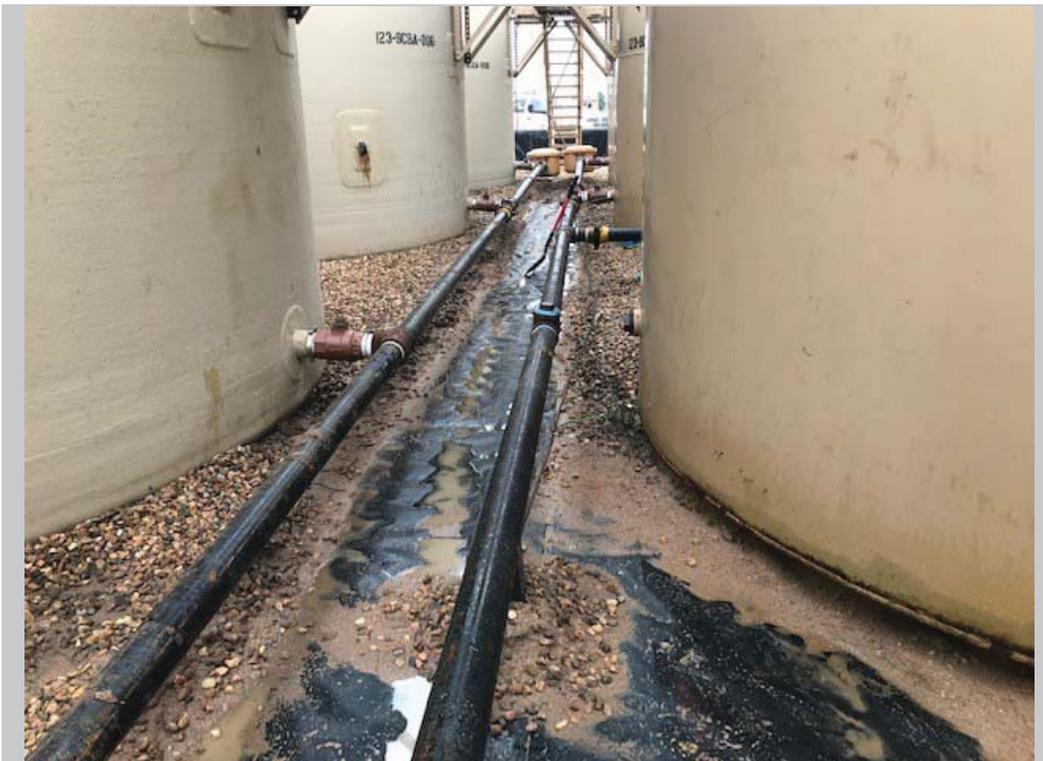
#4 - Looking West at AST that Failed. Impacted Soil has been removed above the liner and partially beneath the AST.

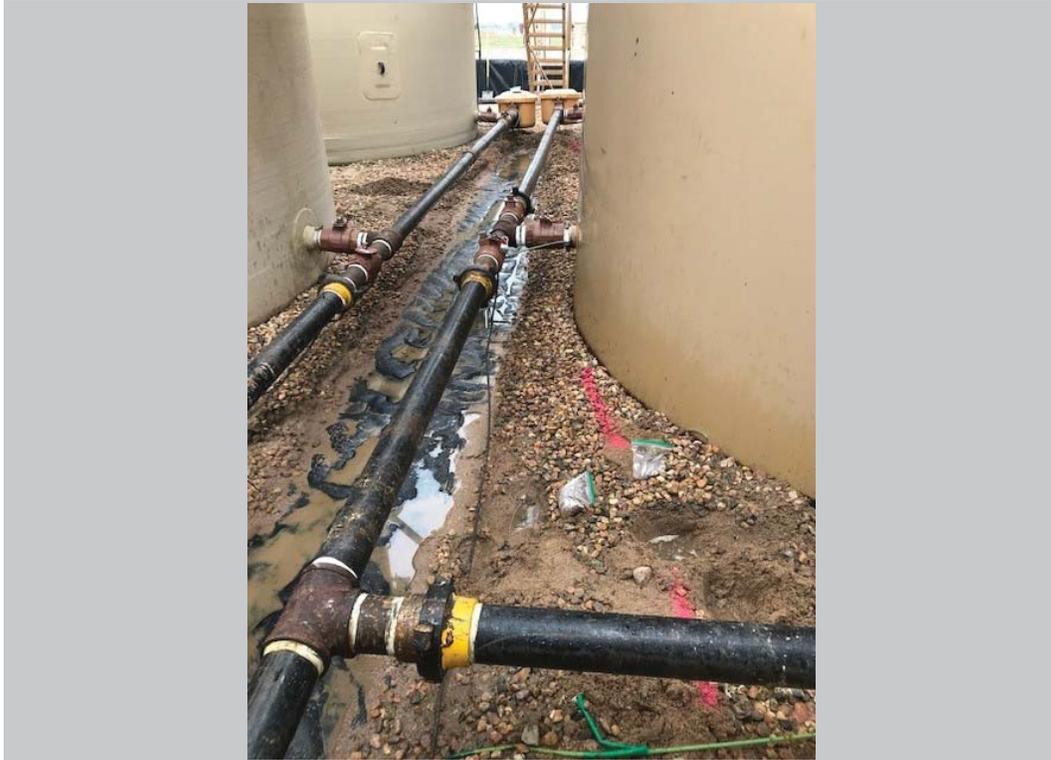
#5 - Looking West at Impacted Area. Pink Line Represents Further Excavation Required.

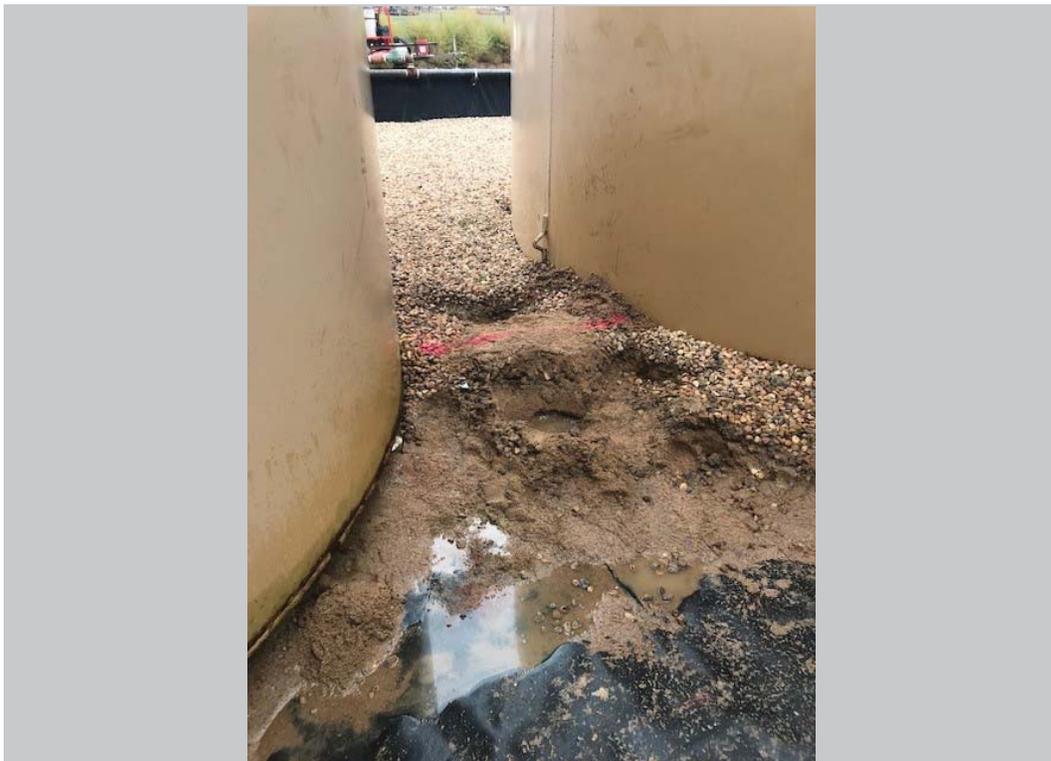
#6 - Looking North at Impacted Area. Note Standing Water Above Liner Indicating Liner Integrity

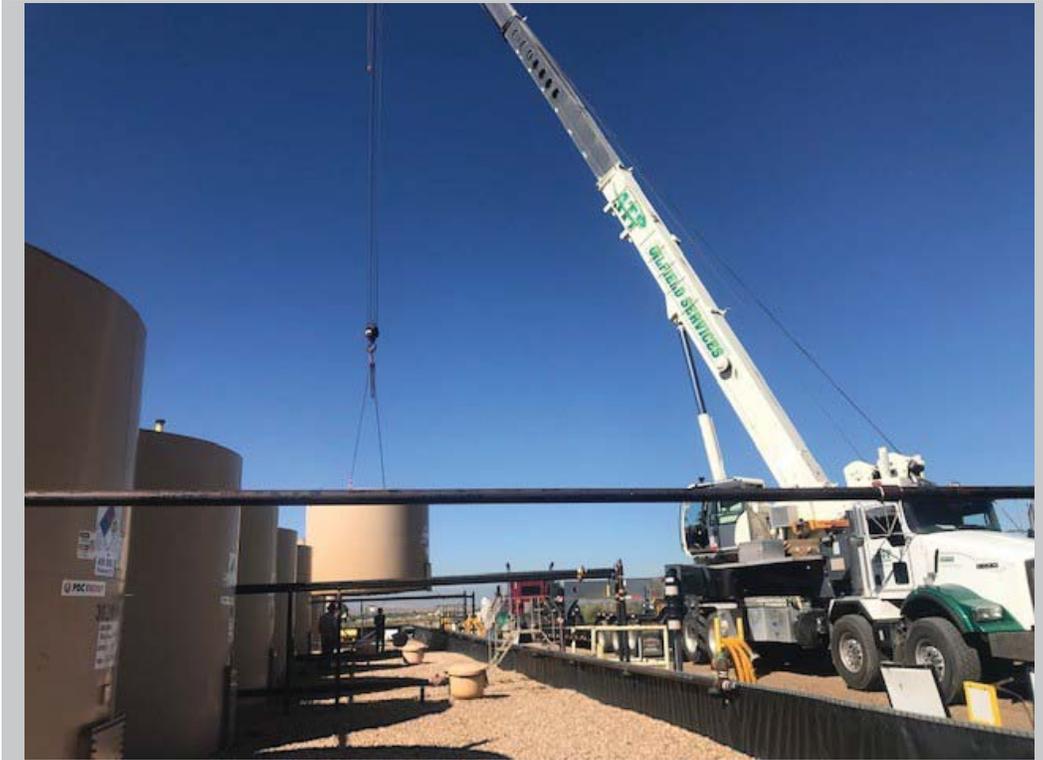
#7 - Looking West While AST is Removed from the Tank Battery

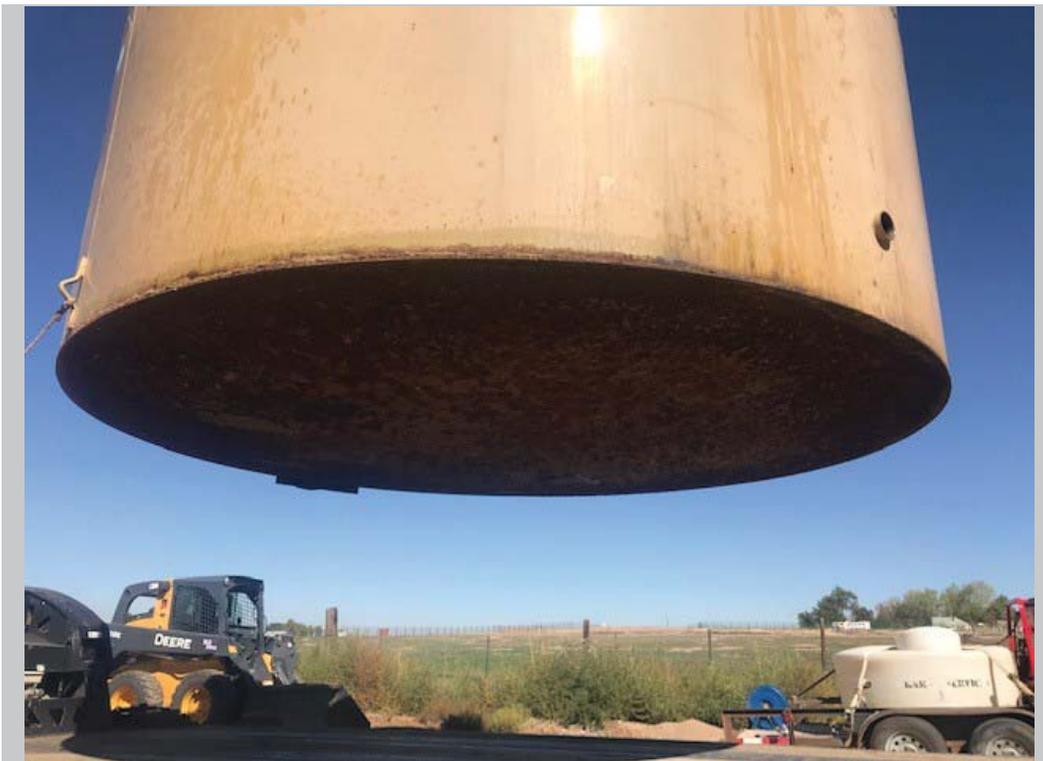
#8 - Inspection of the Bottom of the AST; No Failures Observed in Tank Floor.

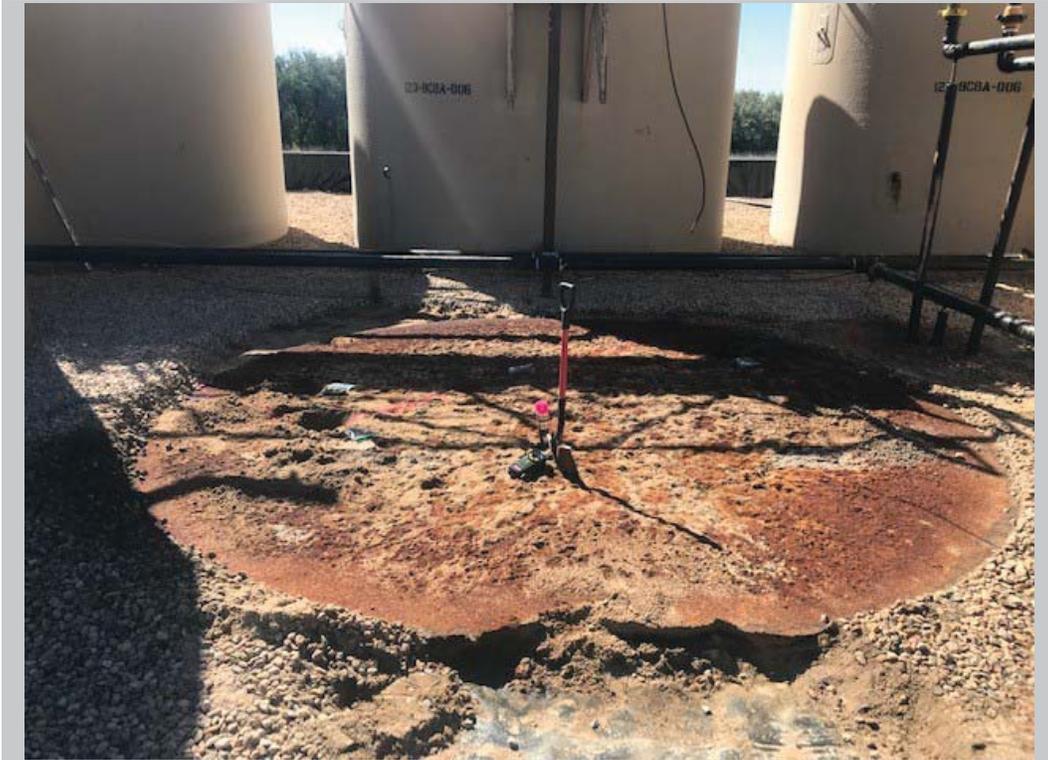
#9 - Looking South at Former AST Pad During Sampling

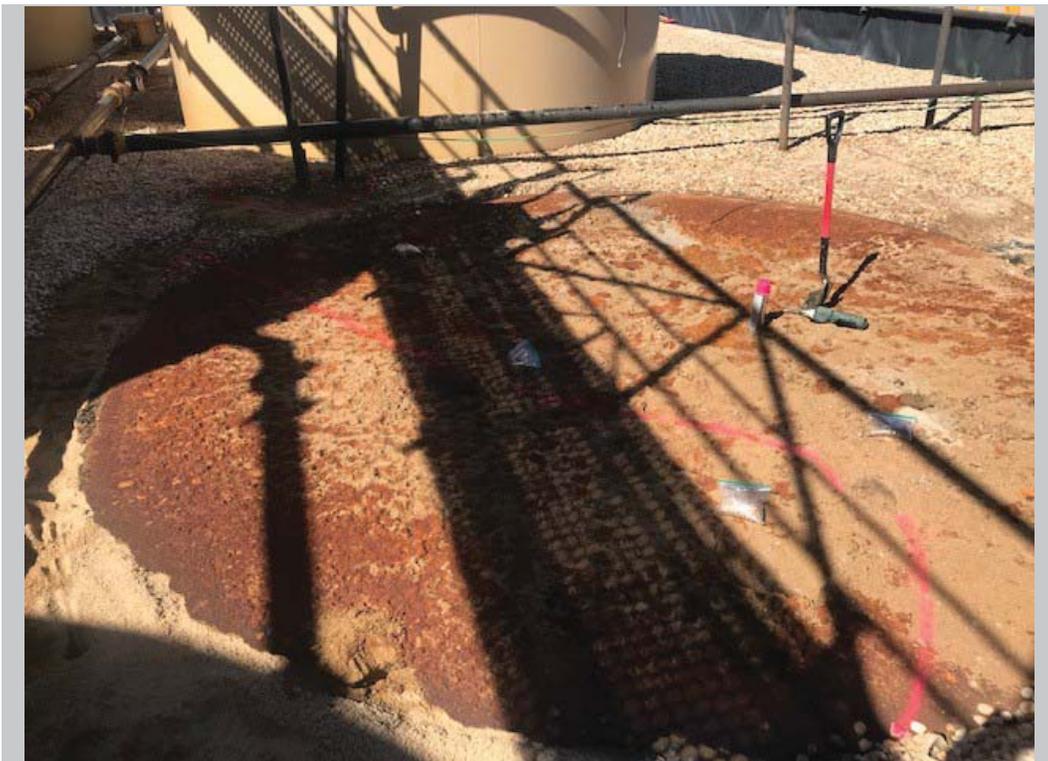
#10 - Looking West at Former Tank Pad. Pink Line Indicates Area Requiring Further Excavation.
