Inspection Photos

Location Name: CAERUS PICEANCE LLC SHIDELER-66S92W /32NESW

Location ID: 334837

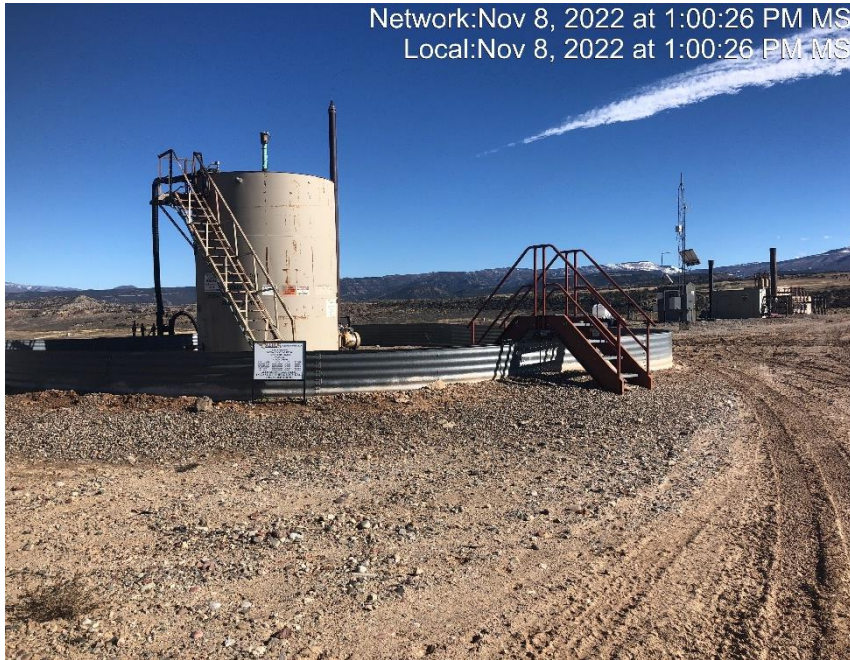
Photo #8330 From entrance to location.

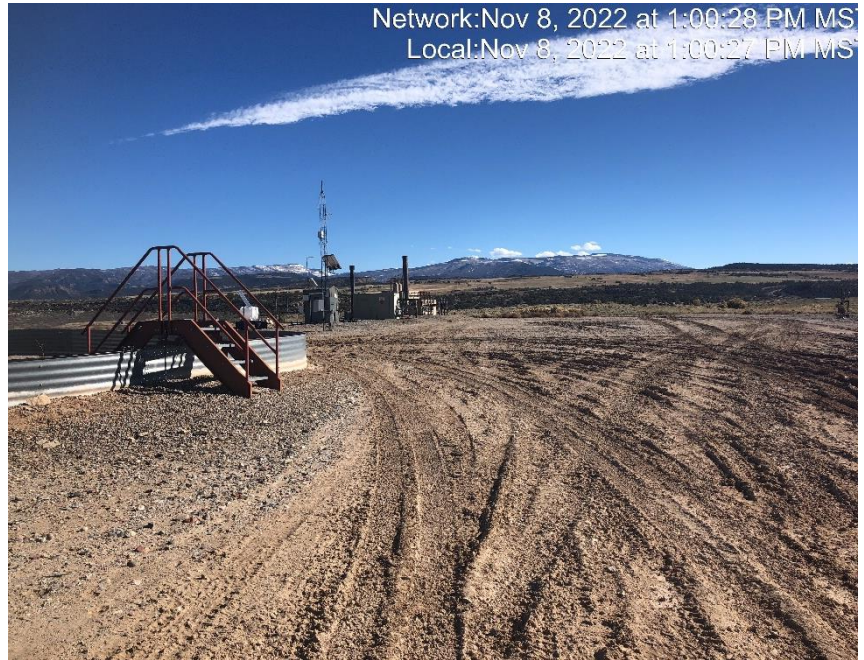
Photo #8331 From entrance to location

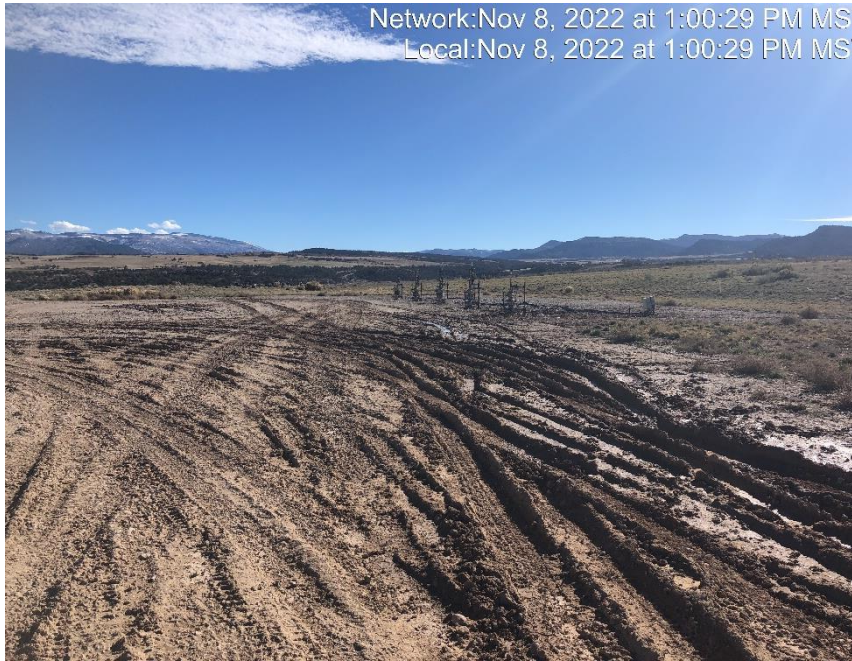
Photo #8332 From entrance to location.

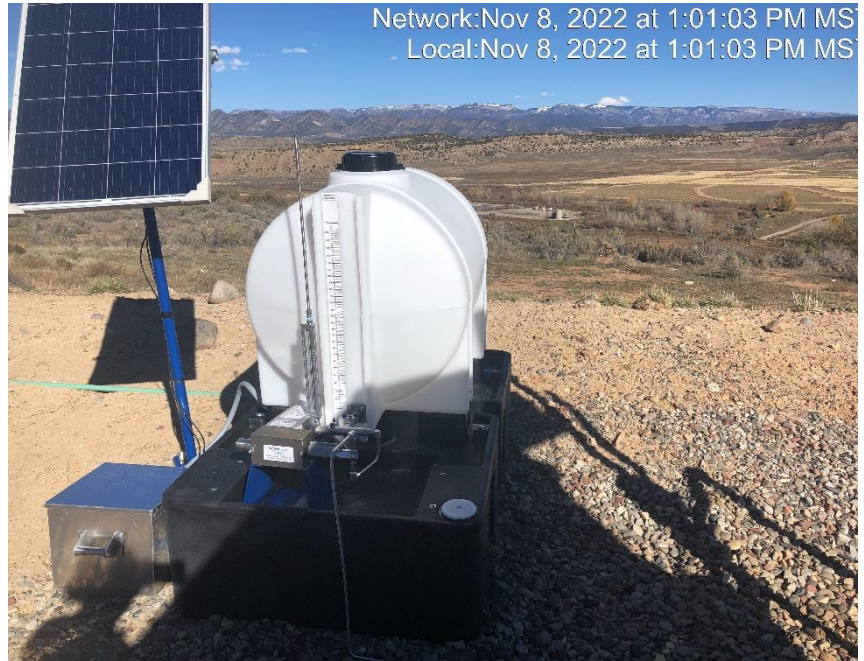
Photo #8333 Chemical tank missing required information.

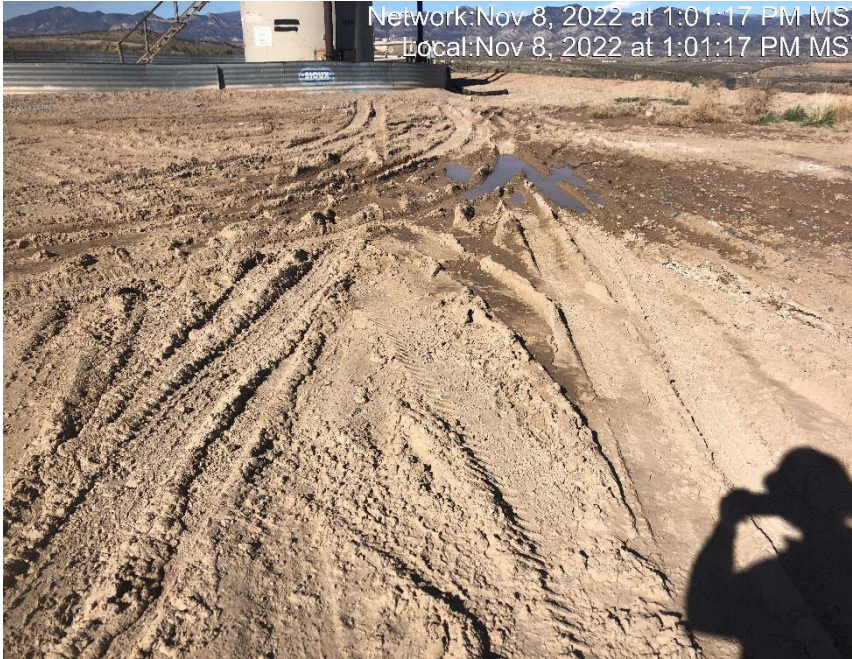
Photo #8334 Location lacks stabilization.

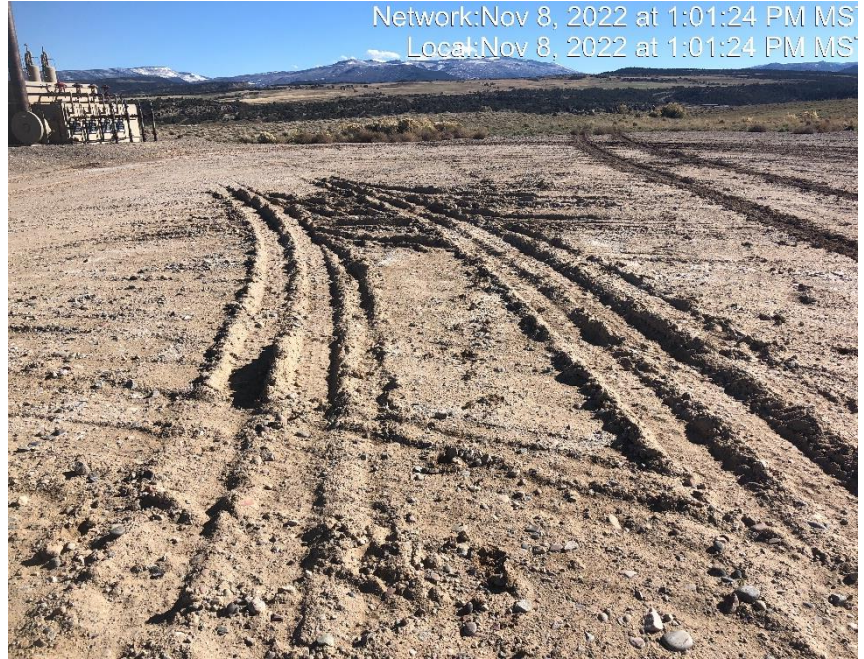
Photo #8335 Location lacks stabilization.

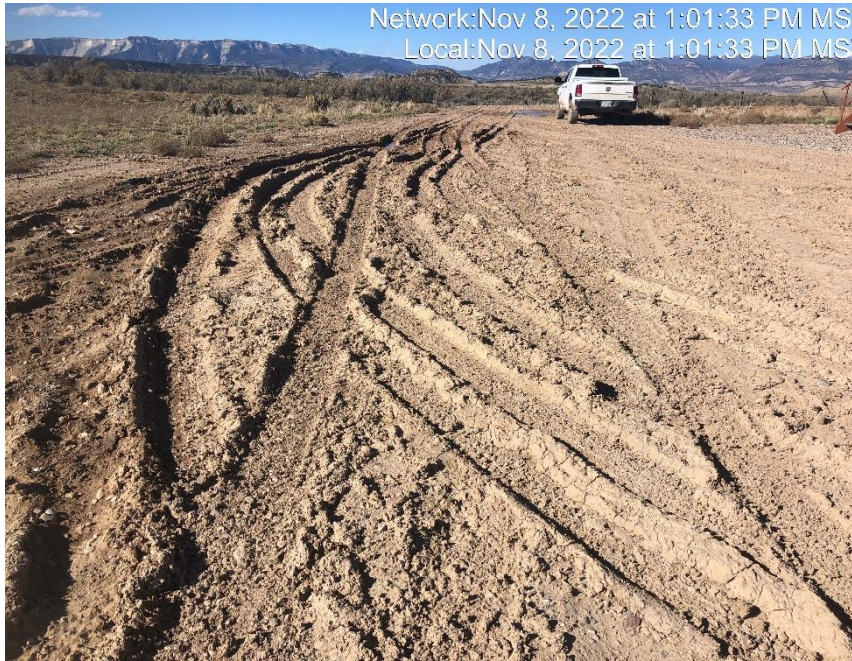
Photo #8336 Location lacks stabilization.

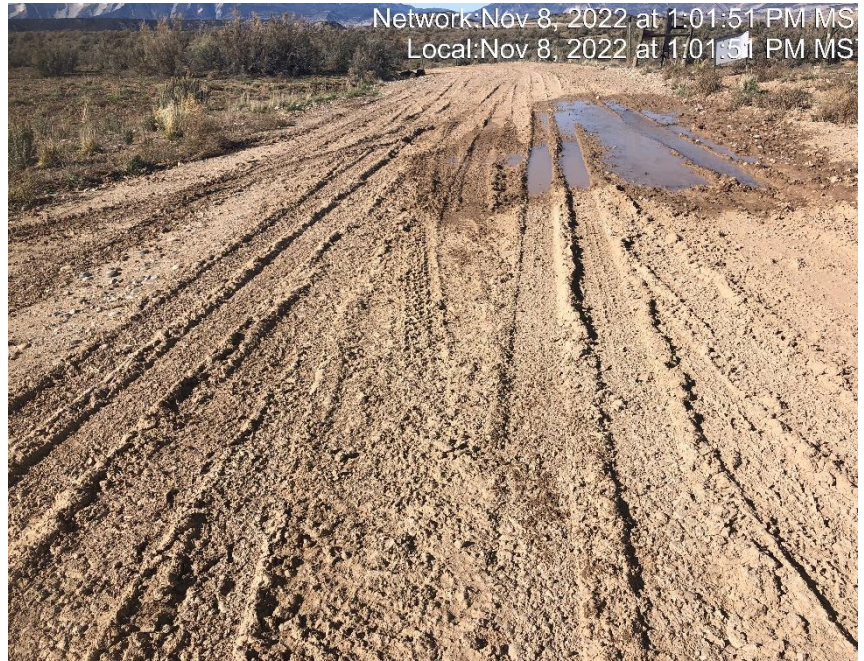
Photo #8337 Insufficient tracking BMP at entrance.
