Inspection Photos
Location Name: Champlin 248 AmocoC#5
Location ID:320092

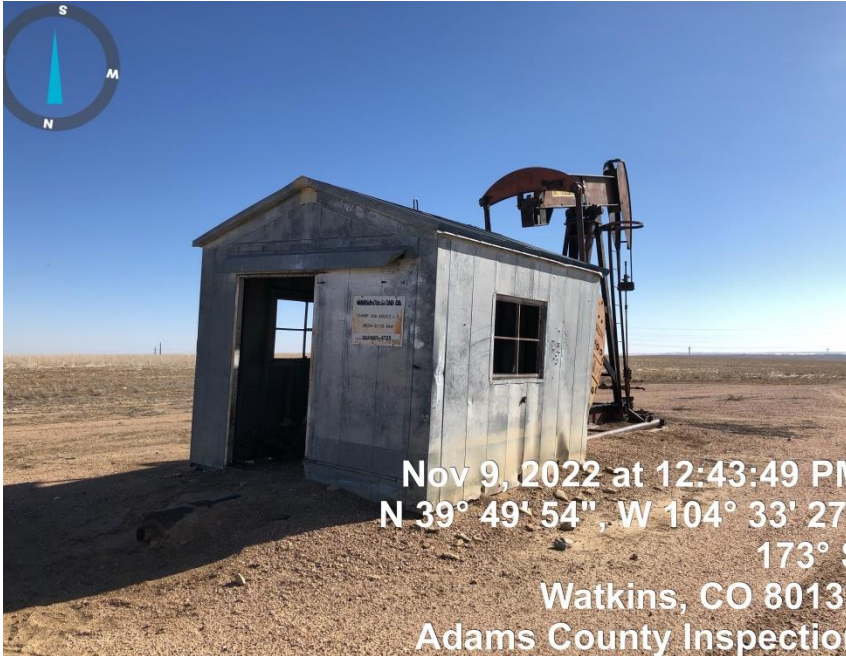
Photo#1 Pumpjack/Wellhead
