Inspection Photos
Location Name: Champlin 248 Amoco C#2
Location ID:320066

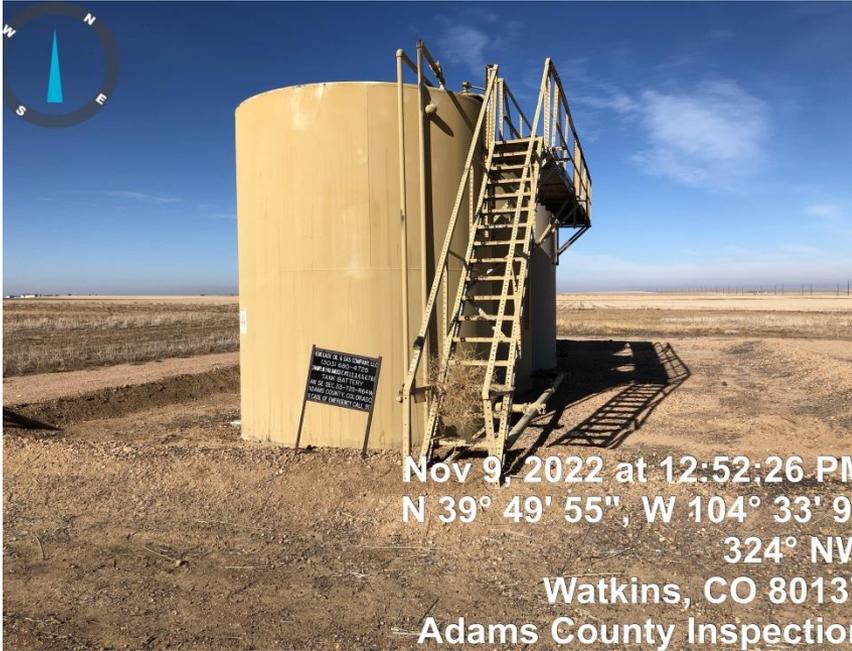
Photo#1 Production Tanks

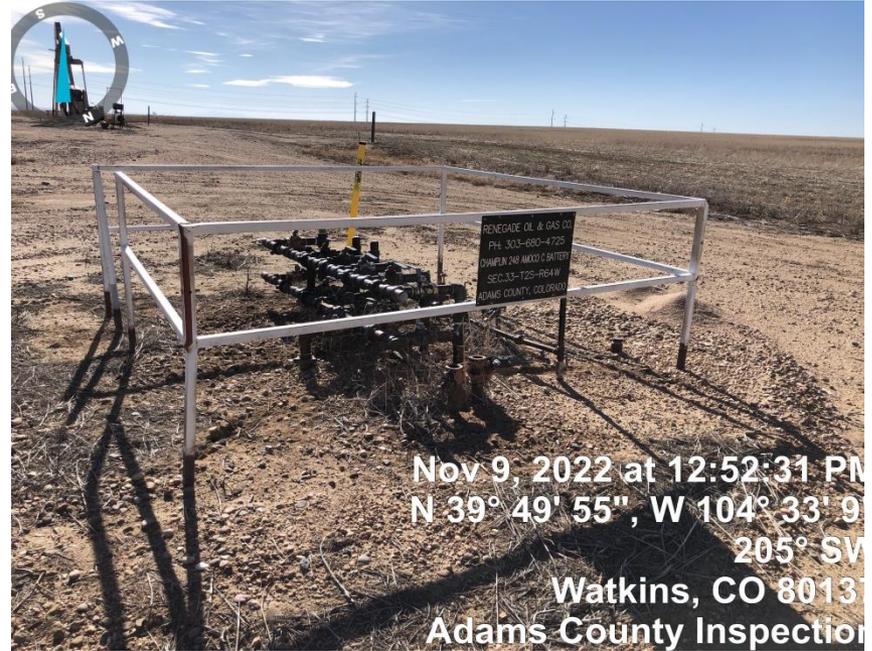
Photo#2 Header Valves

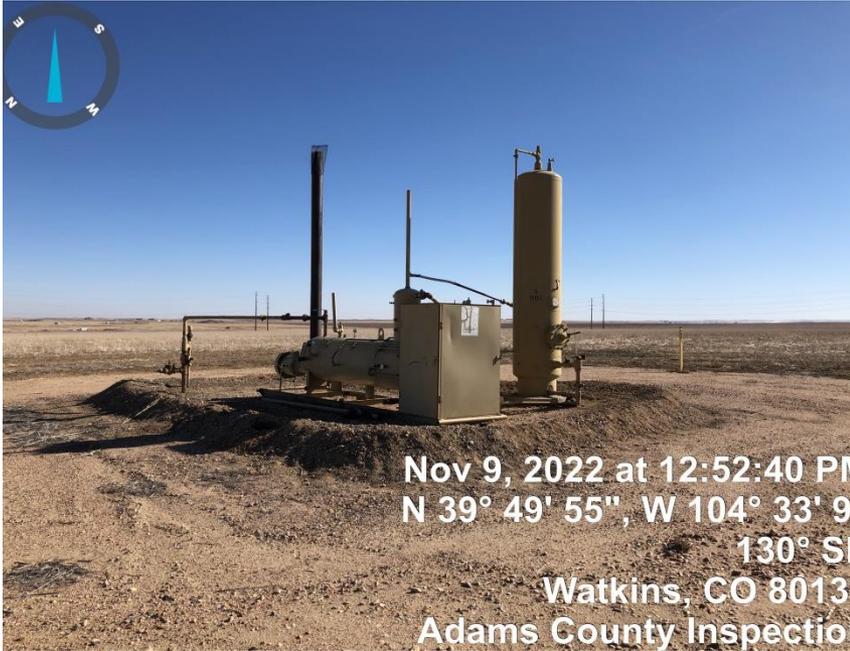
Photo#3 Separator

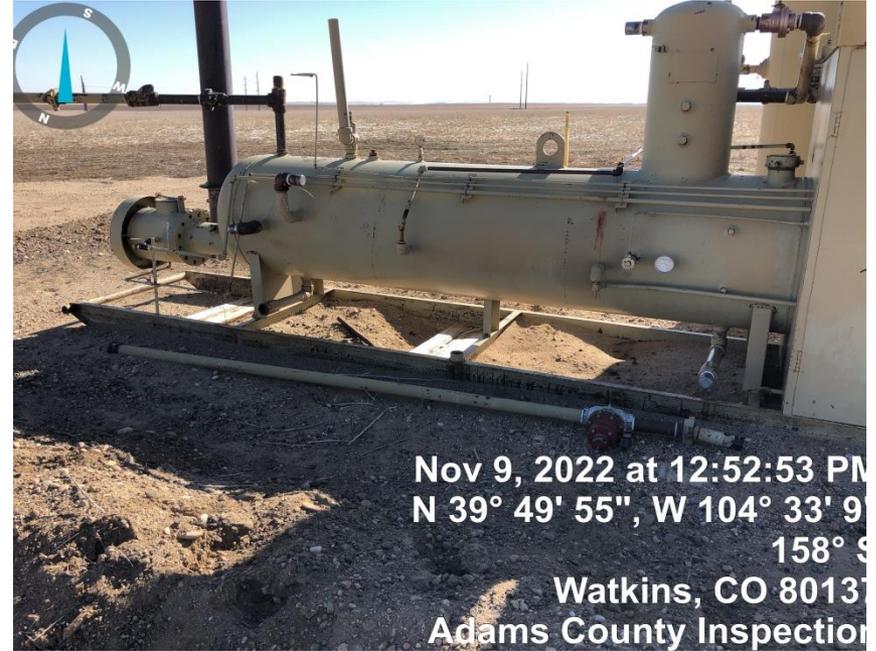
Photo#4 Unused Equipment

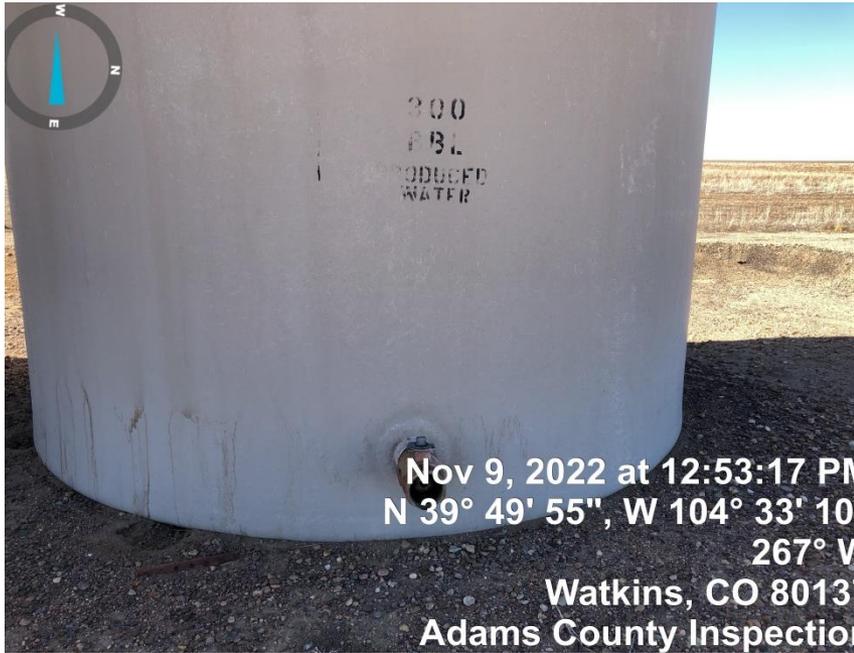
Photo#5 **No bullplug**

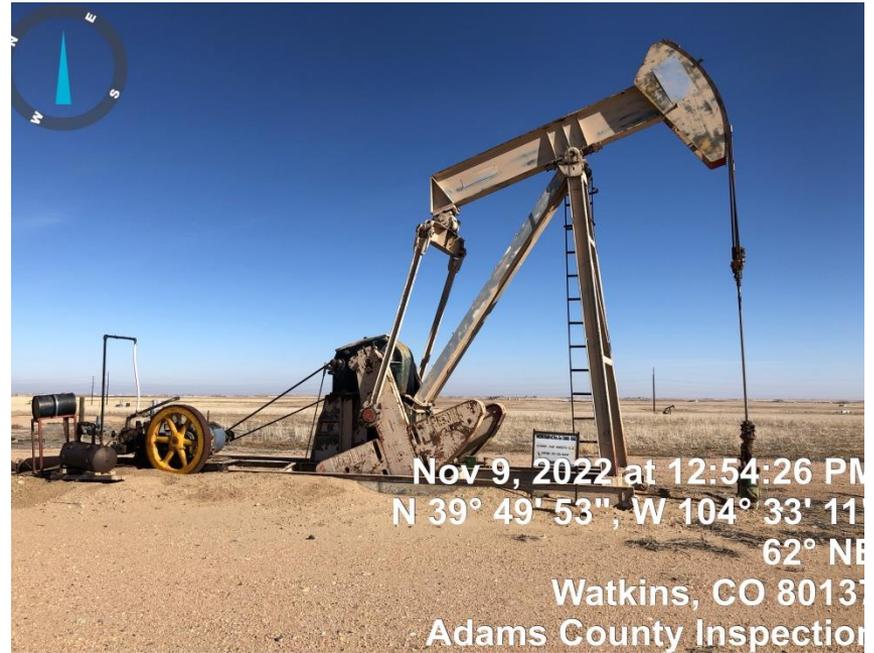
Photo# Pumpjack and Wellhead

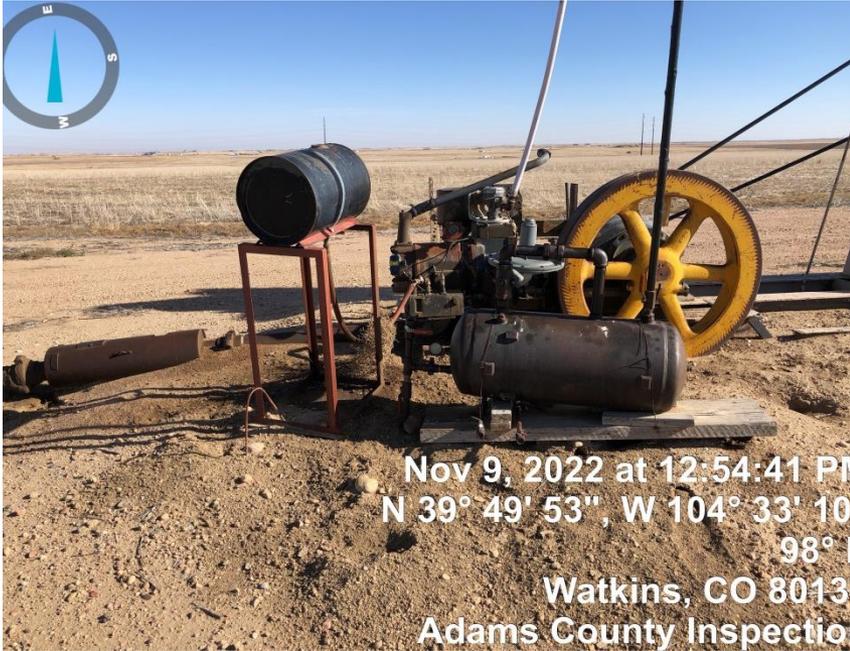
Photo#7 No containment
