Inspection Photos

Operator: TEP Rocky Mountain LLC - #96850

Location Name: FEDERAL-66S94W/10SENE

Inspection Document #: 702800927

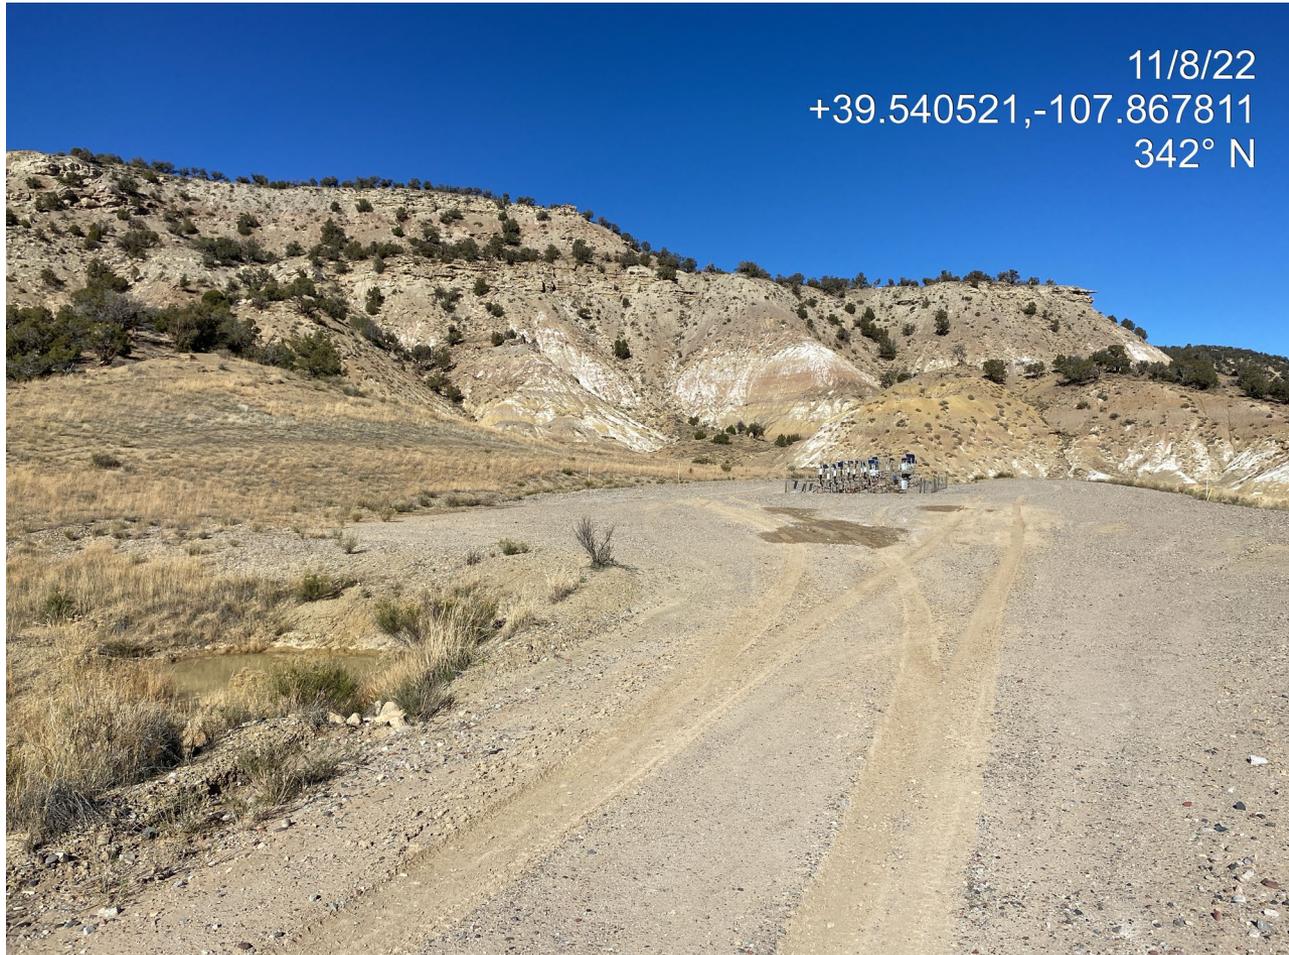
Photo 1. Photo shows an overview of the northern production area.

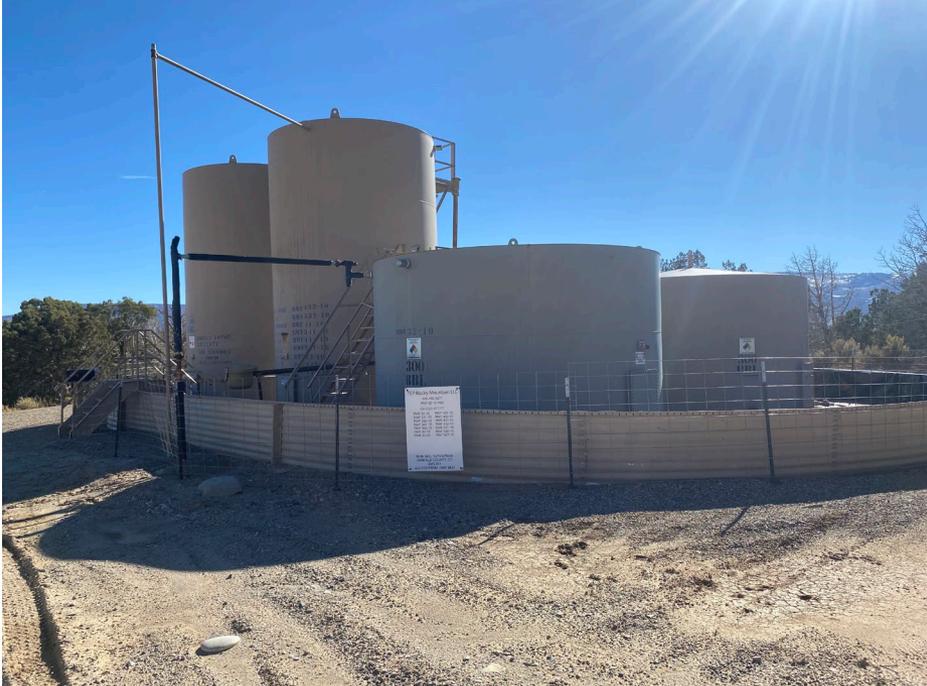
Photo 2. Photo shows the southern production area.

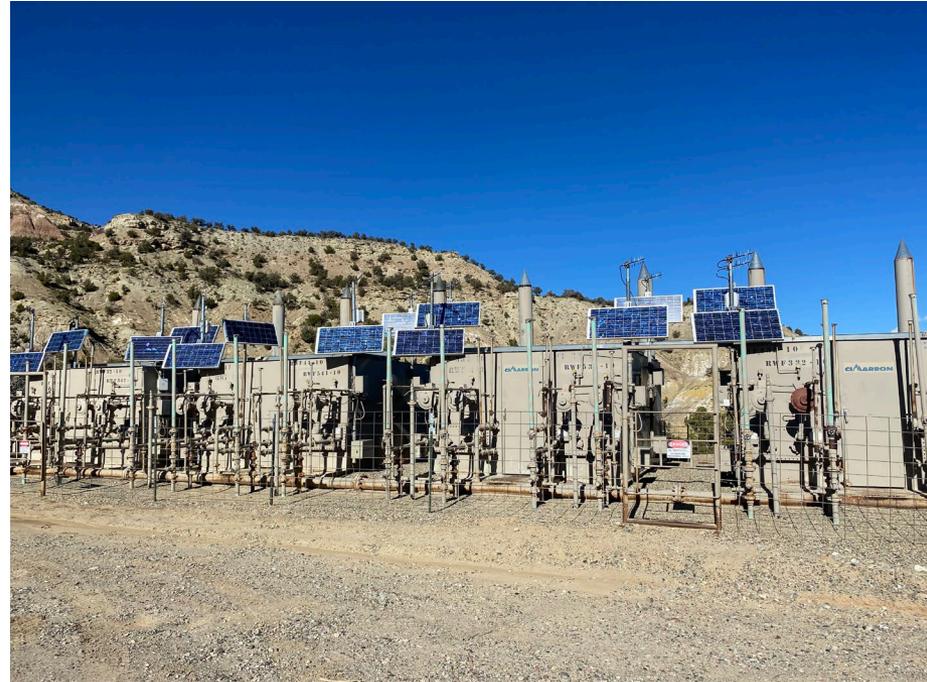
Photo 3. Photo shows the southern production area.

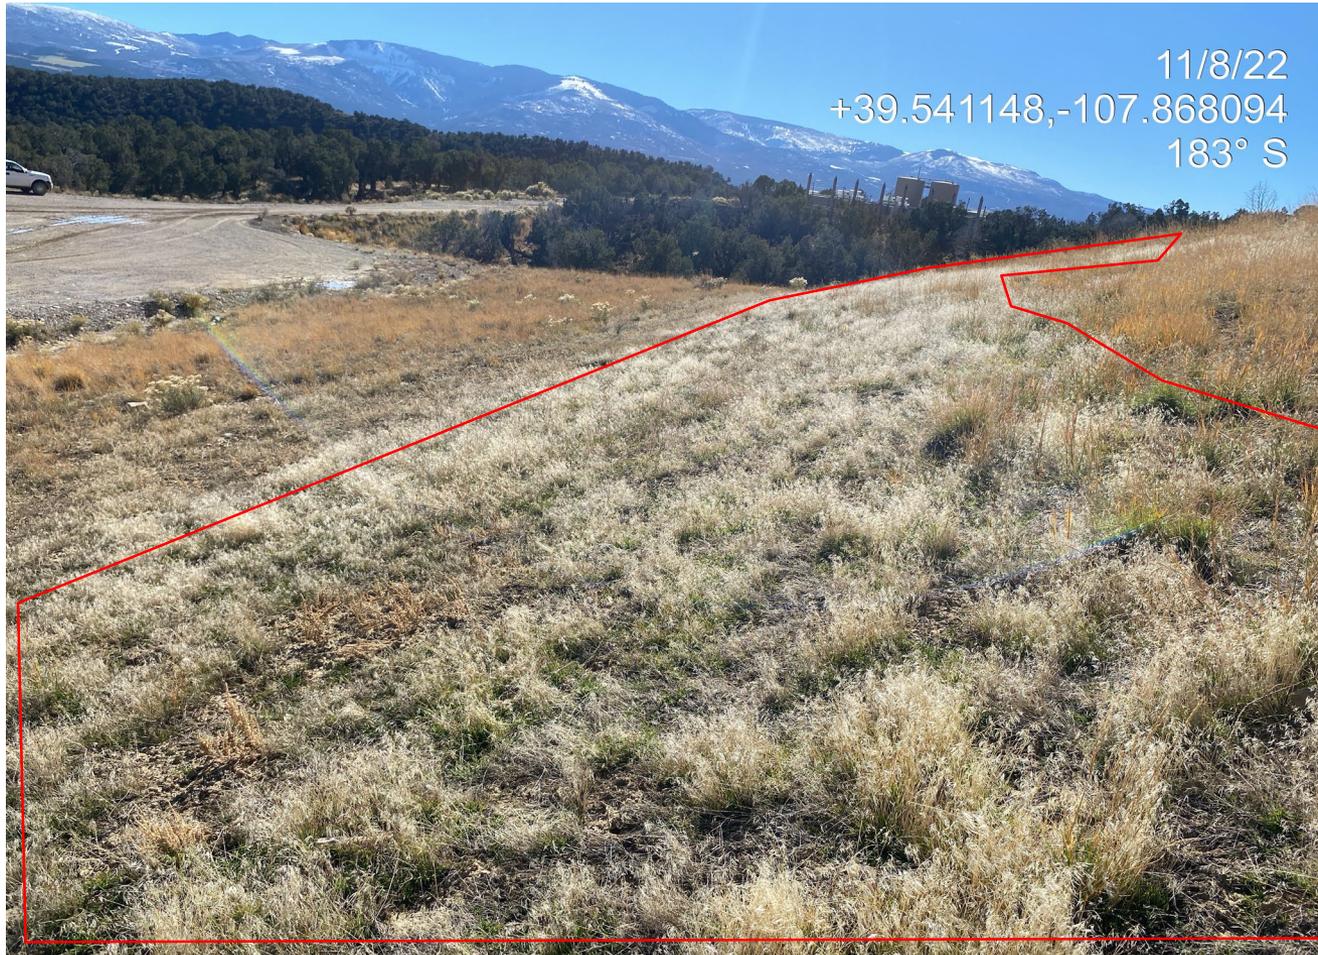
Photo 4. Photo shows the northwestern interim area. Perennial grasses (dark tan/orange) are well established in portions of the interim area. The center of the interim area has poor perennial cover and is dominated by cheatgrass (light tan).

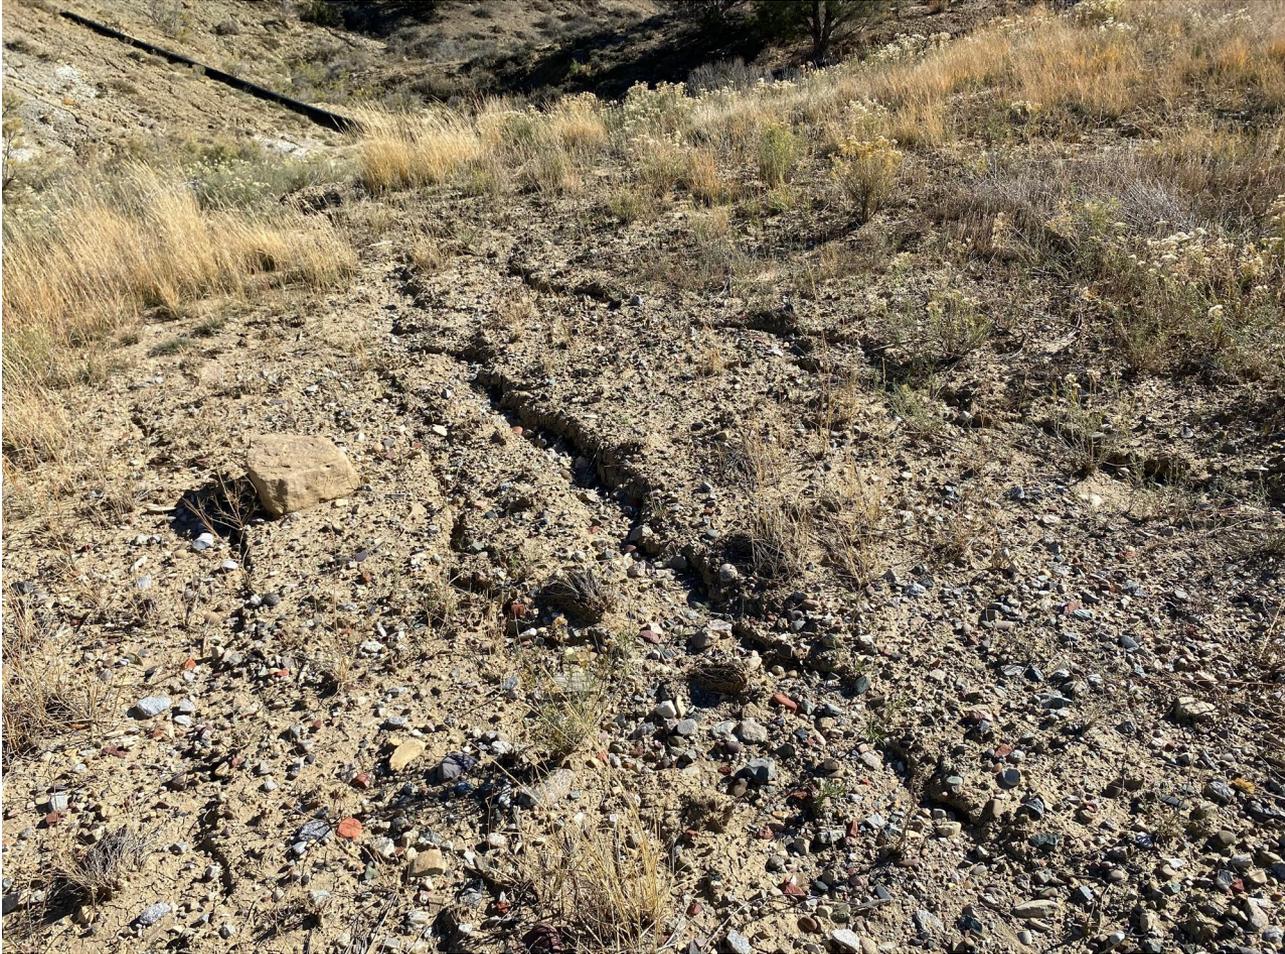
Photo 5. Photo shows rill erosion occurring in portions of the interim area/fill slope to the east. Current vegetative cover is insufficient to stabilize the slope.

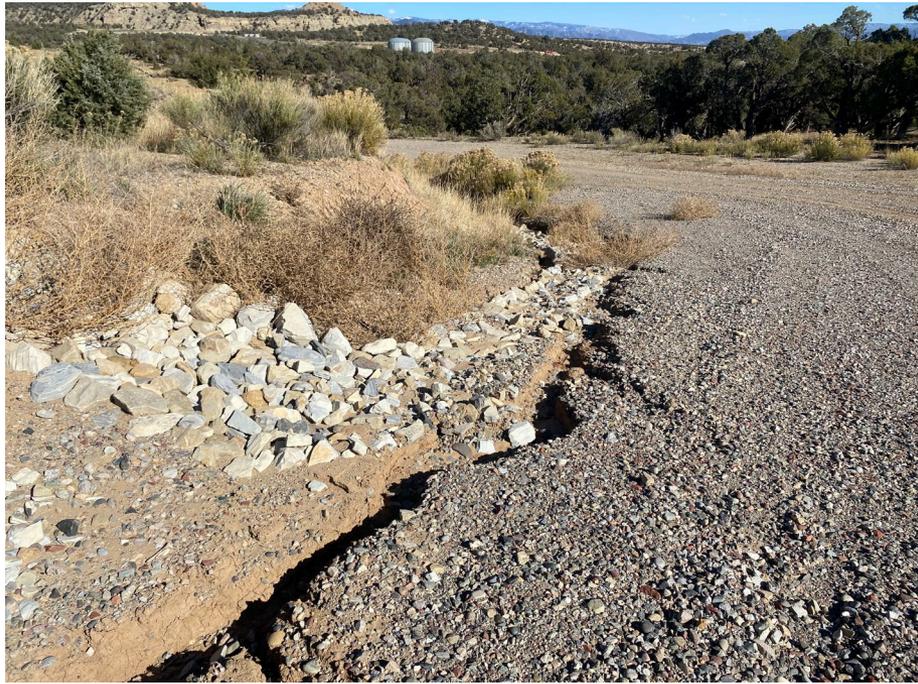
Photo 6. Photo shows erosion degradation migrating from the separators to the access road. Stormwater is cutting beneath rock armor, no geotextile liner observed.

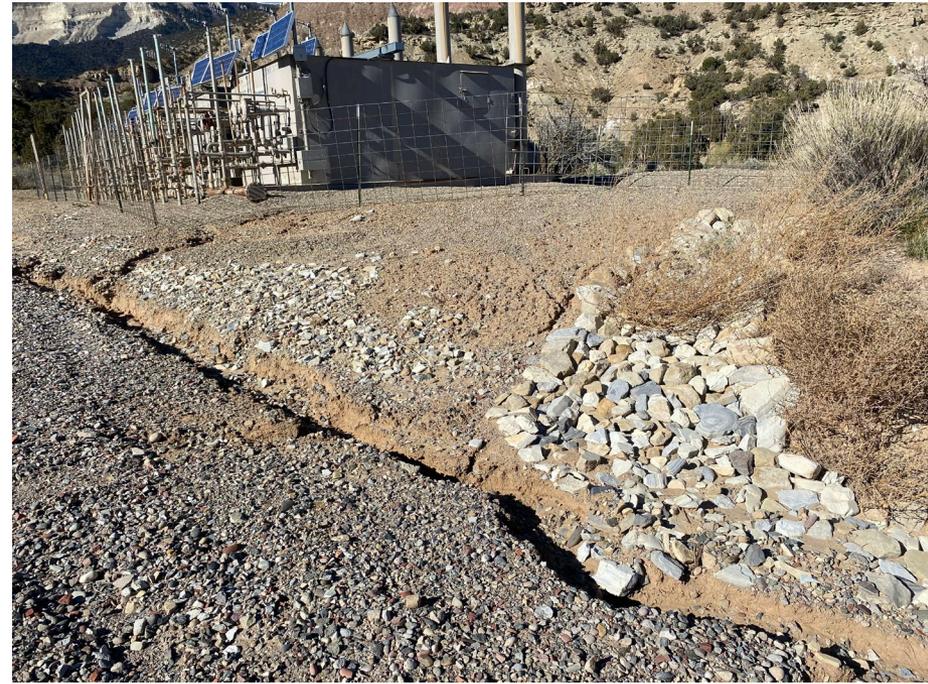
Photo 7. Refer to Photo 6 comment.

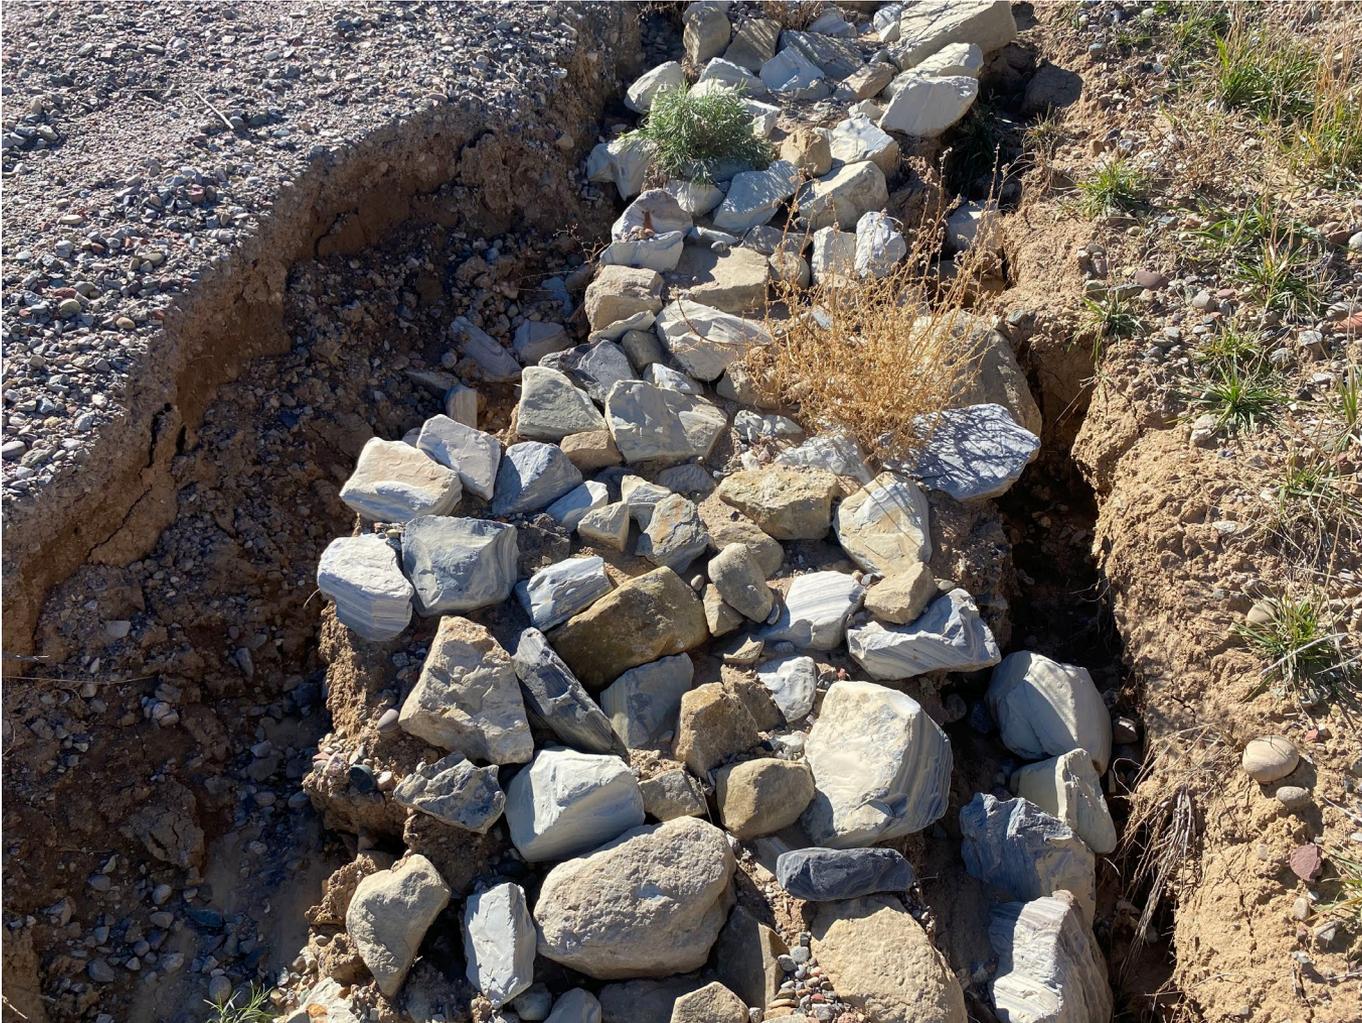
Photo 8. Photo shows a close-up of erosion in Photos 6 and 7.

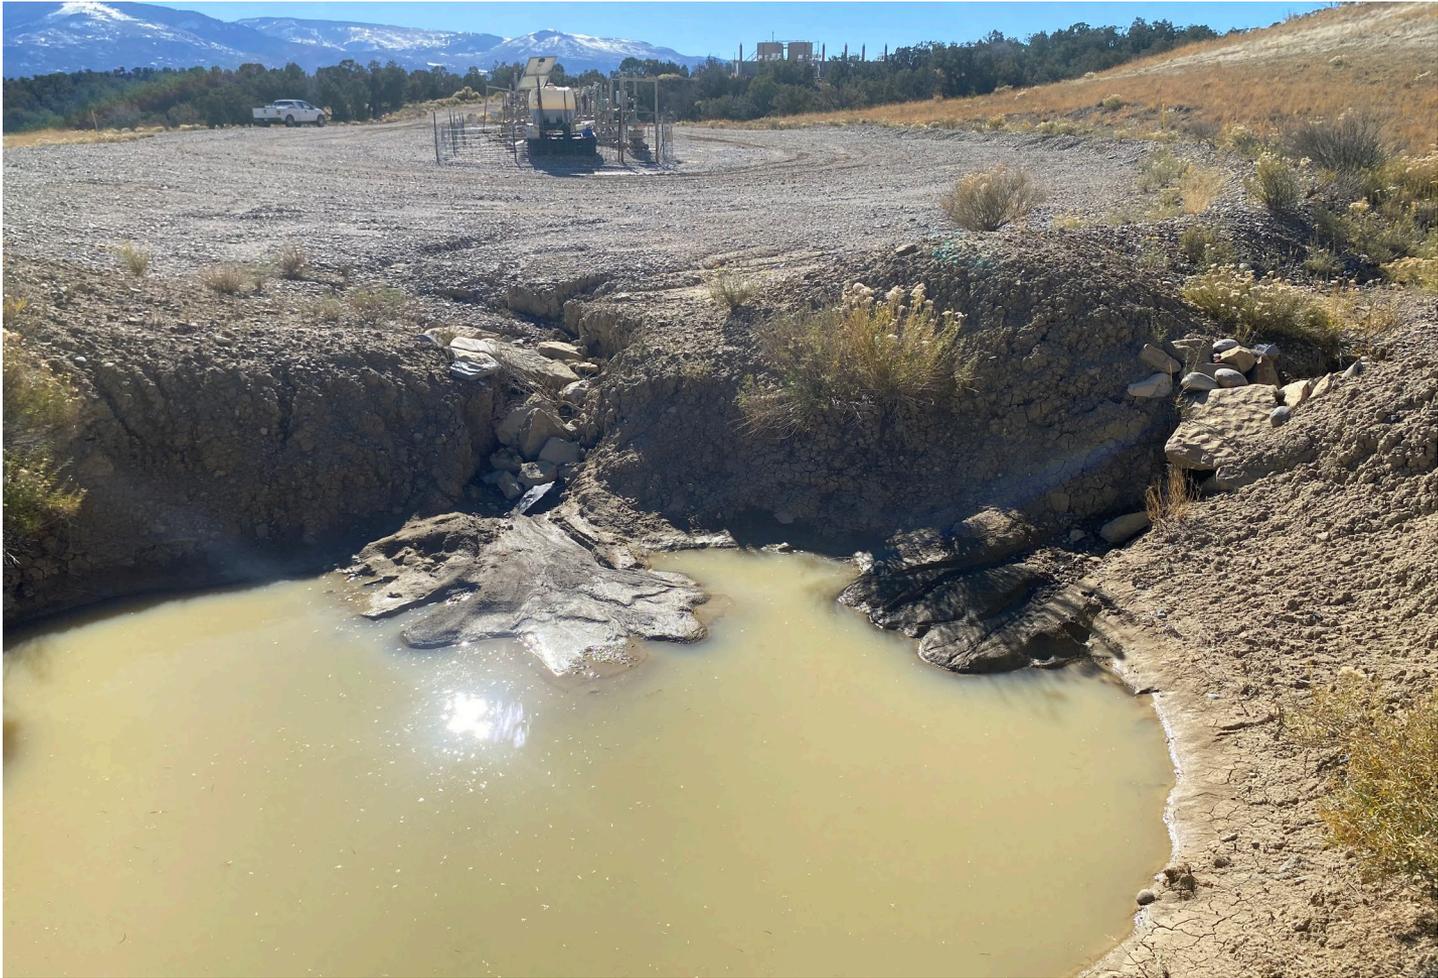
Photo 9. Photo shows an example of a sediment trap inlet where concentrated flows cutting are beneath rock armor. No geotextile liner was observed.

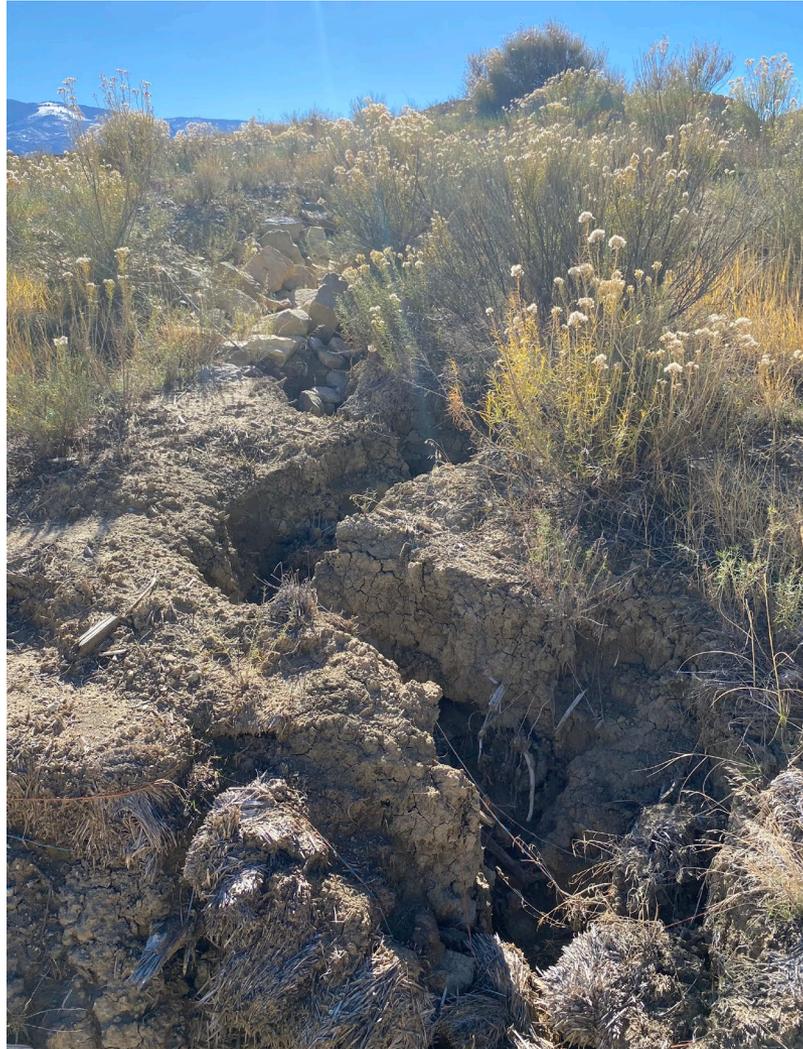
Photo 10. Photo shows an example of a erosion degradation occurring at a sediment trap outlet.
